Lady Well

Dumfries House, South Ayrshire

Evaluation and Stone Catalogue : December 2015

for The Great Steward of Scotland's Dumfries House Trust

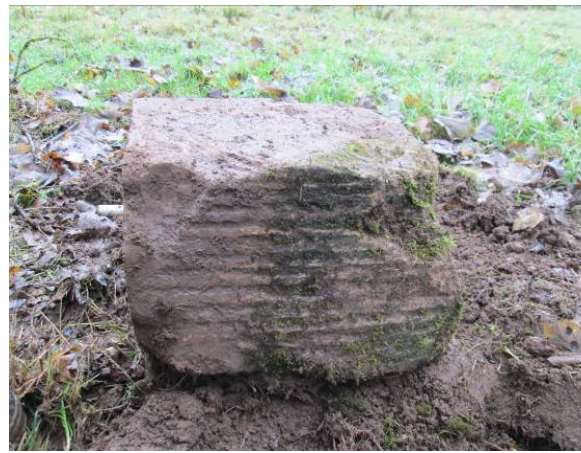
Plate 13 Stone 15 showing broached dressing (076)

Although none of the early photographic images show the interior of the roof structure, the 1944 survey indicates that the soffits of the roof canopy curved inwards - a small groined vault rather than a dome. Indeed a number of the identified stones had clearly formed part of the curvature of the vault; all of the curved surfaces had been finished with *broached* tooling, *Plate 12* and *Plate 13*. It is clear from the early photographs and from the other identified stones that the exterior of the structure, the corner piers, etc., were all in polished ashlar while the broached-dressed faces were confined to the interior.

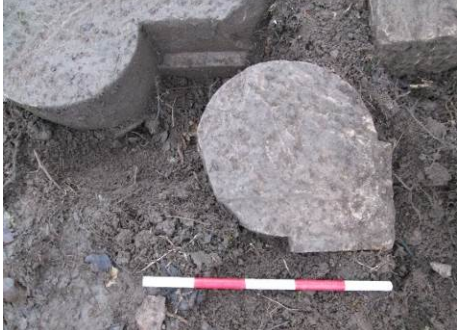
One of the stones that formed part of a corner column (*stone 7*) bore an incised mark on its upper surface (*Plate 9*); this had the appearance of a mason's mark or an assembly mark. While no other stones at Lady Well were found to have marks, similar marks were found upon the disassembled stones of the arch of The Temple during recording works there. The latter were thought to represent assembly marks. The similarity in character of the two suggest the same masons may have been involved (as was likely the case).

Stone No	Description	Condition	Photo
A007	Drum with single projection, incised mark on upper surface	Good

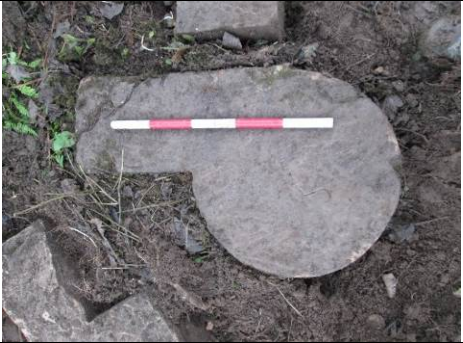
A008	Squared block possibly had a projection now broken off	Good

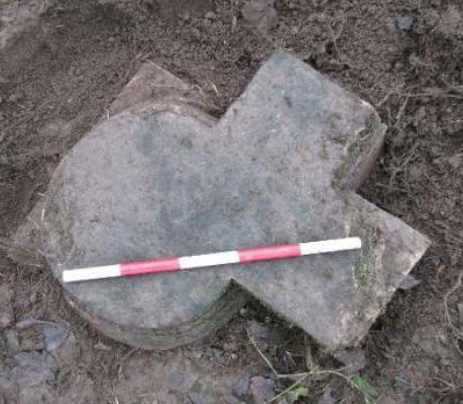
<i>Stone No</i>	<i>Description</i>	<i>Condition</i>	<i>Photo</i>
A010	Squared block with curved edge, would have formed part of the arch.	Good

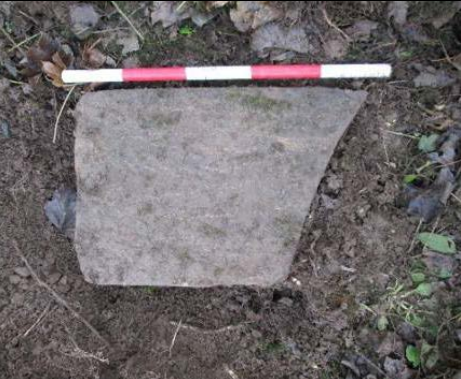
A011	Squared block now split into four.	Poor

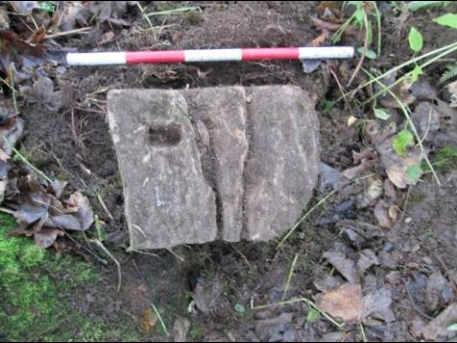
014	Triangular block probably part of roof.	Moderate

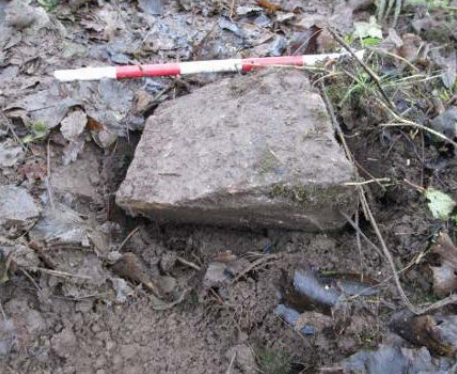
015	Squared block with moulding on one face and broached dressing on the opposite face, possibly part of string course. Only stone found in adjacent field.	Good/moderate

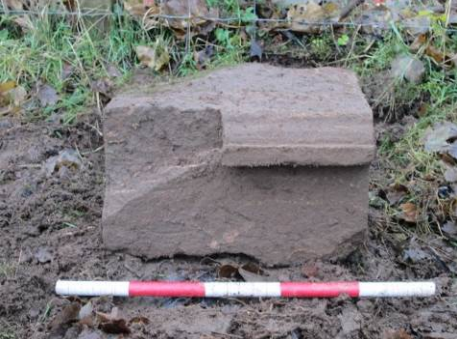
Stone No	Description	Condition	Photo
016	Stone removed during excavation of trench. Squared block badly damaged.	Poor

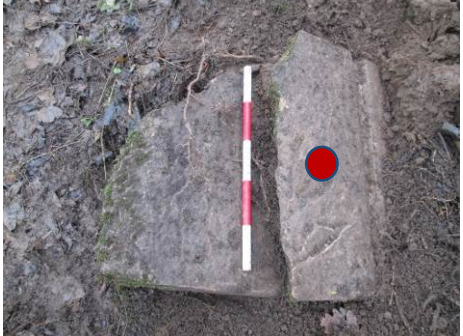
<i>Stone No</i>	<i>Description</i>	<i>Condition</i>	<i>Photo</i>
019	Triangular in profile, slopped edge, possibly part of roof. Marked by red dot in picture	Moderate, damaged edge.

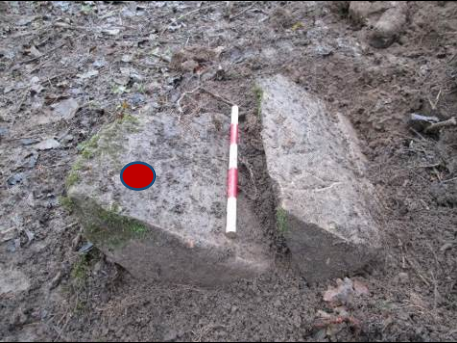
B020	Drum with string moulding.	Moderate

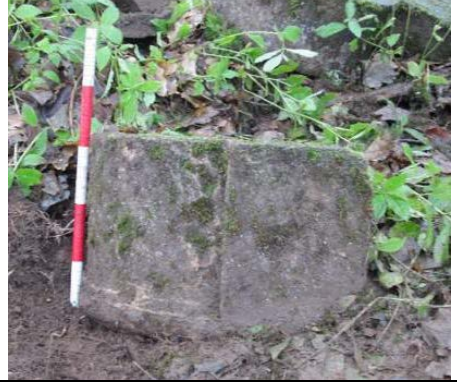
B021	Drum with projection possibly part of plinth course.	Good

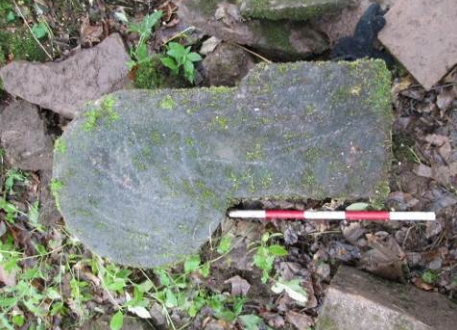
<i>Stone No</i>	<i>Description</i>	<i>Condition</i>	<i>Photo</i>
B022	Squared block, groove in underside	Moderate, some damage.

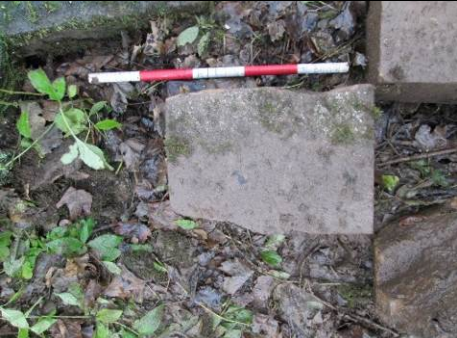
B023	Irregular block with broached dressing, part of interior, possibly roof.	Moderate

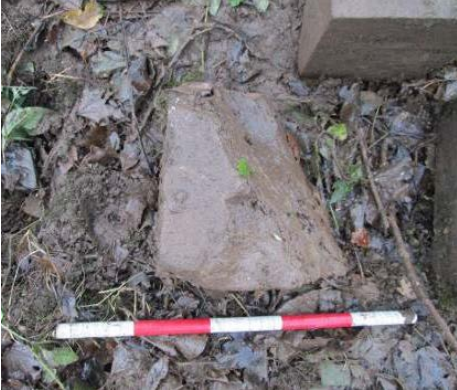
B024	Shallow squared block with pecked surface.	Good

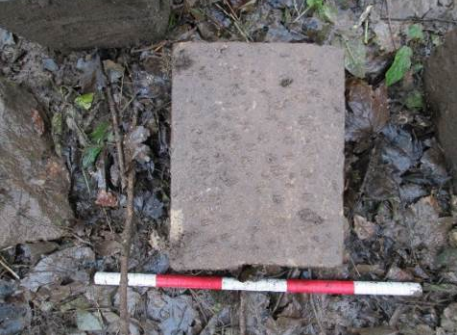
Stone No	Description	Condition	Photo
B025	Shaped block with sloped pecked surface, possibly part of the arch.	Moderate, chipped edge.

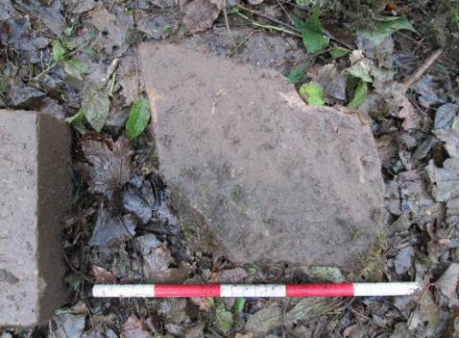
026	<p>Large block with broached dressing on one face part of internal vaulting.</p> <p>Marked by red dot in picture.</p>	Good

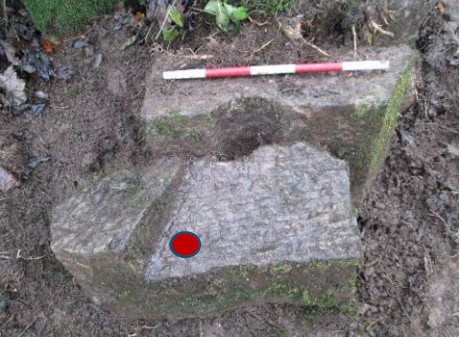
027	<p>Large block, broached dressing on side which would have been on the interior. Carved semi-circular channel on the underside.</p> <p>Marked by red dot in picture.</p>	Good

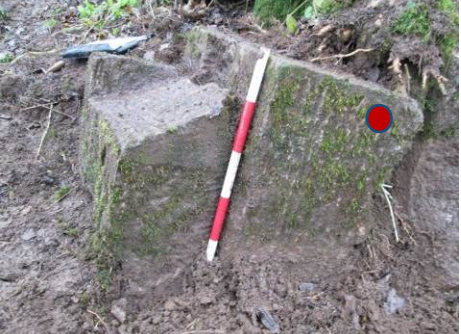
<i>Stone No</i>	<i>Description</i>	<i>Condition</i>	<i>Photo</i>
028	Shaped stone under tree roots. Marked by red dot in picture.	Poor

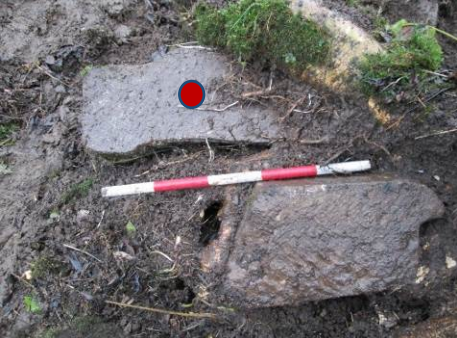
029	Shaped stone encased in roots. Marked by red dot in picture.	Poor

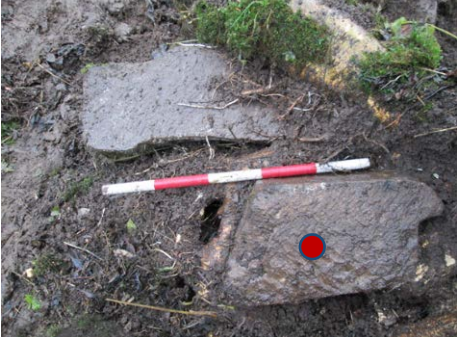
C030	Large flat topped pyramidal stone, part of roof.	Moderate, sides chipped.

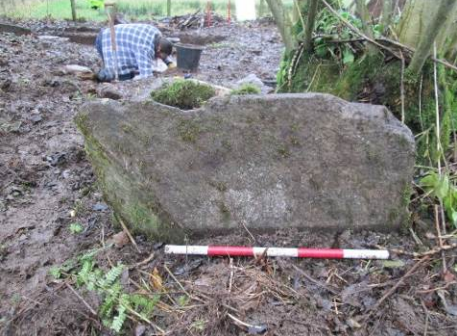
<i>Stone No</i>	<i>Description</i>	<i>Condition</i>	<i>Photo</i>
C031	Shaped stone with moulded edge. Possibly part of pediment at the corner.	Poor	 
C032	Small section of pediment	Poor

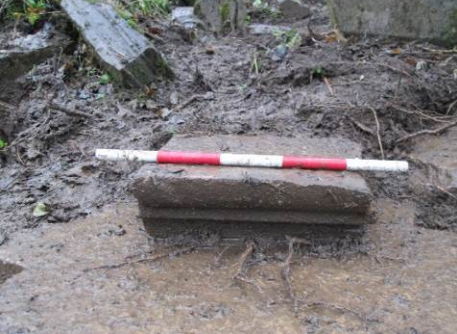
C033	Large corner section of pediment.	Poor

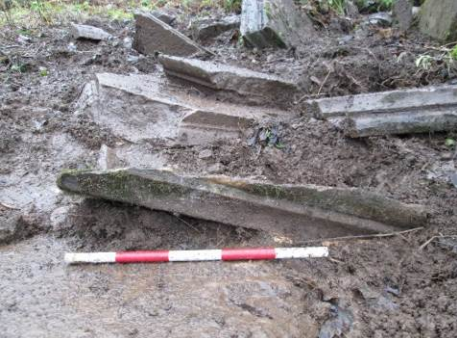
C035	Thick heavy slab with moulding, possibly part of pediment.	Poor

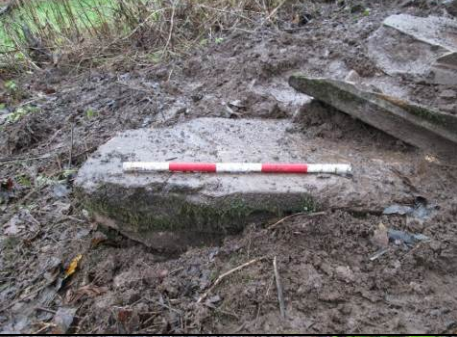
C036	Thin slab with an uneven surface possibly part of the roof, not fully exposed. Marked by red dot in picture	Unknown

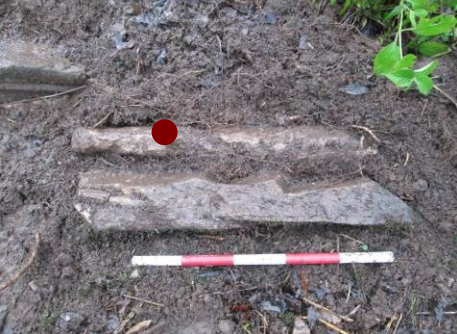
<i>Stone No</i>	<i>Description</i>	<i>Condition</i>	<i>Photo</i>
C037	Thick slab, not fully excavated. Sloping edge and undulating top surface thought to be a part of the roof. Marked by red dot in picture.	Unknown

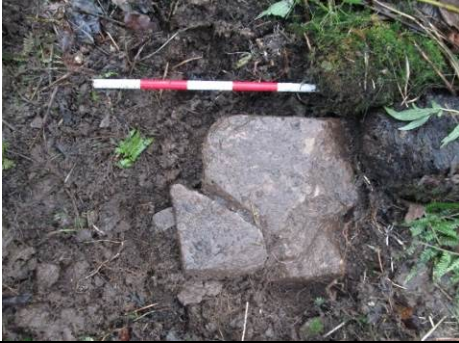
D041	Large flat slab with moulding around two edges, formed part of pediment.	Moderate

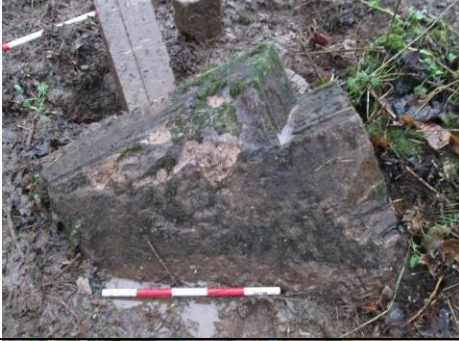
D042	Squared block with sloped top surface, badly damaged by roots so difficult to determine original form.	Poor

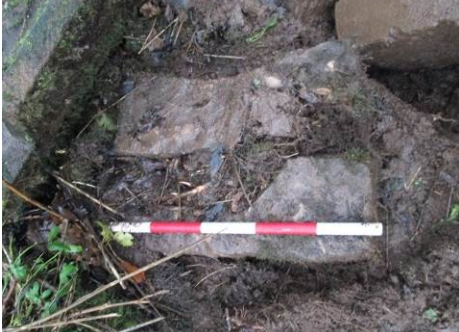
Stone No	Description	Condition	Photo
D043	Large block with one sloped face, opposite face has slight step. It appears to be from above the top of the column capital but below the string course.	Moderate, chipped corners.

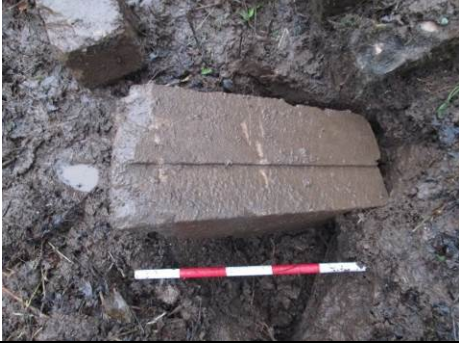
D044	Squared block with one sloping face, formed part of the top of the arch.	Moderate

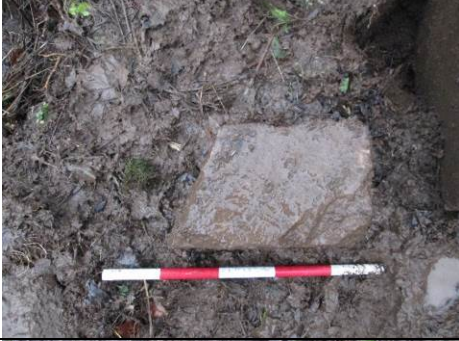
D045	Thin stone with flat top and sloped edge presumably part of the roof.	Good

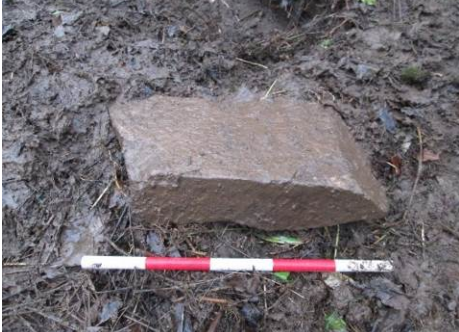
Stone No	Description	Condition	Photo
E046	Large shaped stone with two projections and moulding. One of the four capitals which topped the columns.	Moderate

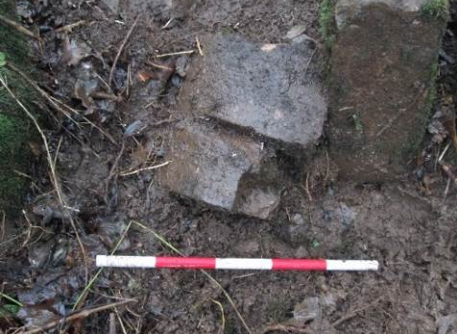
<i>Stone No</i>	<i>Description</i>	<i>Condition</i>	<i>Photo</i>
E049	Irregular stone partially buried by roots, original shape is not clear.	Unknown

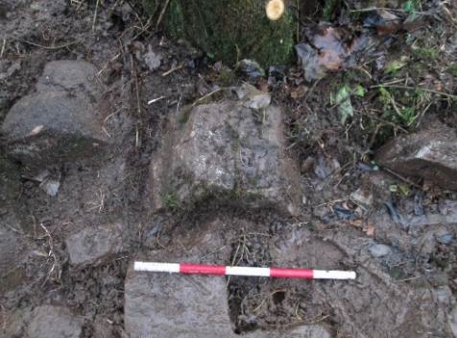
E050	Large squared block with projection, possibly part of a corner above the capital, not fully excavated.	Visible part good.

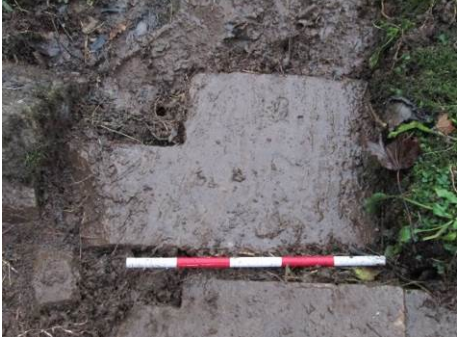
E051	Large squared block, shaped but difficult to determine form due to damage and only being partially excavated.	Poor

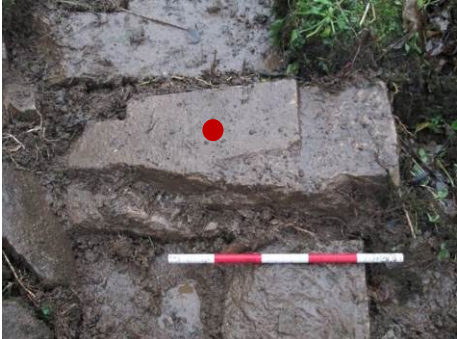
Stone No	Description	Condition	Photo
E052	Medium sized squared block.	Good

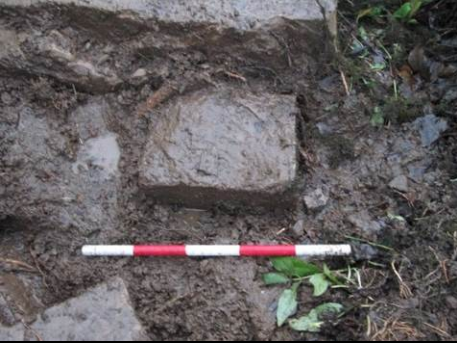
E053	Squared block with projection at base, not fully excavated but looks as though it sat at base of arch same as 004,039.	Poor

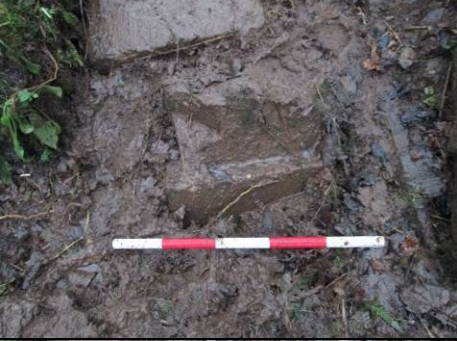
E054	Squared block with stepped out deep base, would have sat above the column height but below the string course probably, similar to 043

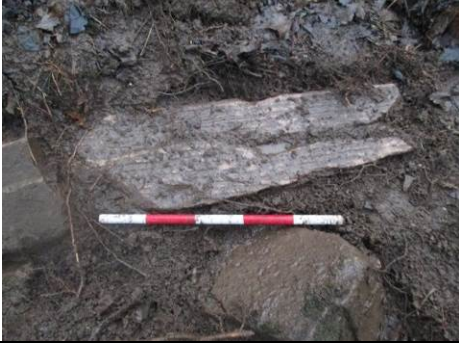
E056	Only partially excavated, squared block appears to be same as 043 and 054.	Visible part is moderate.

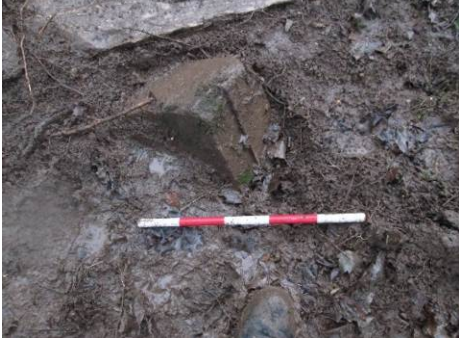
057	Small squared block, sloped edge may be part of an arch.	Moderate

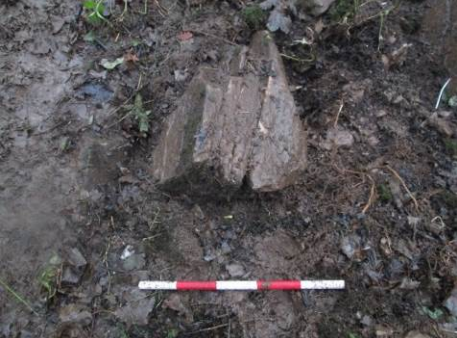
059	Large thick slab with moulded edge, formed part of pediment.	Moderate

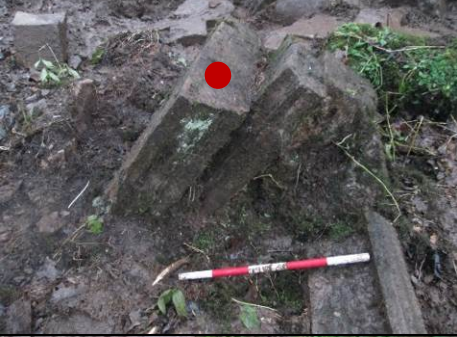
060	Large thick slab with moulded edge, formed part of pediment.	Moderate

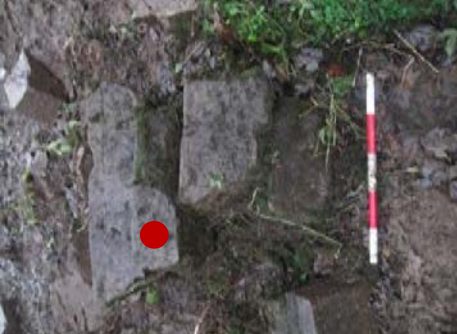
<i>Stone No</i>	<i>Description</i>	<i>Condition</i>	<i>Photo</i>
061	Squared block with sloped face, probably part of arch or internal vaulting.	Moderate

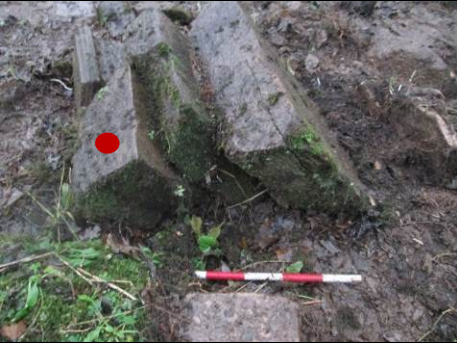
062	Small squared block, at base of stack, not completely visible hence full shape not known.	Unknown

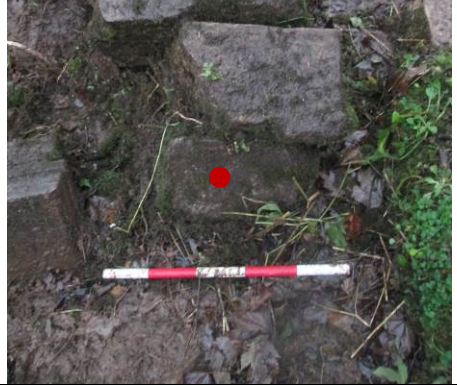
063	Squared block, only partially visible.	Unknown

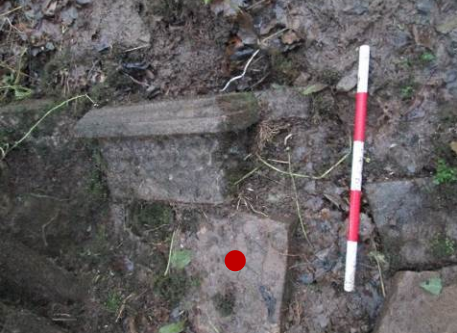
Stone No	Description	Condition	Photo
064	Large block with at least one pecked surface and moulding, not fully excavated so unclear where it belongs.	Good

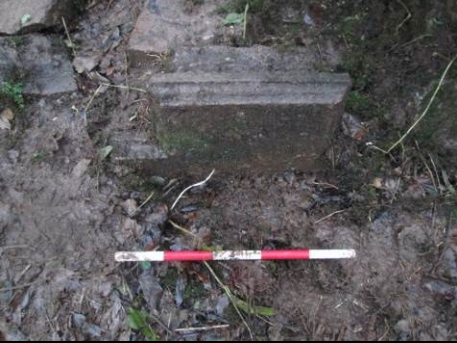
065	Now, irregular damaged stone has one sloped edge suggesting it formed part of roof.	Poor

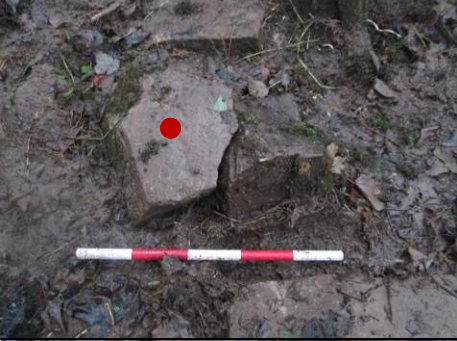
066	Irregular damage block not fully excavated, original form not known.	Poor

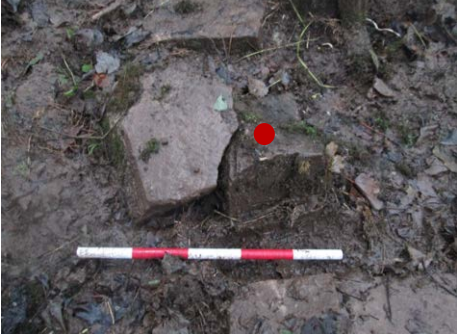
<i>Stone No</i>	<i>Description</i>	<i>Condition</i>	<i>Photo</i>
067	Large narrow block with stepped base on at least one side, check in top surface. Location unknown.	Good

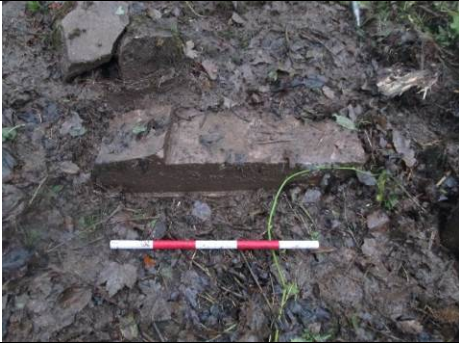
068	Large squared block, slight groove carved in top surface at one end and down adjacent face.	Good
