**FORMER CARRS BILLINGTON PREMISES,  
23-25 HIGH STREET,  
ANNAN**

**Archaeological Building Survey report**

**DATE ISSUED:** February 2018  
**JOB NUMBER:** CL12092  
**OASIS REFERENCE:** wardella2-308485  
**PLANNING APPLICATION REF:** 17/2051/FUL and 17/2052/CAC

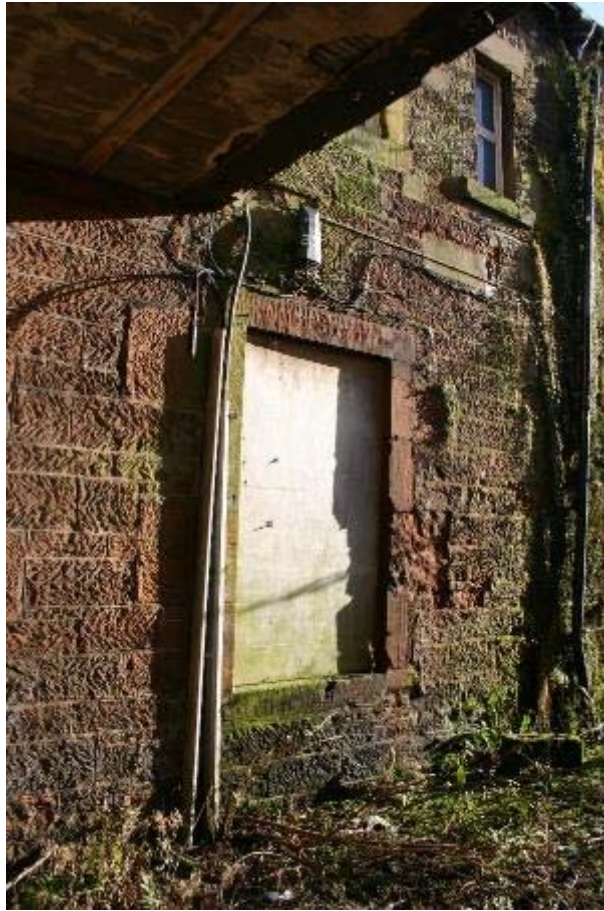
Plate 14: West facing elevation, boarded up window at No 25

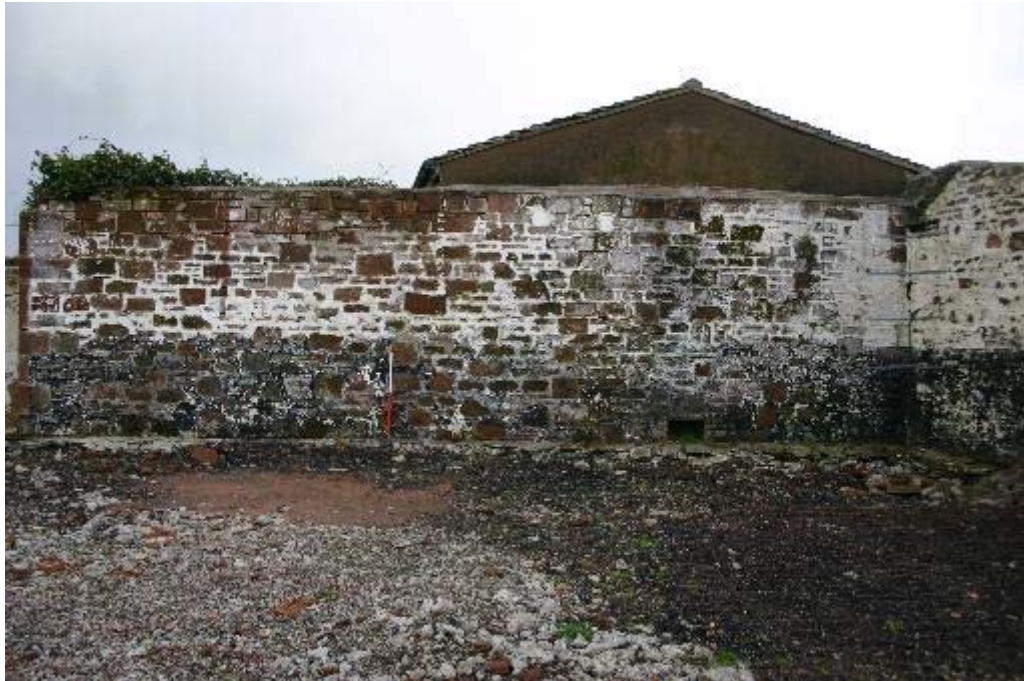
- 4.4.3 The eastern boundary wall of the main site presents a mixture of styles. While the northern end consists of a red brick wall in English garden bond (Plate 85), with some remnants of an earlier stone wall (Plate 86), the slightly lower central section is of modern concrete (Plate 87). The southern end of the boundary wall comprises a roughly coursed rough ashlar sandstone wall (Plate 88).

Plate 88: Southern section of eastern boundary wall

5.1.7 Parts of the boundary walls may also be associated with the enclosed gardens, which took over the entire southern part of the site and are shown on the First Edition Town Plan of 1859 (Figure 4). The sandstone walling of the south, west and end of the east boundary wall may be contemporary with this development.

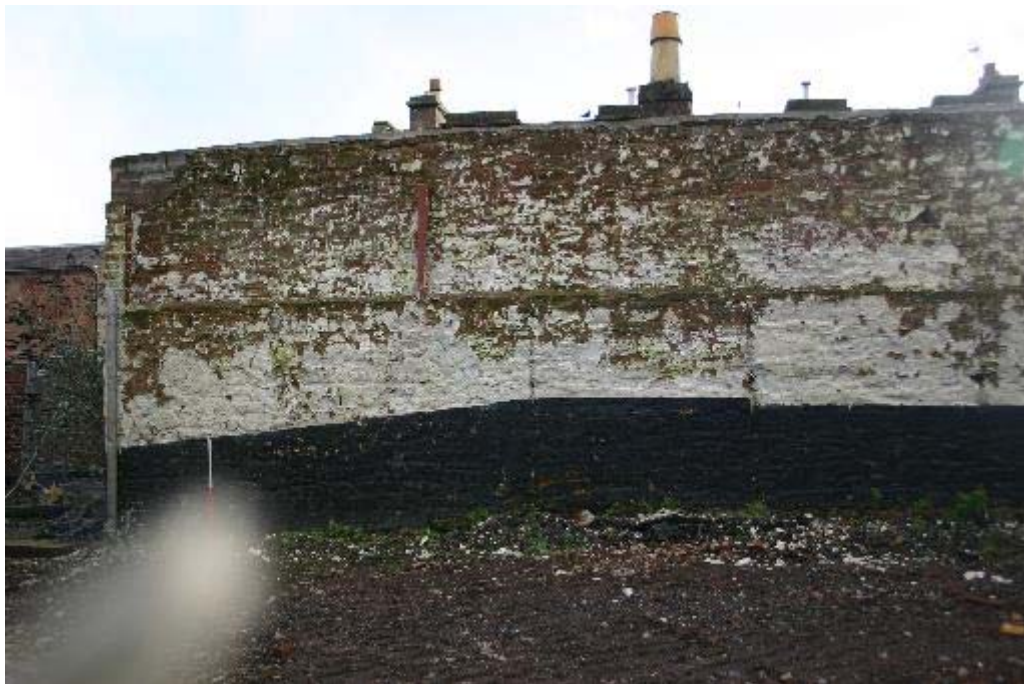
- 4.4.4 This eastern boundary wall interlocks with the eastern section of the southern boundary wall, the upper level of which curves downwards to the west (Plate 89). The entire southern boundary wall comprises roughly coursed sandstone masonry, which in recent times had been painted black and white (Plate 90).

Plate 90: Western section of southern boundary wall

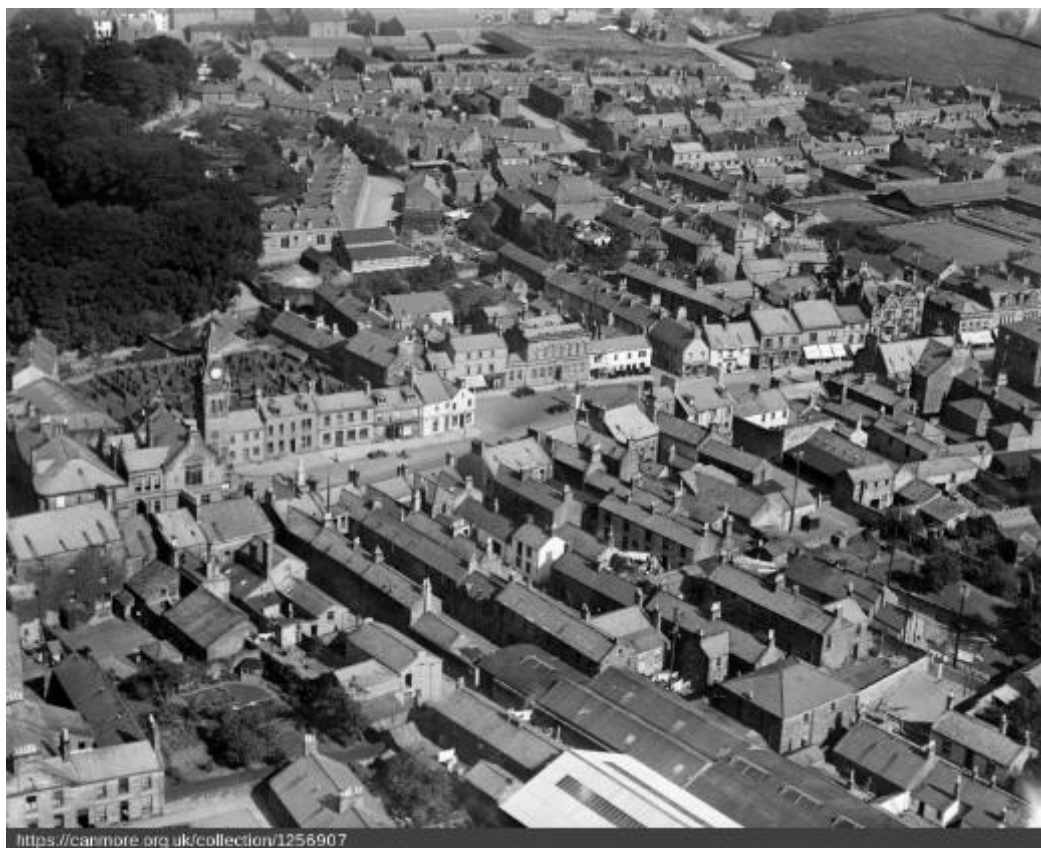
- 5.1.4 Between 1900 and 1929 (Plate 95), the middle section of the No 23 range was built. At this point, there was a clear separation of the roof into at least three sections with four chimneys. Only the southernmost chimney remains today.

Plate 95: Aerial photograph of the site in 1929, Canmore
