**BUILDING SOUTH OF
WHINFIELD COTTAGE**
Windy Bank Road, South Bedburn
Woodland, County Durham
NGR 406578 527310

Historic Building Recording

Project 284-19-HBR | November 2019

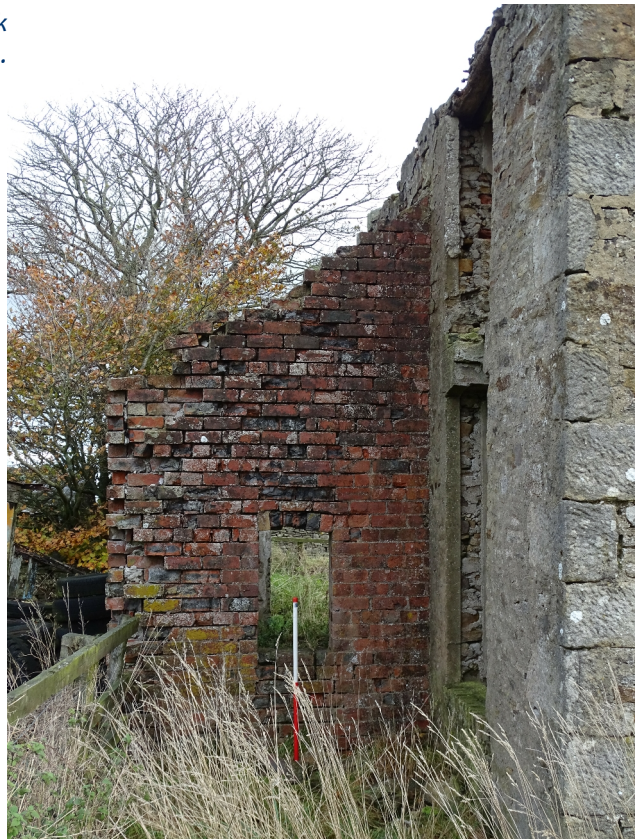
Plate 11 (below). The north-west elevation (frame WCW009).

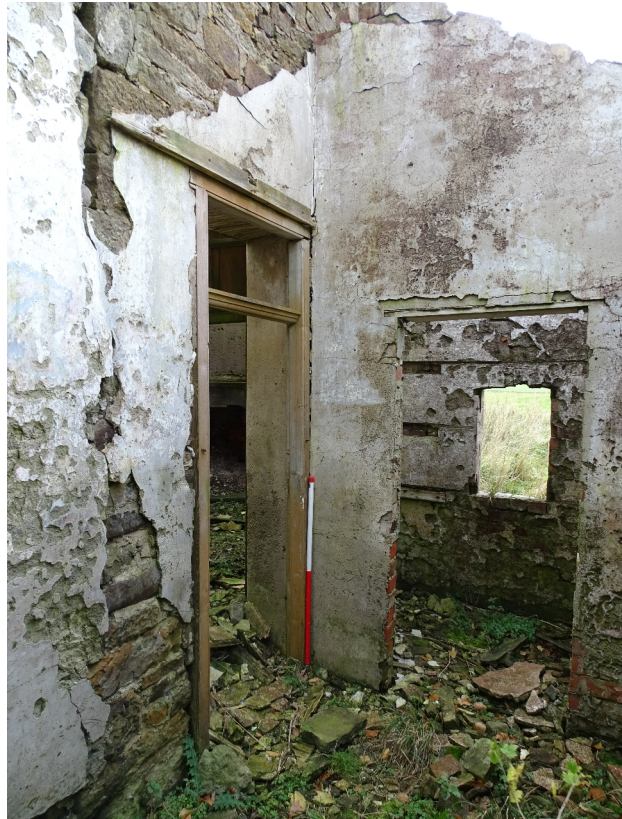
- 3.3.13 As well as the external access in the northeast wall, the lower southeast wall also held a doorway through to the base of the staircase and Room B. The door was set in a timber frame with an overhead, with the western wall curving southwest from the doorway into Room B.
- 3.3.14 **Room D:** This was a small room at the southwestern end of the late 19th century extension. The room had a single window in the southwest wall (as noted in Section 3.2.9) and was rendered. The render bore scars of shelving, suggesting the room's use as storage.

Plate 35. Room D looking southwest (frame WCW037).
