MODEL FARM, THE GREEN, UPPER POPPLETON,
YORK.

REPORT ON A HISTORIC BUILDING RECORDING SURVEY
OSA REPORT NO: OSA19BR04

April 2019.

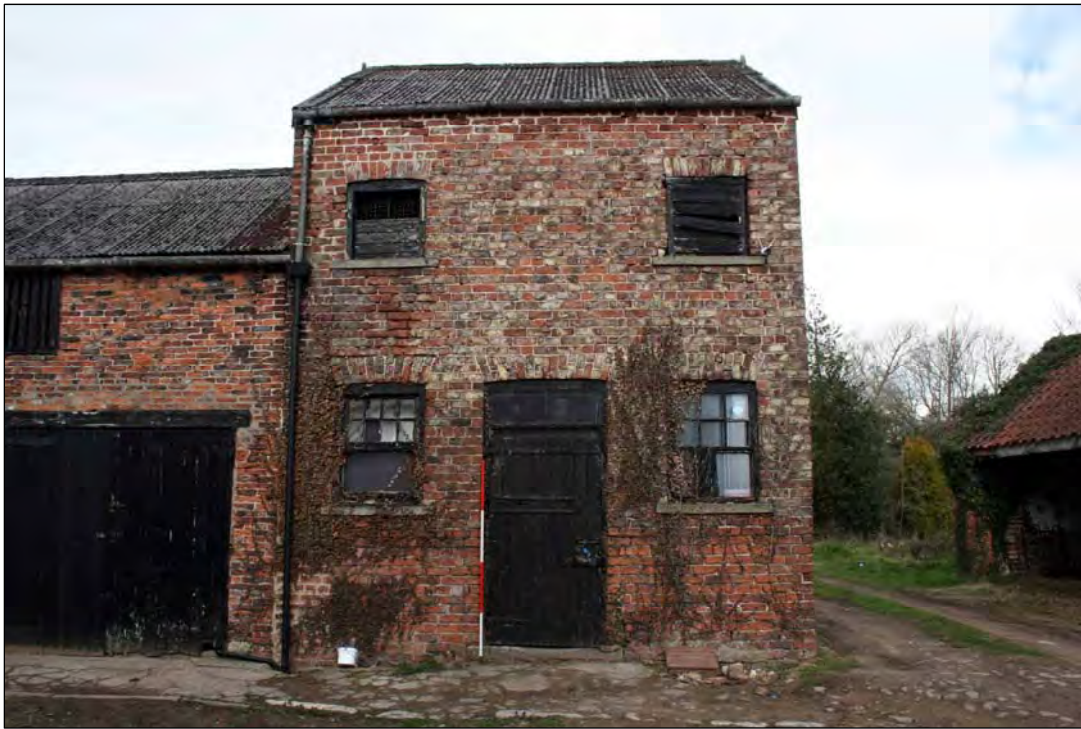
Plate 3. B1 exterior looking NW (image no. 314).

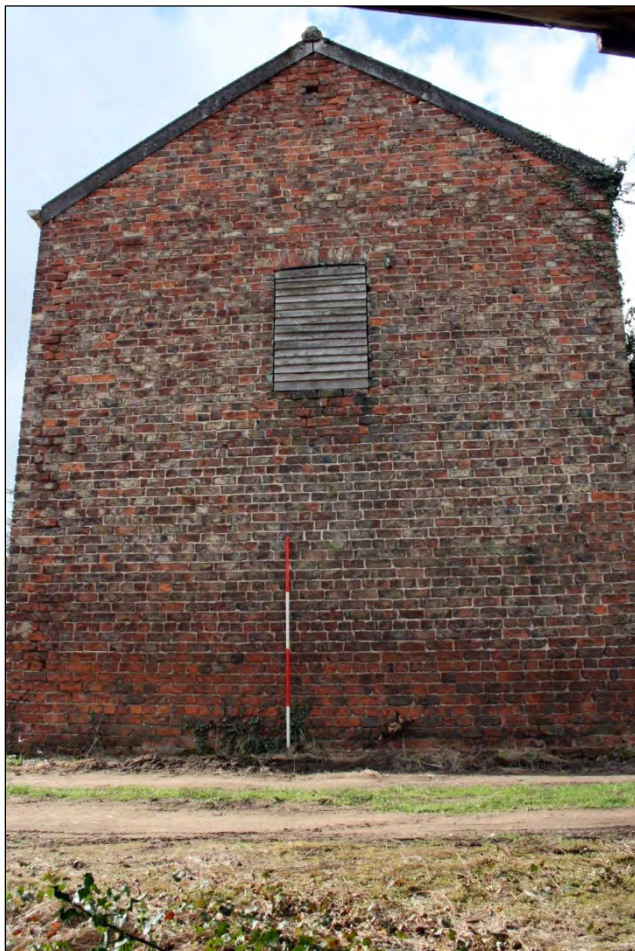
Plate 4. B1 exterior looking SW (image no. 303).

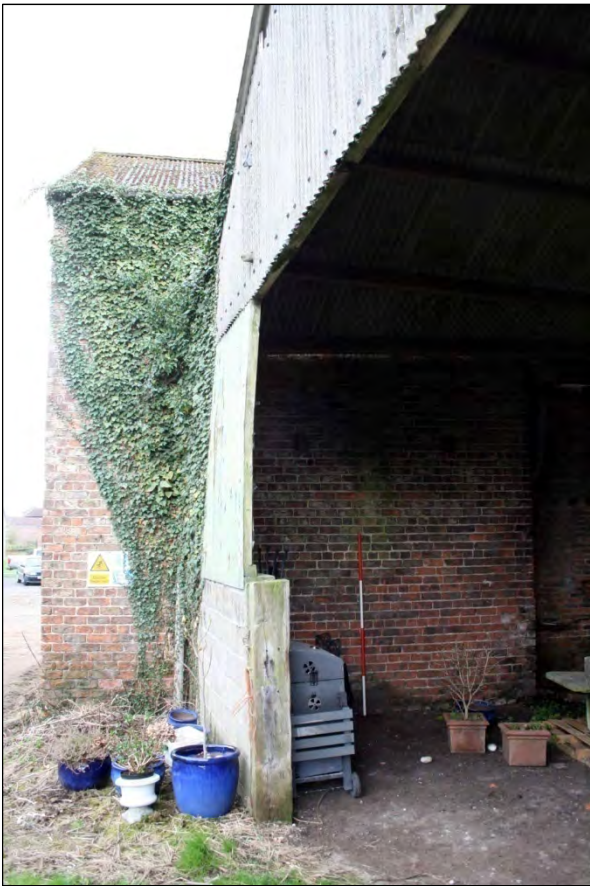
Plate 5. B1 exterior looking SE (image no. 349).

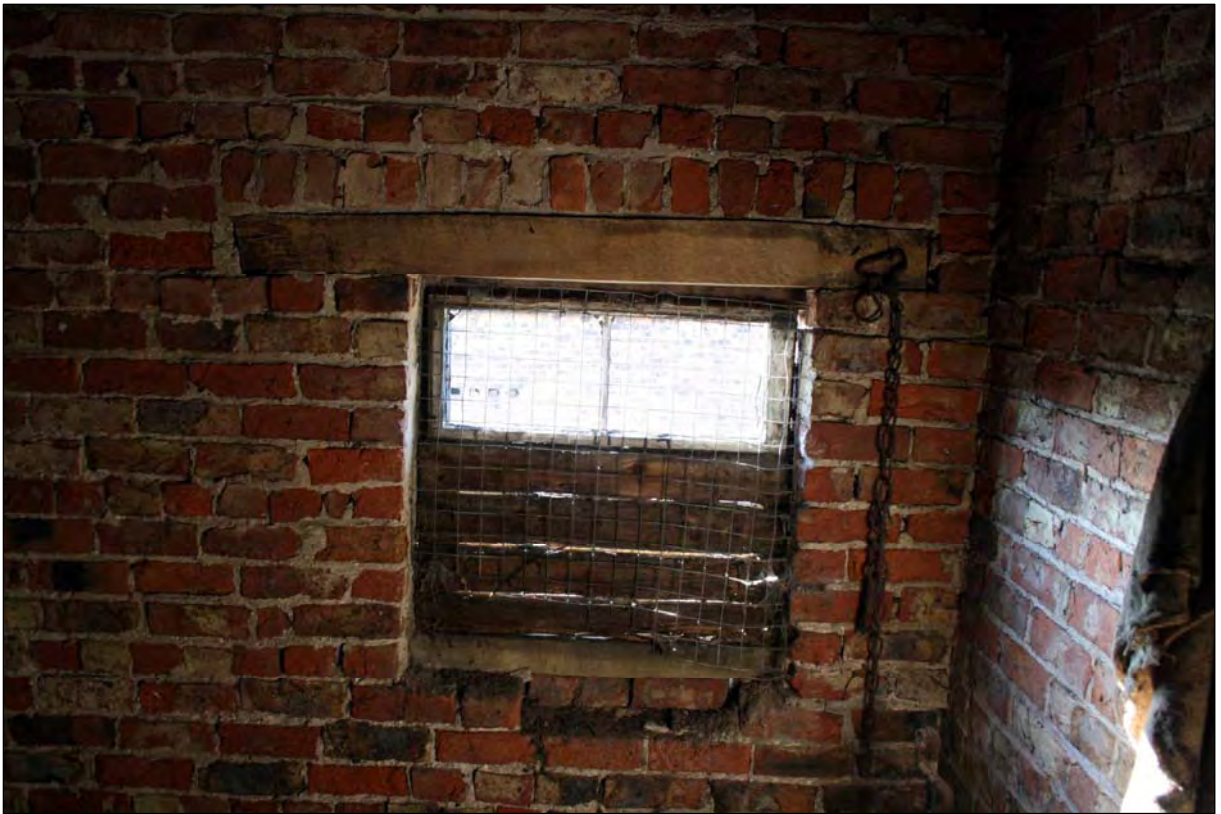
Plate 11. B1 interior window detail looking SE (image no. 038).

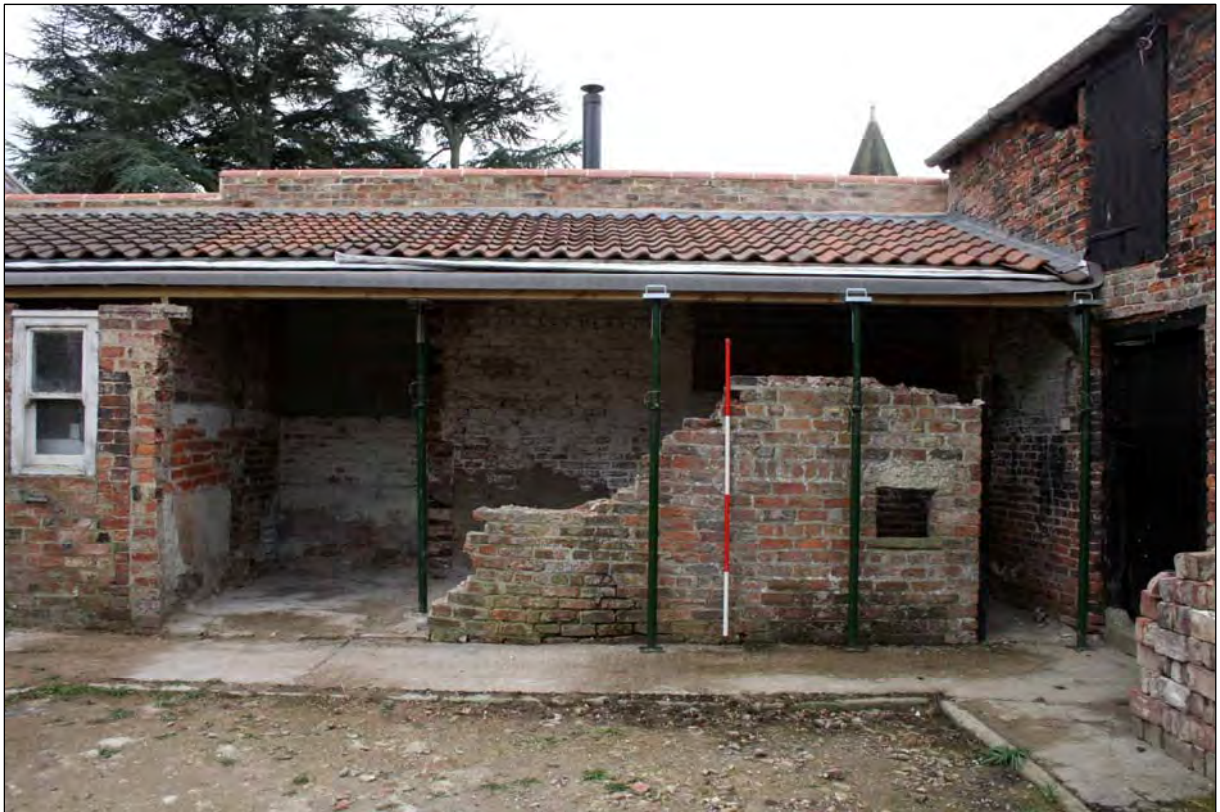
Plate 23. B2 exterior NW looking southwest (image no. 398).

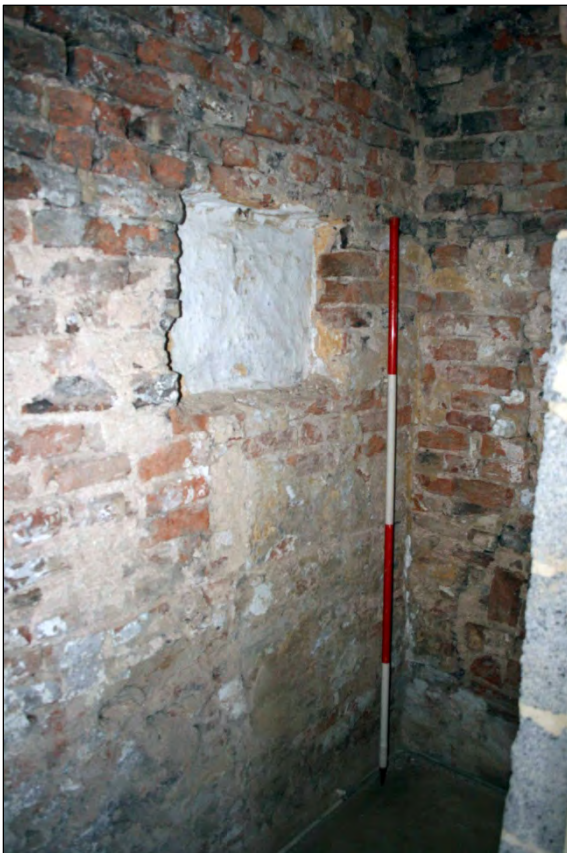
formed by the earlier constructed stable B4 (Plate 28). The construction joined between the two builds could be clearly seen (Plate 29). The southeastern half of the range was part way through conversion and restoration and original wall elevations were exposed. Again these elevations displayed a patchwork of different brick with a blocked up doorways within the northwest southeast and northeast elevations (Plates 30 and 31). Small blocked up openings were visible within the southwest and northwest elevations (Plate 32).

Plate 32. B2 interior SE bricked up small opening looking northeast (image no. 226).

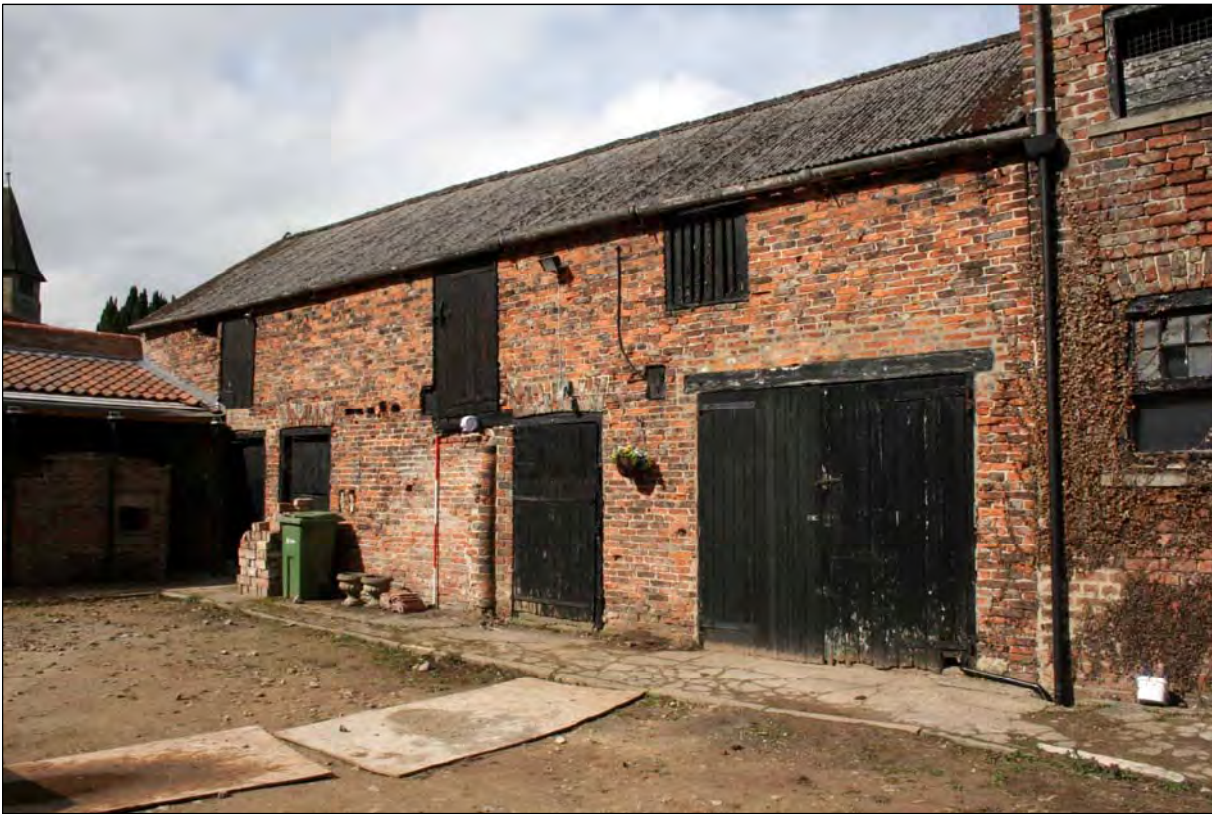
Plate 33. B3 and B4 exterior looking west (image no. 355).

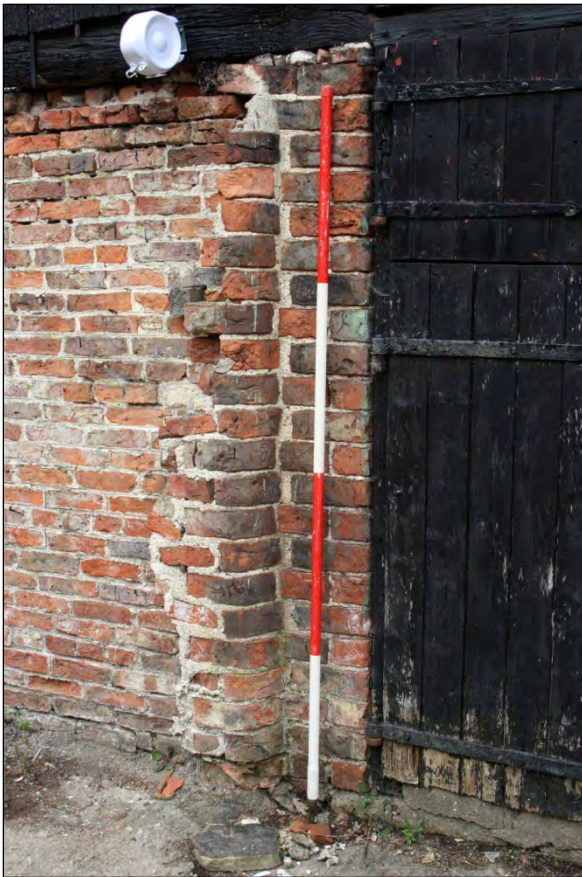
Plate 35. B3 exterior step remains looking west (image no. 379).

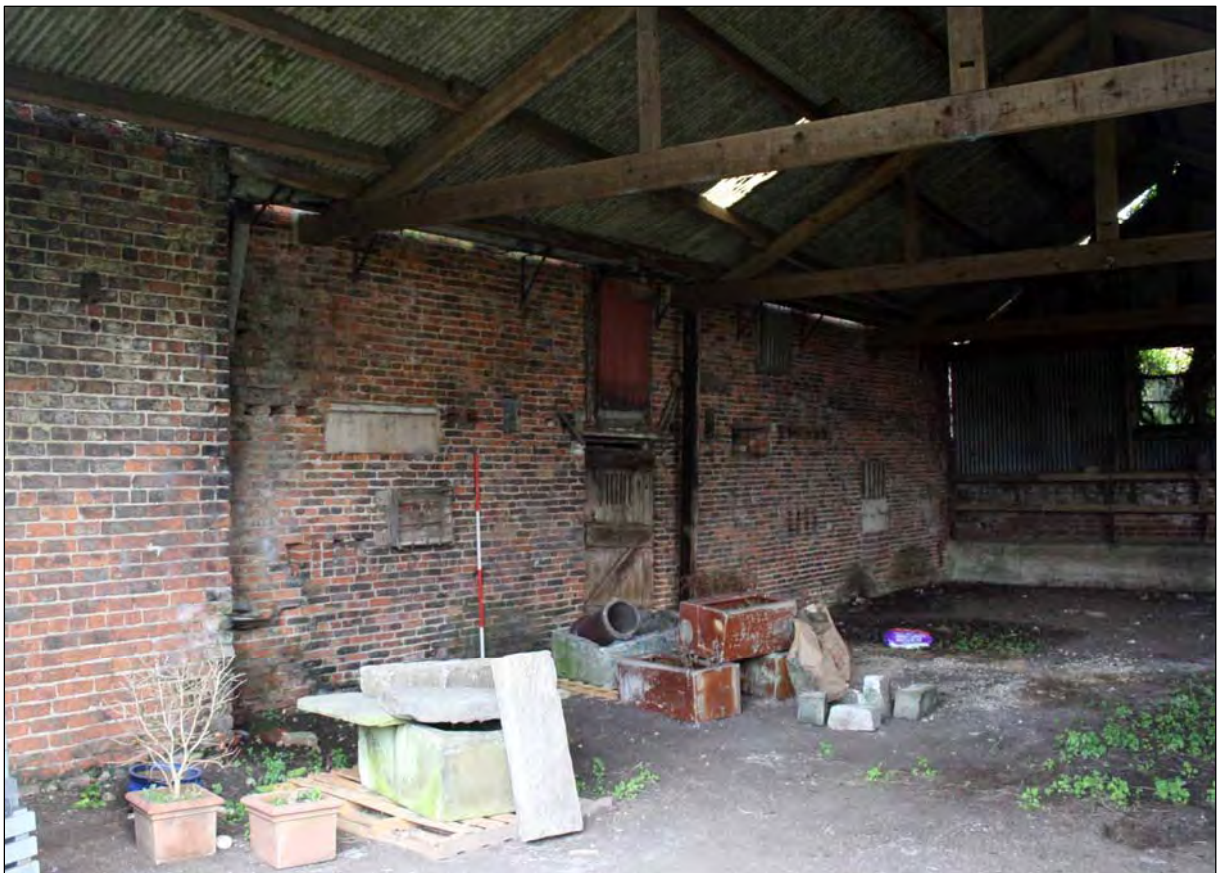
Plate 36. B3 and B4 exterior looking south (image no. 317).

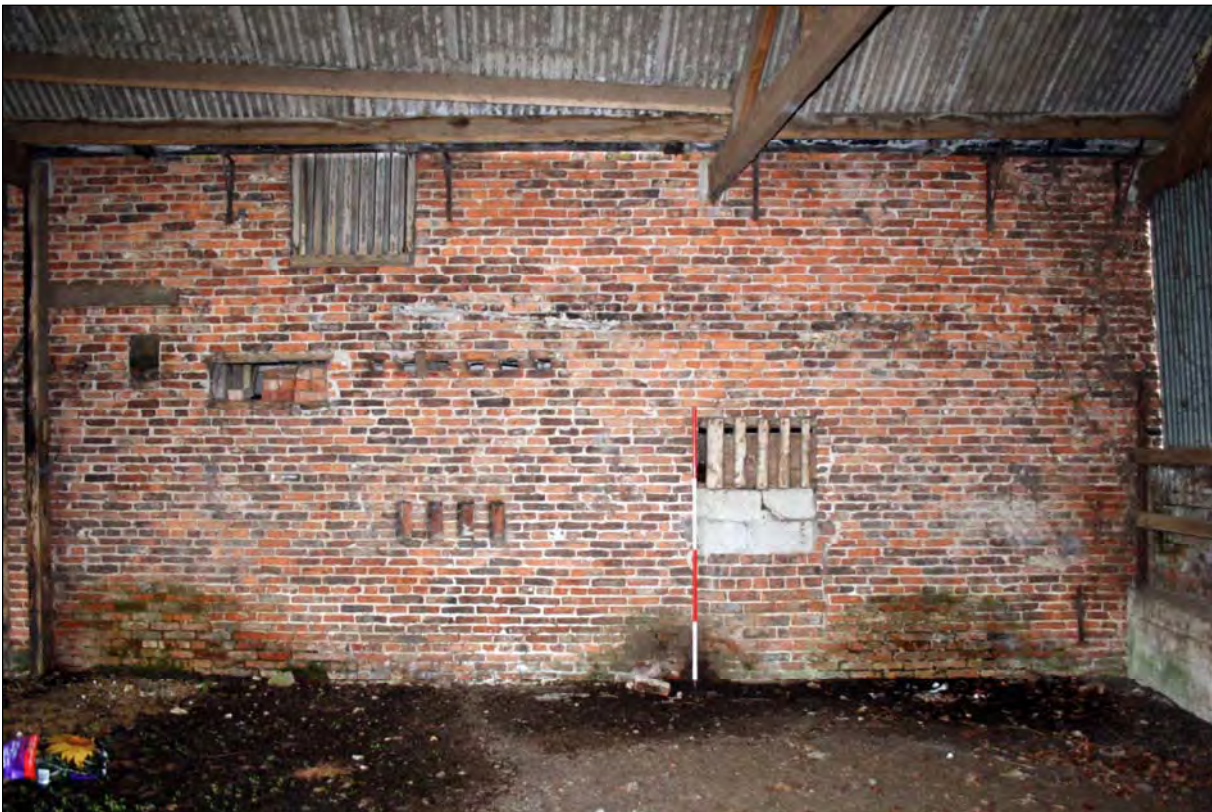
Plate 38. B3 and B4 exterior SW looking southeast (image no. 329).

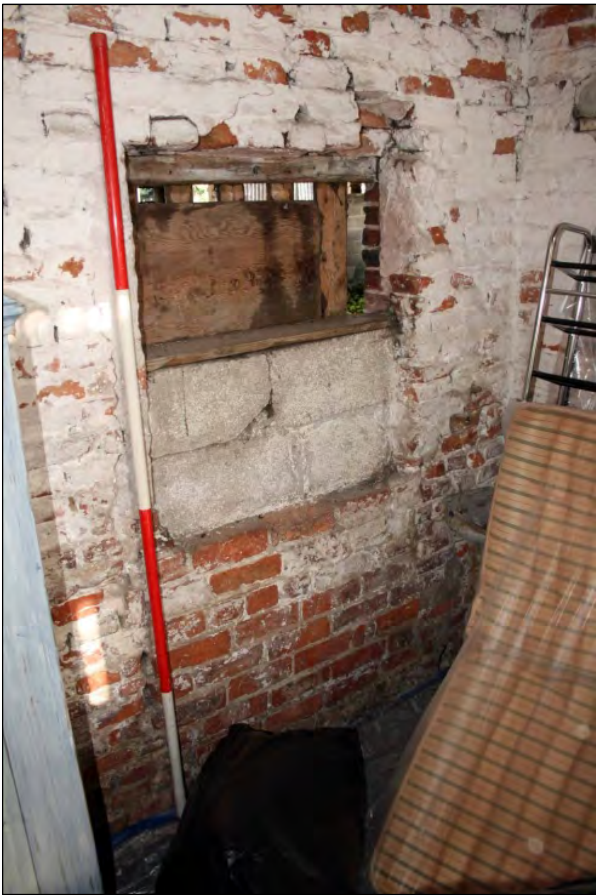
Plate 49. B4 interior blocked door looking north (image no. 183).

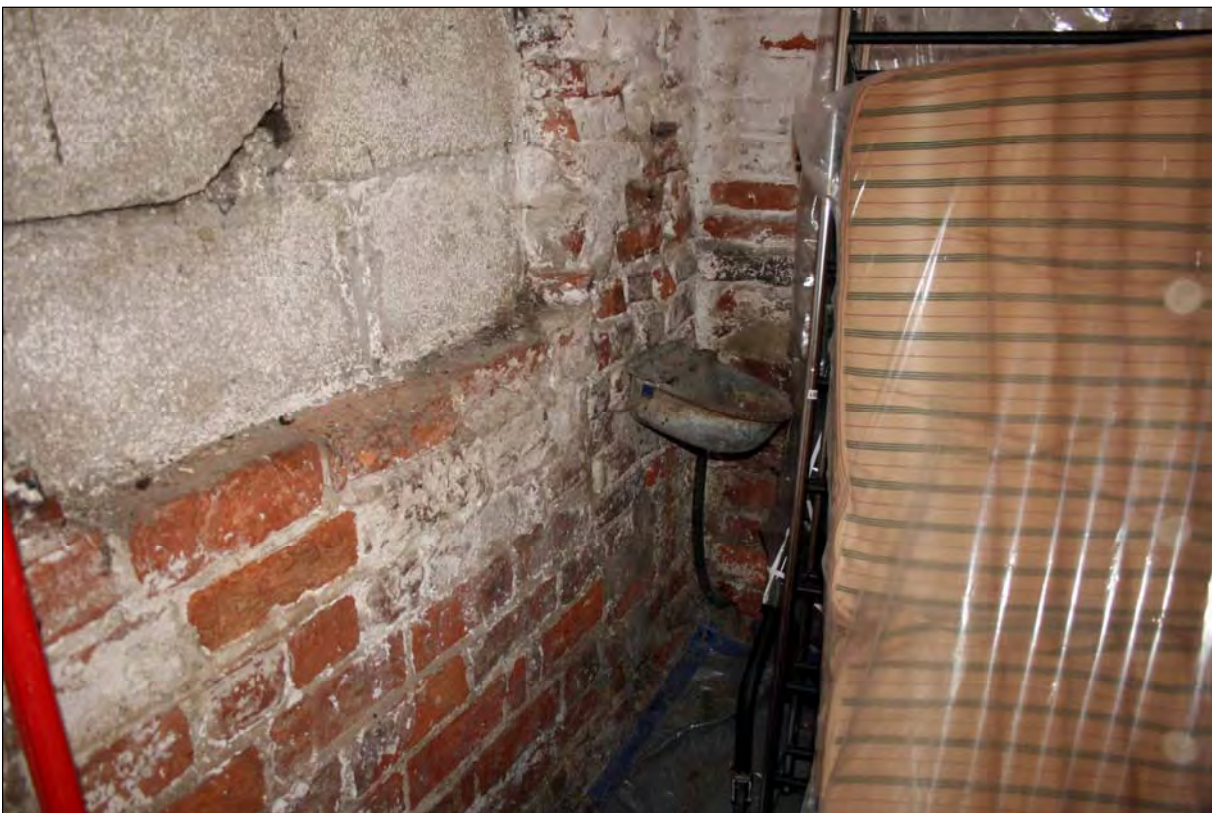
Plate 50. B4 interior small water trough looking north (image no. 184).

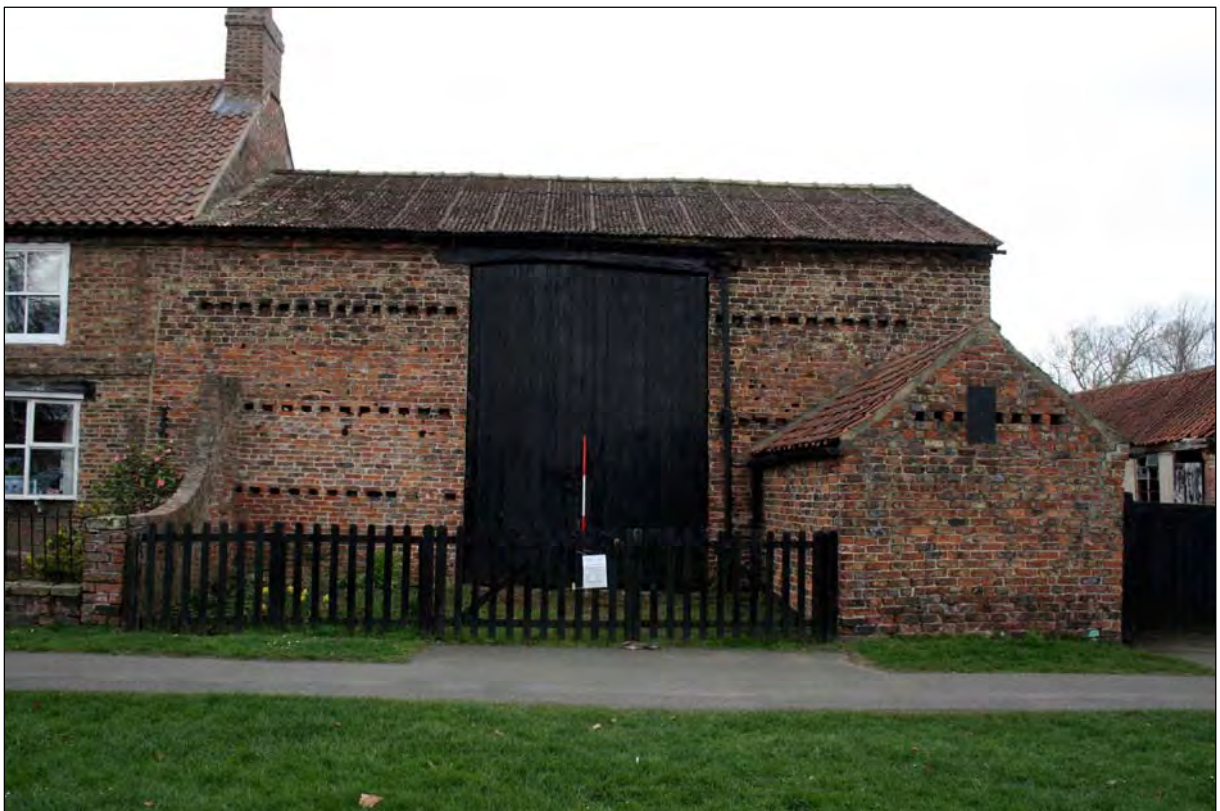
Plate 52. B5 exterior looking NW (image no. 440).

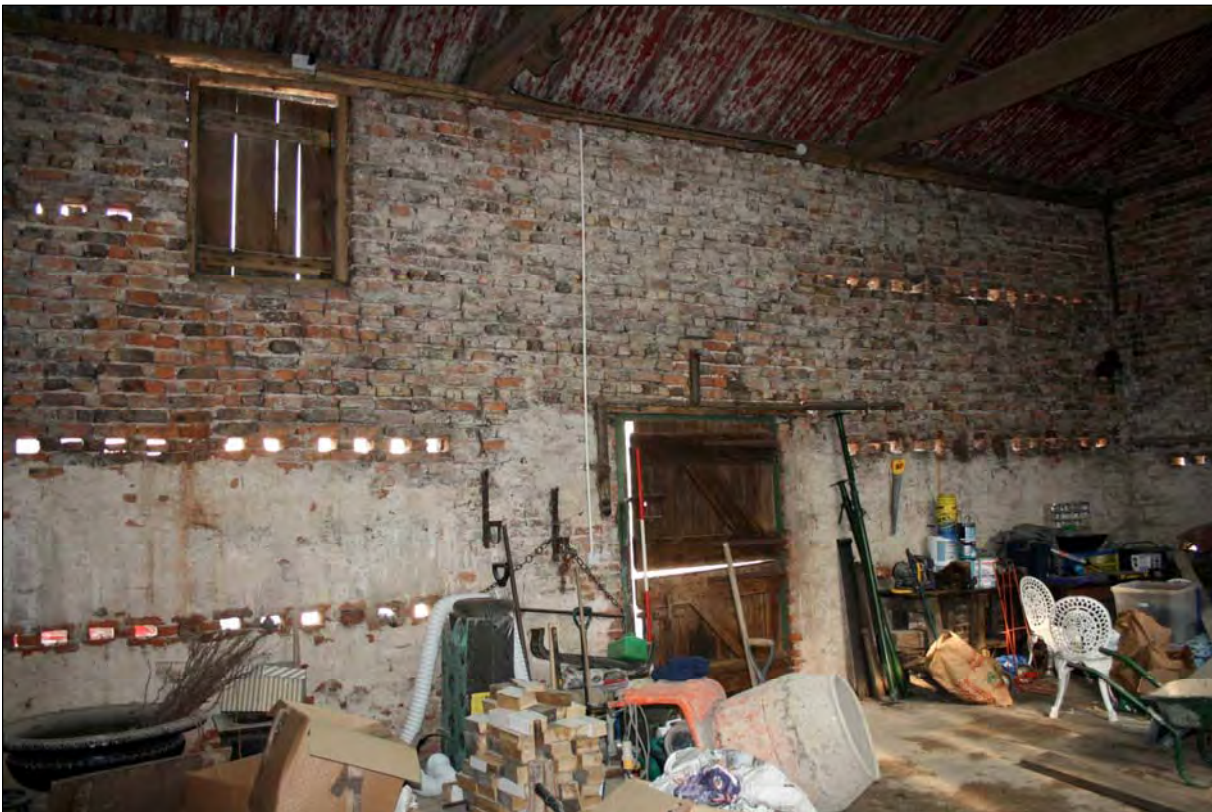
Plate 58. B5 interior looking north (image no. 288).

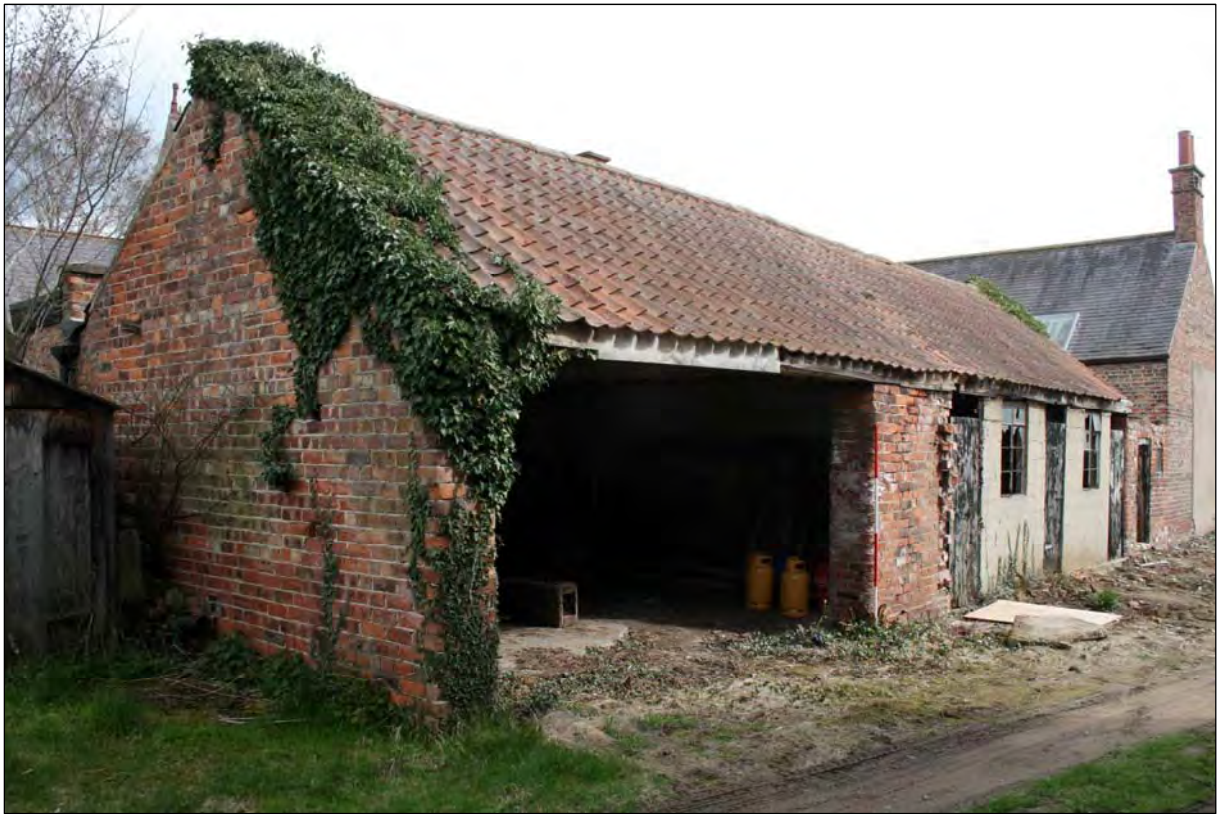
Plate 59. B6 exterior looking east (image no. 450).

B6 formed a separate northwest to southeast range set back from courtyard to the northeast. This range comprised of a single storey with two main cells that probably once formed open fronted cart storage sheds (Plate 59). B6 was constructed in red brick in English garden wall bond with a pitched pan-tiled roof. The southwest elevation had a long continuous wooden lintel (possibly re-used) at roofline level with a wide opening to the northwest with bull-nosed sides (Plate 60). This opening appeared to have been reflected to the southeast where the former opening was in-filled in with modern breeze blocks window and doorway openings (Plate 61). To the southeast was a roofless low extension with a doorway and window opening (Plate 61).
