SHERIFF HUTTON CASTLE,  
SHERIFF HUTTON, NORTH YORKSHIRE

ARCHAEOLOGICAL AND ARCHITECTURAL SURVEY  
OF THE NORTH-EAST TOWER

Report no: 2002/158.R01  
Version: Final  
Date: April 2008  
Author: Shaun Richardson & Ed Dennison

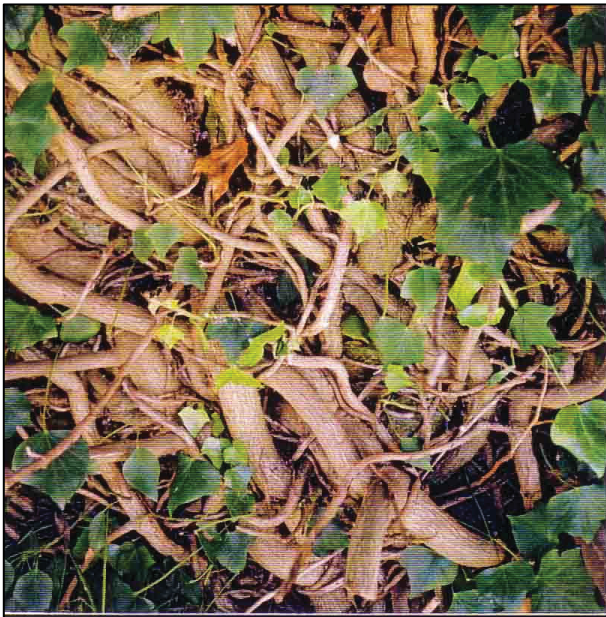
Plate 42: Lattice of intertwined ivy stems  
3m above ground level.
