KDK ARCHAEOLOGY LTD

Historic Building Watching Brief

St Michael and All Angels' Church
High Street
Shefford
Bedfordshire

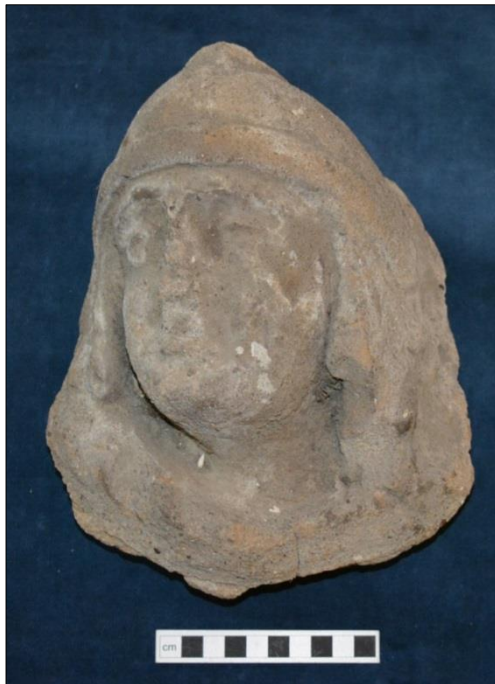
Plate 22: Masonry head 1

Hooded head with shoulder length hair and facing slightly to the right. There is a single masonry nail to the rear.

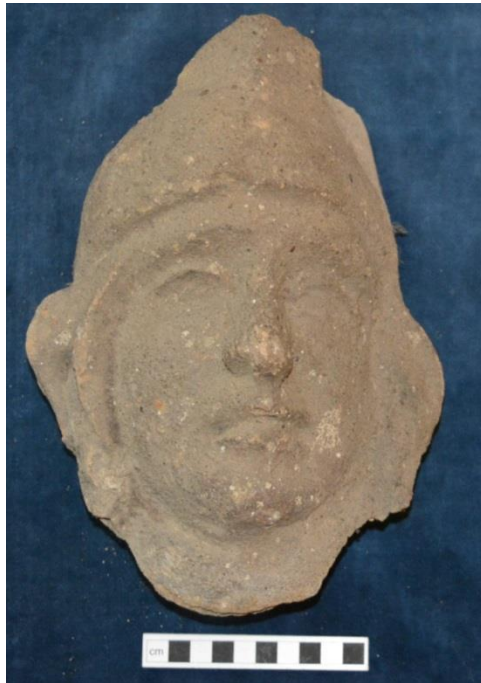
Plate 23: Masonry head 2

Masonry Head 2 (Plates 24-25):
c.18cm wide x 2.5cm high x 12cm deep
Hooded head with shoulder length hair and facing slightly to the left. There are two masonry nails to the rear.

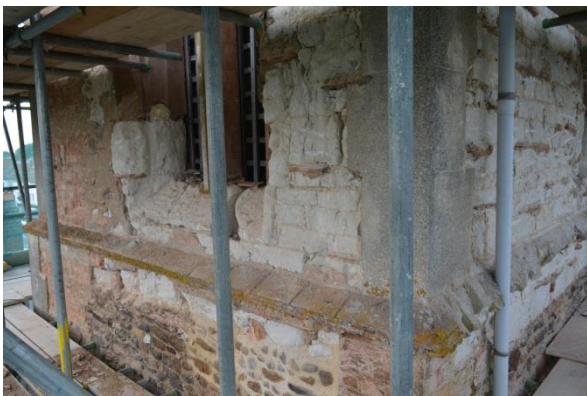
Shot 52: South west corner Stage 4 repair detail
