KDK ARCHAEOLOGY LTD

Historic Building Recording

Wheathampstead Place
Station Road
Wheathampstead
Hertfordshire

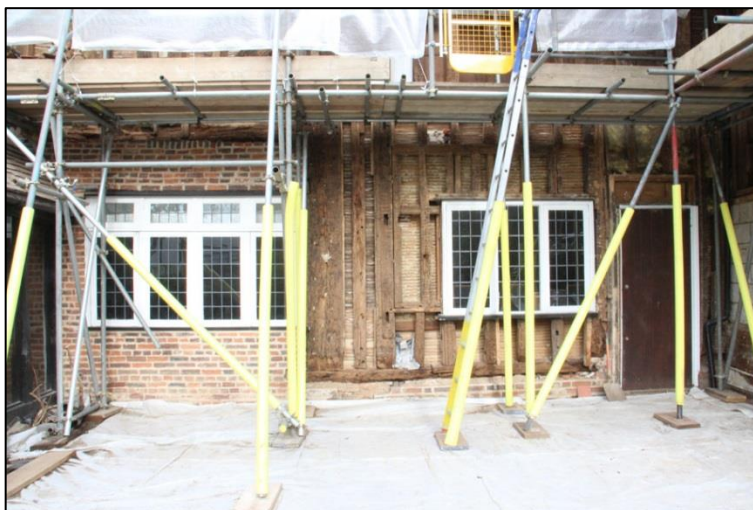
Plate 4: Ground floor

A brick built porch has been added to the northern end of the range in the 20th century and the adjacent wall rebuilt in brick. A modern door was also installed at the southern end of the elevation (Plate 4). Other recent works include the replacement of the lath and plaster above and below the southern window on the ground floor, which contrasts with the original riven oak laths between the two principal posts.

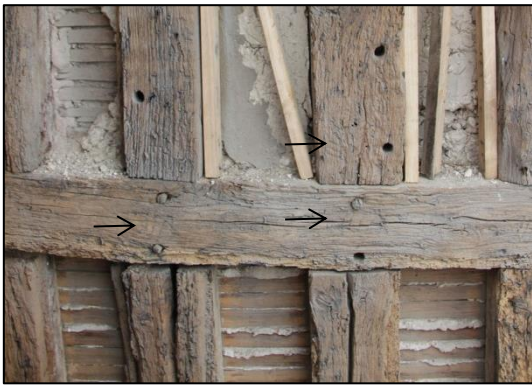
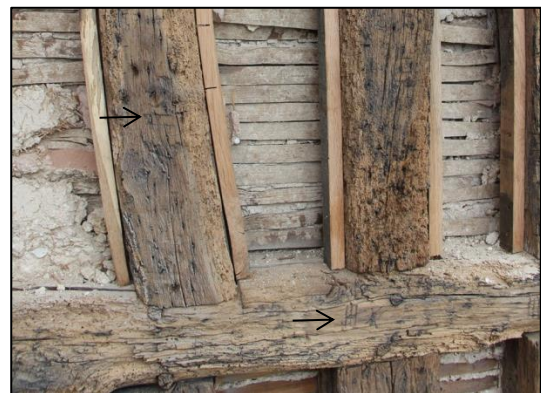
Amongst the most interesting features of the cross wing is the series of carpenter's marks on the north elevation. These are incised into the original wallplate and the studs above. Not all survive as many of the timbers have decayed, but nonetheless, it is possible to see the figure 13 -15 in Roman numerals to the south of which are the numbers 20 -24 (Plates 17-21).

Plate 17-18: Carpenter's marks on the north elevation

Plate 19-20: Carpenter's marks on the north elevation

Plate 21: Carpenter's marks on the north elevation

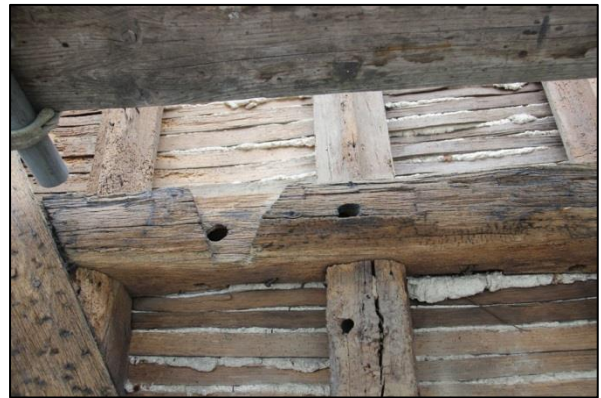
Plate 29: Redundant mortice and peg holes

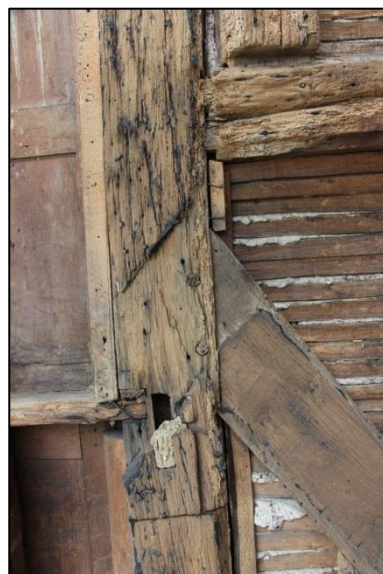
Plate 33: Reused post

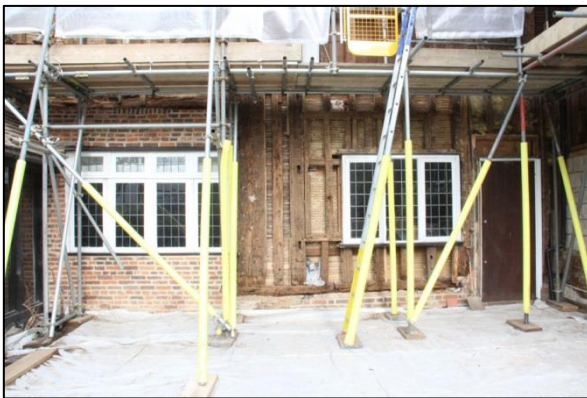
Plate 36: Ground floor

The fenestration has inevitable been altered over the centuries to accommodate the latest styles. The mortices in the principal posts to either side of the ground floor window (Plate 36) and the mortices in the beam above (Plate 41) suggest there was a large oriel window at the southern end of the range. Three mullions from a timber mullioned window now support the existing ground floor window. It is possible that the reconfiguration of the studs above the southern first floor window may have been associated with the installation of a sash window that has since been replaced.

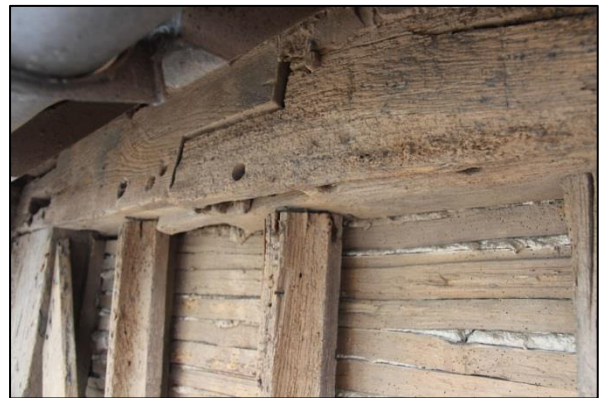
Plate 37: Bridle butted scarf joint in the wallplate

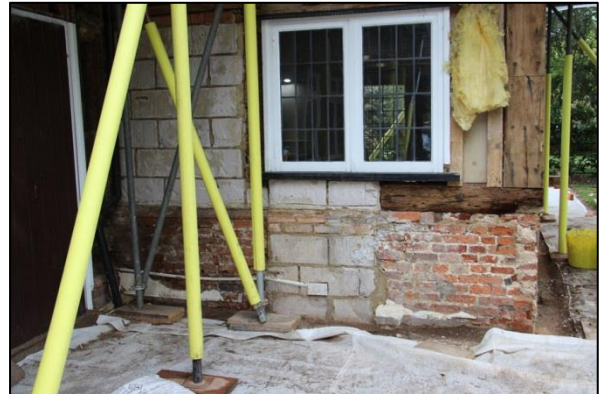
Plate 46: Ground floor with original brick dwarf wall

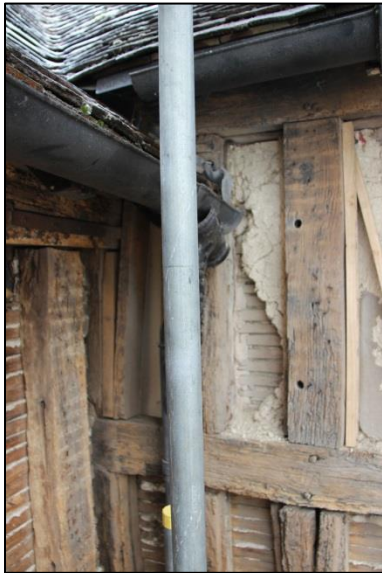
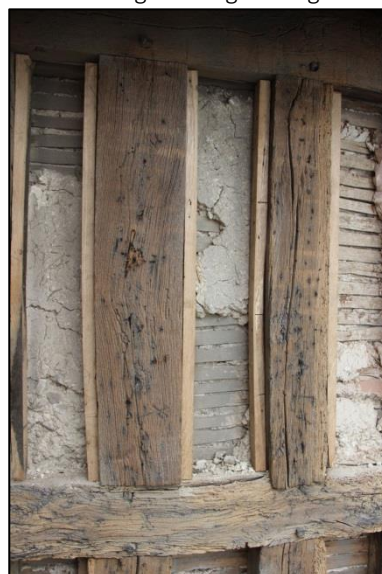
The cross wing has seen several episodes of rebuilding. It was clearly heightened, as is evident in the addition of an entire series of studs above the original wall plate in the north elevation (Plates 6 & 7). Further evidence can be seen in the south elevation where the tops of the jowlposts have been cut and reinstated above the original wallplate (Plates 8 & 9). The northern jowlpost in the west elevation remains unaltered, but its counterpart to the south has been replaced by a straight corner post. Indeed, the posts adjacent to this in the south elevation, like the corner post, extend as far as the heightened roof and must all have been inserted when the roof was raised. Within this section of timberwork at the western end of the south elevation, is a timber mullioned window that houses a more recent single light casement window at its eastern end (Plates 10 & 11). The central mullion is square section and the iron rod to the north of it survives. The principal posts to either side of this mullioned window have mortices which appear to have been for a large window, which could either suggest that the mullioned window is a later insertion or that the posts have been reused, as is the case with a post to the east of the southern chimney stack.

Plate 47: Stage 1: later studs to heighten the wing

Plate 48: Stage 1: heightening studs ii

Plate 49: Stage 1: heightening studs iii

Plate 50: Stage 1: heightening studs iv

Plate 51: Stage 1: heightening studs v

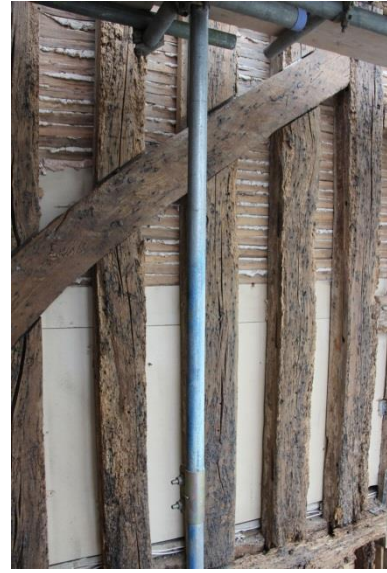
Plate 54: Brace ii

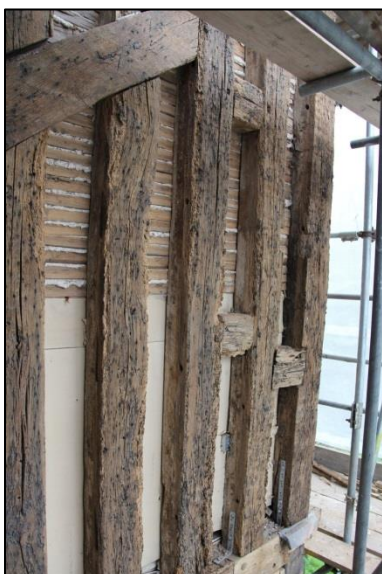
Plate 55: Western end

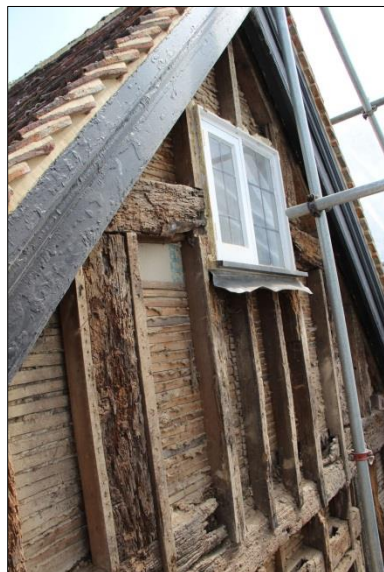
Plate 58: Upper window from the north

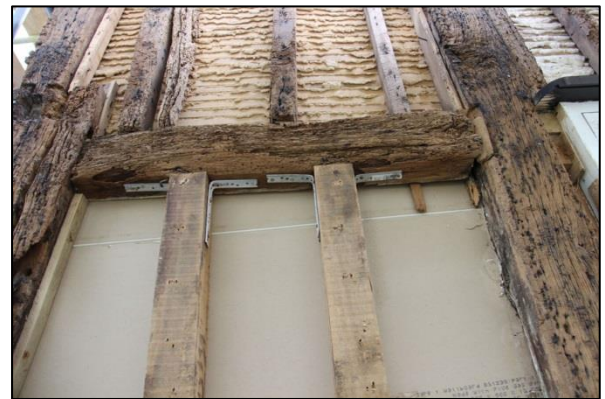
Plate 67: Detail of jowlpost and neighbouring timbers

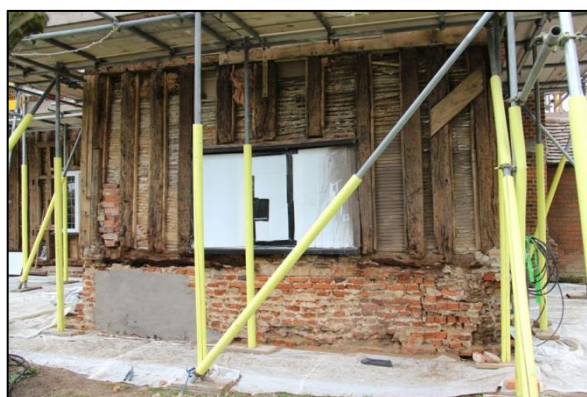
Plate 74: Ground floor with the original dwarf wall

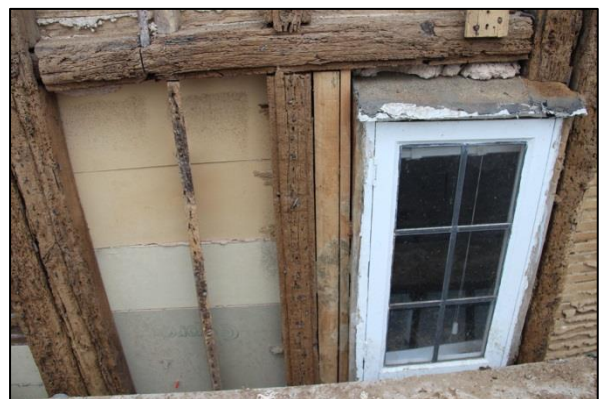
Plate 78: Top stage : later window set within frame of mullioned window

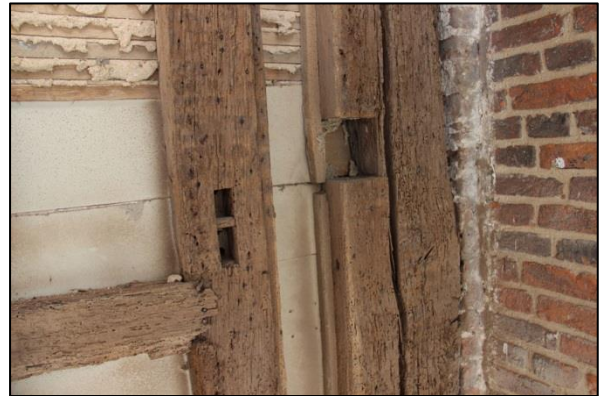
Plate 88: First floor: mortice details

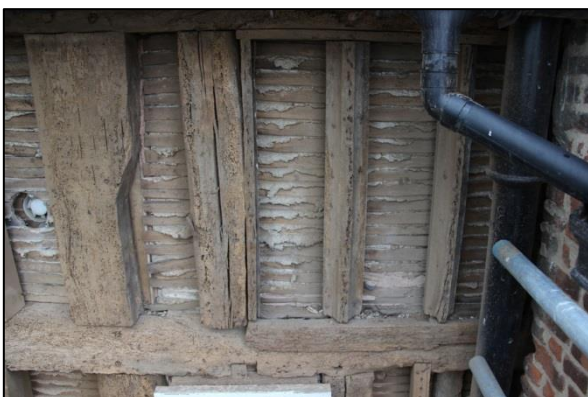
Plate 94: Top stage: eastern end detail

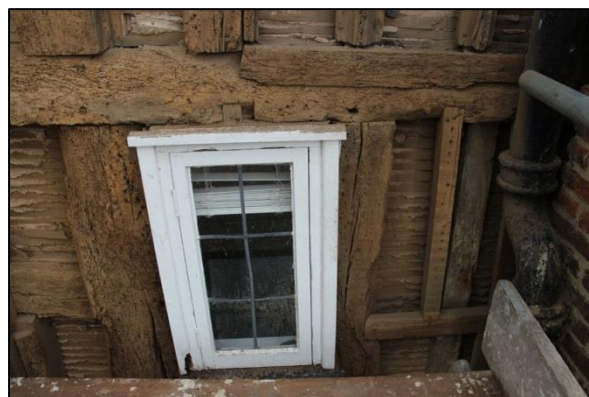
Plate 95: Top stage: later window detail

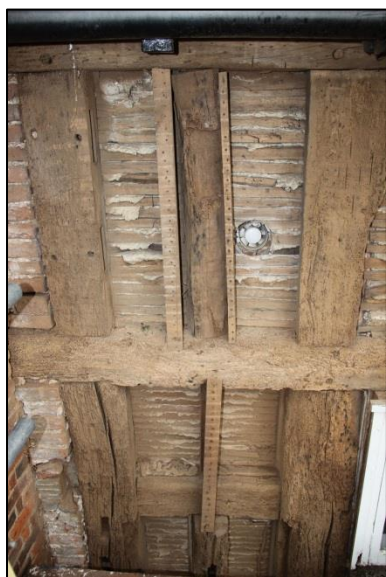
Plate 96: Top stage: western end

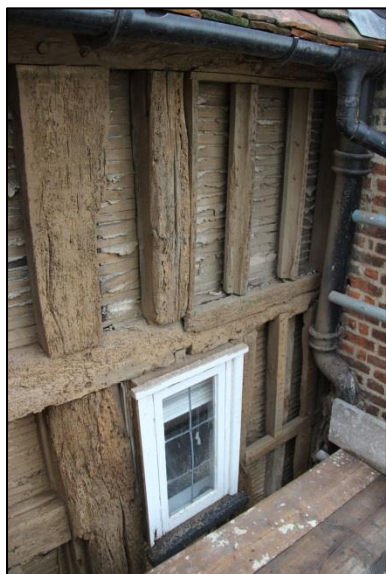
Plate 98: Top stage: eastern end

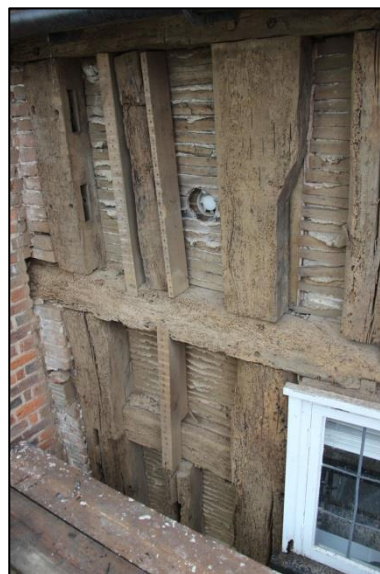
Plate 99: Top stage: western end

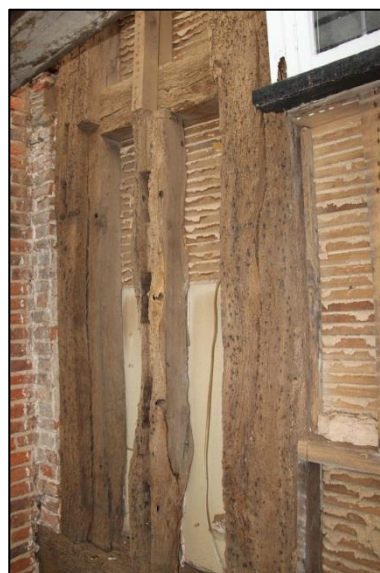
Plate 101: First floor: western end

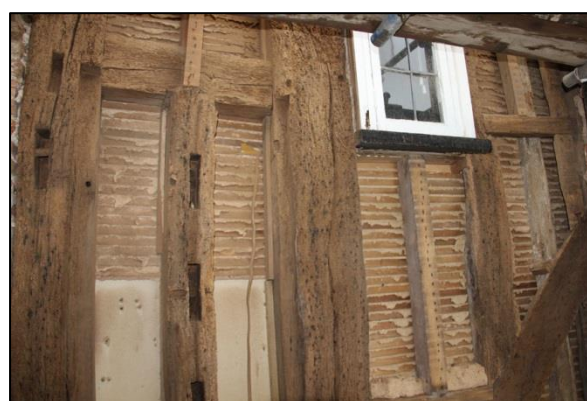
Plate 103: First floor level

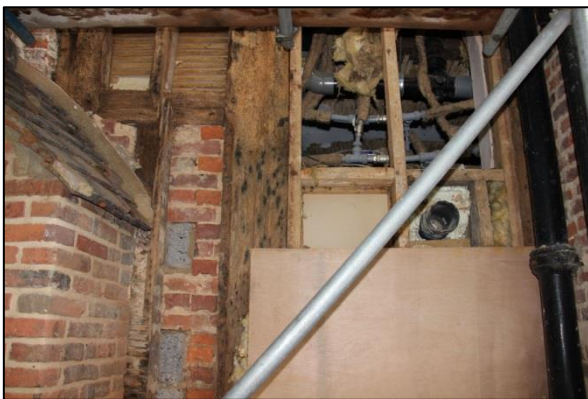
Plate 106: Ground floor

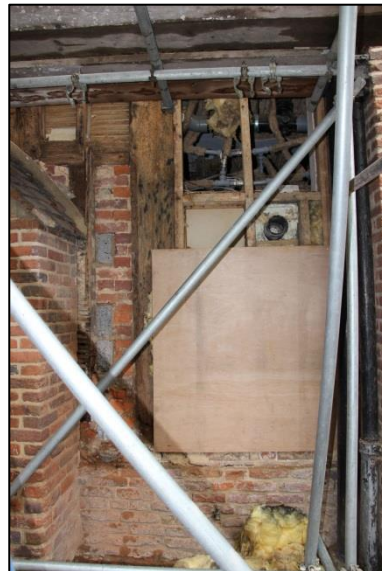
Plate 107: Ground floor
