KDK ARCHAEOLOGY LTD

**Historic Building Recording,
Historic Building Watching Brief &
Archaeological Watching Brief**

Abdale House/Northside
32-34 Warrengate Road
North Mymms
Hertfordshire

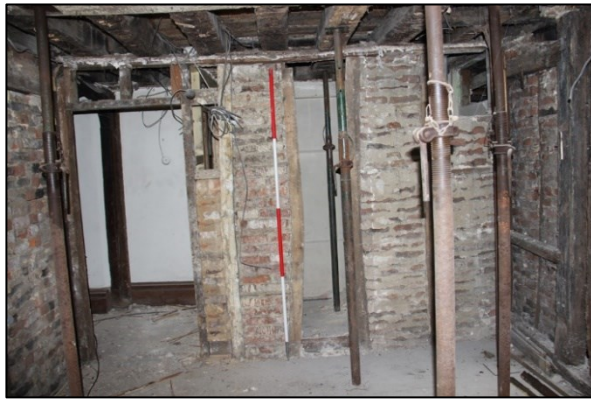
Photo G64: G8: southwest corner

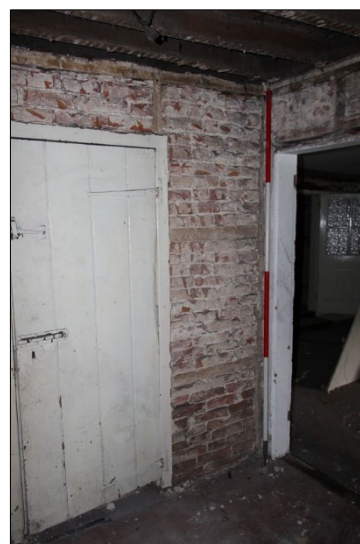
Photo G70: G10: southeast corner

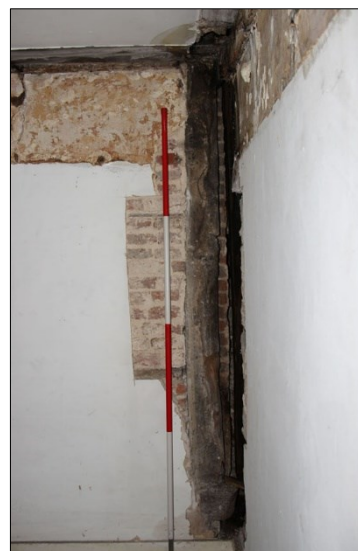
Photo G76: G11: detail of timber in northeast corner

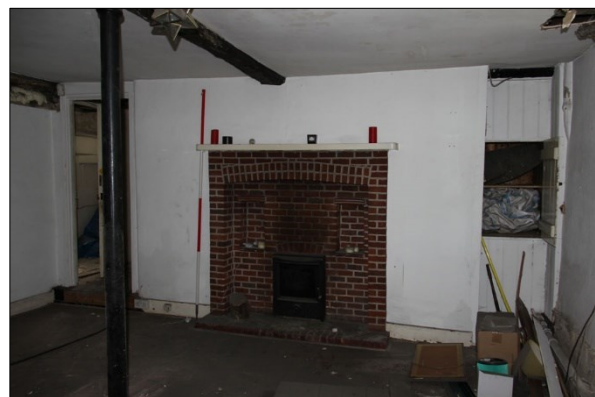
Photo G80: G11: detail of fireplace in south wall

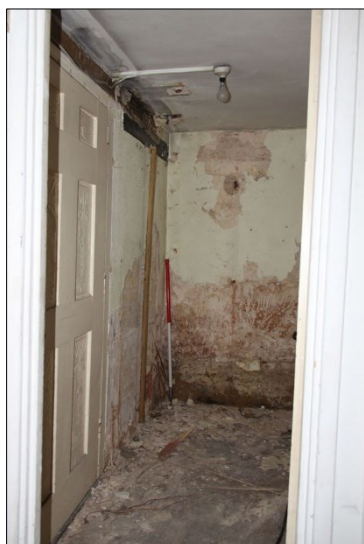
Photo G86: G13: facing south southeast

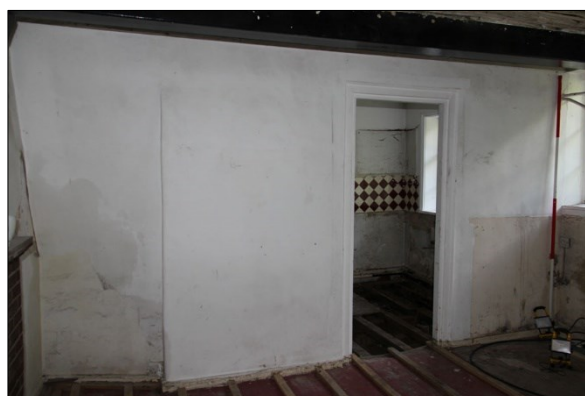
Photo G93: G15: south wall

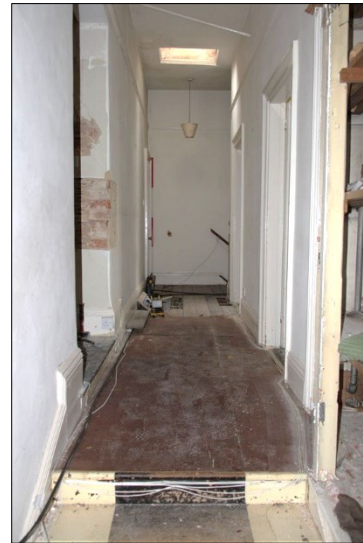
Photo F4: F1: view to west

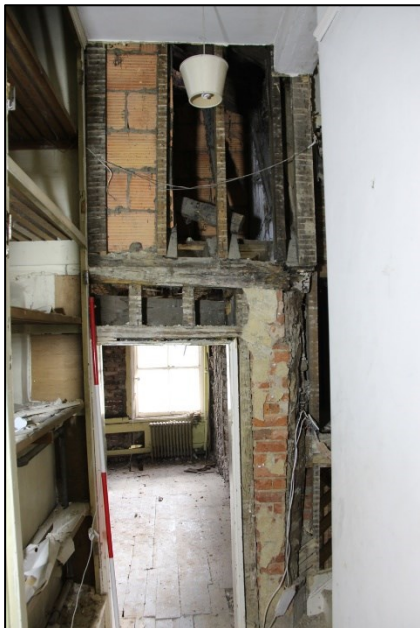
Photo F11: F1: walling over entry to F4

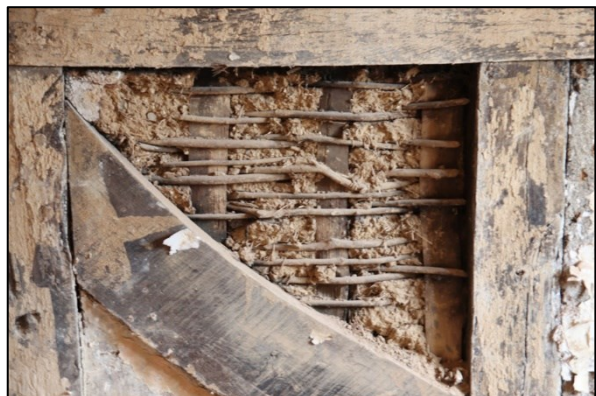
Photo F14: F1: wattle & daub detail

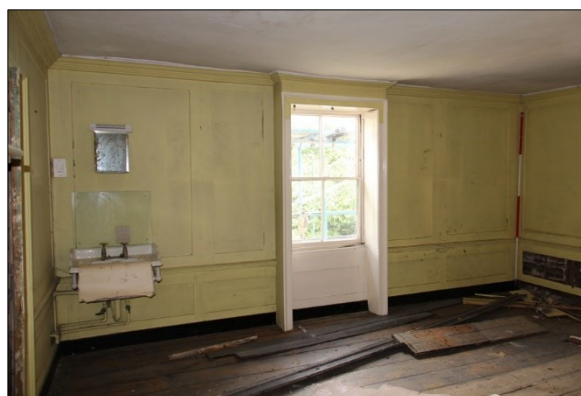
Photo F23: F4: west wall, door to right blocked with brick

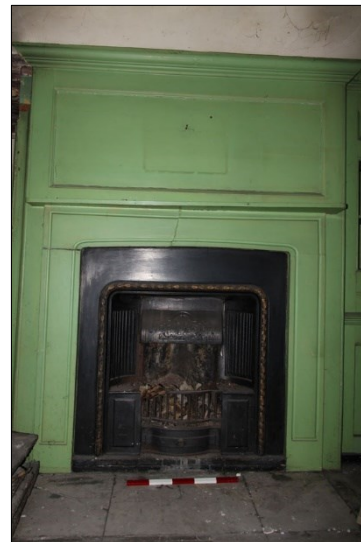
Photo F63: F11: detail of fireplace

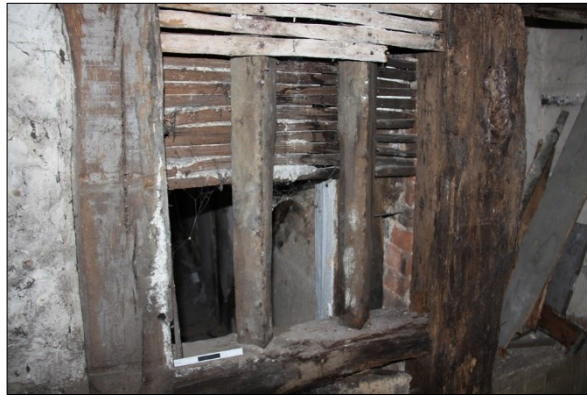
Photo F66: F11: detail of mullion window

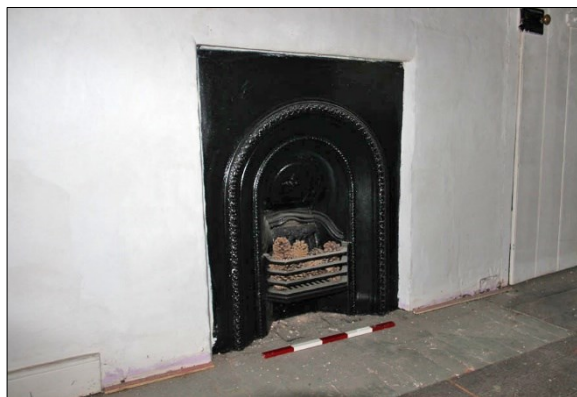
Photo F85: F15: detail of fireplace in south wall

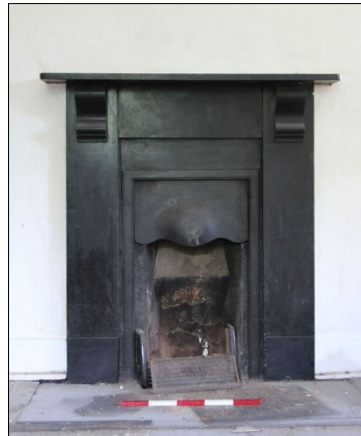
Photo F91: F16: east wall

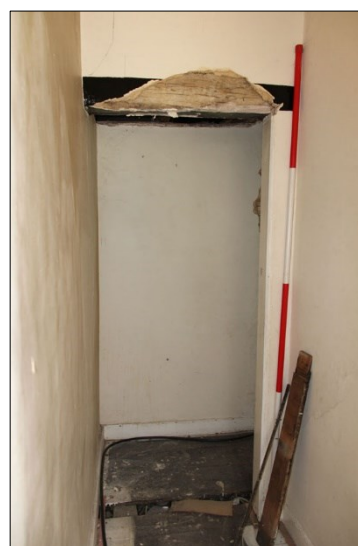
Photo F94: F17: north wall

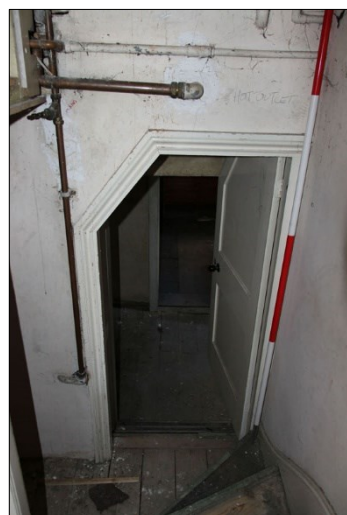
Photo S3: S1: steps down to S2 from S1a

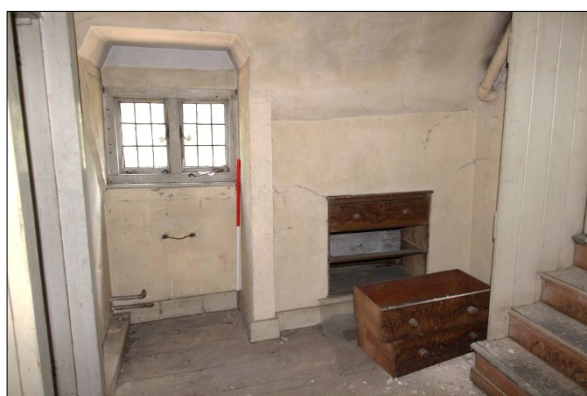
Photo S6: S2: east wall with built in chest of drawers

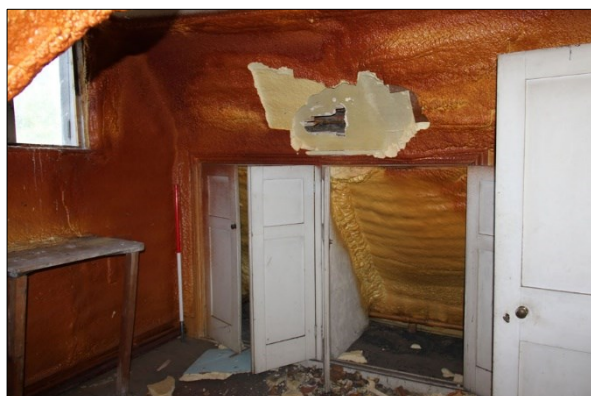
Photo S11: S3: facing northeast

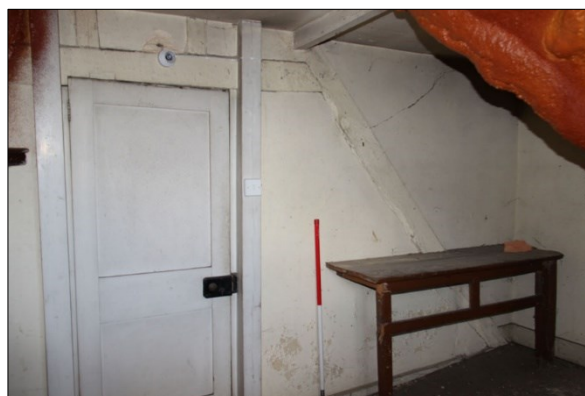
Photo S12: S3: facing southwest

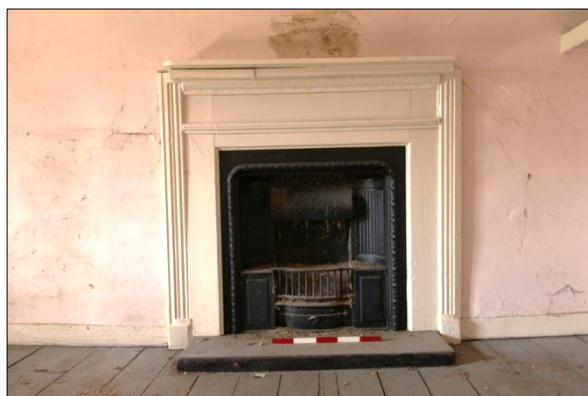
Photo S15: S5: detail of fireplace

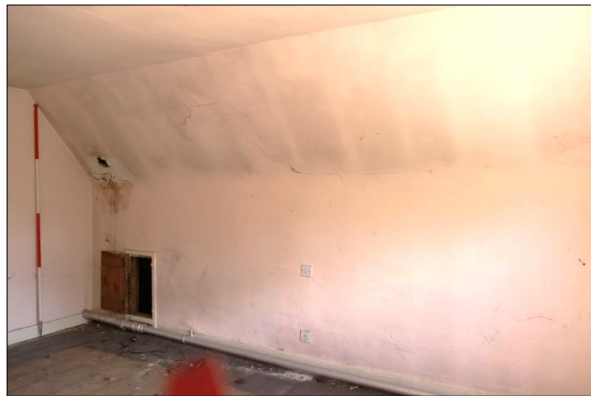
Photo S17: S5: east wall

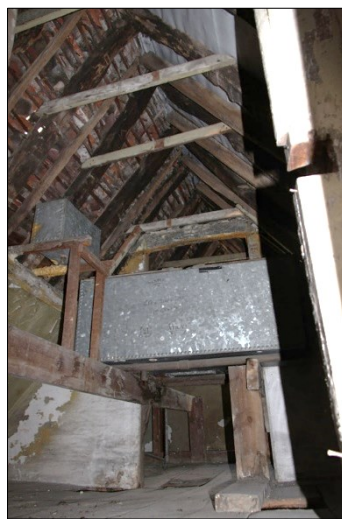
Photo S19: S6: View from F12, facing west
