KDK ARCHAEOLOGY LTD

Historic Building Recording

Minsden Chapel

Scheduled Monument 1003543

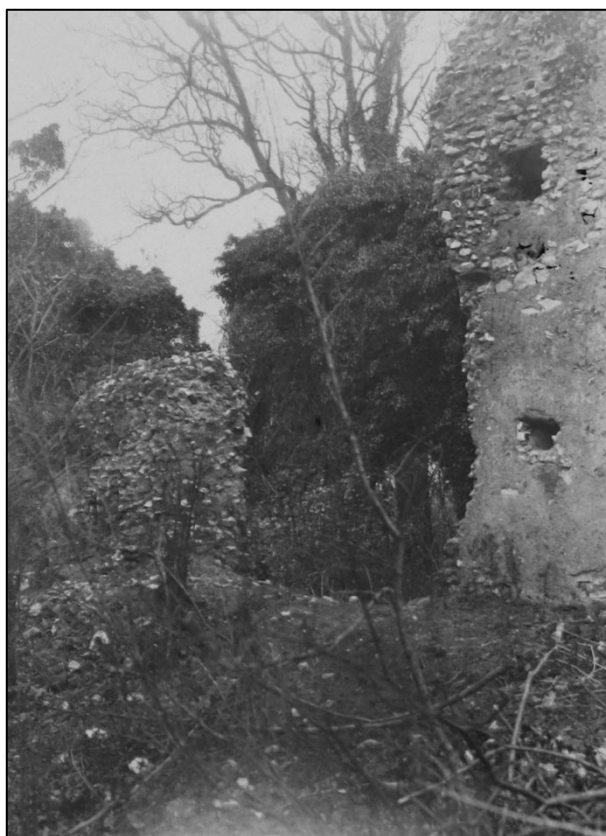
By 1909 a great deal of damage had occurred and the ruins had become heavily overgrown, but the chancel arch and some of the east window was still standing (Fig. 7). Two photographs taken in 1922 show the deterioration was advanced, but by the chancel arch was still intact in 2001 even if the east window had by then disappeared (Figs. 9 & 10).

Figure 9: View from the northwest 1922 (HALS DE/1042/8/76a)

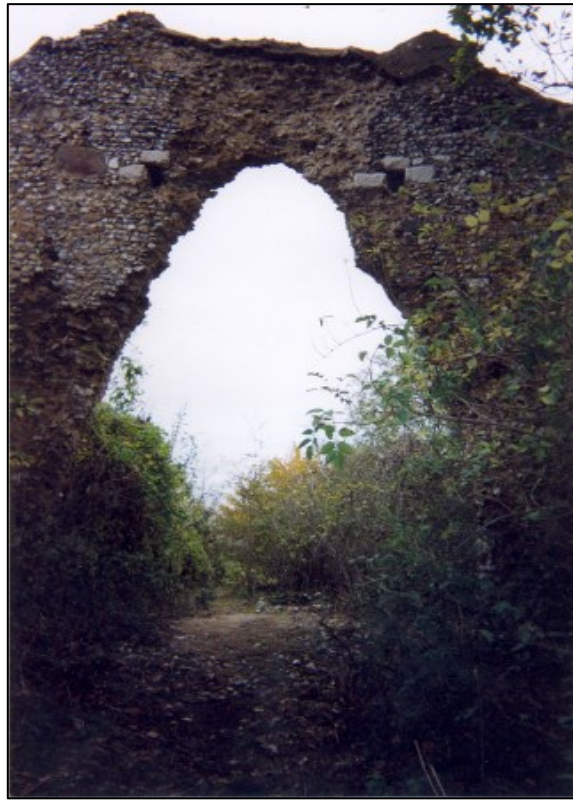
Figure 10: Chancel arch looking east in 2001 (<https://www.hertsmemories.org.uk/content/herts-history/places/churches-and-places-of-worship-2/minsdn-chapel-hitchin>)

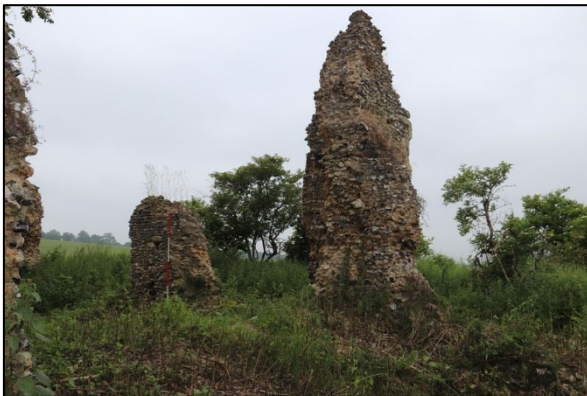
Plate 12: Remains of the chancel arch (5)

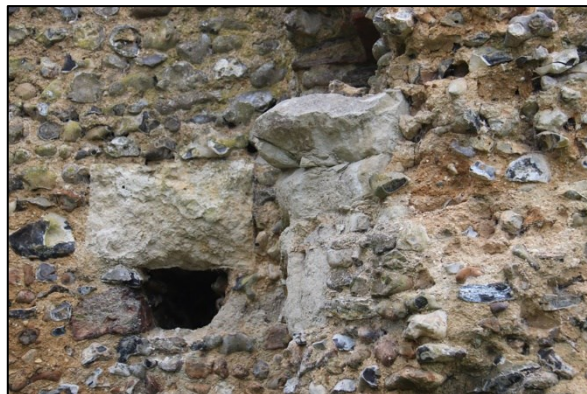
The nave has an angled buttresses on both sides of the west elevation, three further buttresses along the south wall and one to the north. The door and window openings in the north and south nave walls have largely been lost, but voussoirs in the south wall survive at the western end, as does a springer in the wall opposite and the base of the door opening to the east of it.

Plate 14: Springer in the north wall (17)

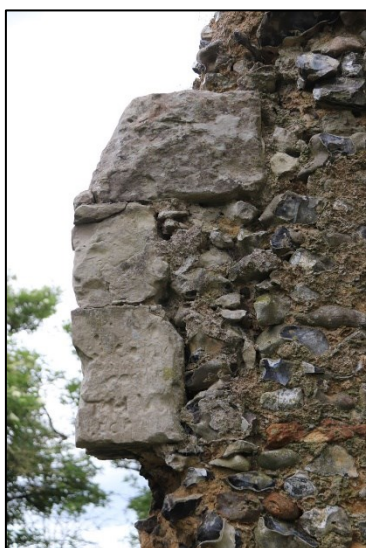
Plate 15: Ashlared clunch, SE buttress (30)

The walls were plastered, some of which is still evident on the internal west wall of the nave. Whether the exterior of the walls was plastered and painted, as would have been the norm, is uncertain as the clunch quoins do not stand very proud of the walls (Plate 15). Identifying building lifts within the walling was challenging in part because the thicker mortar beds applied at the end of the building seasons are less obvious in a wall of relatively well packed and coursed small flints and fieldstones. A short line of tiles in the external face of the west wall could well indicate the beginning/end of one of building lifts, but the variations in mortar and the closeness with which the wall has to be viewed did not allow any satisfactory conclusions to be drawn.

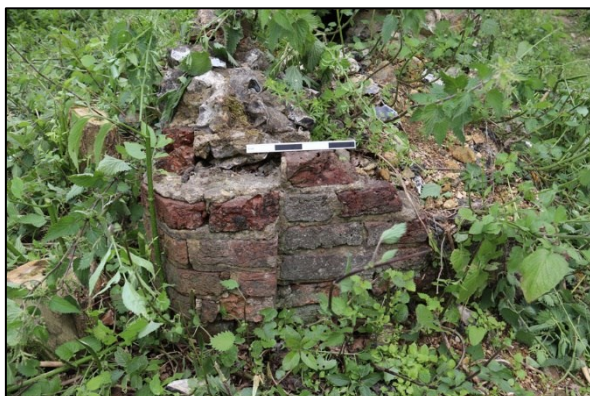
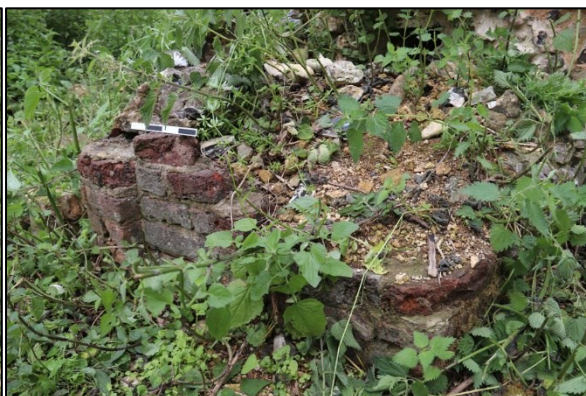
Brick has also been used within the structure; as a repair to the door opening in the north wall, and to construct a belfry in the southeast corner of the nave. The bricks within the door opening are c.13 x 10 x 6cm although some are only 5cm high and others are bullnosed. They are poorly puddled reds, with a few stone inclusions but no spanish and appear to be 18th century. The mortar is hard and cement based, which would suggest that the bricks have been re-used. The bricks used for the belfry could only be studied in detail through the camera lens and photograph. They are also handmade reds, with no apparent inclusions and appear to be c.5cm high. There is a narrow arched opening 4 courses high and roughly 29cm wide more clearly evident from within the church. The bricks are handmade reds and the return wall to the left of the opening is bullnosed. Bricks have also been used in later repairs to the south wall.

Plate 23: Brickwork in northern door opening (48)

Plate 24: Brickwork in northern door opening (49)

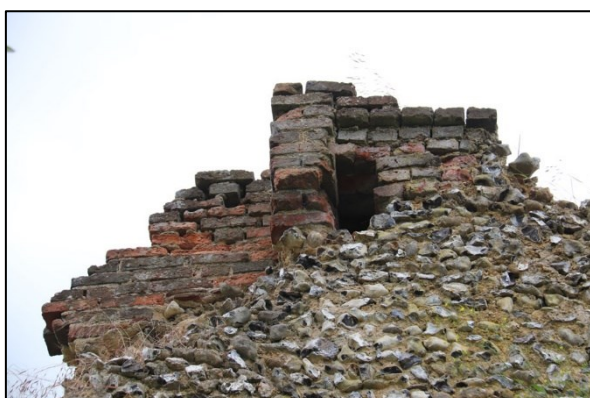
Plate 25: Bell cote on west wall (59)

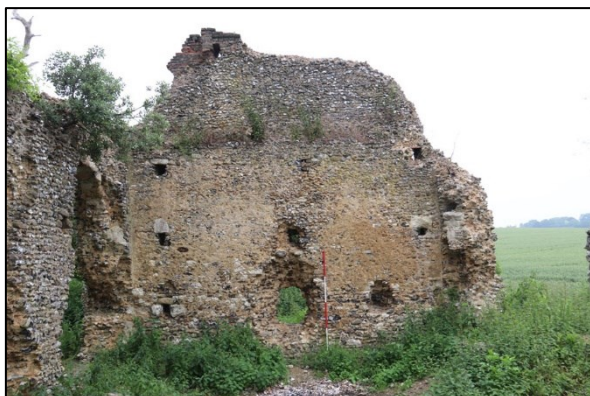
Shot 8: Southwest corner of the nave

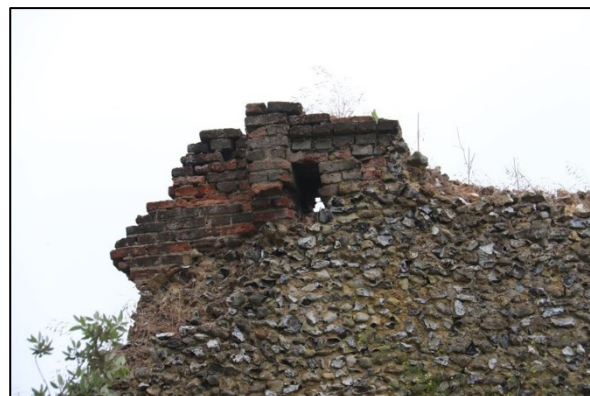
Shot 9: West wall

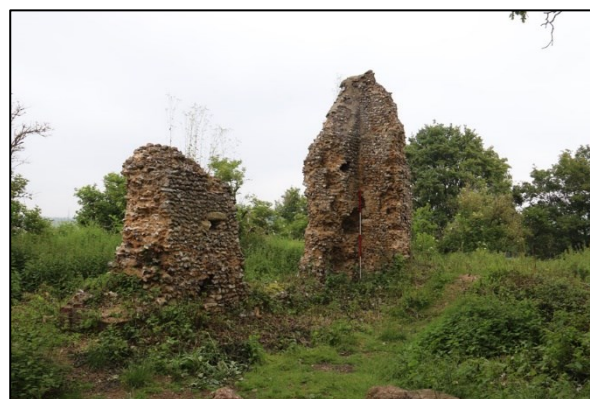
Shot 11: South wall of nave

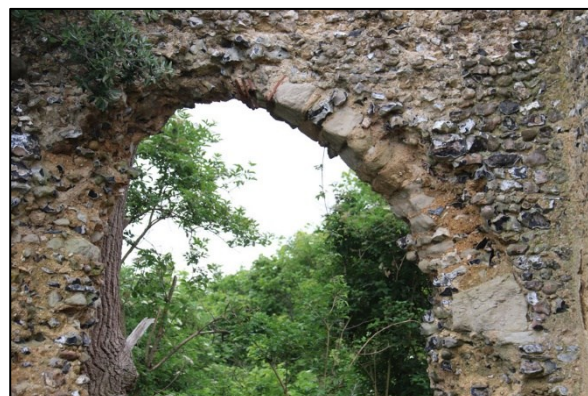
Shot 18: Voussoirs in south wall
