## Historic Building Watching Brief

Minsden Chapel

Langley

Scheduled Monument 1003543

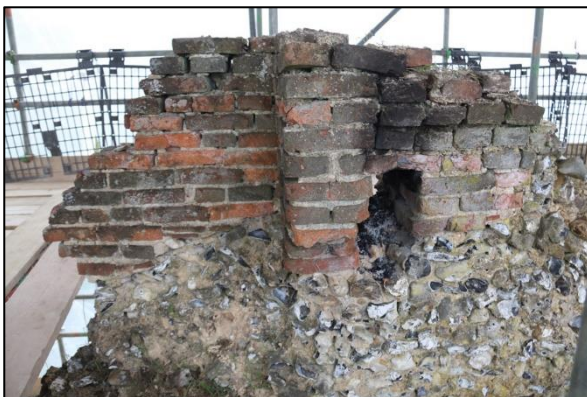
The opportunity was taken during an early site meeting to photograph elements of the building from the upper stages of the scaffold. The bricks used to construct the bellcote, which had been damaged by vandals in 2022 who had lit a fire within the opening were of variable quality, with some very poorly puddled and others well puddled and fine grained (Plates 1-3). They contained a small amount of spanish and stone inclusions and were set in lime mortar. The size and inclusions suggest a date of c.1600 for the bricks.

**Plate 1:** Bellcote from the east

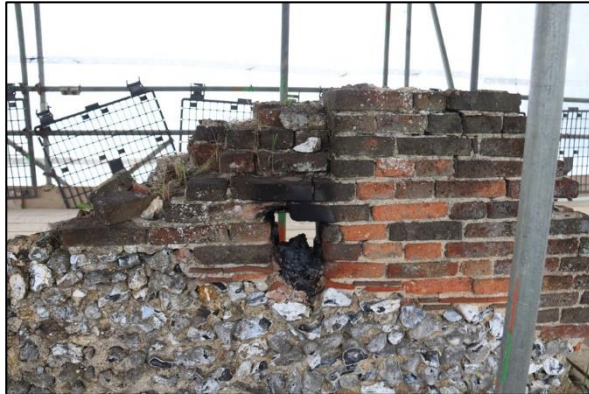
**Plate 3:** Bellcote from the west

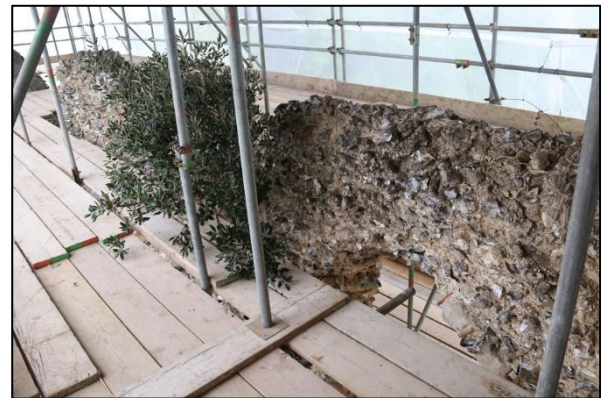
**Plate 6:** Wall over the south nave wall opening from the northwest

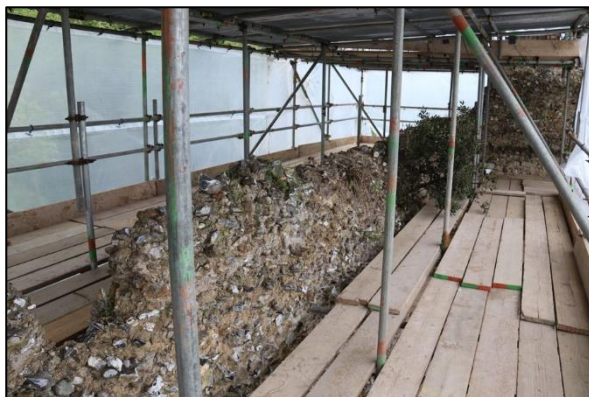
**Plate 7:** Detail of the south nave wall from the east

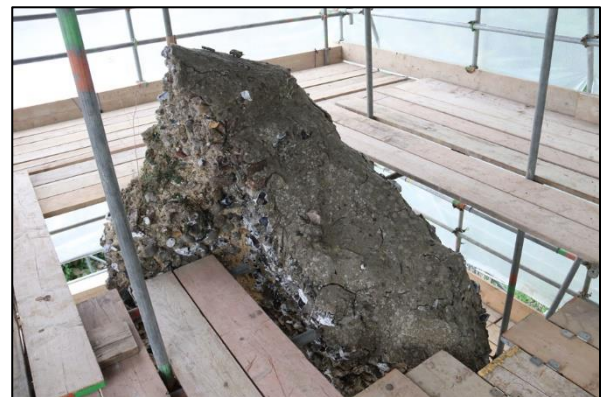
**Plate 8:** Upper level of south chancel upstanding wall from the west

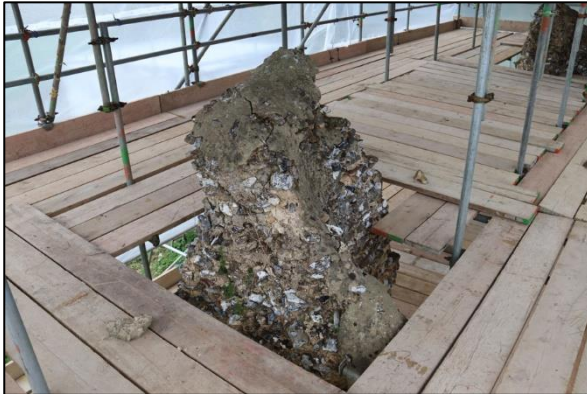
**Plate 9:** Upper level of south chancel upstanding wall from the northwest

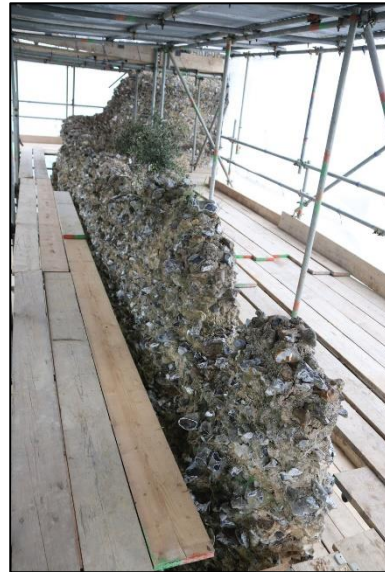
**Plate 10:** Upper level of south nave wall from the northeast

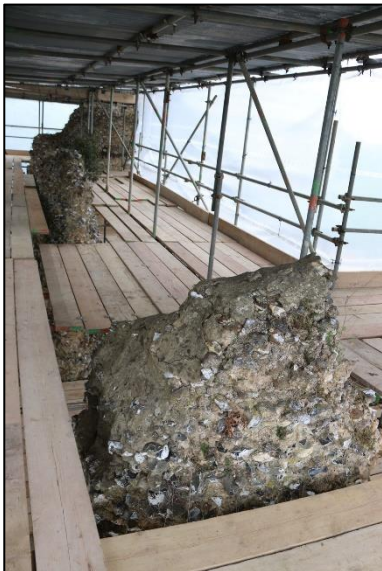
**Plate 11:** Upper level of south nave wall from the northeast

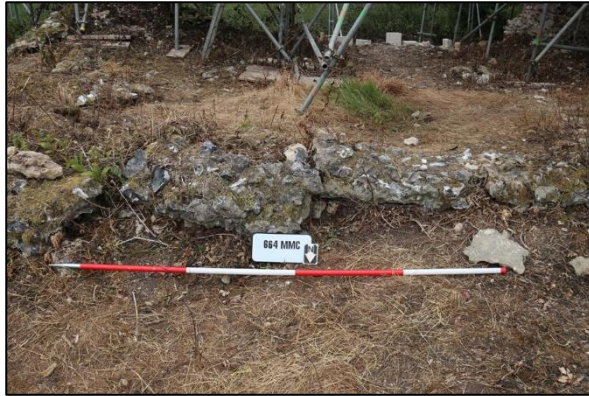
**Plate 1:** North chancel wall from the north

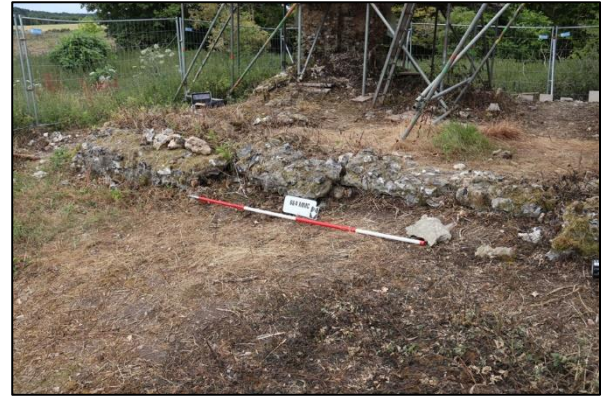
**Plate 2:** North chancel wall from the northwest

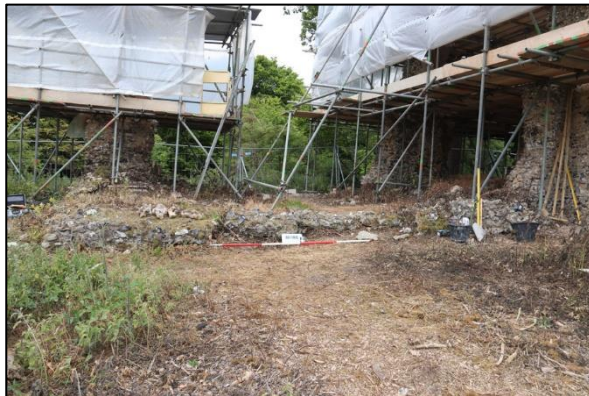
**Plate 3:** North chancel wall from the north

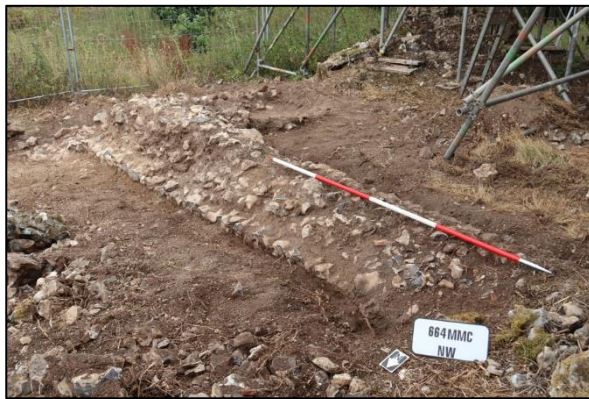
**Plate 1:** North chancel wall from the northwest

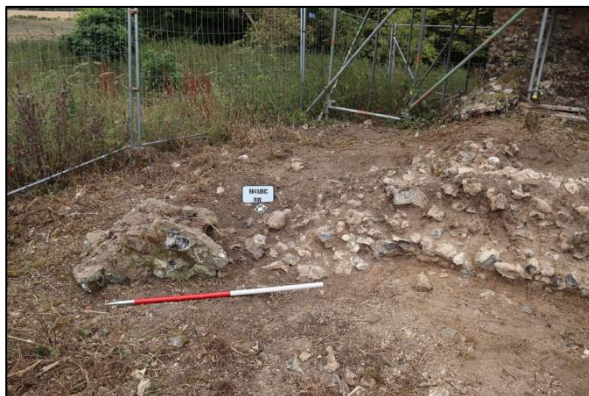
**Plate 3:** North chancel wall and buttress from the northwest

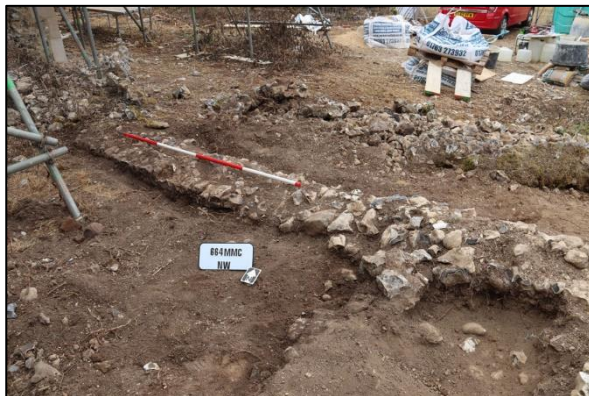
**Plate 7:** North chancel wall from the southeast

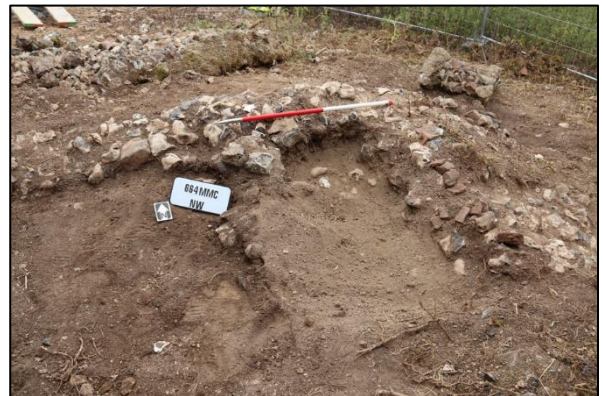
**Plate 8:** North and east chancel walls from the southwest

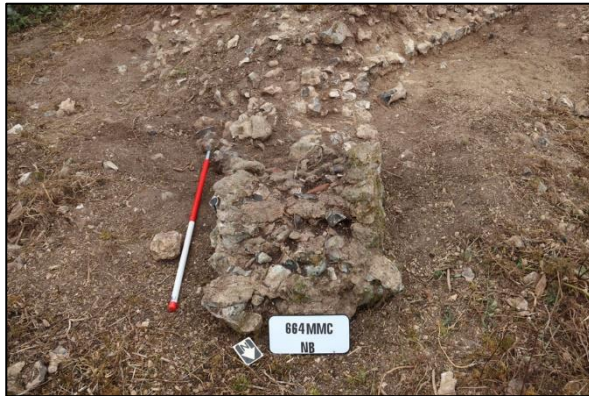
**Plate 12:** East chancel wall and northeast buttress from the south

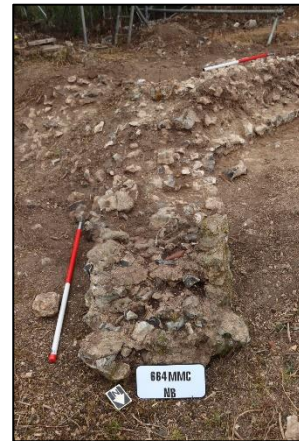
**Plate 13:** Northeast chancel buttress from the northeast

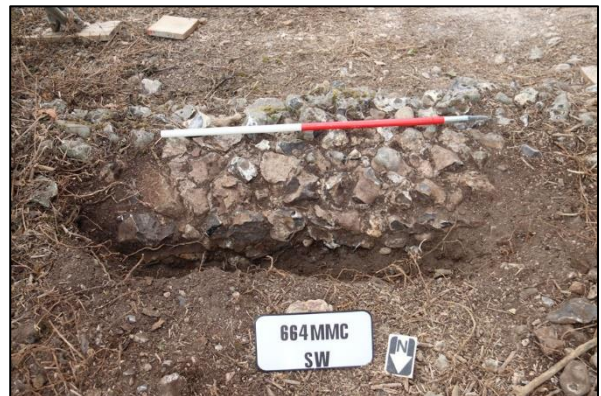
**Plate 15:** Slot to south chancel wall from the south

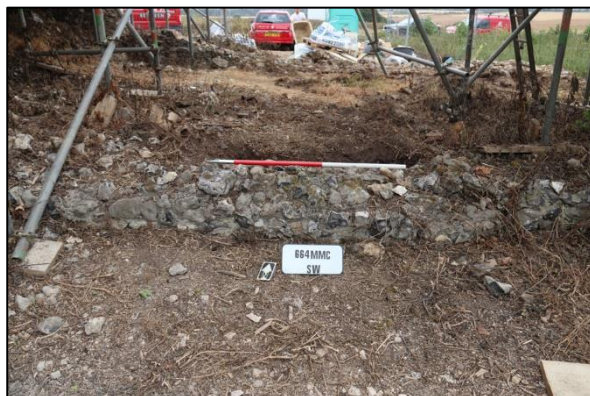
**Plate 16:** South chancel wall from the south

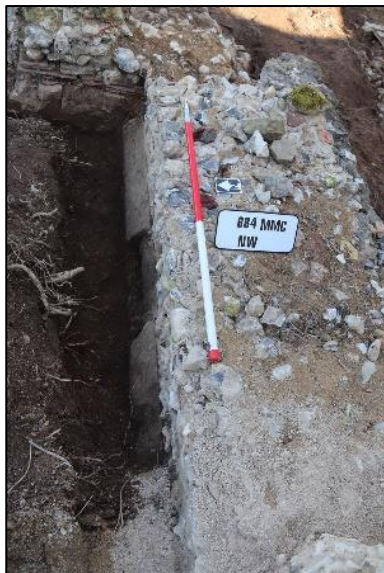
Three large moulded stone pieces were revealed to the west of the opening and c.0.30m below the top of the wall. On further investigation they were found to be of Totternhoe Stone and appeared to form part of a drip ledge. The stones were 0.74m, 0.43m and 0.55m (min) long and 0.20m deep (Fig. 4). Other worked pieces of stone were also present in the north nave wall between the gable end and the door opening, although none of the others were moulded. The varied building materials exposed in this part of the chapel included 4 courses of tiles immediately above the basal course of ashlar stone in the return wall immediately adjacent to the moulded stones (Plate 25).

Plate 24: Moulded stones in the north nave wall

Plate 25: North nave wall and moulded stones from the northwest

Plate 26: Detail of moulded stones from the north in the north nave wall

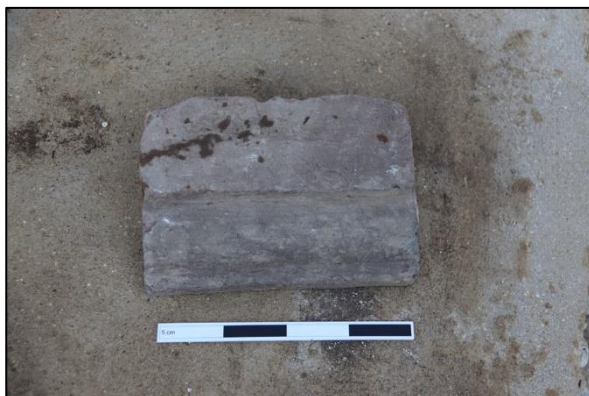
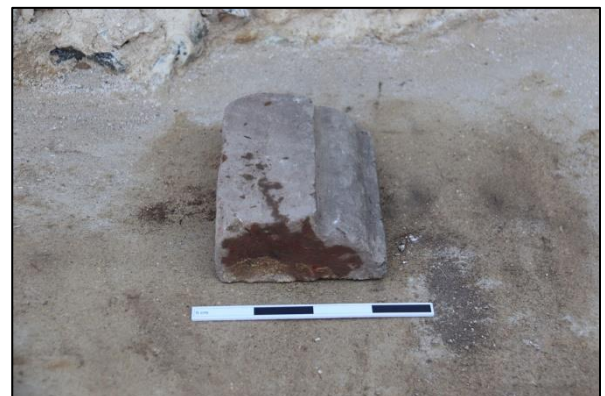
An isolated red brick with roll moulding and hard lime mortar was found during works on the eastern side of the chapel. It was well puddled with no inclusions and measured 22 x 15 x 5.5cm. The form and fabric suggest that this dates from the 1840s (Fig. 3; Plates 27-28).

Plate 27: Mid 19<sup>th</sup> century moulded brick

Plate 28: Mid 19<sup>th</sup> century moulded brick

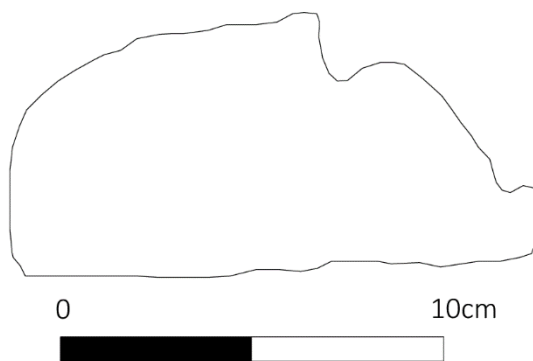
**Figure 3:** Mid-19<sup>th</sup> century moulded brick section (scale 1:2)

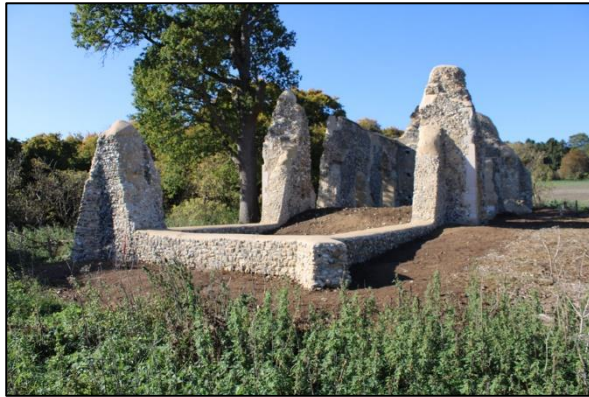
**Plate 1:** Chapel from the northeast

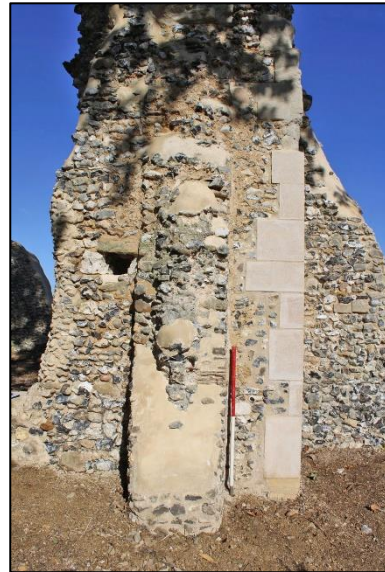
**Plate 9:** Southeast chancel buttress and south chancel wall from the south

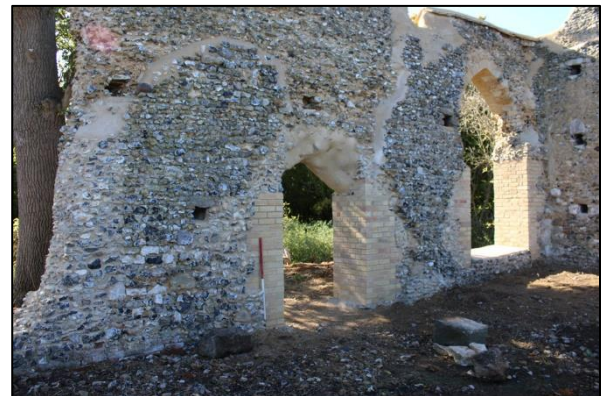
**Plate 17:** South wall at the nave/chancel interface from the northwest

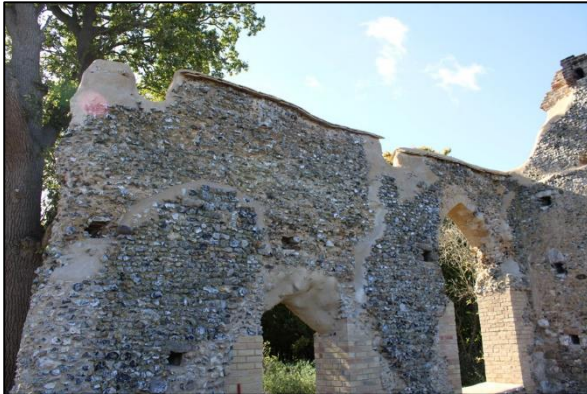
**Plate 18:** South nave wall from the northeast

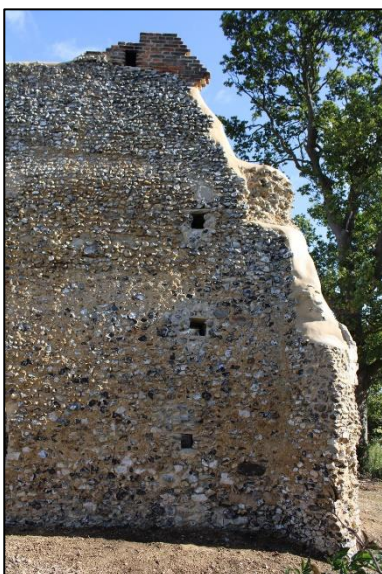
**Plate 22:** Detail of putlog hole in the west wall from the west

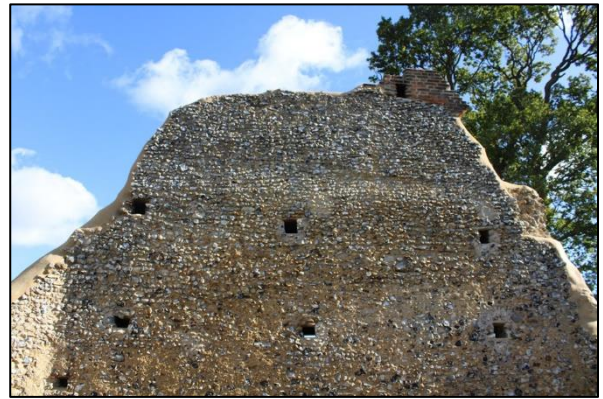
**Plate 25:** Detail of putlog hole in the west wall from the west

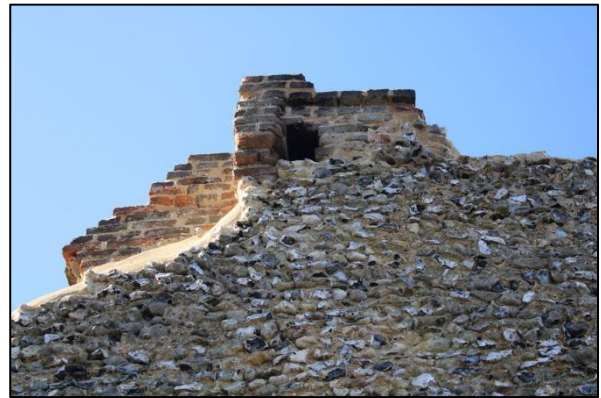
**Plate 31:** Detail of putlog hole in the west wall from the east

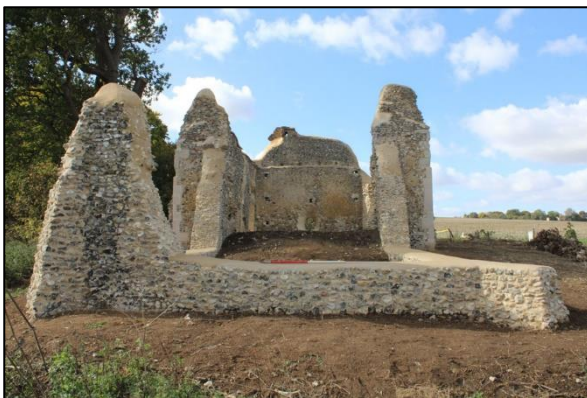
**Plate 40:** Chancel from the north

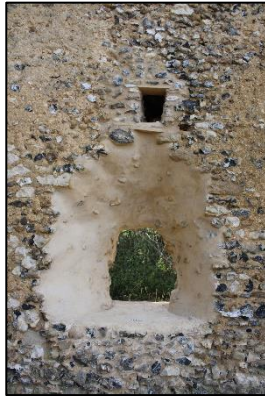
**Plate 42:** Detail of repaired opening in the west wall

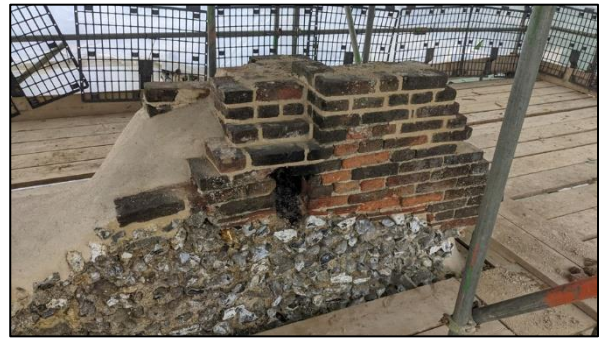
**Plate 4:** Western side of the bellcote

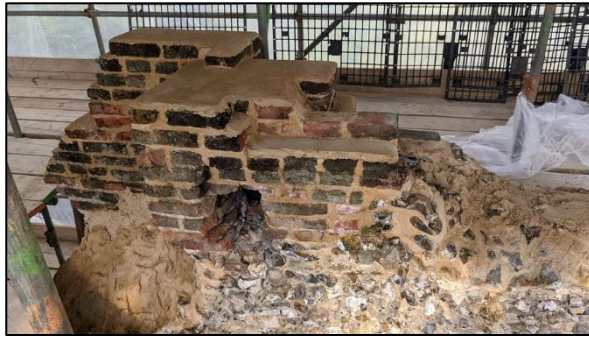
**Plate 5:** Eastern side of the bellcote

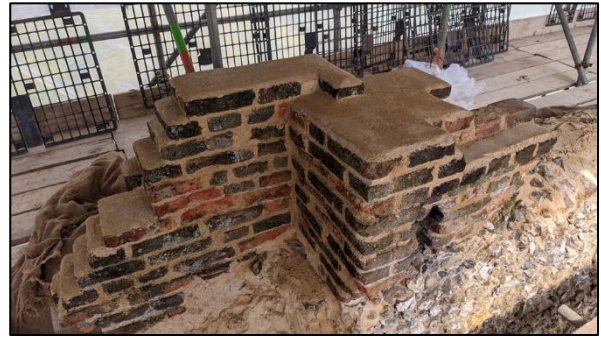
**Plate 6:** Bellcote from the southeast

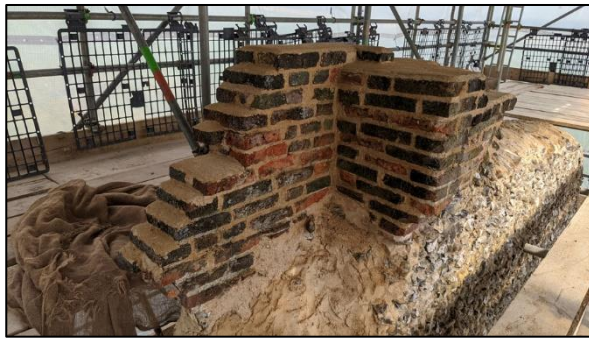
**Plate 7:** Bellcote from the southeast

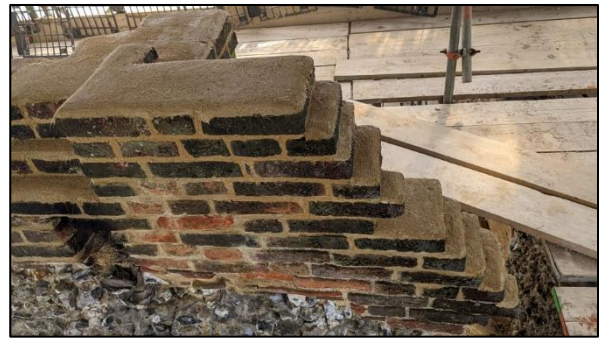
**Plate 8:** Bellcote from the west

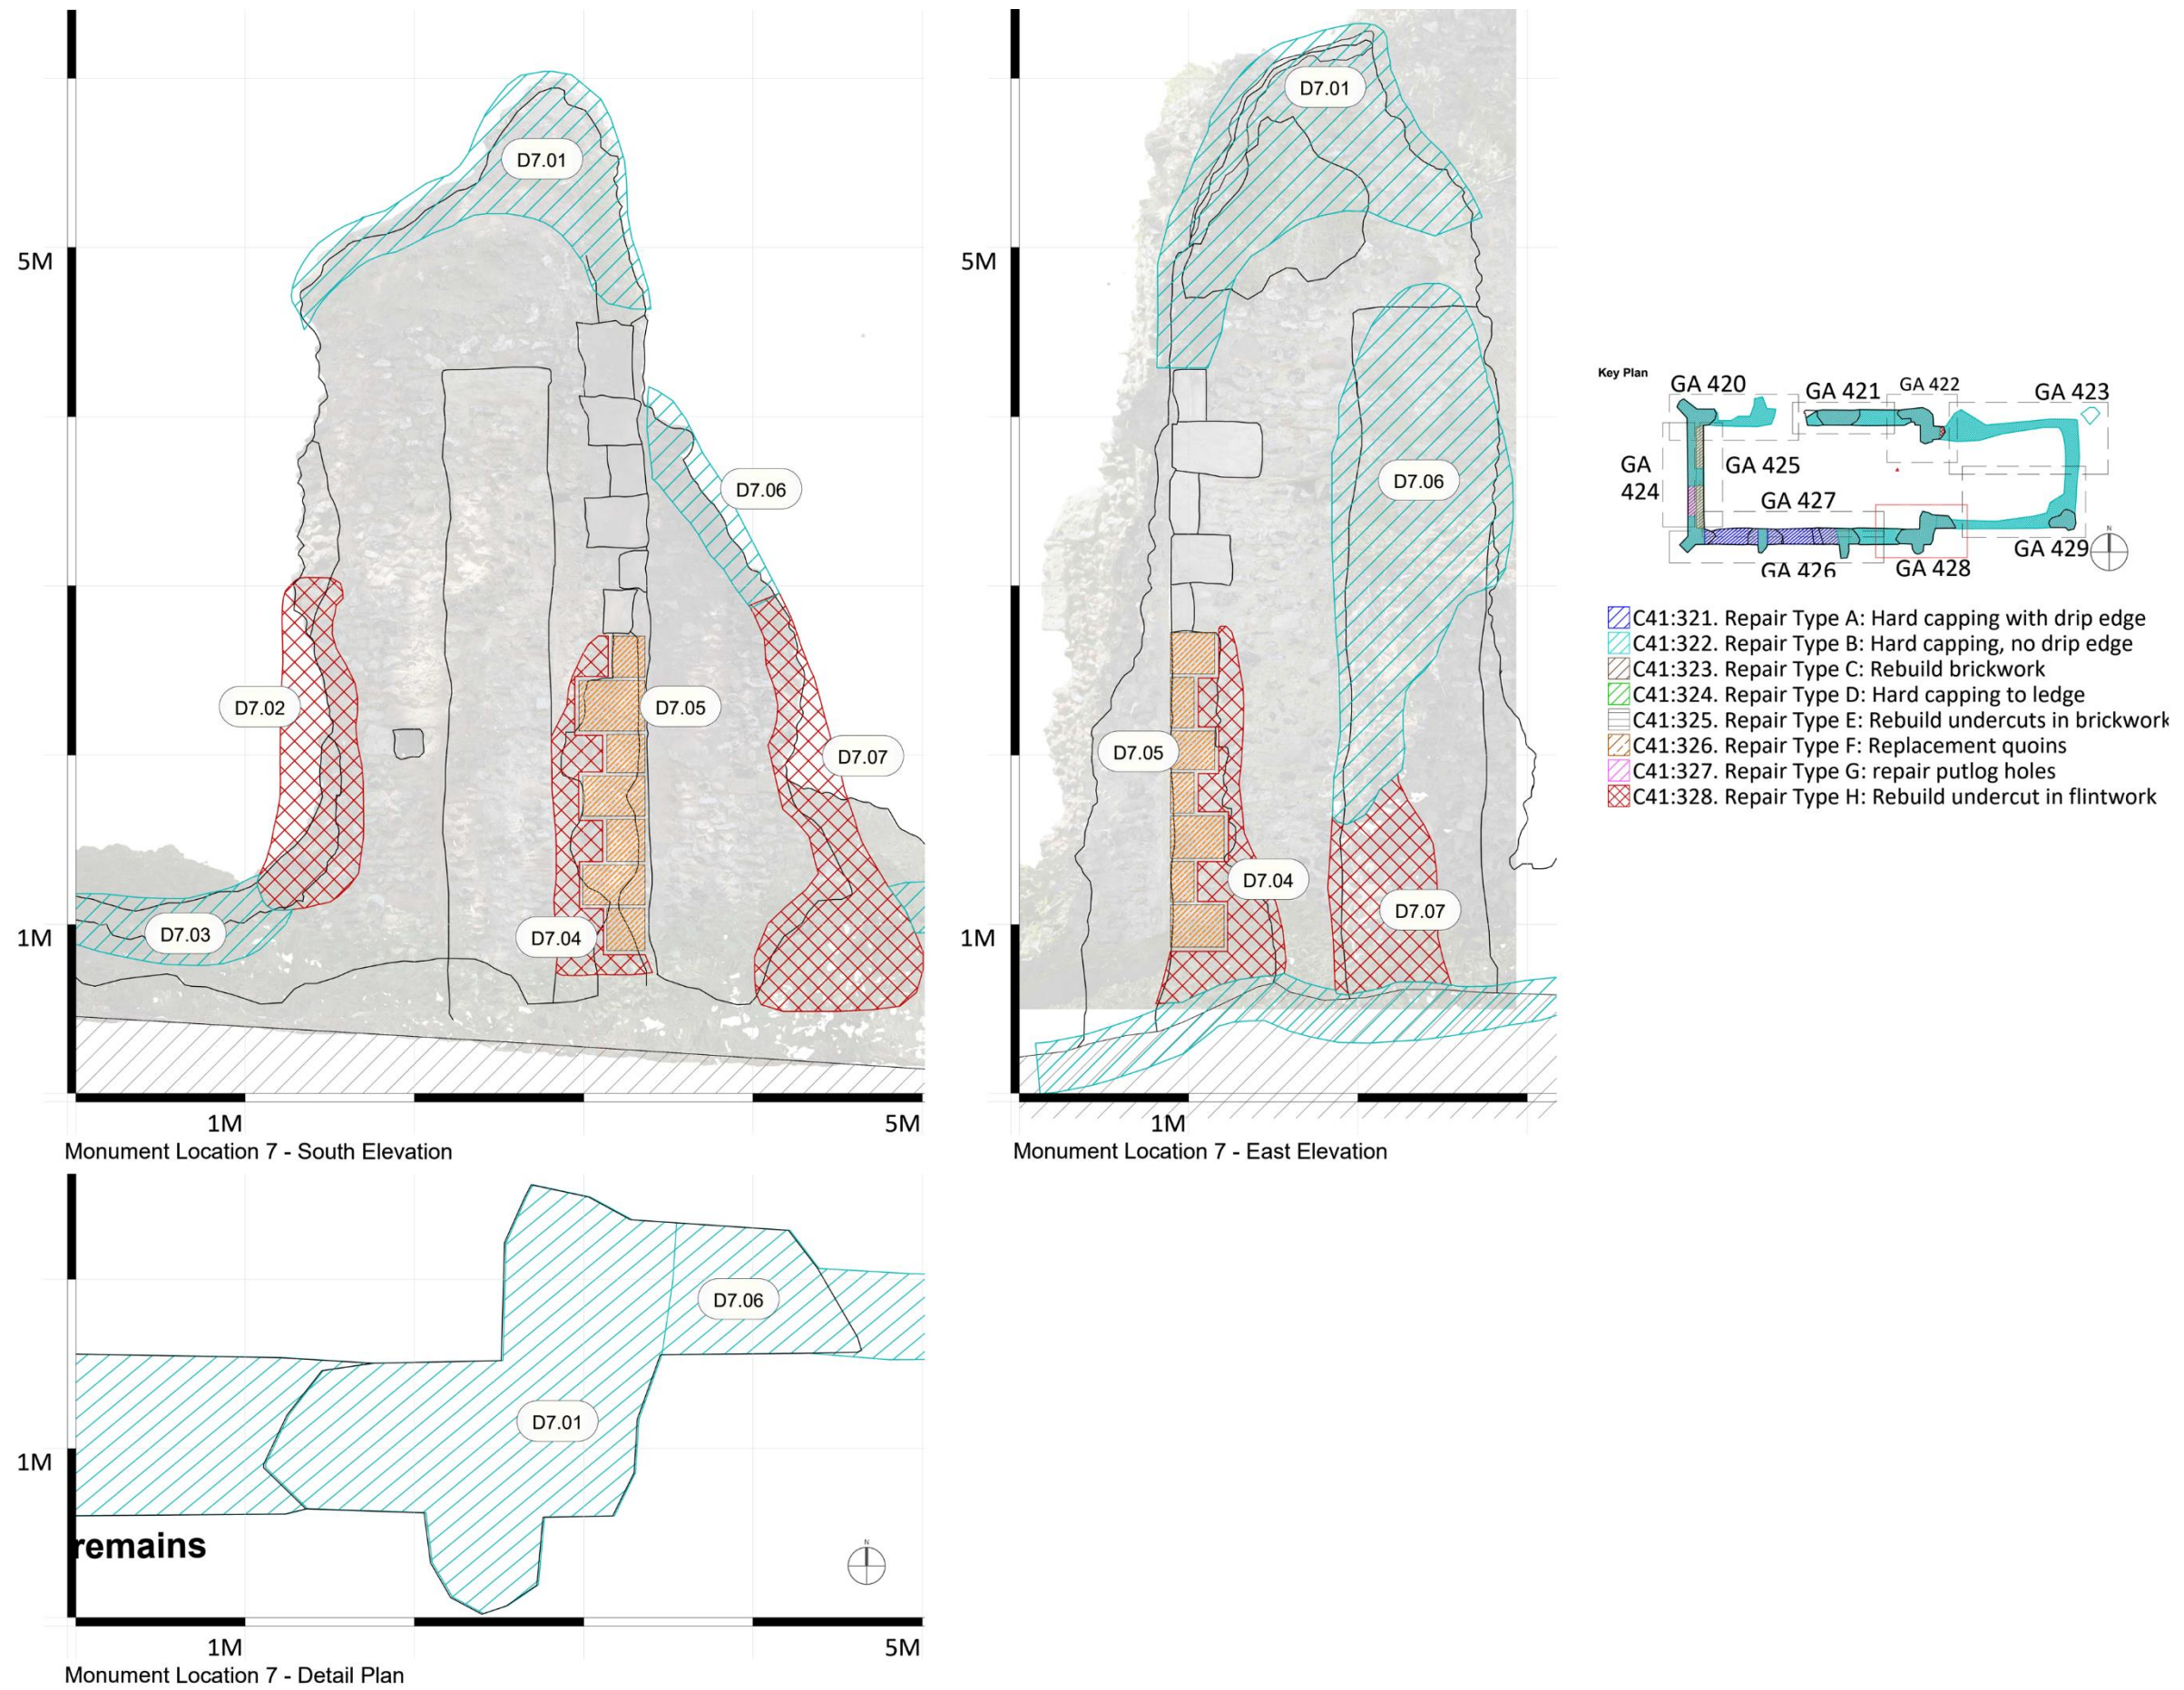
Figure 20: Works undertaken to the southeast nave corner (scale 1:40)
