# Historic Building Recording at the former Anchor Brewery, Mill Road Oundle, Northamptonshire May 2015 – March 2016

Report No. 16/51  
Author & Illustrator: Amir Bassir

© MOLA Northampton 2016  
Project Manager: Amir Bassir  
Planning ref: 15/01967/FUL  
NGR: TL 03740 87920  
Event No. ENN108310

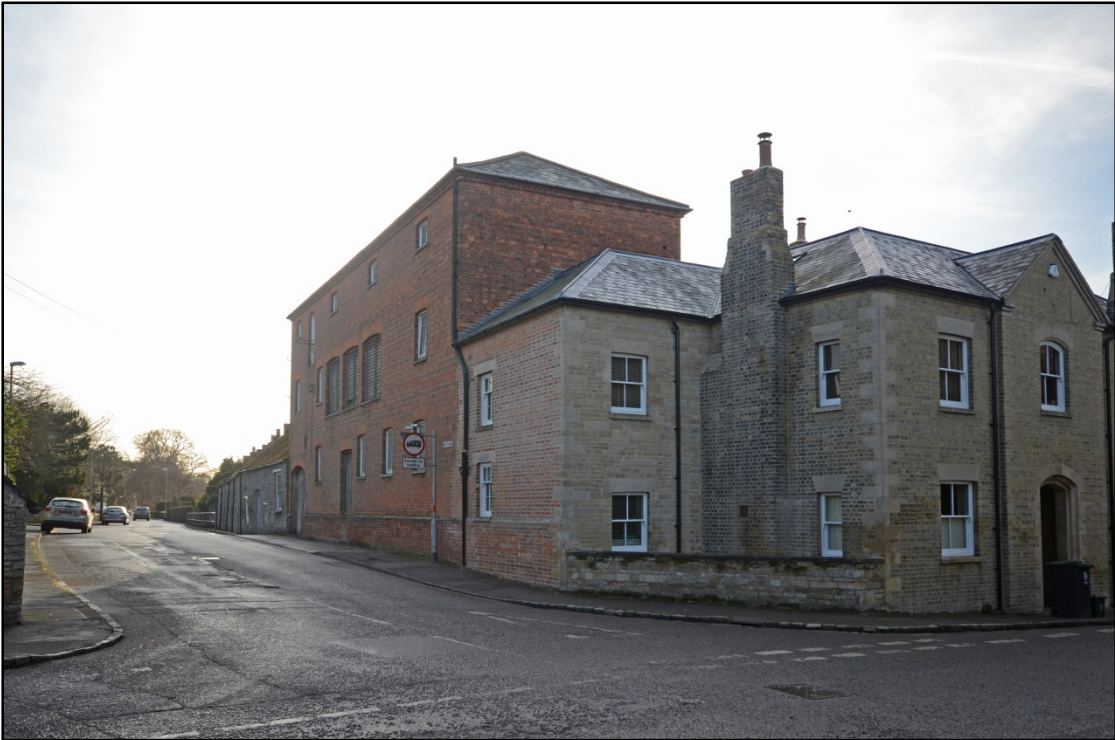
General view of the Brewery, looking south-east Fig 9

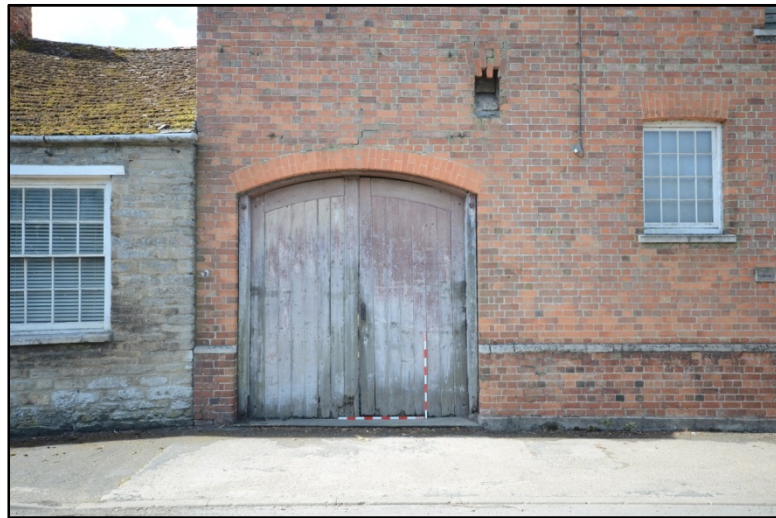
A narrow, sloping chute is located just above and to the west of the carriage arch door. This has a rectangular opening with a damaged flat arch over. The chute opens at first-floor level, close to the access stair, near the firebox. It was used for discarding spent grain from the first-floor copper into a cart or barrel outside the building.

Carriage arch with chute over Fig 12

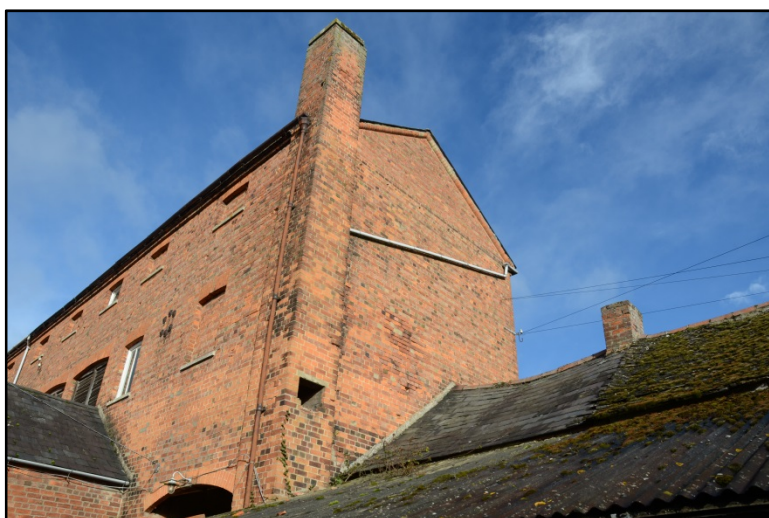
The east gable elevation similarly has no openings and comprises plain brickwork. The dentil course seen at the eaves of the north and south elevations are here replaced with inverted bullnose bricks. The line of a former drain pipe can be seen running horizontally from the eaves to the chimney with a downpipe descending to the ground. The modern drainage runs diagonally across the elevation from the corner of the roof with an uPVC downpipe located alongside the brackets of a now removed pipe. The brickwork above the south pitch of the cottage roof indicates that a rectangular cistern or tank was formerly attached to the wall alongside the former downpipe, to which it probably connected.

East elevation of the Brewery Fig 15
