St Paul's Cathedral: archaeological recording of installation of new lift and external cleaning, 2006–11

Sitecode: PUF06

**John Schofield
Cathedral Archaeologist**

August 2011

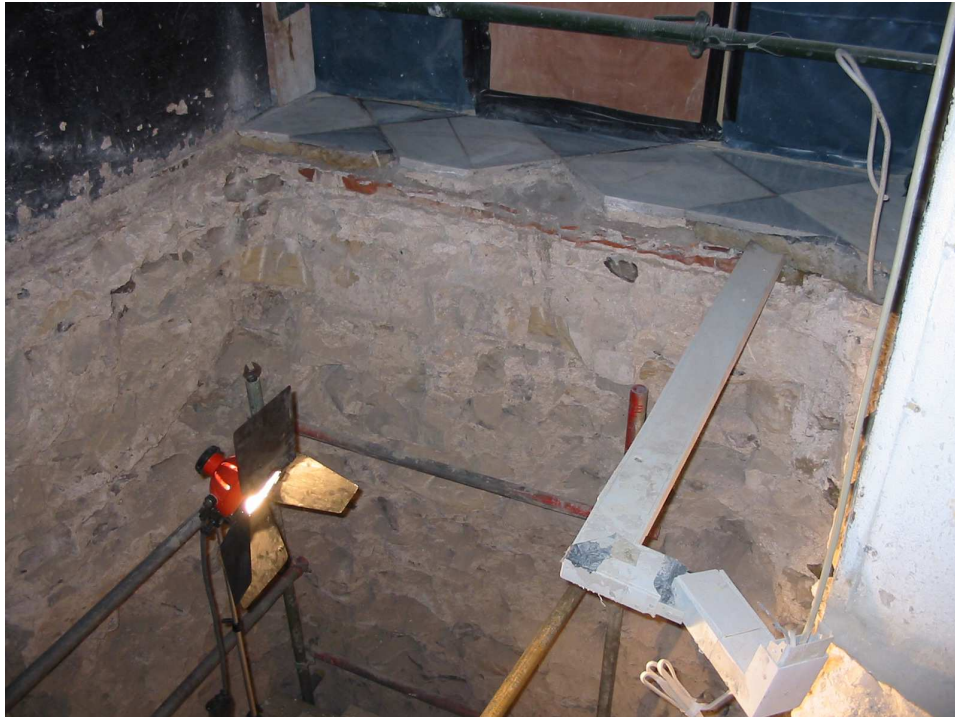
identifiable course of squared stones within the foundation; no special structural purpose is attached to these, and they may only have been a course within the foundation. They did not appear in the north or south sides of the excavated area (see Fig 11).

Fig 11 Section 1 viewed from the south-east, at church floor level with the boards above removed, showing the paving of 1705–9 in the passage

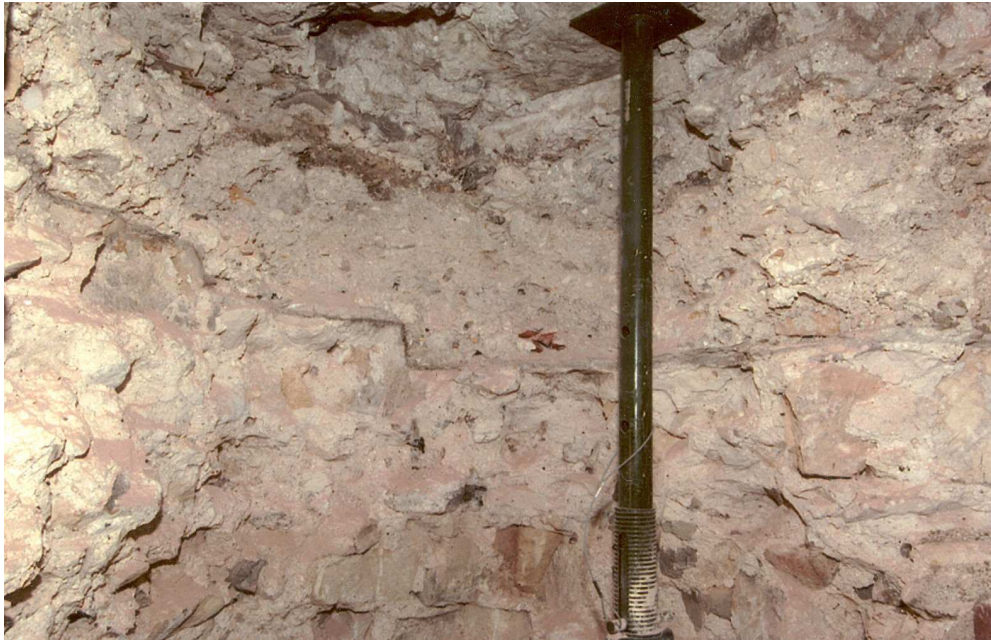
The dark line was clearly the trace of a former or first phase stair. The sharp corners of the three outlines of risers indicates that steps were formerly in place, but were later removed. It is possible that these were timber steps, but equally likely that they were stone.

Fig 12 Evidence of first phase stair line showing in the masonry beneath the stair (for explanation see Fig 13) (MoLAS neg 19807016)

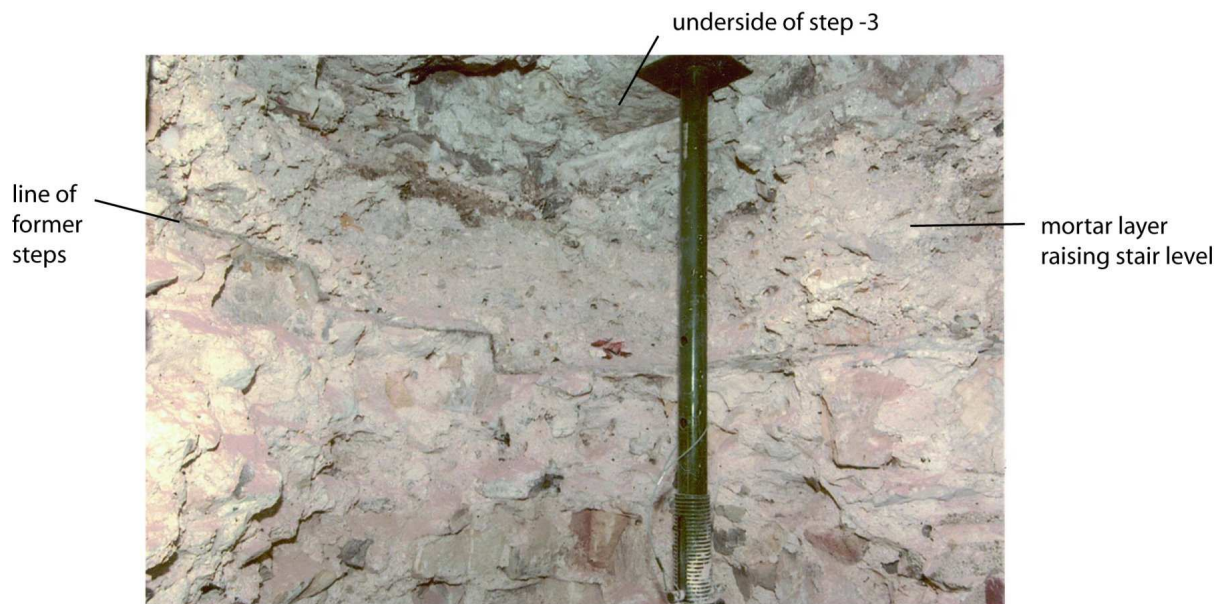
Above this line was a layer or dump of fine gray mortar including chips of chalk and brick, with charcoal flecks. This infill was approximately 0.6m thick where seen at the south end (the right hand side of Fig 12) and 0.57m thick below what had been step -1, the first step down from the landing.

Fig 13 Annotated version of Fig 12

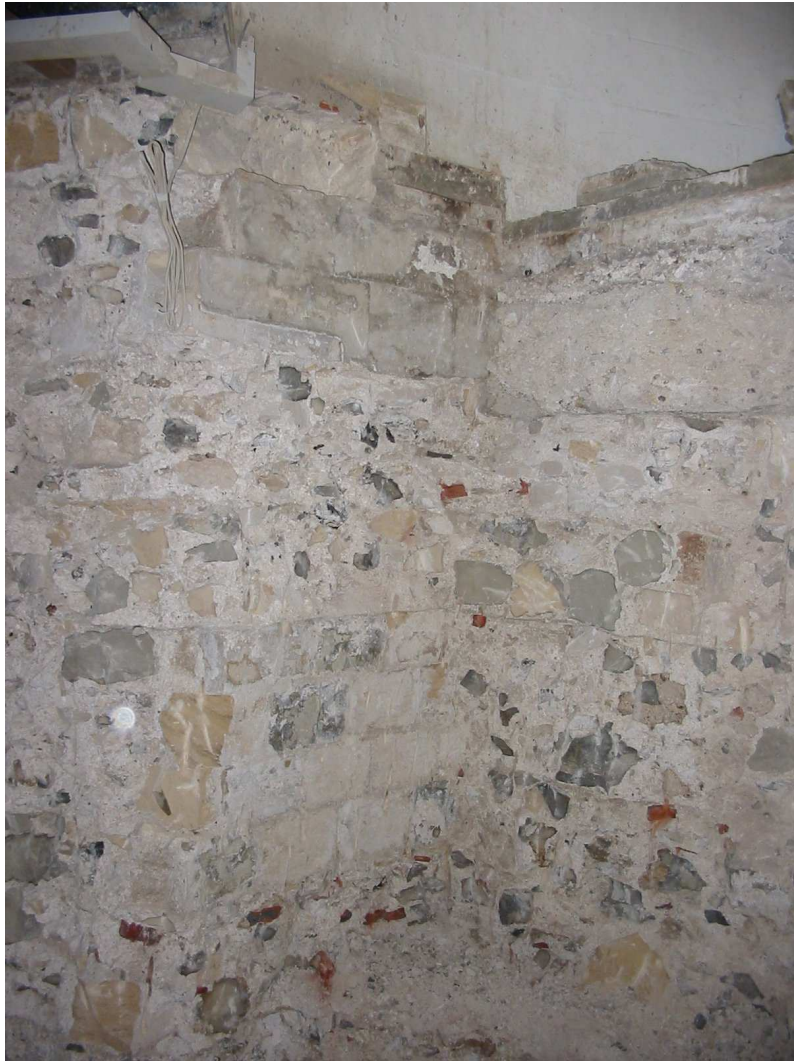
Fig 14 Section 2 of masonry, looking north-east (for explanation see Fig 15)

1. The masonry of the nave wall, together with similar masonry beneath the stair. Within this masonry is the lower section of apparent ashlar walling seen in Section 2 (Fig 14 and Fig 15). The function of these five courses of ashlar cannot be suggested.

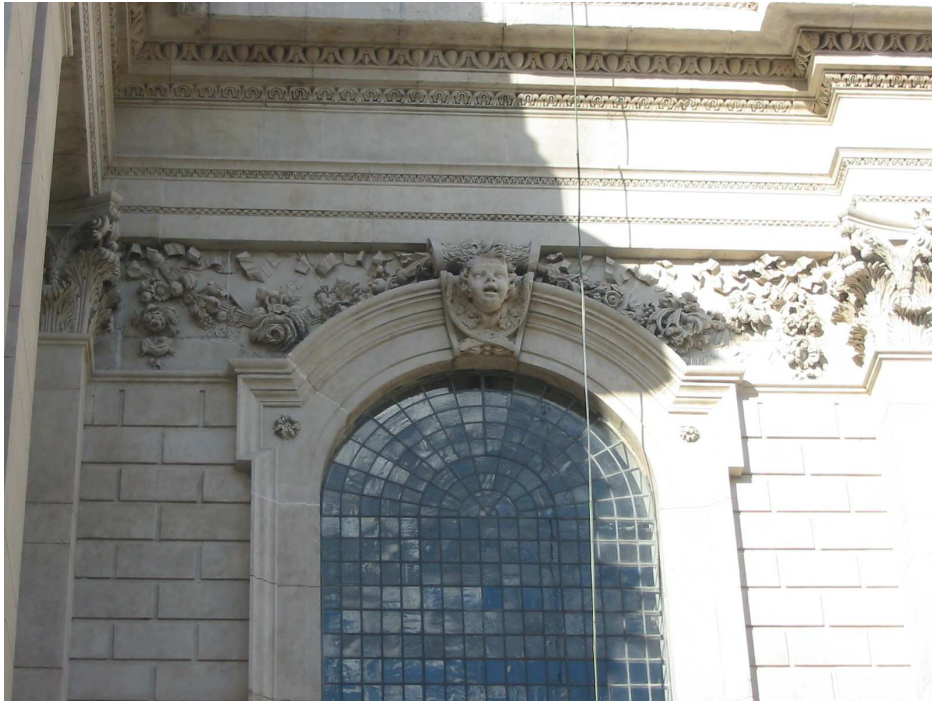
Fig 22 Bay SN3 after cleaning

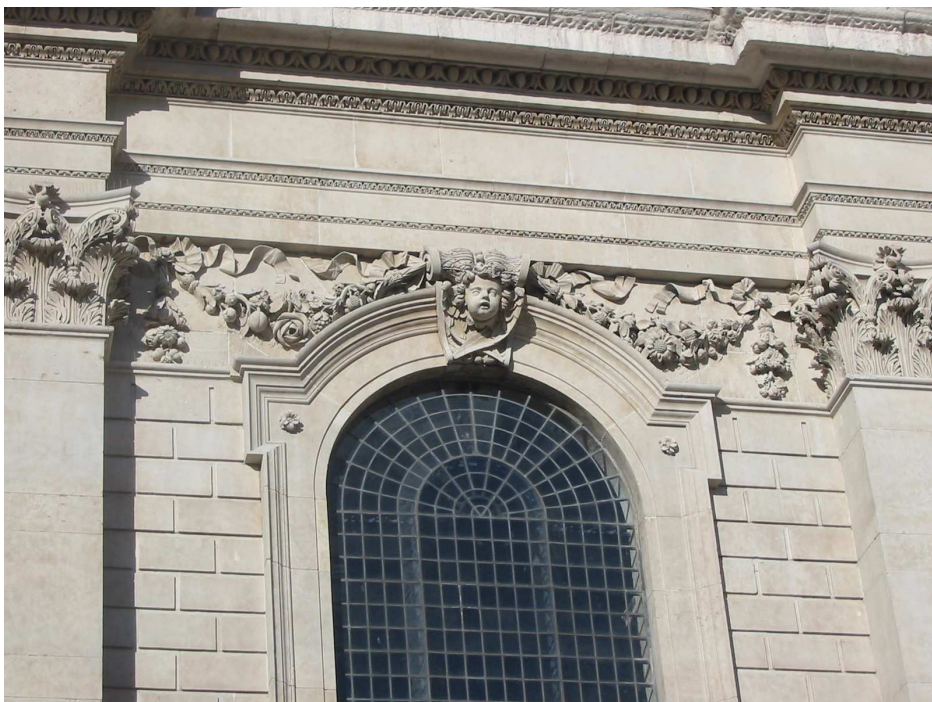
Fig 23 Bay SN2 after cleaning

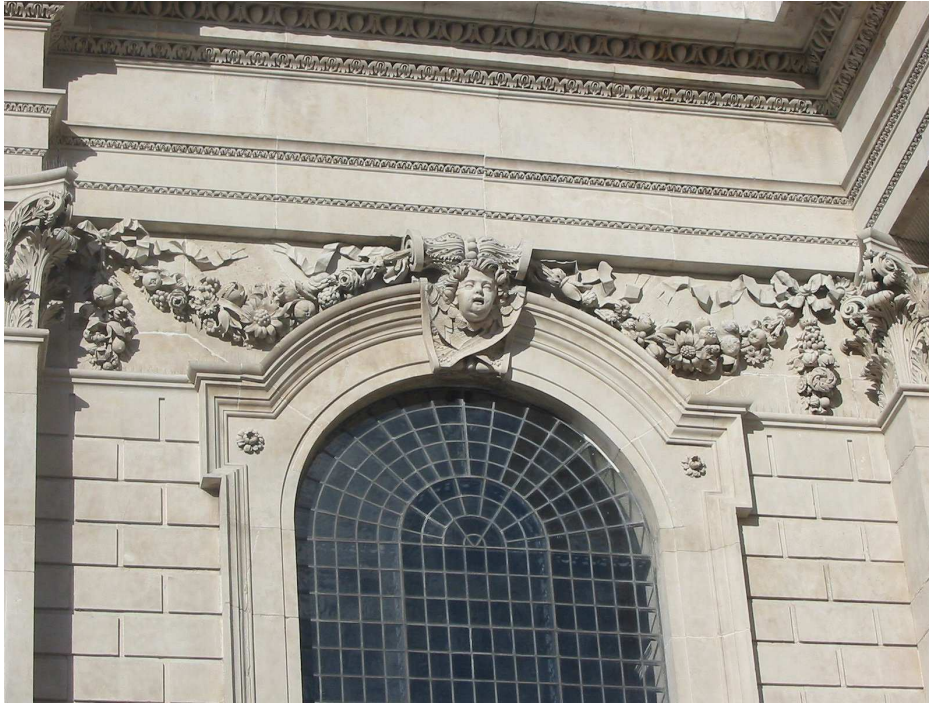
Fig 24 Bay SN1 after cleaning

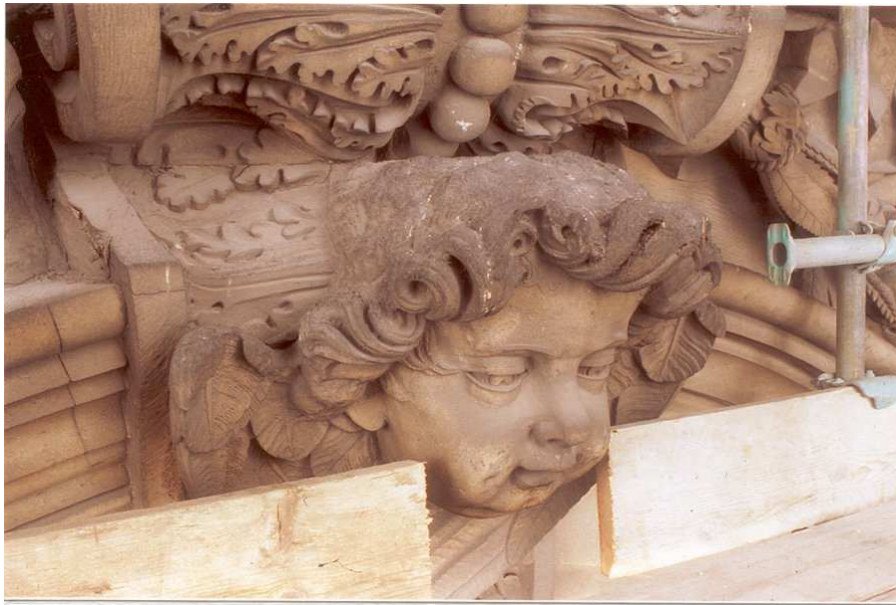
Fig 26 Cherub's head above window SN1, before cleaning, January 2007 (MoLAS neg 00107006)

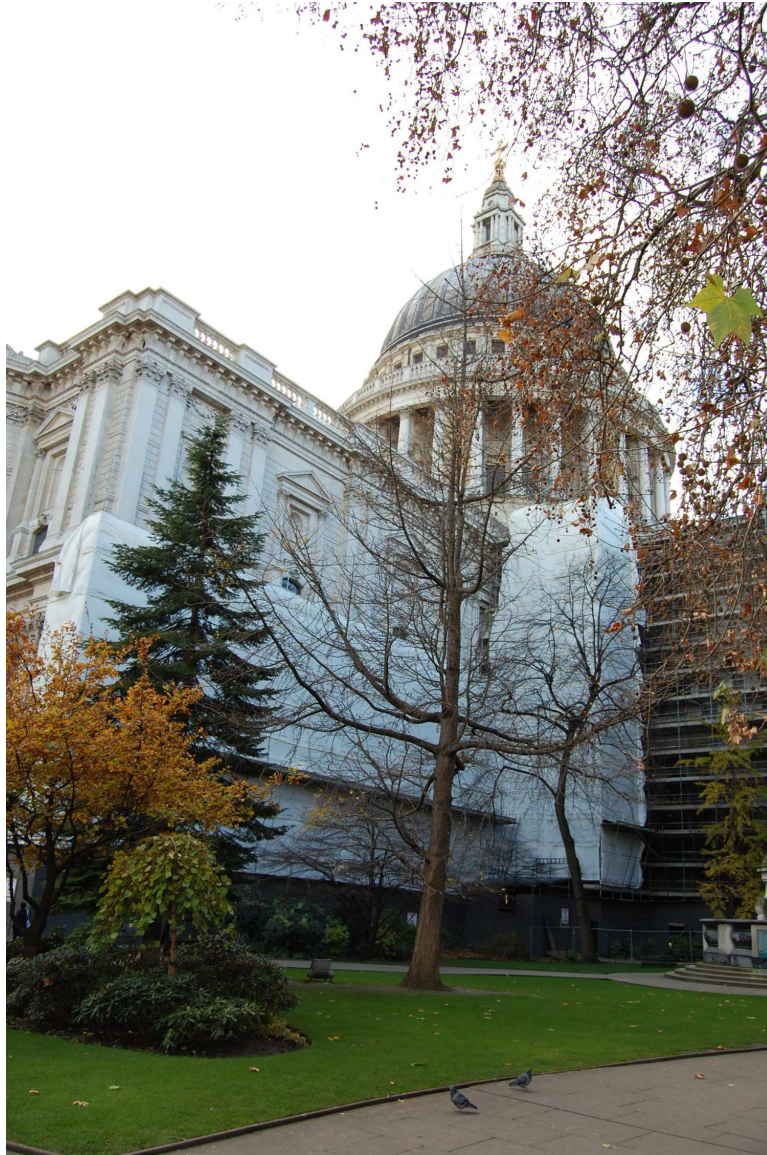
Fig 30 The north choir elevation in December 2008, as the scaffolding and plastic covering was being removed in stages

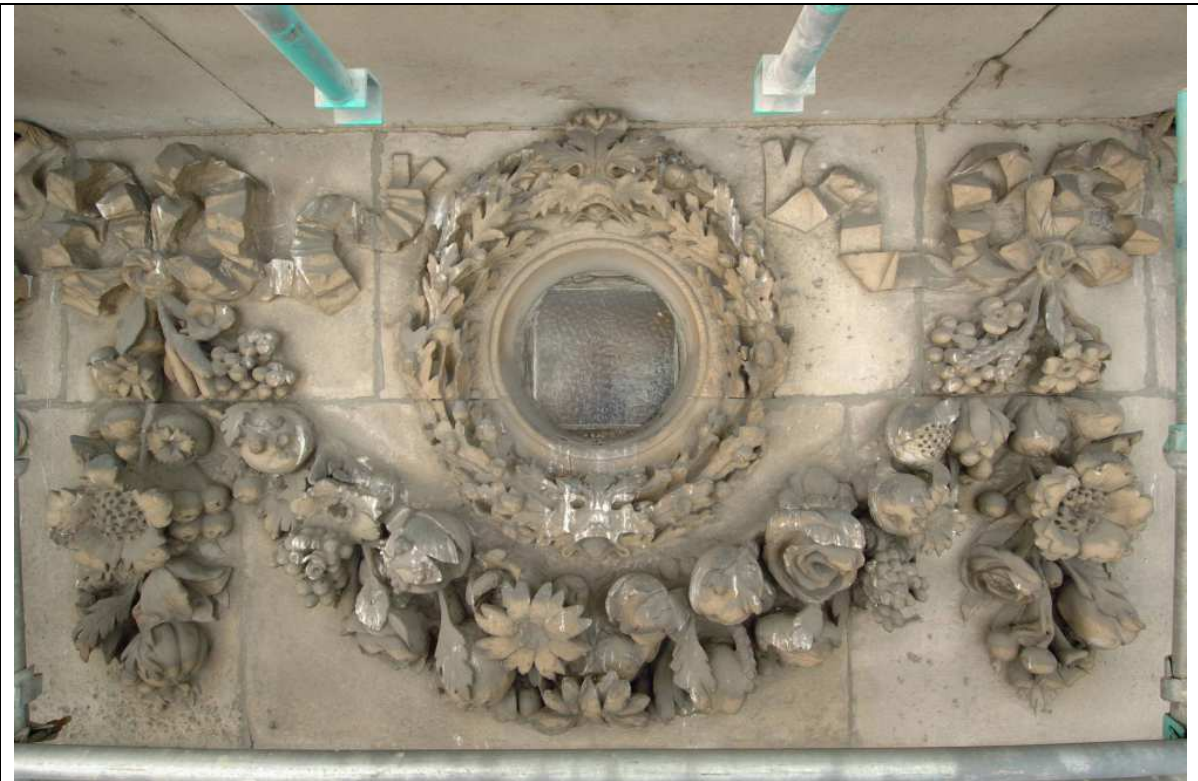
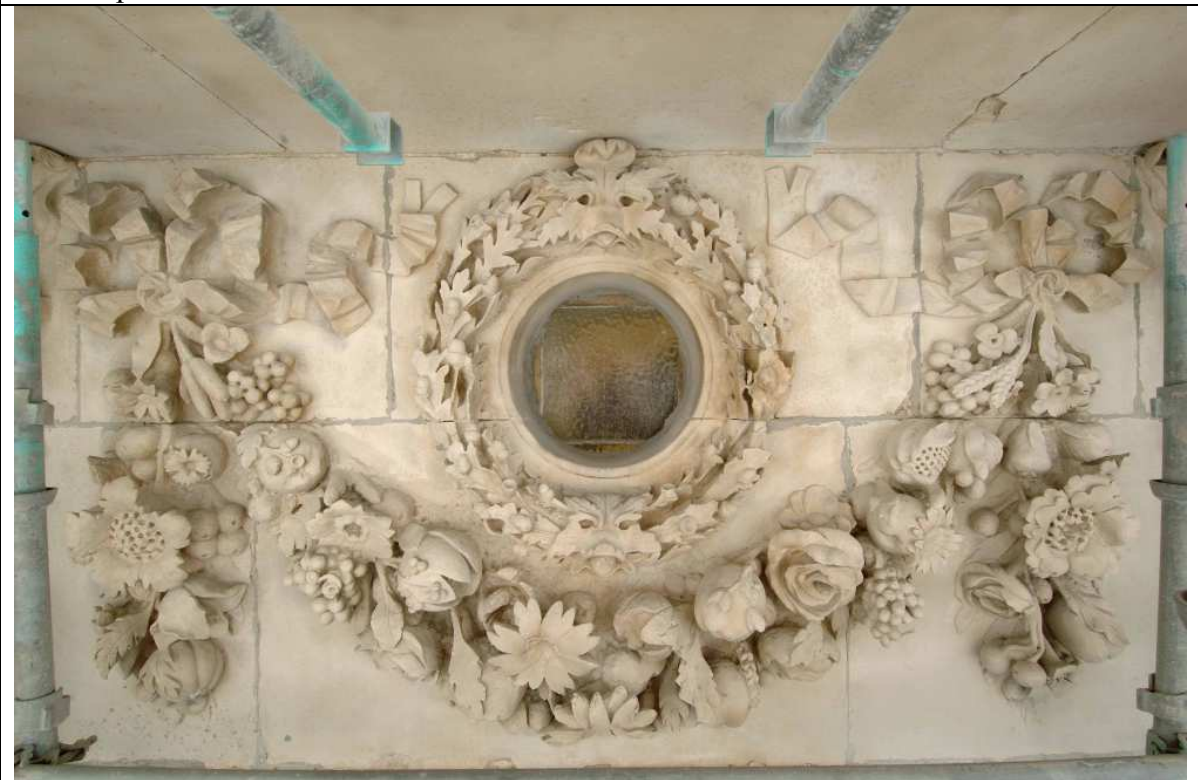
Fig 31 Bull's eye window and swag in bay NC1A before and after cleaning (all north nave elevation photographs are looking south)

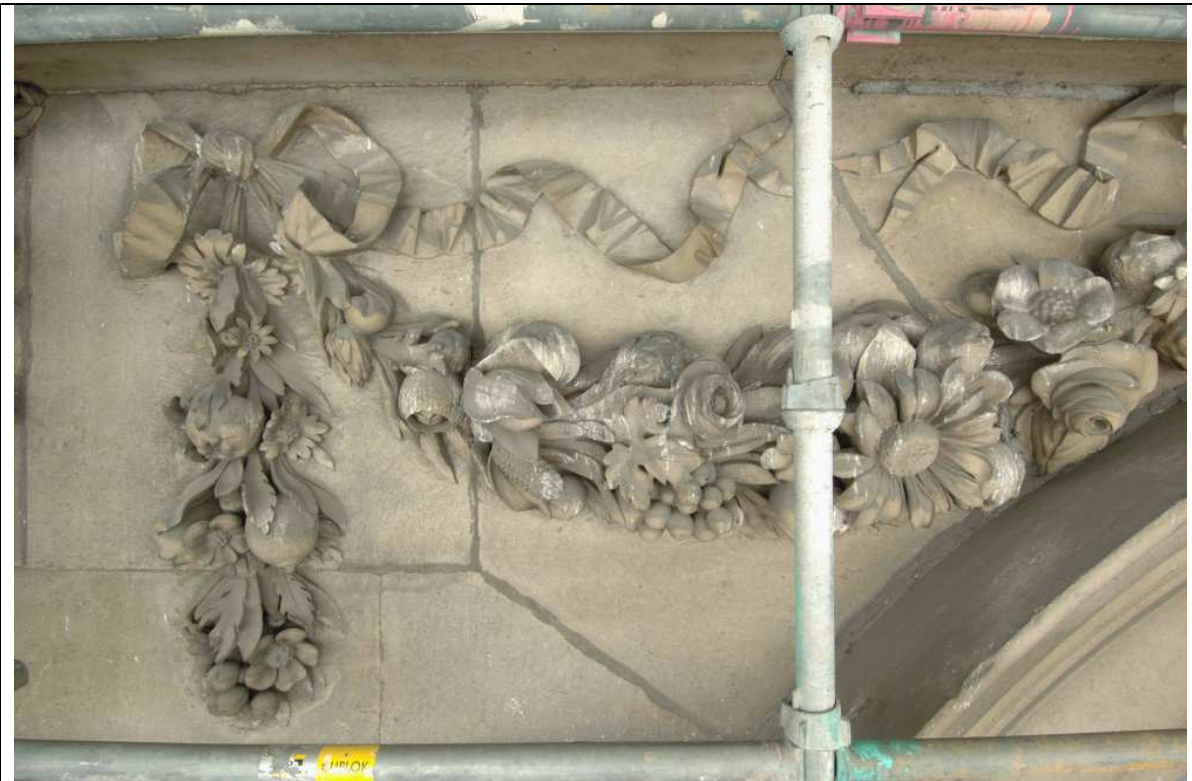
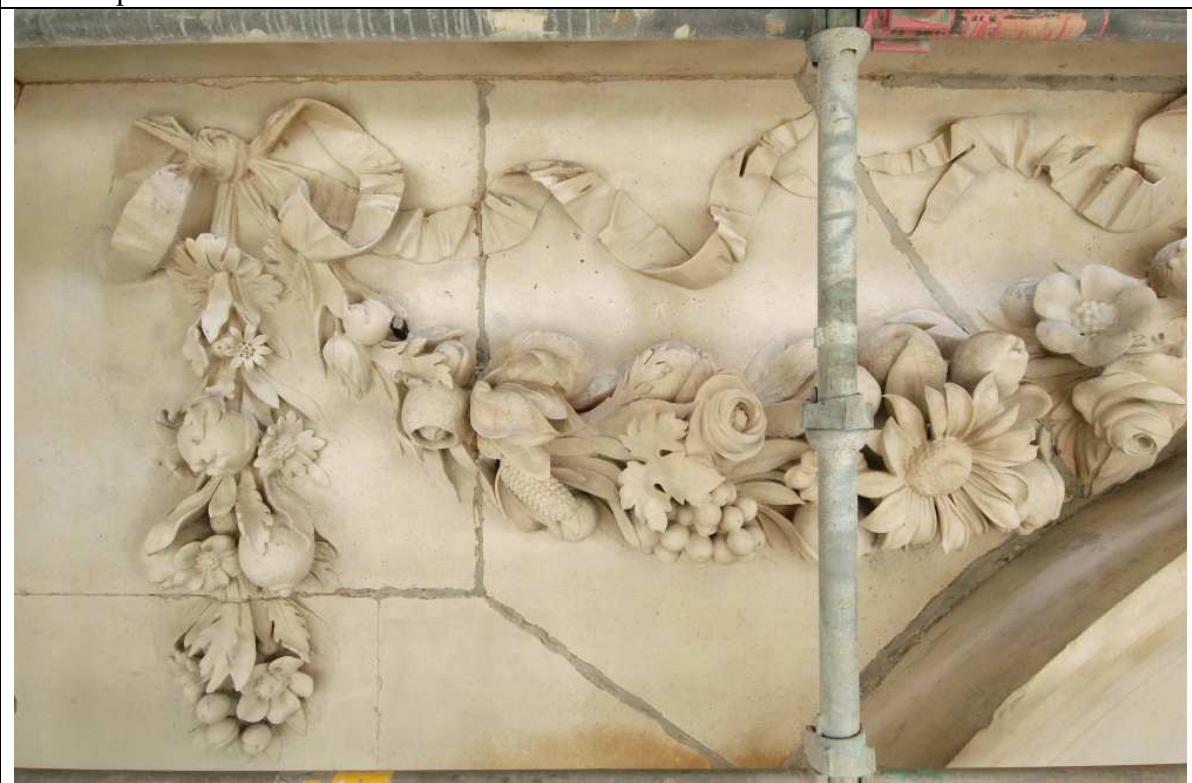
Fig 32 Swag in bay NC1B, east side of window

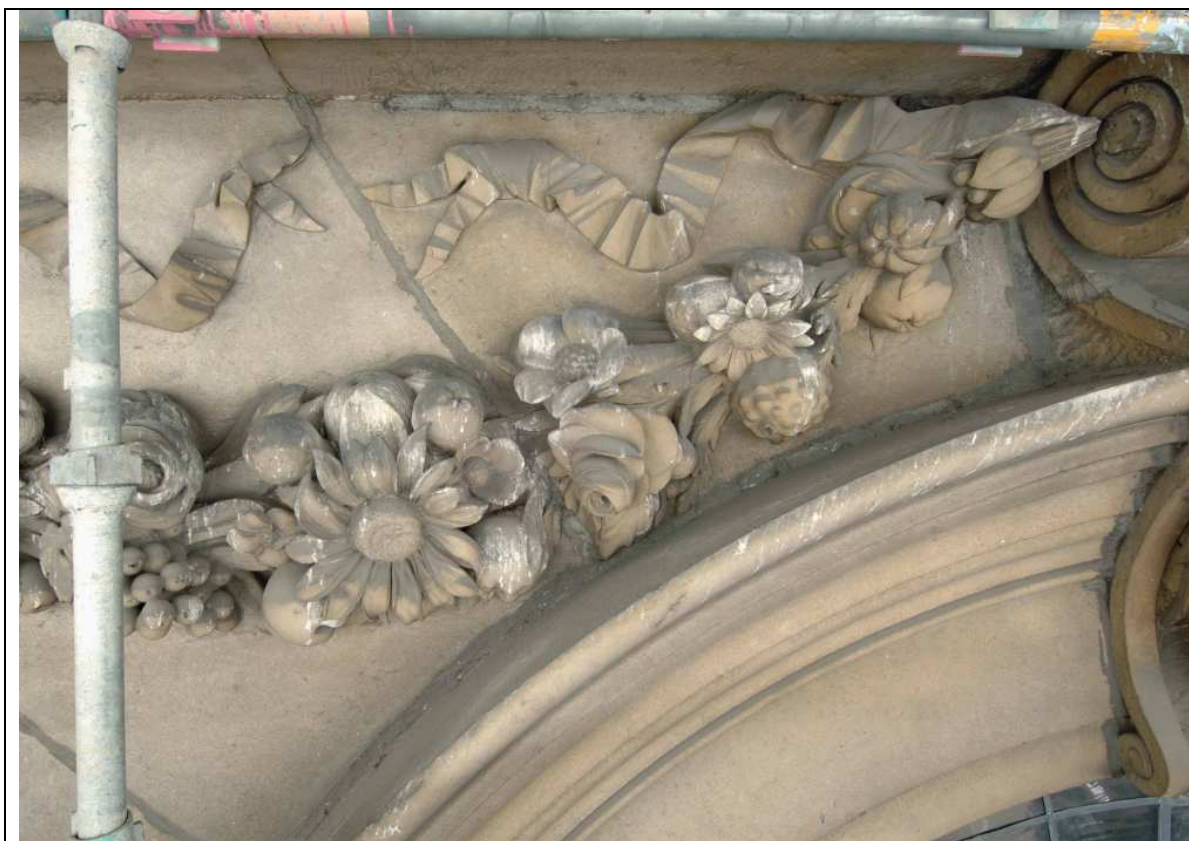
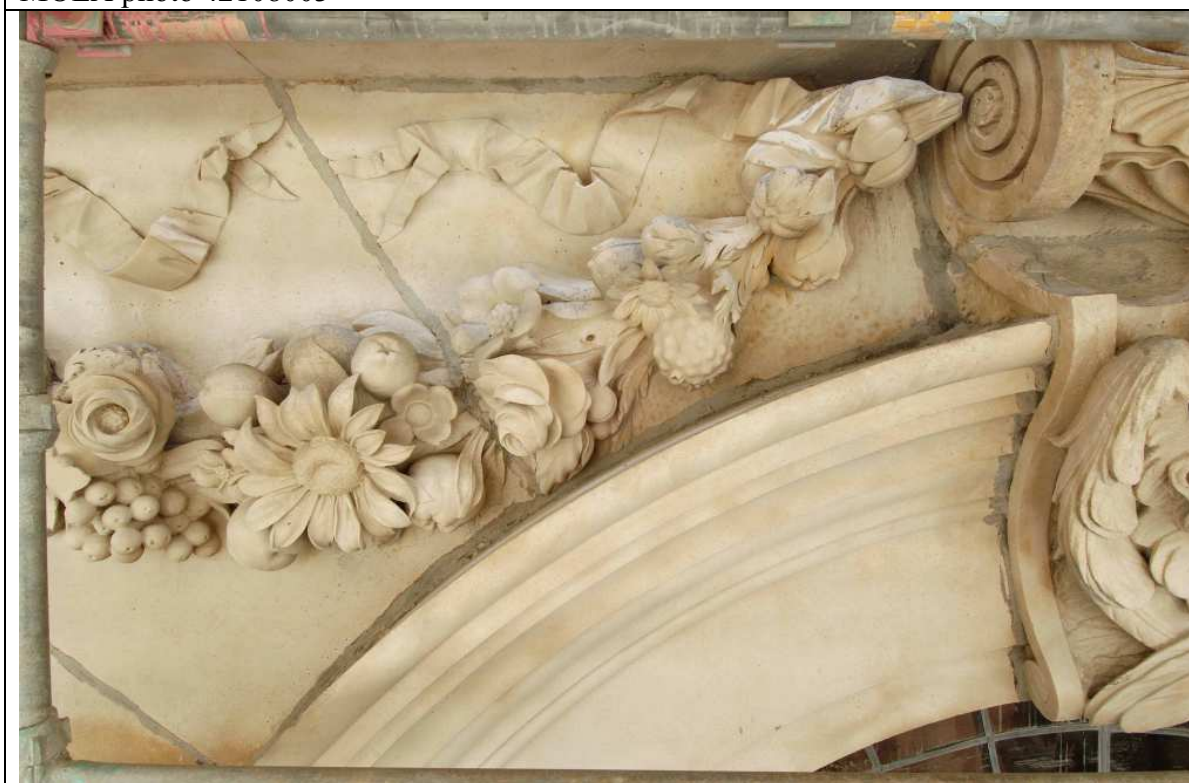
Fig 33 Swag in bay NC1B, east side of window

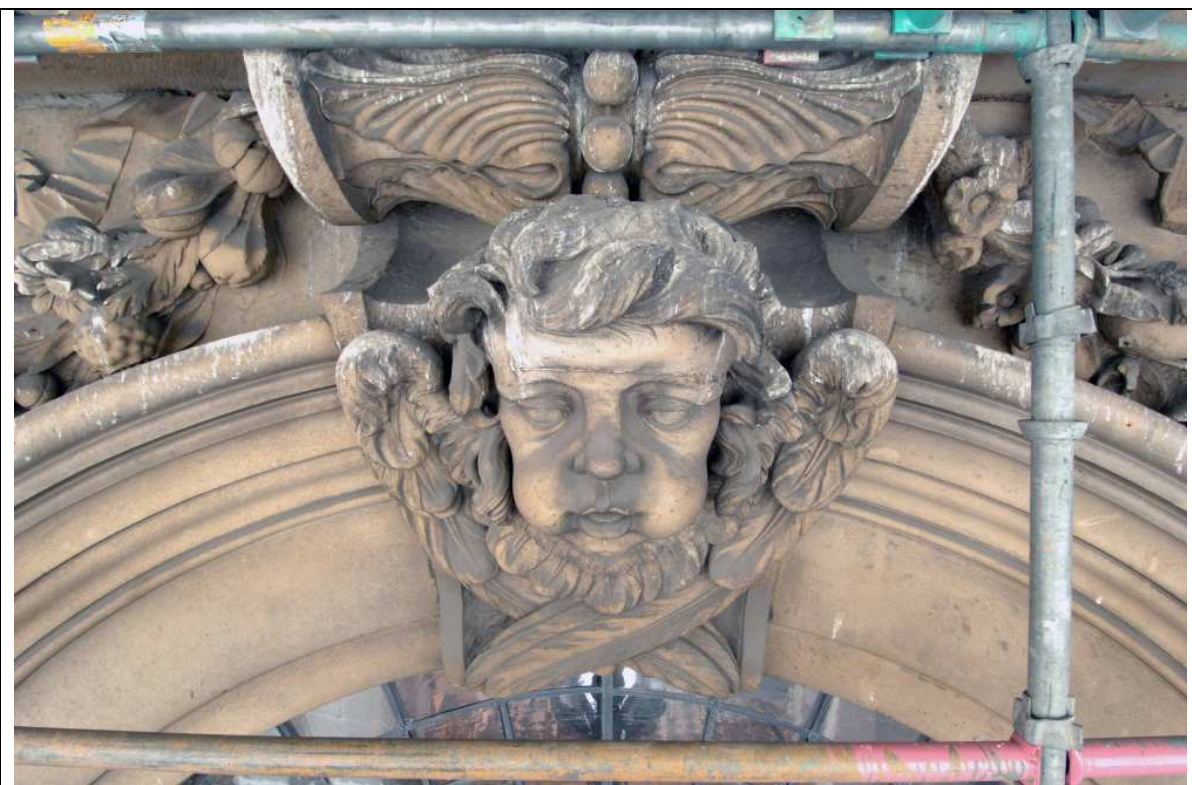
Fig 34 Cherub keystone in bay NC1B

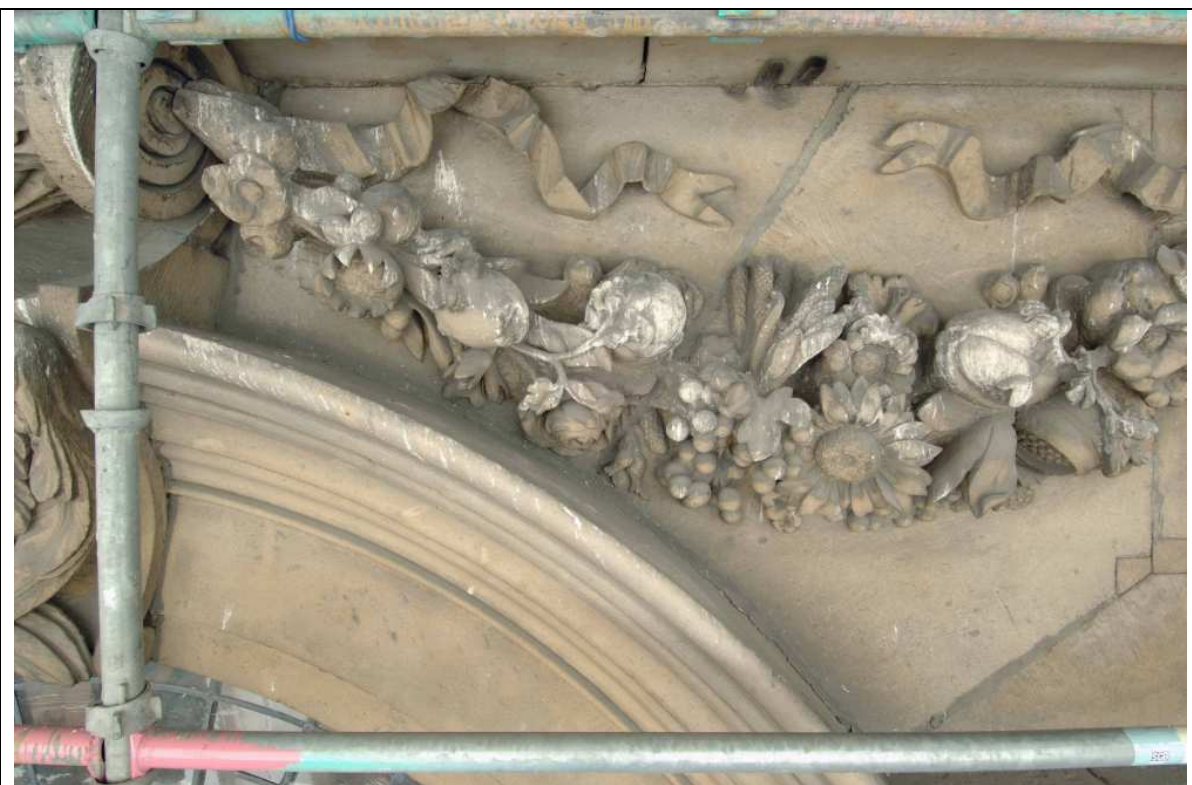
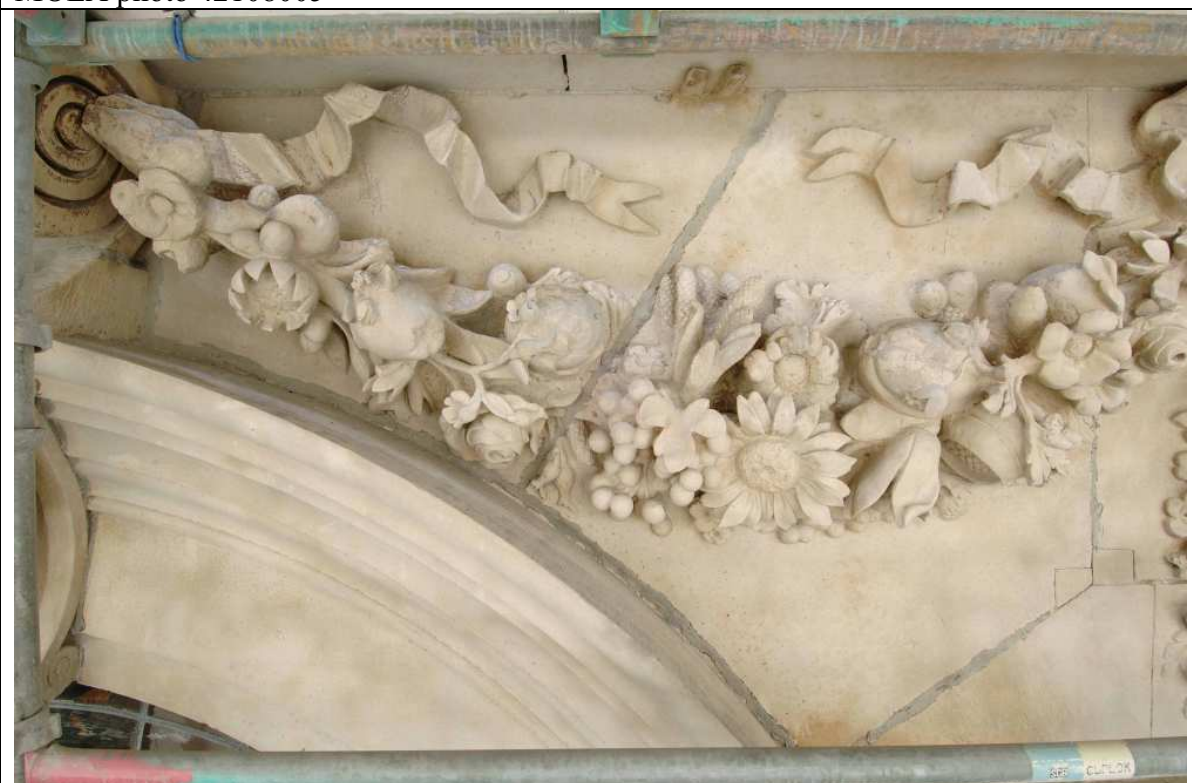
Fig 35 Swag in bay NC1B, west side of window

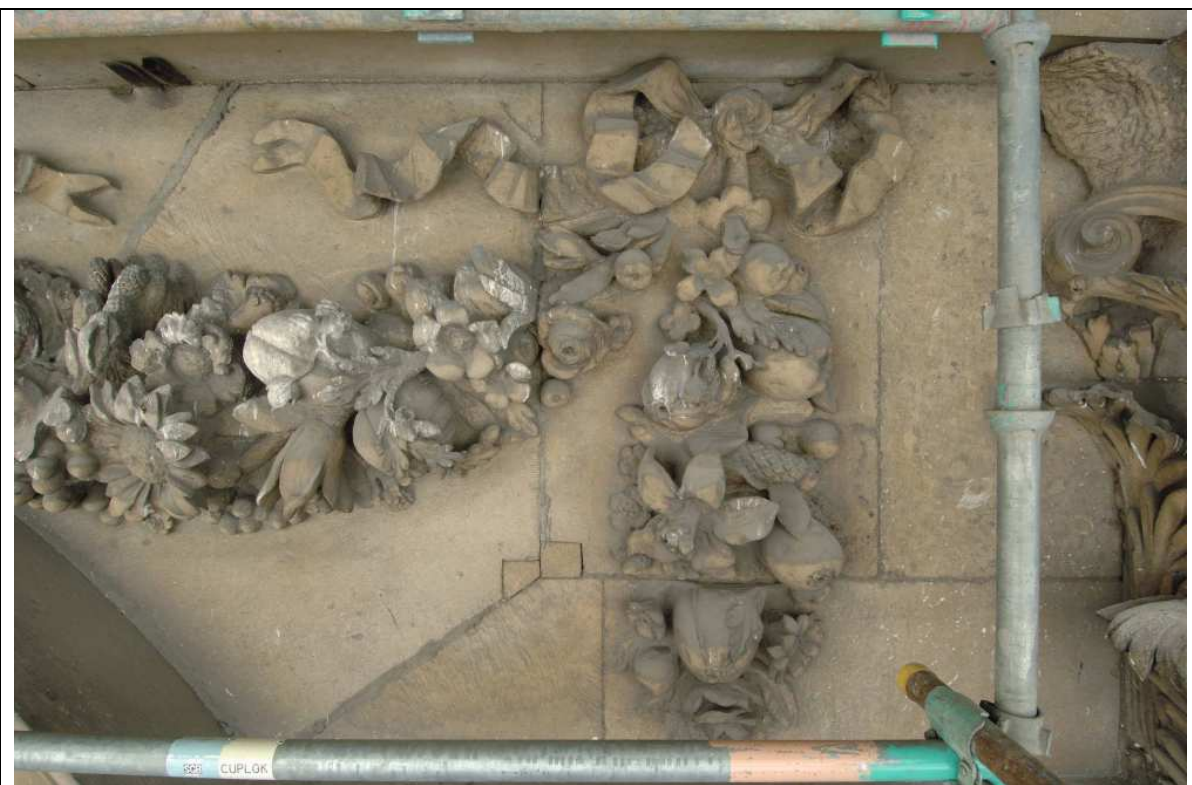
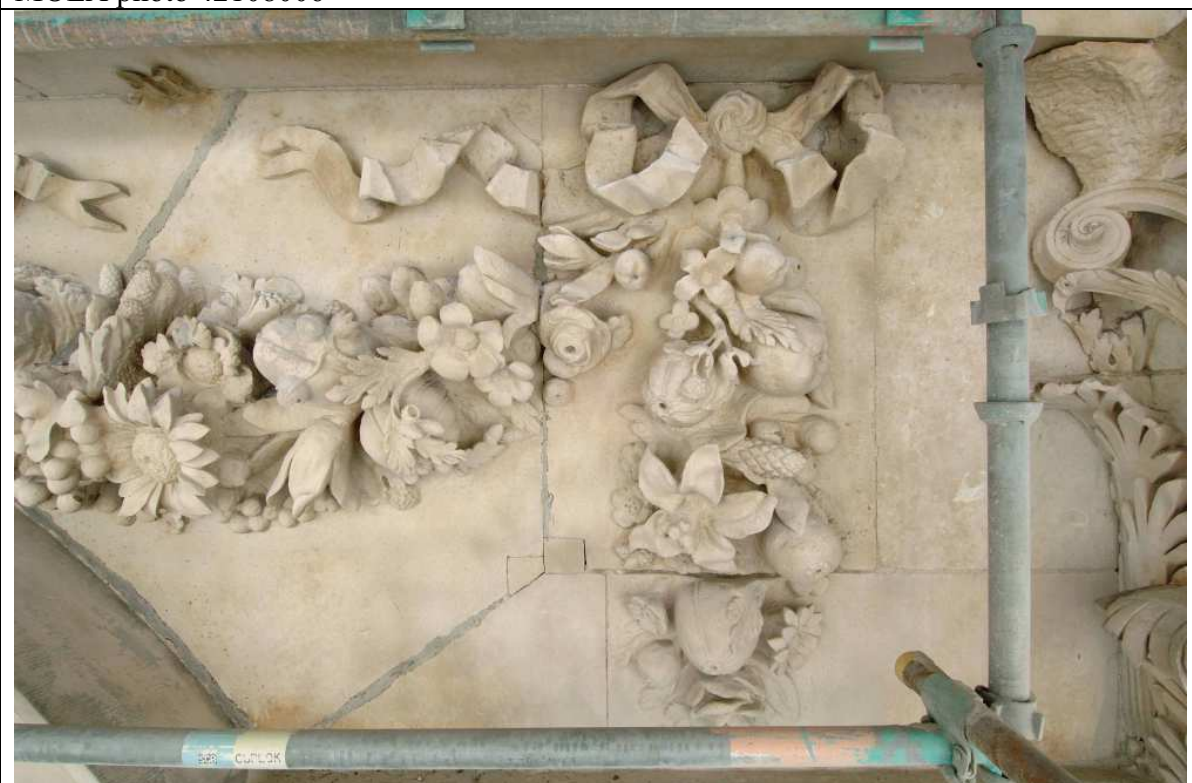
Fig 36 Swag in bay NC1B, west side of window

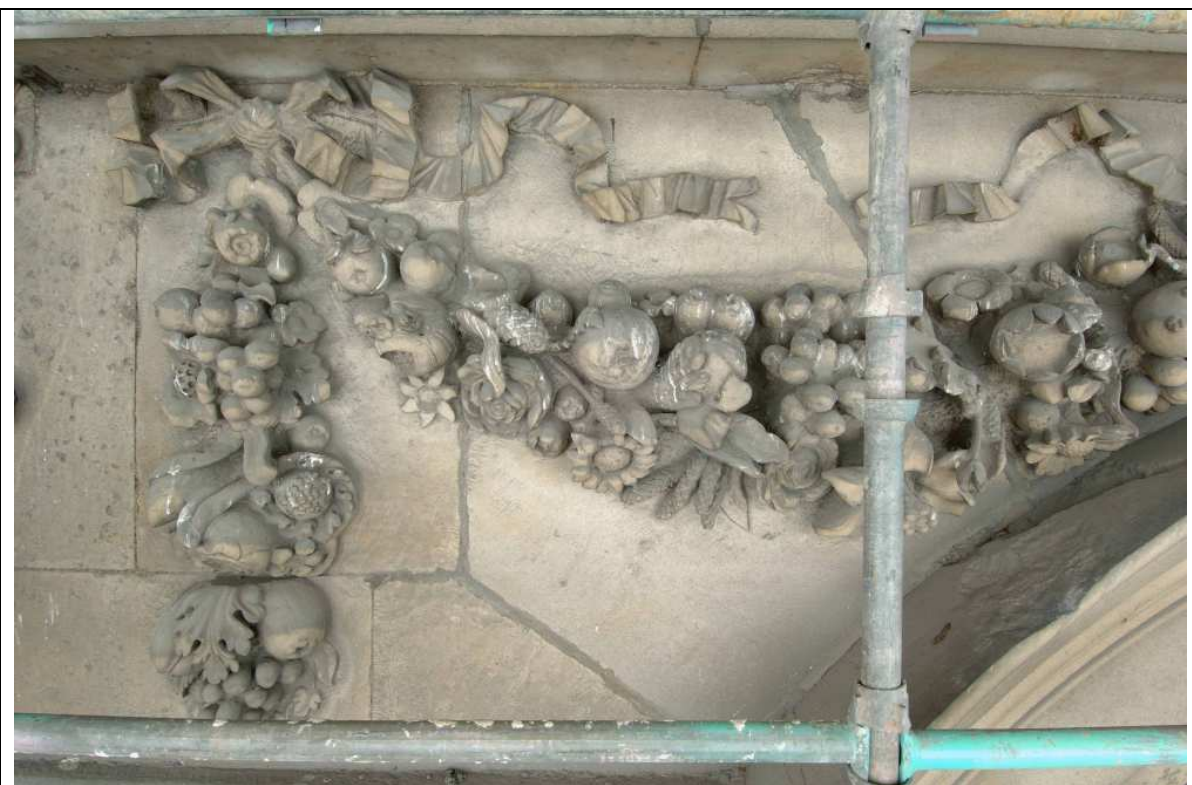
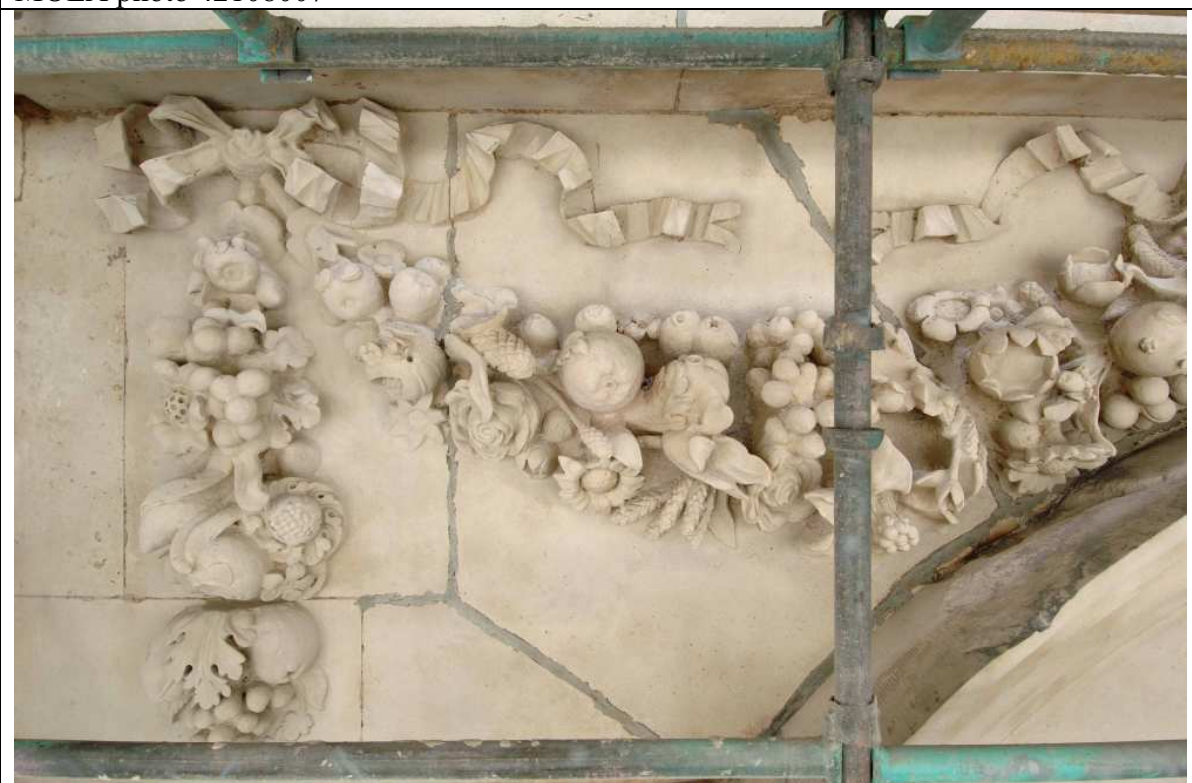
Fig 37 Swag in bay NC2, east side of window

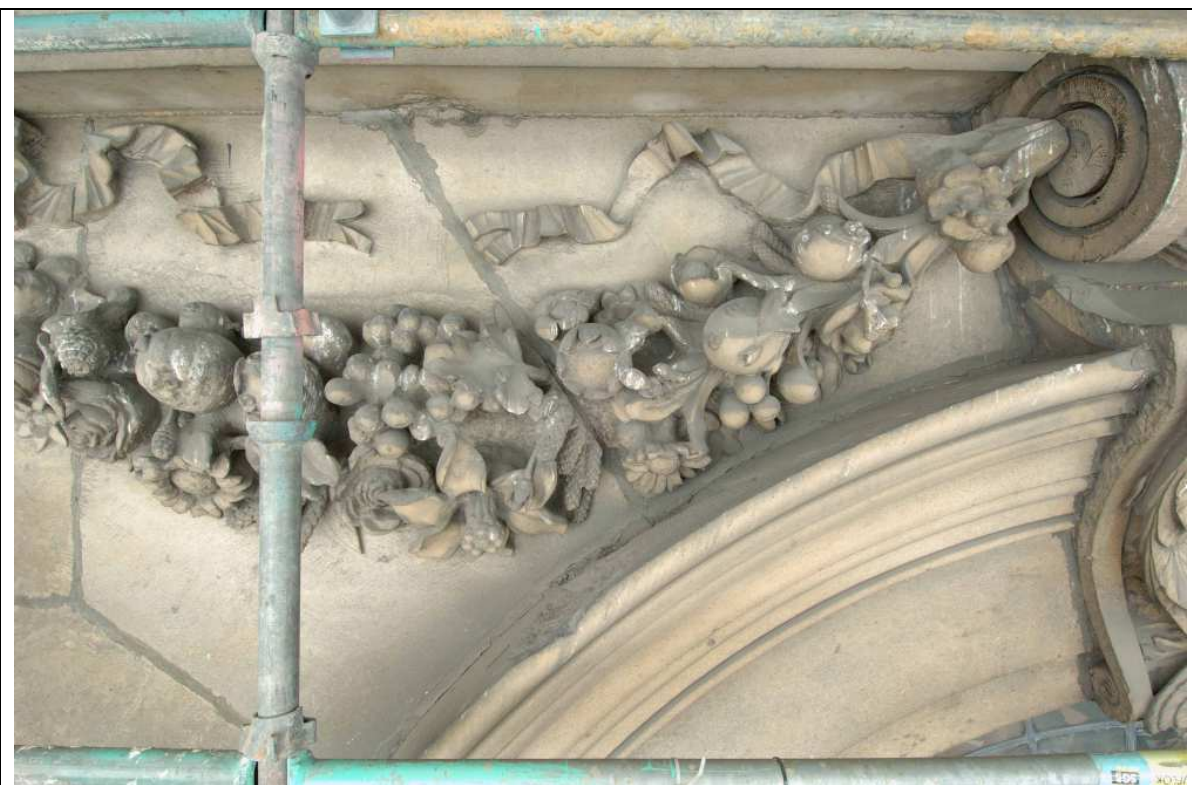
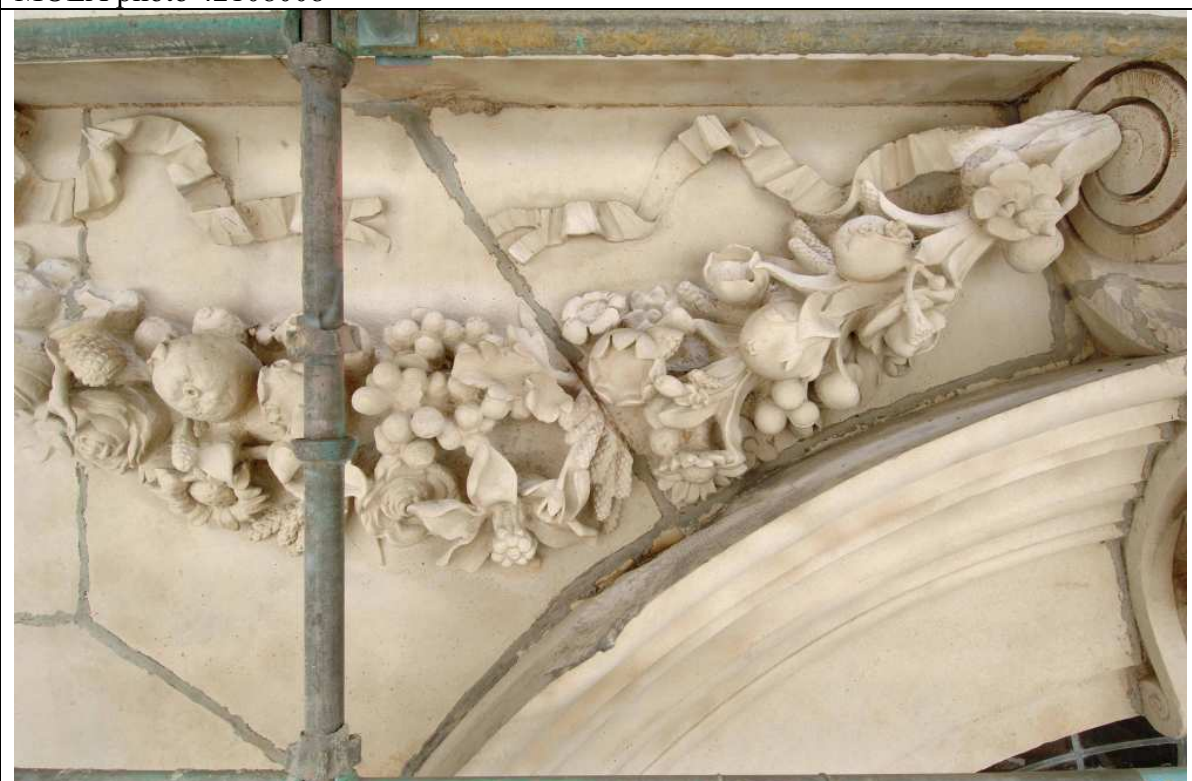
Fig 38 Swag in bay NC2, east of window

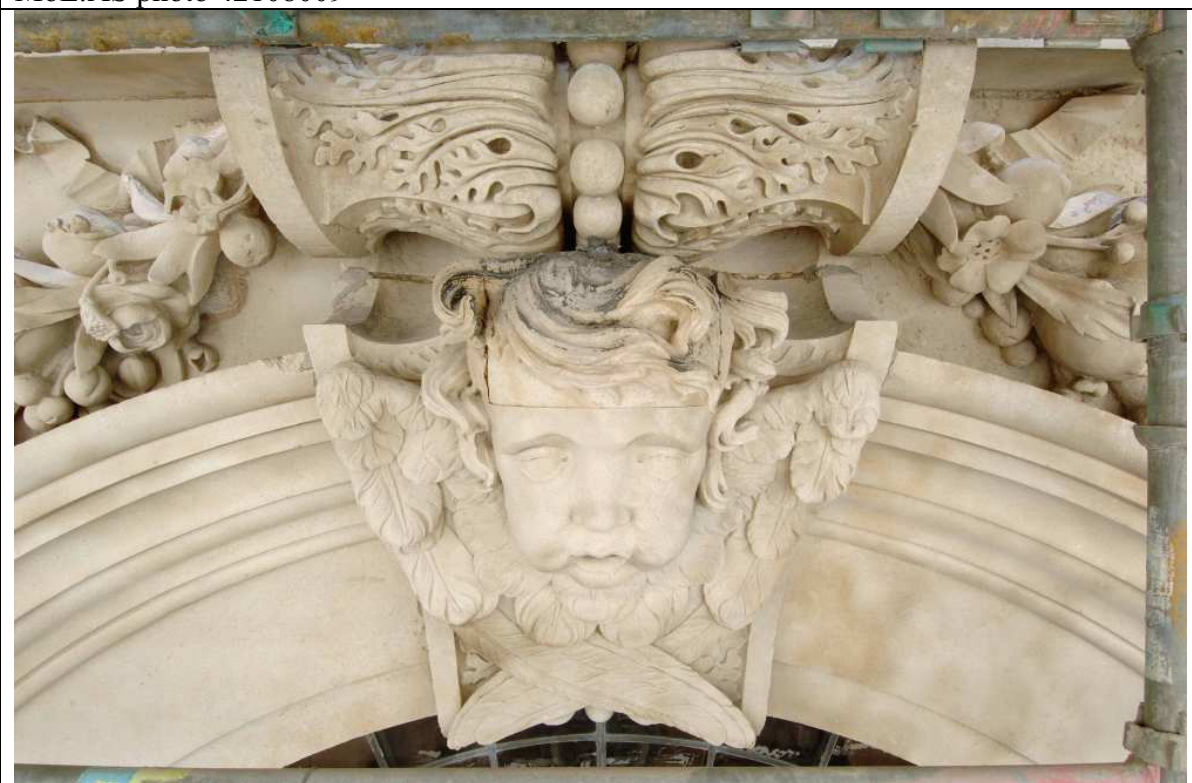
Fig 39 Cherub keystone in bay NC2
