St Paul's Cathedral: archaeological recording of installation of new lift and external cleaning, 2006–11

Sitecode: PUF06

**John Schofield
Cathedral Archaeologist**

August 2011

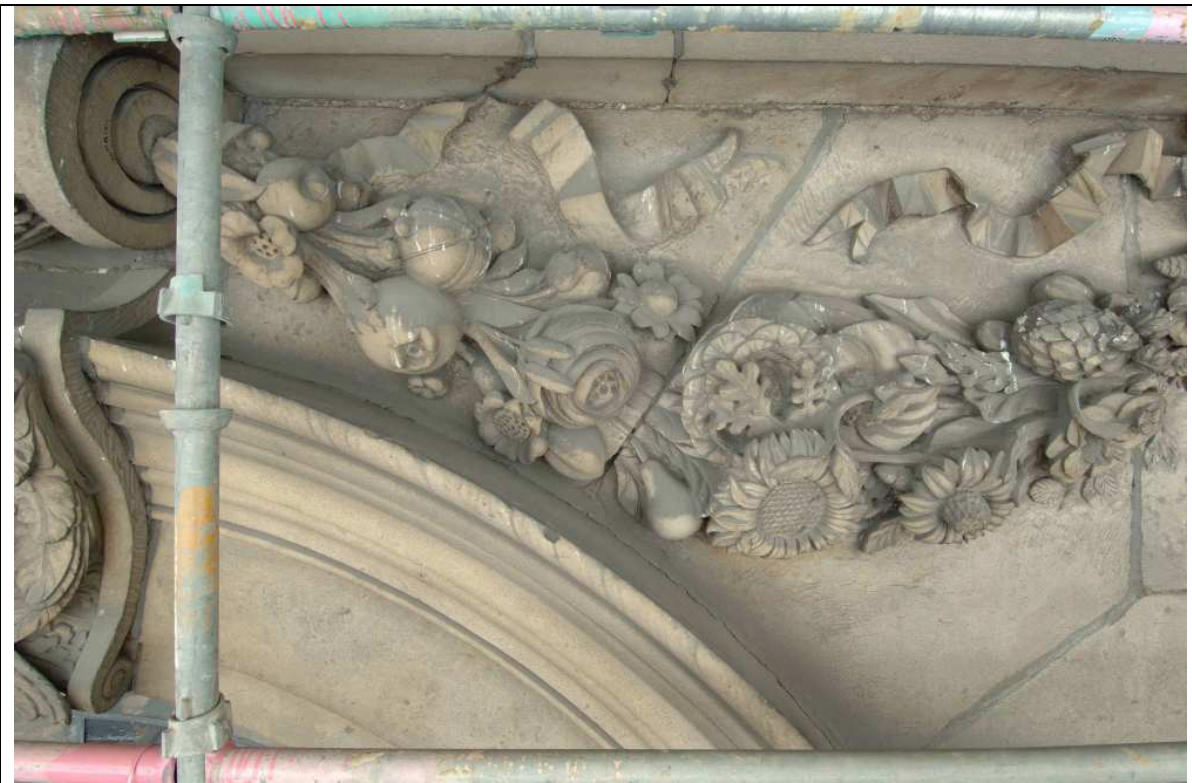
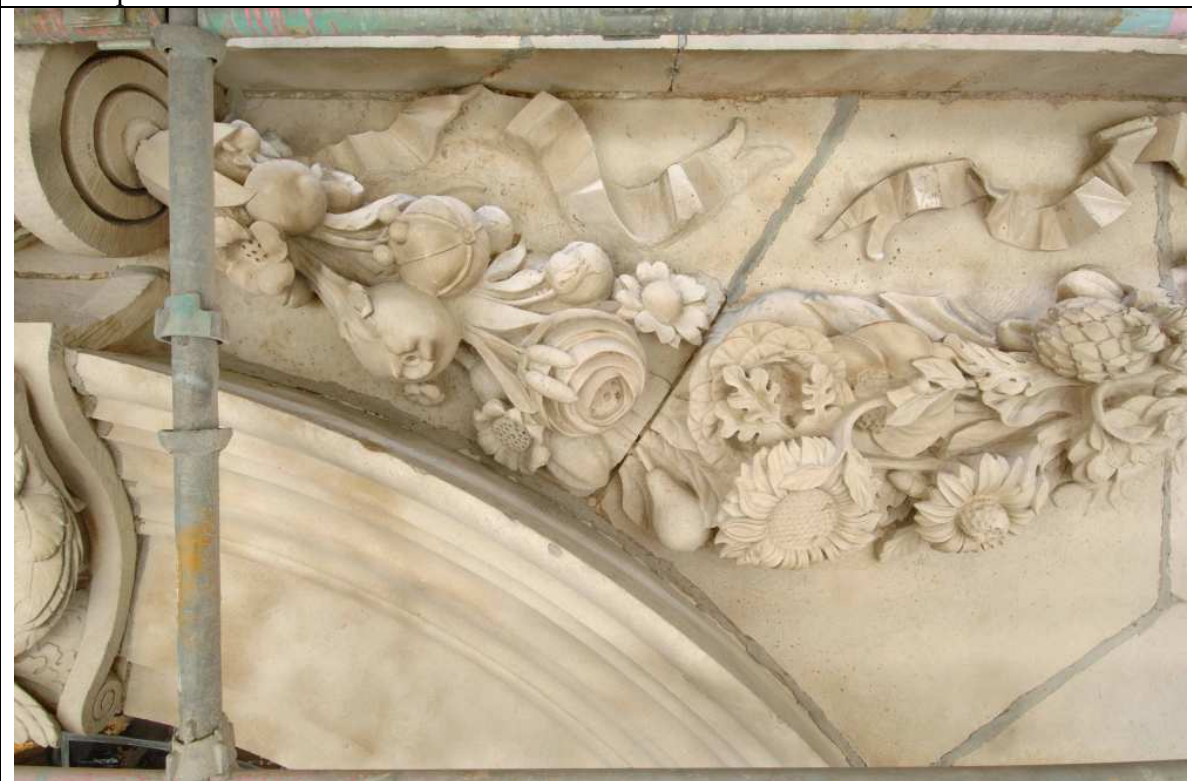
Fig 40 Swag in bay NC2, west side of window

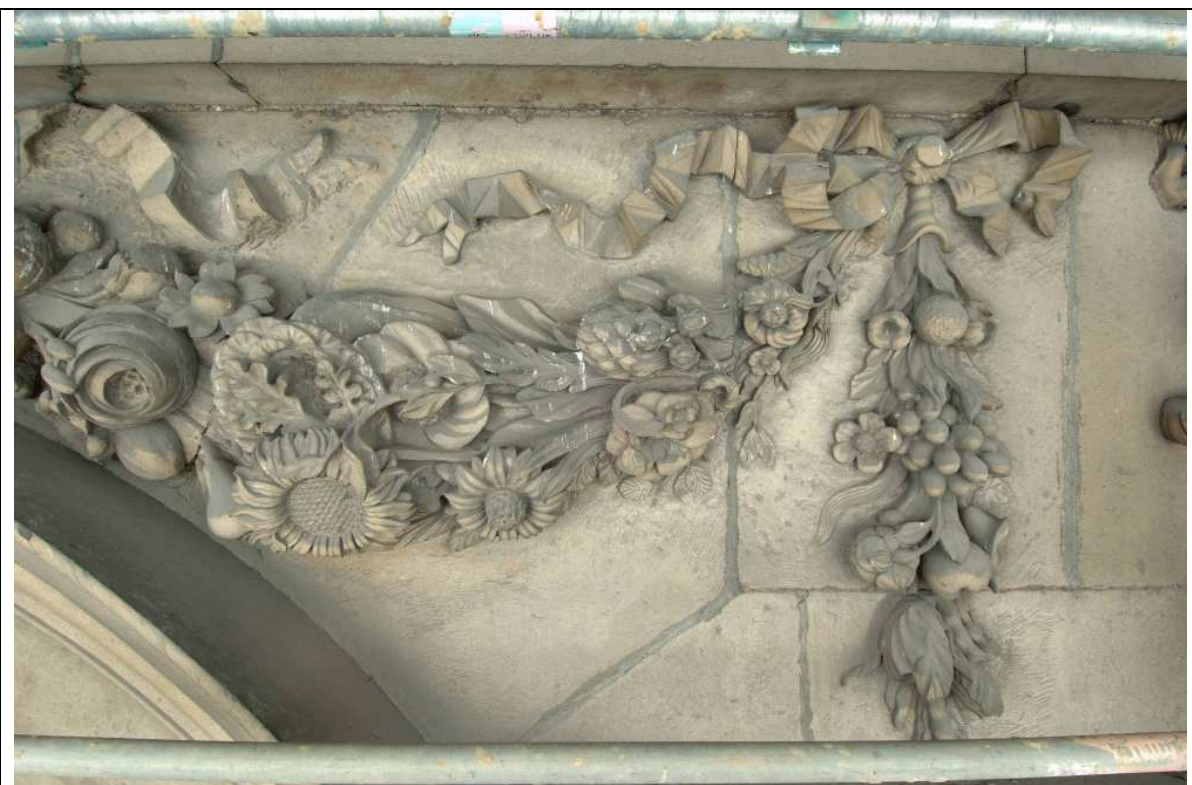
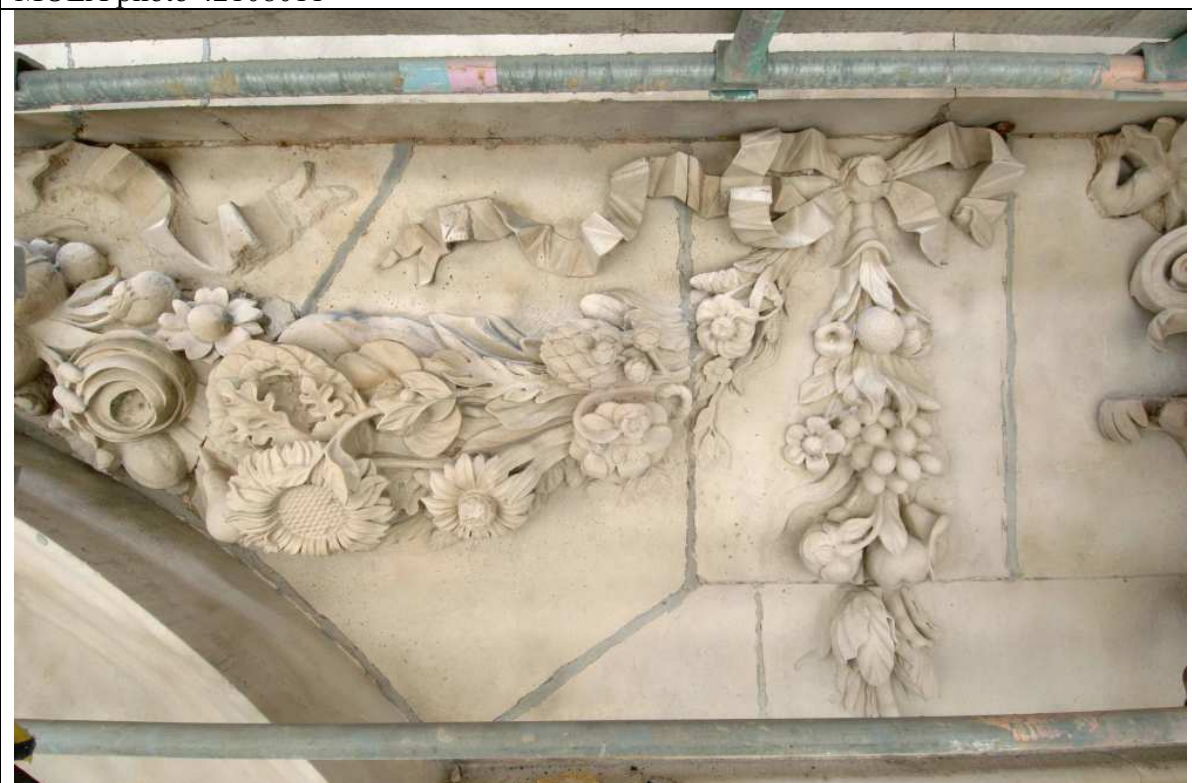
Fig 41 Swag and drop in bay NC2, west side of window

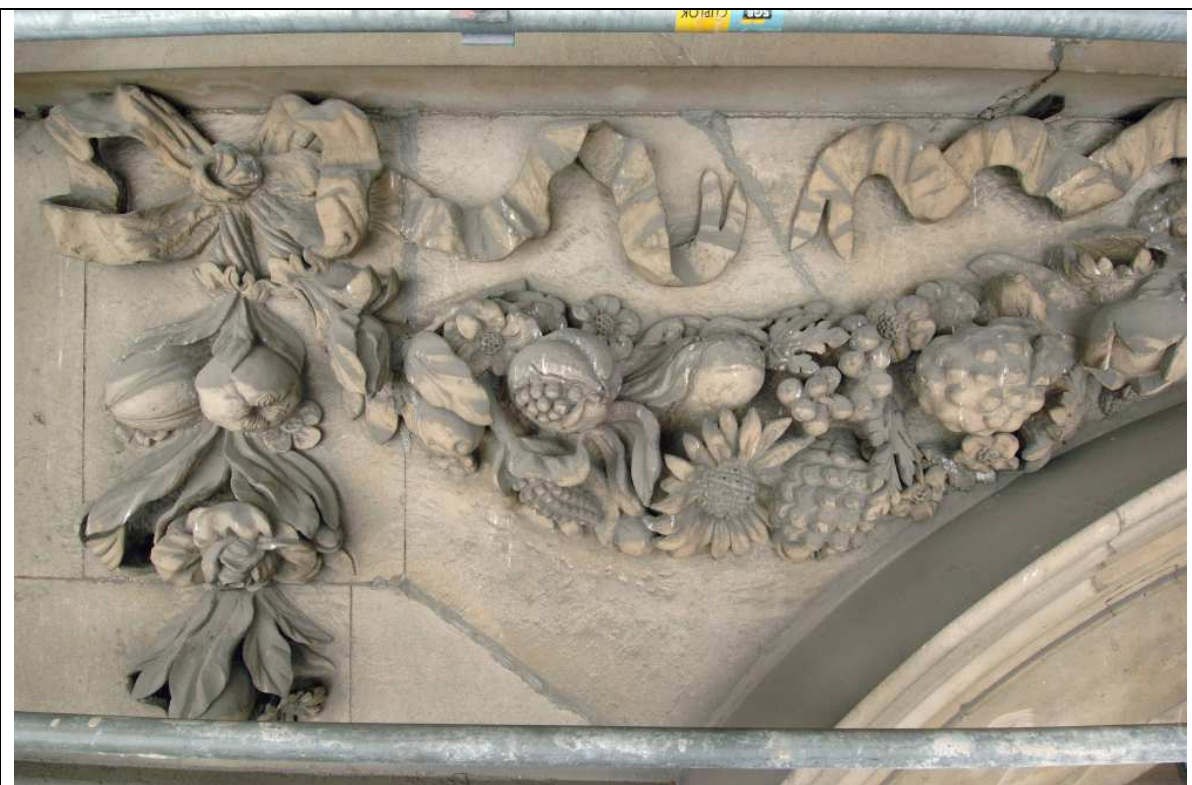
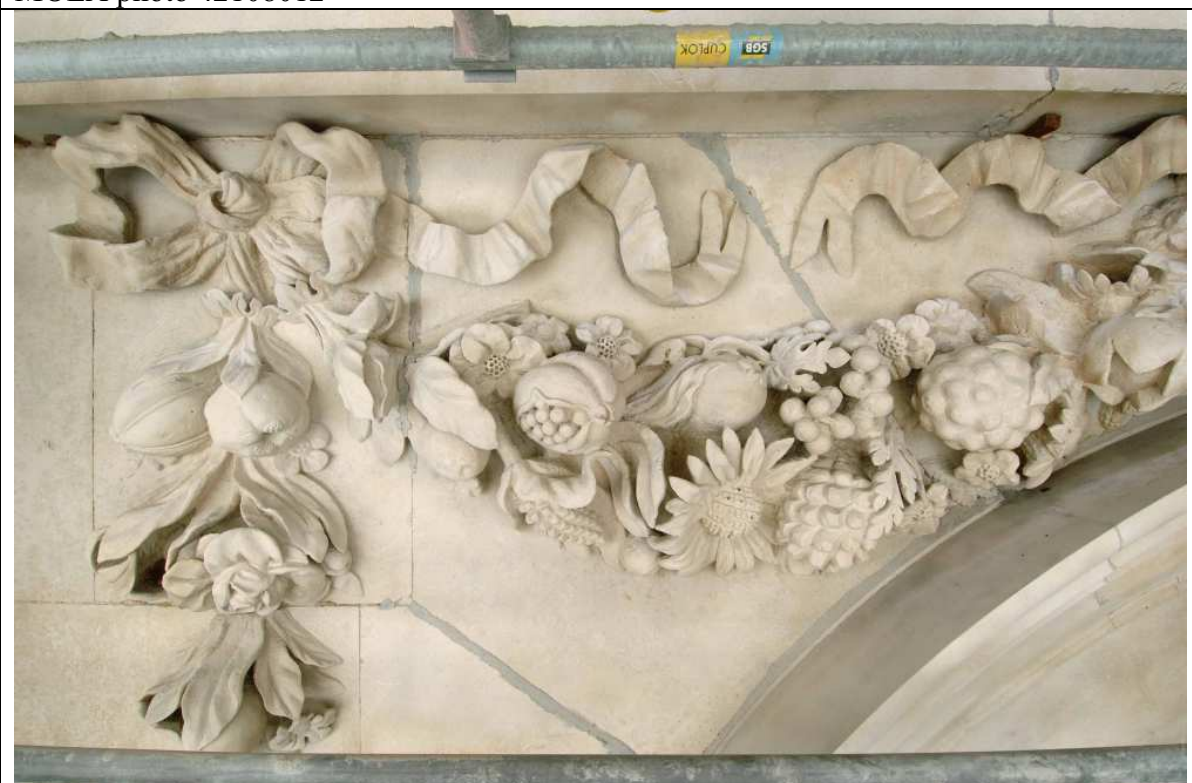
Fig 42 Swag and drop in bay NC3, east side of window

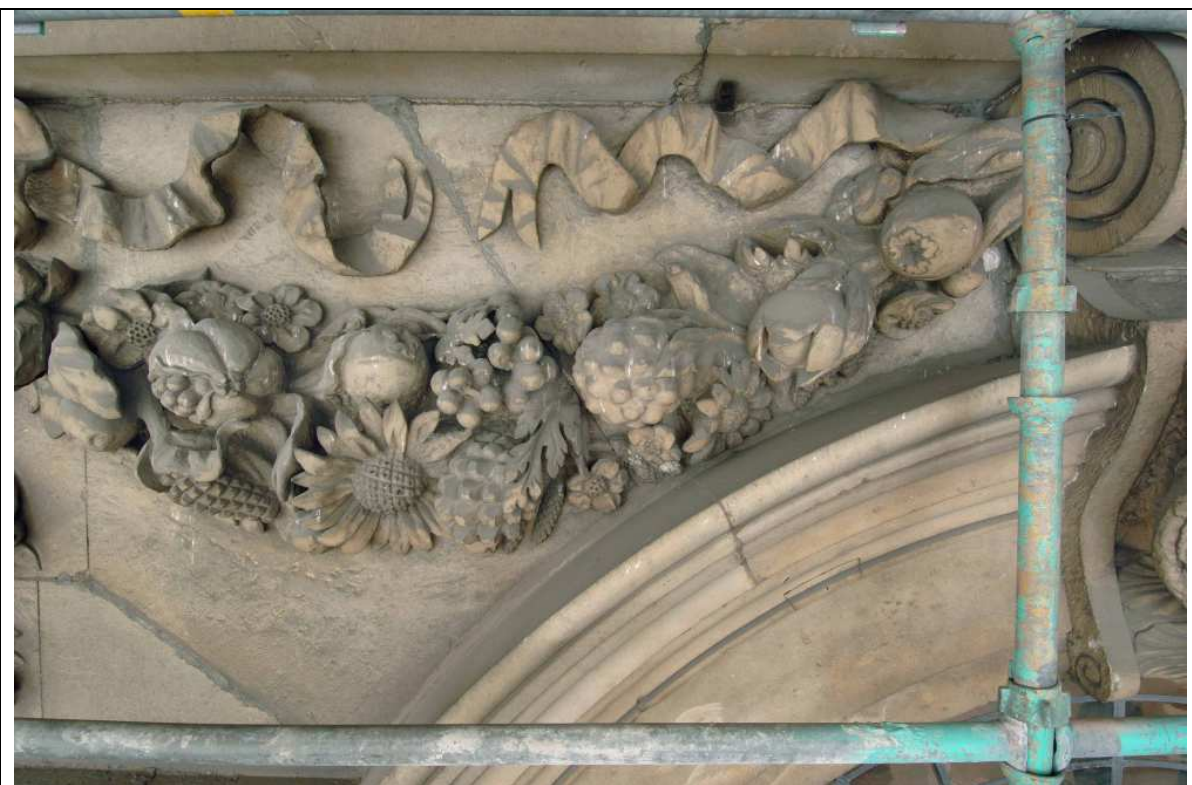
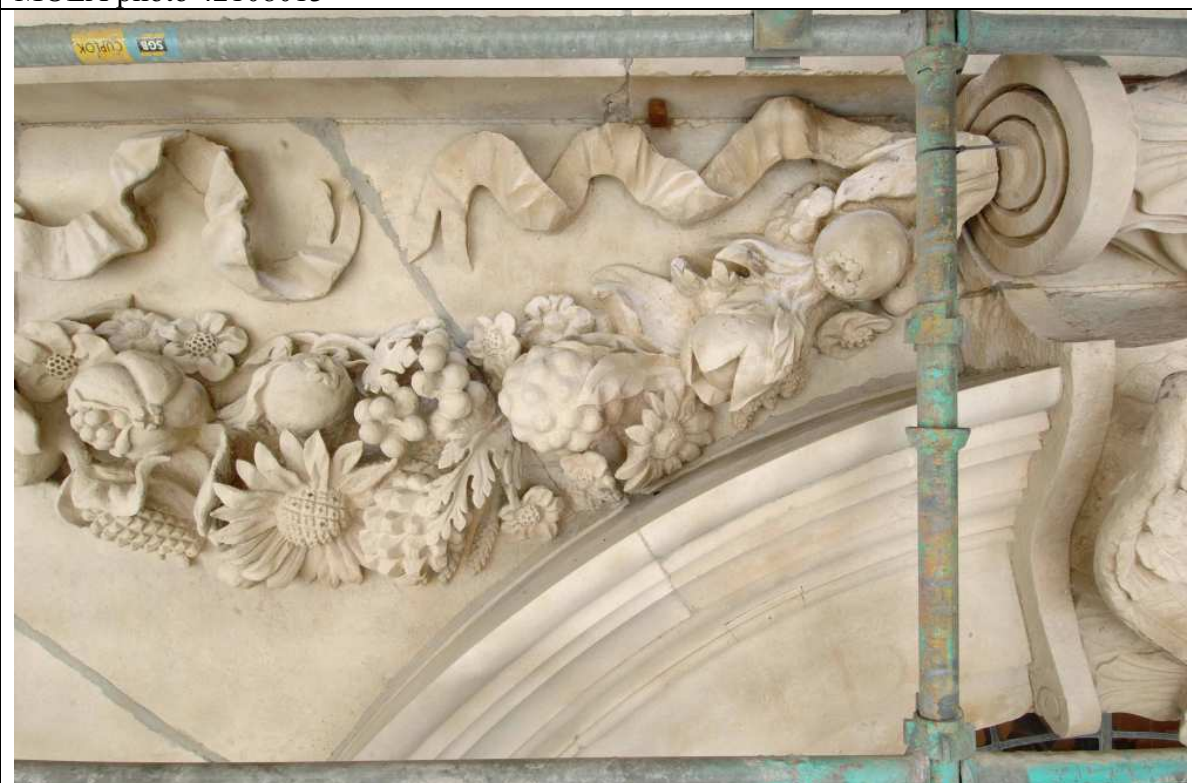
Fig 43 Swag in bay NC3, east side of window

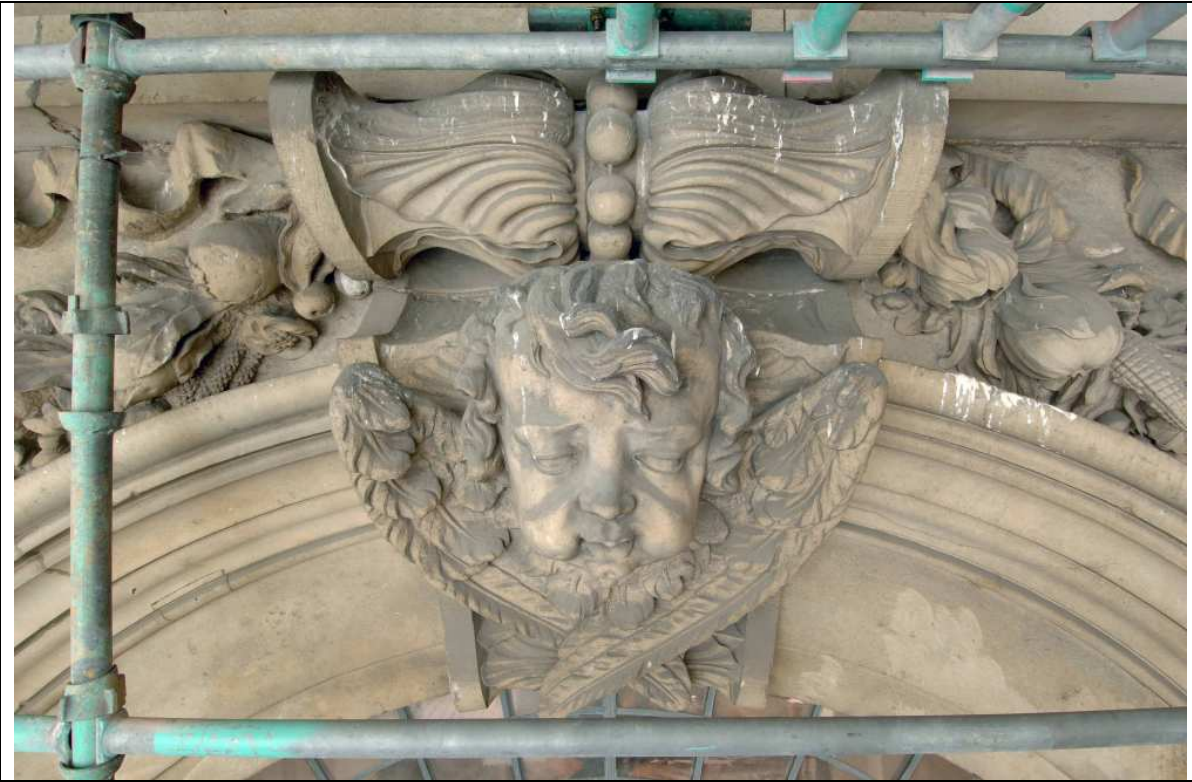
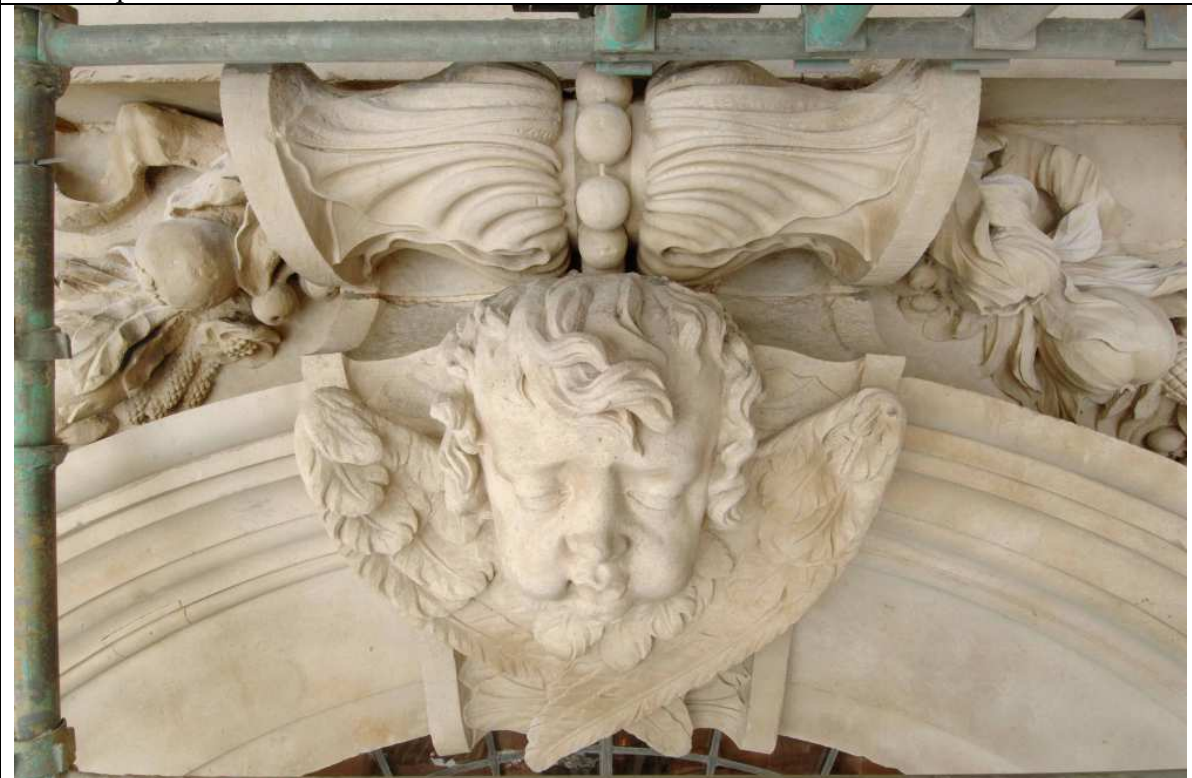
Fig 44 Cherub keystone in bay NC3

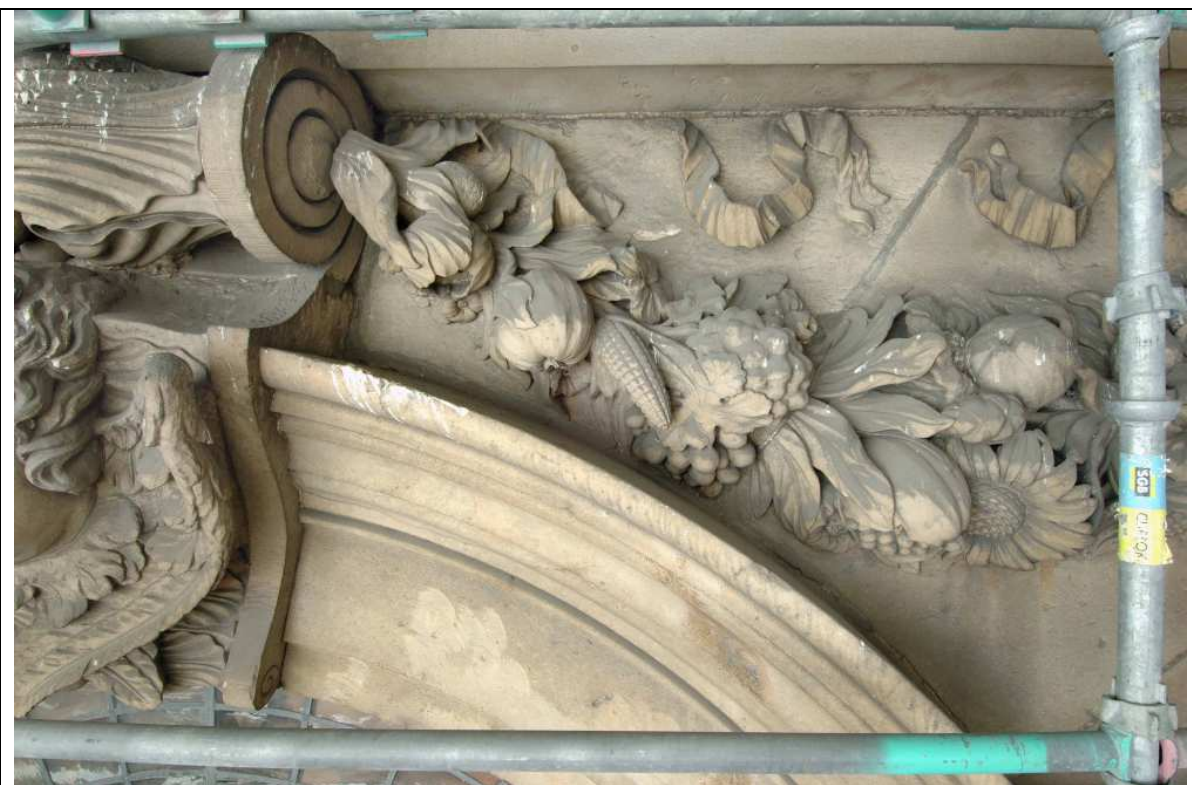
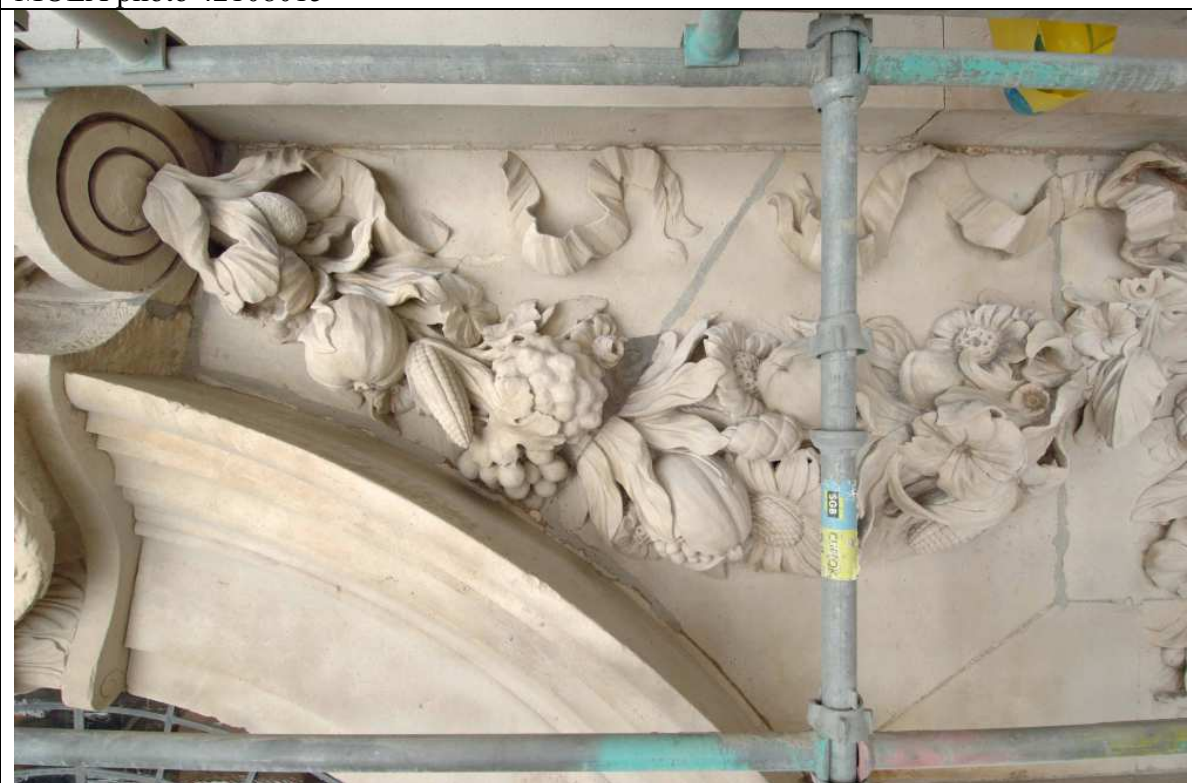
Fig 45 Swag in bay NC3, west side of window

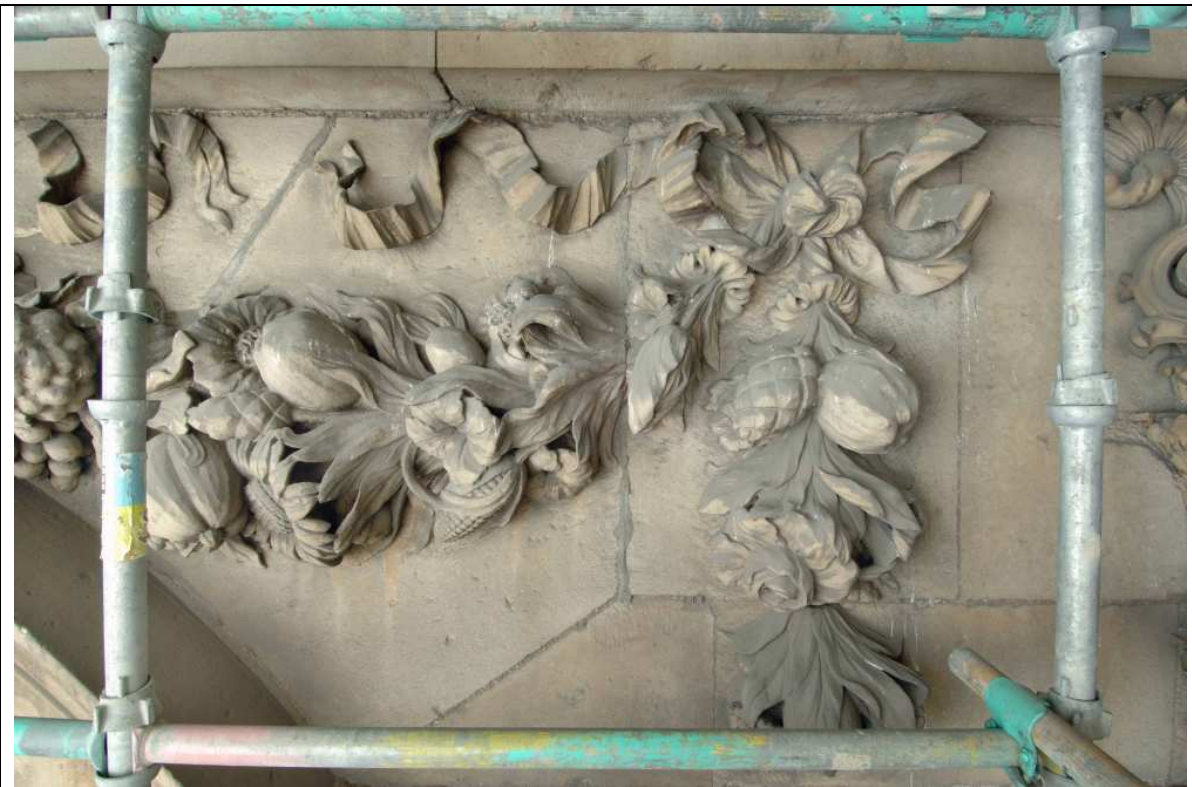
Fig 46 Swag and drop in bay NC3, west side of window

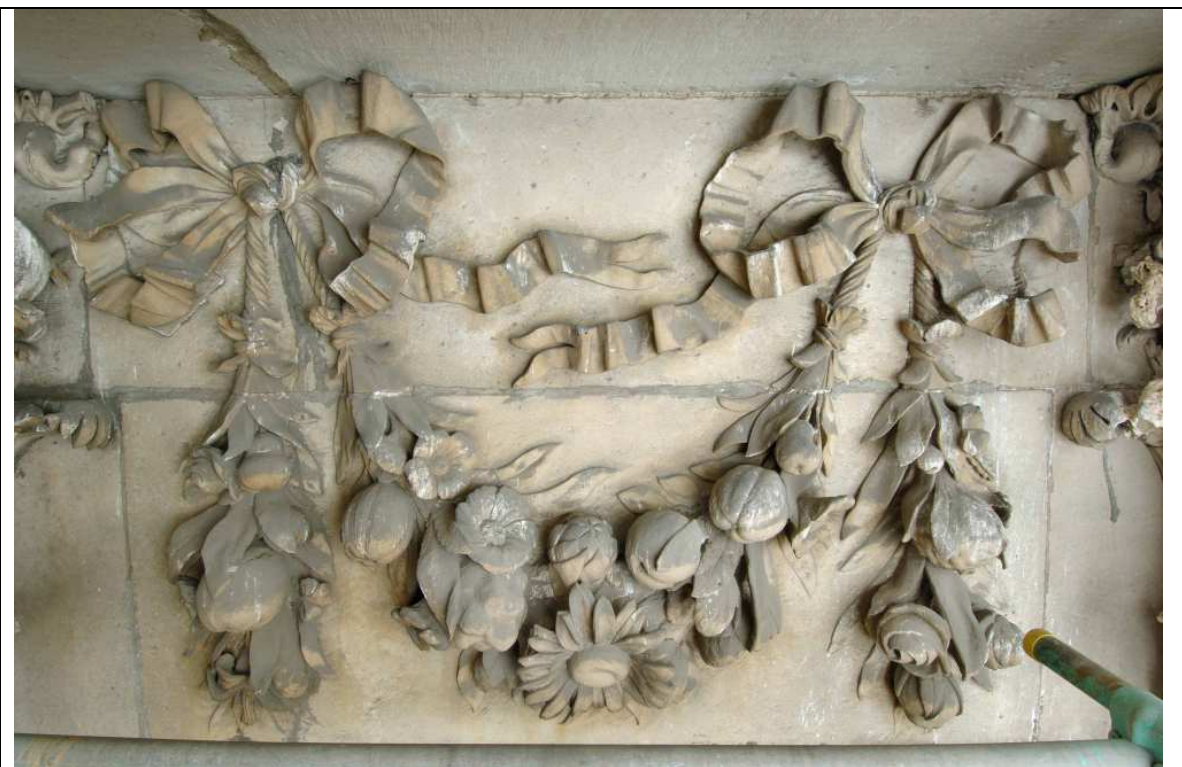
Fig 47 Swag in bay NT3, E side of N transept

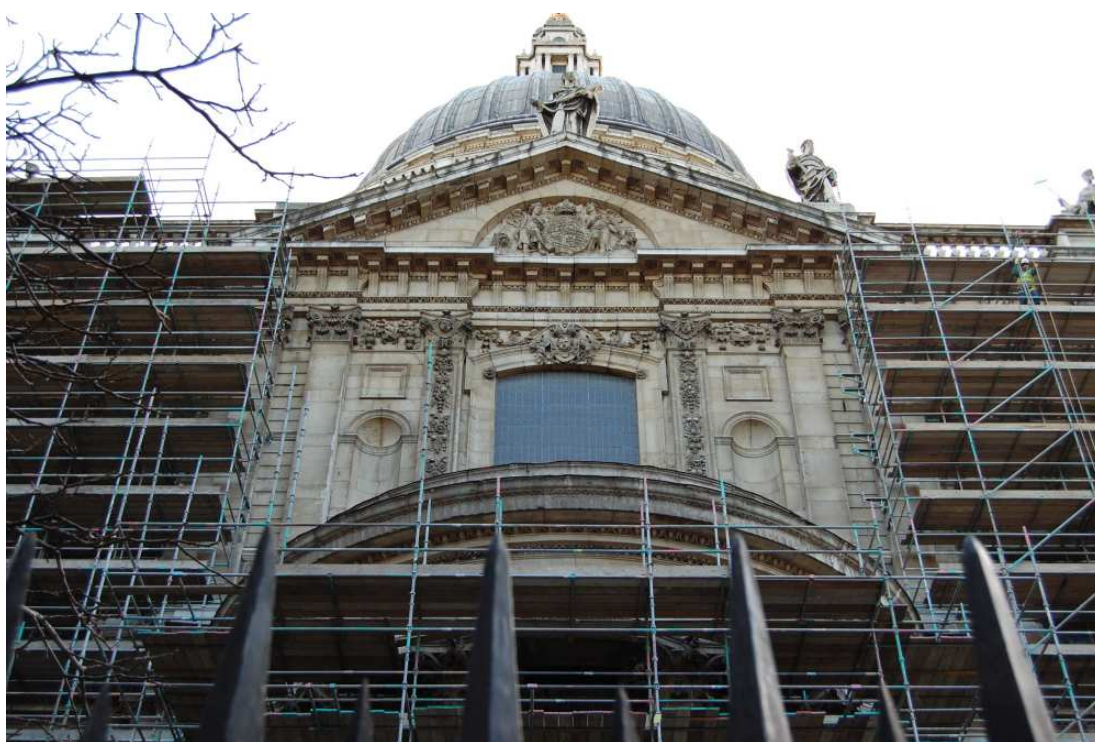
Fig 49 The north transept as the scaffolding was being erected around it, December 2008. The missing statue of St Philip at the east (left-hand) end of the pediment has since been restored to its position in a related project. The pediment bears the arms of William III

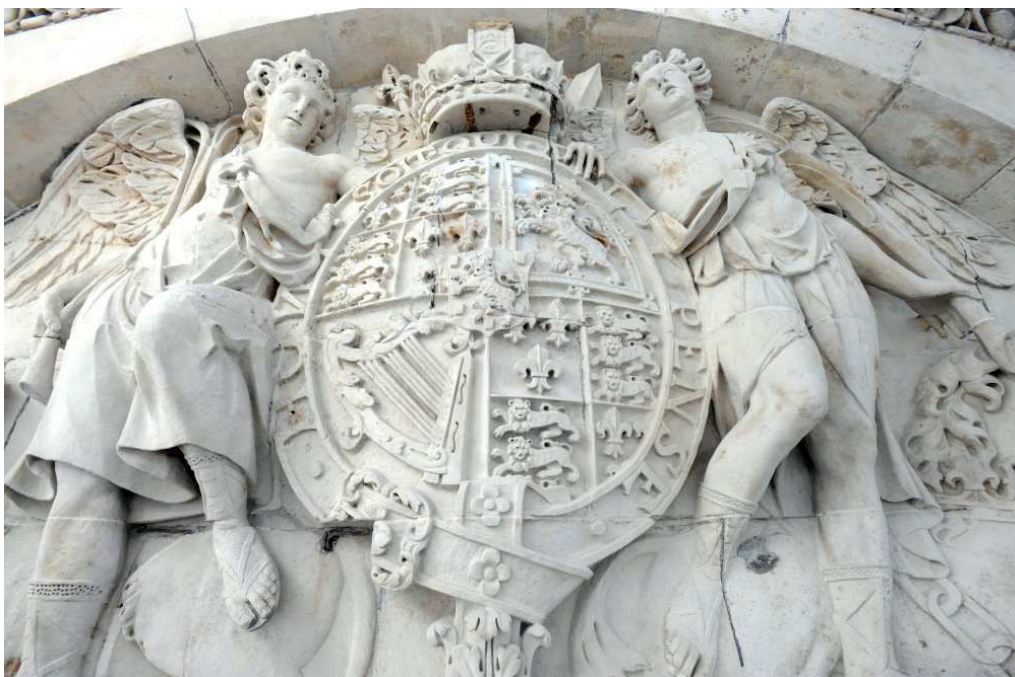
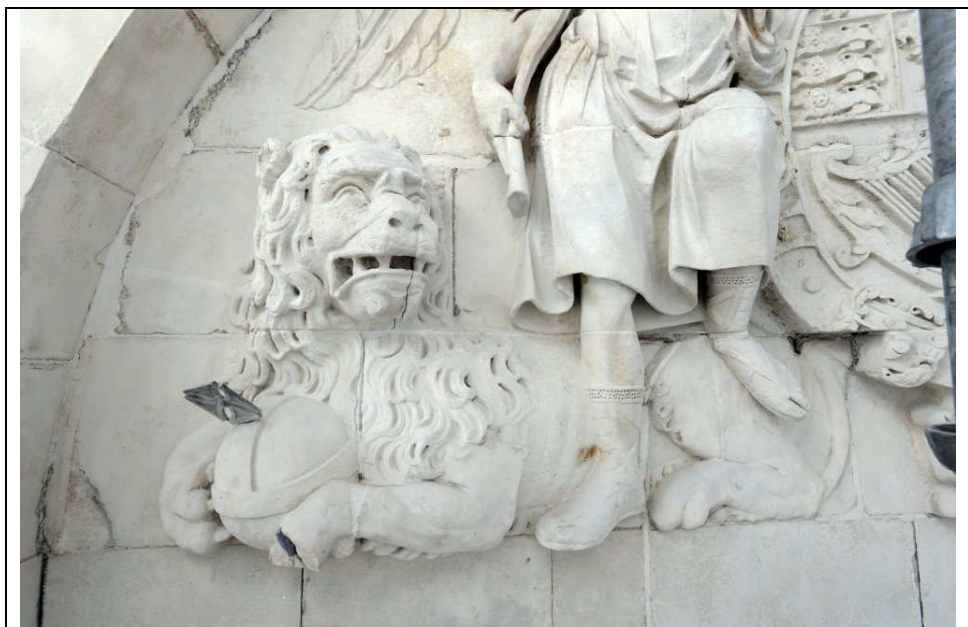
Fig 51 The royal arms in the pediment on the north transept, cleaned (MOLA photo 22309013)

Fig 52 The royal arms in the pediment of the north transept, details of supporters, left and right, cleaned

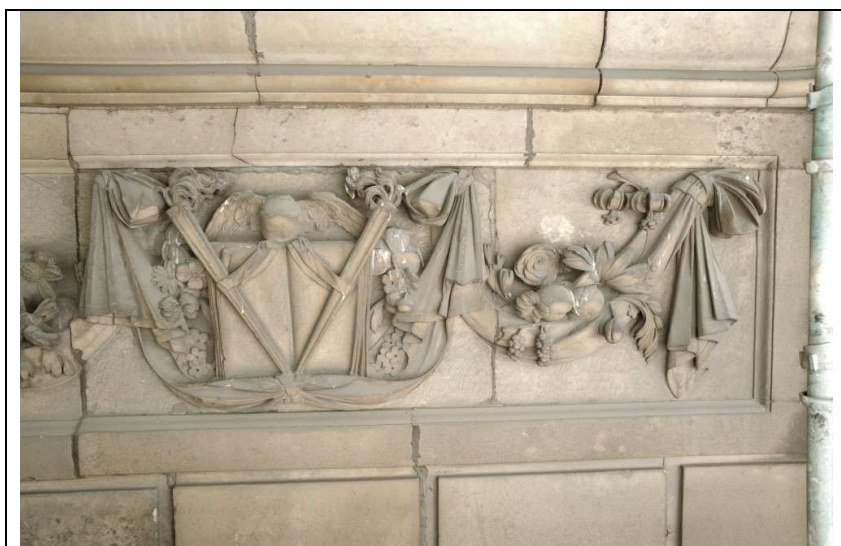
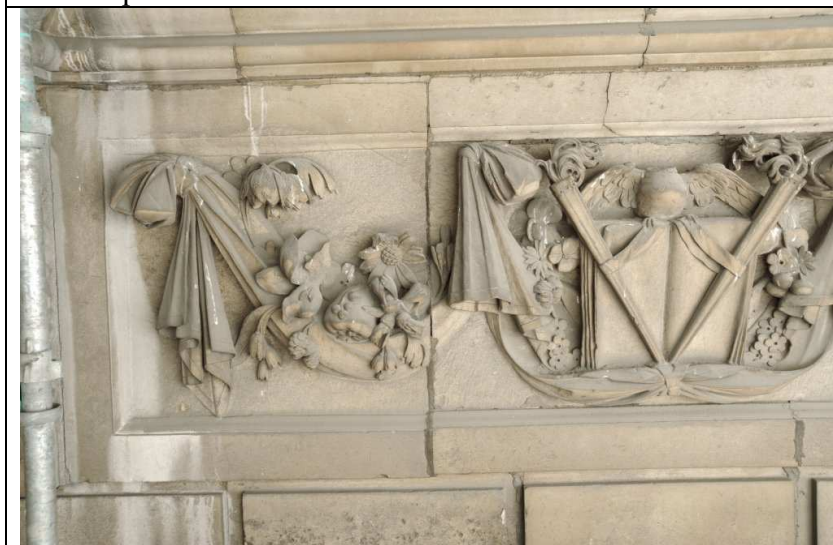
Fig 53 Bay NT3 (east side of N transept): panel below window before cleaning

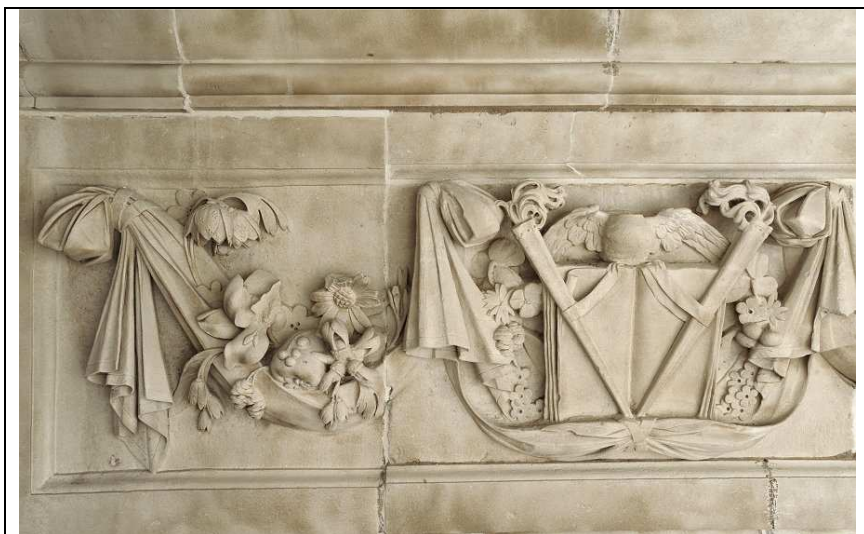
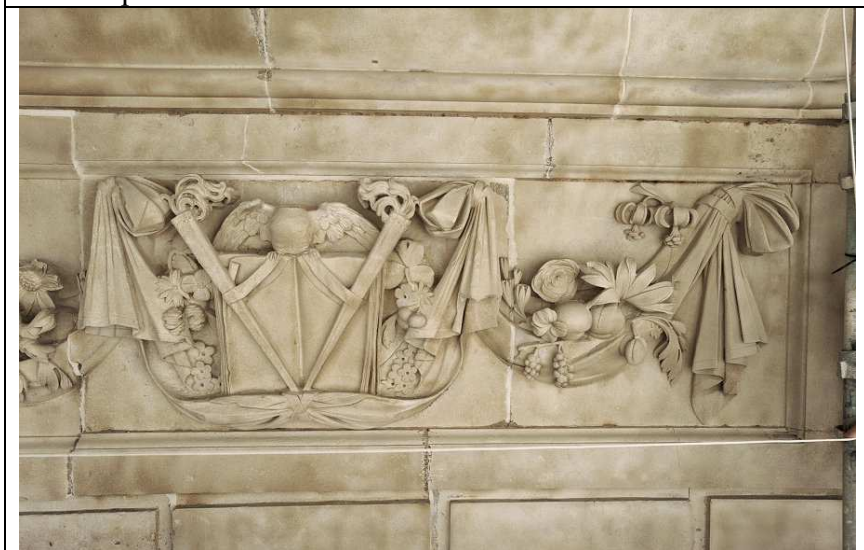
Fig 54 Bay NT3 (east side of N transept); panel below window after cleaning

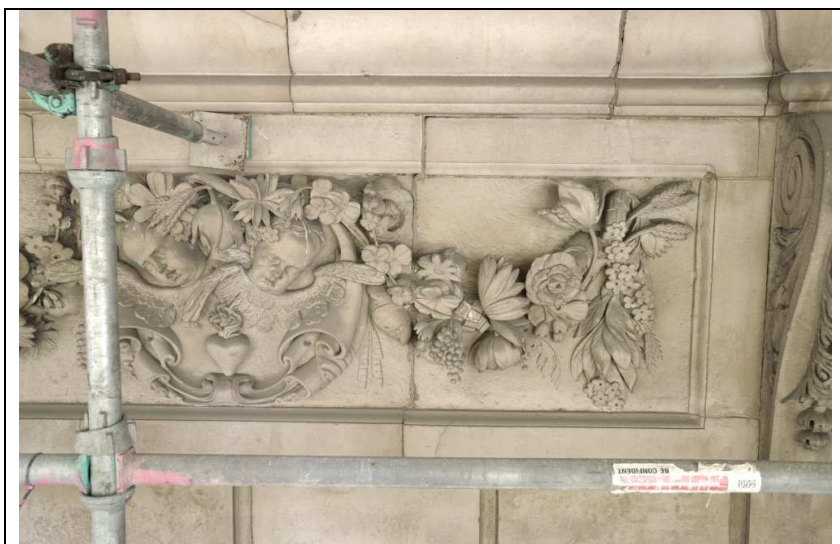
Fig 55 Bay NT4 (north side of north transept): panel below window before cleaning

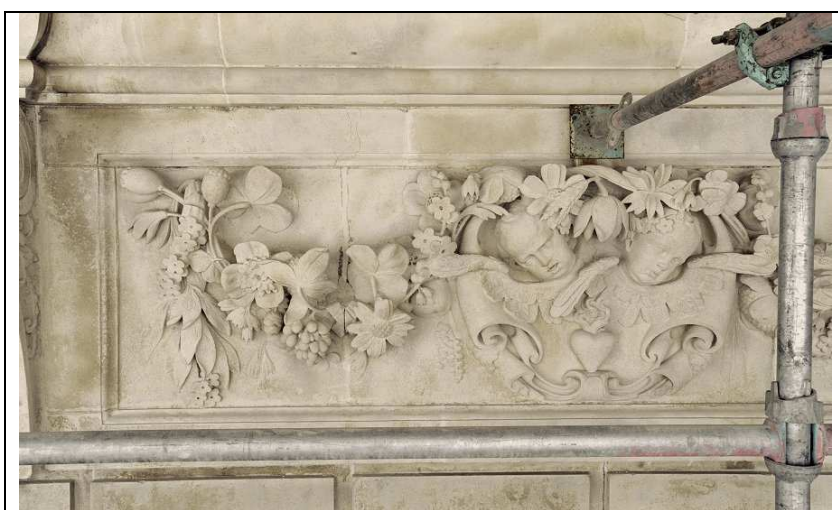
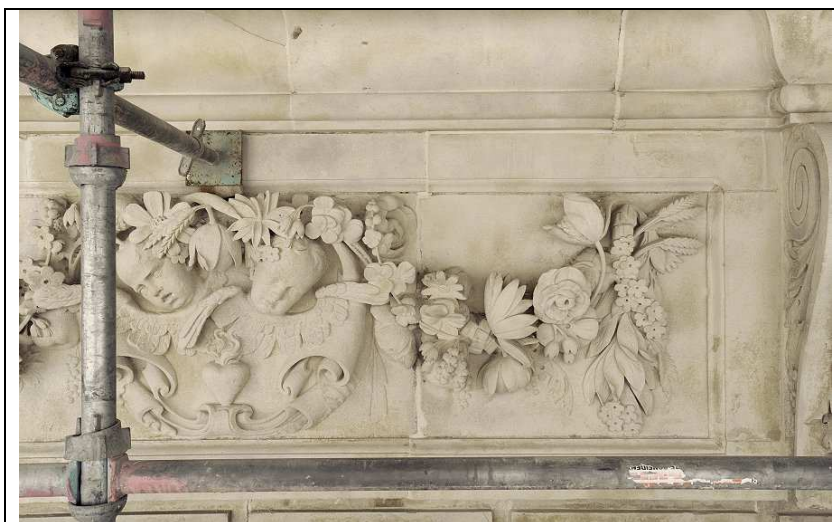
Fig 56 Bay NT4 (north side of north transept): panel below window after cleaning

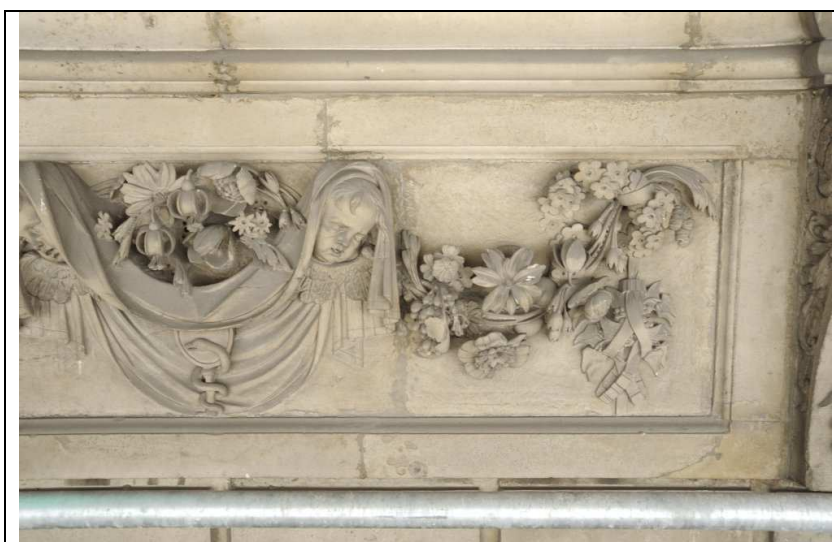
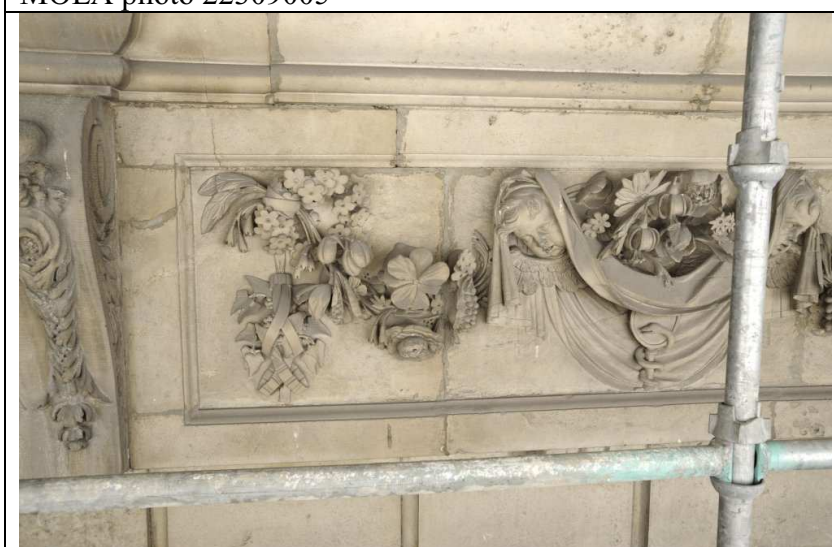
Fig 57 Bay NT6 (north side of north transept): panel below window before cleaning

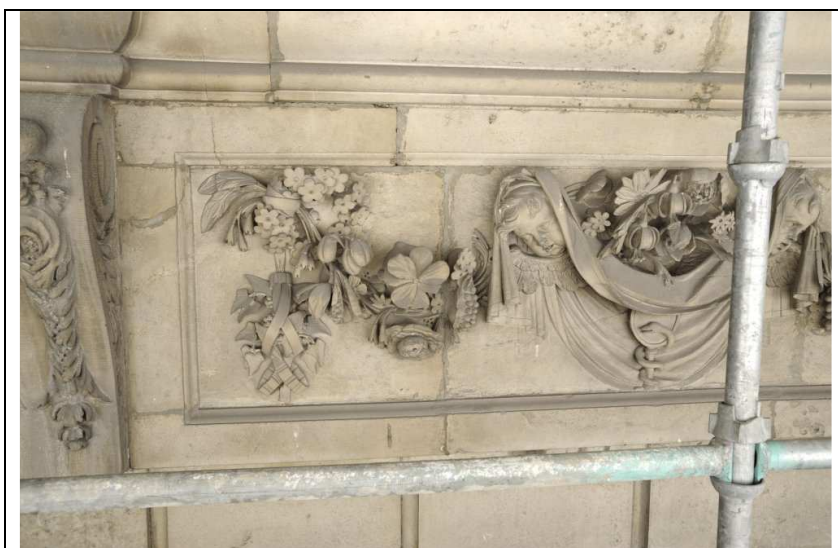
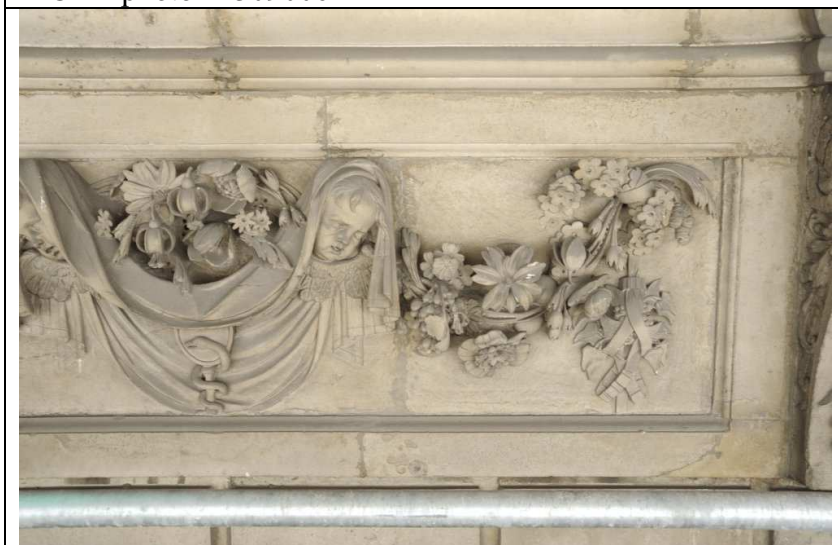
Fig 58 Bay NT6 (N side of N transept): panel below window before cleaning

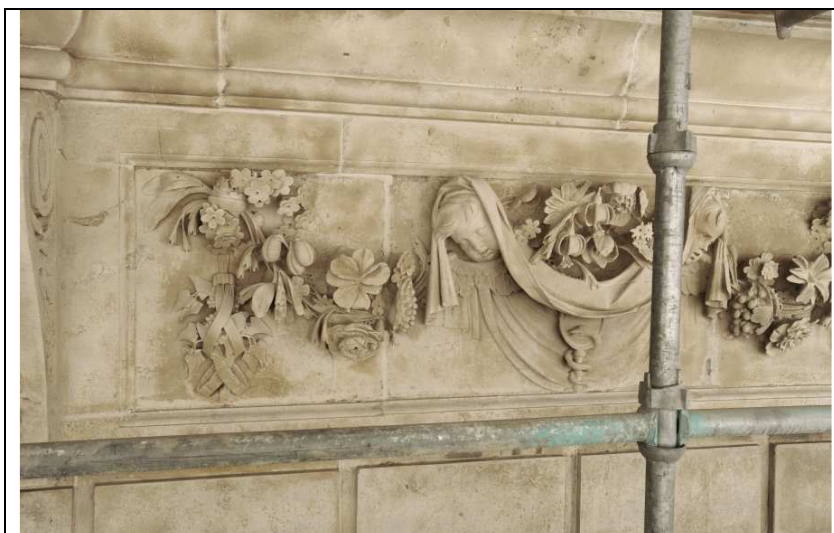
Fig 59 Bay NT6 (N side of N transept): panel below window after cleaning

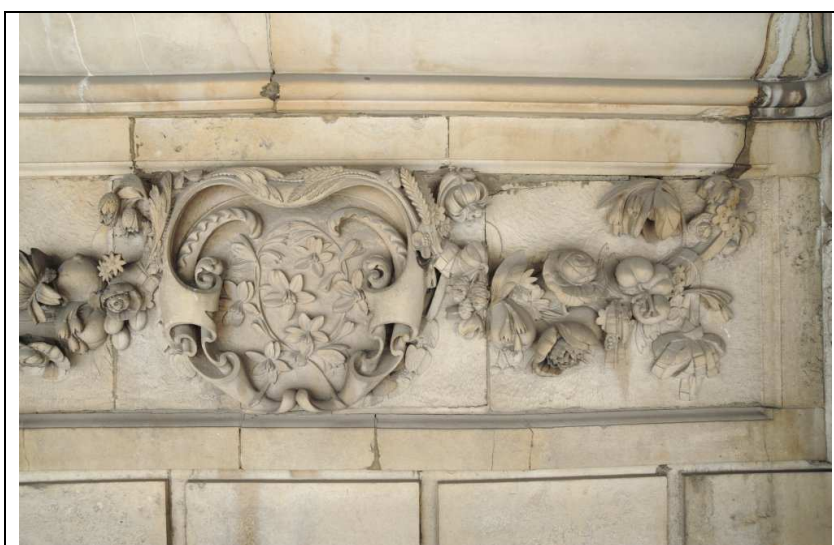
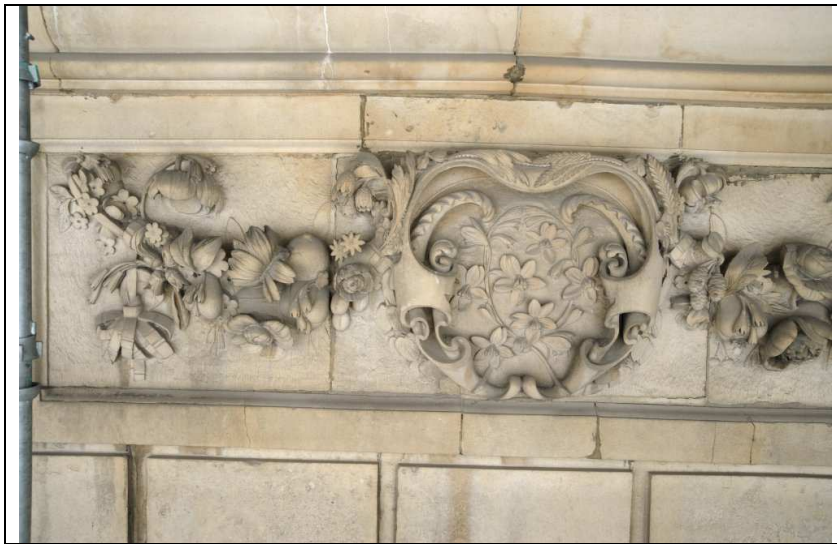
Fig 60 Bay NT7 (west side of north transept): panel below window before cleaning

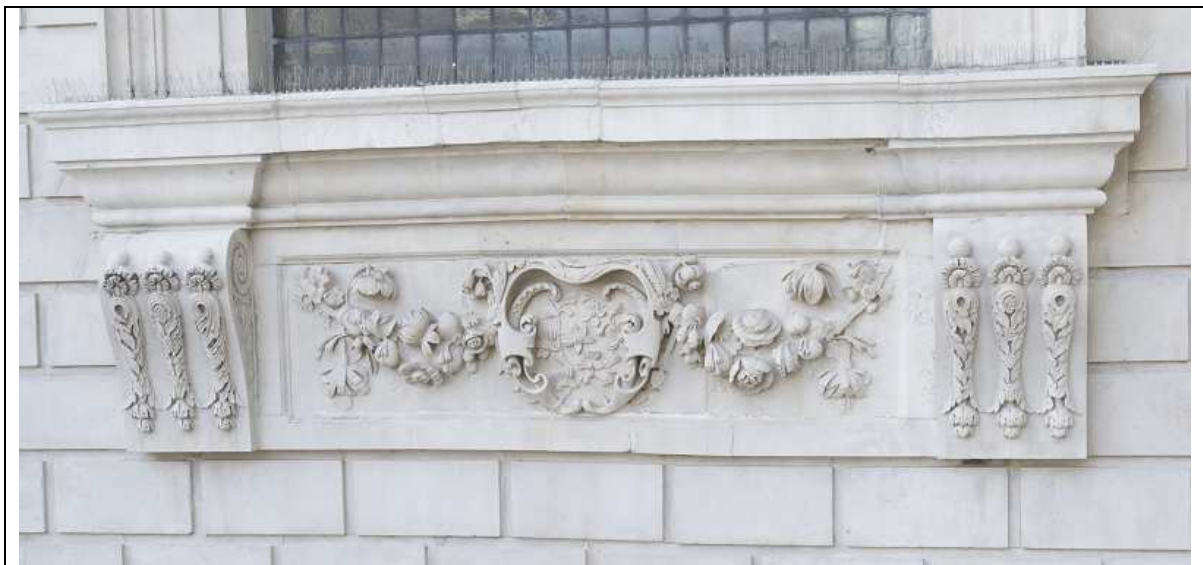
Fig 61 Bay NT7 (W side of N transept): panel below window after cleaning
