St Paul's Cathedral: archaeological recording of installation of new lift and external cleaning, 2006–11

Sitecode: PUF06

**John Schofield
Cathedral Archaeologist**

August 2011

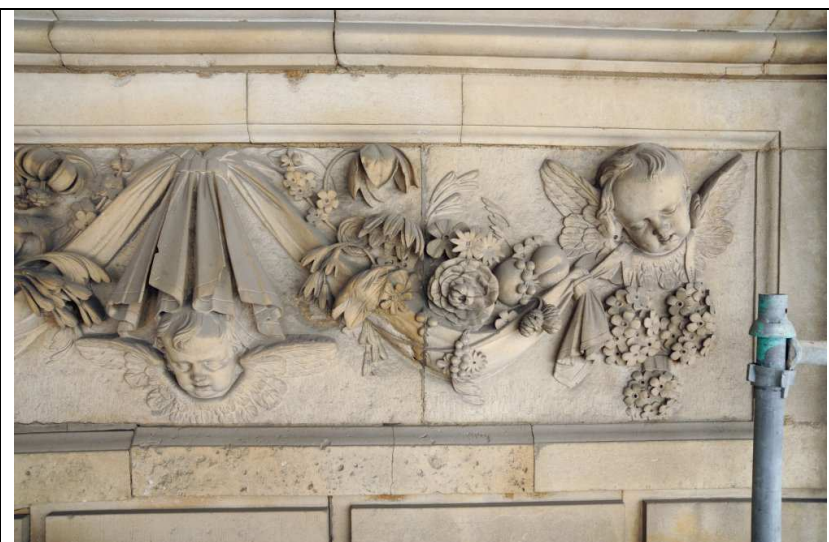
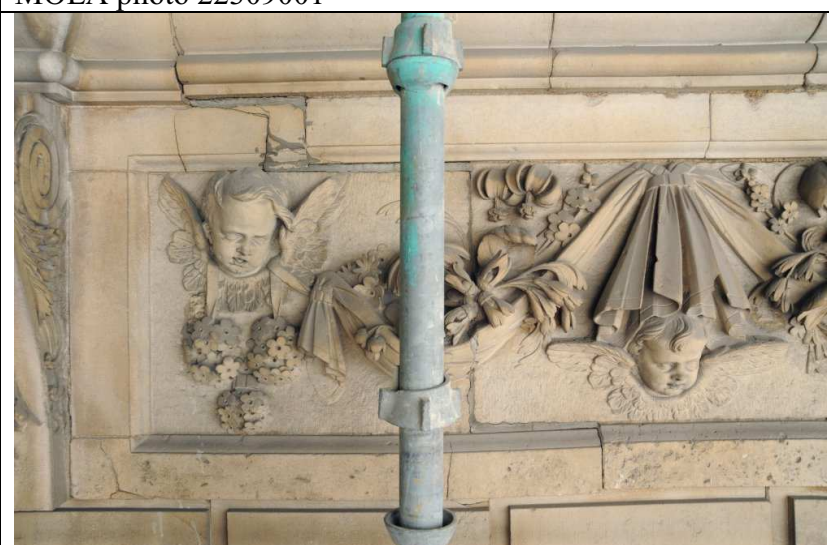
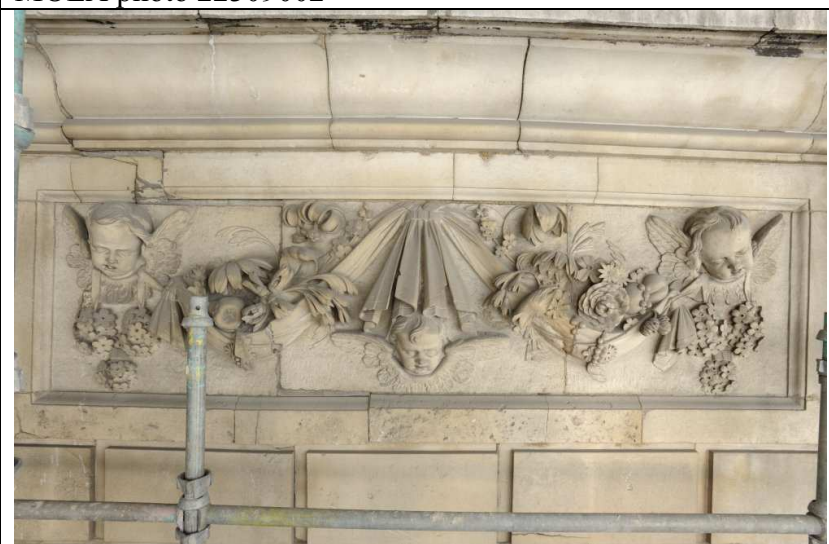
Fig 62 Bay NN1 (N side of nave): panel below window before cleaning

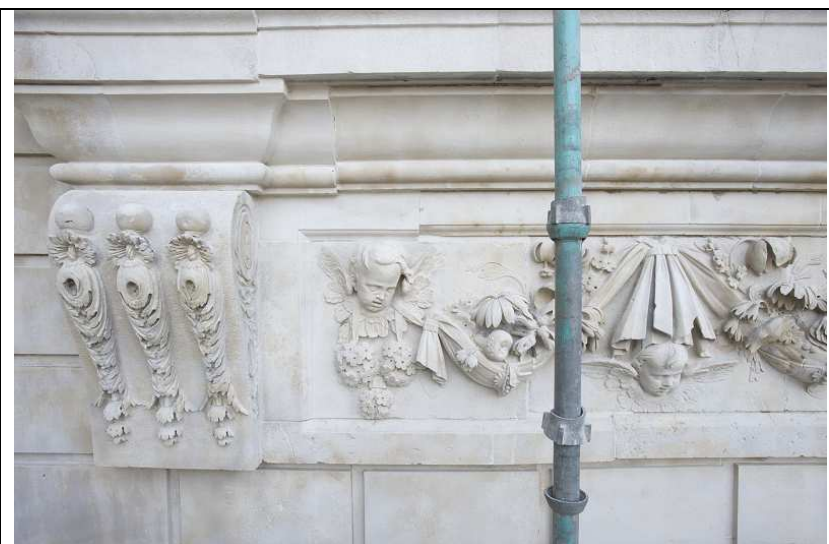
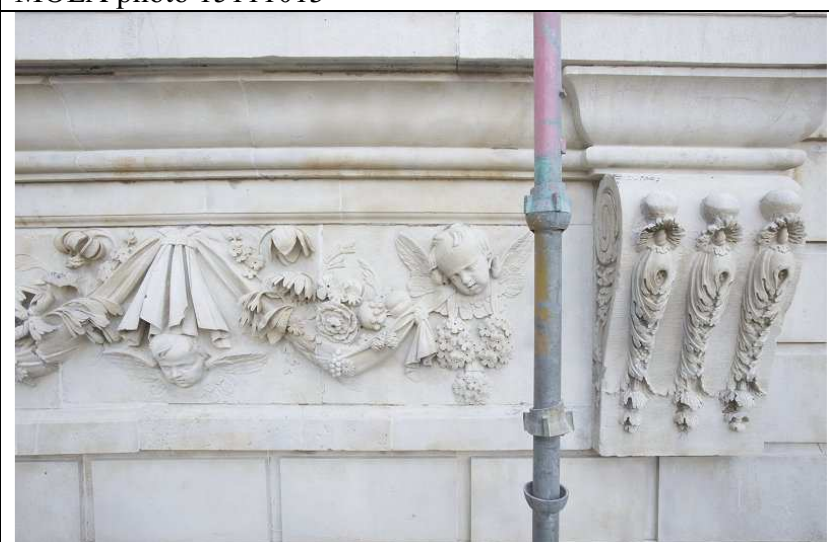
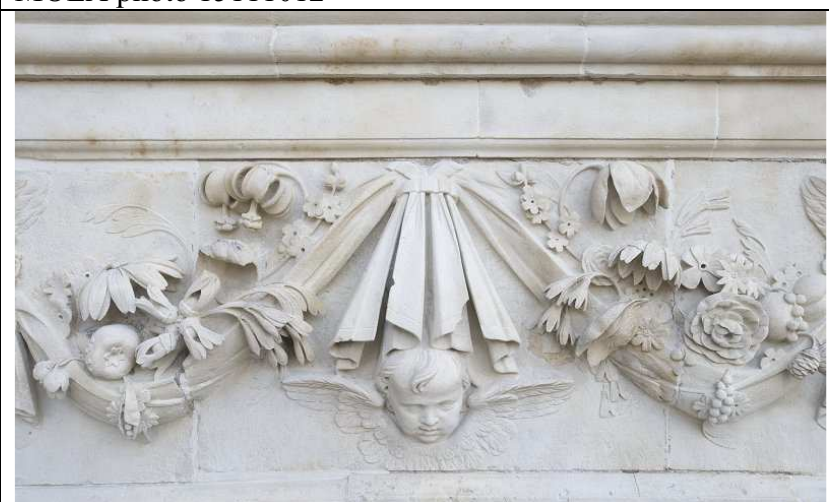
Fig 63 Bay NN1 (N side of nave): panel below window after cleaning

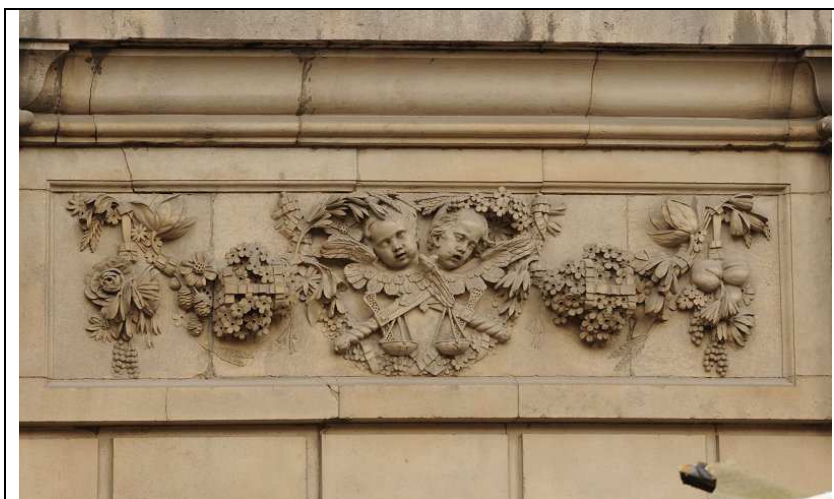
Fig 64 Bay NN2 (N side of nave): panel below window before cleaning

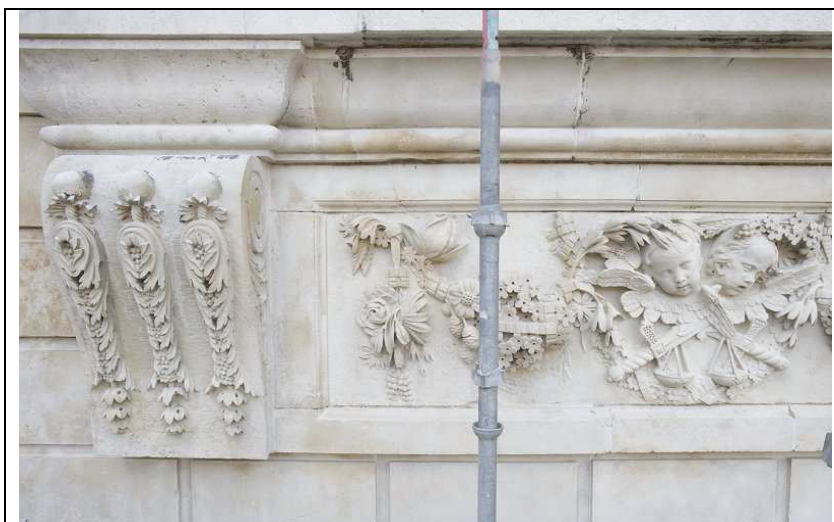
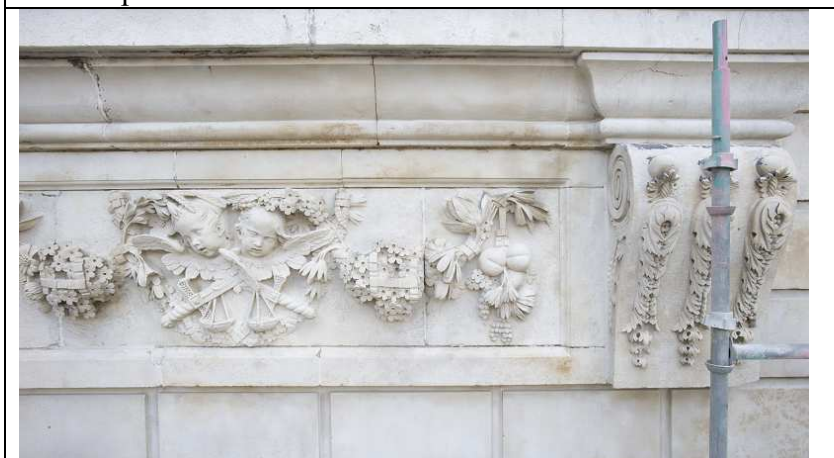
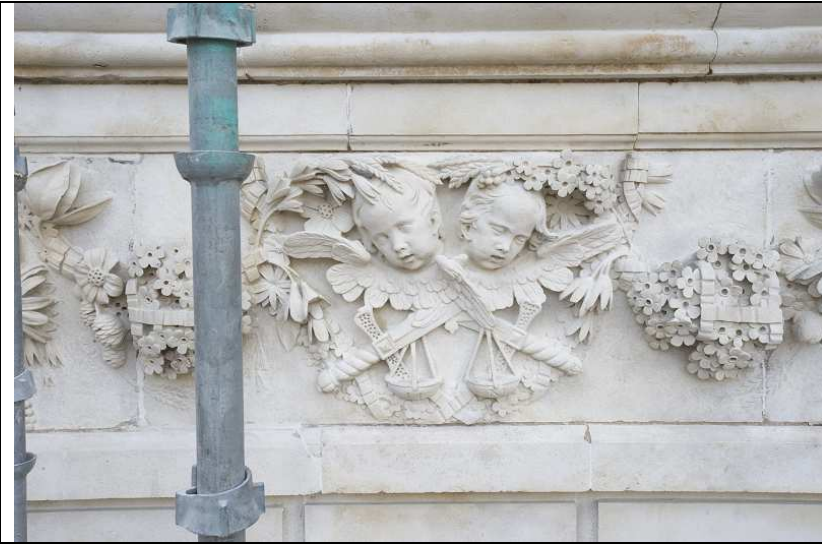
Fig 65 Bay NN2 (N side of nave): panel below window after cleaning

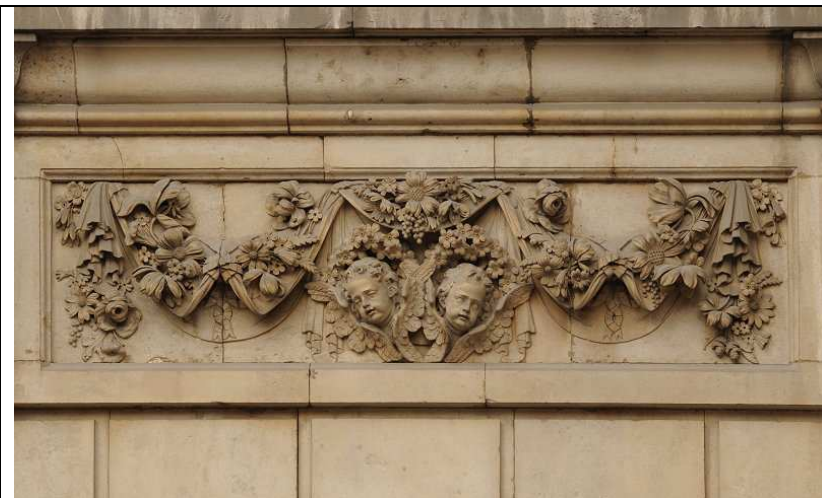
Fig 66 Bay NN3 (N side of nave): panel below window before cleaning

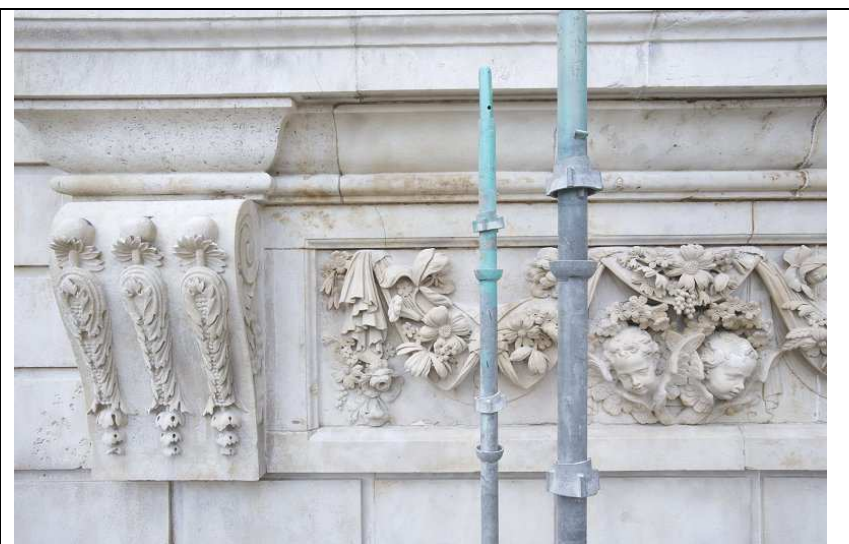
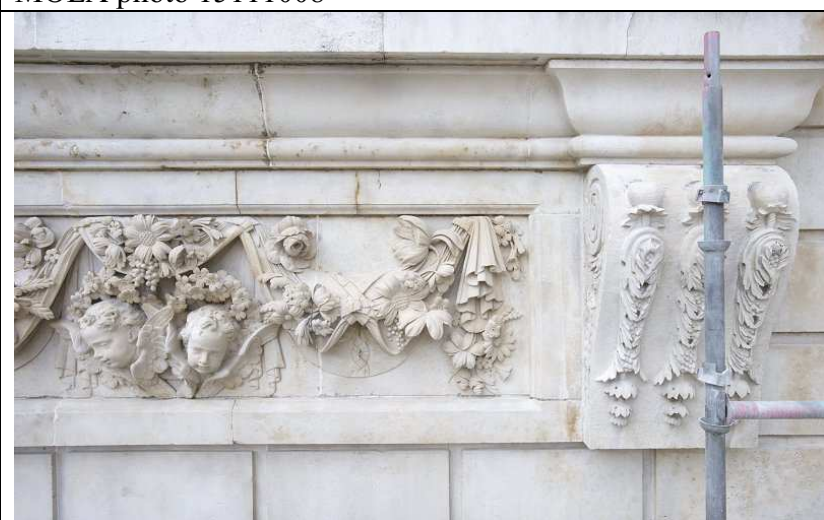
Fig 67 Bay NN3 (N side of nave): panel below window after cleaning

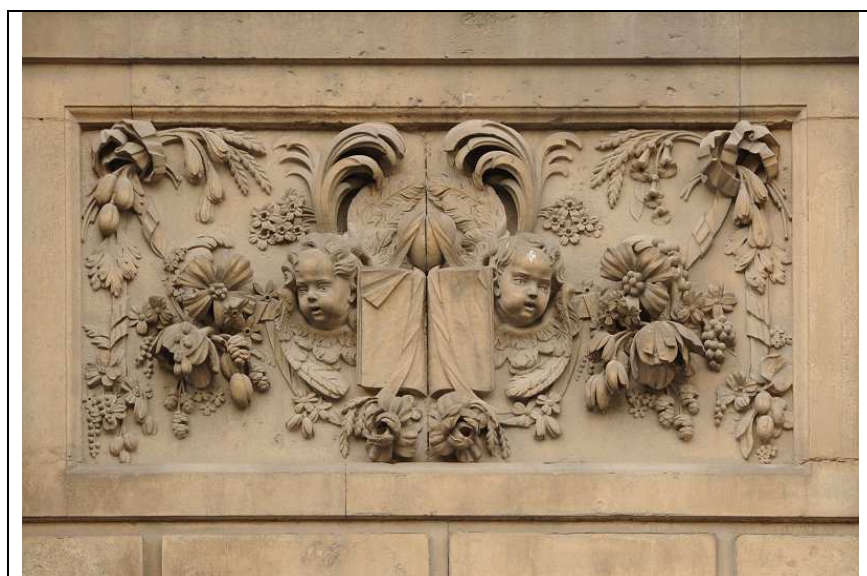
Fig 68 Bay NN5 (N side of nave): panel below window before cleaning

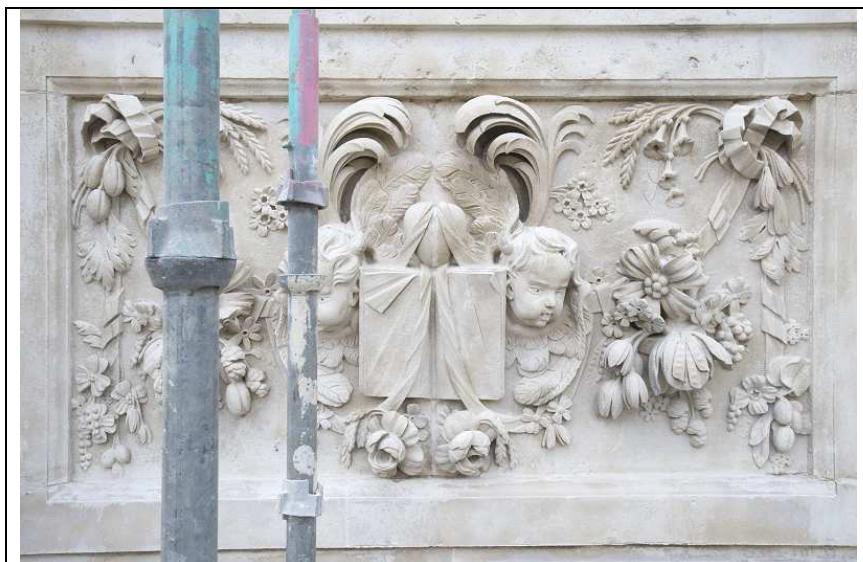
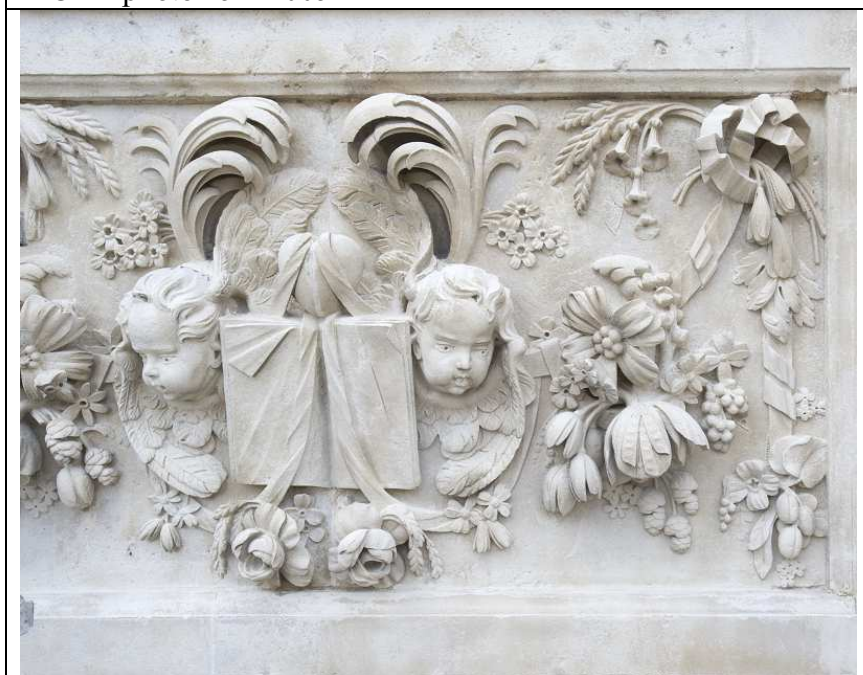
Fig 69 Bay NN5 (N side of nave): panel below window after cleaning

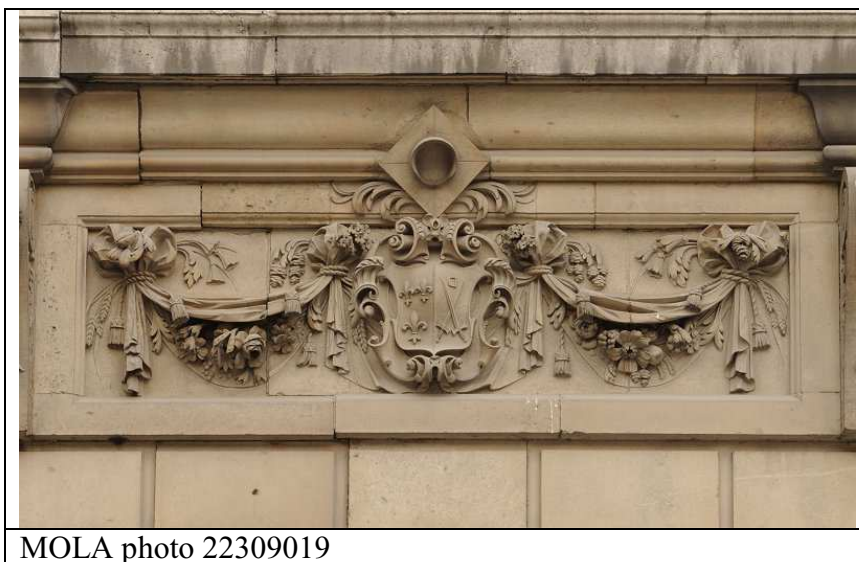
Fig 70 Bay NN6 (N side of nave): panel below window before cleaning

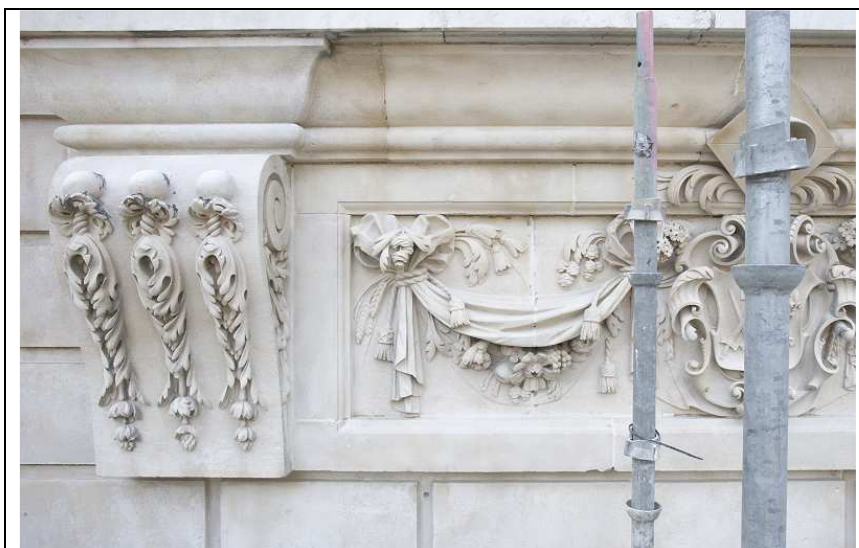
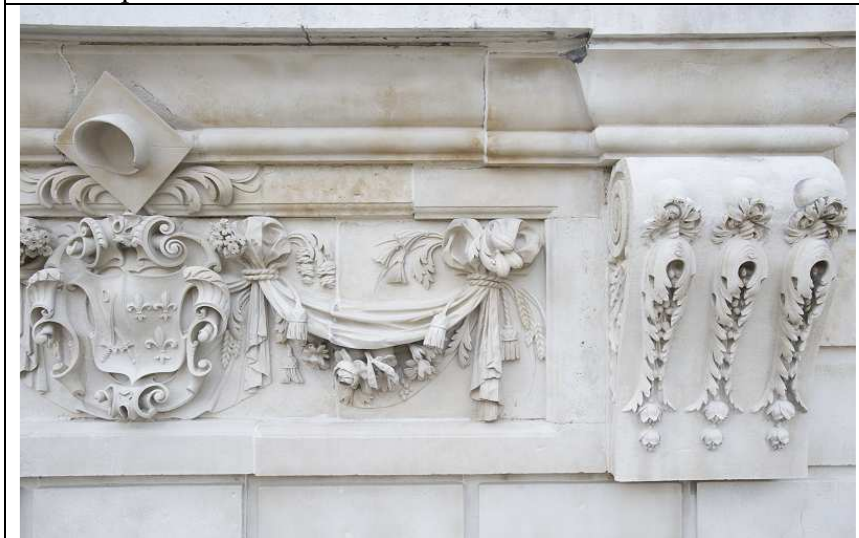
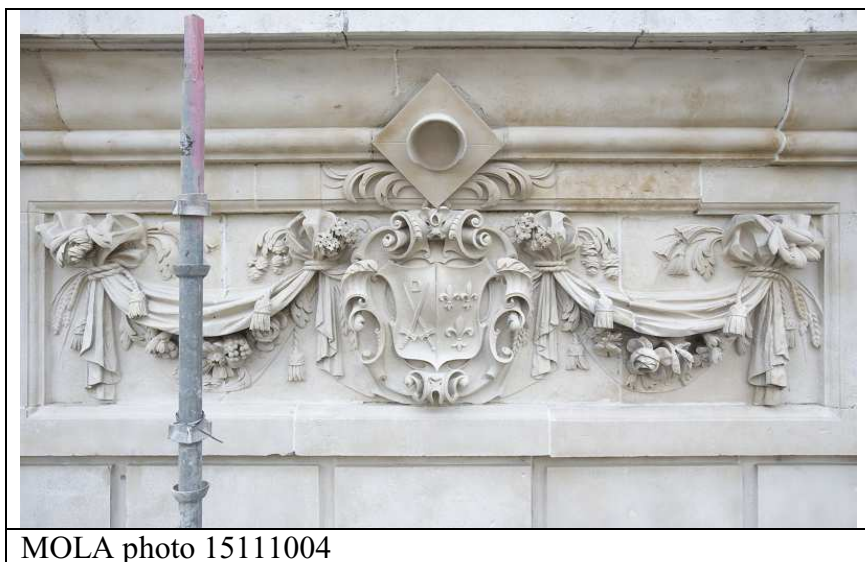
Fig 71 Bay NN6 (N side of nave): panel below window after cleaning

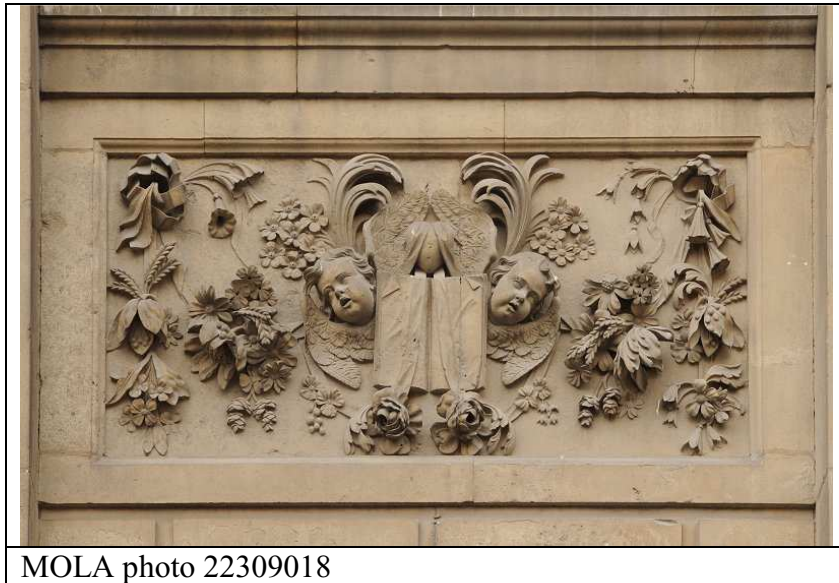
Fig 72 Bay NN7 (N side of nave): panel below window before cleaning

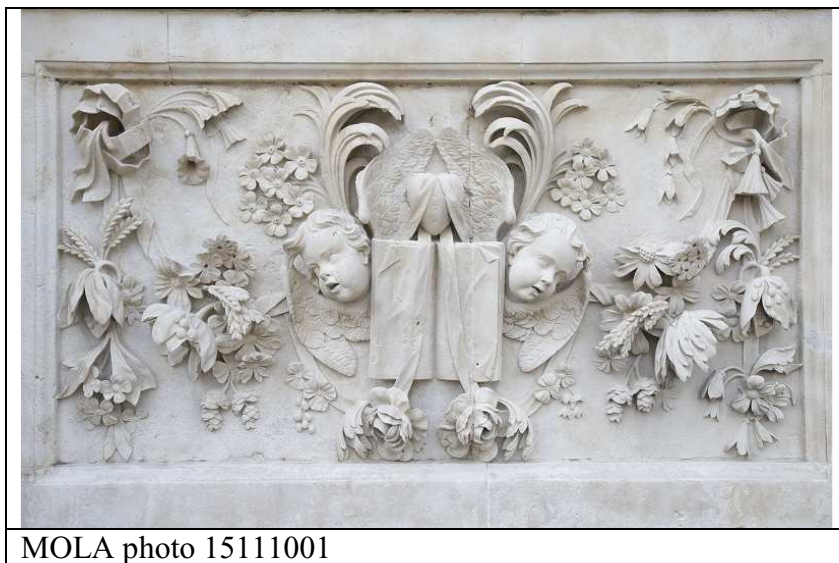
Fig 73 Bay NN7 (N side of nave): panel below window after cleaning

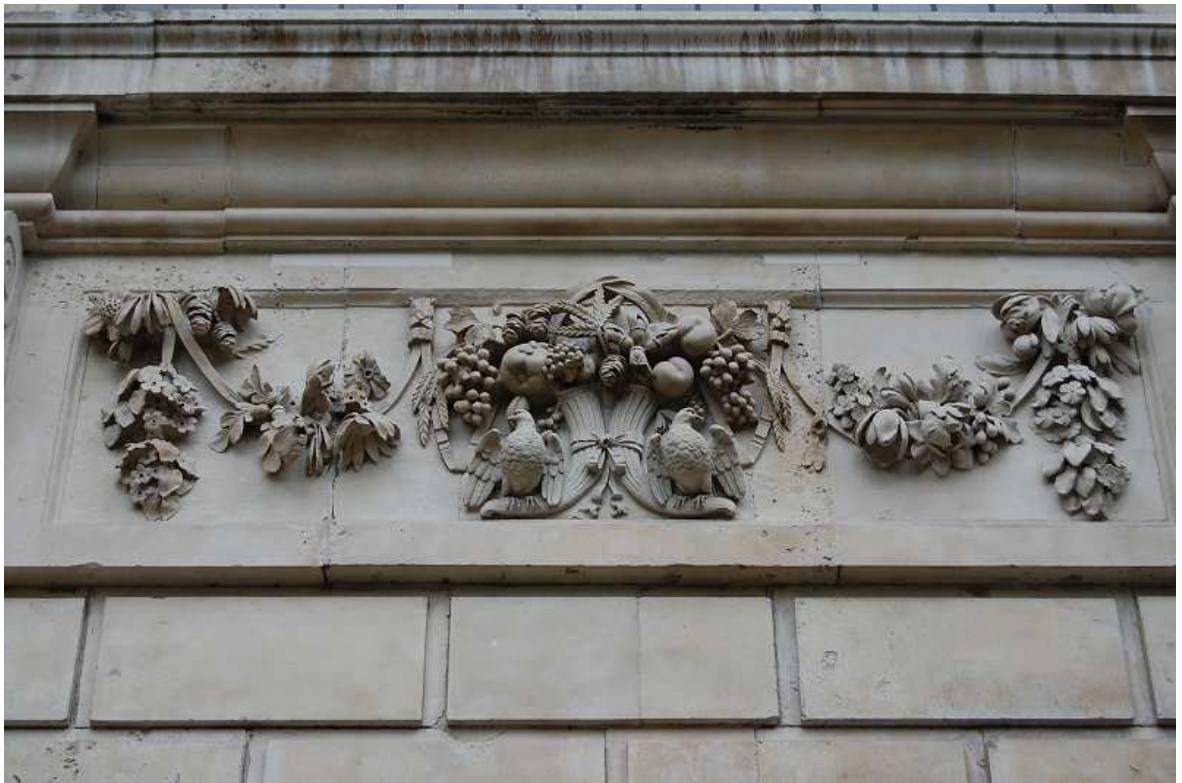
Fig 78 Panel below the window at the E end of the N aisle, facing E (Bay EE01), cleaned state (August 2011)
