Hallmark Developments (Northwest) Ltd

Dexine Rubber Works, Rochdale

Level 2 Archaeological Building Survey

22 November 2019

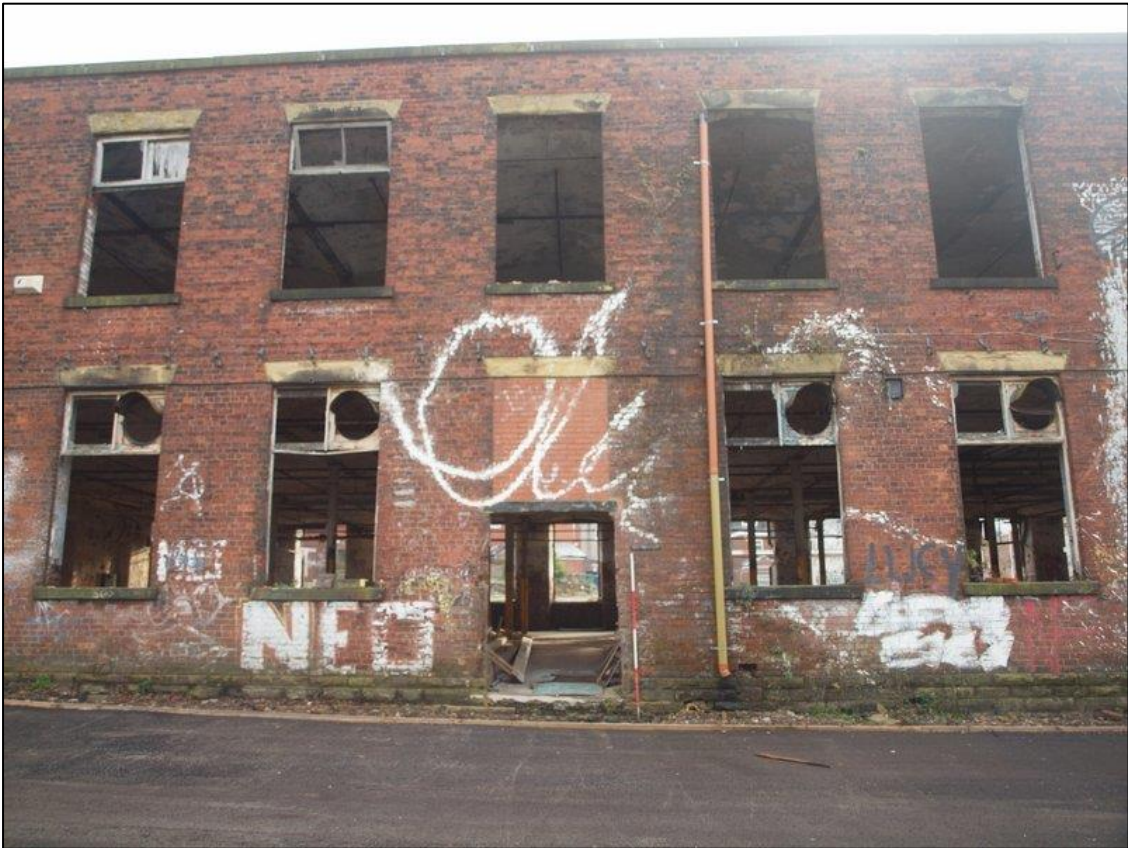
Plate 6: Northwest elevation bays 4 to 8

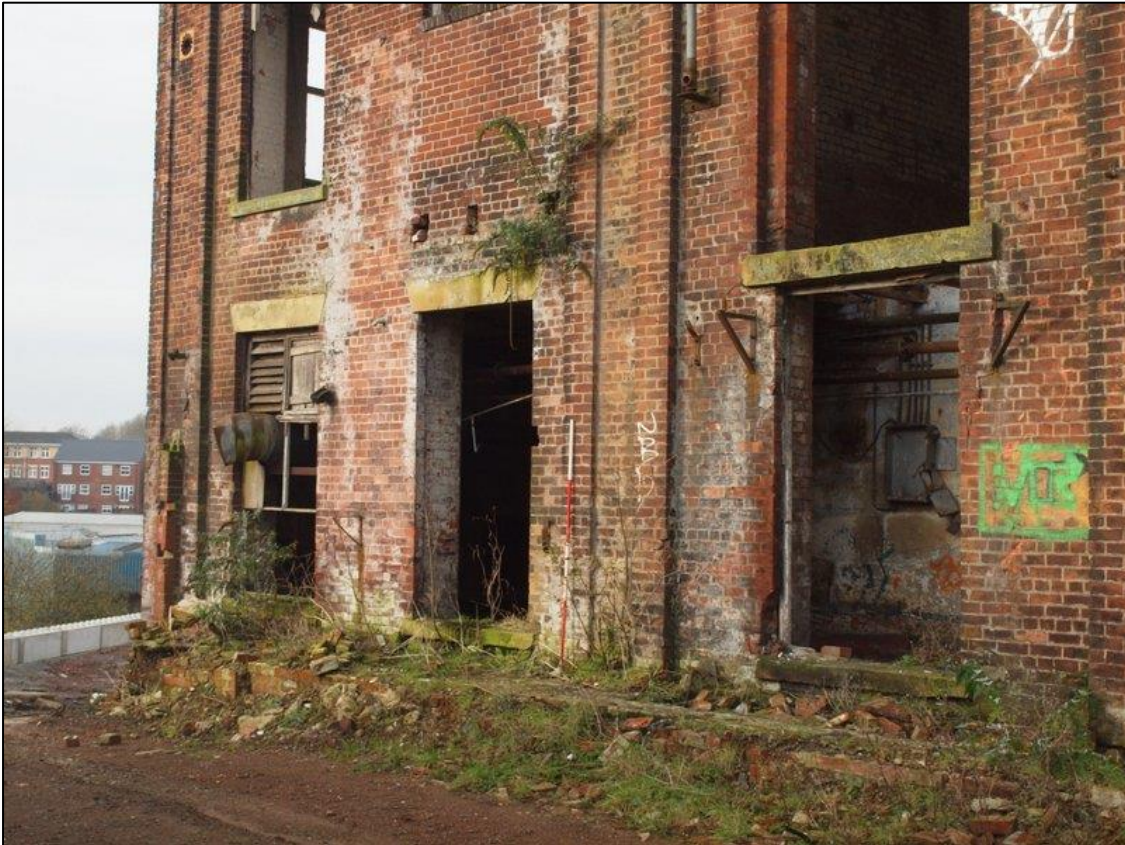
Plate 24: Detail of ground floor of above

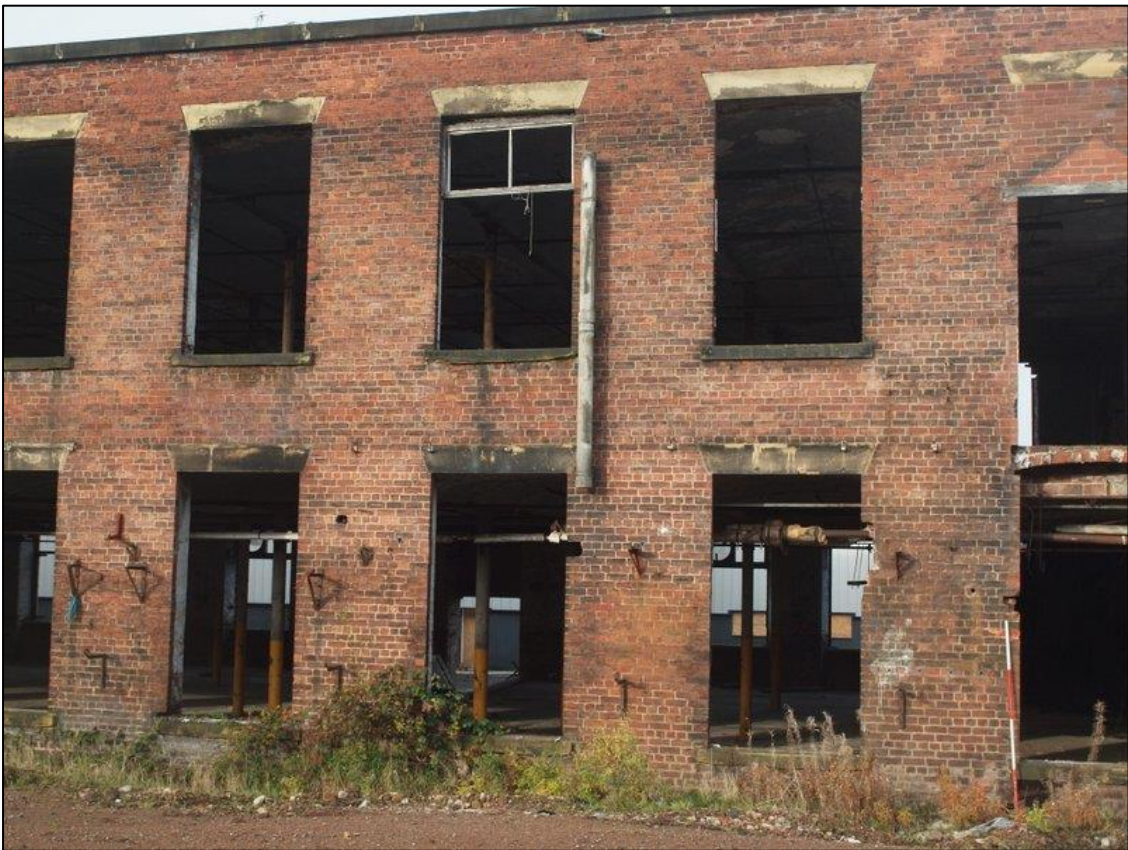
Plate 30: Southwest elevation bays 12 - 14

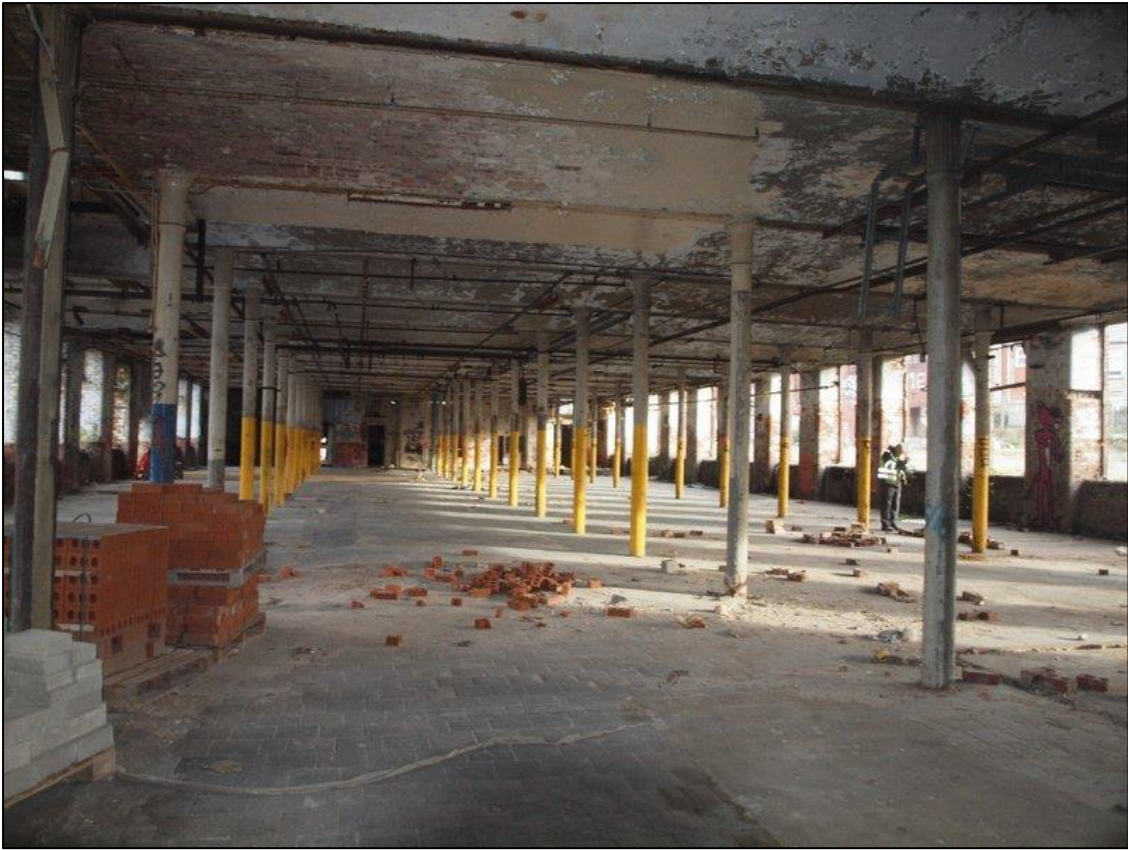
Plate 37: General shot of ground floor interior

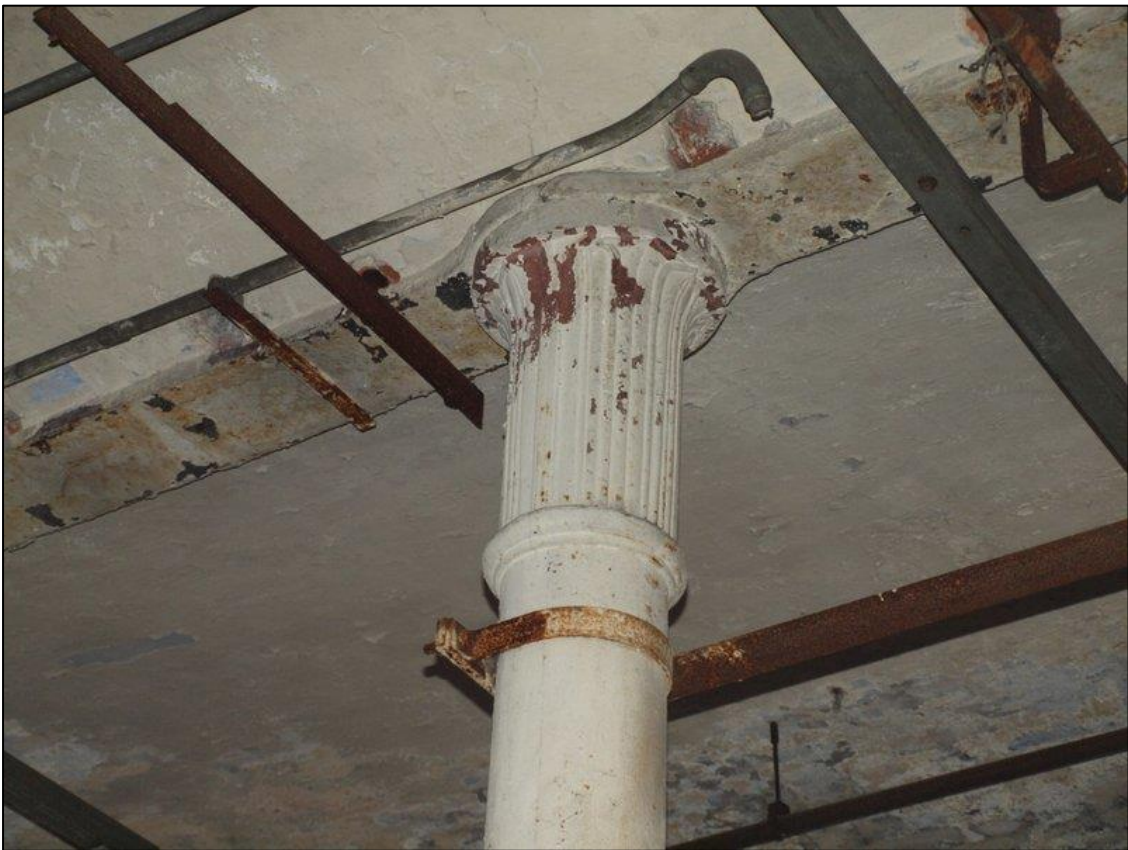
Plate 38: Detail of stanchion

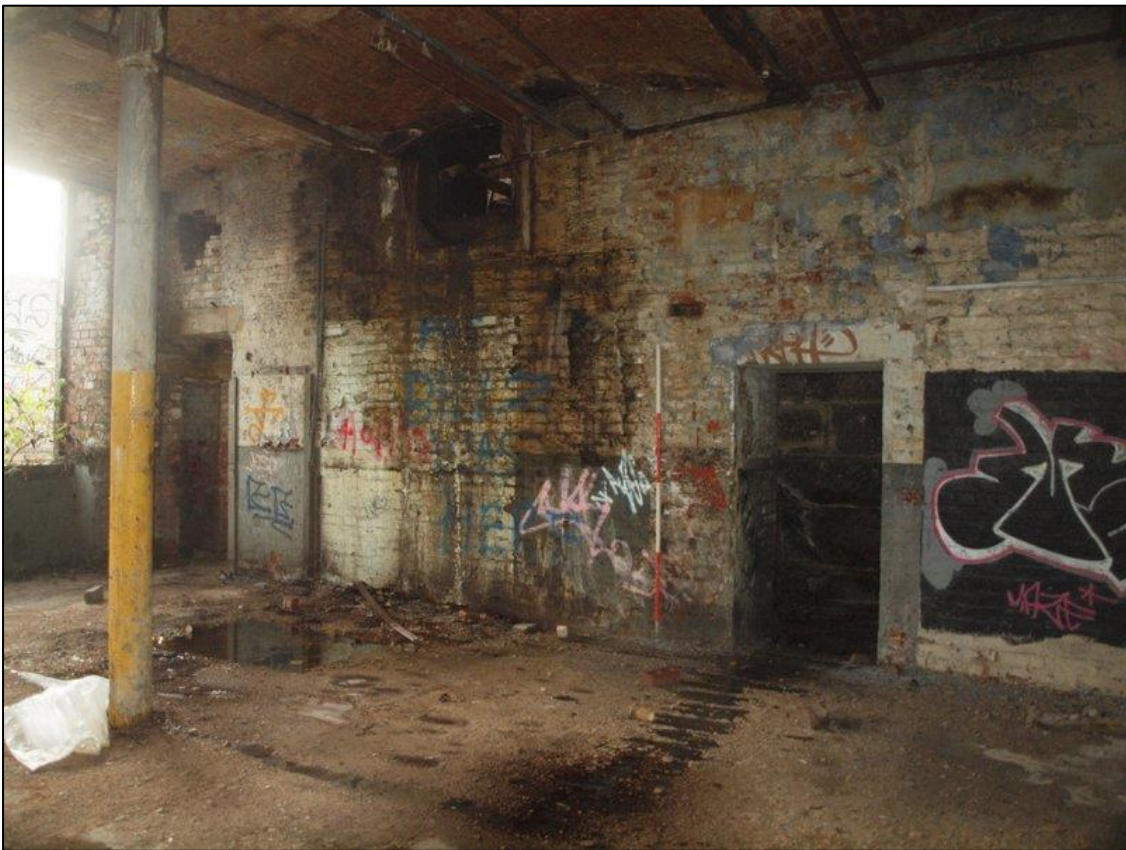
Plate 48: Southwest wall showing doorways at eastern end and transmission window

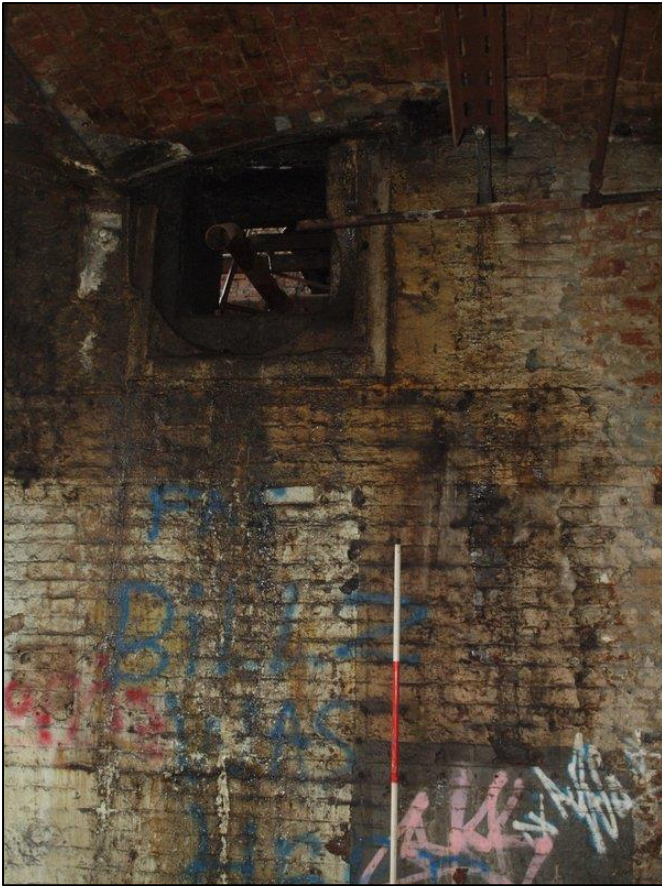
Plate 49: Detail of transmission window shown above

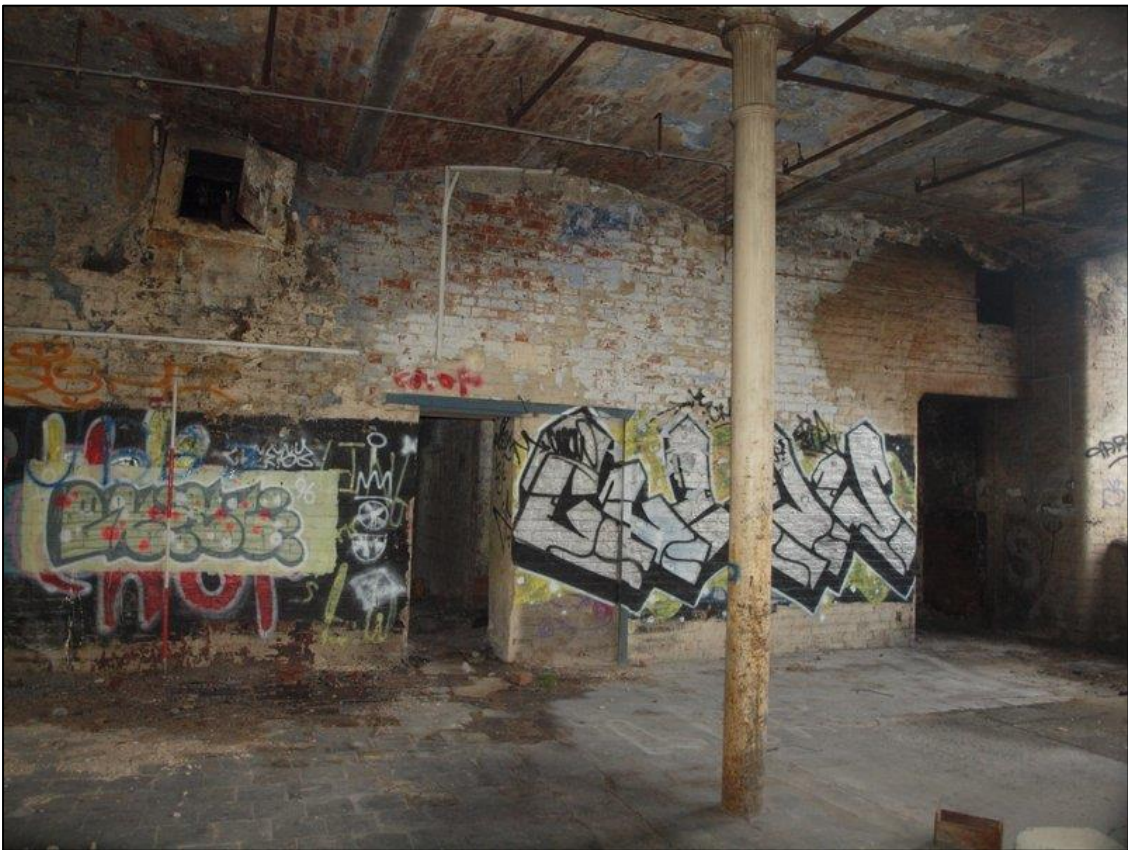
Plate 52: Western end of southwest wall

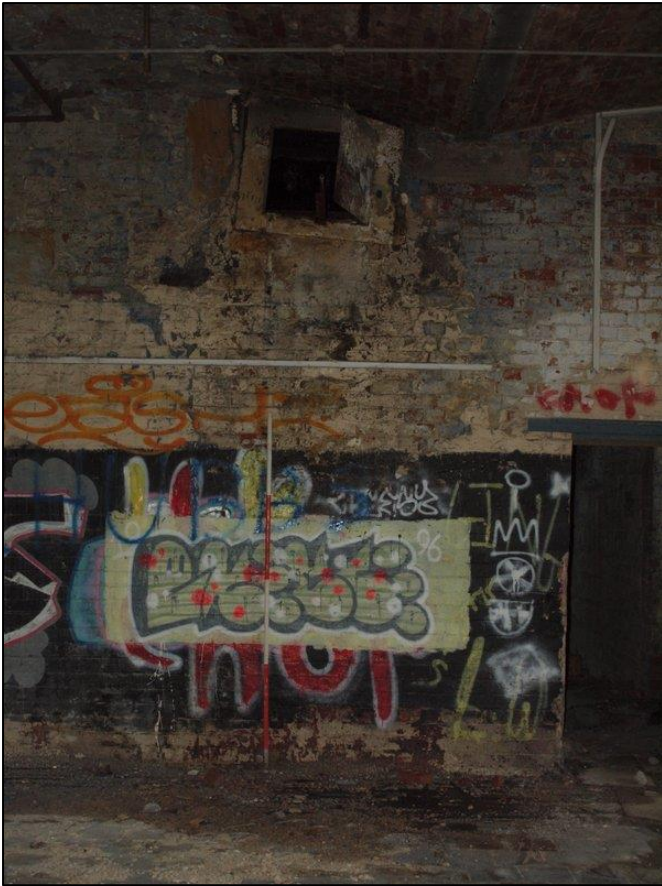
Plate 53: Detail of transmission window shown above

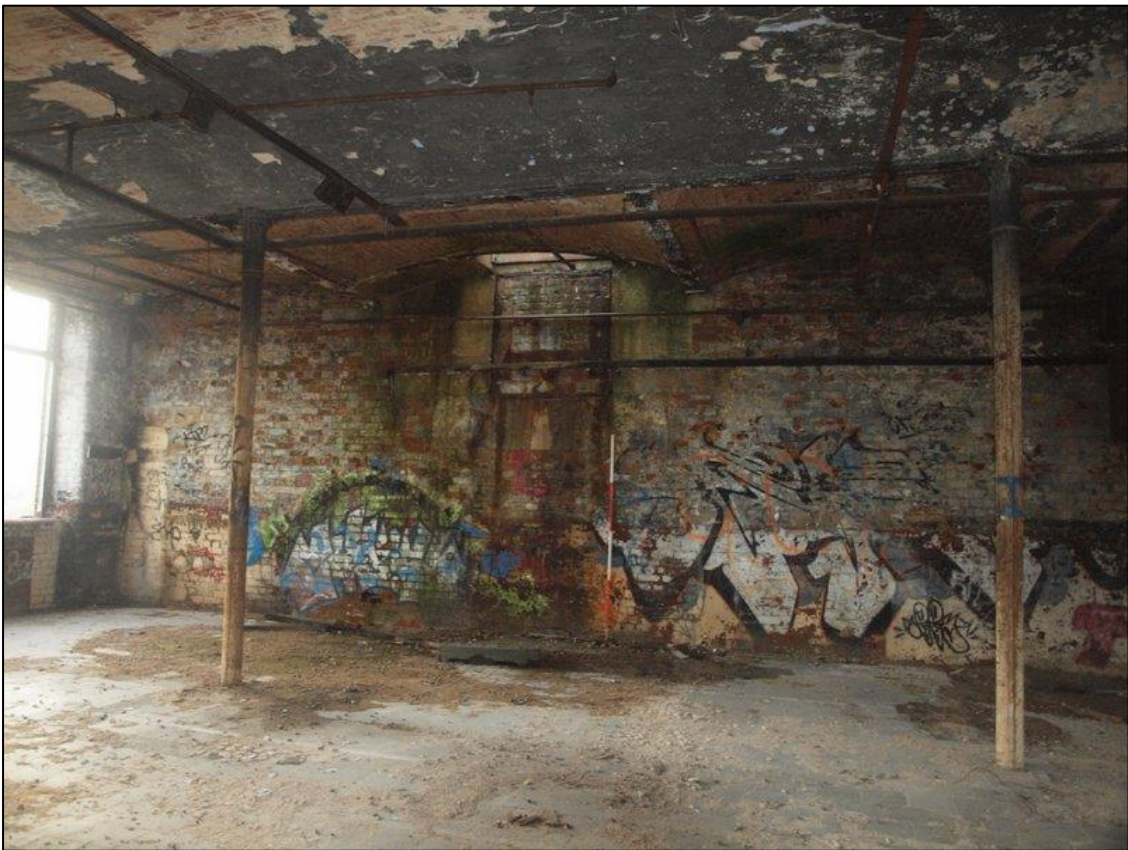
Plate 72: Southwestern party wall showing transmission window
