North End Farm

Wase Homes Limited

Archaeological Building Survey

28 September 2022

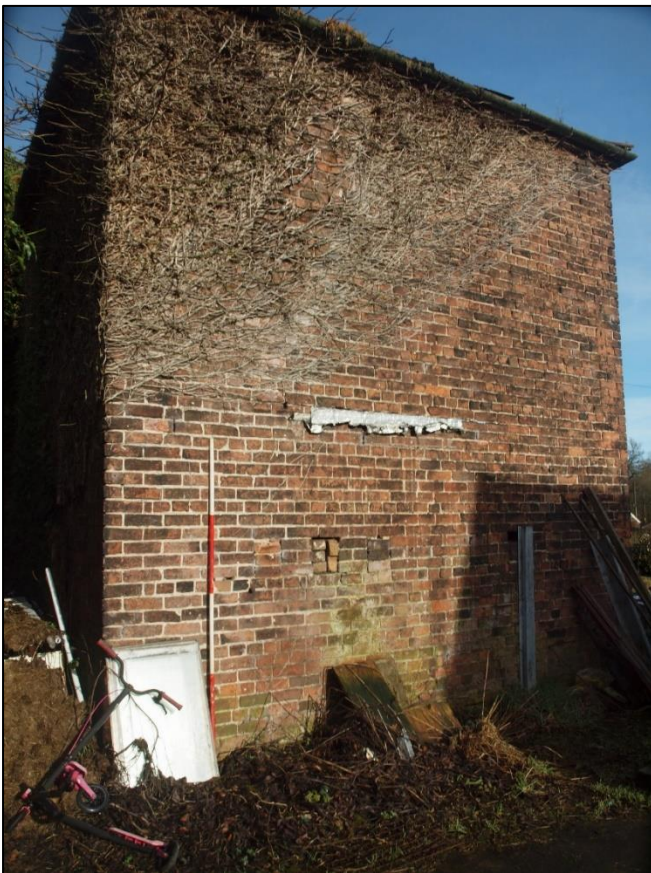
- 6.11 Southeast elevation (plates 36, 40 - 42). This elevation is featureless with the exception of six rectangular blocked ventilation holes at ground floor level. The lead flashing of a removed lean-to was present above them.

Plate 40: Southeast elevation

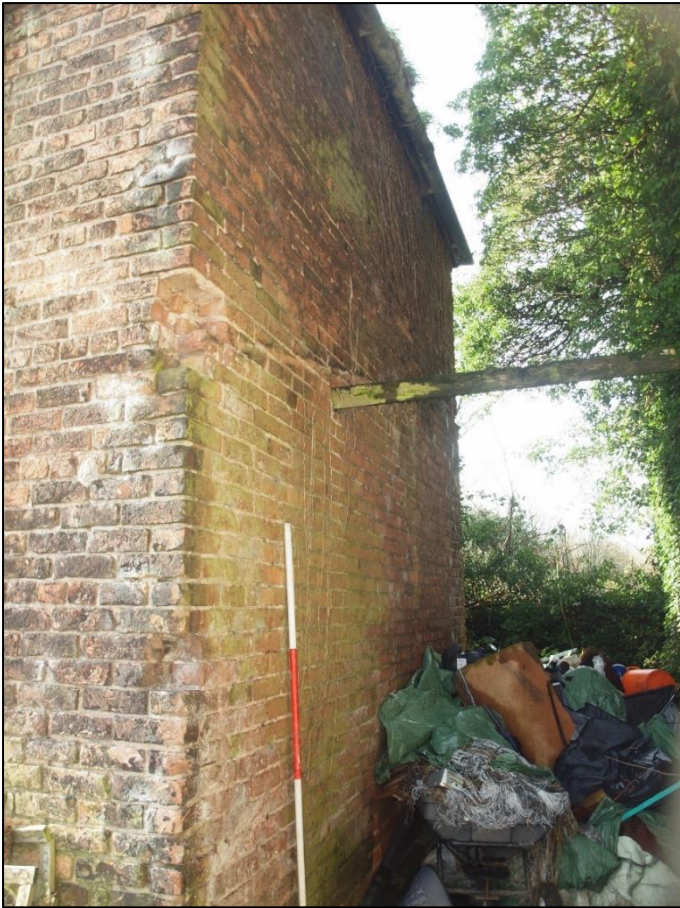
- 6.12 Southwest elevation (plate 42). This elevation faced onto the site boundary and was featureless.
- 6.13 Northwest elevation (plates 43 - 44). This elevation faced the barn and was also featureless with the exception of a timber beam protruding and connecting to the barn.

Plate 43: Northwest elevation

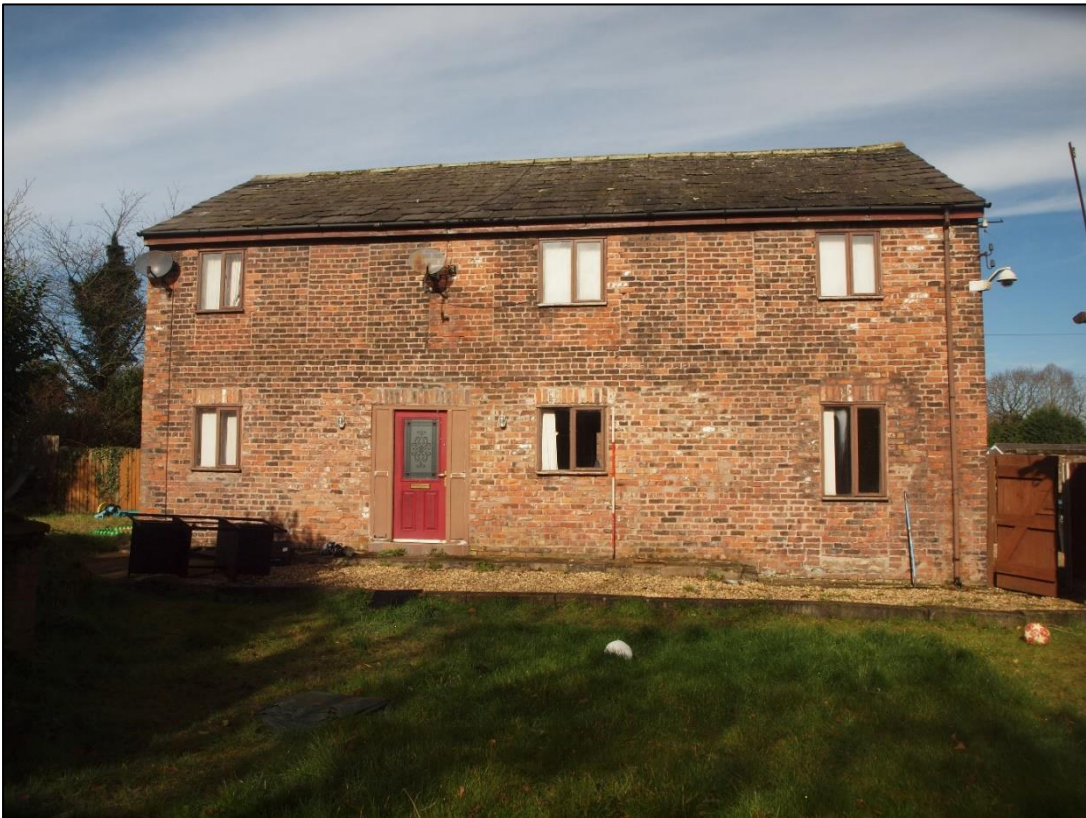
- 6.16 Southeast elevation (plates 50 - 54). This forms the main 6 bay frontage of the building. Bay 1 contains an inserted window at each level, with that at first floor level having been inserted with a blocked window. Bay 2 contains a further blocked portrait window at first floor level, with rebuilding shown at ground floor. The third bay contains the personnel door entrance to the building, set within a wide opening, flanked with timber panelling. Above, is a further blocked window. Bay 4 contains a square window at both ground and first floor levels. That at first floor has been inserted in place of a blocked window, and the ground floor shows evidence of rebuilding. This rebuild appears across bays 2 – 5 at ground floor level, with the brick being a much lighter orange than the rest of the building, which is an orange brown. At first floor level bay 5 contains a further blocked portrait window. Bay 6 contains a square window at first floor level, with a portrait window at ground floor level. The latter has been inserted in place of a former doorway. Finally, to the left side, a rough joint runs up the face close to the corner

Plate 50: Southeast elevation

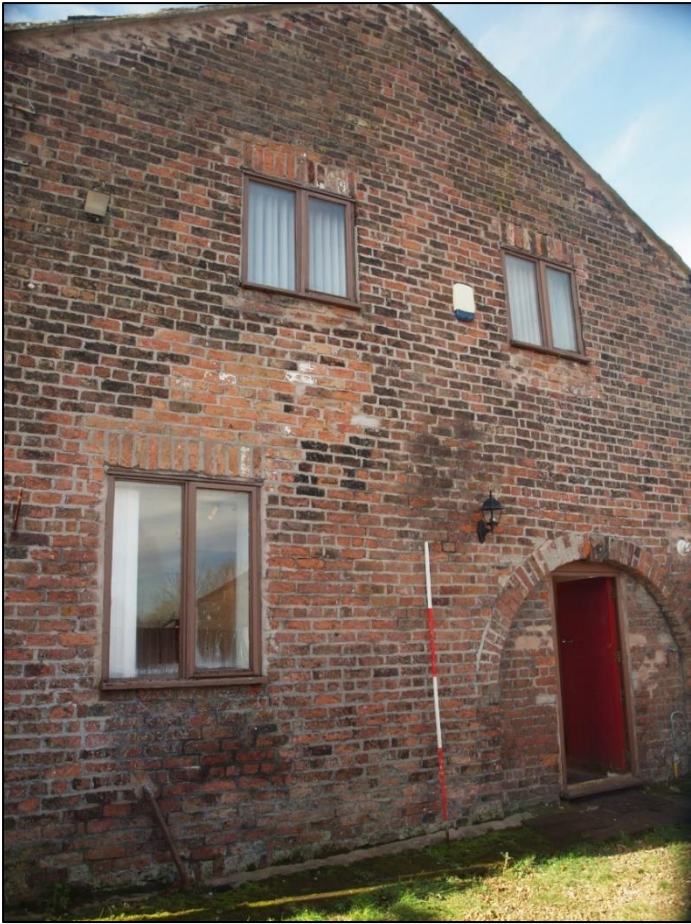
- 6.17 Northeast elevation (plates 55 - 58). This forms the gable end of the building. At the southern end a portrait window has been inserted. To the north a wide opening is present with large rounded arch lintel of brick. The opening has been blocked and a personnel doorway set within it. At first floor level a pair of square windows have been inserted, set closer to the centre of the face than the openings below.

Plate 55: Northeast gable

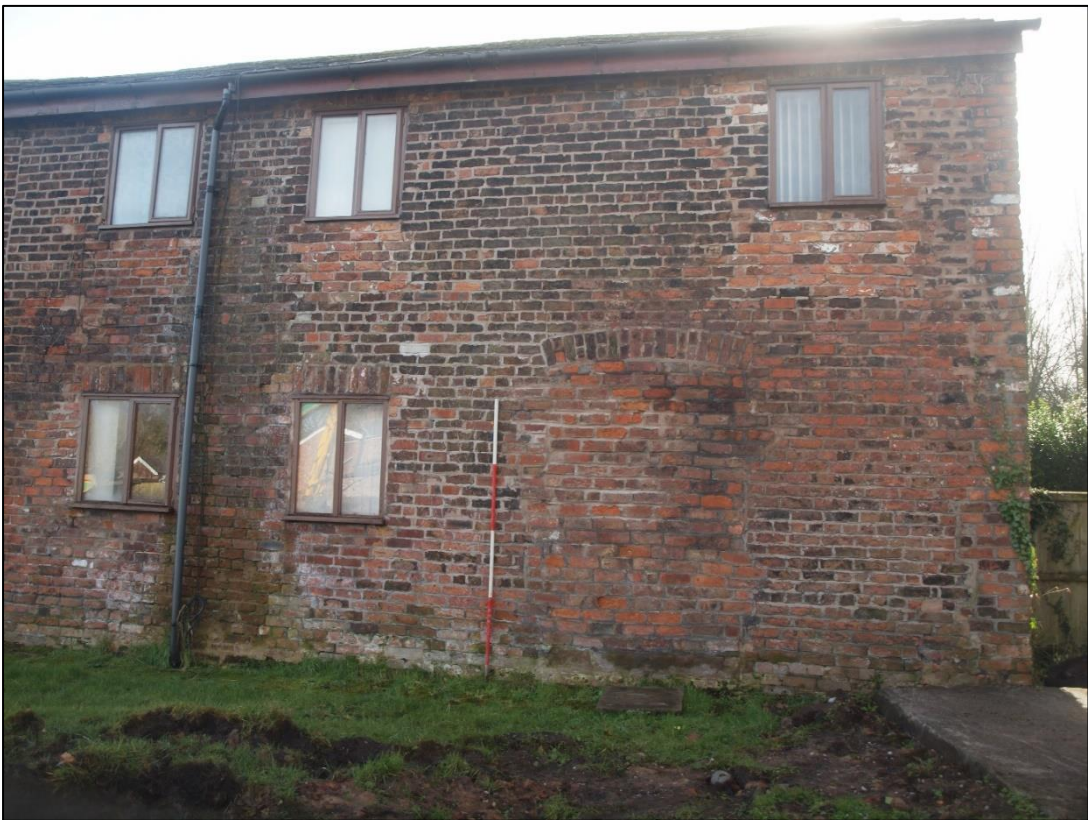
- 6.18 Northwest elevation (plates 59 - 65). This forms the rear of the building. Bays 1 and 2 each contains a square window at ground floor level, with bay 1 having another at first floor level. Bay 2 contains a blocked portrait window. Bays 3 and 4 likewise have windows at ground and first floor levels, with those at first floor level each showing rebuilding below, suggesting they replaced earlier windows. Bay 5 contains a blocked doorway at ground floor level, with a depressed arch lintel of brick. The first floor is featureless. The final bay is featureless at ground floor level with a window at first floor level. This appears to have been inserted in place of an earlier window, with rebuilding below. Finally, a rough joint runs up the right hand side of the building, close to the corner.

Plate 60: Western end

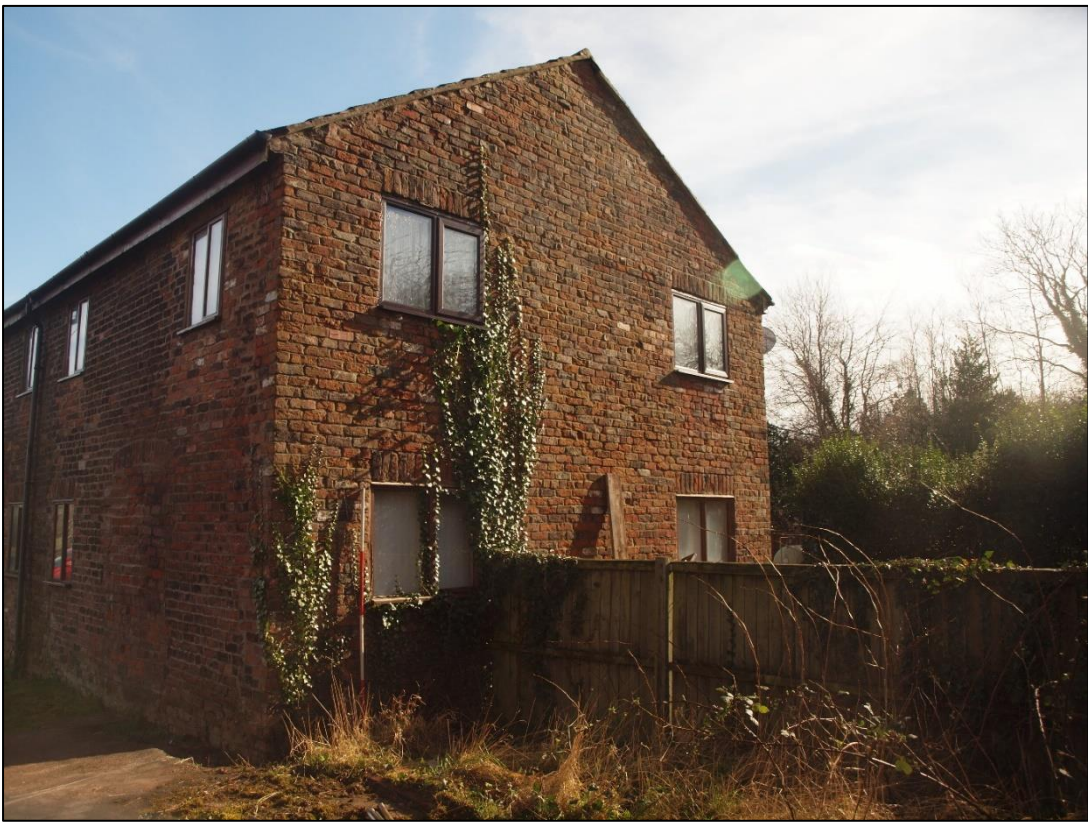
- 6.19 Southwest elevation (plates 66 - 67). This forms the other gable end of the building, with two windows to ground and first floor levels. The elevation appears to be a later rebuild, as evidenced by the rough joints found on the southeast and northwest elevations

Plate 66: Southwest gable

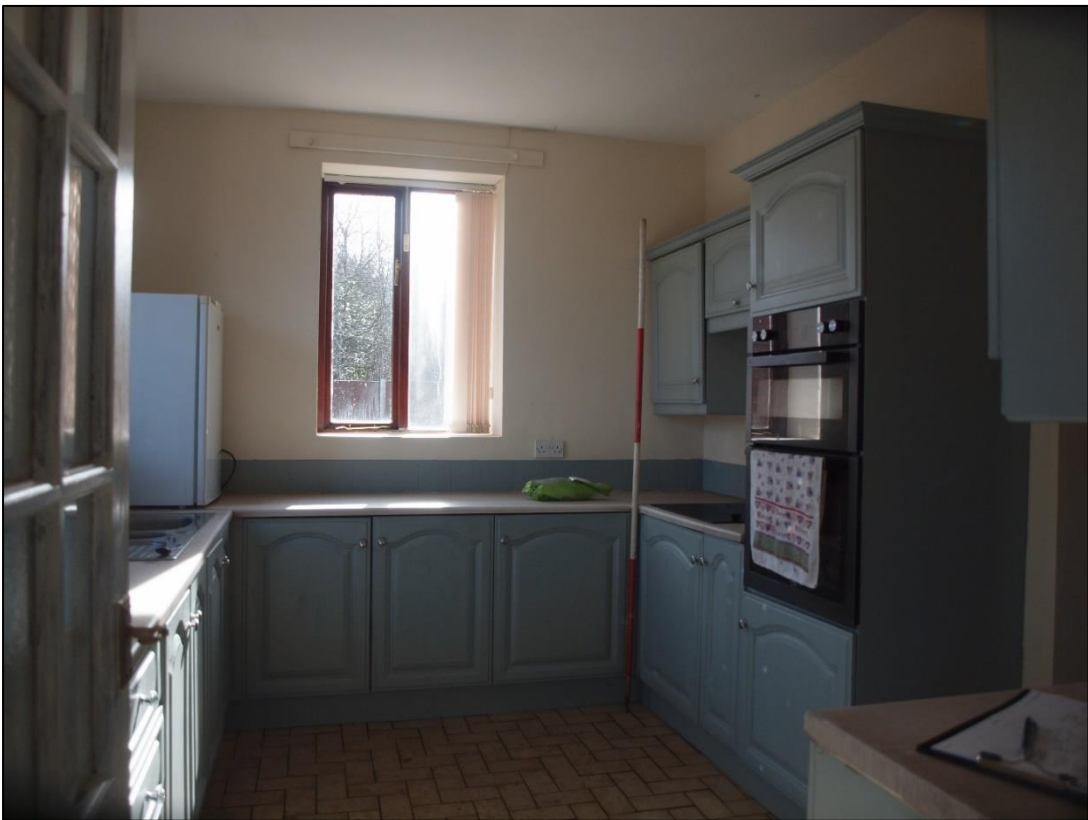
- 6.20 Ground floor. The doorway in the northeast gable leads into a small room, fitted out as a modern kitchen (plate 68), with toilet to the north corner. A set of steps in the southwest wall lead up to an opening giving access to a large room spanning the width of the building (plates 69 - 71). Windows lie in the northwest and southeast walls. The walls are plastered and painted along with the ceiling and the floor is carpeted. In the south end of the western wall a set of double doors lead through to a hallway and staircase (plates 72 - 74). The staircase is modern and rises up to the northwest. This lies opposite the doorway in the southeast elevation. Beyond the staircase to the northwest is a small toilet room. Adjacent to the bottom of the stairs is a further wide doorway leading to a further room, at the western end of the building (plates 75 - 76). This matches the others, with plastered walls and ceiling and carpeted floor. A recess lies in the northwest wall, in the location of the blocked doorway seen externally.

Plate 68: Modern kitchen

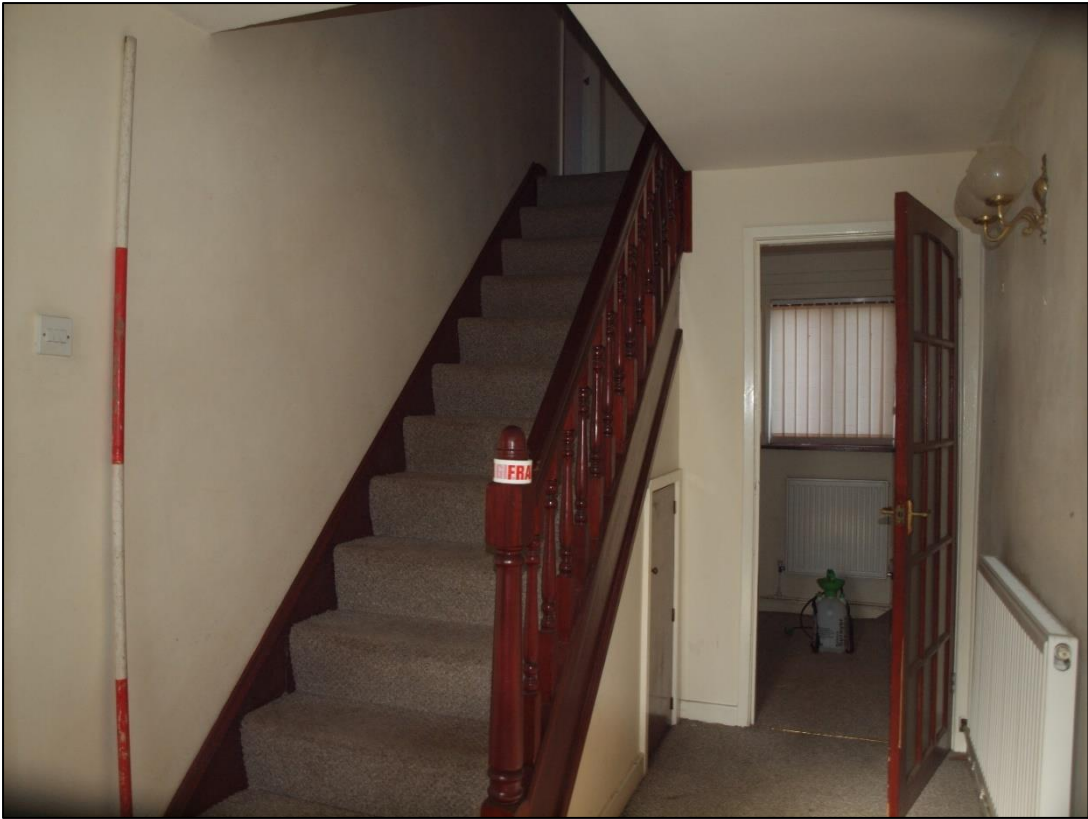
Plate 73: Inserted modern staircase

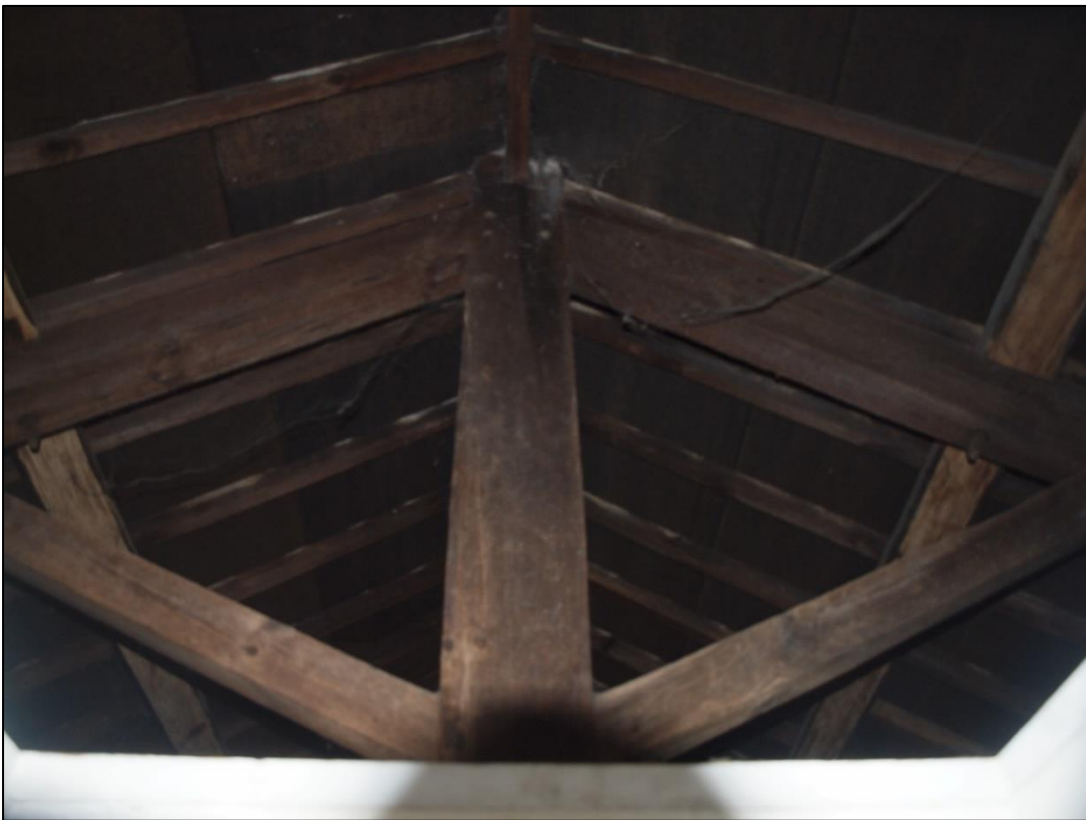
Plate 88: Truss detail

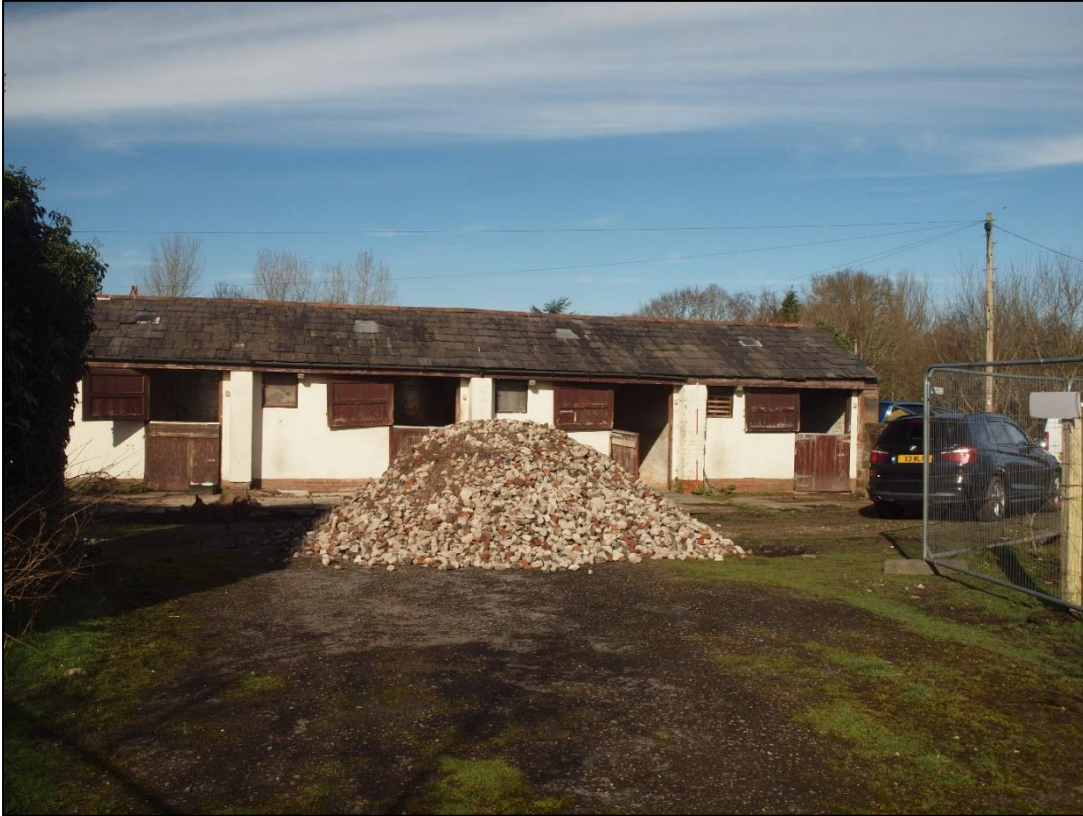
Plate 89: Southeast elevation

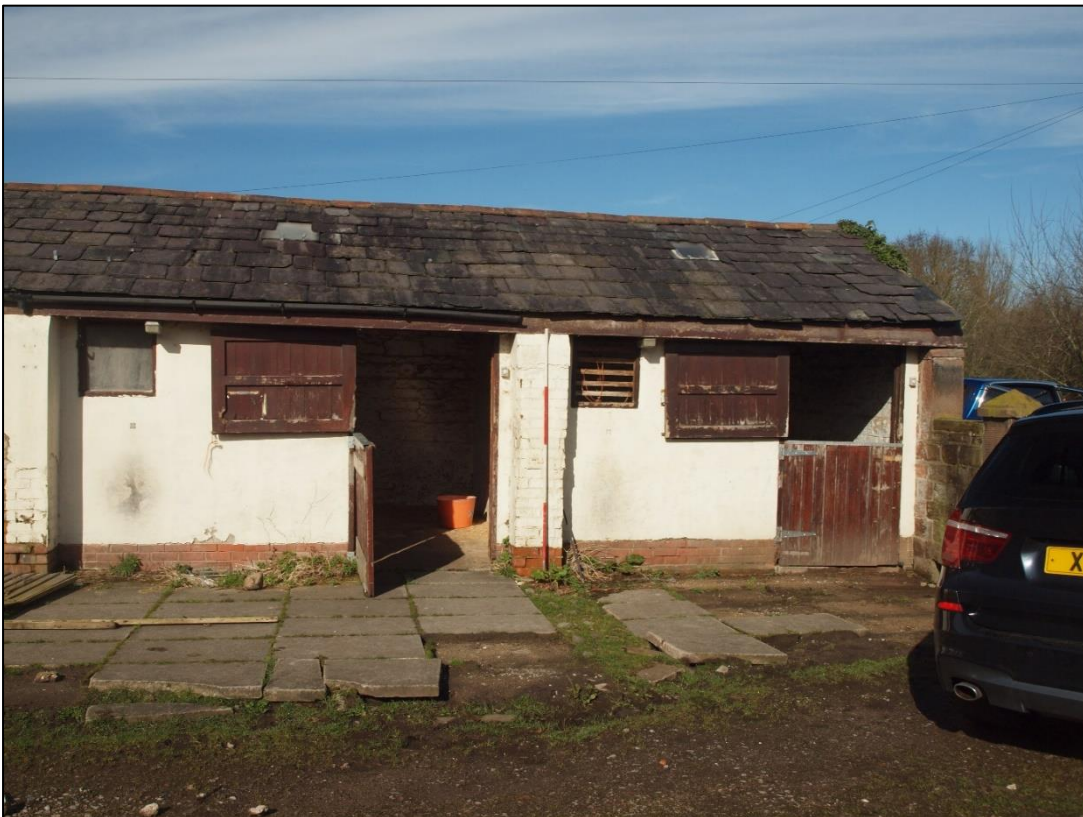
Plate 90: Detail of east end

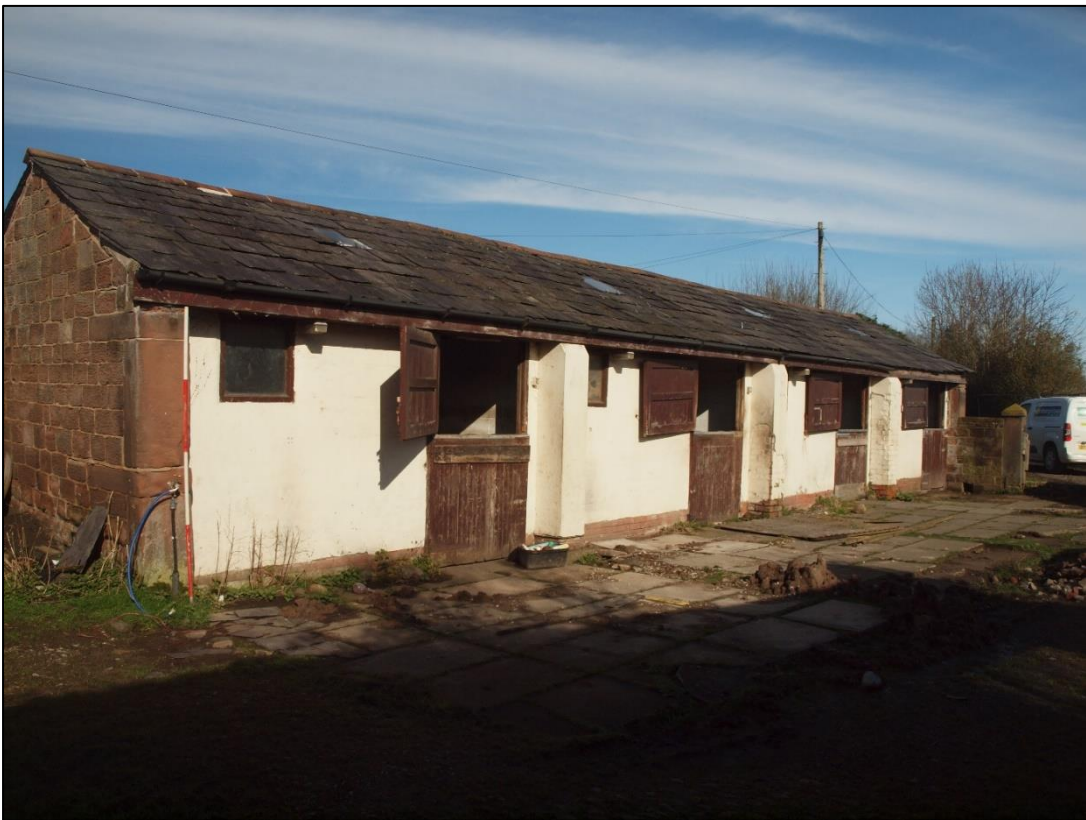
Plate 92: Southeast elevation

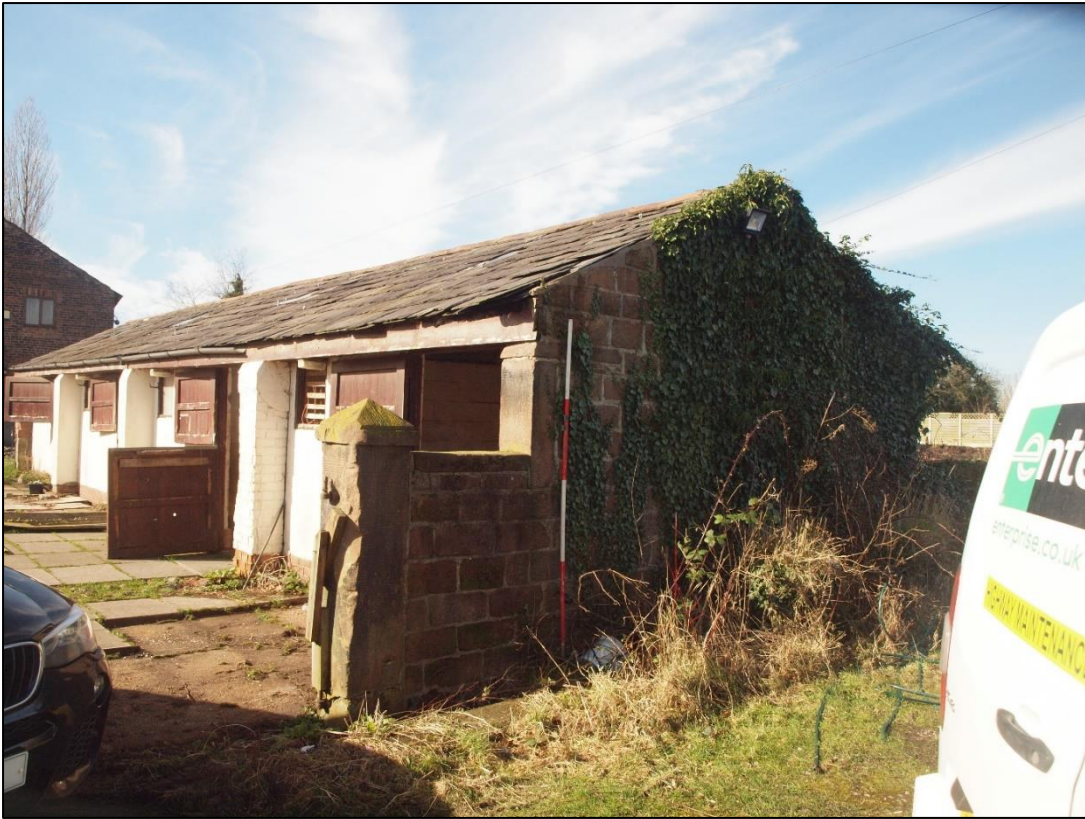
- 6.24 Northeast elevation (plates 93 - 94). This comprises the gable end of the building and is built in shaped and coursed sandstone rubble. The majority is covered in ivy, but is featureless.

Plate 93: Southeast and northeast elevations

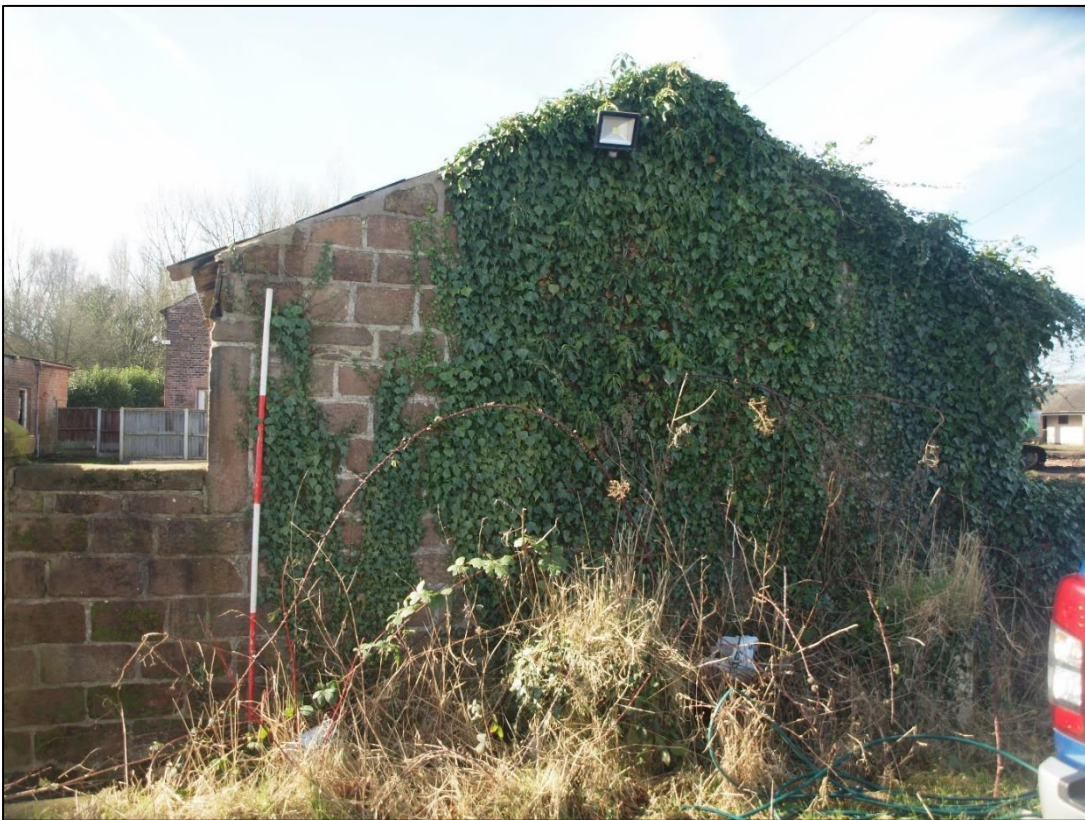
Plate 94: Northeast elevation

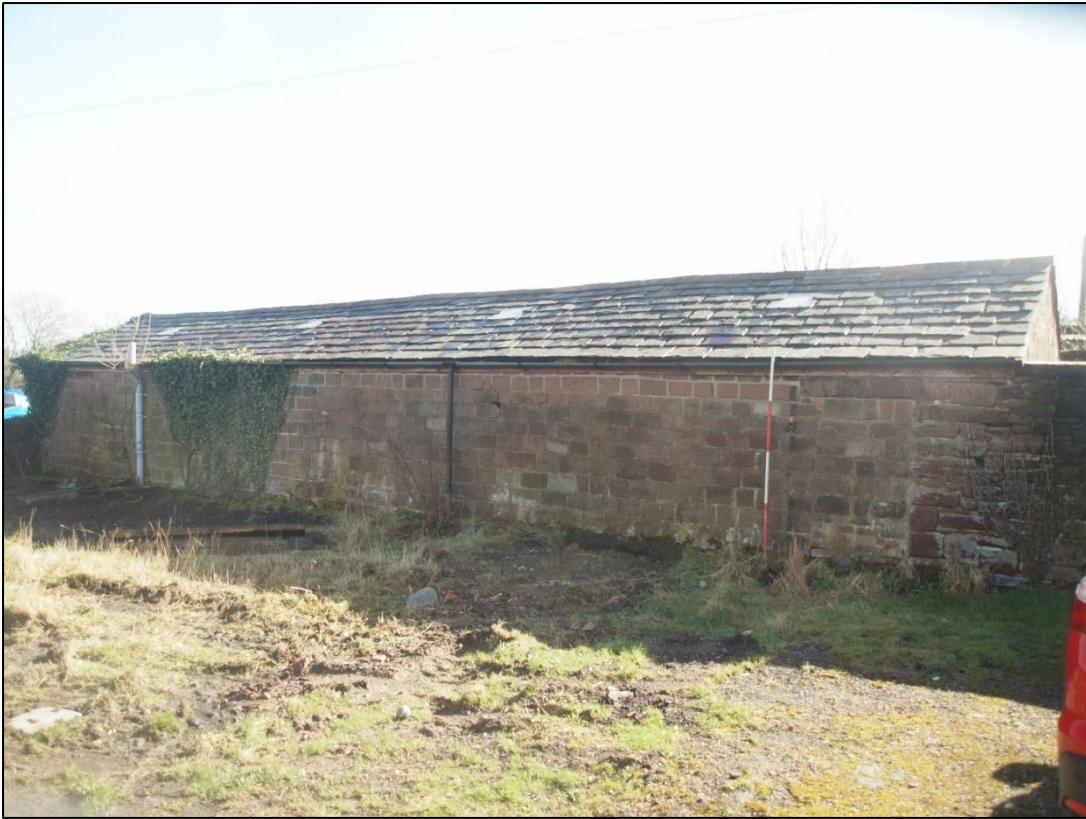
- 6.25 Northwest elevation (plates 95 - 97). This comprises the rear elevation of the building. It is again shown to be constructed of shaped and coursed sandstone rubble. A blocked personnel doorway lies at the western end with sandstone lintel over. The face is otherwise featureless.

Plate 95: Northwest elevation

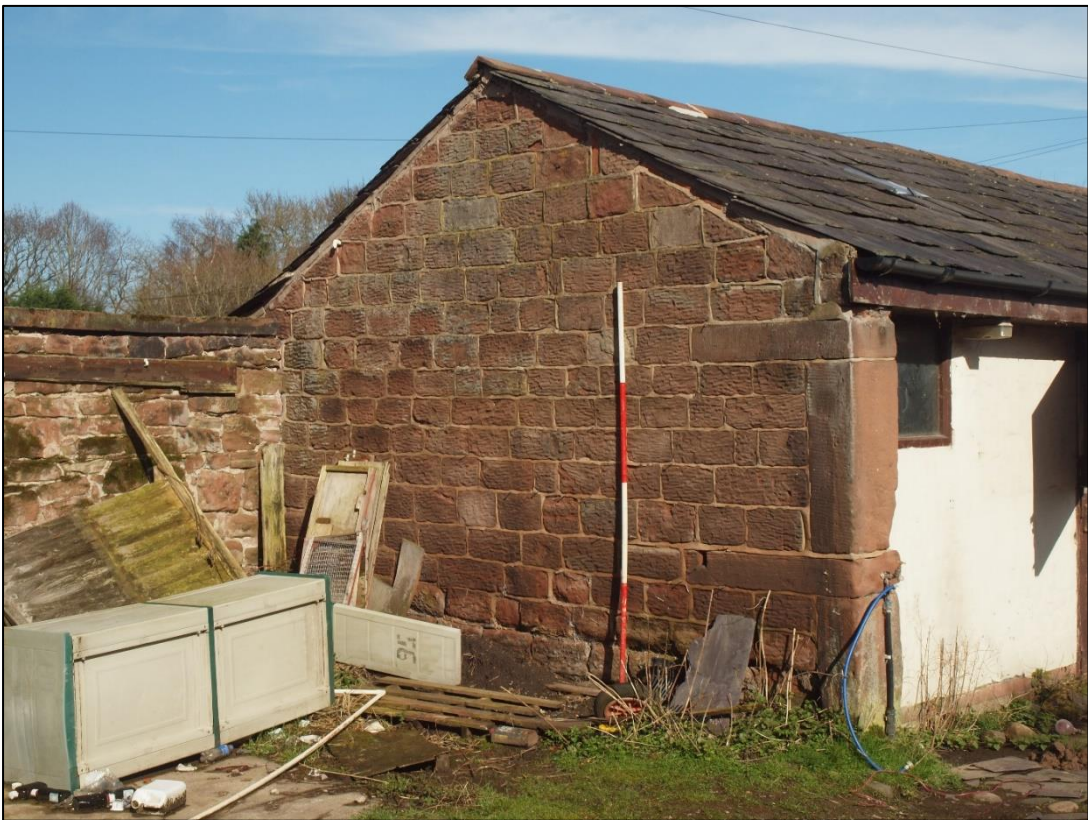
- 6.26 Southwest elevation (plate 98). This forms the other gable end of the building and is again sandstone. The stone pier to the southern corner is visible, formed of tall sandstone uprights, with long stone blocks between. The face is otherwise featureless.

Plate 98: Southwest gable

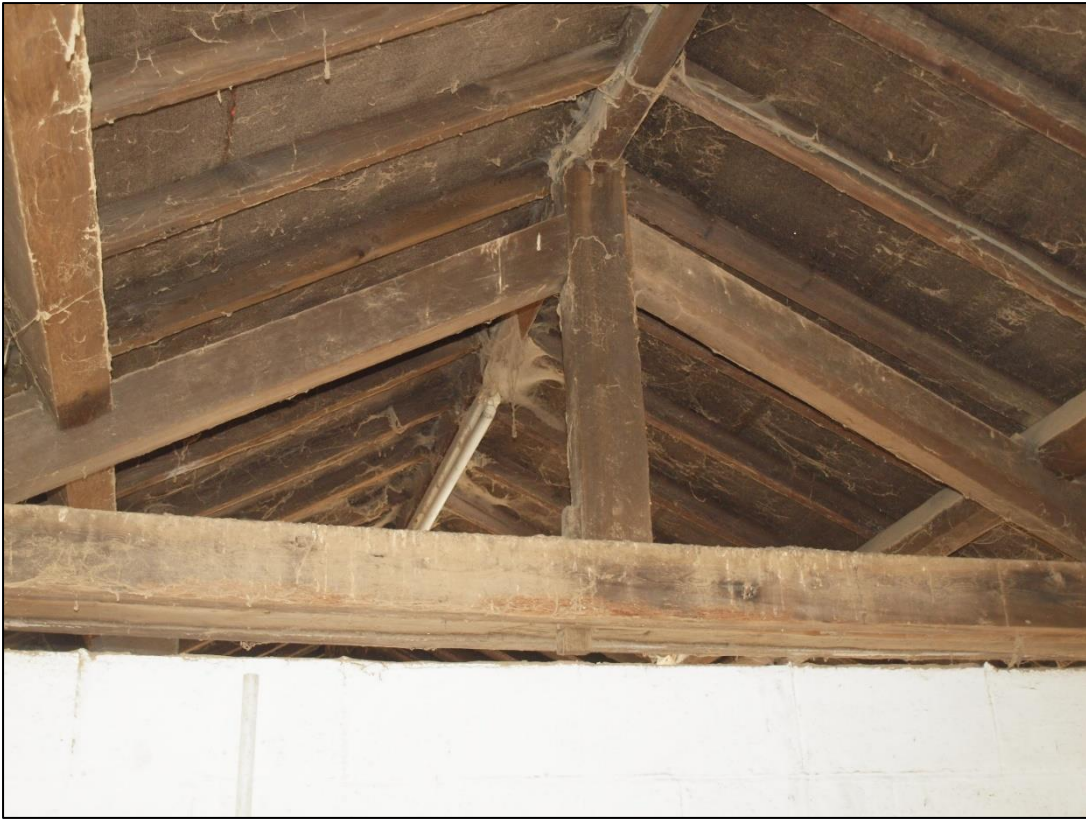
Plate 101: Truss detail

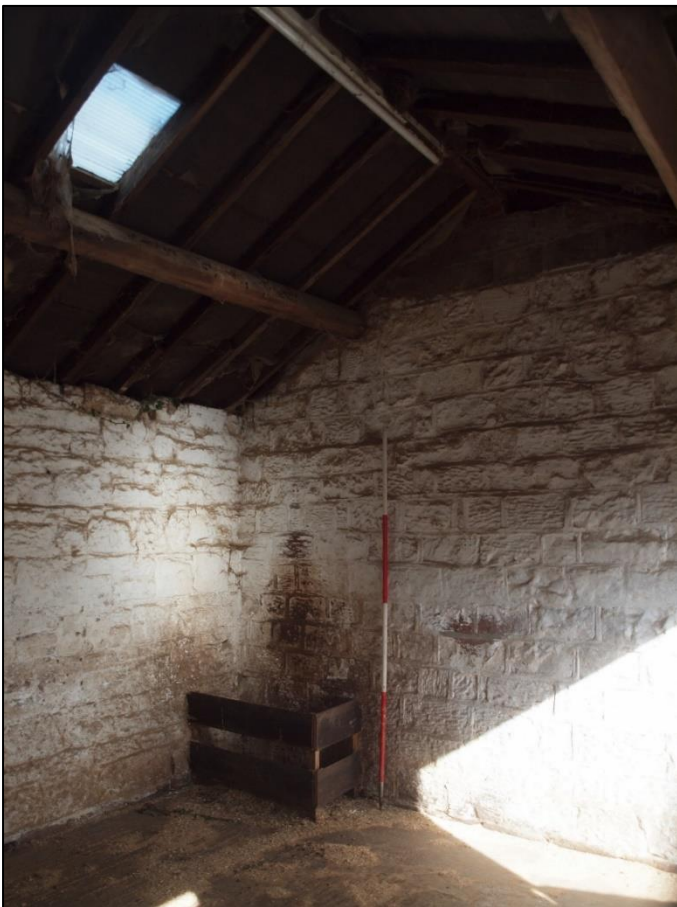
Plate 104: Whitewashed gable detail

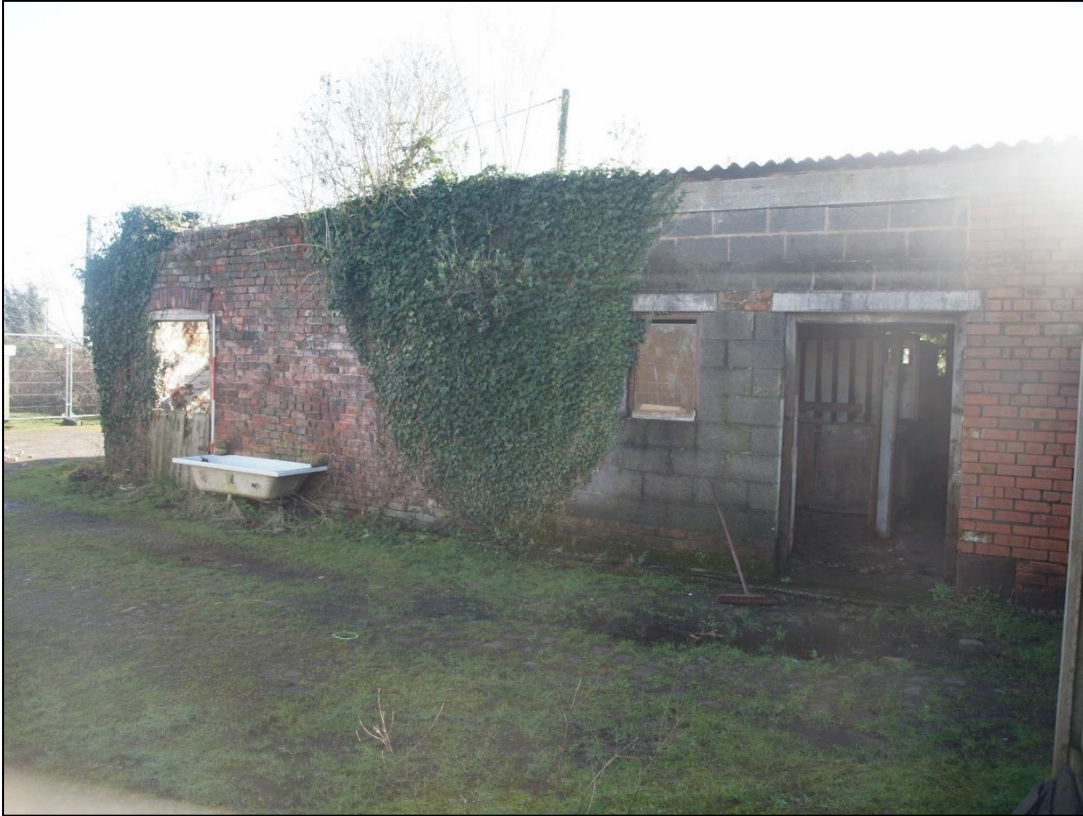
6.29 Northwest elevation (plates 105 - 109). This forms the main frontage of the building. At the eastern end the building is brick built in English Garden Wall bond (4:1). A personnel doorway lies at the eastern end of this section, with a depressed arch lintel of brick. The timber frame is present, although only the bottom of the timber door itself remains. The rest of the face is featureless, although ivy lies to the west. Beyond this the face is constructed of concrete block over a brick base. A small window lies to the east side with a wide doorway to the west. each has a concrete lintel. The western jamb of this doorway is formed of modern brick, which the remainder of the face is constructed in. This contains a personnel doorway to the eastern end, with concrete lintel, and the rest of the face is featureless.

Plate 105: Northwest elevation

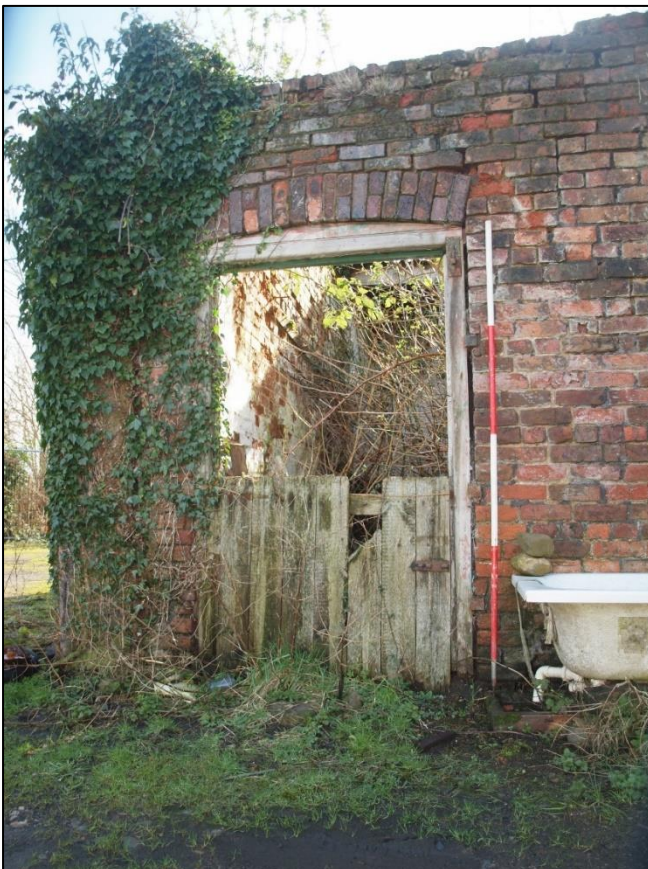
Plate 106: Doorway to eastern end into derelict section

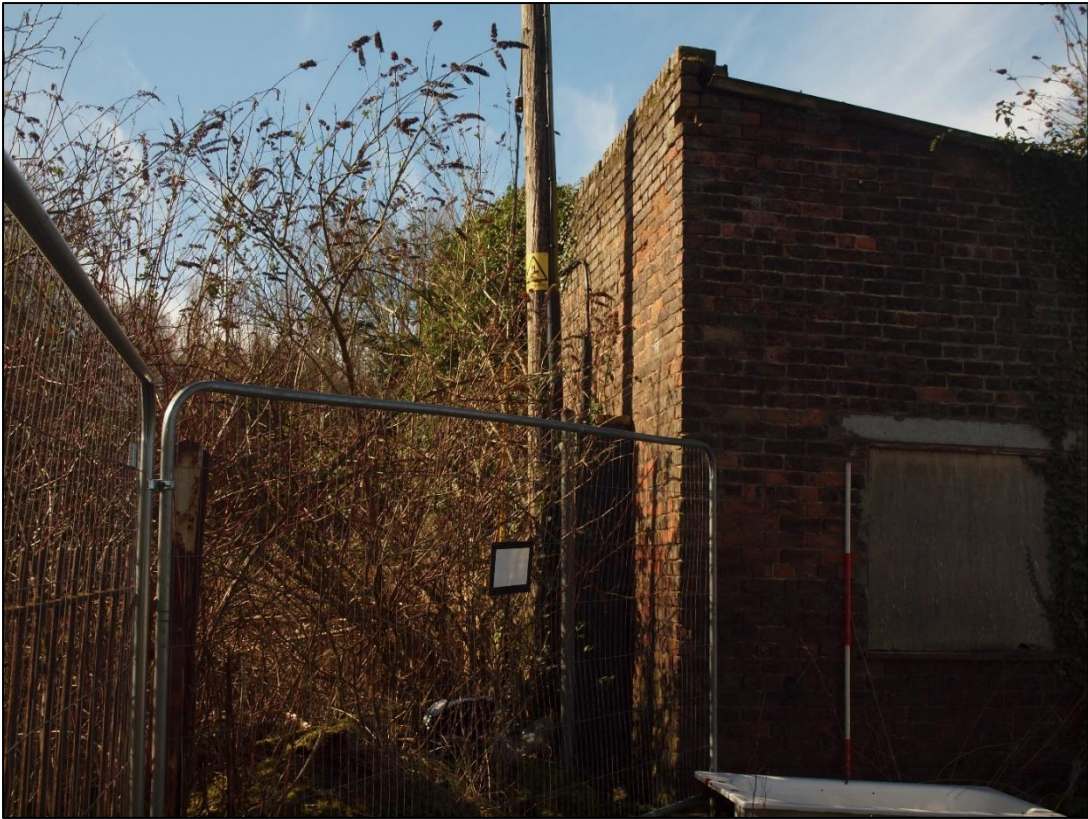
6.30 Northeast elevation (plates 110 - 111). This forms the single pitched end of the building. To the southern side a large square window is present, blocked with ply. Ivy covers the central part of the face, but it is otherwise featureless.

Plate 111: South end of northeast elevation and east end of southeast elevation

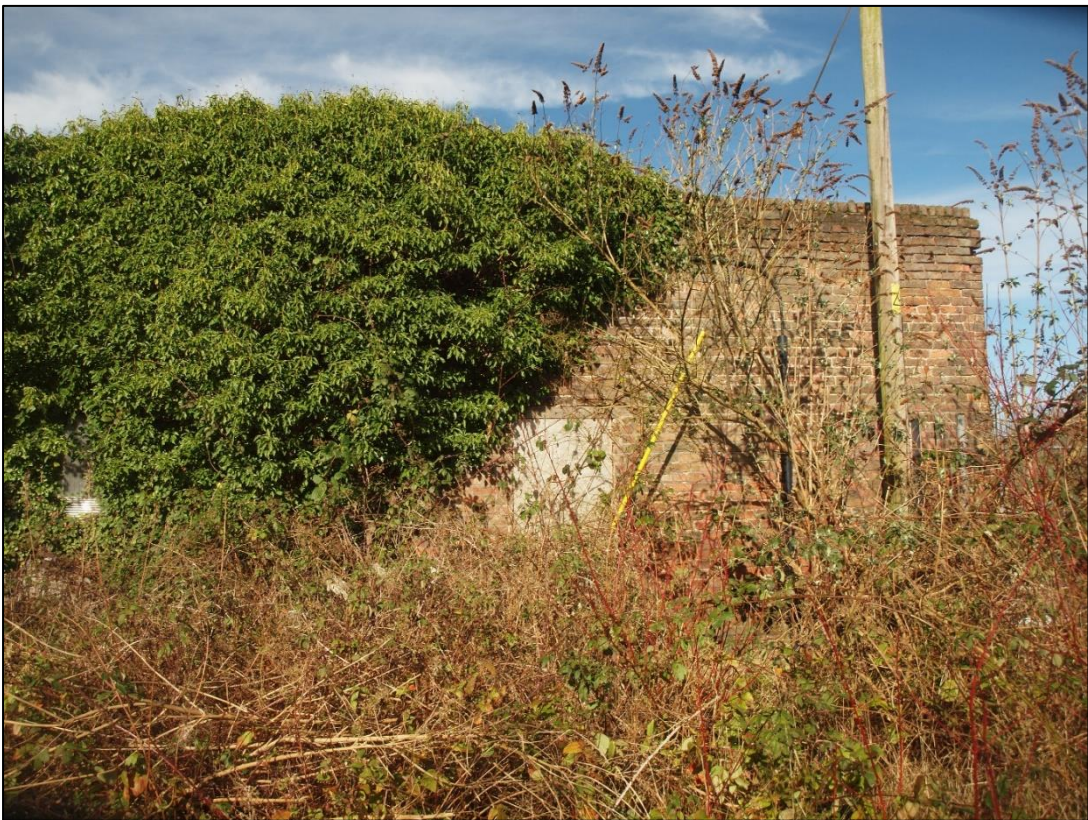
6.31 Southeast elevation (plates 111 - 113). This elevation forms the southern site boundary and is heavily overgrown. The face, where visible is brick and windows covered with ply are present to the eastern end.

Plate 112: Southeast elevation

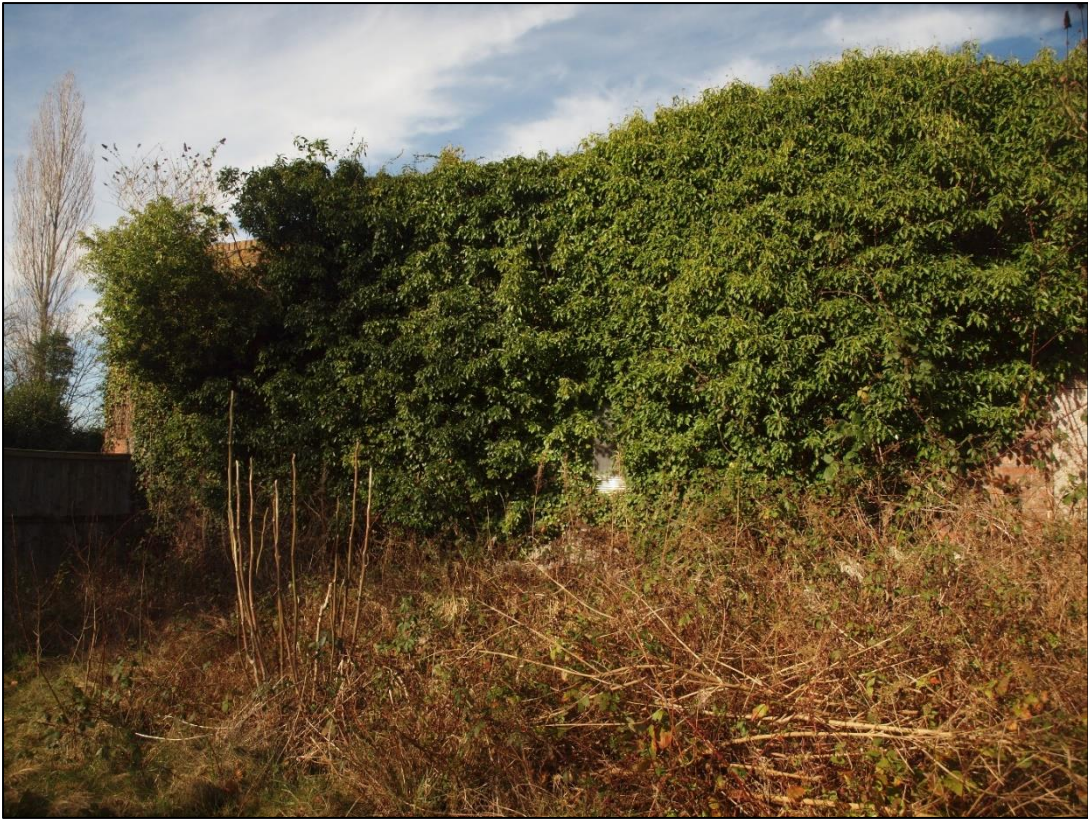
Plate 113: Southeast elevation

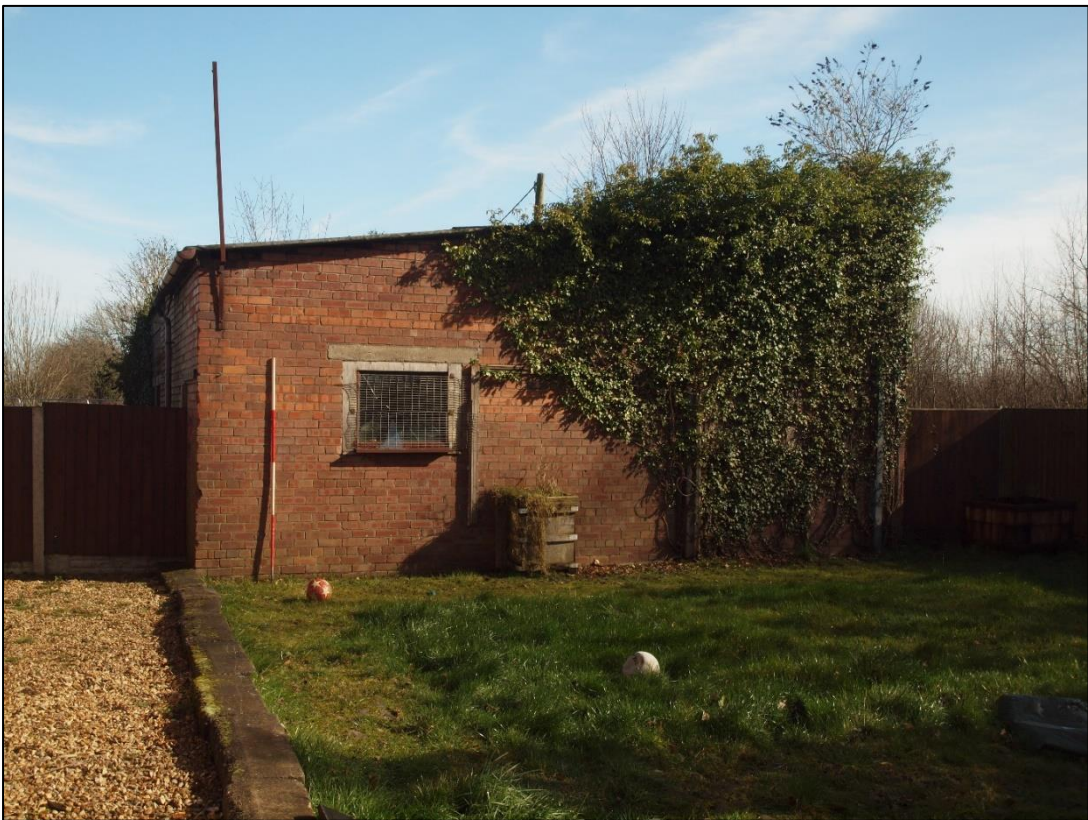
6.32 Southwest elevation (plate 114). This comprises the other single pitched end of the building. This is in better condition, being constructed of modern brick with a landscape window to the north side, with a concrete lintel. Ivy covered the southern end.

Plate 114: Southwest elevation

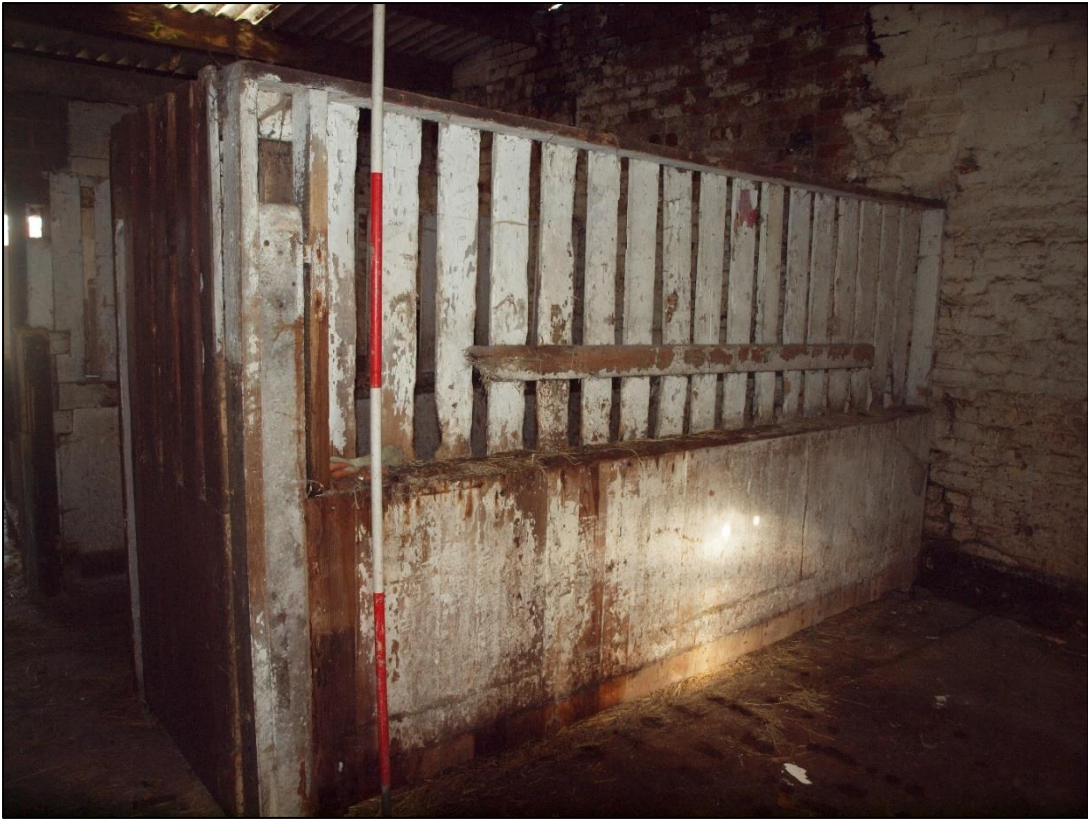
Plate 119: Stall detail
