North End Farm

Wase Homes Limited

Archaeological Building Survey

28 September 2022

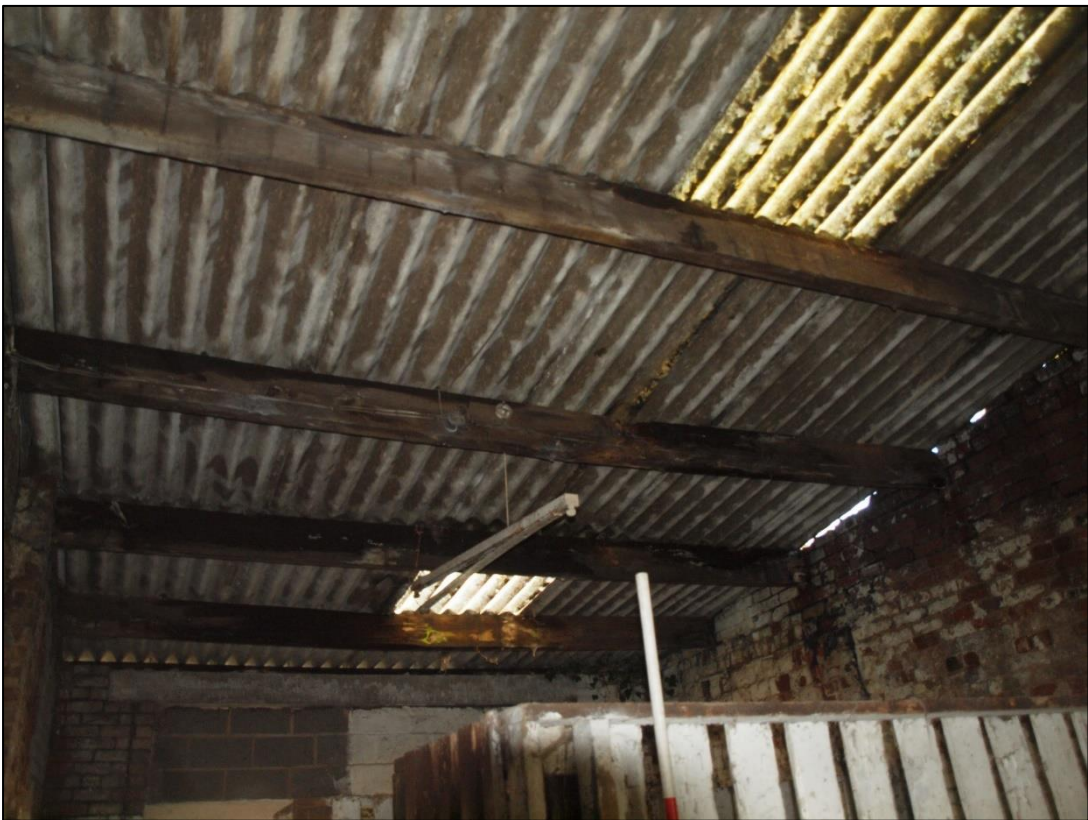
Plate 120: Roof detail

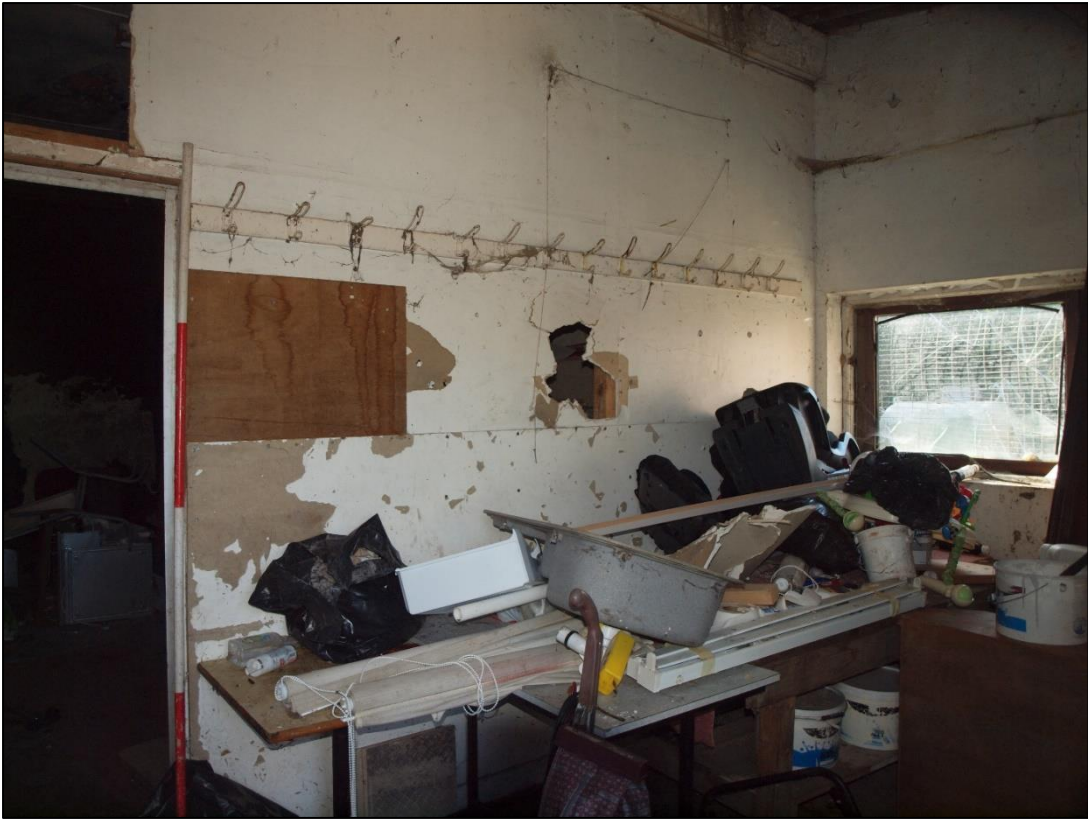
Plate 125: Western unit

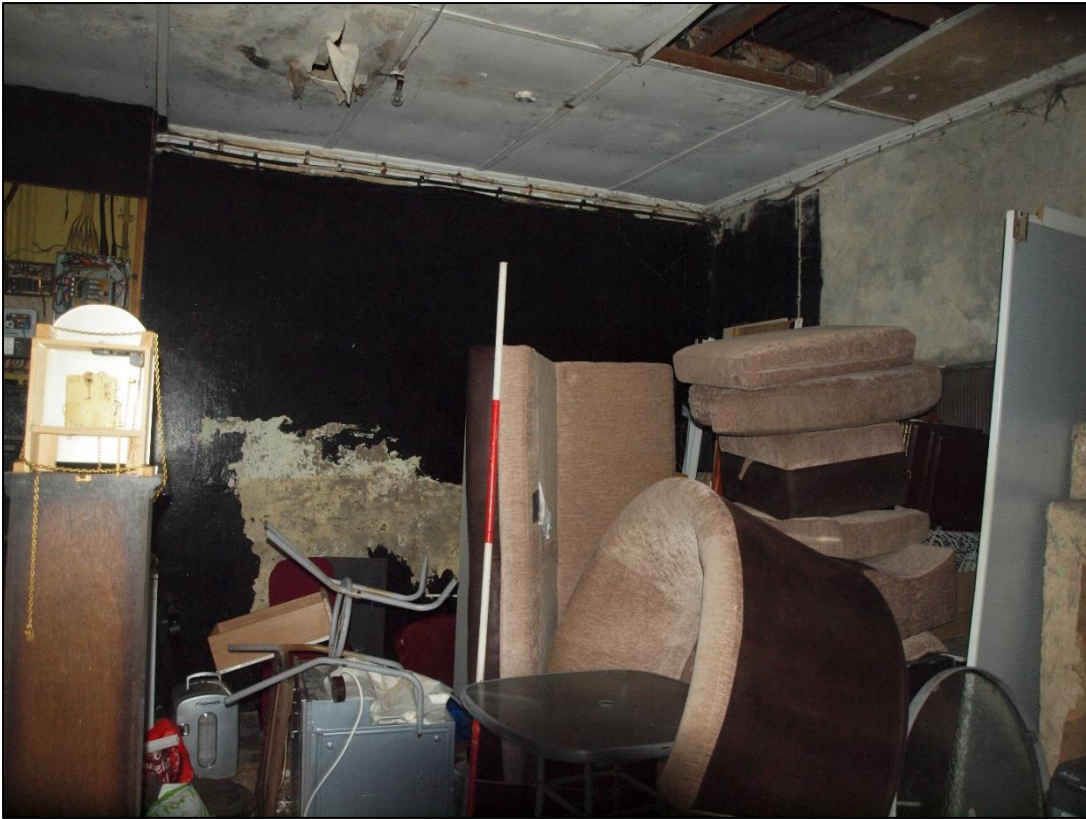
Plate 127: Southern end of western unit

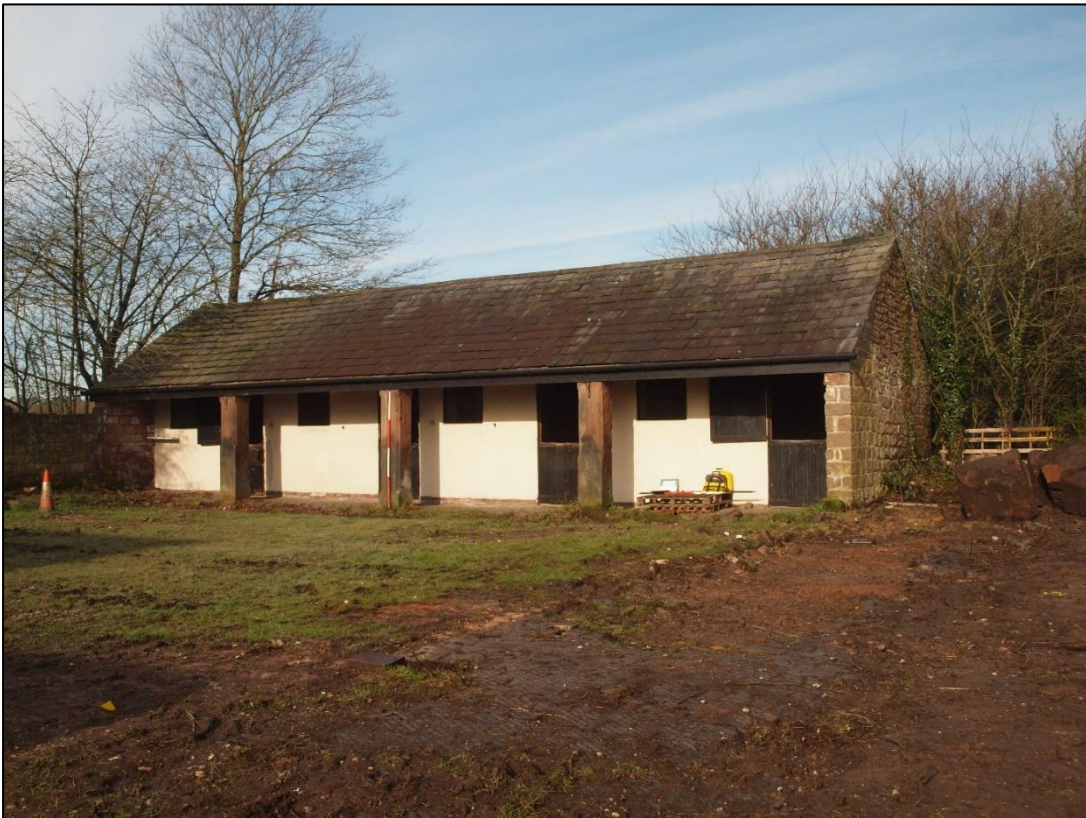
- 6.35 Southeast elevation (plates 128 - 130). This forms the main 4 bay frontage of the building. Each bay is identical, having an inserted rendered concrete block wall with a window to the west and stable door to the east. The roof line projects forward, beyond the rendered wall, and rests on three sandstone columns, each one having chamfered and stopped corners.

Plate 128: Southeast elevation

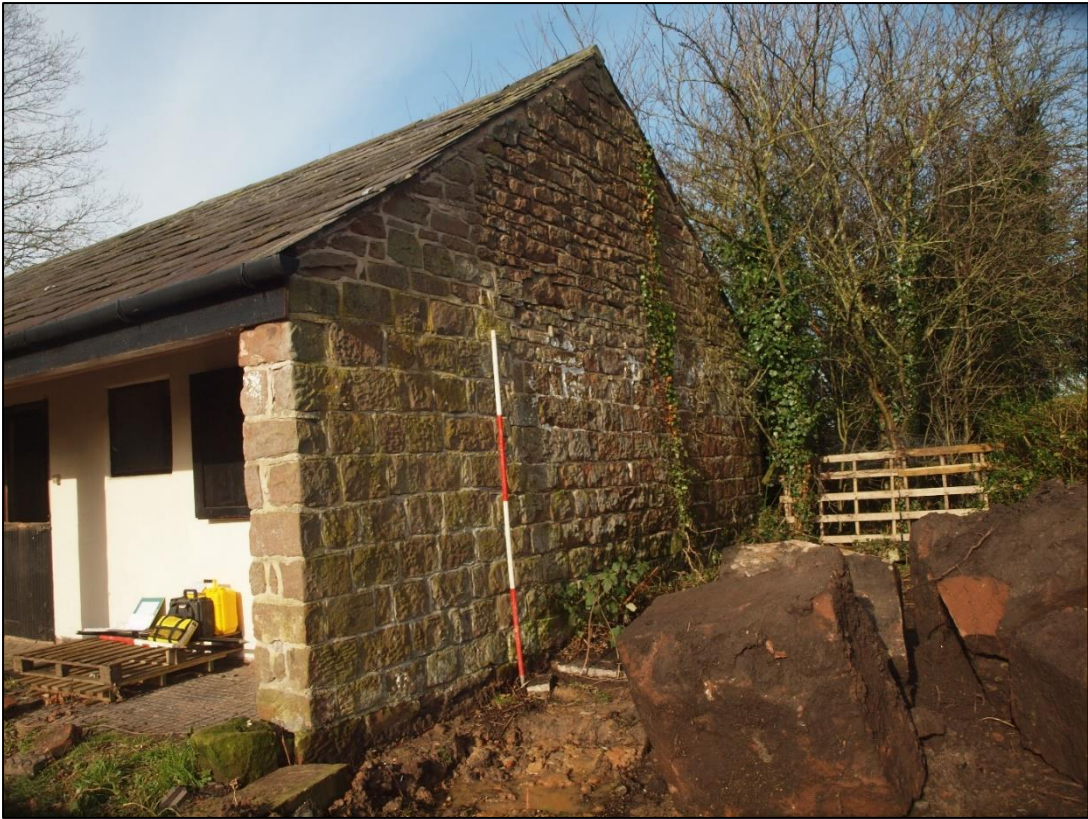
- 6.36 Northeast elevation (plate 131). This forms the gable end of the building. To the south side the building is constructed in a shaped and coursed sandstone rubble. A rough joint runs up the face, and beyond this the face is different. The construction is similar, although the coursing doesn't match in places. Towards the apex, the construction is different again, with the rubble being unshaped and only occasionally brought to course. All of the shaped sandstone shows tooling marks, or rustication marks. No other features are present.

Plate 131: Northeast gable

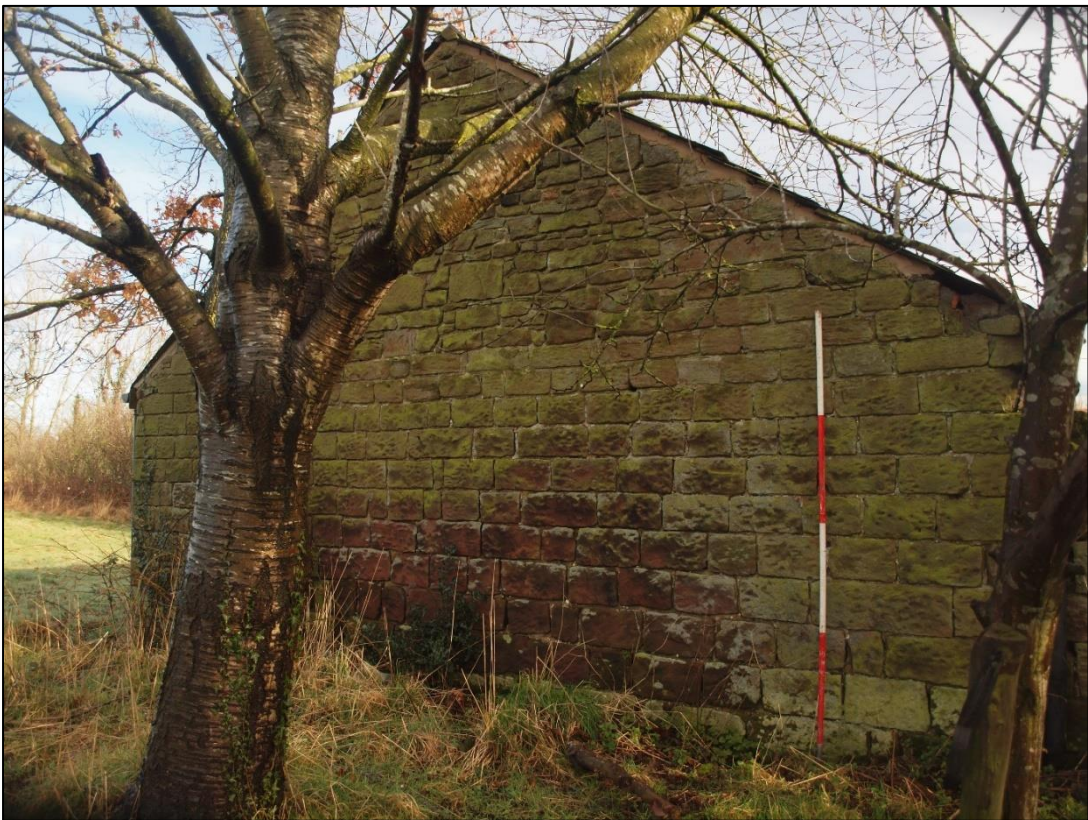
- 6.38 Southwest elevation (plates 132, 134-135). This forms the other gable end of the building. This comprises the coursed and shaped sandstone rubble found to the other elevations. Above, much like the other gable, the top is constructed in a rough rubble, occasionally brought to course. The face is otherwise featureless.

Plate 134: Southwest gable

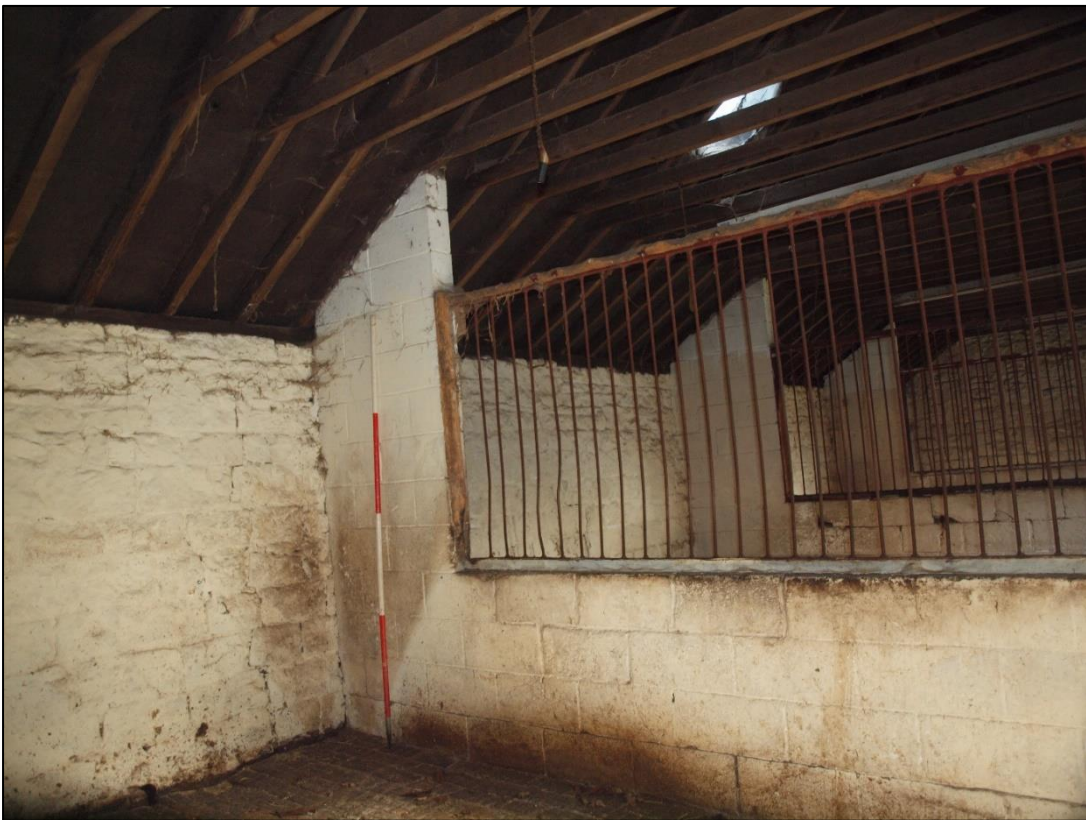
Plate 135: Southwest gable

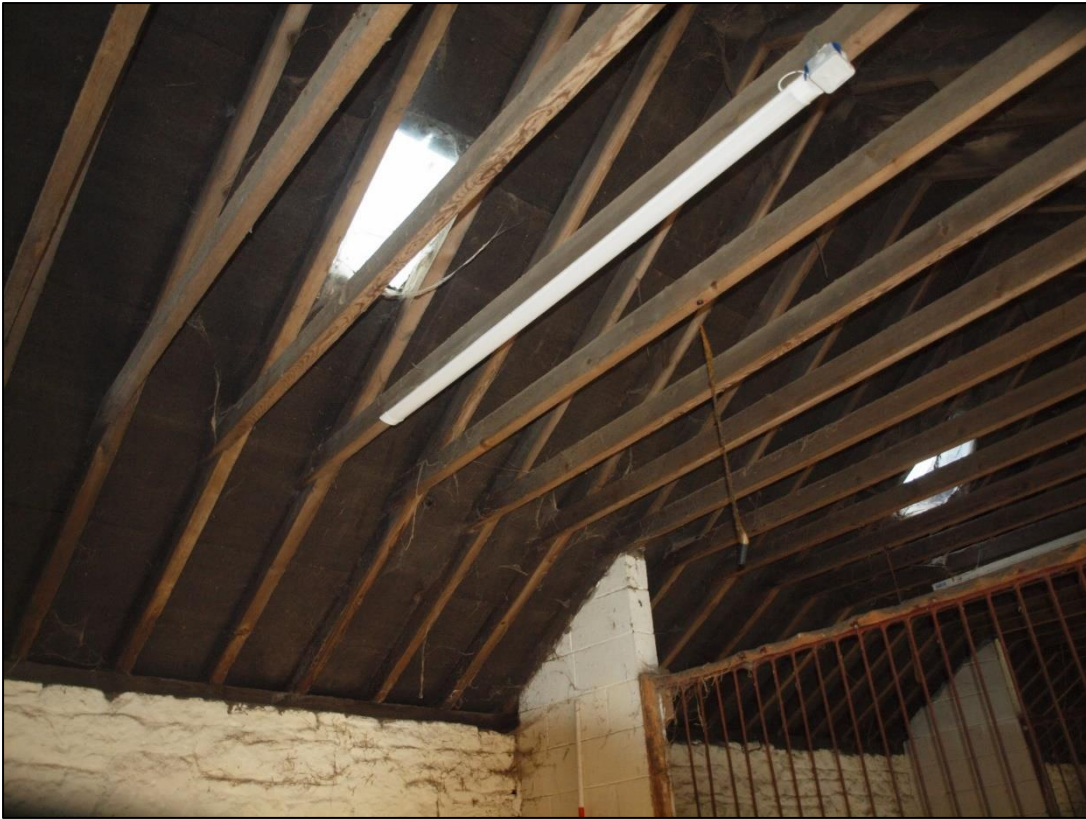
- 6.39 (Plates 136 – 140) The interior is divided into four identical units, through the insertion of concrete block walls with metal grates fitted across. All of the walls are whitewashed, with the stone construction visible to the northwest and the concrete block walls to the southeast. The roof is modern, with timber rafters and tie beams throughout, with no truss present. The floor is covered with modern grooved tiles.

Plate 136: Interior showing inserted cross walls

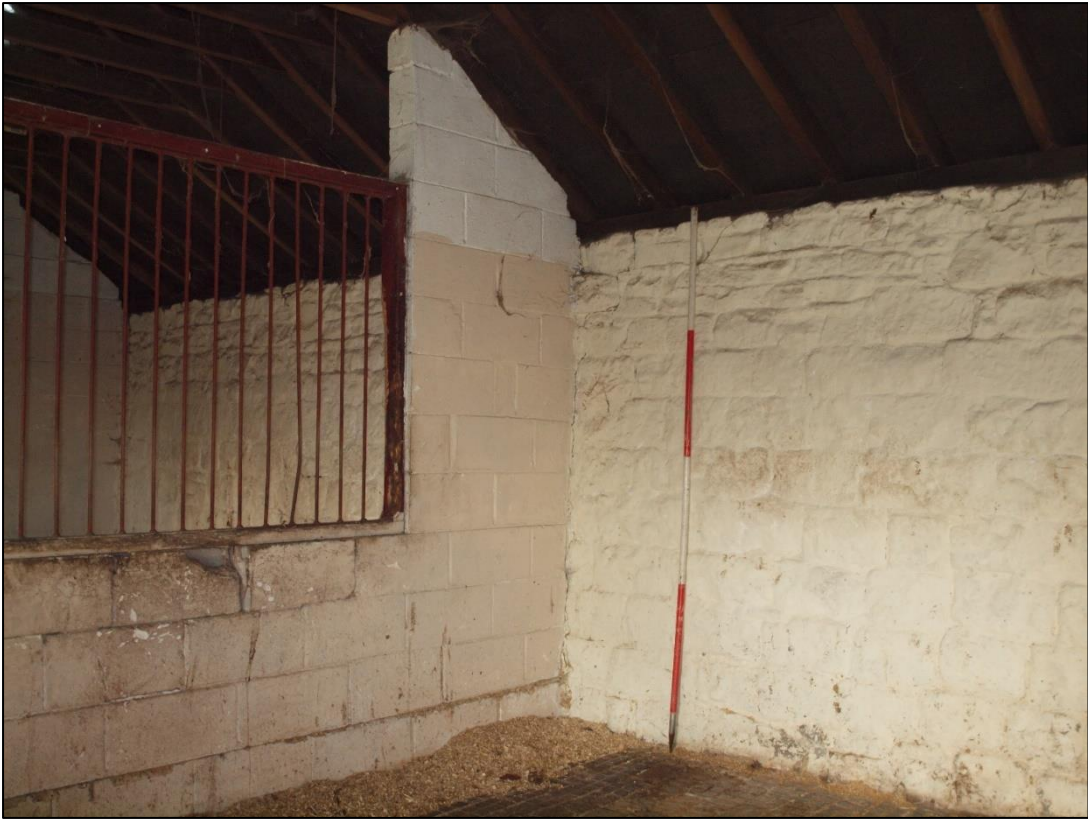
Plate 138: Inserted wall to main frontage

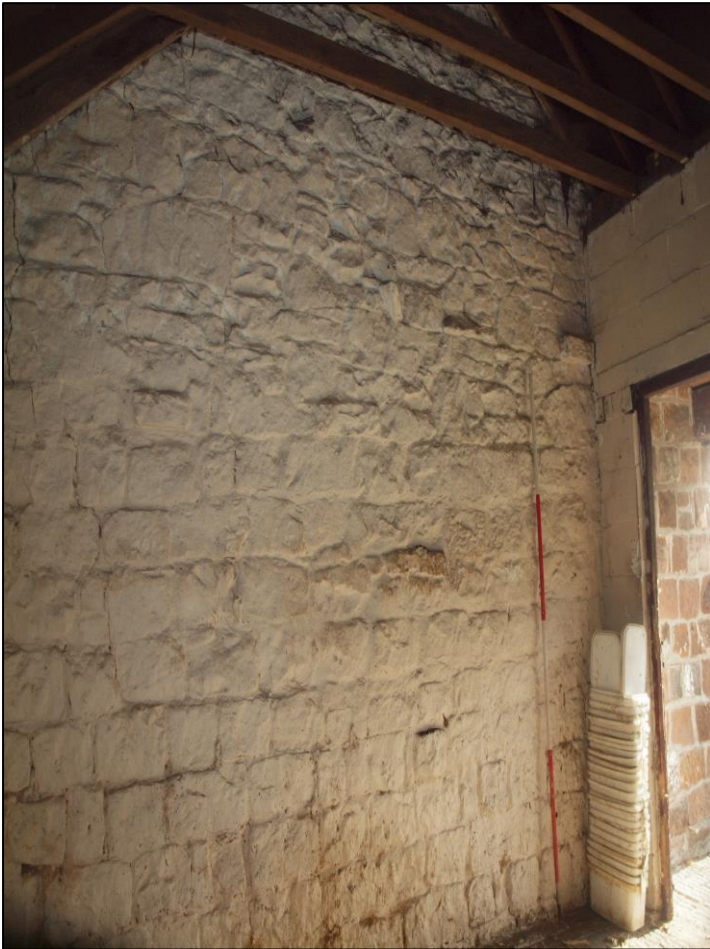
Plate 139: Whitewashed stone wall
