**THE ARCHAEOLOGY CO.**

Old Market Hall, Bacup  
Historic Building Survey

April 2016

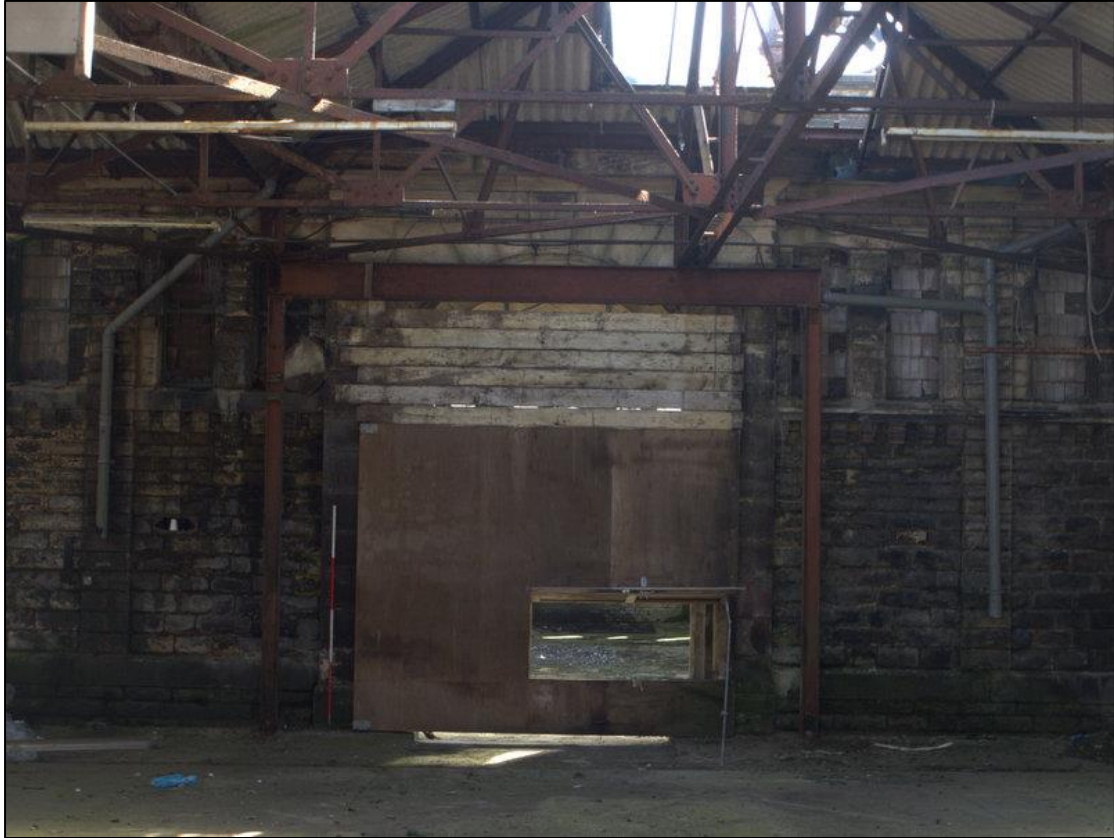
Plate 21: Detail of doorway in centre of west elevation

6.5 West elevation (Plates 17 - 22). The majority of this face lies within the later extension, with only the first two bays facing the street. This is much the same as the east elevation, without the lower ground shop fronts. The first bay contains a pair of portrait windows matching those on the east face, with the majority of the other bays containing two pairs of windows at first floor level and decorative recesses at ground floor level. One of the exceptions to this is bay 5, which contains a large doorway with rounded arch lintel and sandstone surround, matching that on the north elevation. The ninth bay also differs from the east elevation, as at ground floor level there is a doorway, next to a window, both having a rounded sandstone lintel with false keystone. All of the windows on this face have been blocked with brick.

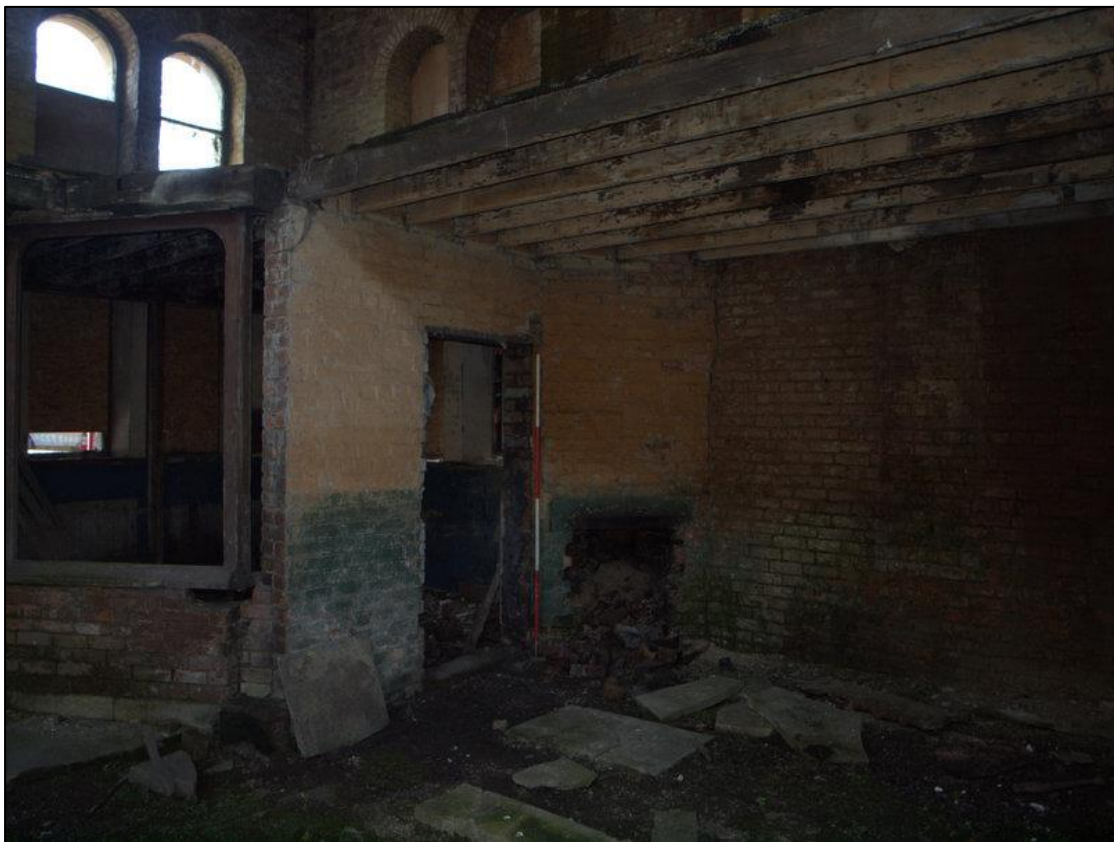
Plate 26: Detail of doorway and fireplace in office

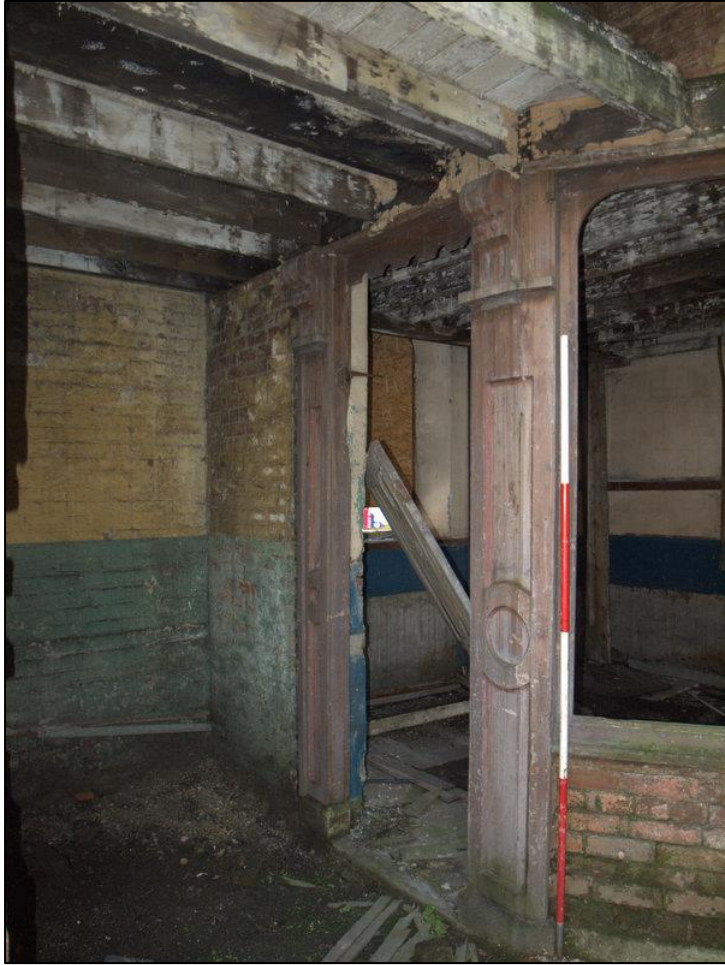
Plate 27: Detail of carved timber doorway surround to corner office

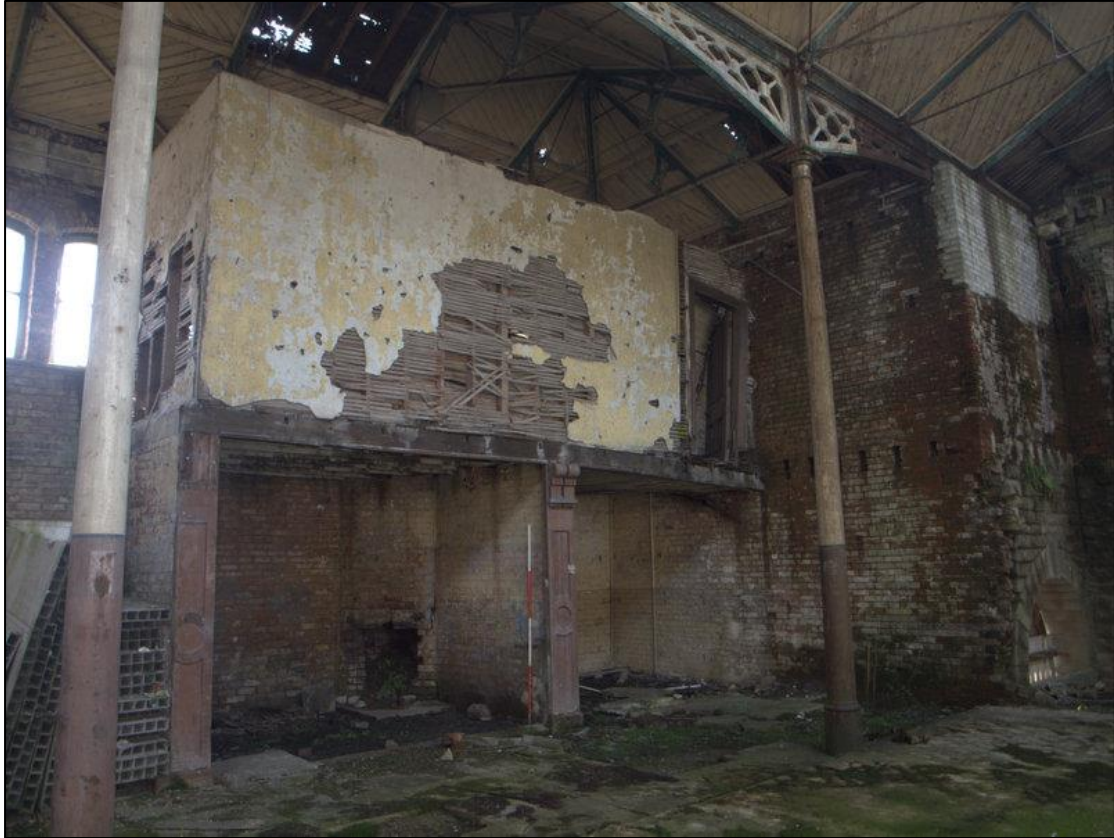
Plate 29: Office units at southern end of east side

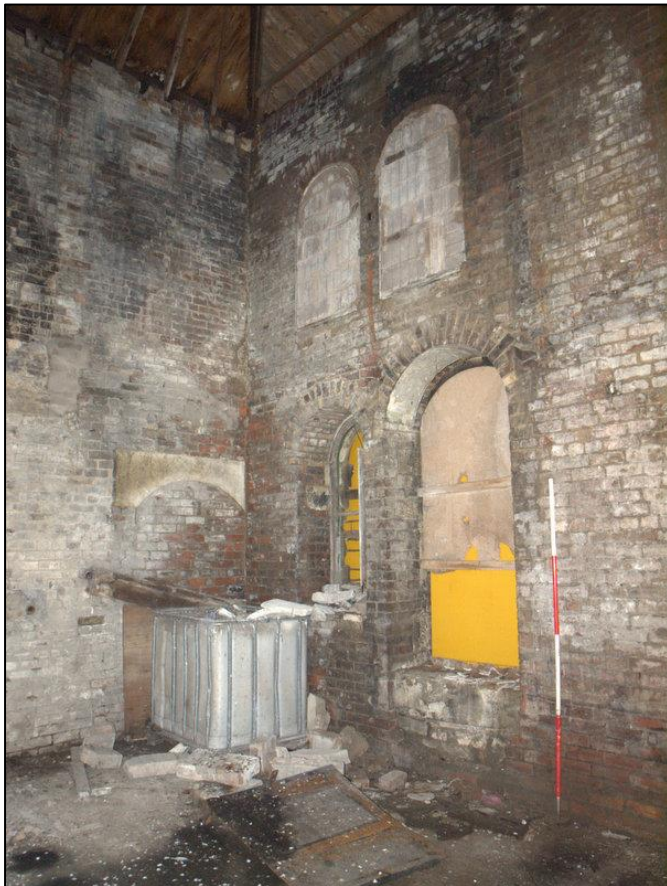
Plate 34: Blocked window and doorway in southwest corner

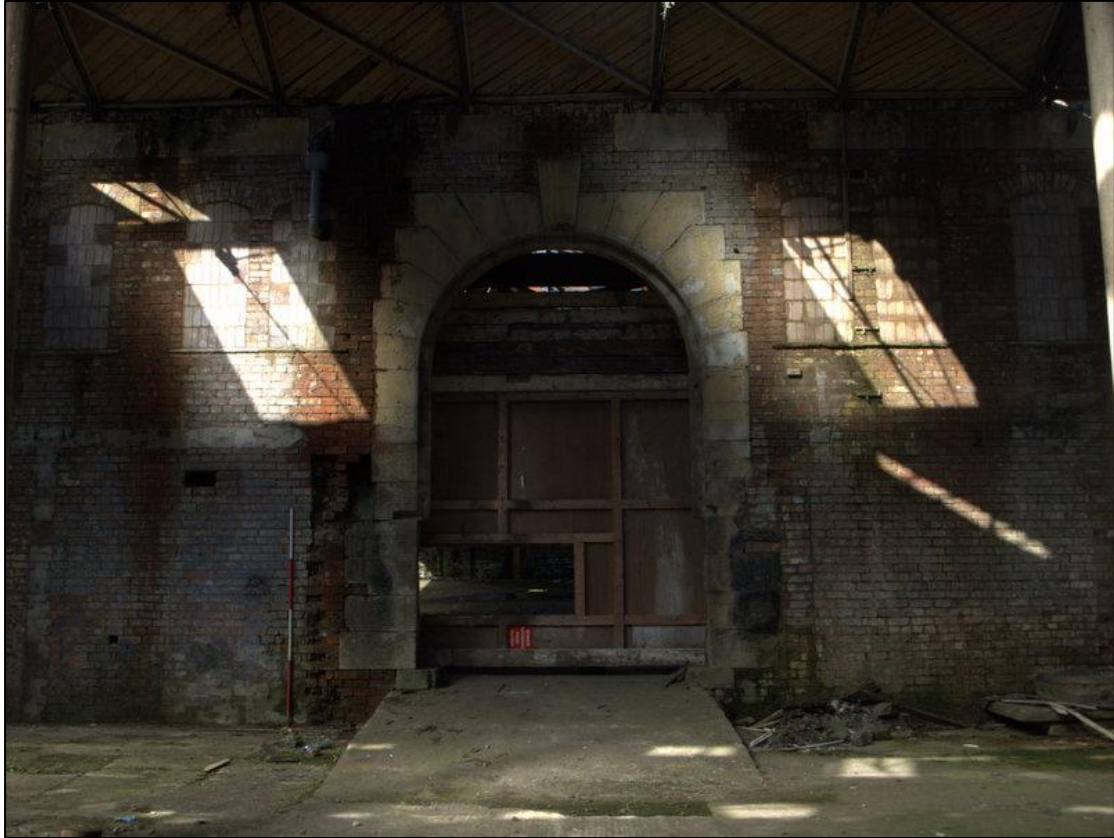
Plate 35: Detail of doorway in west wall

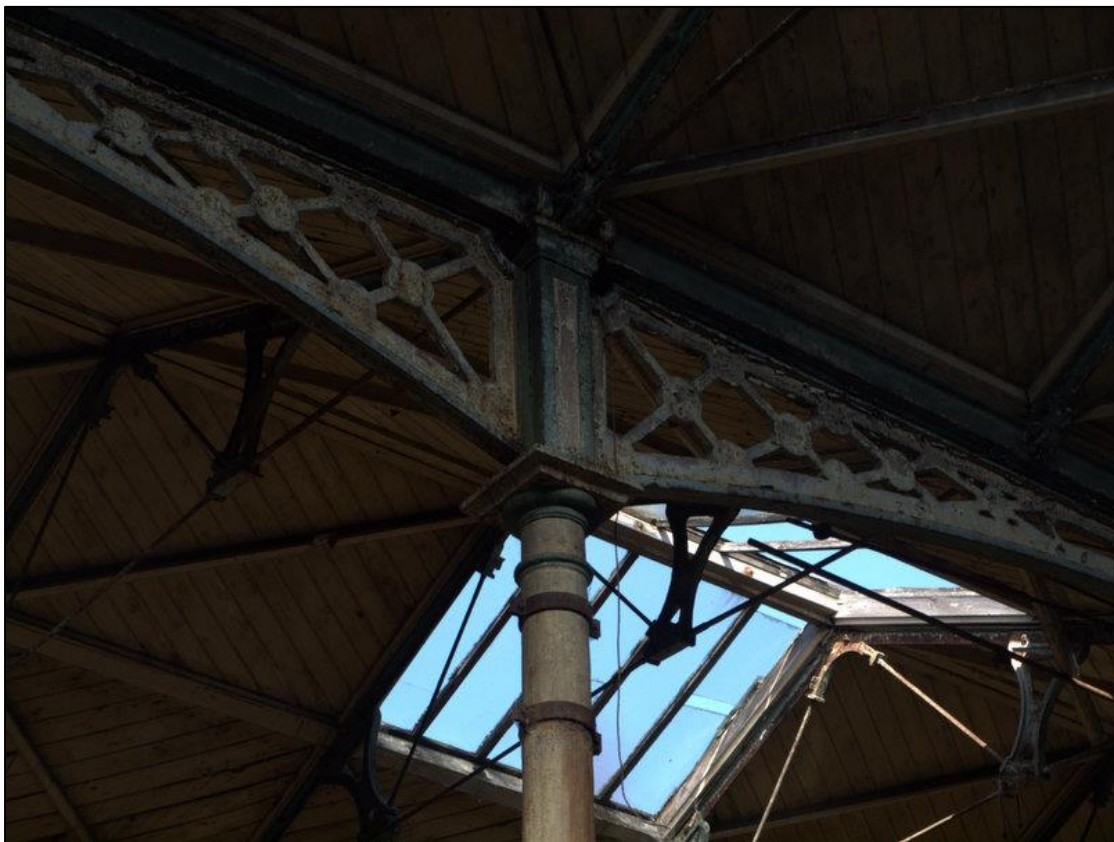
- 6.7 The roof structure (Plates 37 – 40) is supported by 12 cast iron stanchions aligned in pairs running north – south. Between these, also running north south, are ornate tie beams attached to the square capitals of the stanchions. Running east – west between the tie beams are a series of nineteen thin iron trusses, supporting the pitched roof containing a long central skylight on each side. The situation is mirrored to the east and west bays, although the trusses are smaller.
- 6.8 The lower ground floor units (Plates 41 – 46) are comprised of a single open space with access via the doorway in the east wall. The ceilings are formed of brick arches and the walls are painted brick. In the south wall of the north unit a narrow doorway has been inserted, leading to the unit beyond. This also has a doorway inserted through the southern wall into the next unit.

Plate 38: Detail of stanchion capital

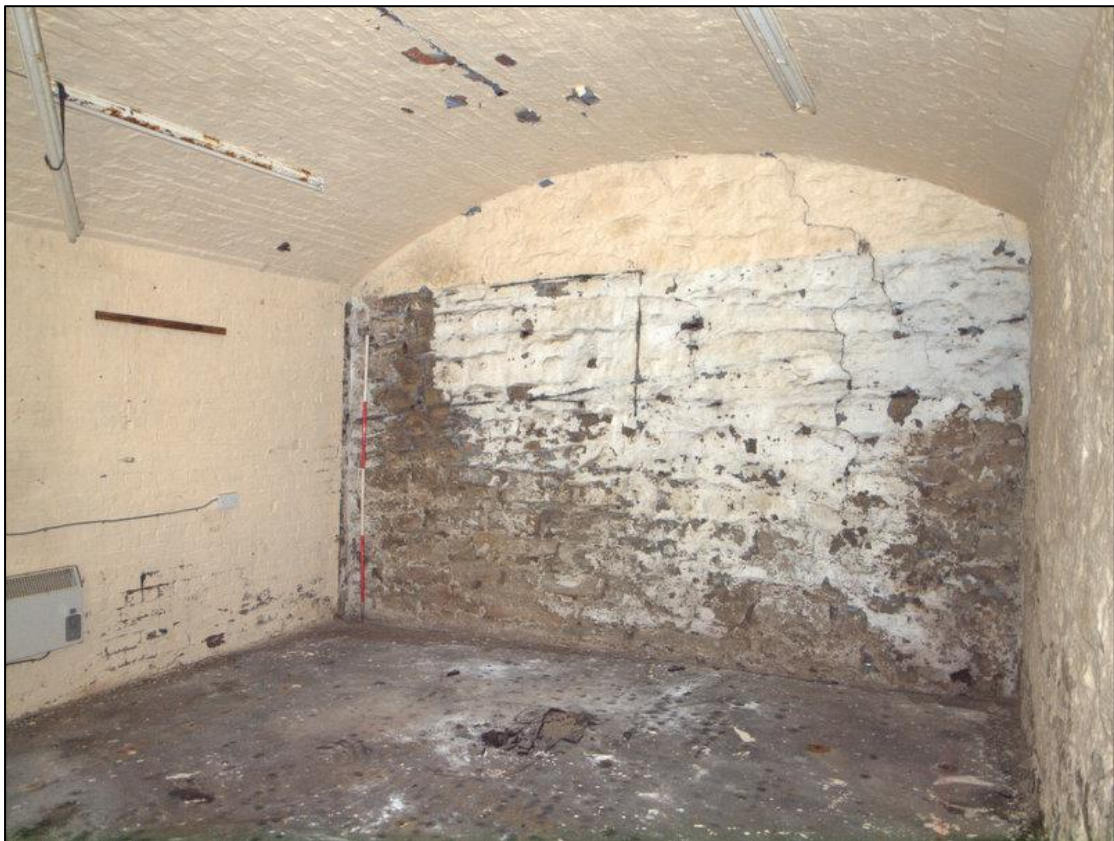
Plate 42: Western wall of lower ground floor unit

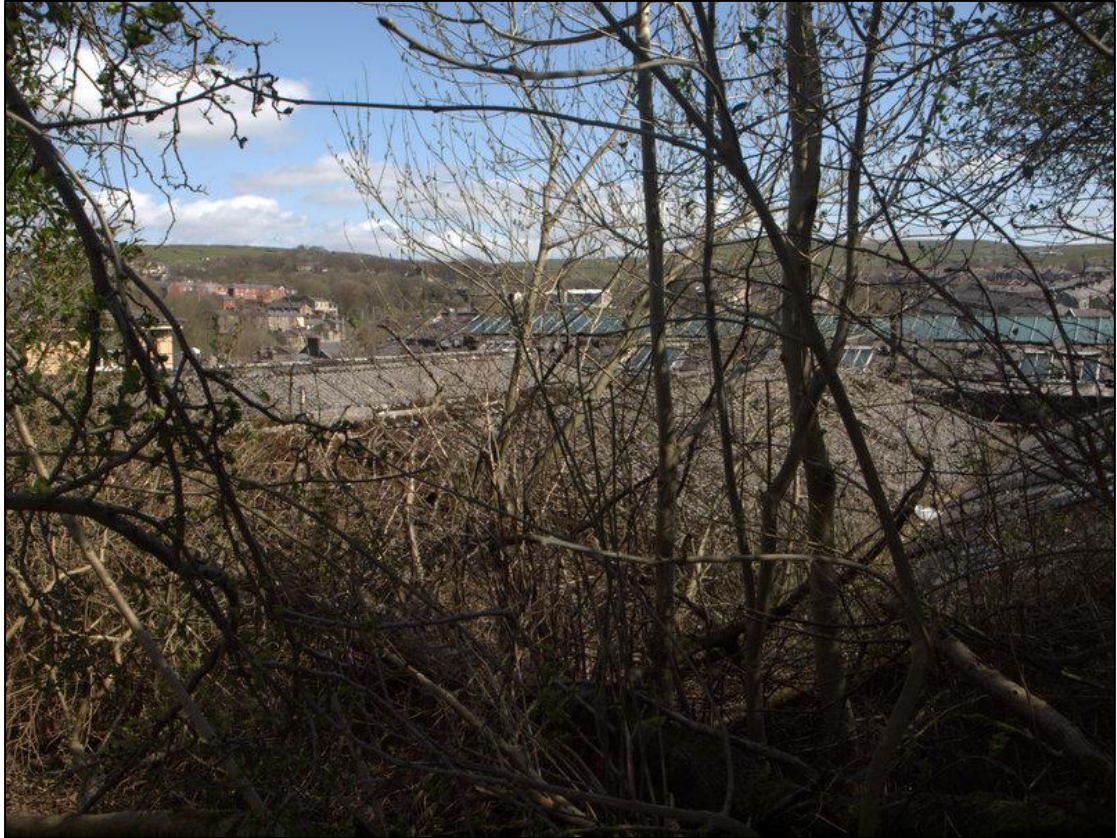
Plate 52: Extension viewed from the west showing roofs and market hall beyond

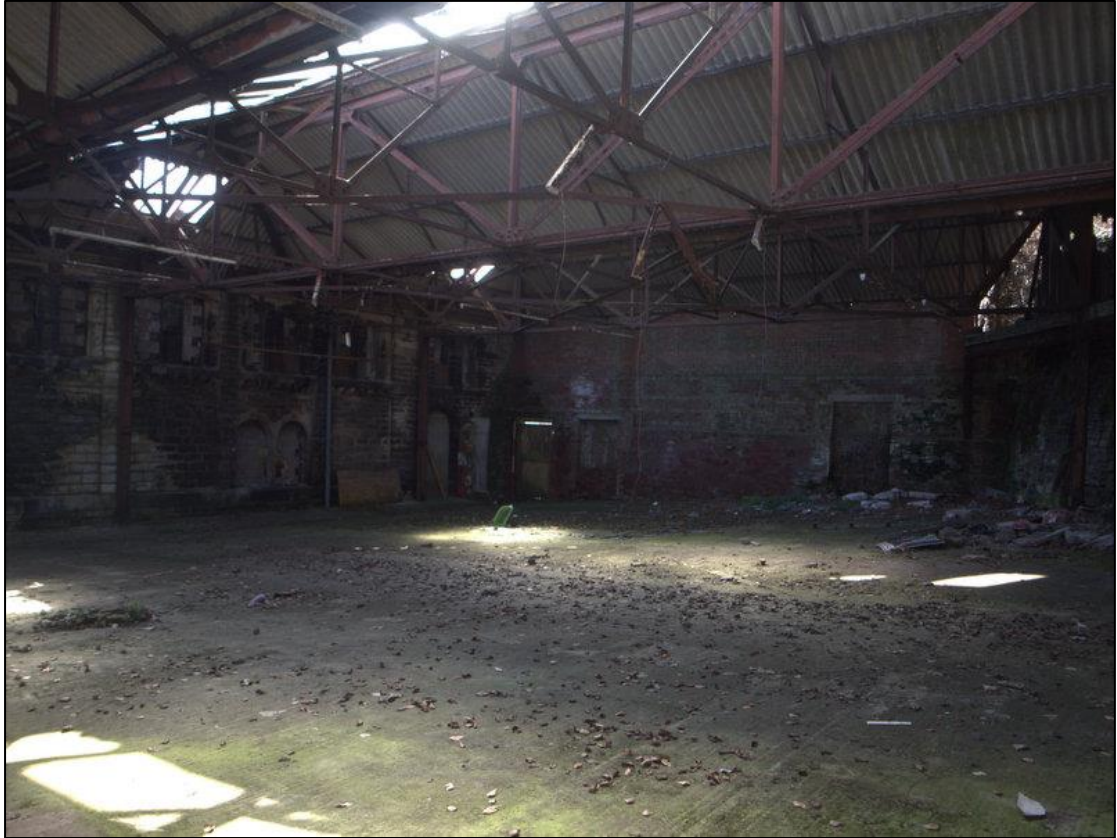
- 6.12 As noted the interior (Plates 55 – 61) of this space is formed from the western wall of the market hall as well as the stone boundary wall to the west. The southern

Plate 55: General shot showing interior of extension

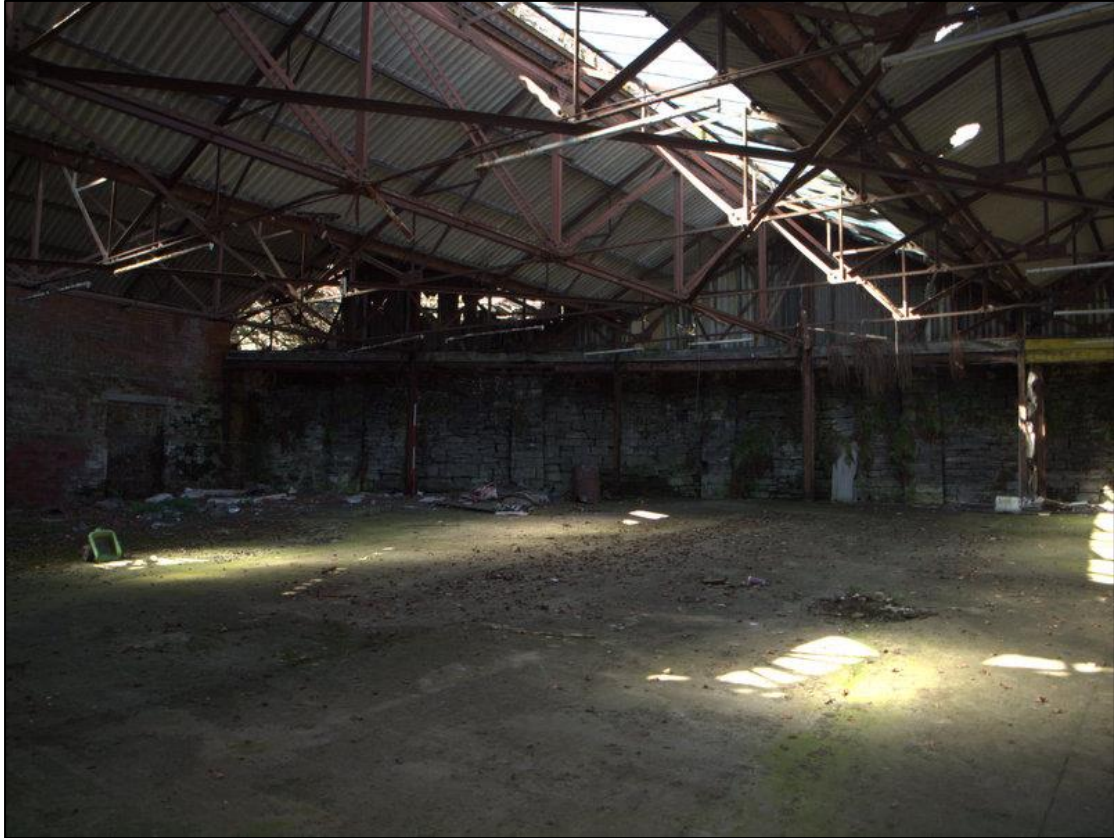
Plate 57: General shot showing stone boundary wall

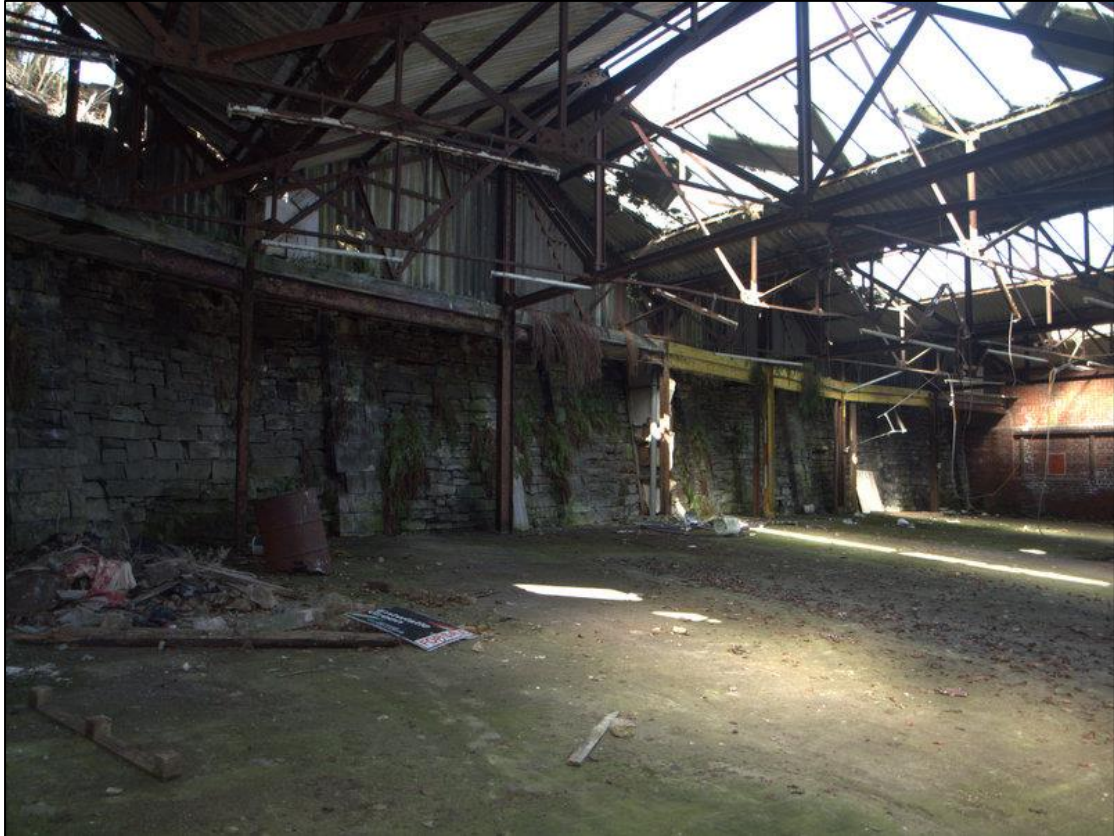
Plate 58: General shot showing stone boundary wall

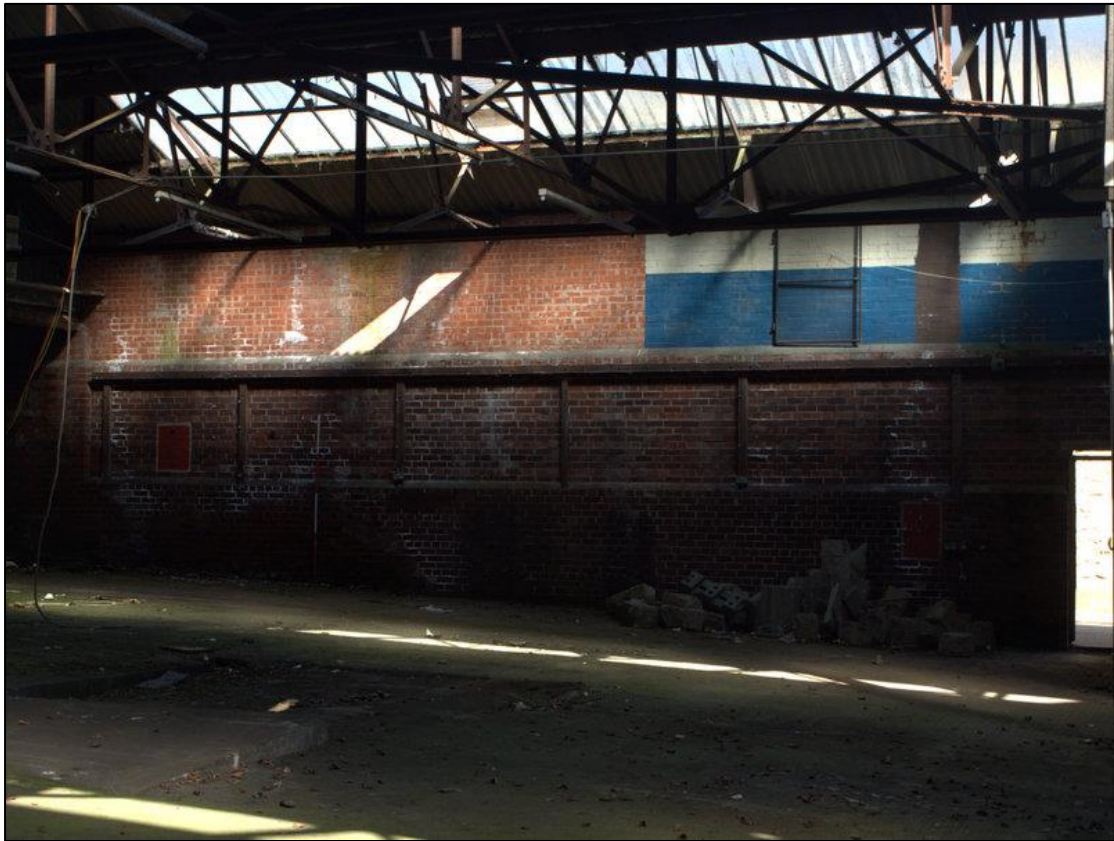
wall is brick and contains three blocked doorways (Plate 56). Two of these lie to the east and are both personnel doorways. The easternmost is blocked with ply, whereas the western is bricked up. To the west is a further blocked doorway. All have concrete lintels. To the north is the other brick face (Plates 59 & 60). As with the exterior it contains a loading doorway to the east and a personnel doorway to the west. The face steps in twice as the wall rises and a timber frame has been put in place along the central section. Between the two doorways a first floor office has been inserted (Plate 61), resting on RSJ beams and timber joists. A stud wall runs along the west side. No staircase remains.

Plate 59: Northern wall of extension

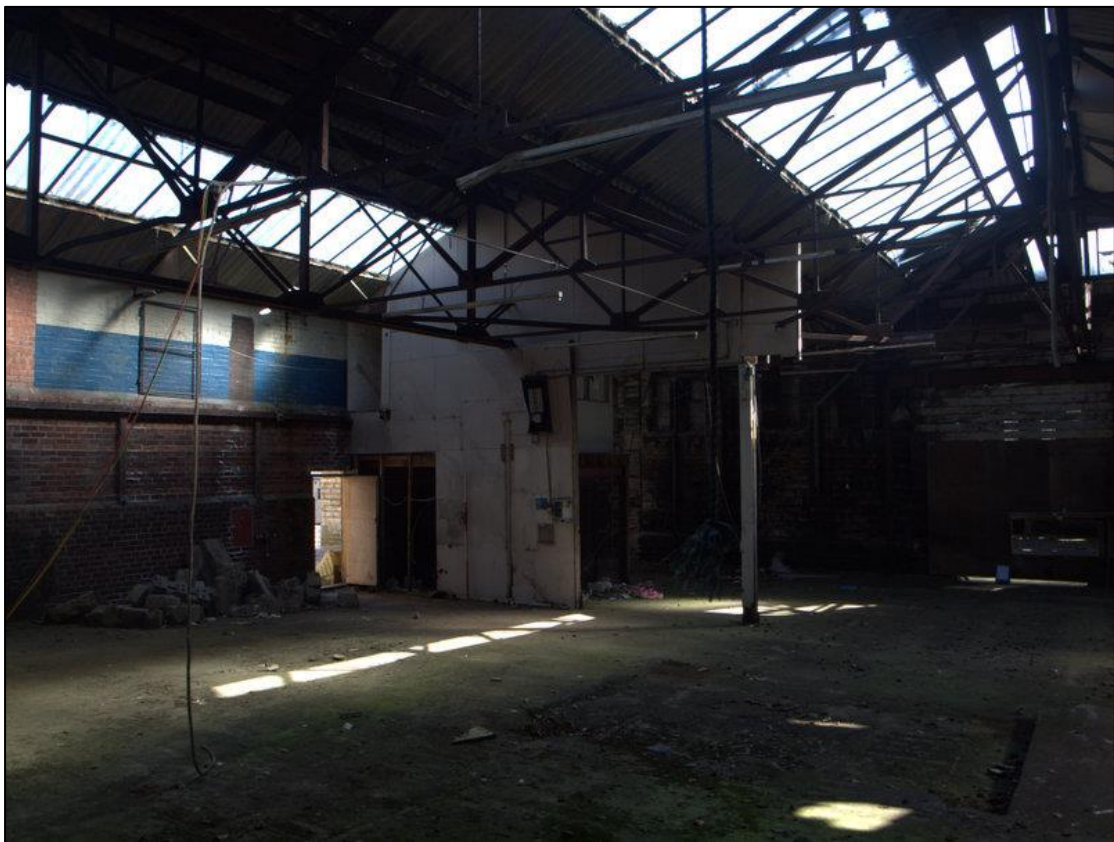
Plate 60: Northern side of extension
