5 - 9 Queens Road, Chorley  
Photographic Building Survey

December 2018

## **NON-TECHNICAL SUMMARY**

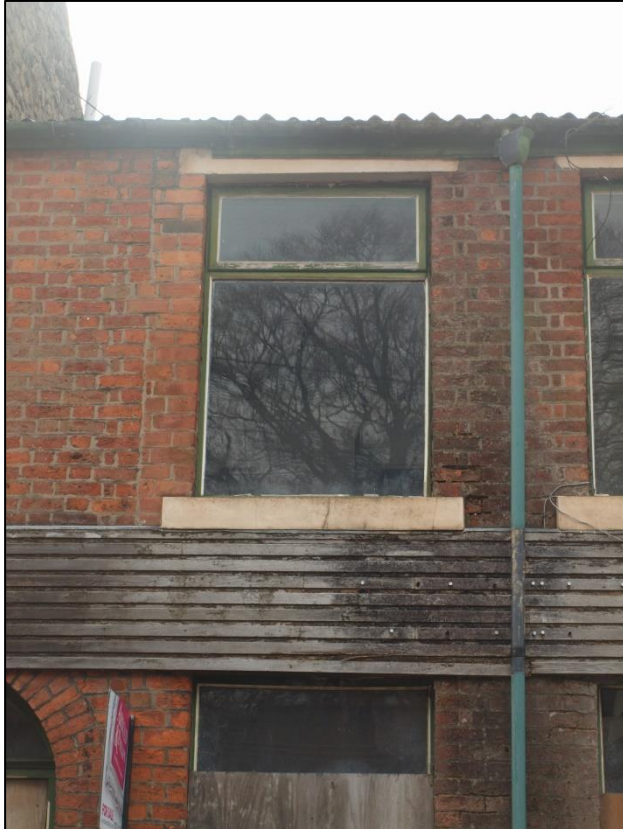
Plate 9: Detail of first floor windows of 5 Queens Road showing straight joint

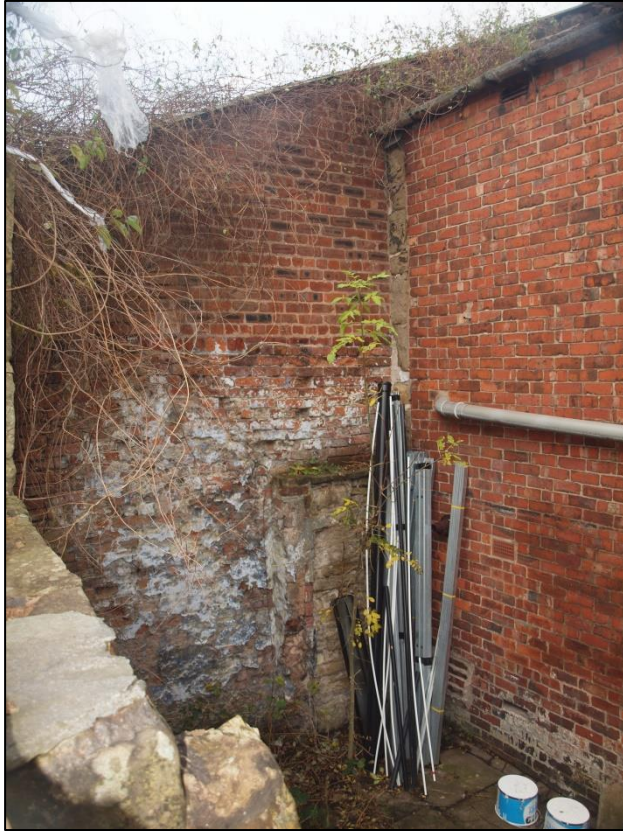
- 6.4 West elevation (Plate 17). The elevation of the former yard wall extends beyond that of the adjacent building. This shows a rough brick construction, rendered, with a possible doorway, blocked with sandstone. At first floor level the brickwork is cleaner and in a visible English Garden Wall bond.

Plate 17: Southern end of east elevation

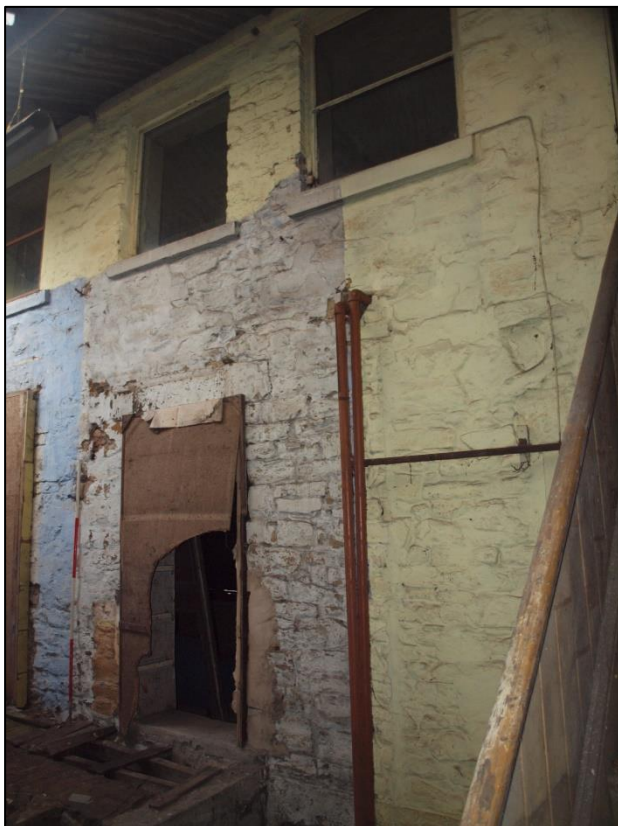
Plate 28: Former rear wall of number 5

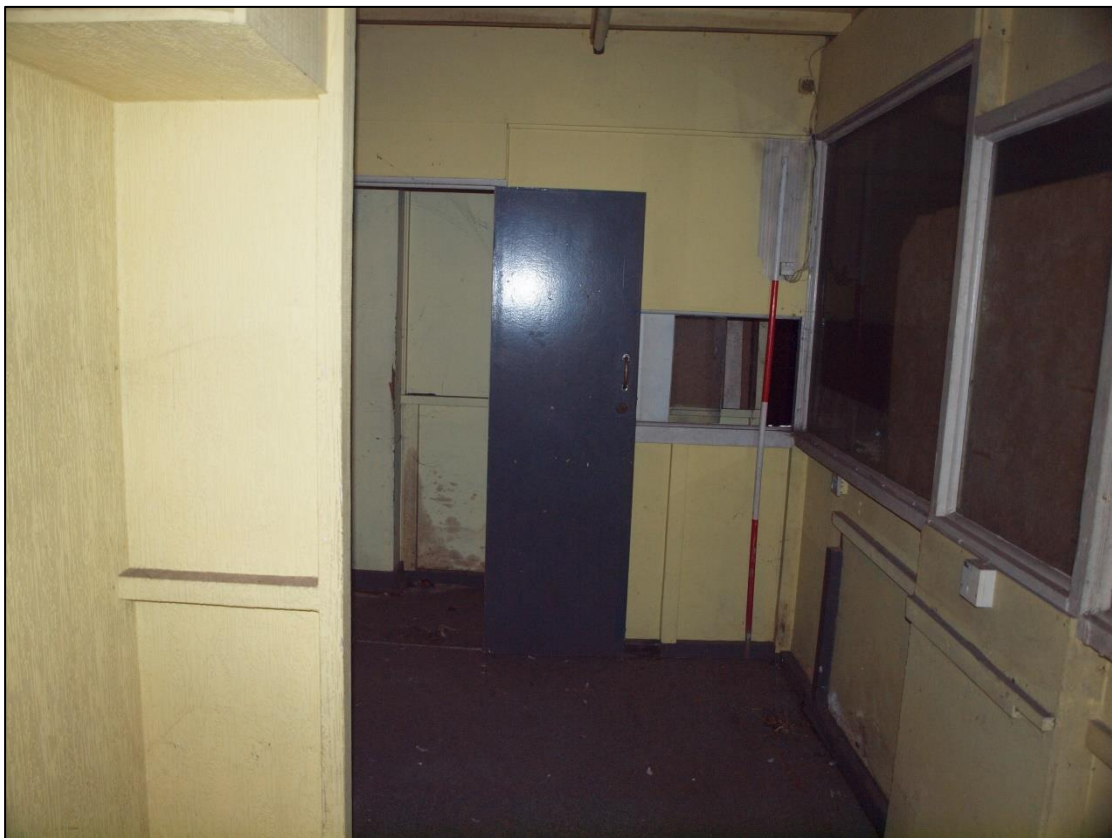
Plate 34: Office in 7 - 9

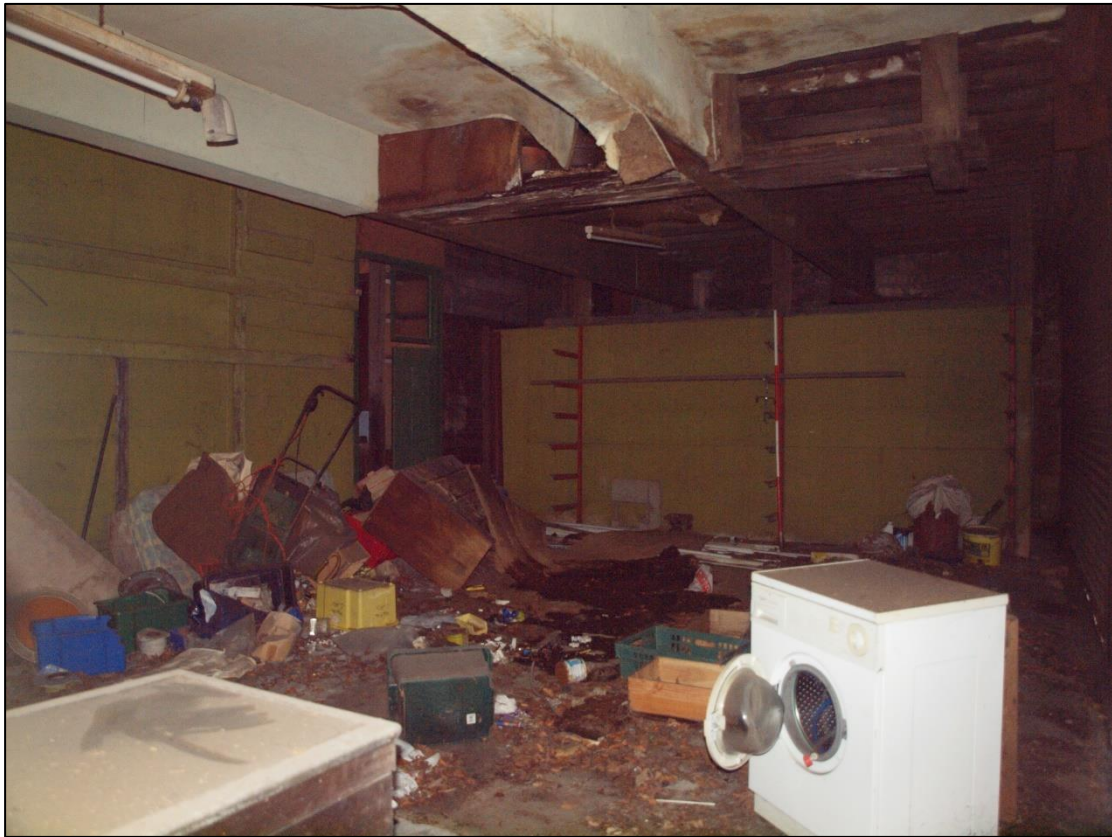
Plate 35: Loading bay

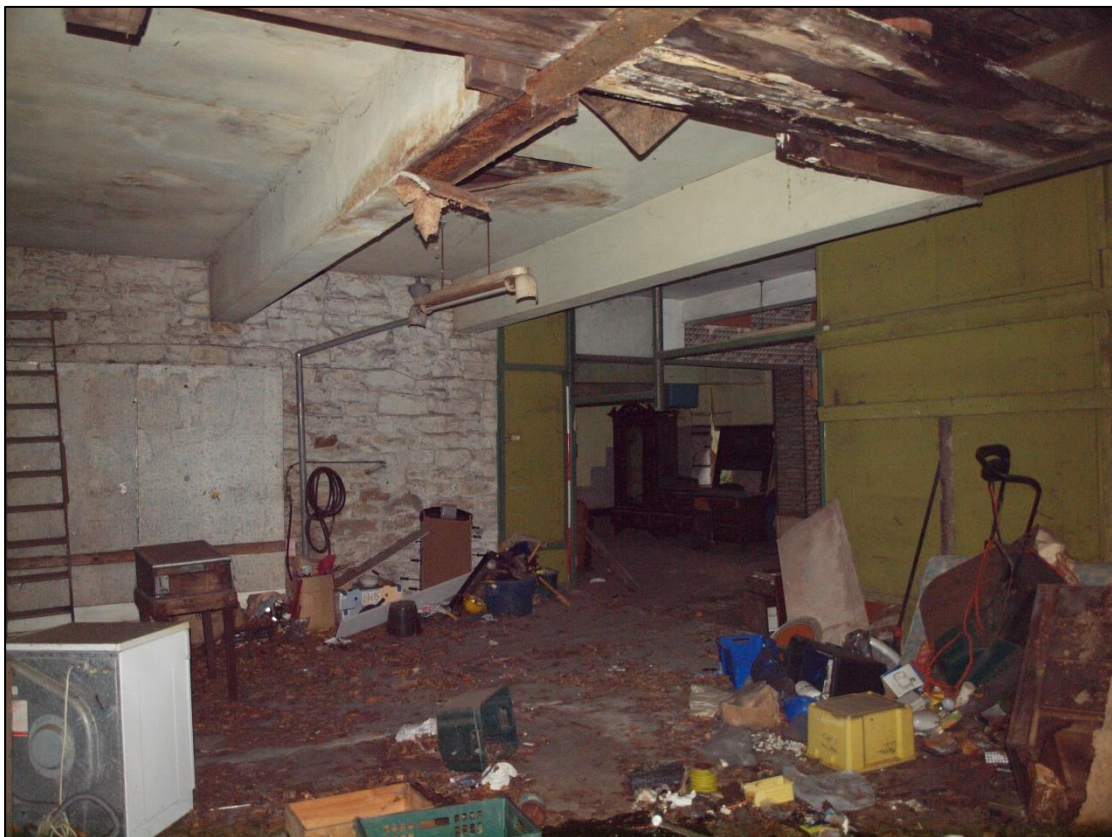
Plate 36: Loading bay

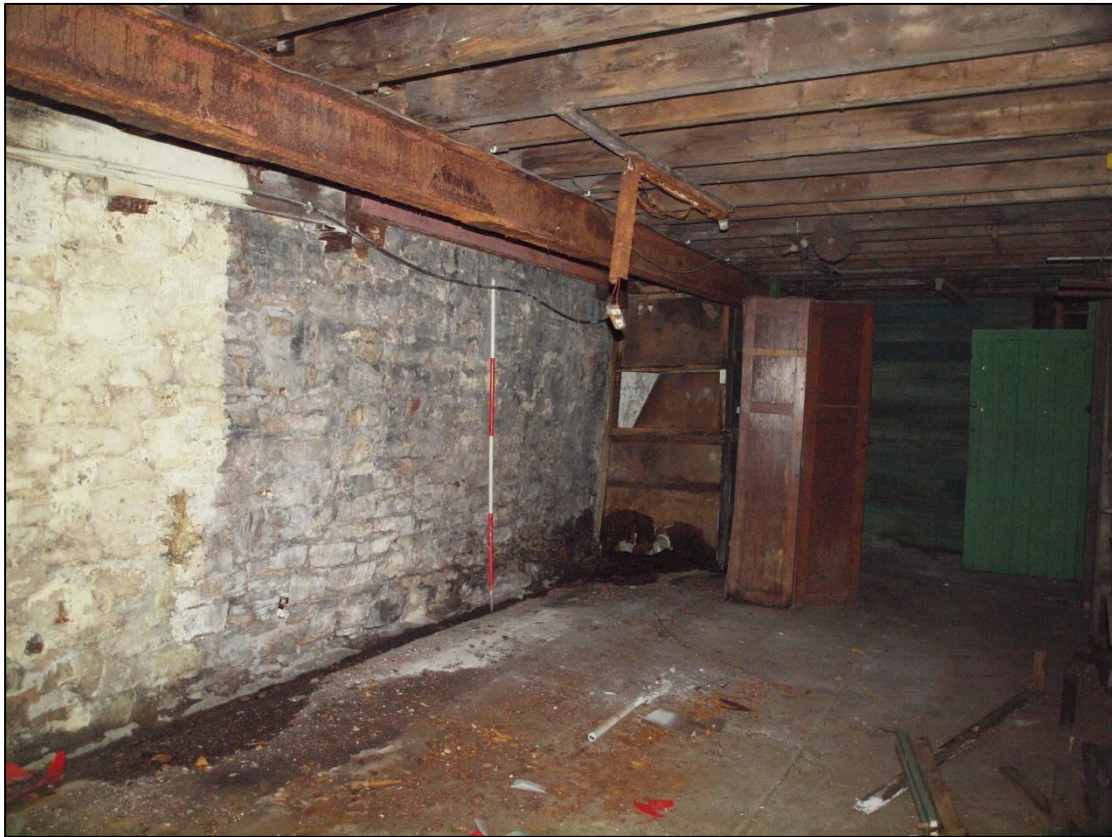
Plate 37: Rear yard of 7 - 9

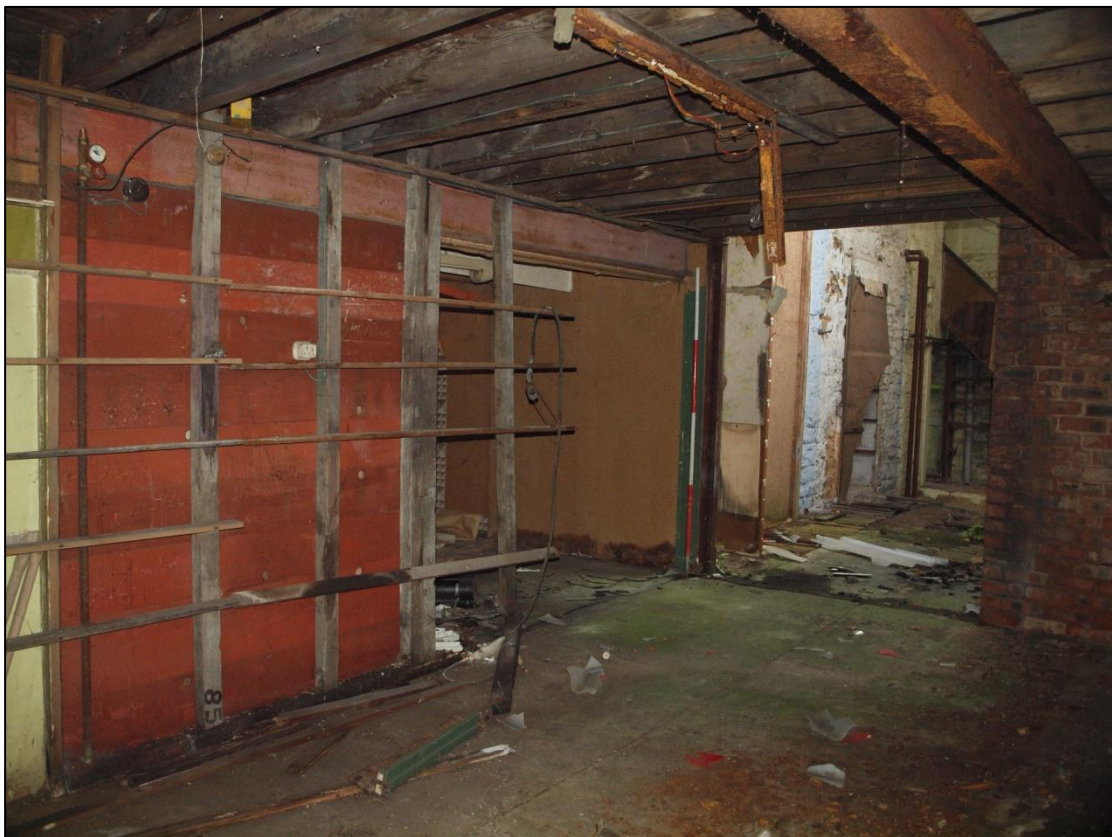
Plate 38: Rear yard of 7 - 9

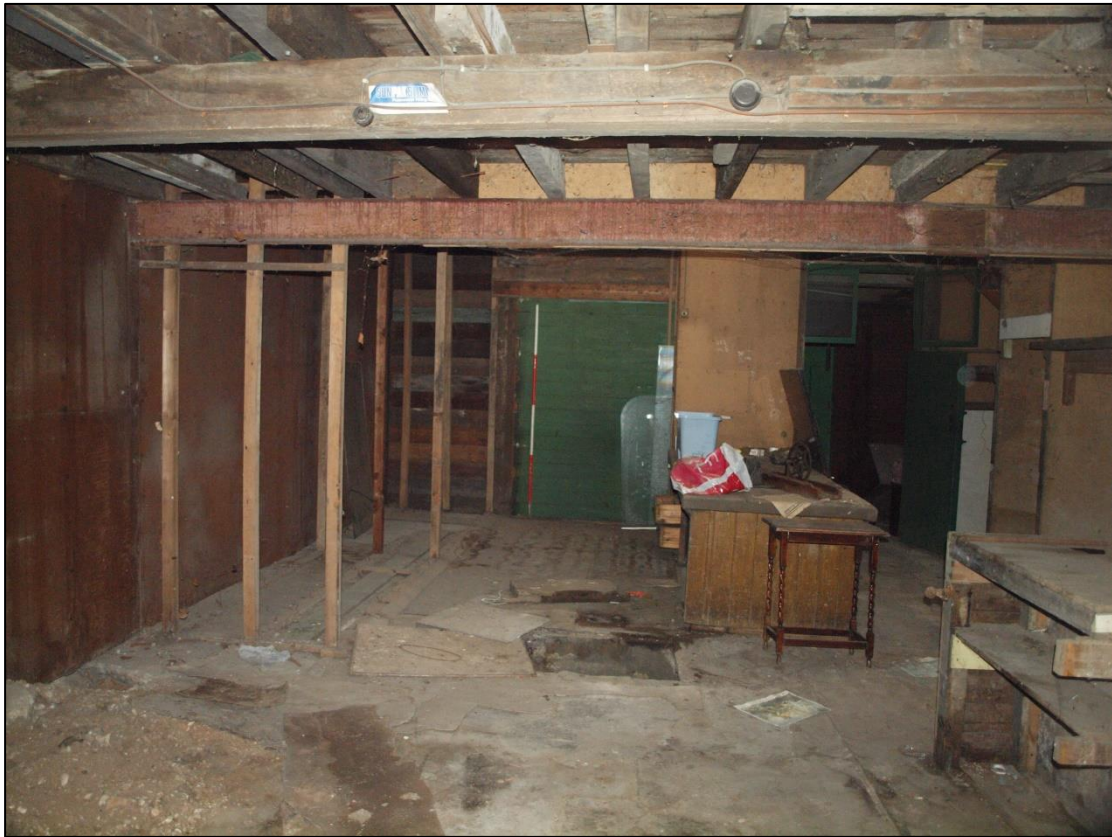
Plate 39: Workshop in 7 - 9

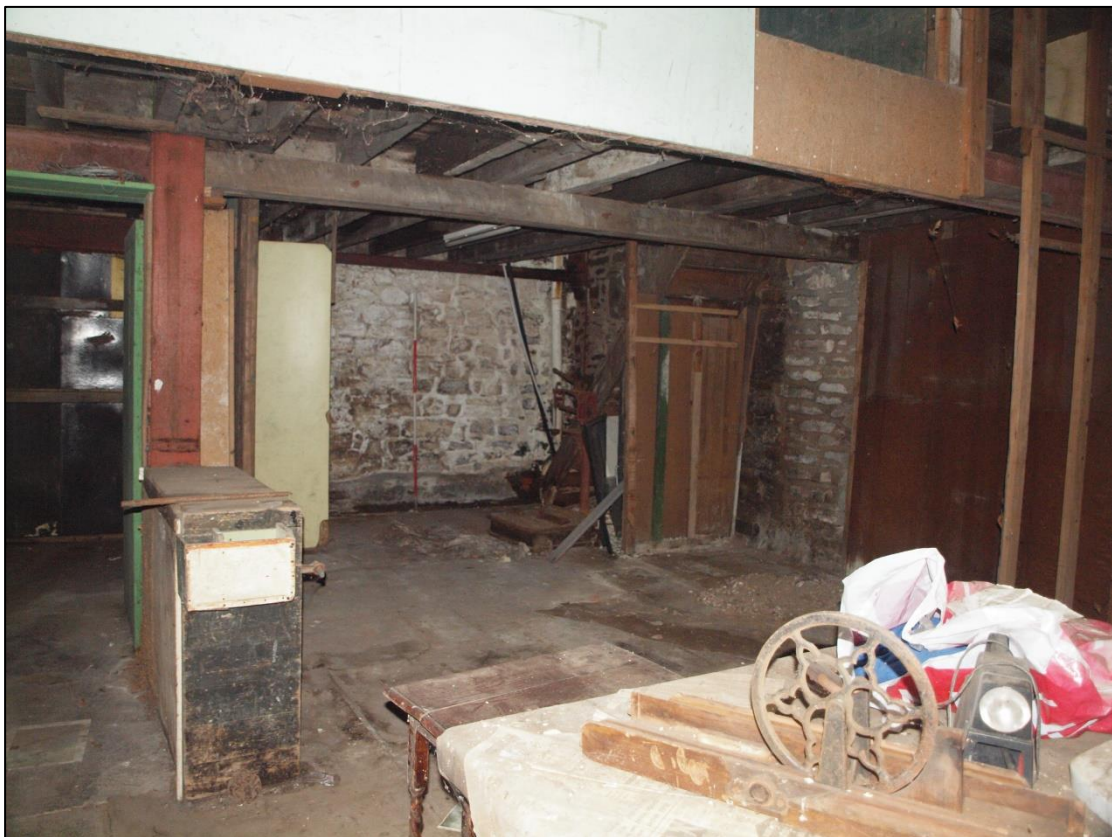
Plate 40: Workshop in 7 - 9

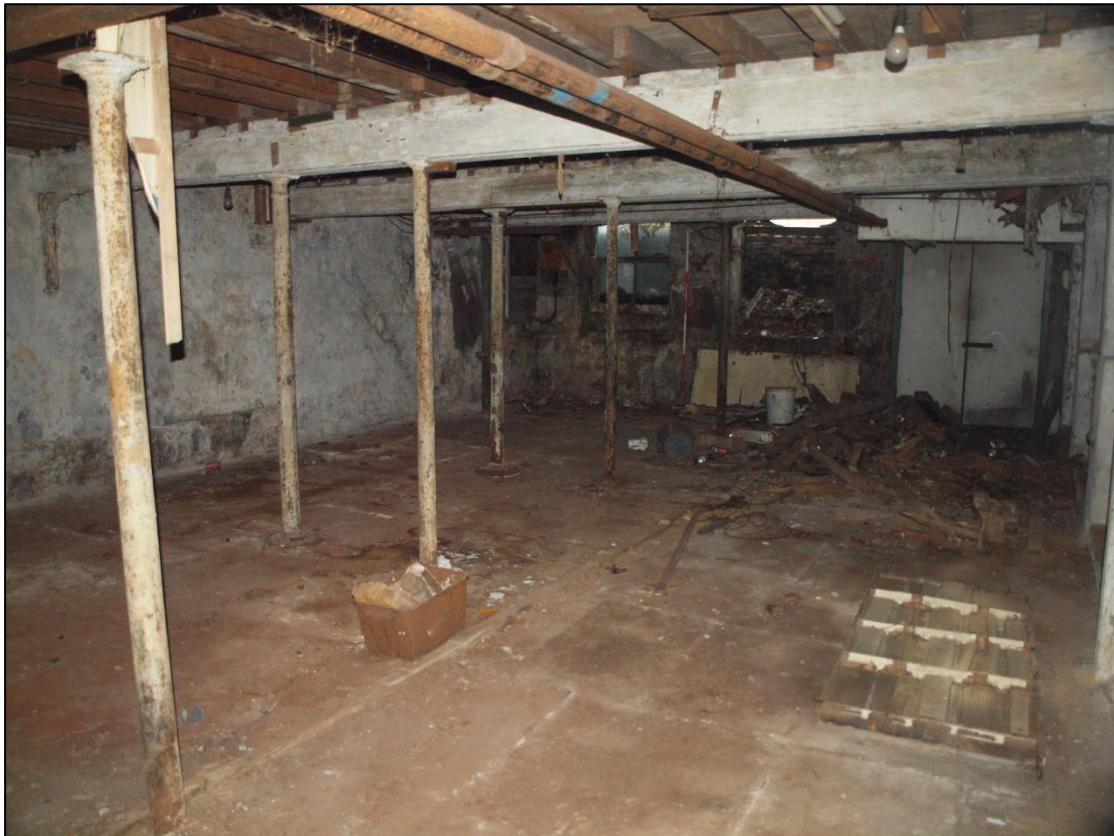
Plate 43: General shot of cellar

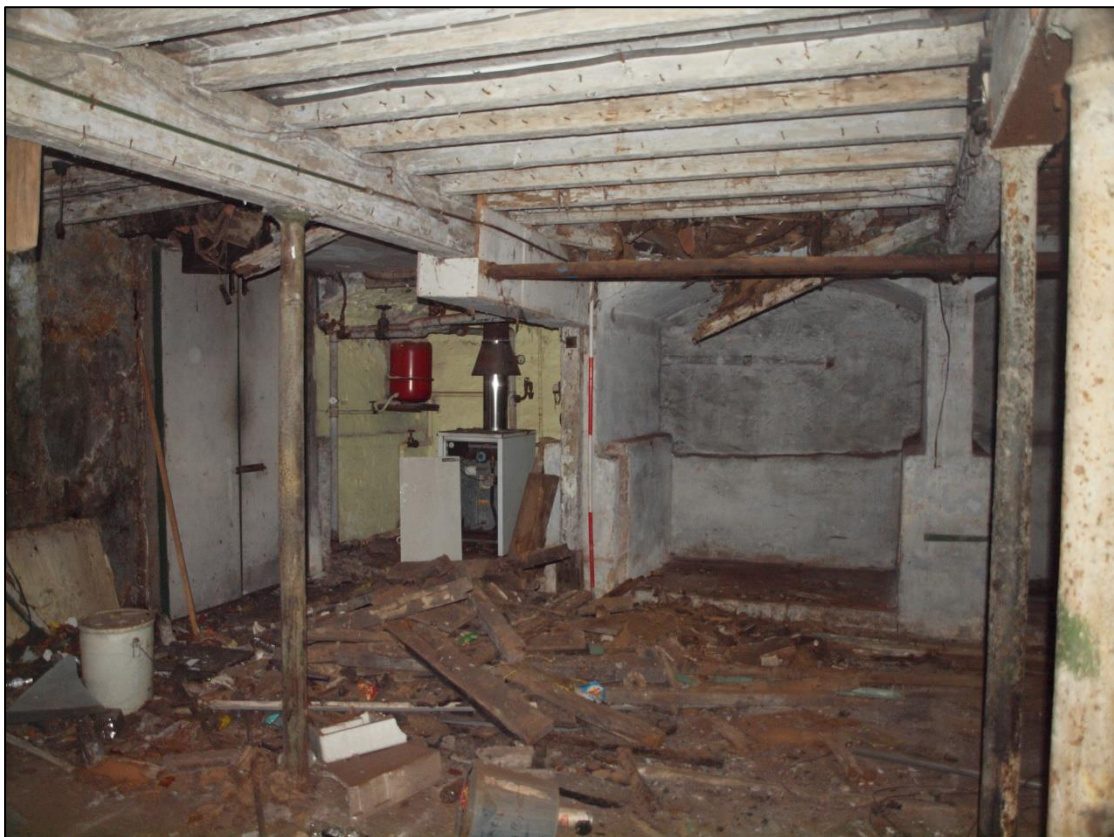
Plate 44: General shot of cellar

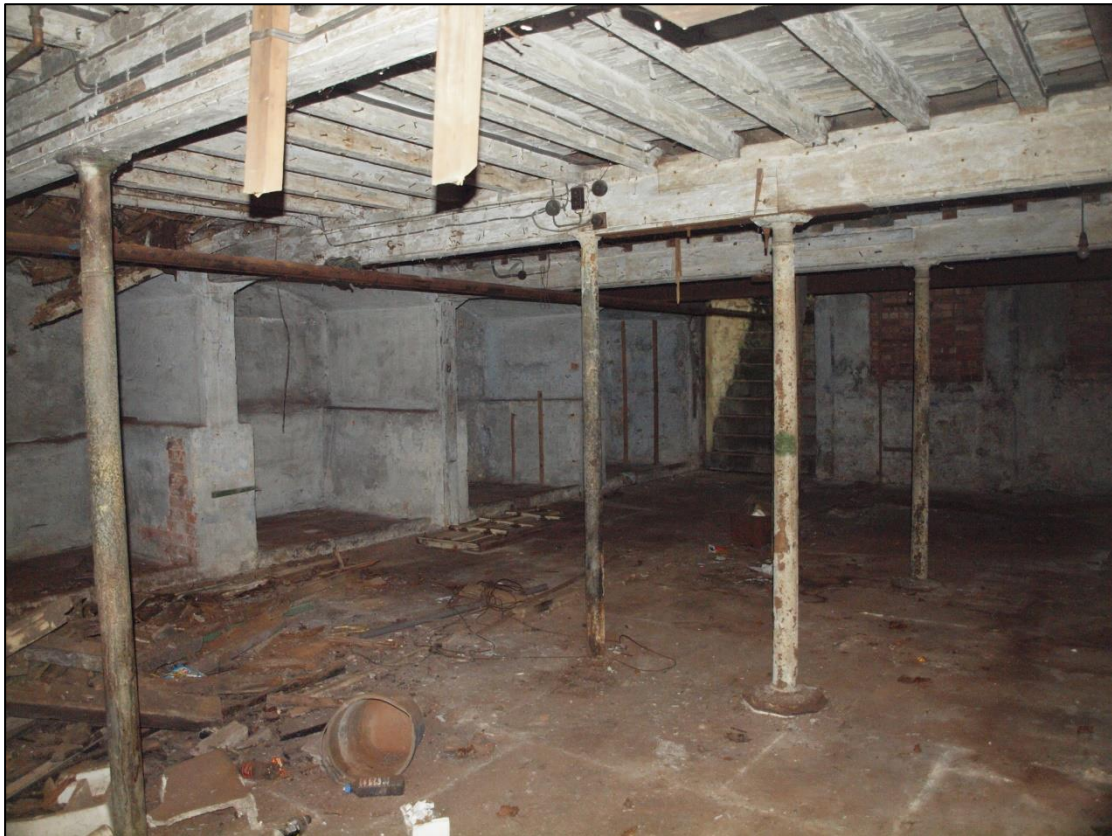
Plate 45: General shot of cellar

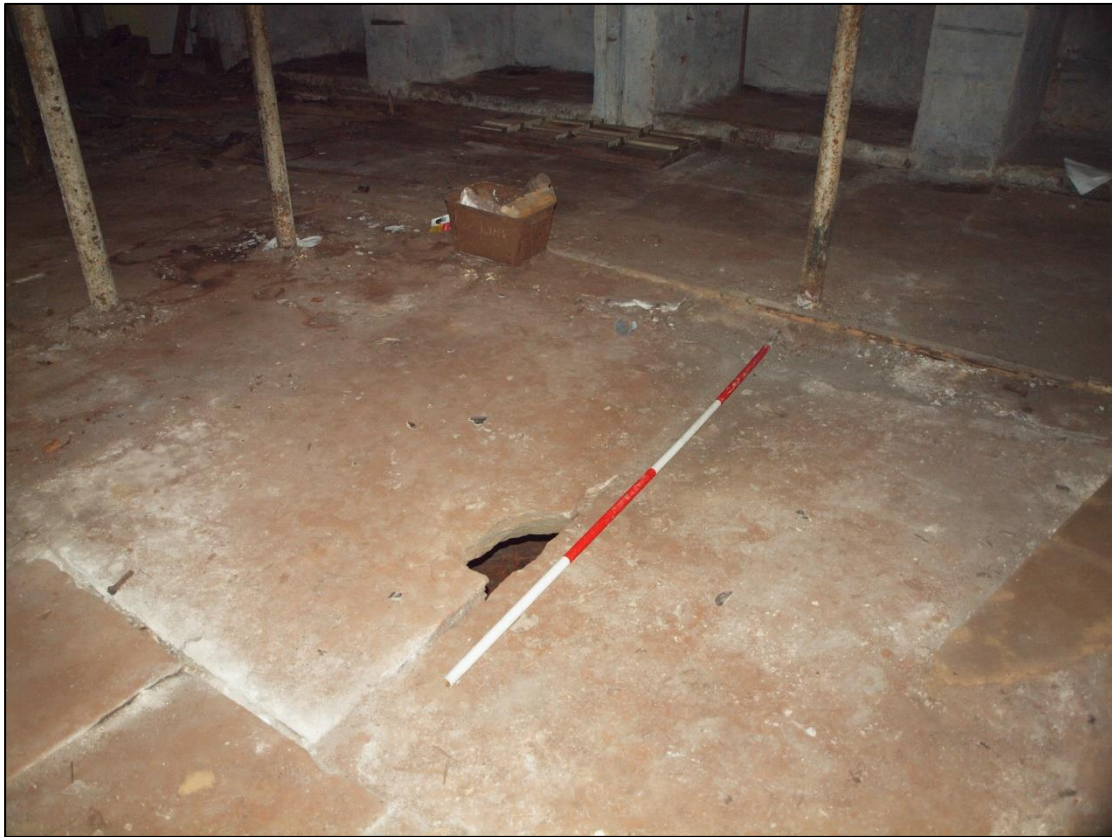
- 7.3 The presence of a 'well' found beneath the flagged surface of the cellar may indicate a method of ensuring the cellar was kept humid. It is not known how deep the well was or whether other 'wells' are located below other flags in the basement. The alcoves along the eastern wall have recesses half way up, as if to support a shelf. It seems reasonable to assume that the cellar may have been used as a hand-weavers loomshop, the presence of the 'well' suggesting the humid conditions and the alcoves used for storage. The cellar windows along the rear

Plate 49: Well location

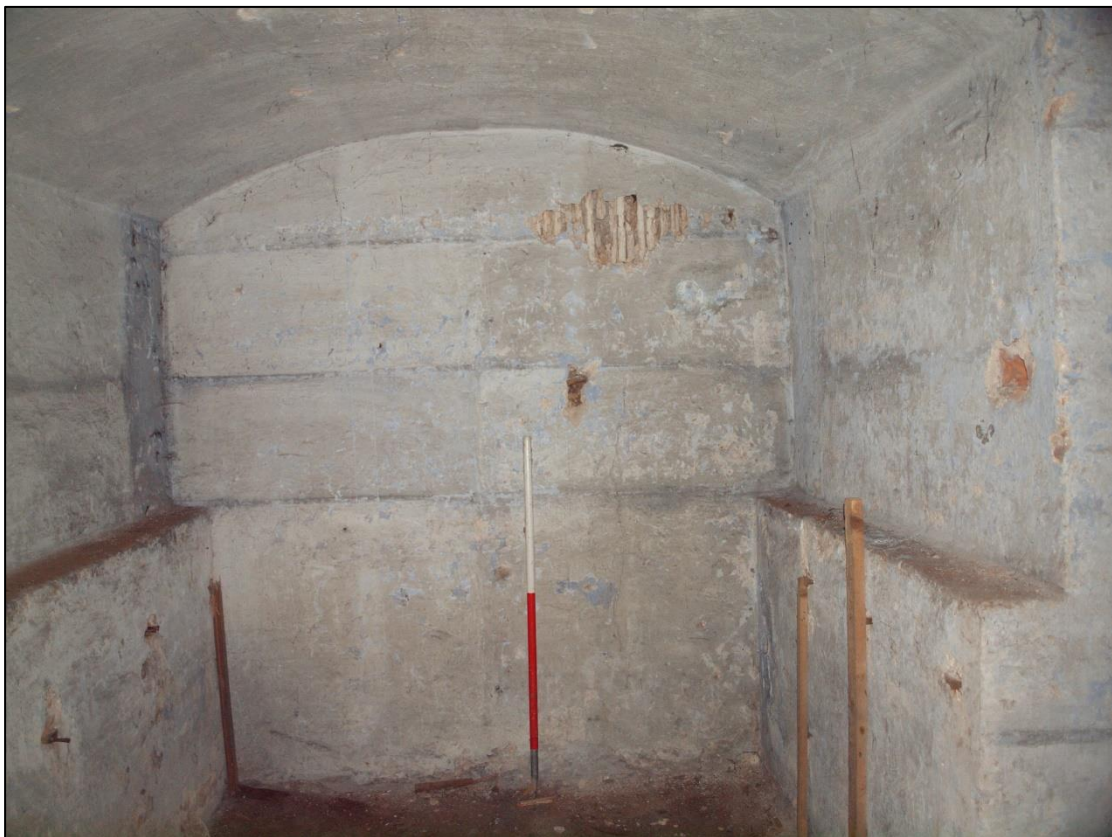
Plate 50: Alcove detail

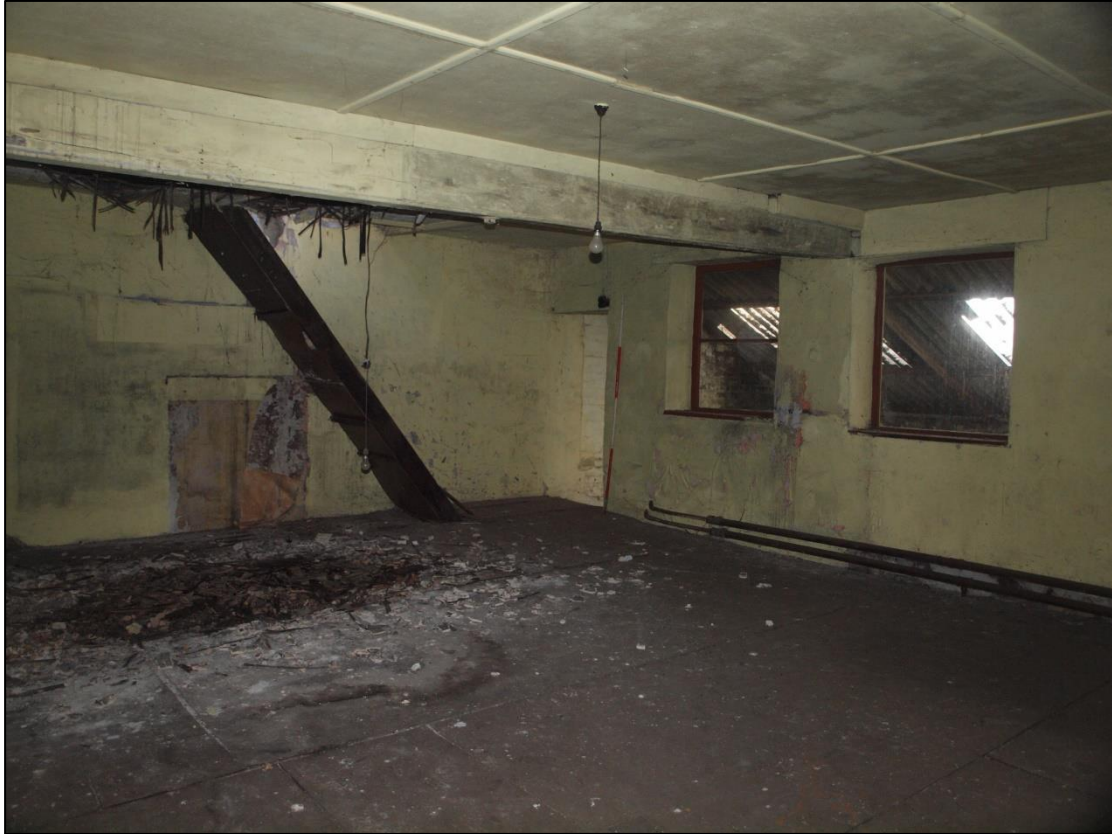
Plate 53: First floor of number 5

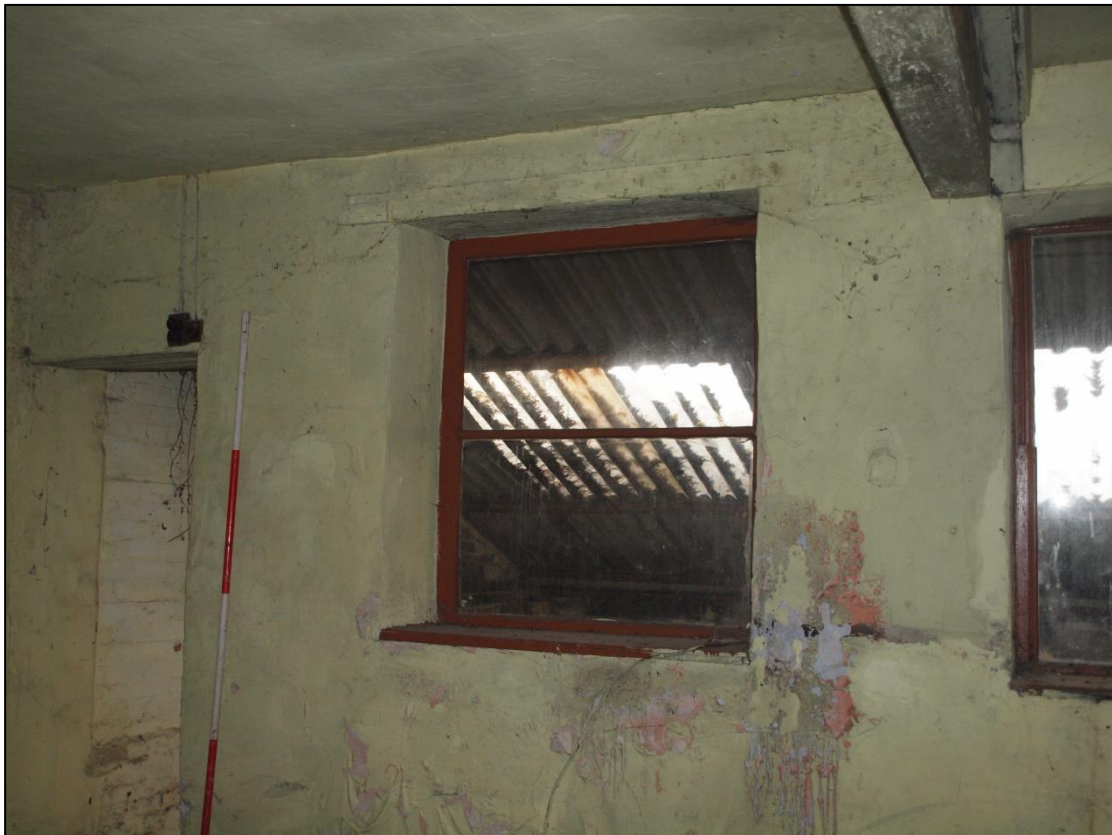
Plate 54: Details of first floor windows of number 5

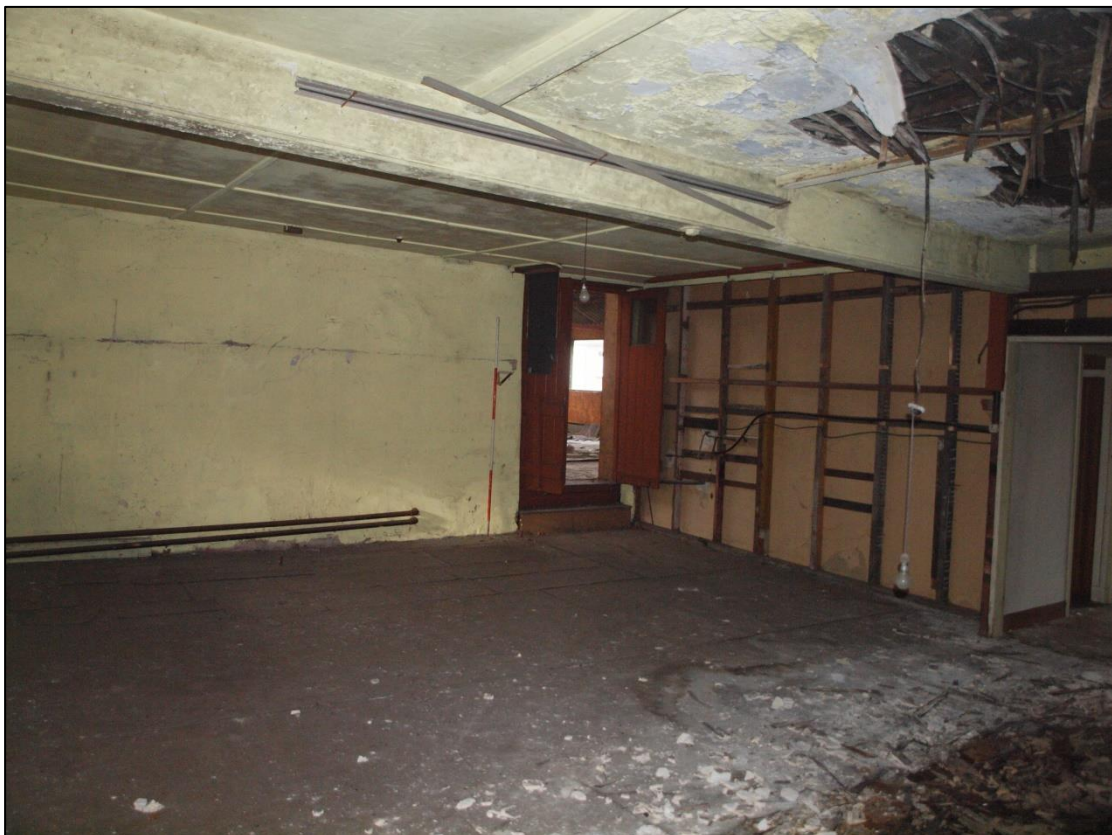
Plate 56: First floor of number 5

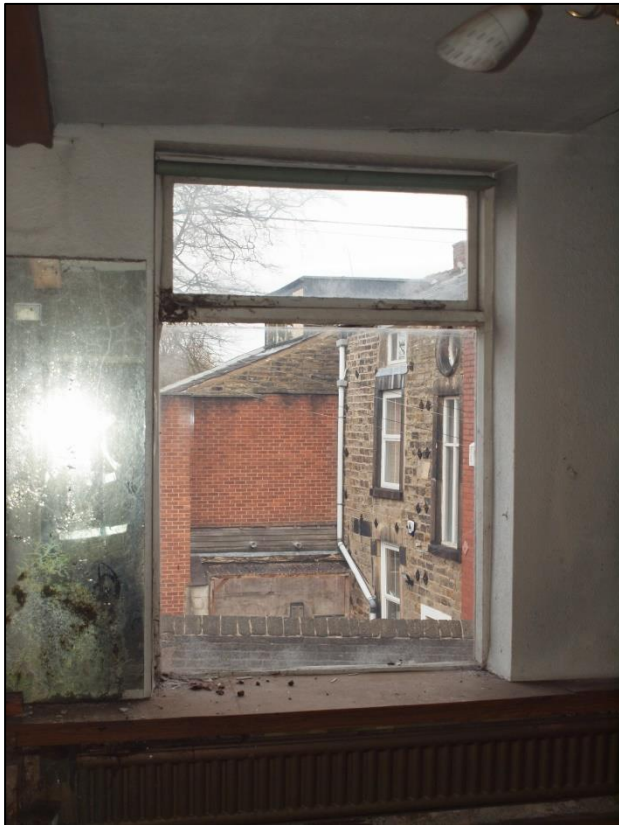
Plate 59: Livingroom window at north end of number 5 first floor

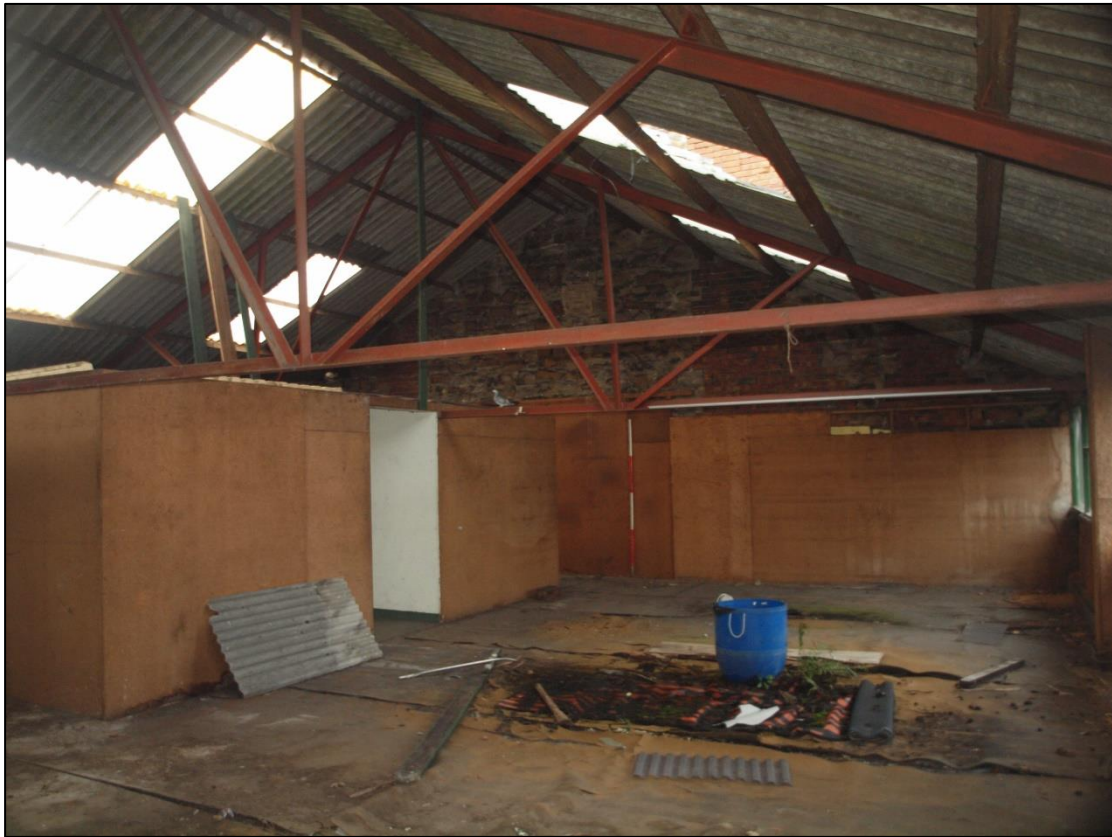
Plate 63: First floor of 7 - 9

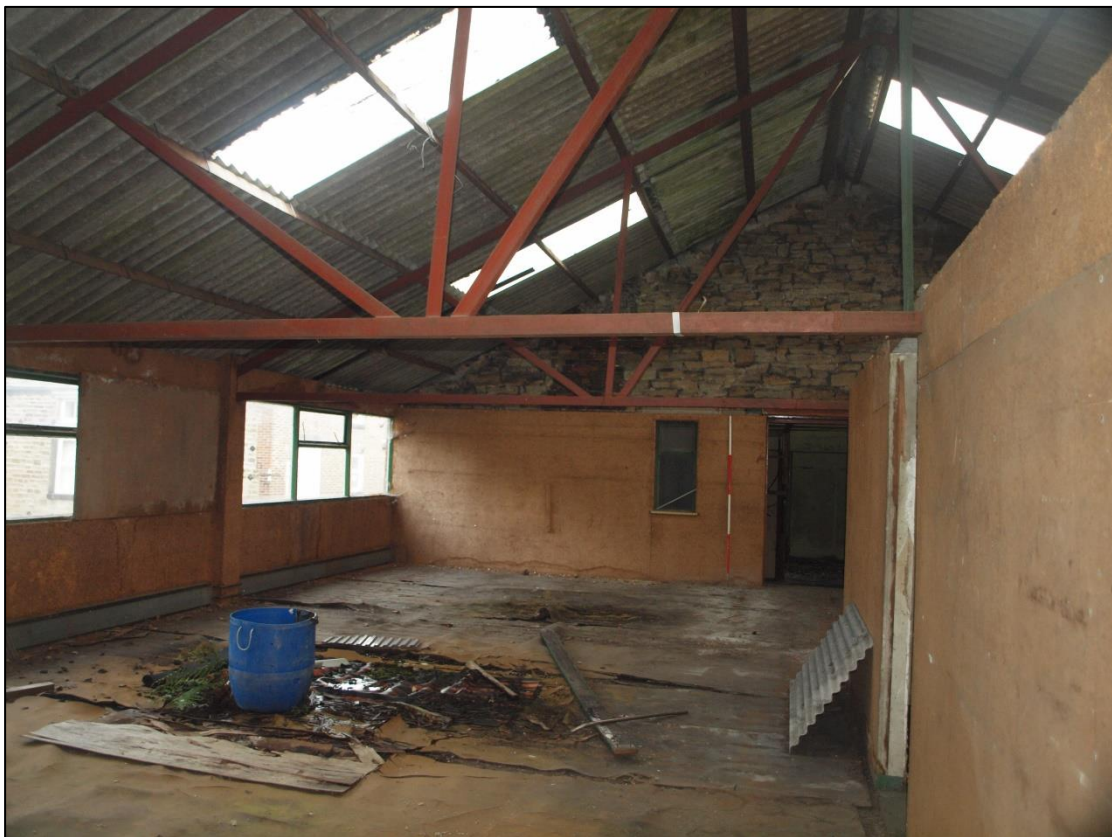
Plate 64: First floor of 7 - 9

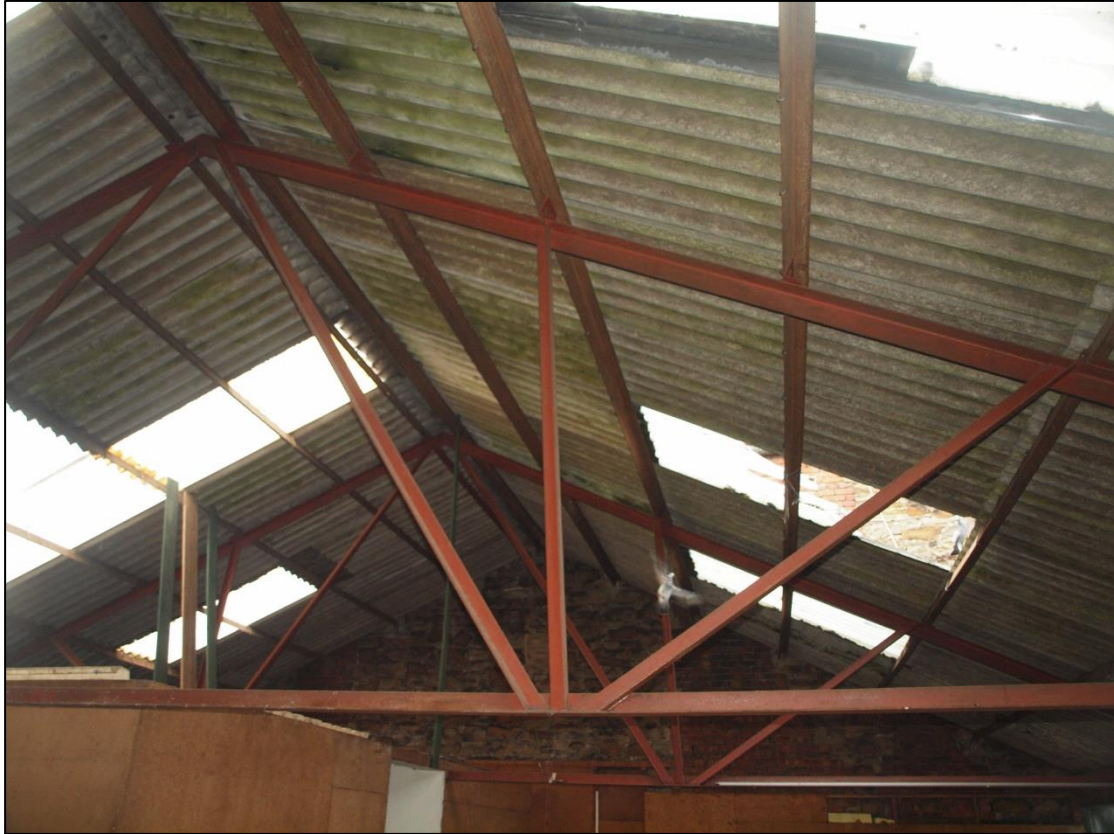
Plate 65: Detail of metal truss of 7 - 9

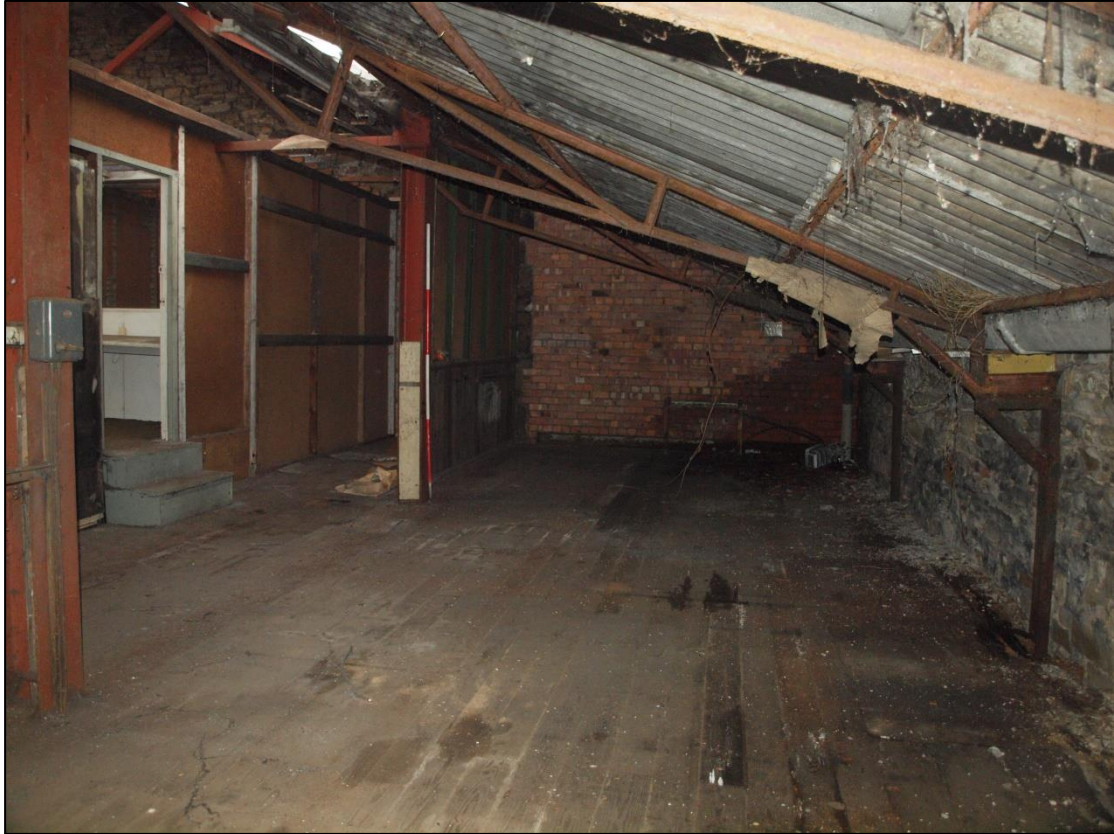
Plate 67: Southern end of 7 - 9 first floor

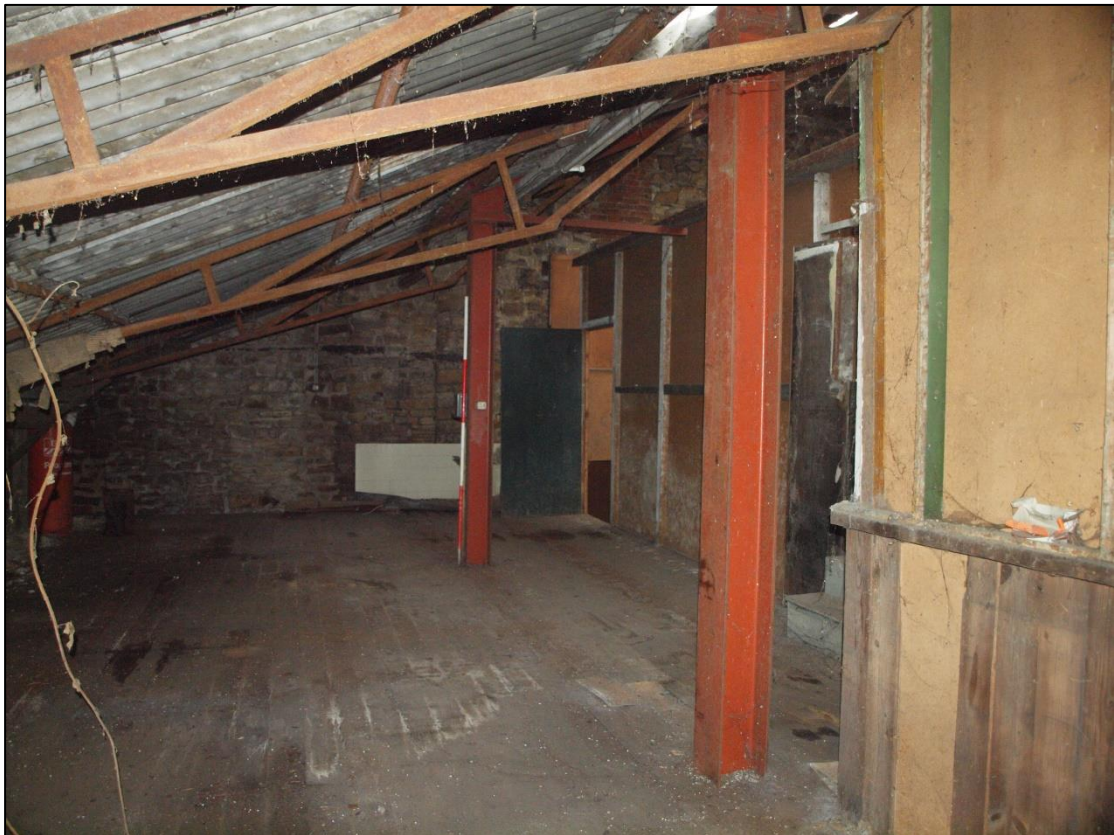
Plate 68: Southern end of 7 - 9 first floor

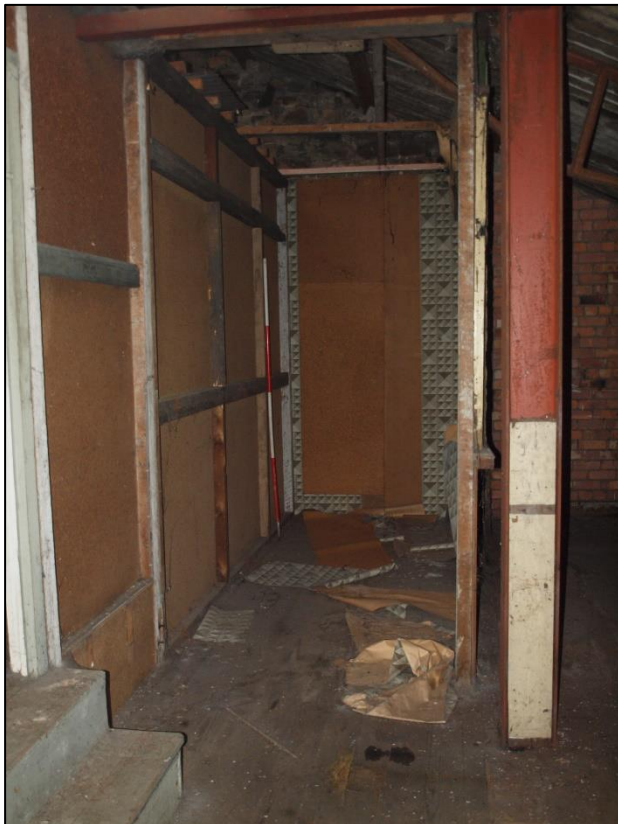
Plate 70: Partitioned room at southern end of first floor of 7 - 9

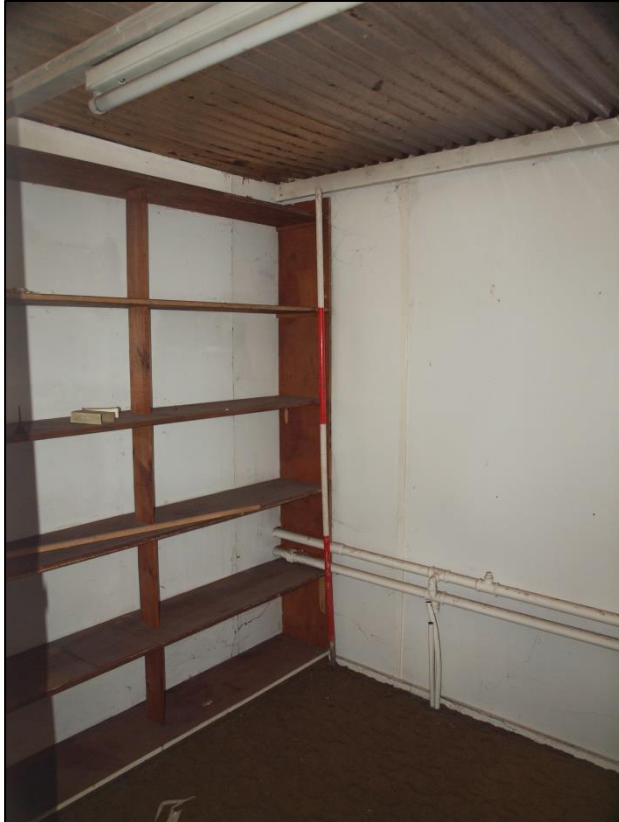
Plate 71: First floor office in 7 - 9

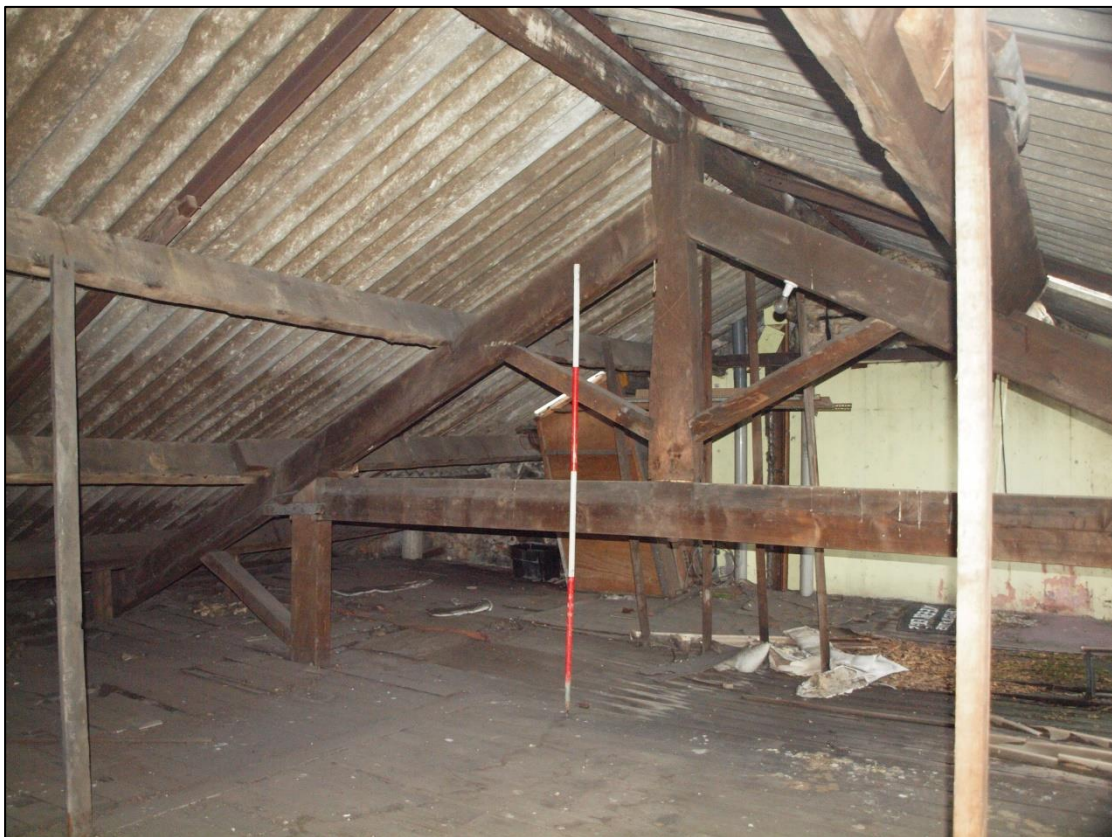
Plate 74: Truss detail
