5 - 9 Queens Road, Chorley  
Photographic Building Survey

December 2018

## **NON-TECHNICAL SUMMARY**

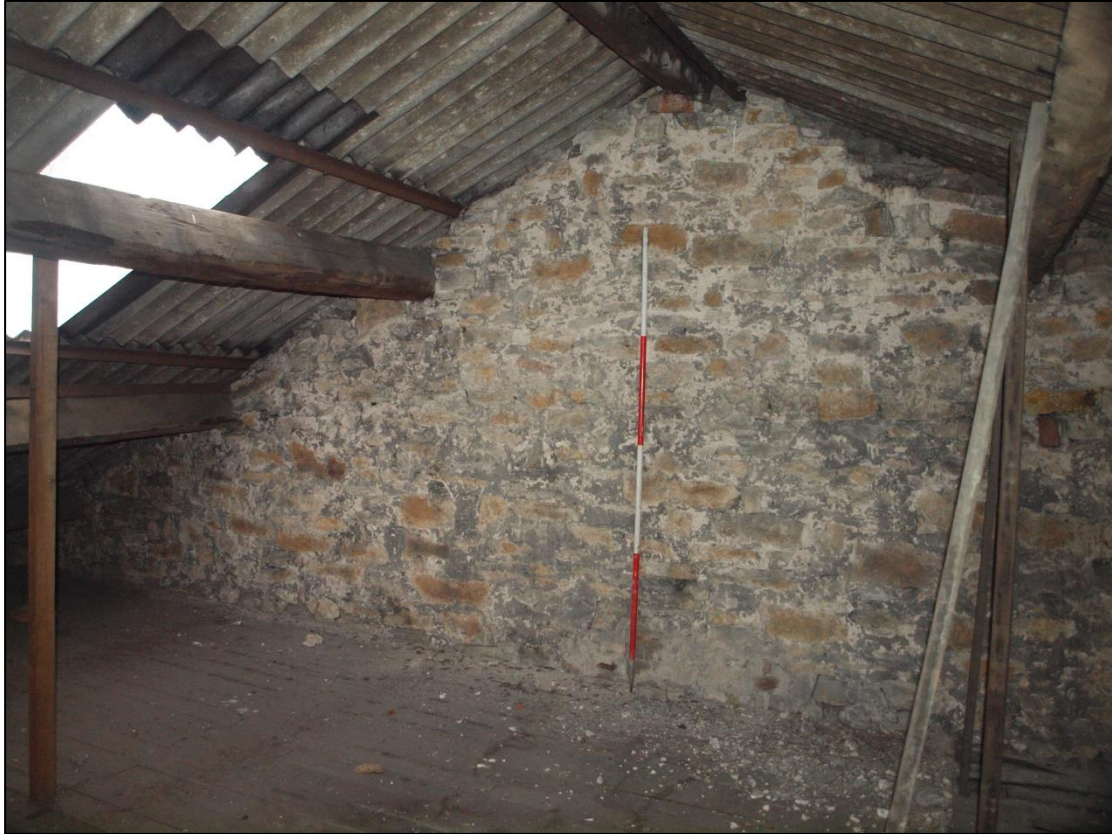
Plate 75: West gable in attic

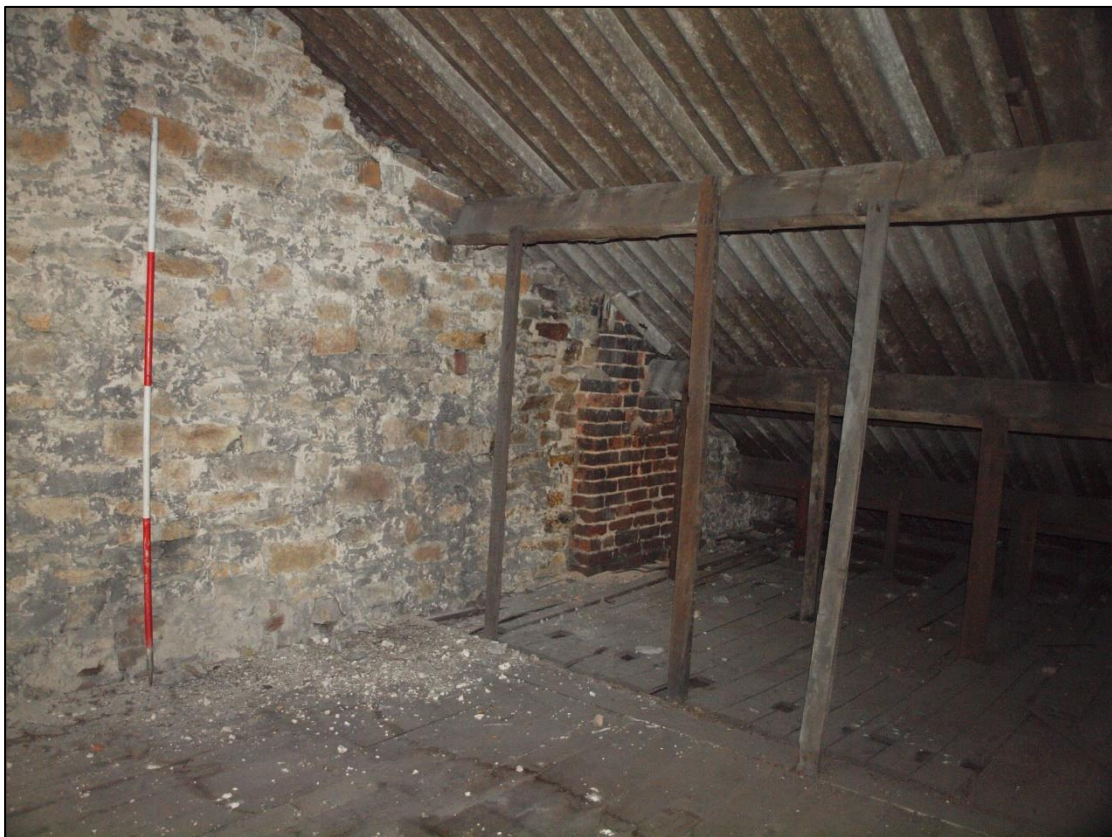
Plate 76: West gable in attic

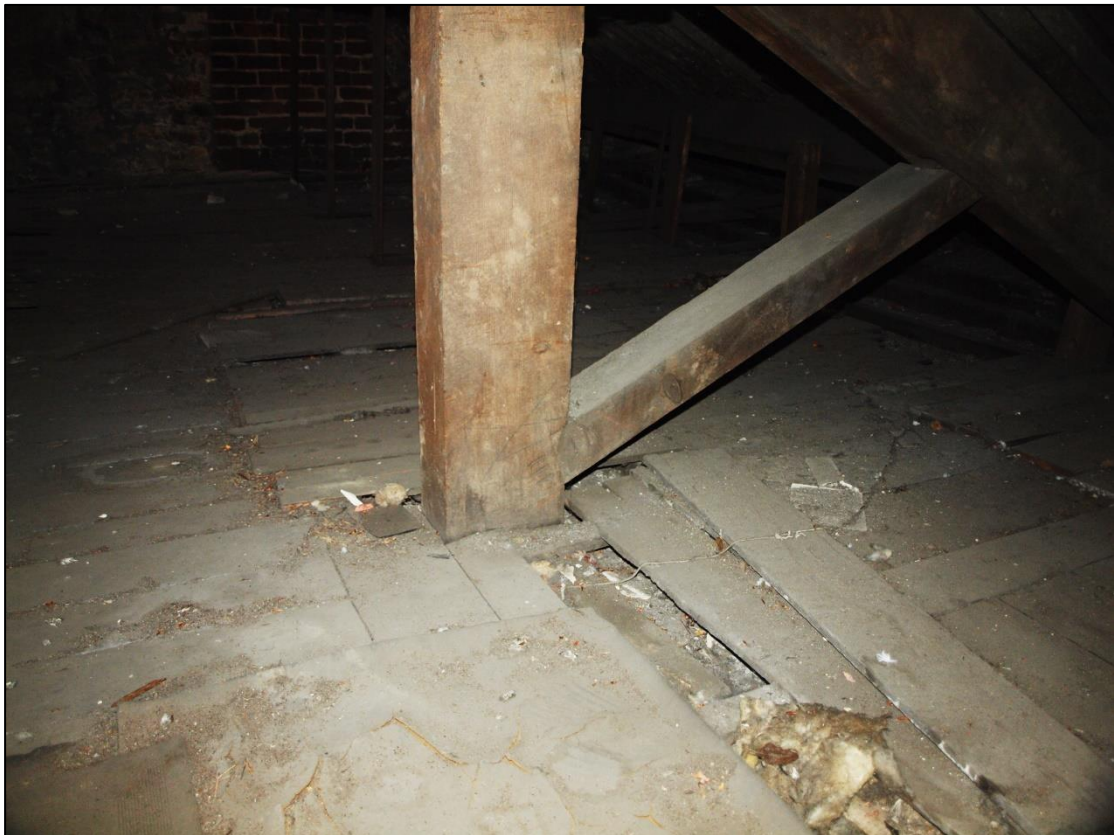
Plate 78: Carpenters marks on truss
