Burgess Farm, Worsley Historic Building Survey

February 2020

An archaeological building survey was required prior to demolition of the farm buildings at Burgess Farm, Worsley. The work was carried out on behalf of Realacre Developments Limited by The Archaeology Co.

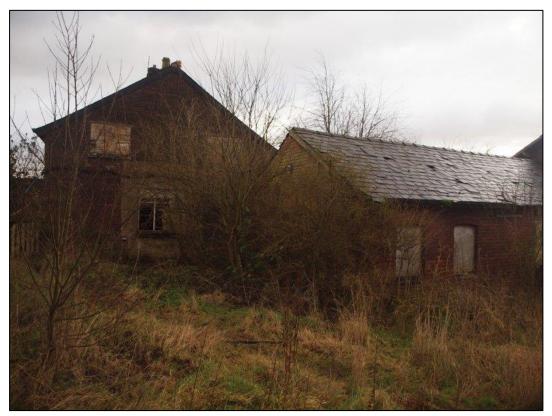
Plate 2: General shot showing gable end of farmhouse (left) and milking parlour (right)

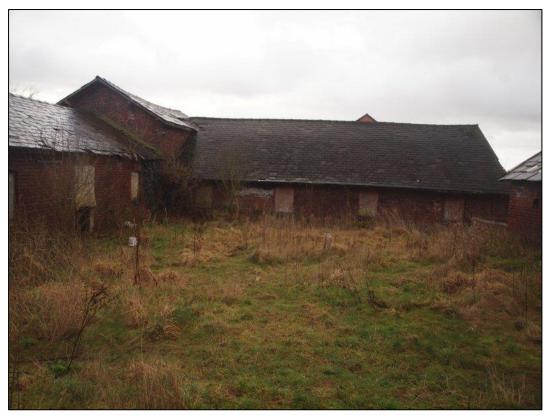
Plate 3: General shot of courtyard area showing milking parlour

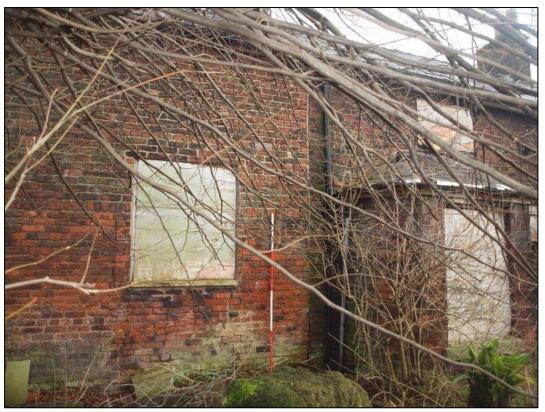
Plate 5: South elevation of west extension

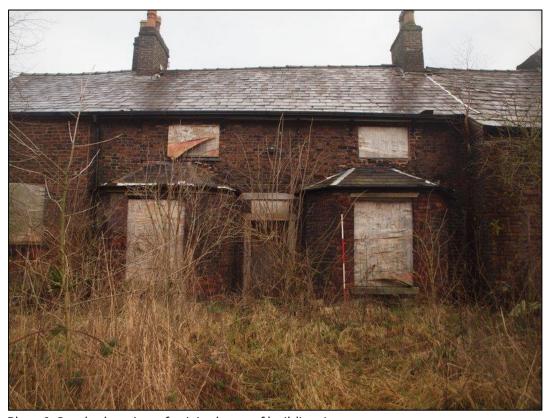
Plate 6: South elevation of original part of building 1

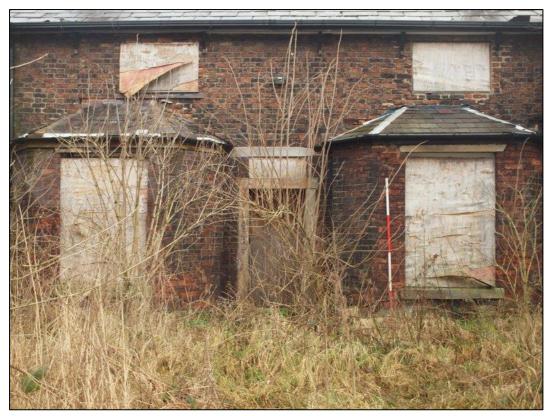
Plate 7: Detail of doorway and bay windows

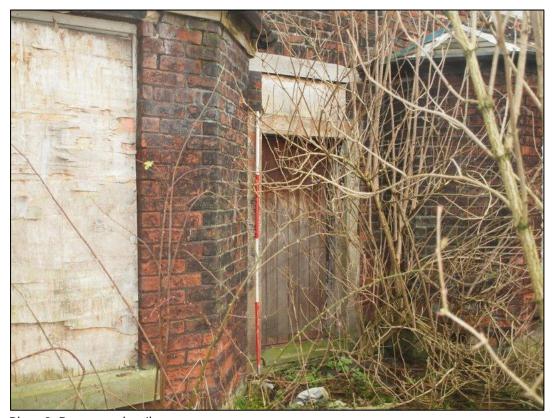
Plate 8: Doorway detail

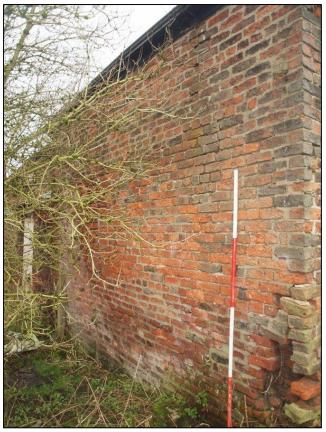
Plate 9: South elevation of east extension

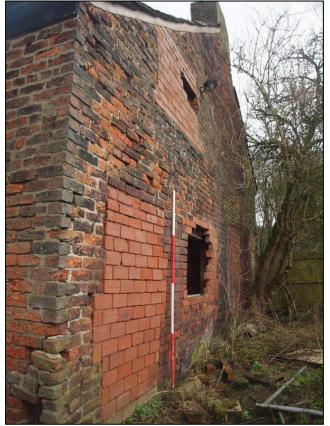
- 6.3 East elevation (Plates 10 12). This is gable of the eastern extension and is likewise constructed in English Garden Wall bond (5:1), with a chimney stack rising at the apex. At the northern and southern ends are personnel doorways, both blocked with brick. That to the south has uneven jambs, possibly

Plate 10: Southern end of east elevation

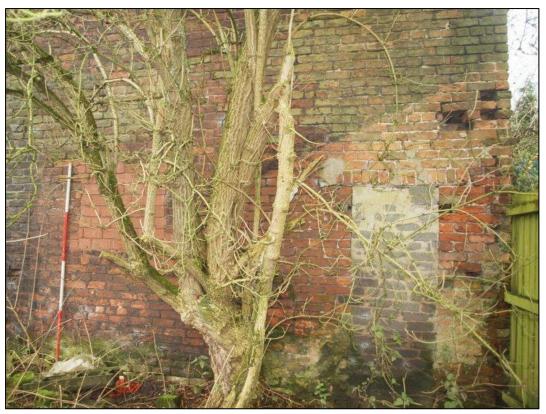
Plate 11: Northern end of east elevation

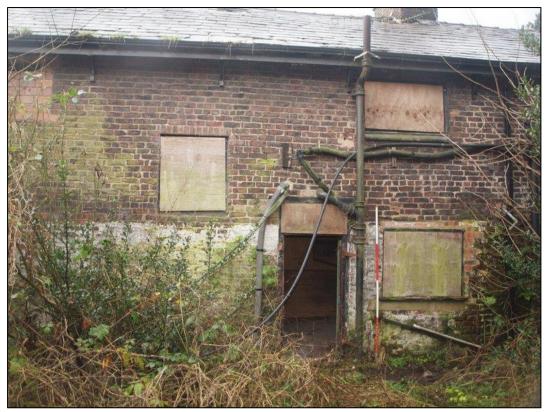
Plate 15: North elevation showing back door

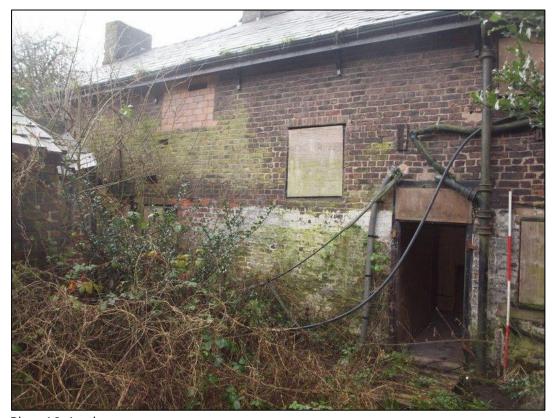
Plate 16: As above

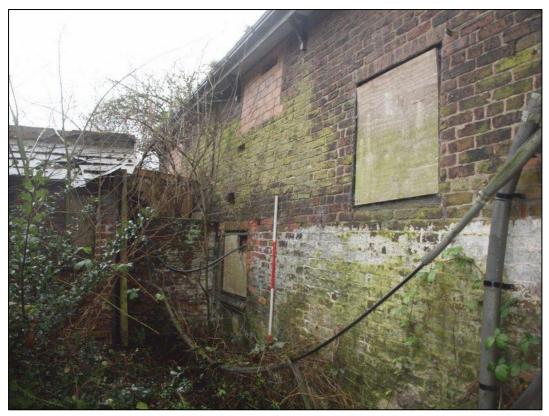
Plate 17: North elevation to the east of the doorway

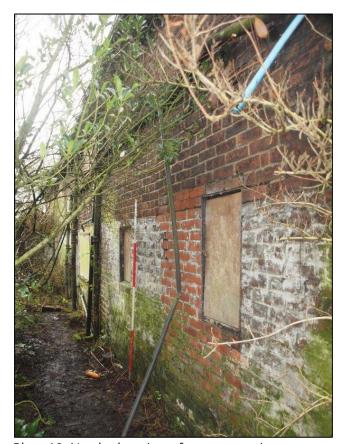
Plate 18: North elevation of west extension

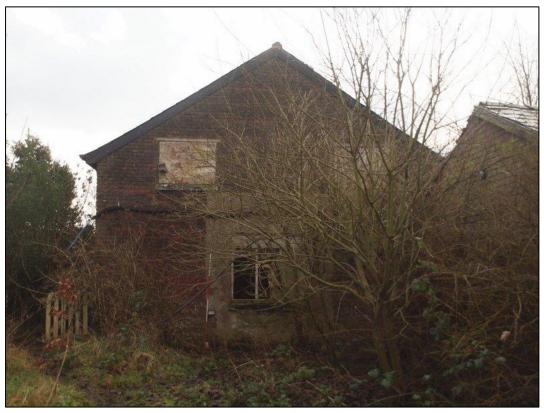
- 6.5 West elevation (Plates 19 & 20). This forms the gable end of the west extension. In the centre of the face at ground floor level is a large landscape window, with parts of the timber framed casement still remaining. The whole are around the window is rendered. At first floor level are a pair of landscape windows, boarded over, but with sandstone cill and lintel.

Plate 19: West gable

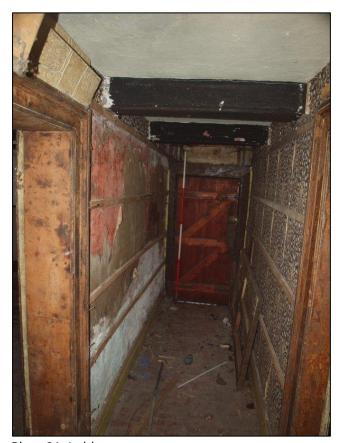
6.6 The building was originally accessed via the personnel doorway in the south elevation. This leads into a terracotta tiled lobby running northwards (plate 21).

Plate 21: Lobby entrance

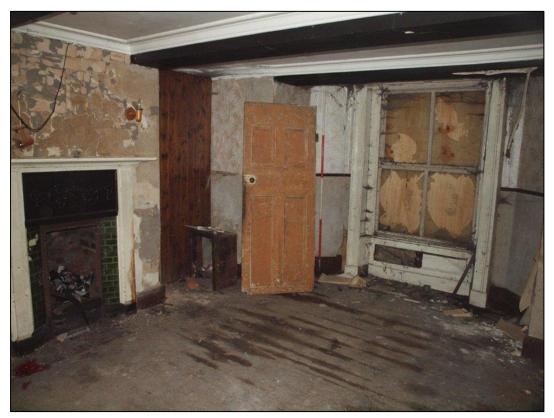
At the northern end a doorway leads into the northern side of the house, as well as a pair of doorways leading to the east and west. All have large moulded timber surrounds. The doorway to the east leads into a large open room (plates 22 – 25) with a bay window to the south. This has a large timber framed four light casement within it. In the east wall is a tiled fireplace and a pair of machine cut timber beams span the room east to west. The floor is timber boards and the ceiling plastered. The lobby doorway to the west leads into a similar room (plates 26 & 27), although here the fireplace is set in the west wall and a small serving hatch inserted into the north wall. Additionally, a doorway has been inserted to the south of the fireplace, leading into the western extension (plates 28 – 31), up a small set of steps. This comprises a single open room with ply flooring and lath and plaster ceiling. A large landscape window lies in the west wall with a further window in the south wall. This is a portrait window with the four light timber framed casement still present, although boarded externally by play. The walls are plastered and to the west wall is a fireplace. North of the fireplace stud walling has been removed, revealing a blocked doorway in the west wall and another in the eastern end of the north wall.

Plate 22: Eastern room of main house

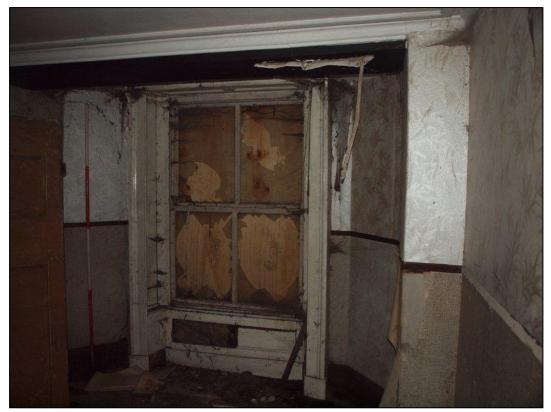
Plate 23: Bay window

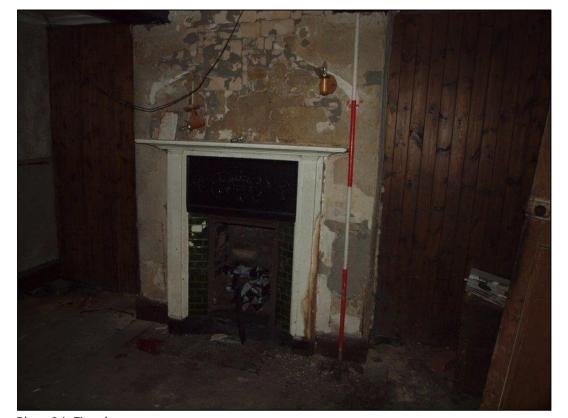
Plate 24: Fireplace

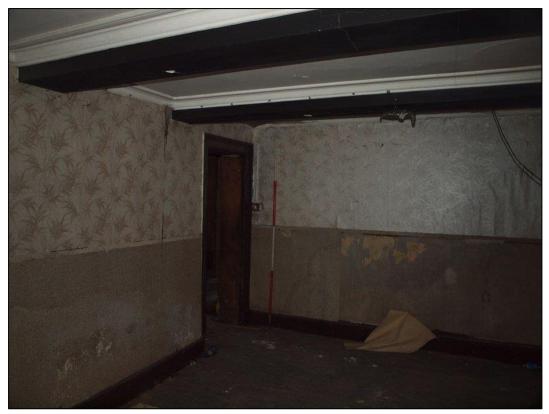
Plate 25: Eastern room of main house

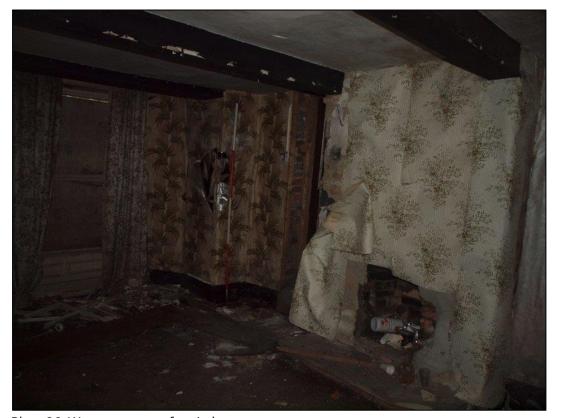
Plate 26: Western room of main house

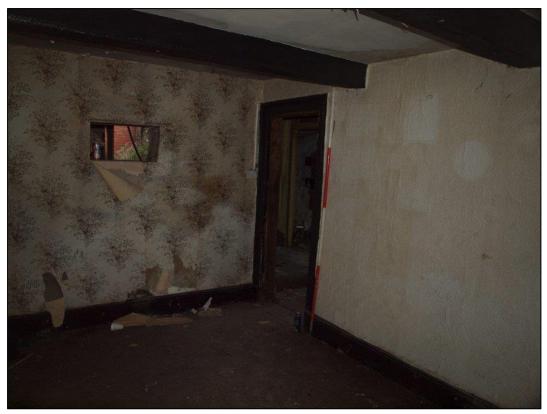
Plate 27: Western room of main house

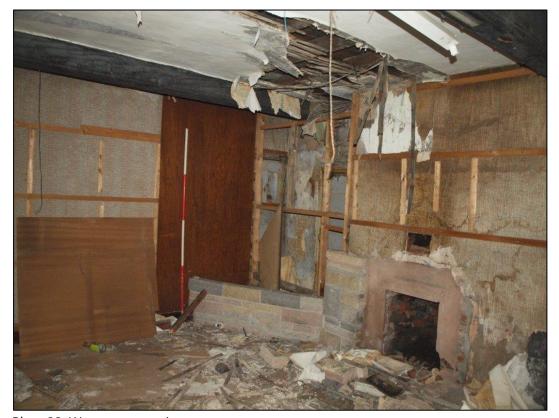
Plate 28: Western extension

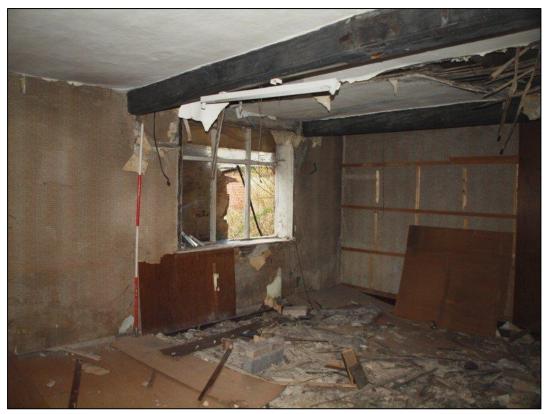
Plate 29: Western extension
