**THE ARCHAEOLOGY CO.**

Naychurch Farm, Upper Hulme

Historic Building Survey

December 2020

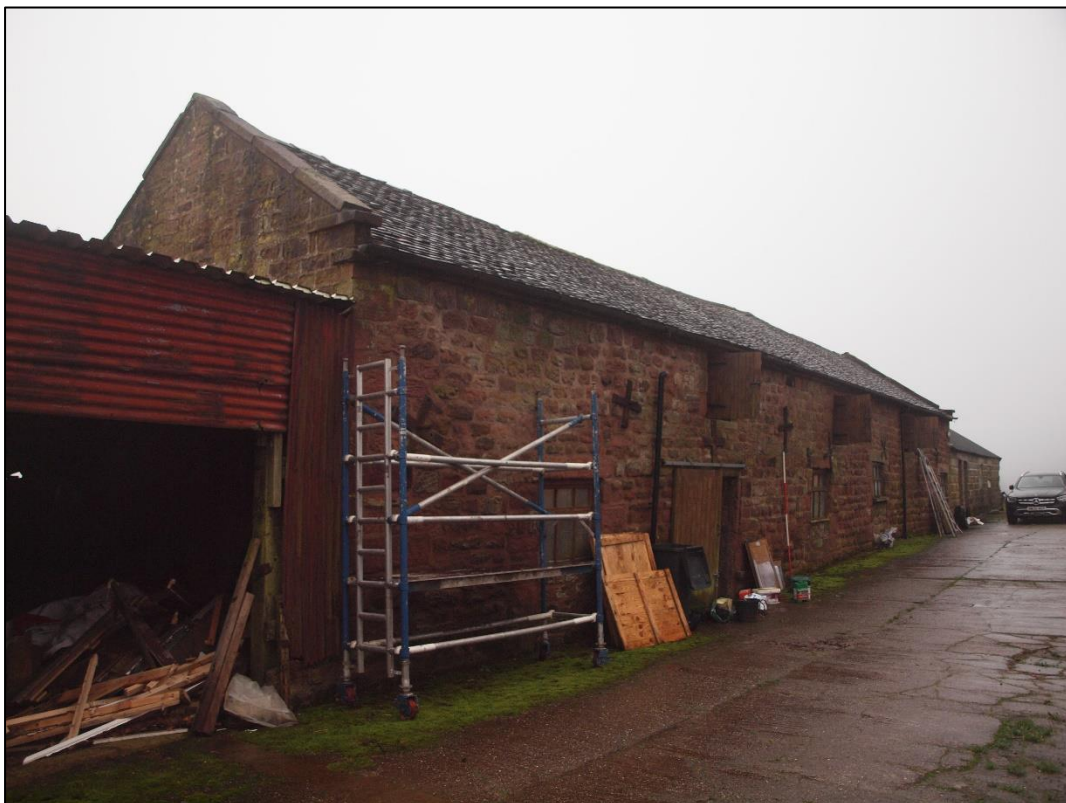
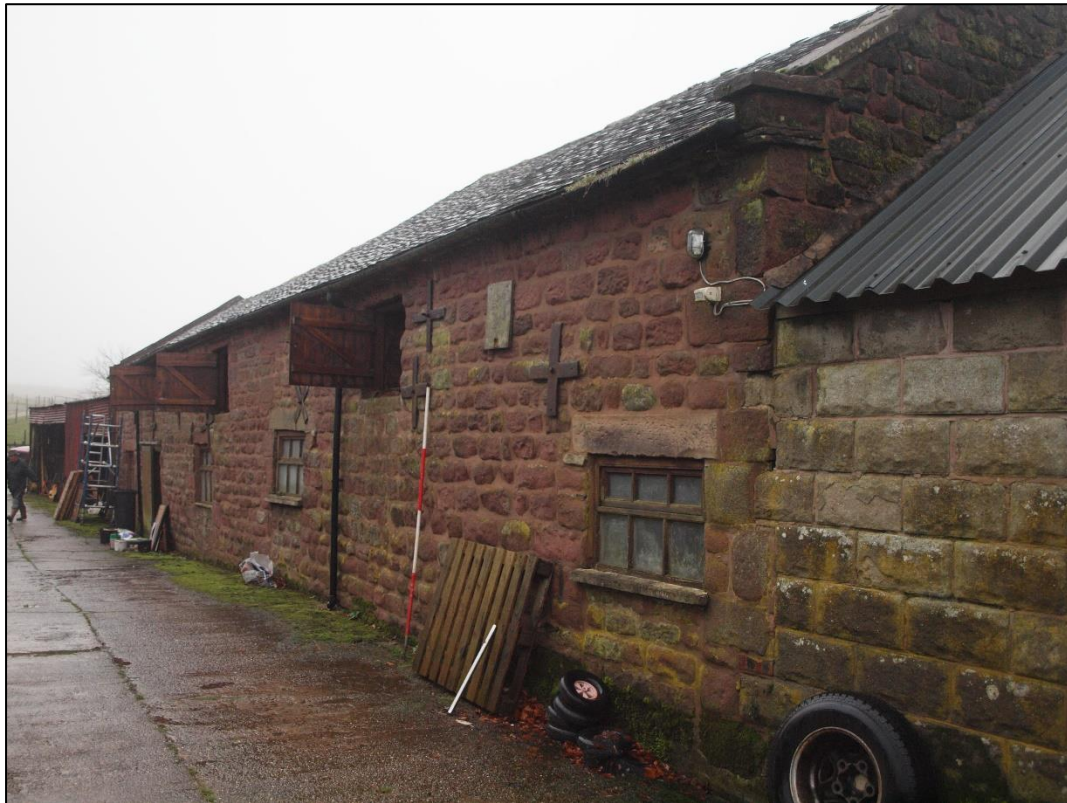
6.2 North elevation (Plates 4 - 17). This comprises the main frontage, facing onto the track. It is of five unequal bays all constructed of shaped and coursed sandstone. The first (east) bay contains a six light timber framed casement at ground floor level, with a heavy sandstone lintel over. Below straight joints are present, showing it to be a former doorway. Bay two contains a doorway at ground floor level with heavy sandstone lintel over and simple sandstone jambs. A timber sliding door is hung on modern metal rail. Above a square pitching eye has a timber door fitted. The cill is sandstone and the lintel is formed by the eaves. Bay three contains a window at ground floor level, matching that to bay one, and was also a former doorway. Above and to the west a further square pitching eye is present. This matches the previous, with the exception that it is set slightly lower in the face and has a sandstone lintel. To the west end of the bay a straight joint rises up the face with quoins visible to the east side, showing the former end of the building. Bay four is thus the face of the first extension. A window matching the other lies at ground floor, also show to be a former doorway. The east jamb of this is formed by the straight joint and the lintel is of a paler sandstone. Above and to the west is a further square pitching eye with timber doors. This is like the aforementioned, with a sandstone cill and lintel. Finally, bay five contains a further matching window that was formerly a doorway, again with a pale sandstone lintel. To the west the later single-story extension is attached, and tied into the stonework.

Plate 4: General shot of north elevation of barn

Plate 5: General shot of north elevation of barn

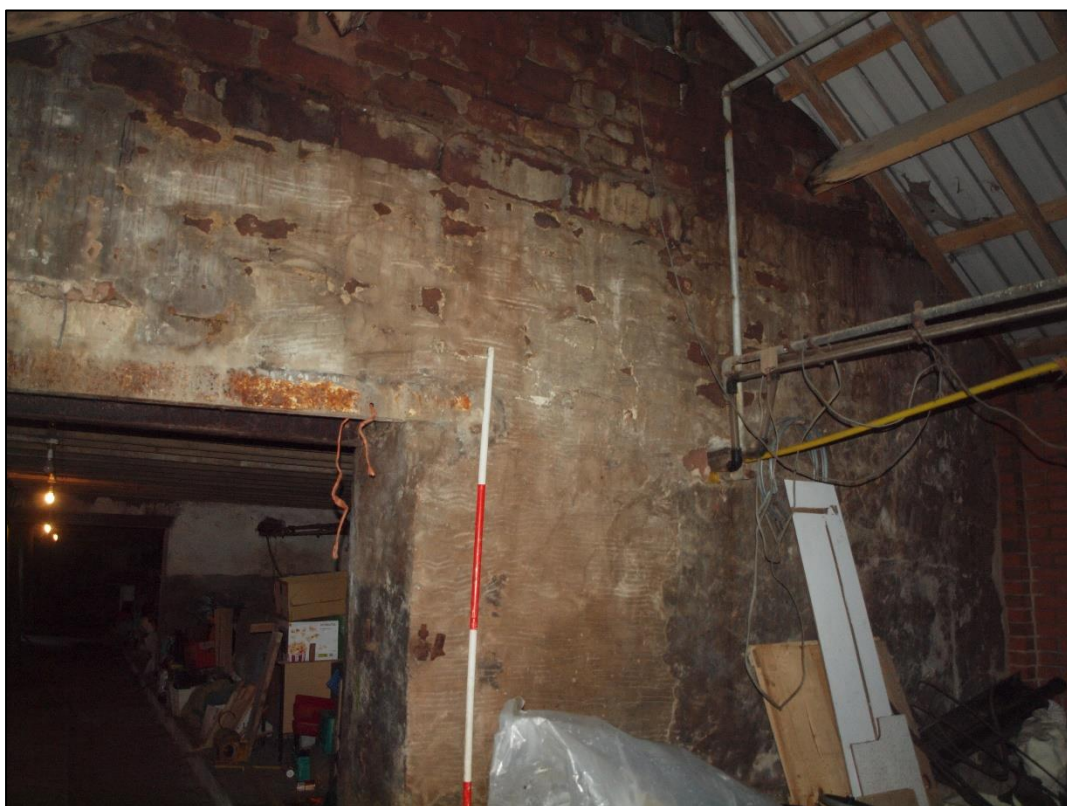
- 6.3 West elevation (Plates 18 & 19). This forms the gable end of the building and is mostly hidden within the later extension. Externally only the top part of the gable is visible, showing no features other than a stone coped verge on simple kneelers. Within the extension the rest of the face is visible. A large opening has been inserted to the north end with RSJ lintel. Most of the face still has concrete render, although towards the top the red stone face is visible. A small square opening lies close to the apex of the extension roof.

Plate 18: Western gable showing rendered face

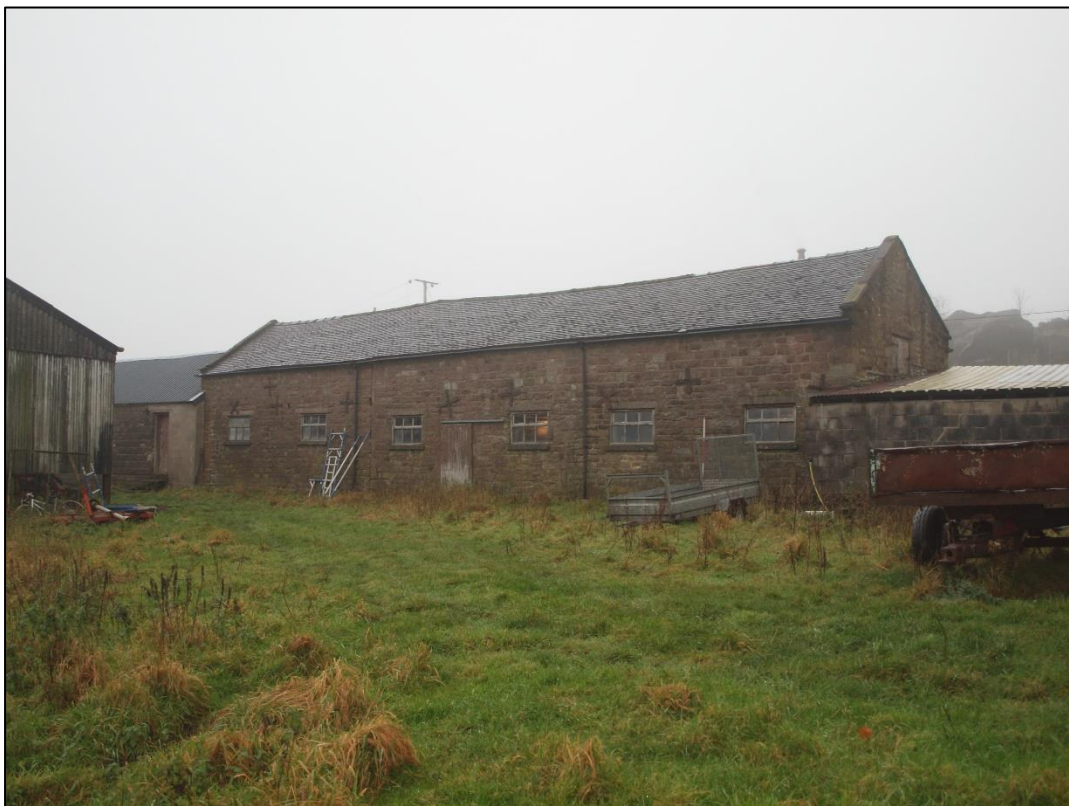
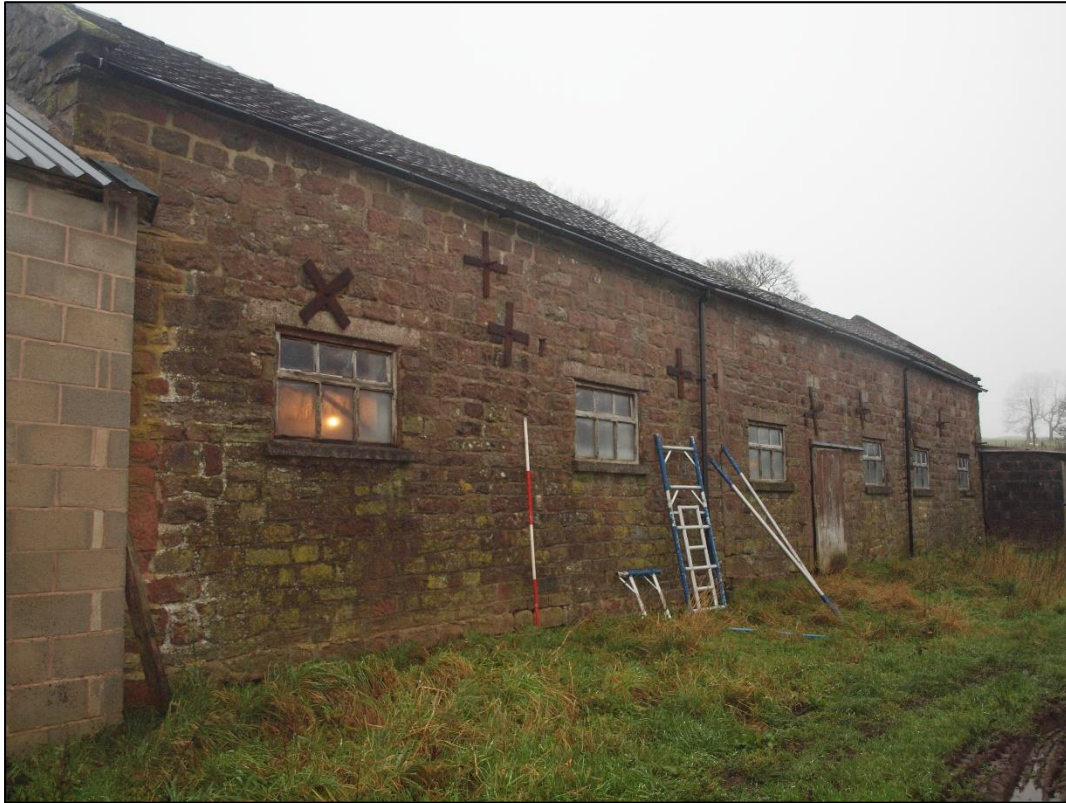
- 6.4 South elevation (Plates 20 - 31). This comprises the rear of the building. Six landscape windows line the face, each identical, with six light timber framed casements and concrete cills and lintels. All are later insertions. To the east, bay one contains a window and to the west of it a small blocked portrait window is visible, with sandstone lintel. Bay two contains a pair of windows, between which is a blocked doorway, likewise with a sandstone lintel. The western jamb is still visible, showing a vertical stone between a pair of large horizontal stones. The third bay contains a window with a doorway to the east of it. This has sandstone jambs and lintel and a timber sliding door hung on a modern metal rail. To the west is the straight joint showing the original end of the building, with quoins to the east side. Bays four and five each contains a window.

Plate 20: South elevation

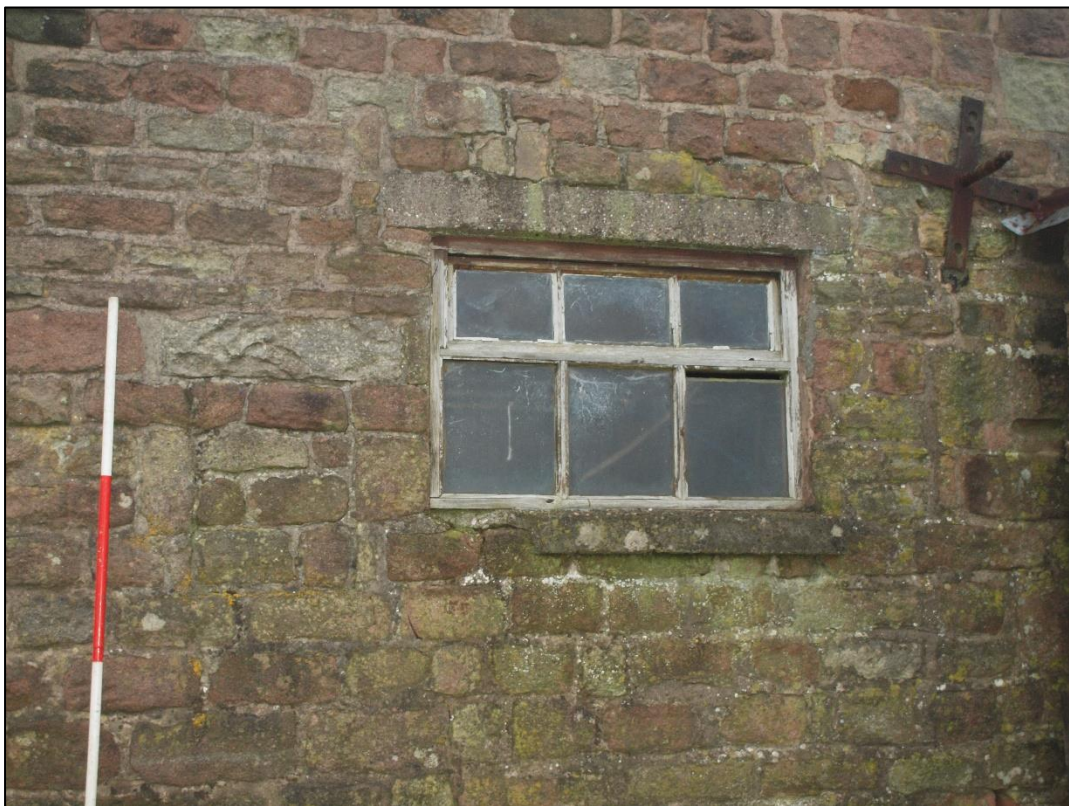
Plate 24: As above in relation to inserted window

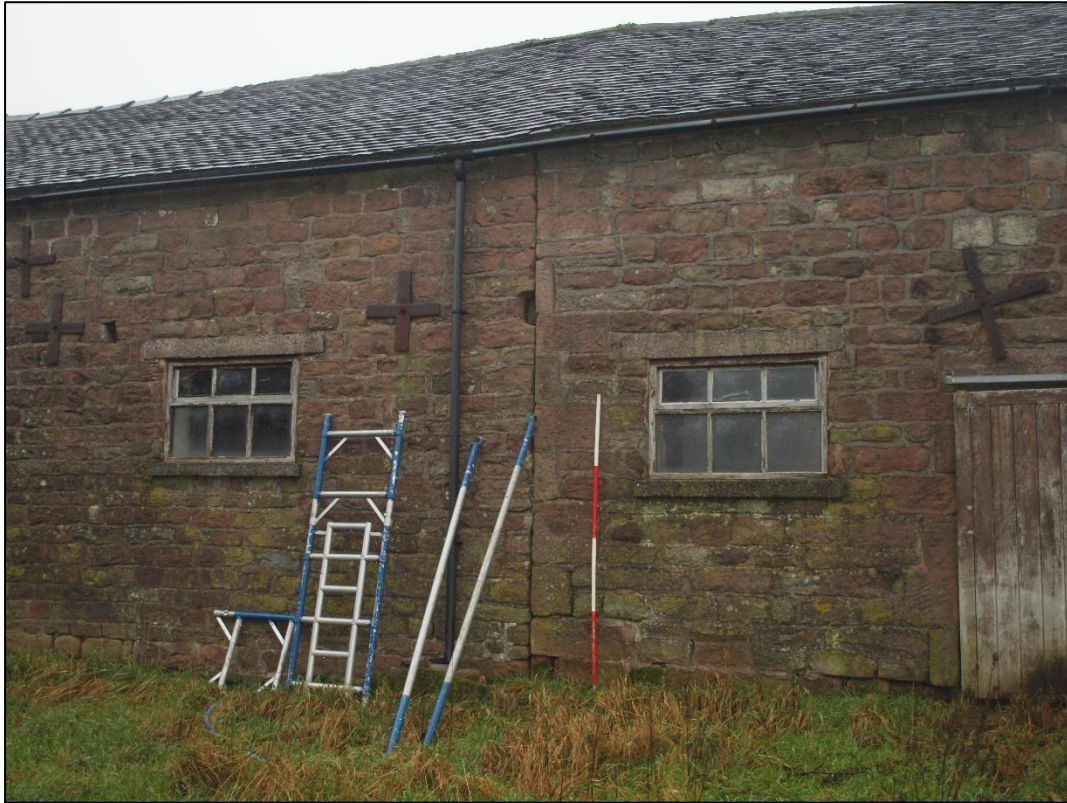
Plate 29: As above

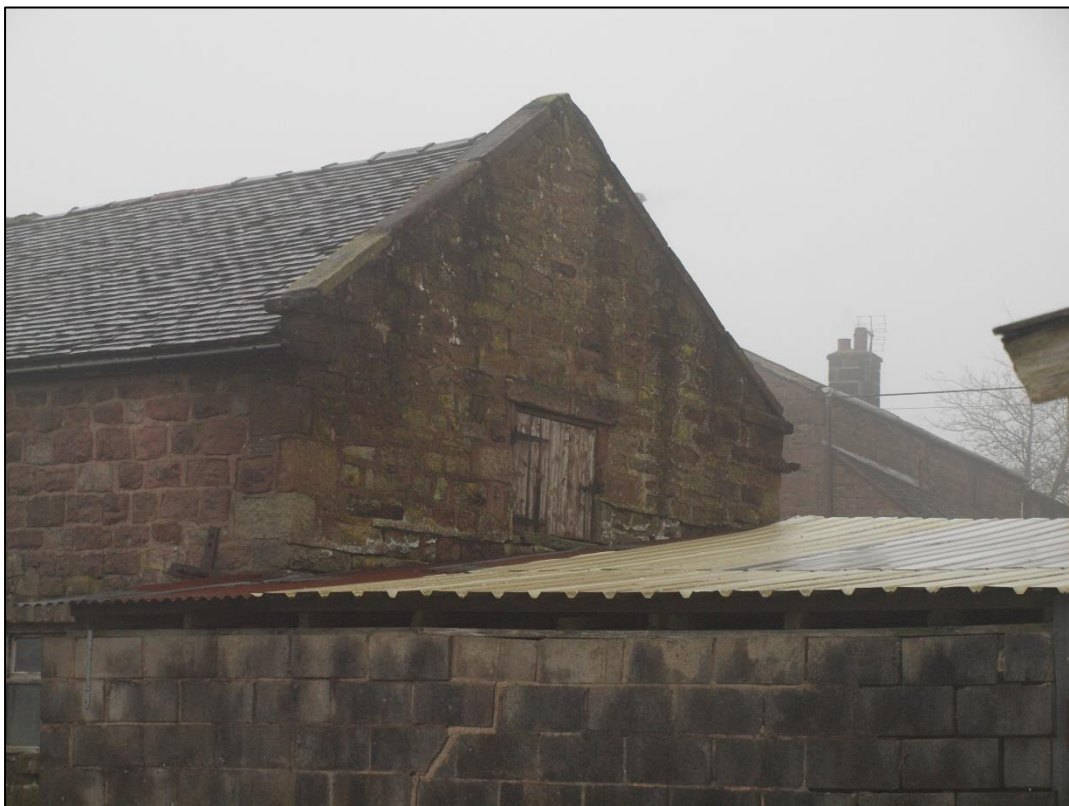
- 6.5 East elevation (Plates 32 & 33). This forms the other gable end of the building. The ground floor is covered by the later extension, which, when viewed internally, is shown to be featureless. At first floor level a square pitching eye is present with timber shutter hung. A stone coped verge lies on simple kneelers above.

Plate 32: East gable showing pitching eye

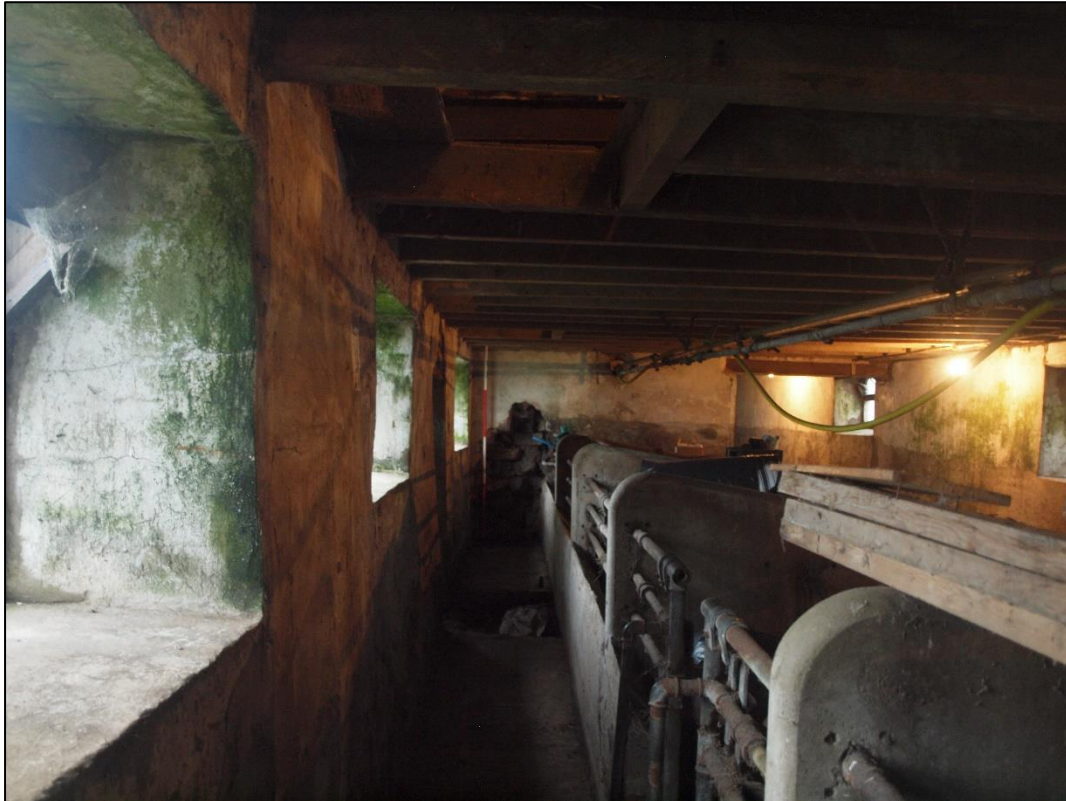
Plate 43: View down feeding passage in main barn

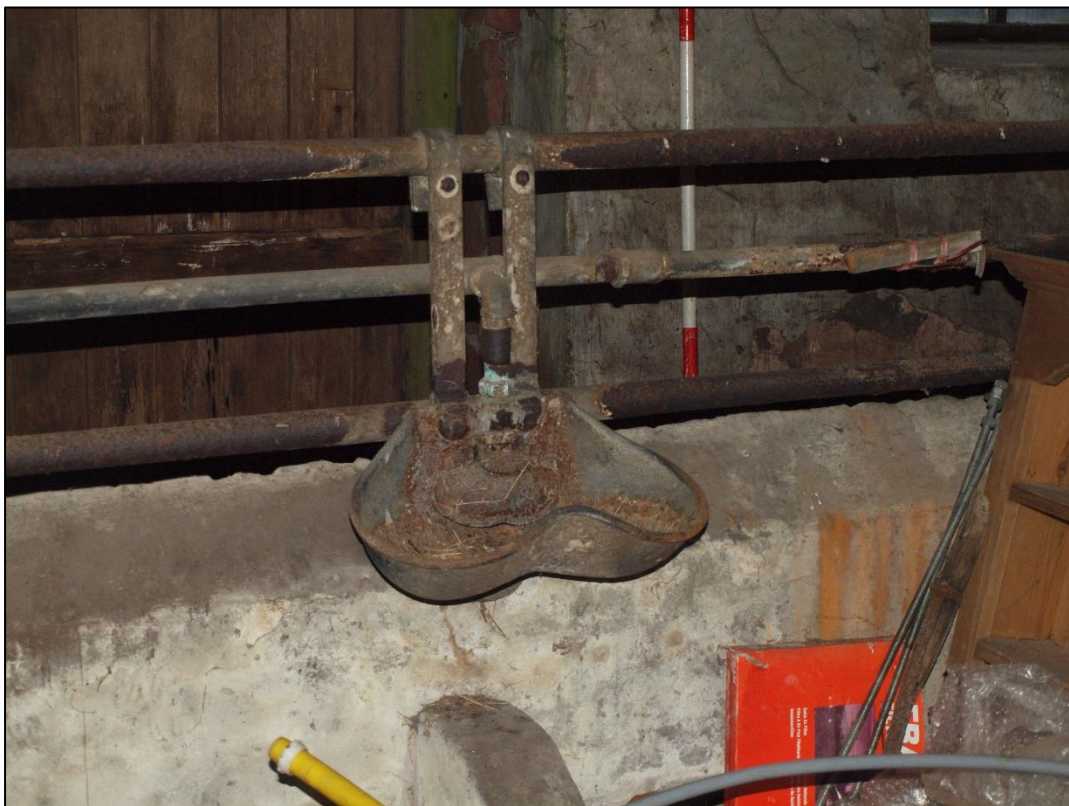
Plate 46: Modern feeding trough

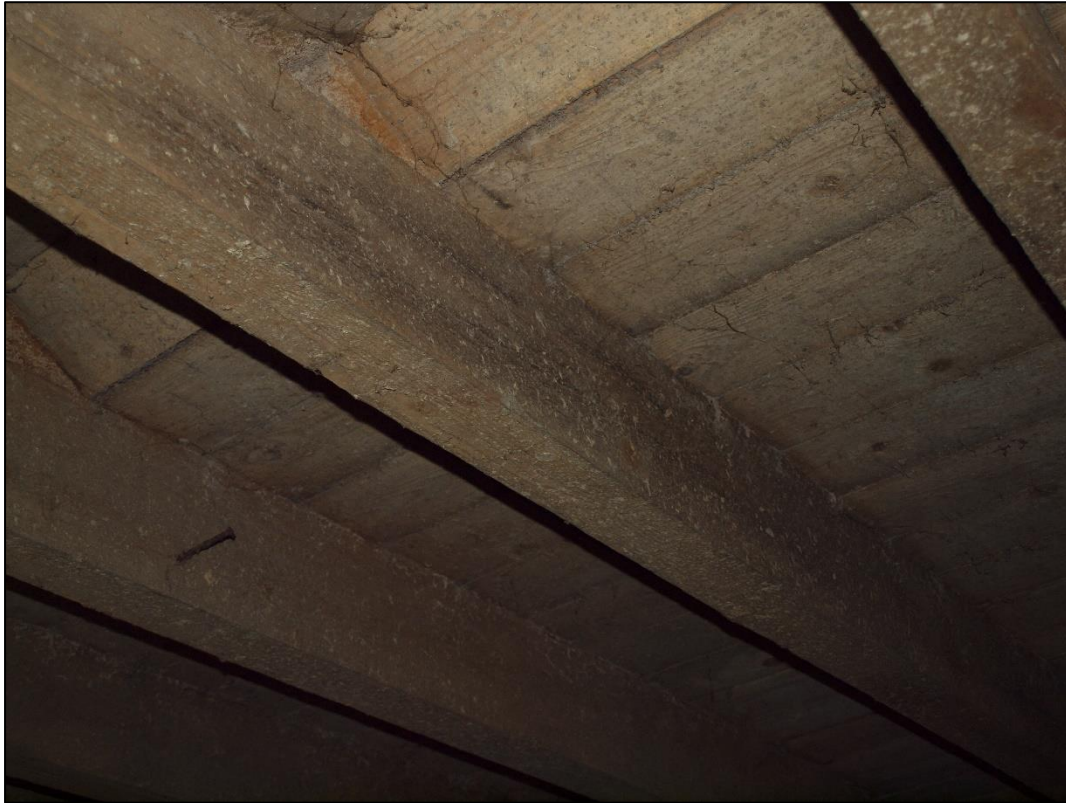
Plate 47: Modern timber ceiling

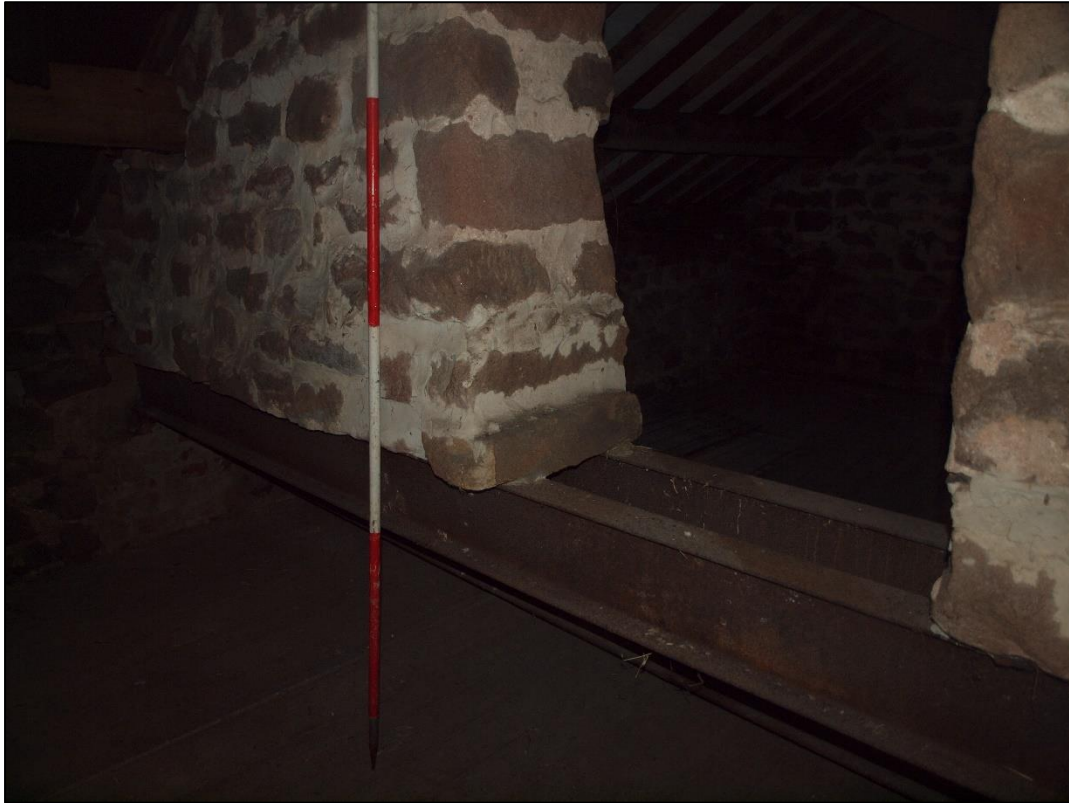
Plate 49: Detail of beam carrying wall

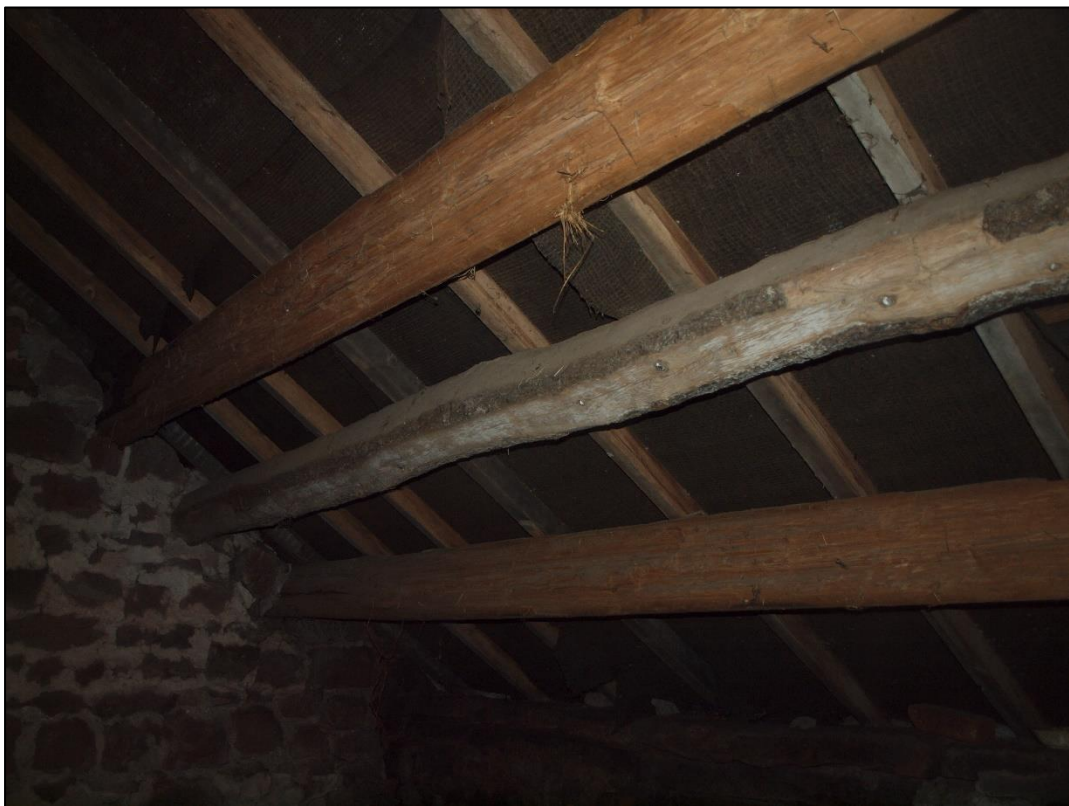
Plate 50: Detail of purlins

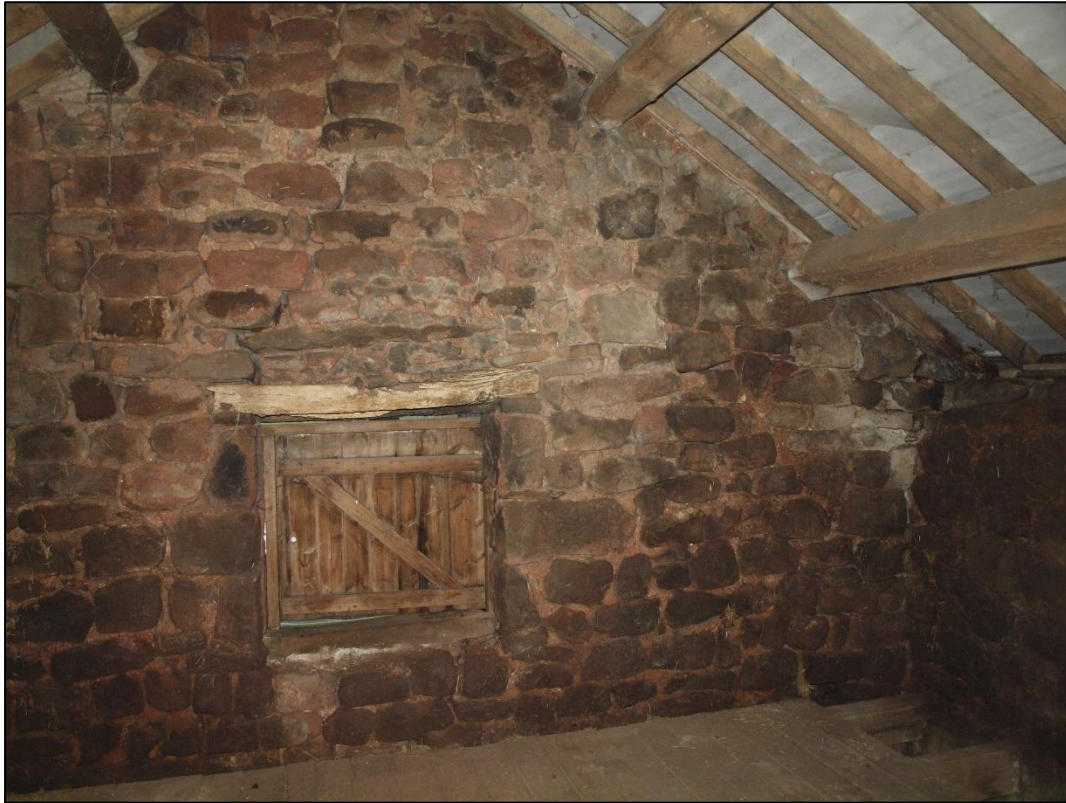
Plate 53: Pitching eye in east gable

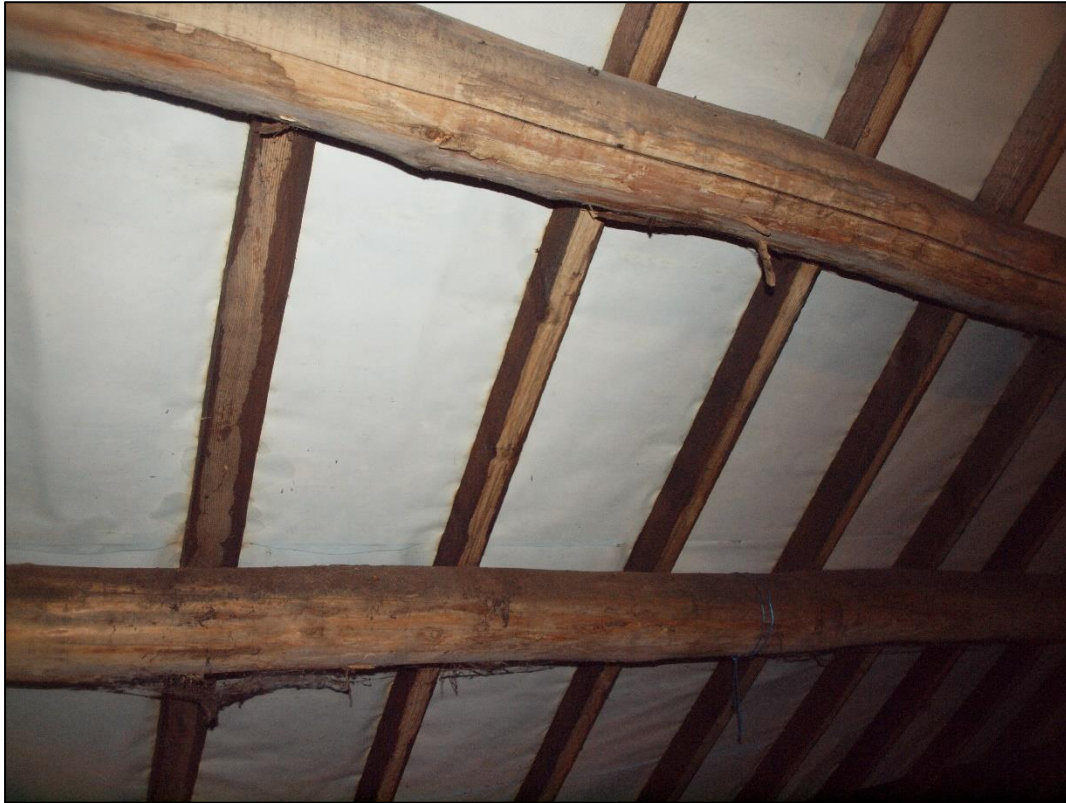
Plate 59: Detail of purlins

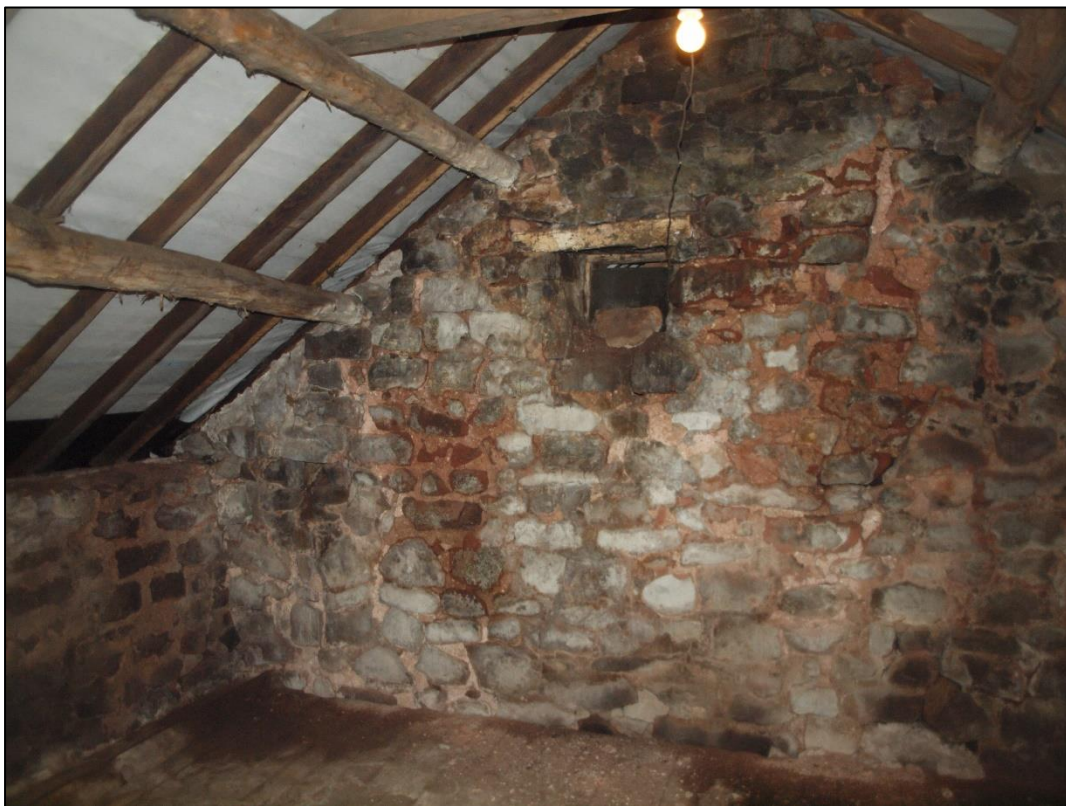
Plate 60: Gable end of extension showing small window
