THE ARCHAEOLOGY CO.

Dean Gate Farm, Bolton
Historic Building Survey

May 2022

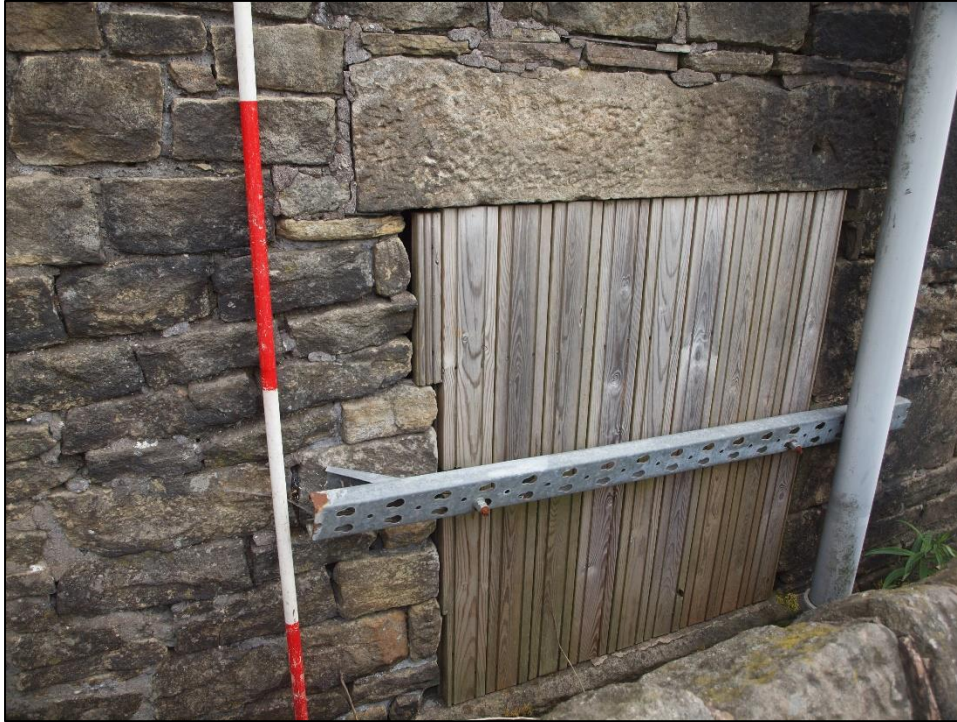
Plate 29: Window detail

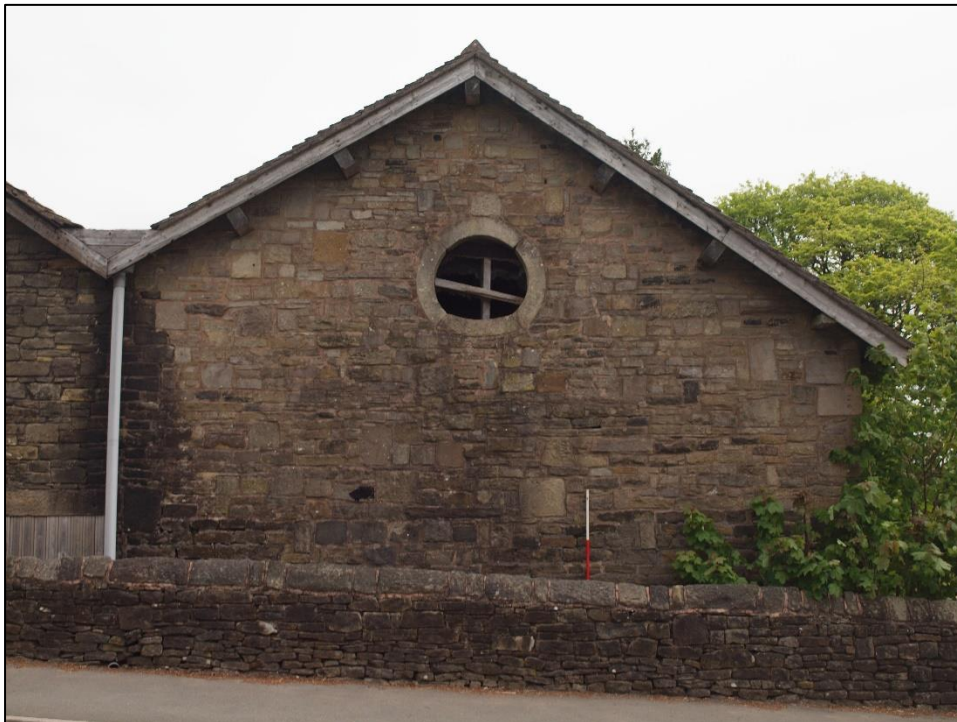
Plate 30: Southernmost gable

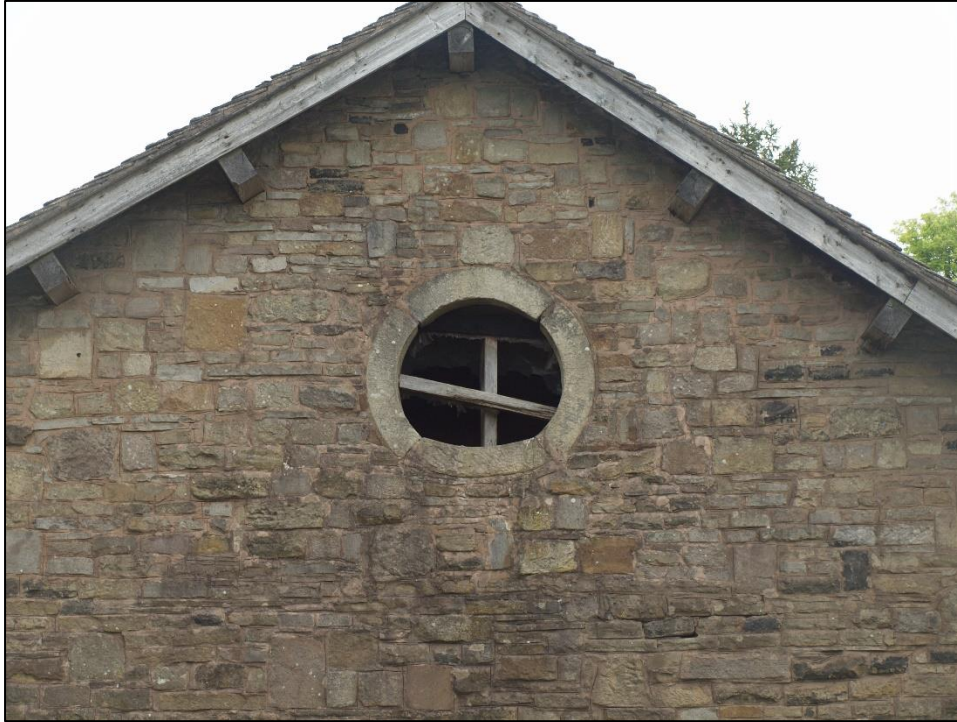
Plate 31: Window detail

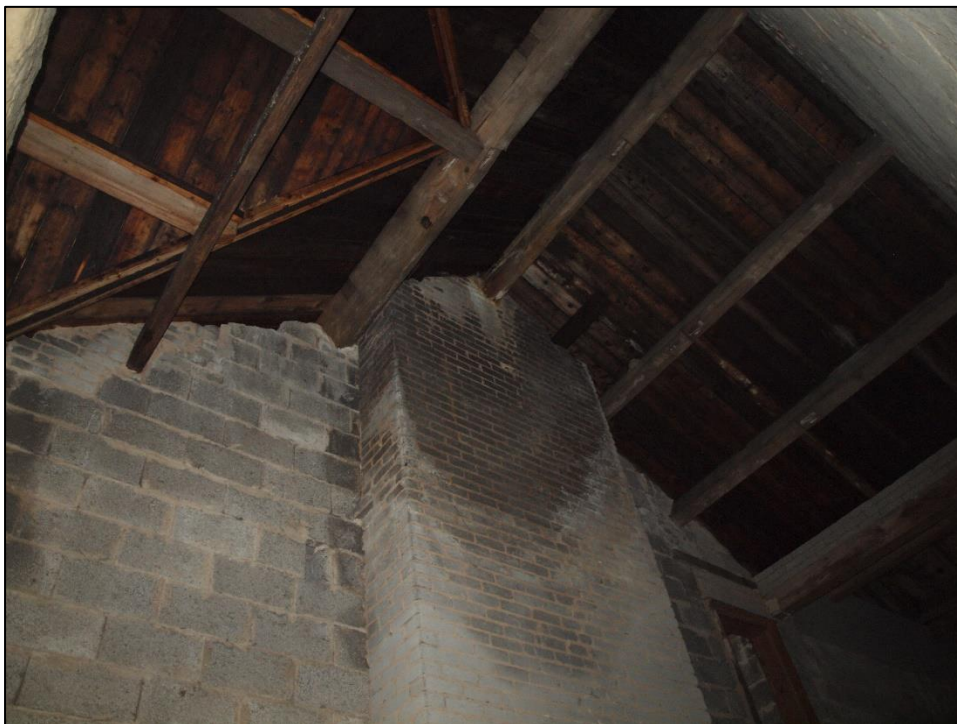
Plate 36: Modern roof

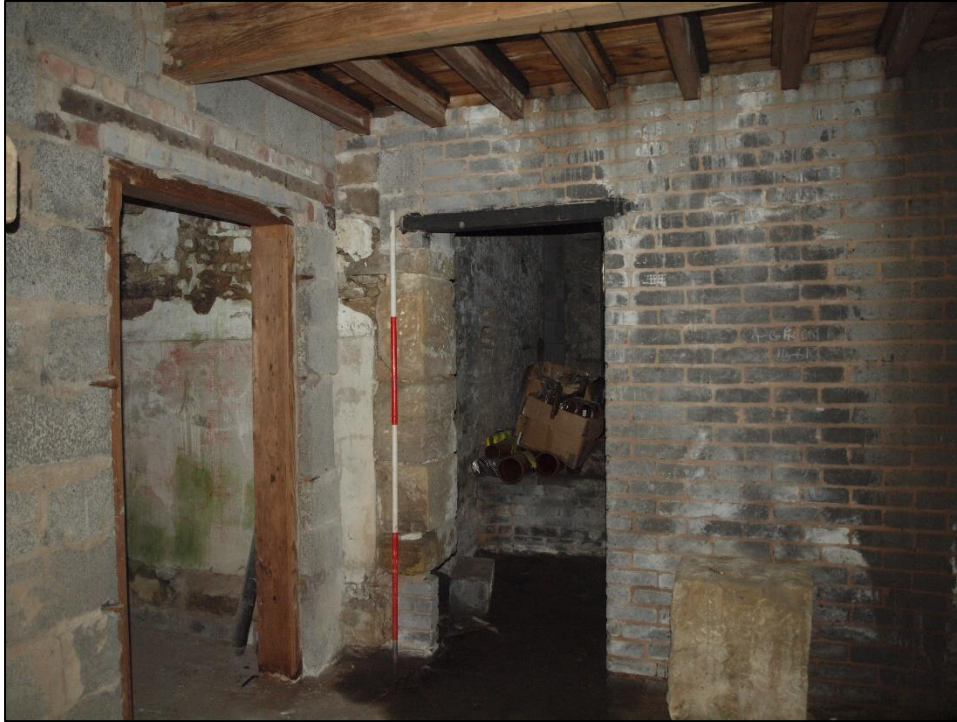
Plate 37: Northern end of corridor showing doorways

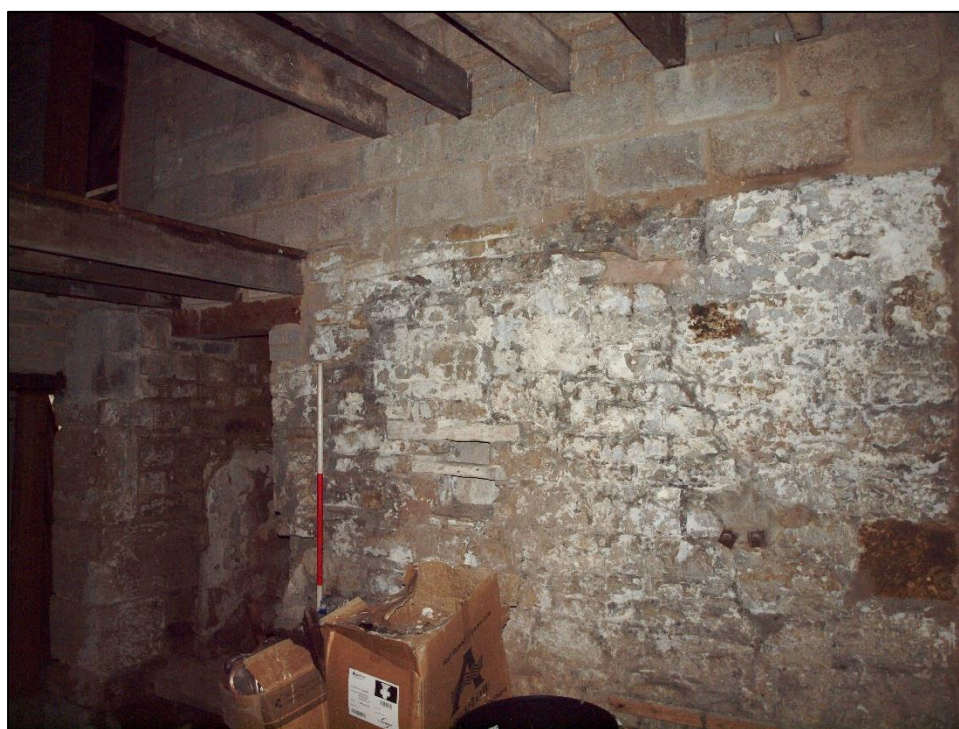
Plate 40: Western stone wall

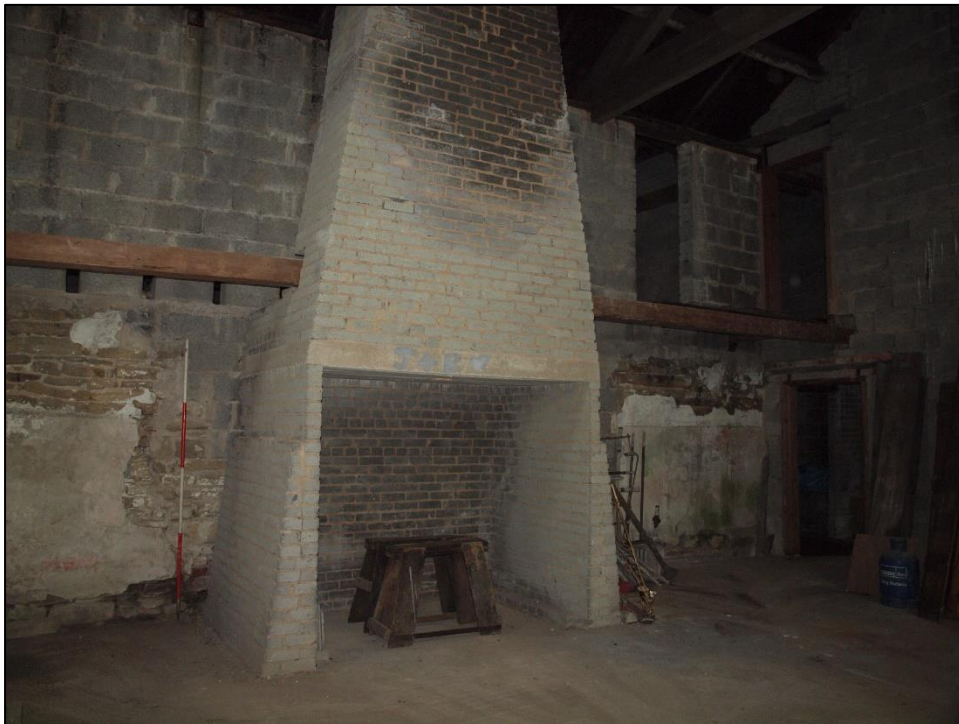
Plate 42: Inserted fireplace

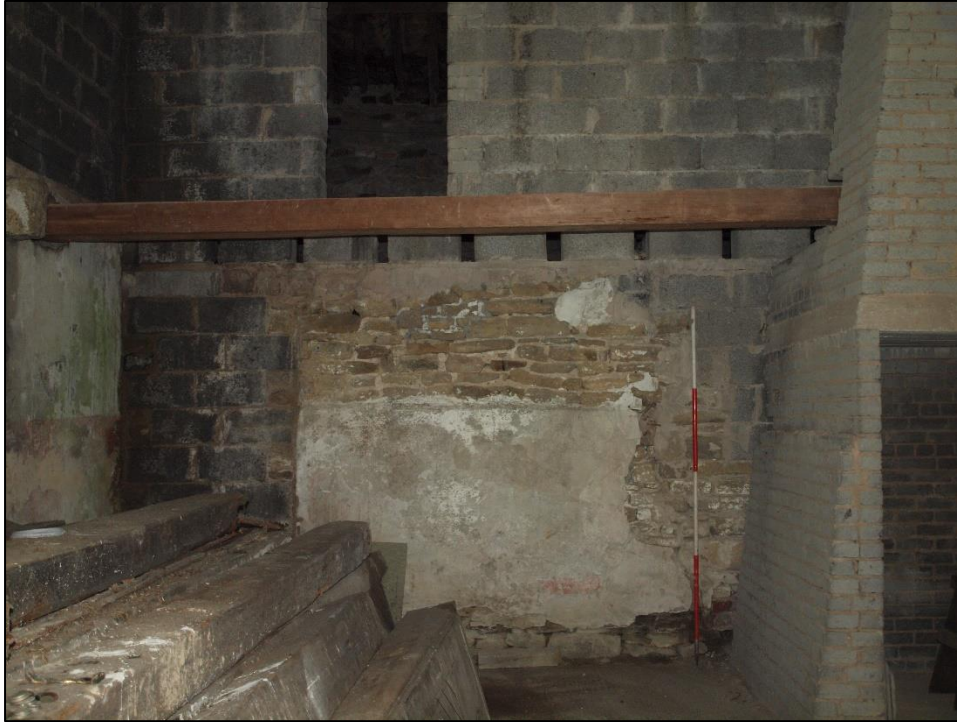
Plate 43: Remains of stone wall to shippon

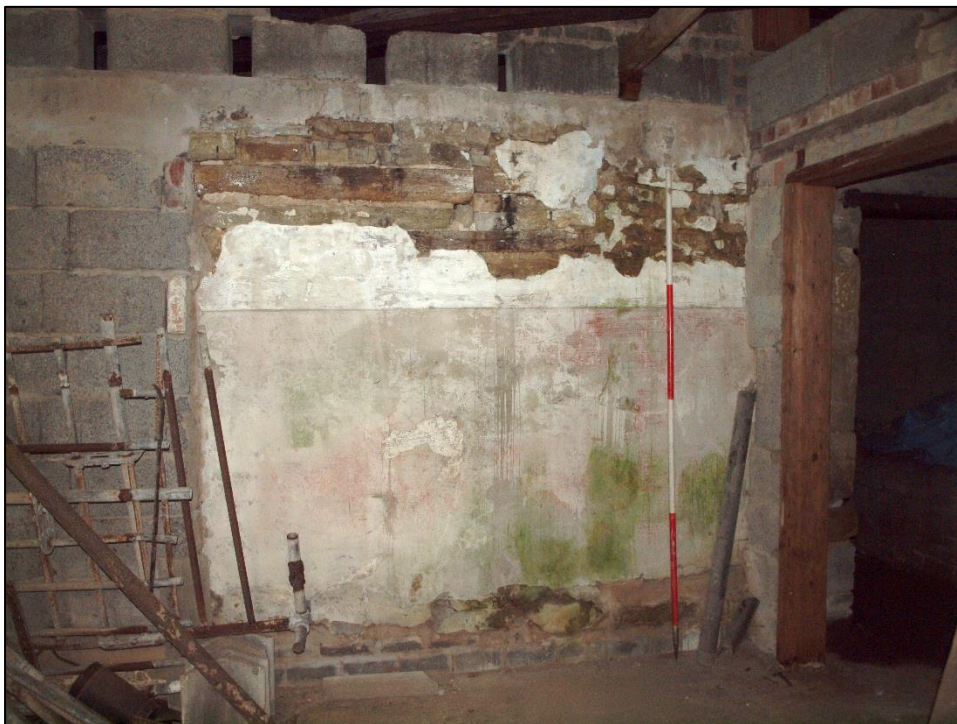
Plate 44: As above to east of inserted chimney

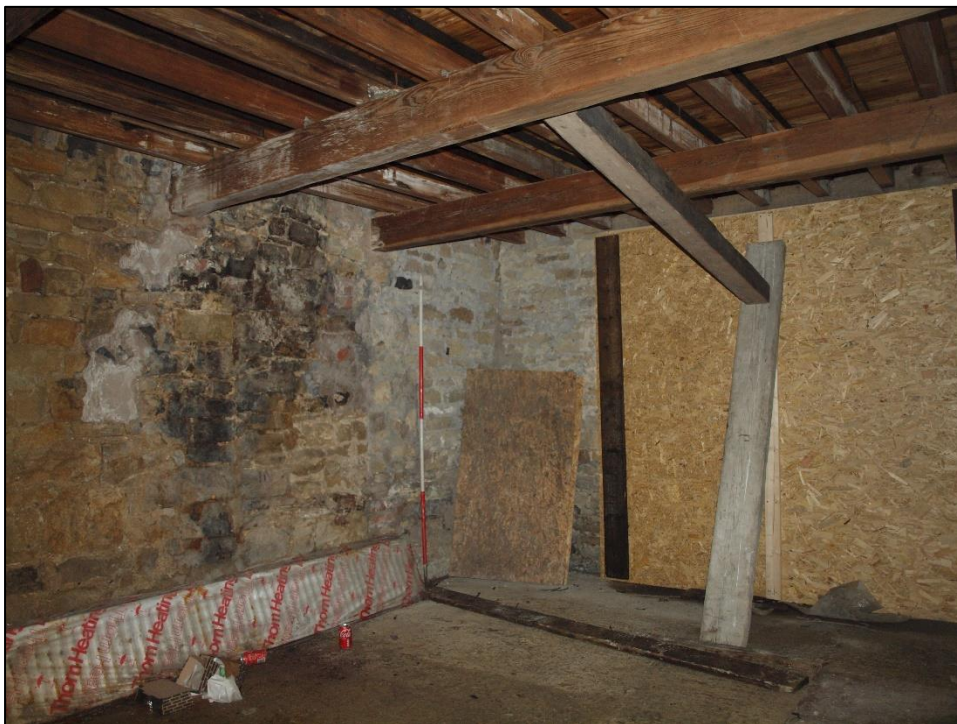
The eastern room shows the bare stonework (plates 52 & 53). The corridor itself is formed of modern brickwork. To the south side of the corridor is a large open room (plates 55 – 58). All of the walls are formed of modern concrete block, with the exception of the eastern. A concrete block fireplace has been inserted in the centre of the room. The first floor is present throughout this area, with the machine cut timber beams and joists visible. Doors in the eastern wall lead through to a later extension to bay 6, divided by a modern brick wall (plates 59 – 61). To the north of this wall was presumably a staircase to the first floor, since removed. At the southern end is a small room with stone walls to the west, east and south. The east wall contains a stone-built fireplace. An inserted doorway to the south of the fireplace leads into the lean-to (plates 62 & 63). This shows the stone construction of the walls and the machine cut timber of the trusses above supporting the roof. A flue appears to have been in the southwest corner of the lean-to, adjacent to the door, although the base, and presumably former fireplace, has been replaced with modern brick. A pair of blocked doorways are visible in the west wall to north side.

Plate 52: Room with stone walls to the east of above

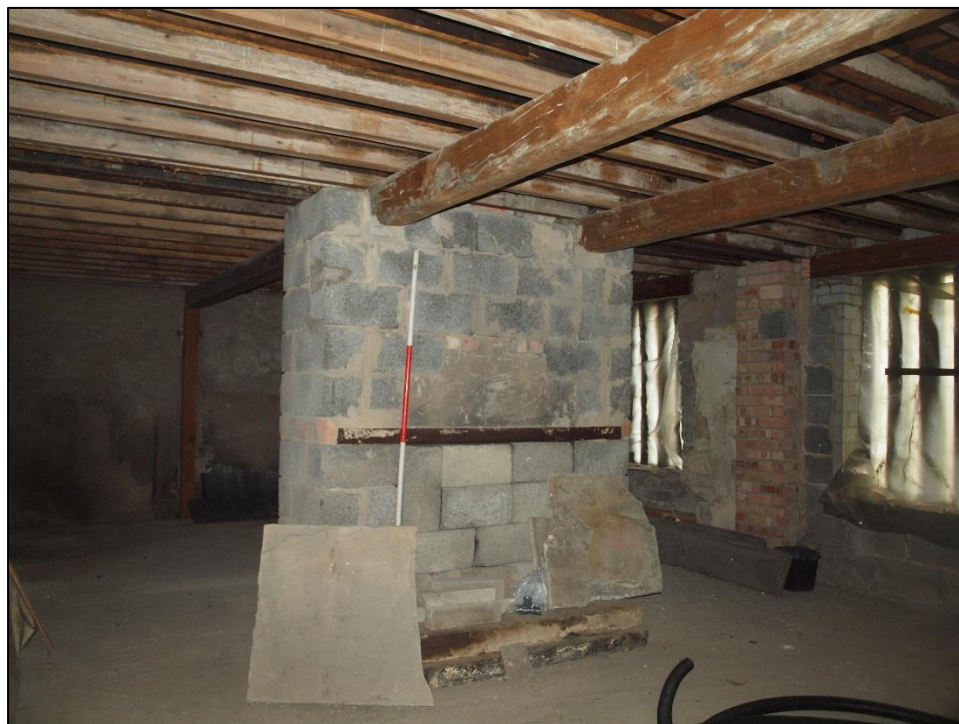
Plate 57: Inserted fireplace
