Ling Villa Barn, Mickleton
Historic Building Survey

January 2023

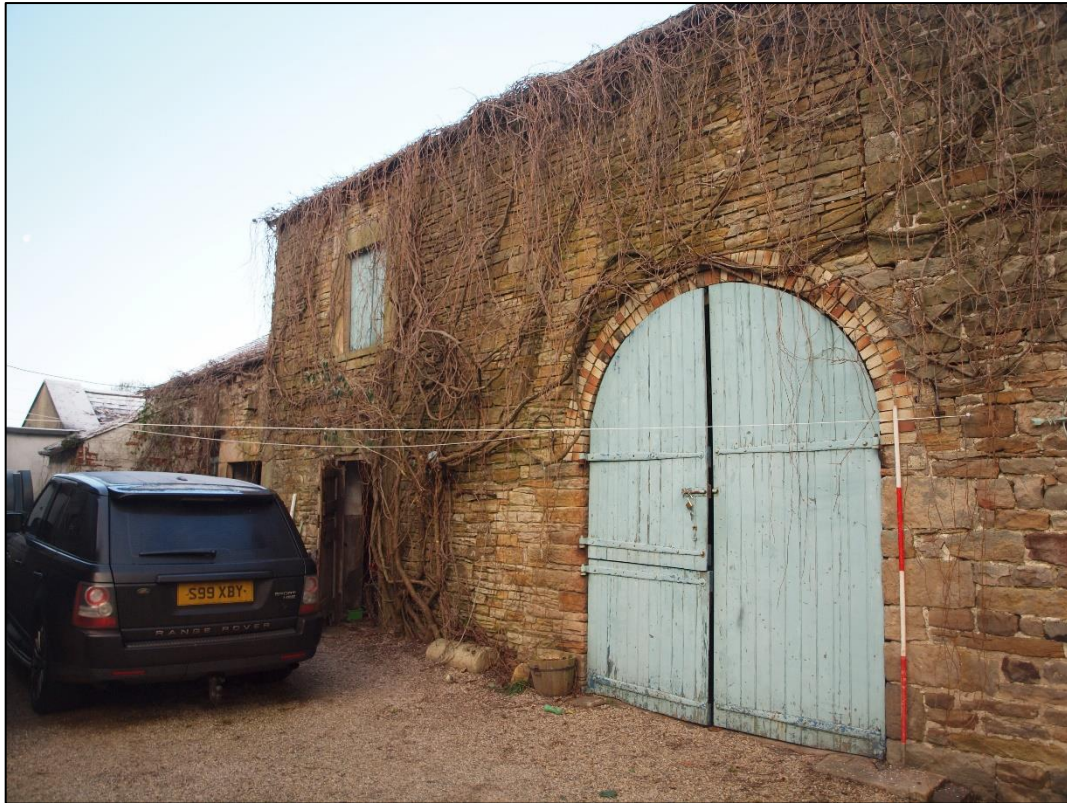
Plate 7: General shot of west end of barn looking northwest

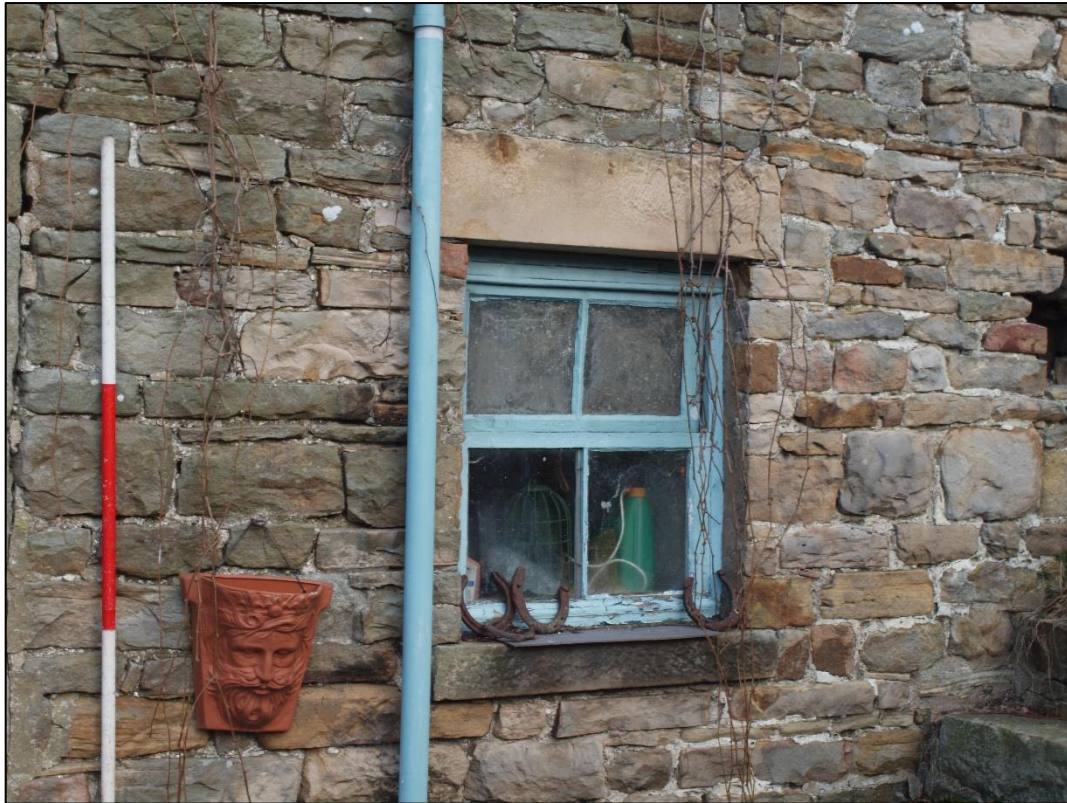
Plate 13: Window to bay 8 looking northeast

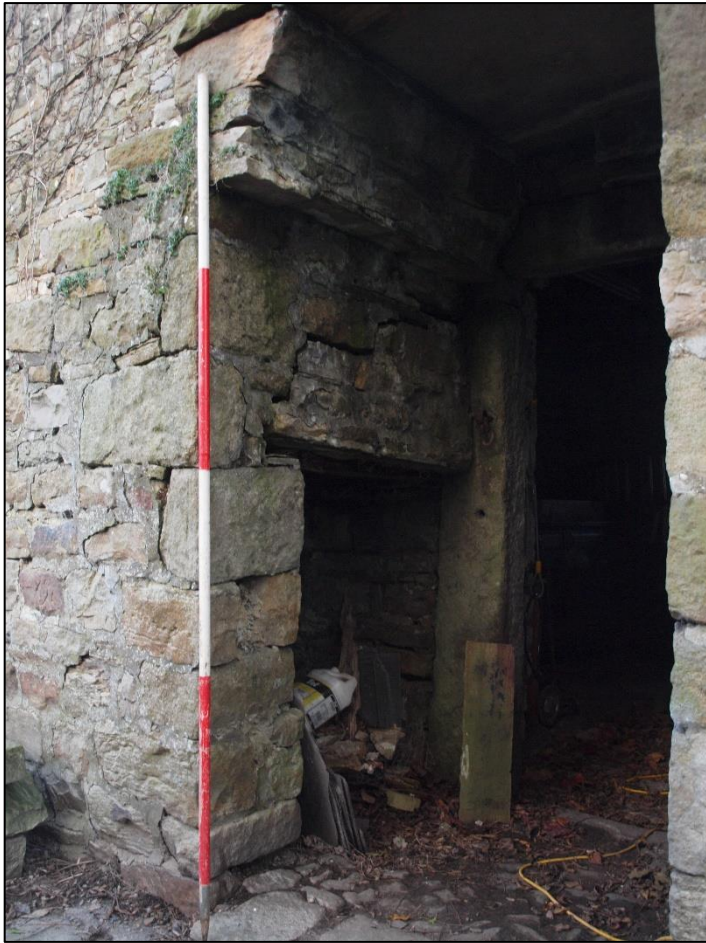
Plate 15: Ground floor doorway to bay 10 below stairs looking northwest

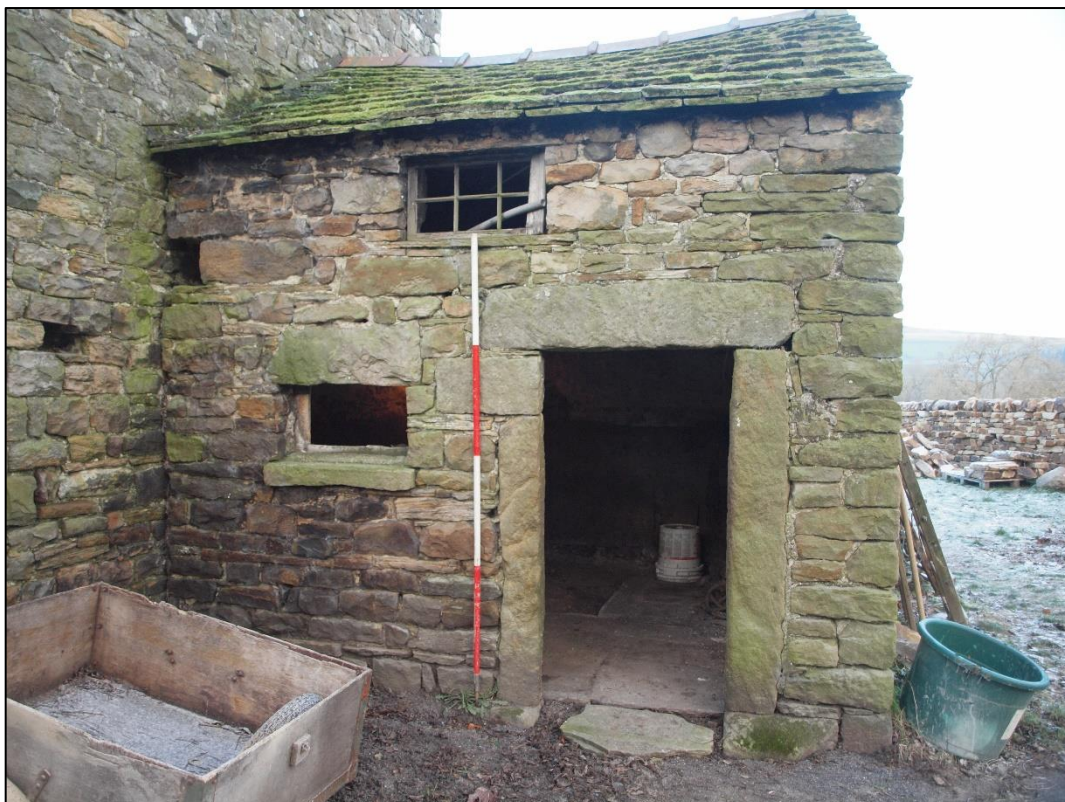
- 6.3 (Plates 17 & 18) Bay 11 is set back from the main barn elevation. It contains a doorway with sandstone surround to the east side with a small landscape window to the west with sandstone cill and lintel. Between them and above lies a further landscape window, close to the eaves.

Plate 18: Detail of above looking north

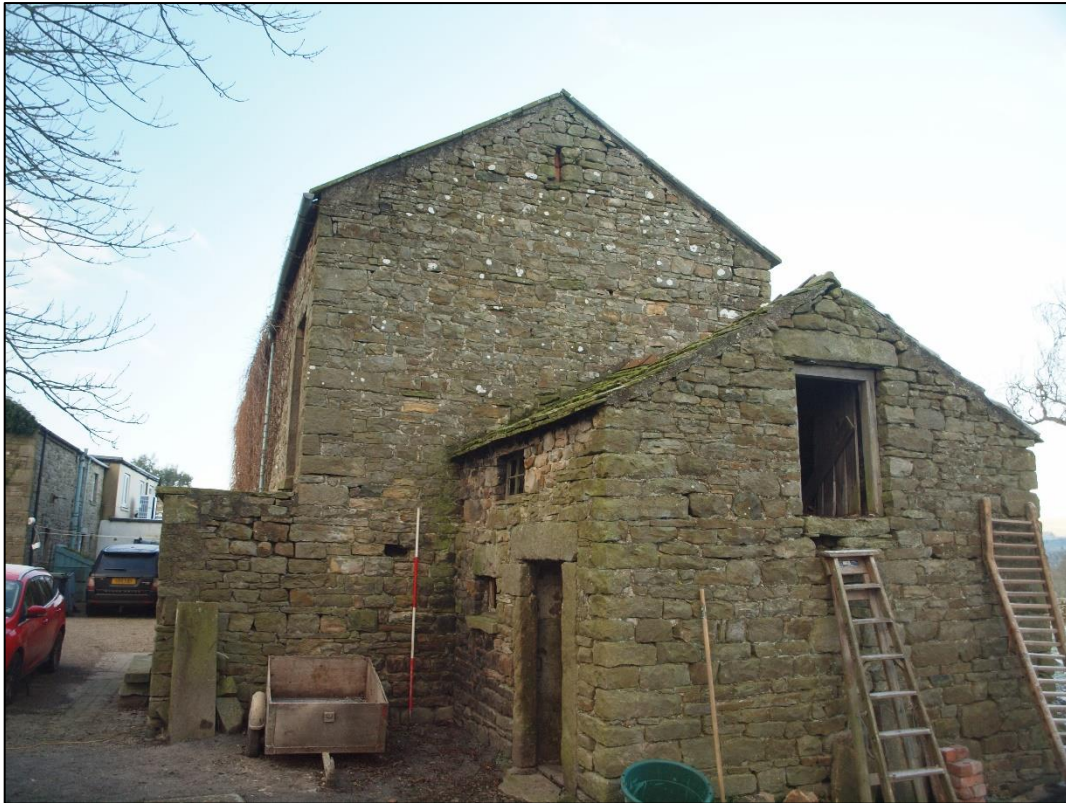
- 6.4 East elevation (Plates 19 - 21). This forms the gable end of the building. It is relatively featureless, with a ventilation slot close to the apex. At ground floor level is the elevation of the small extension. This contains a small window at attic level, with timber surround and sandstone cill and lintel.

Plate 19: Eastern gable looking west

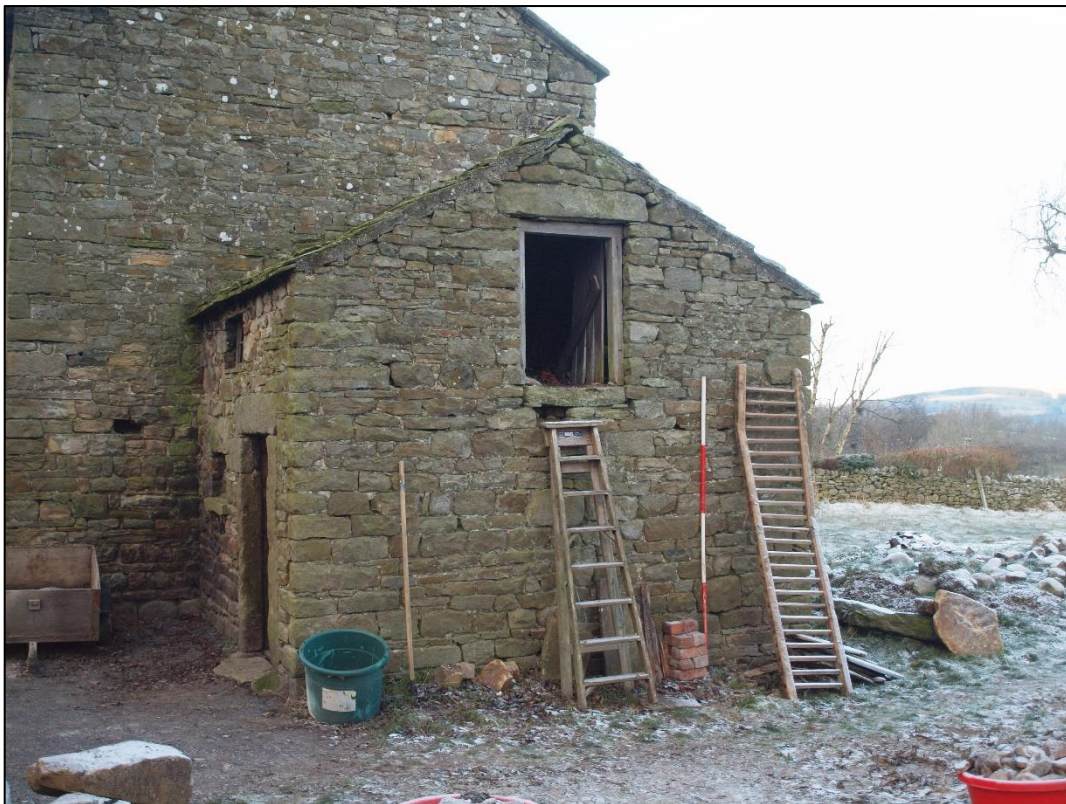
Plate 20: East gable of extension looking west

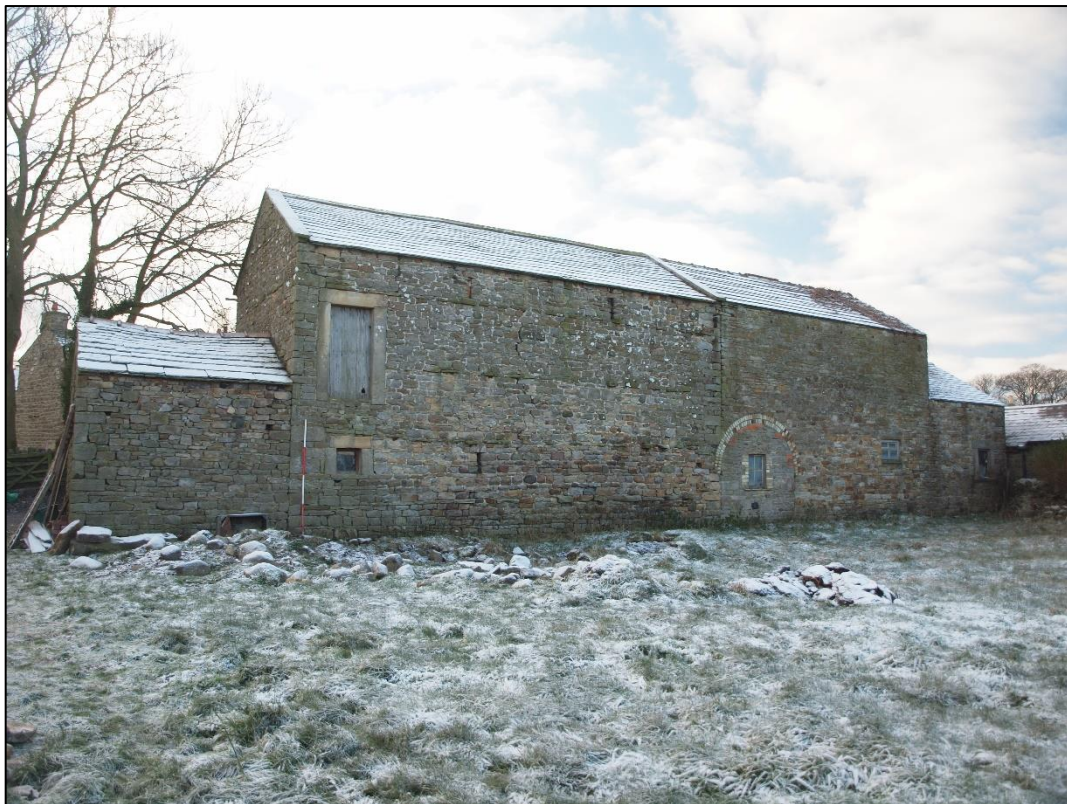
Plate 22: General shot of north elevation

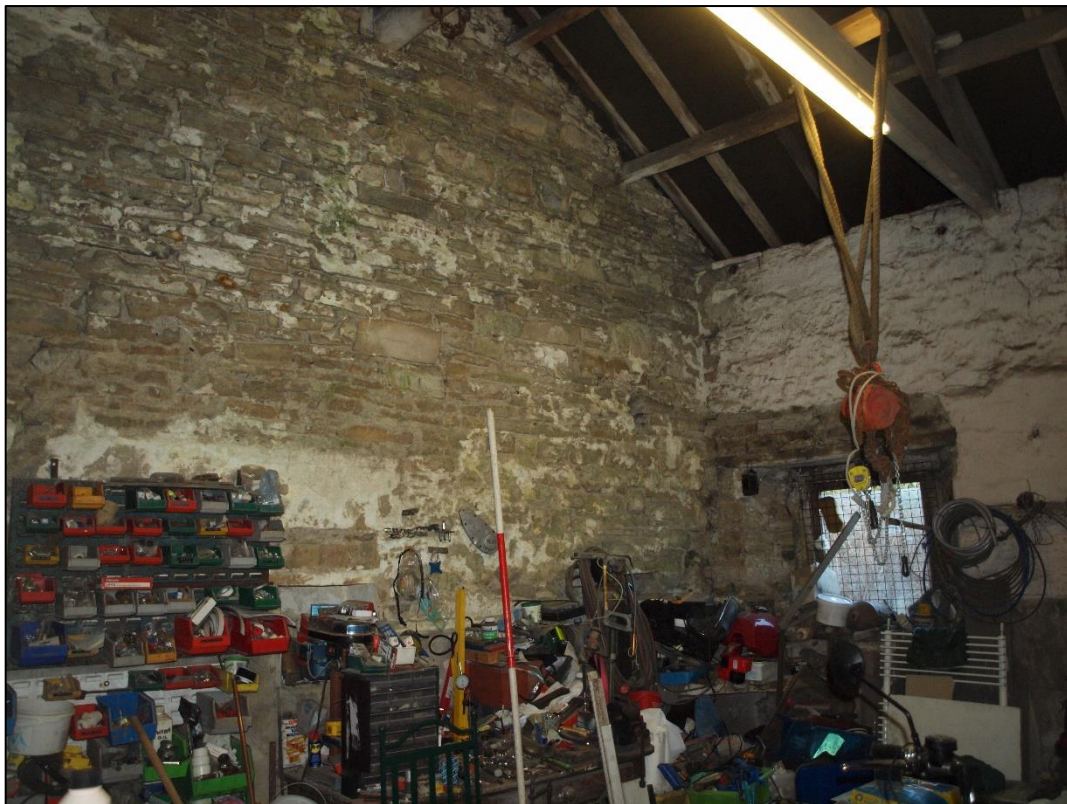
Plate 30: Room at western end of barn in bays 1 & 2 looking northwest

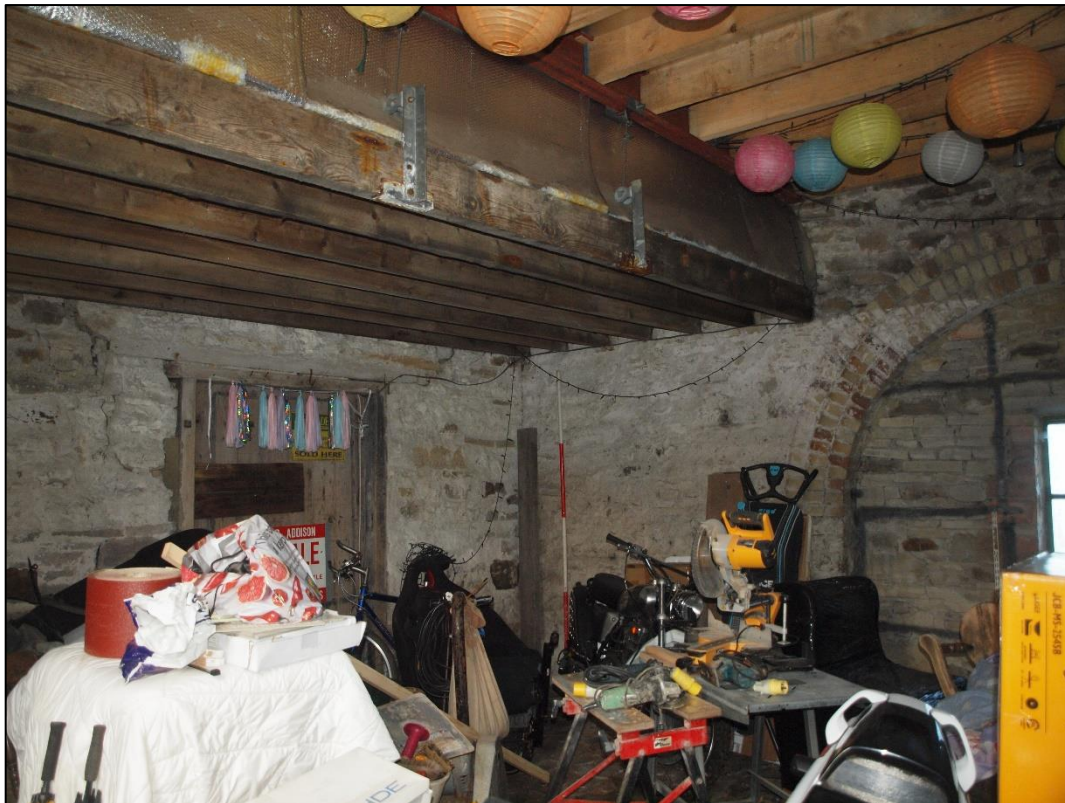
Plate 35: Threshing barn in bays 4 and 5 looking northwest

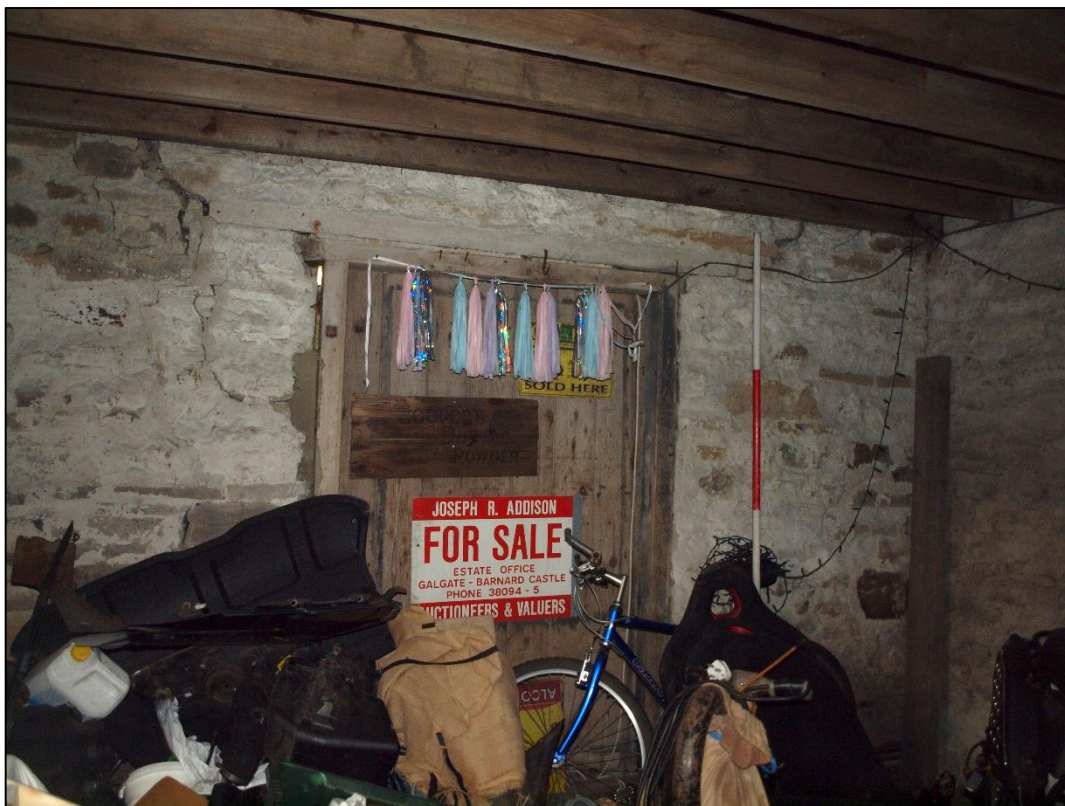
Plate 36: Doorway to bay 3 in west wall looking northwest

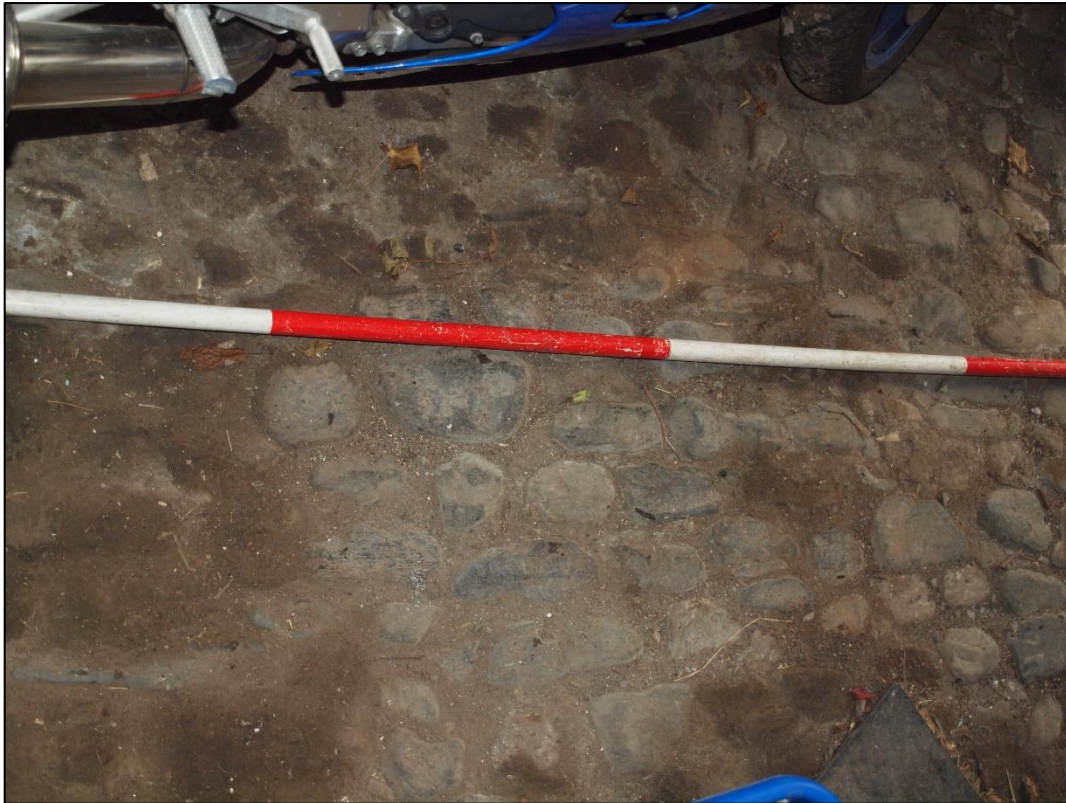
Plate 39: Cobbled floor looking southeast

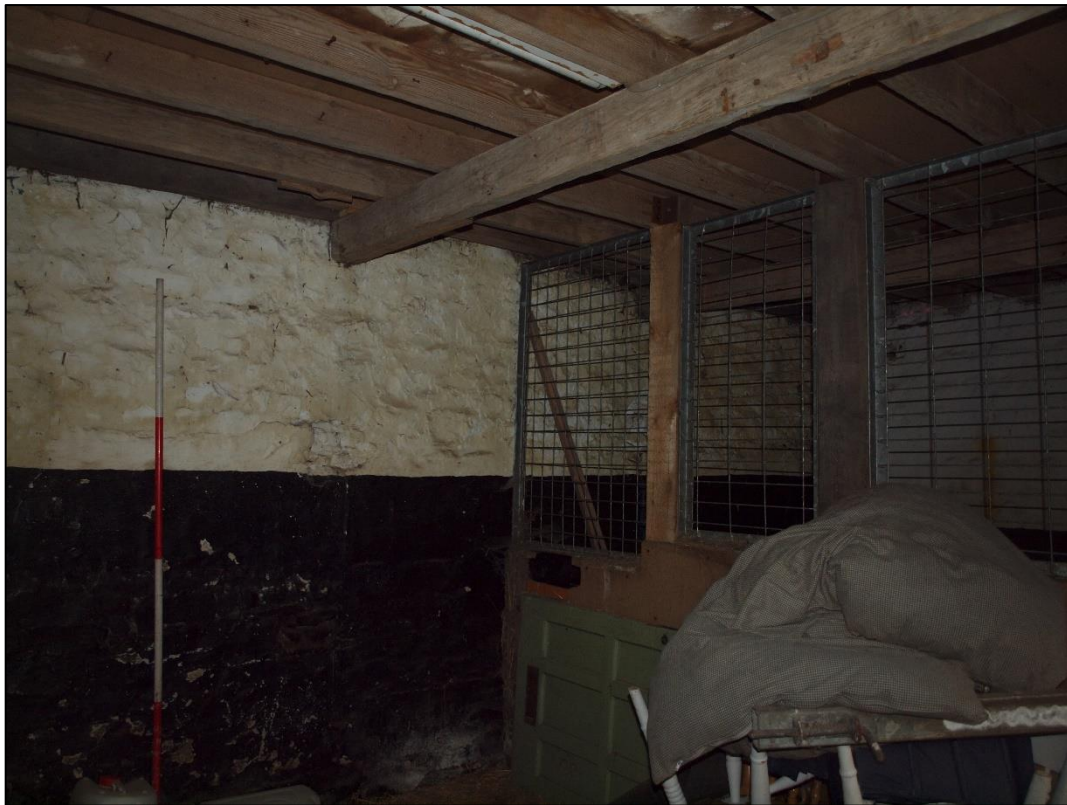
Plate 41: As above looking northeast

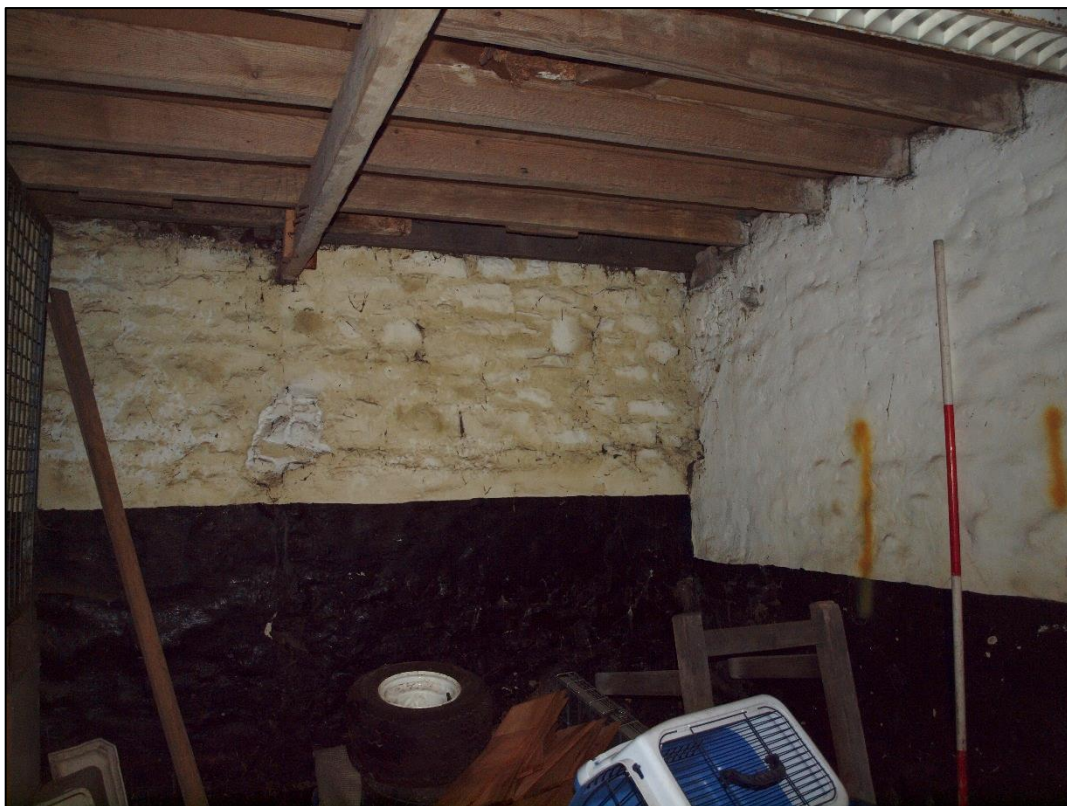
Plate 42: Eastern end of room

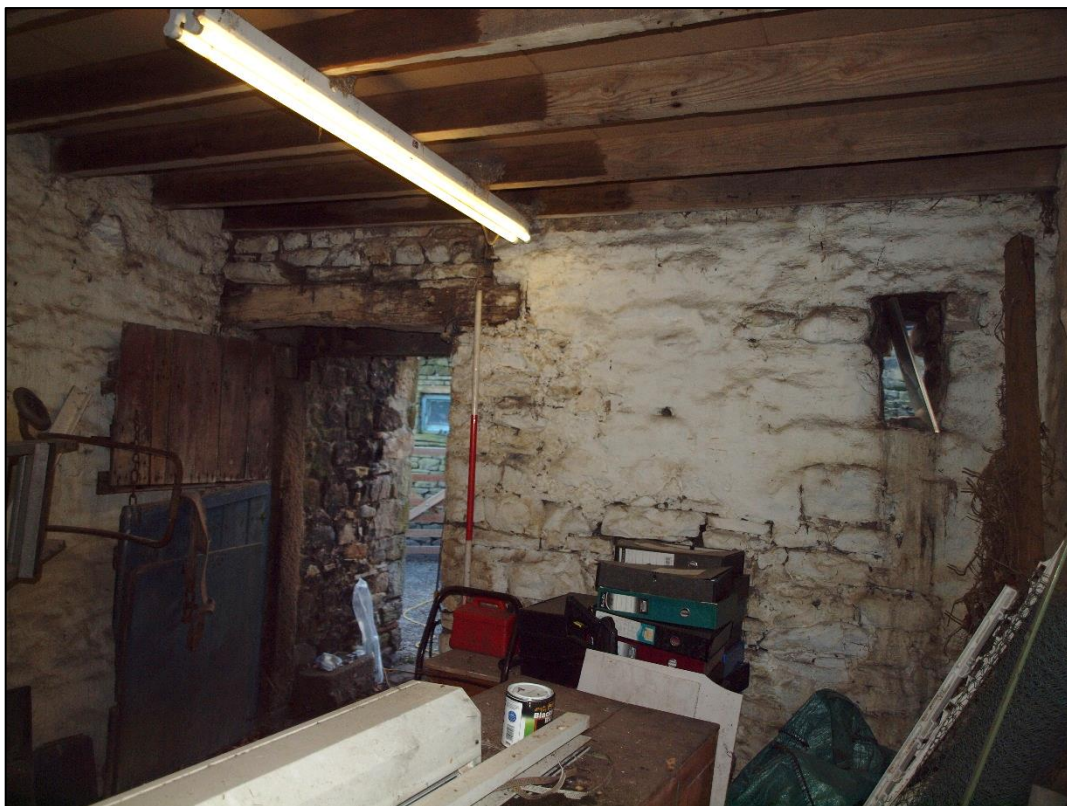
Plate 46: South wall of above looking southeast

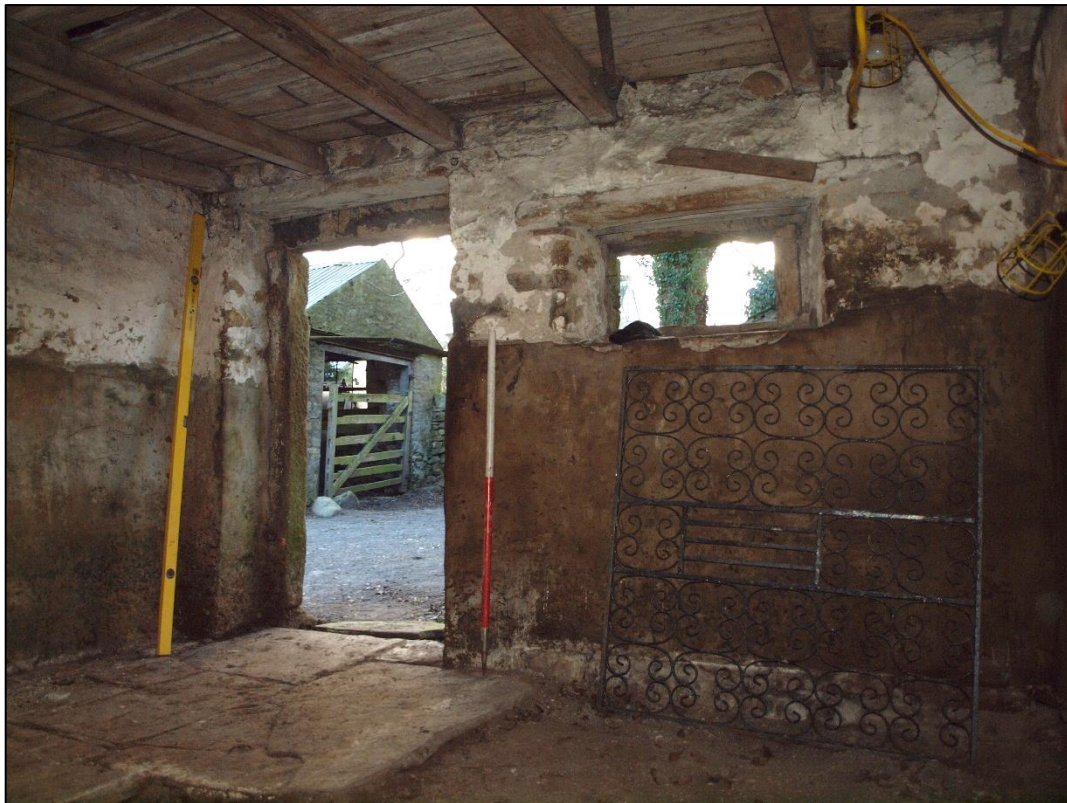
Plate 49: As above looking southeast

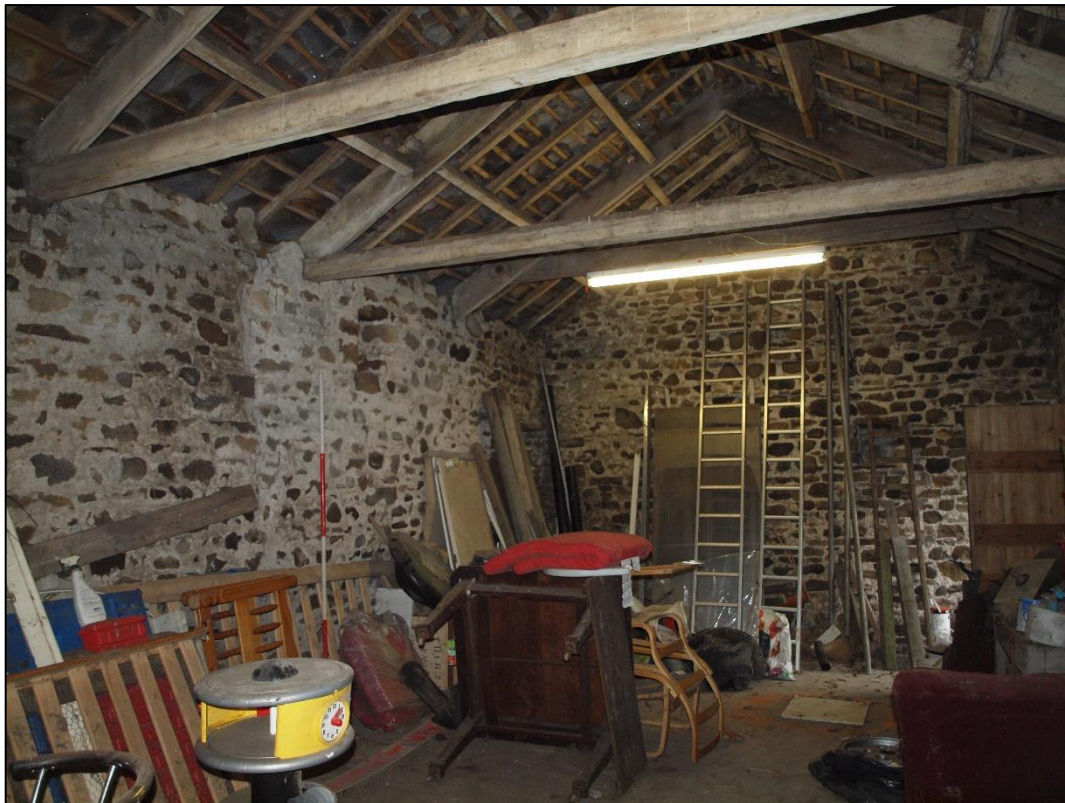
Plate 55: General shot looking east

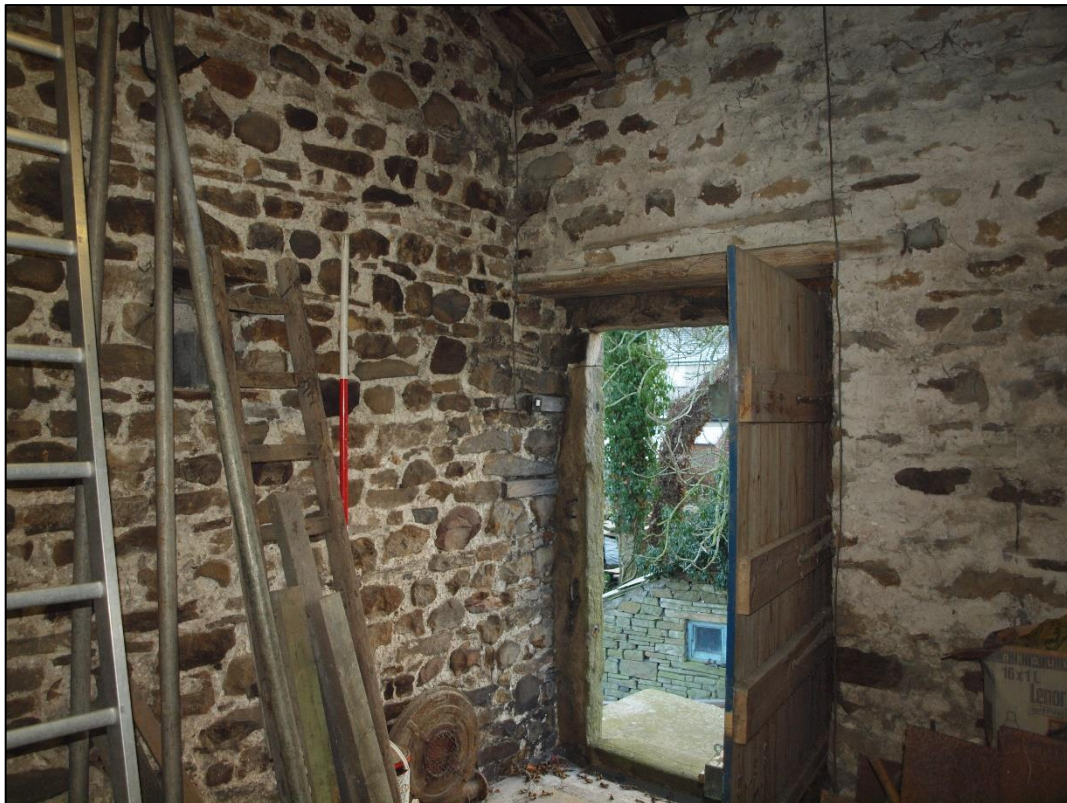
Plate 57: Entrance from south elevation looking southeast

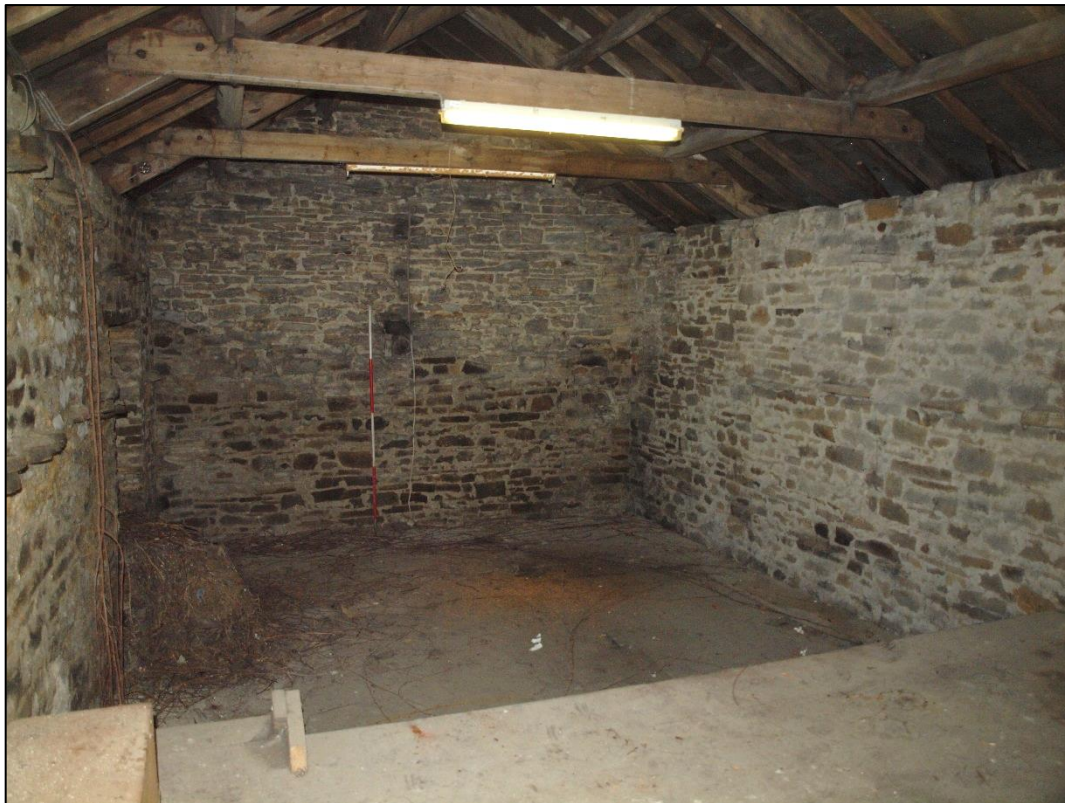
window in the south wall, with hand cut timber lintel visible. At the southern end of the west wall a doorway has been inserted, with concrete lintel over. It is set higher than the floor level and set of timber steps lead up to it. This leads into the first floor of the western end of the barn (plates 59 - 63). Here the floor is higher at the eastern end, over the location of the barn doors to bay 3, before dropping down to match the eastern side. The floor is again ply sheets with the stone walls whitewashed. The roof had three A-frame trusses supporting the roof, all of which is again modern timber. A pitching window lies in the south wall, this time with a modern timber lintel.

Plate 59: Western end of first floor looking west

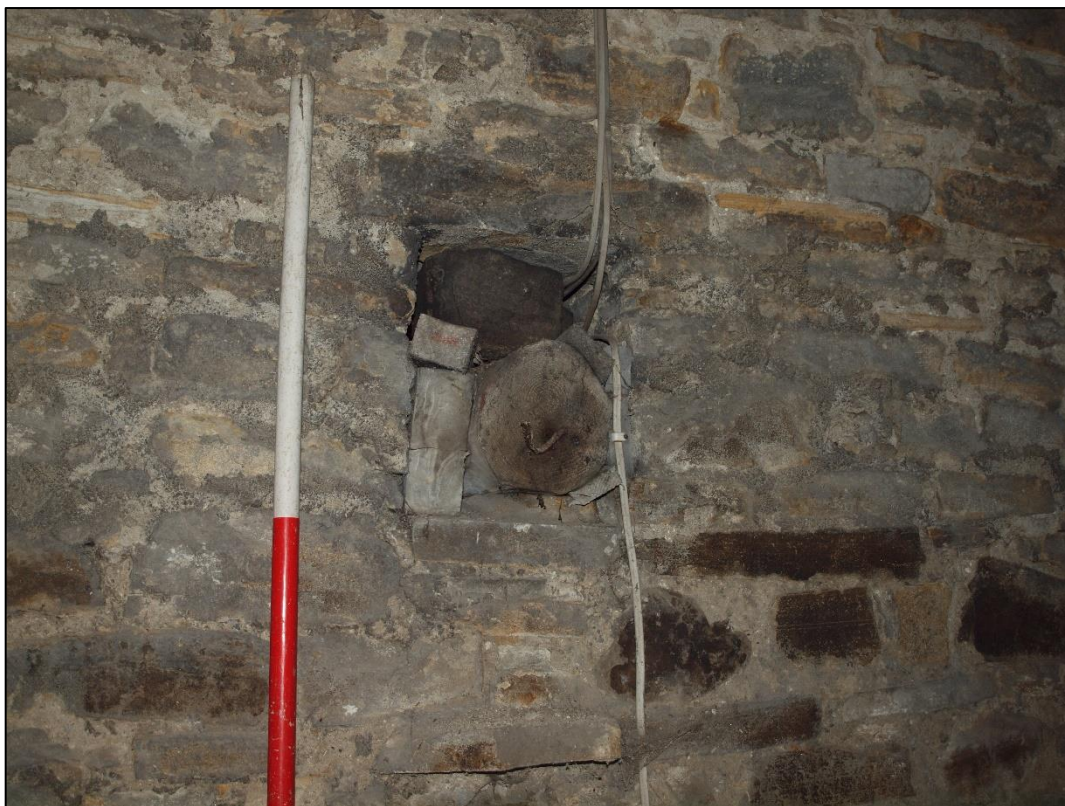
Plate 60: Ventilation slot in west gable
