Photographs - Mezzanine

f14_003_14.05.20
Ashcombe Park - Historic Building Record

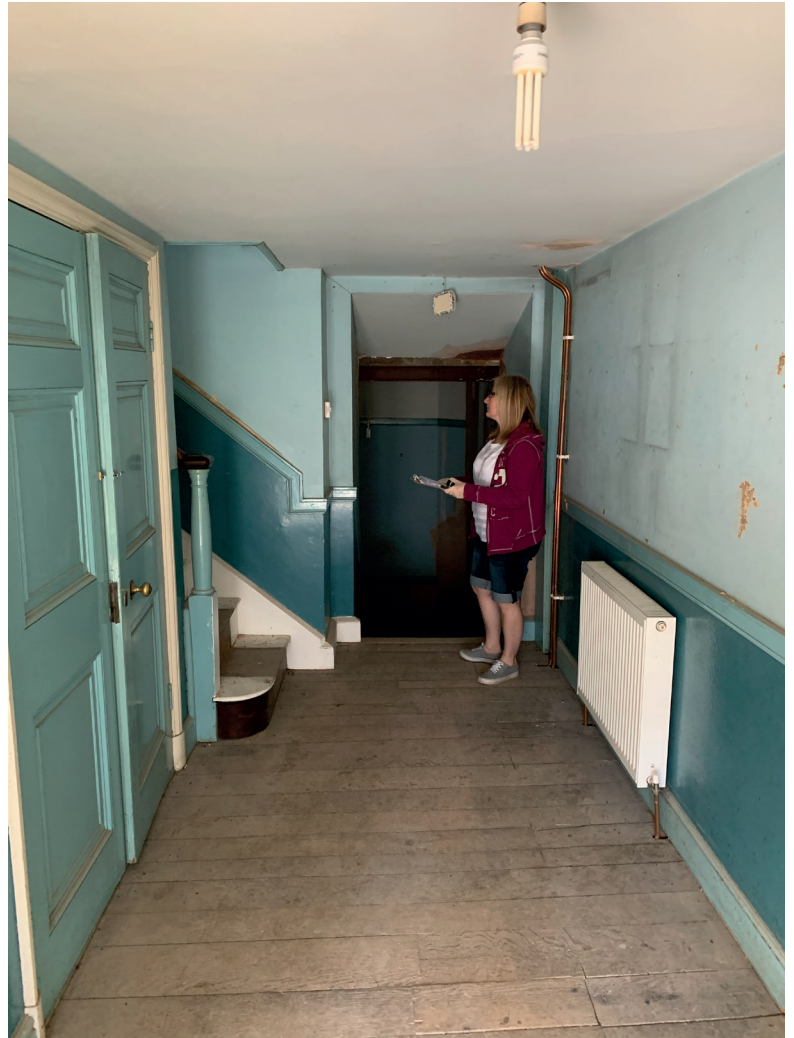
i2_001_22.04.20
linen cupboard to left IS

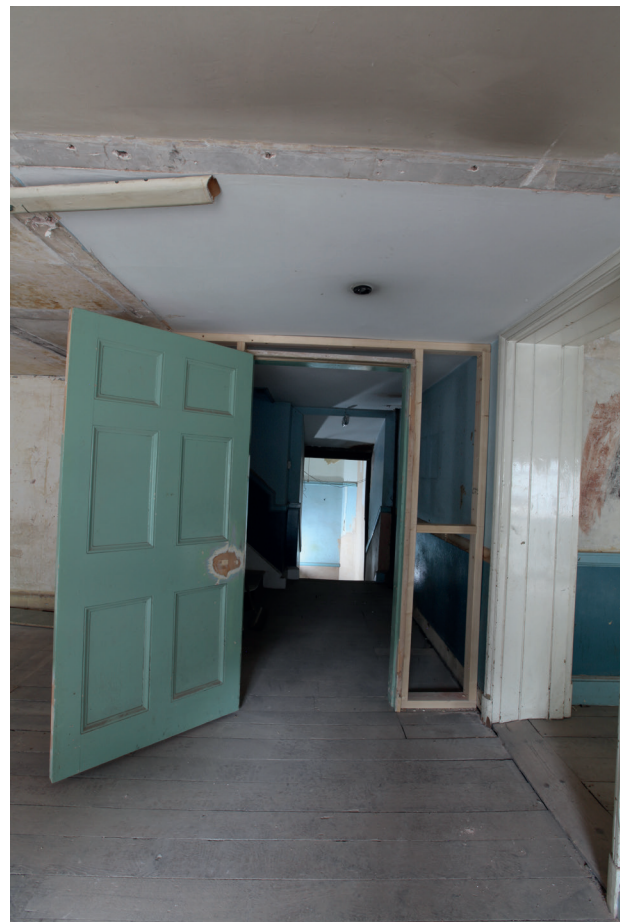
i2_002_14.06.21
linen cupboard removed - new partition

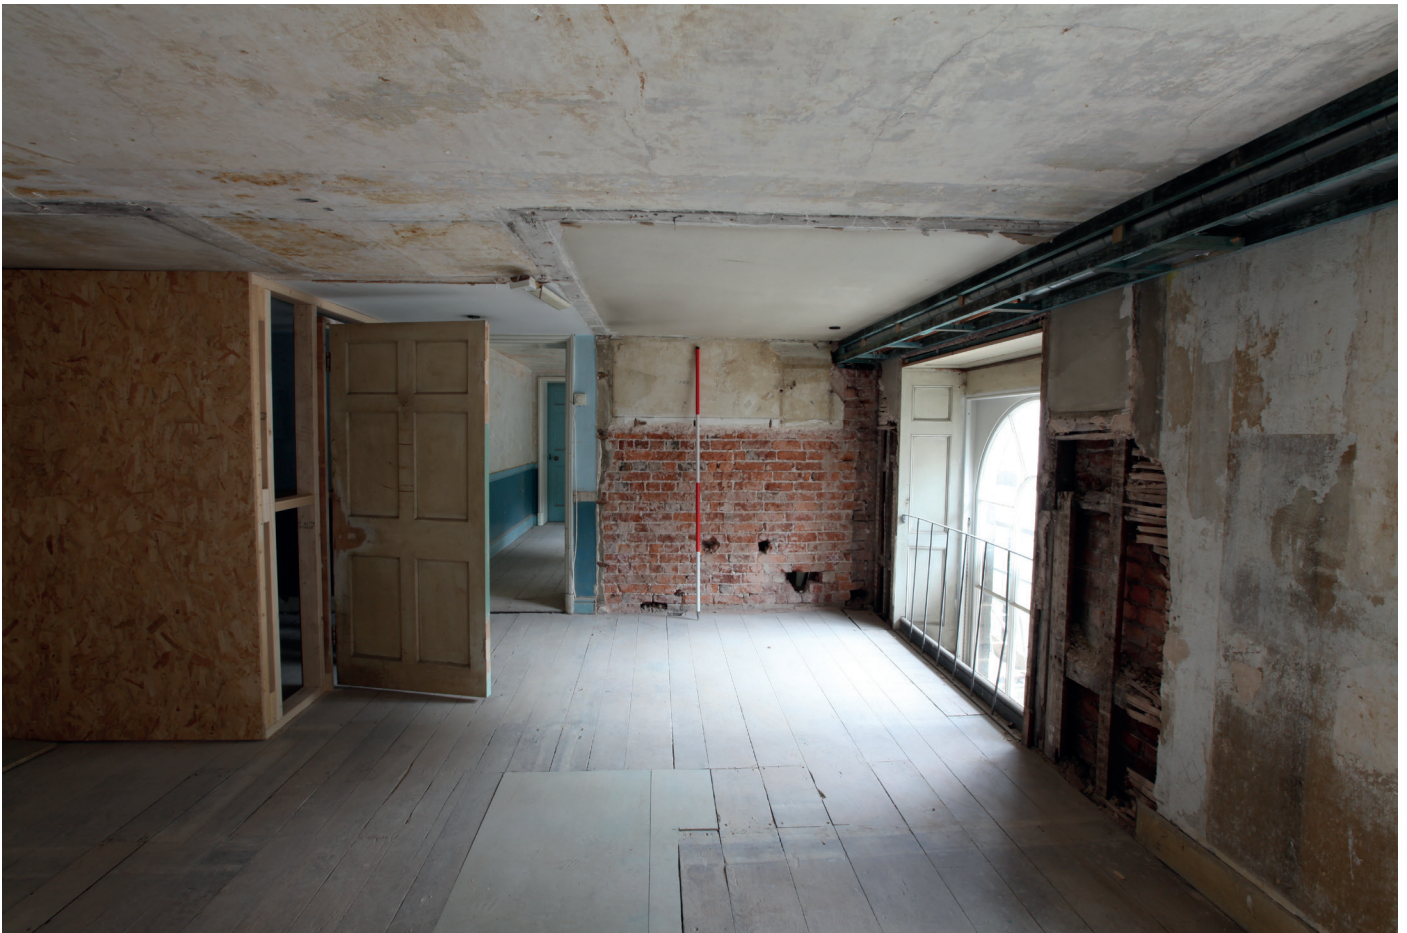
i8_004_14.06.21
new partition to replace linen cupboard to left.
Outer wall lined with studwork and lathe-and-plaster.

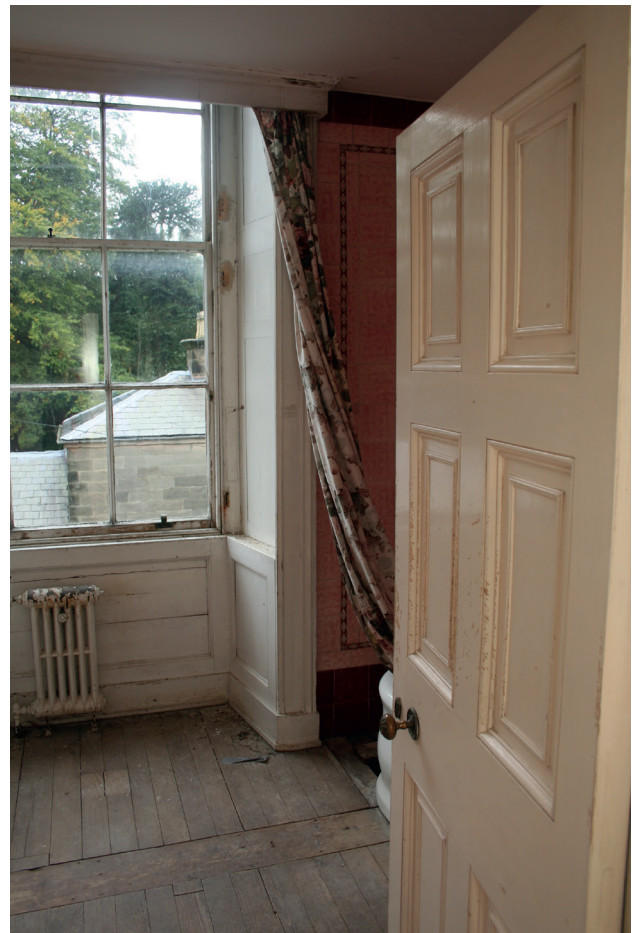
Note arch to niche to right of current doorway,
indicates previous 1806 doorway position.
Inserted ceiling removed and raised to original height.

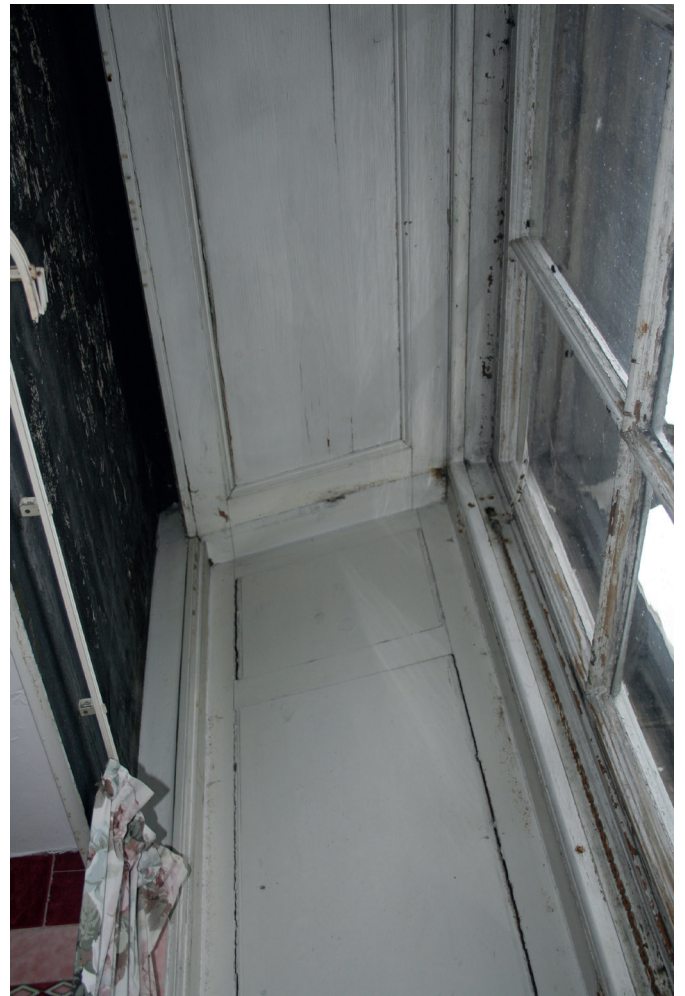
f7_004_22.12.15

Bulkhead to former inserted ceiling.

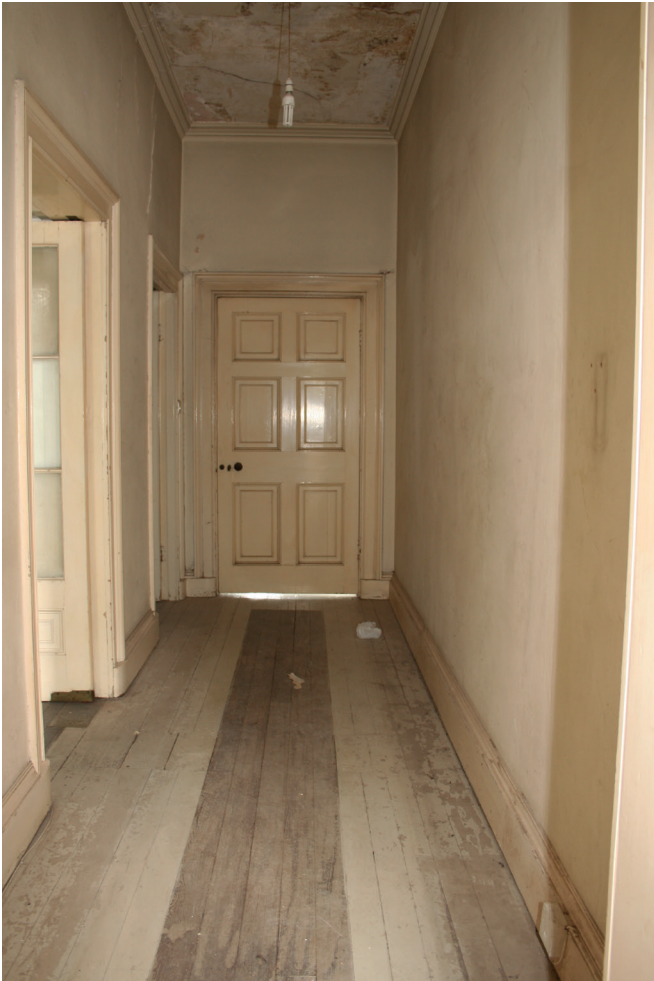
f8_006_14.06.21 - former location of hearth visible in floor by made-up boards replacing stone hearth

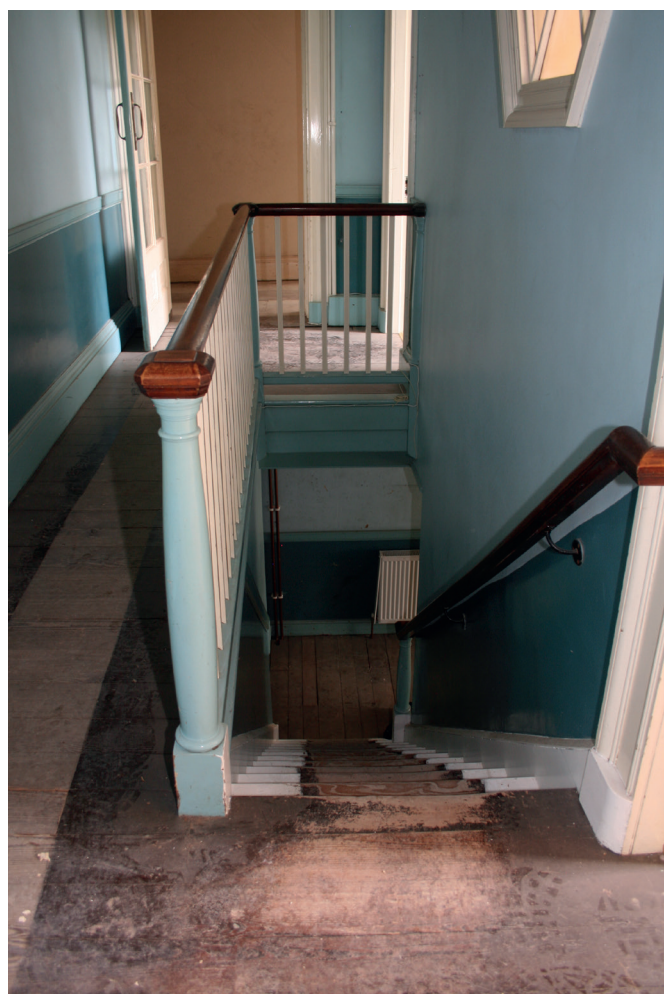
f9_003_14.06.21 - partition with fanlight re-located

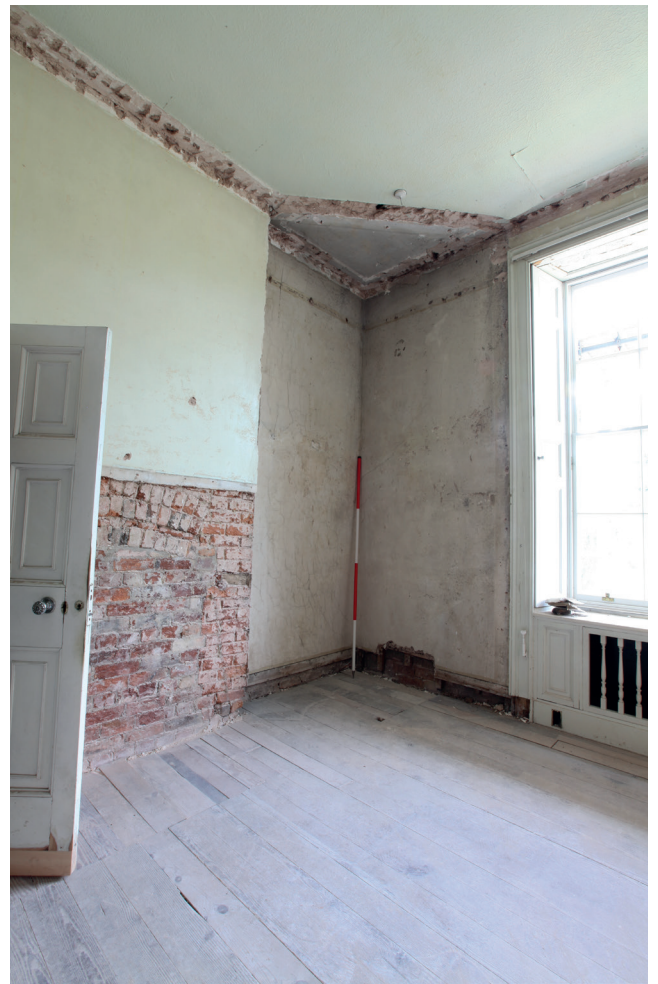
f14_002_14.06.21 - after removal of angled wall

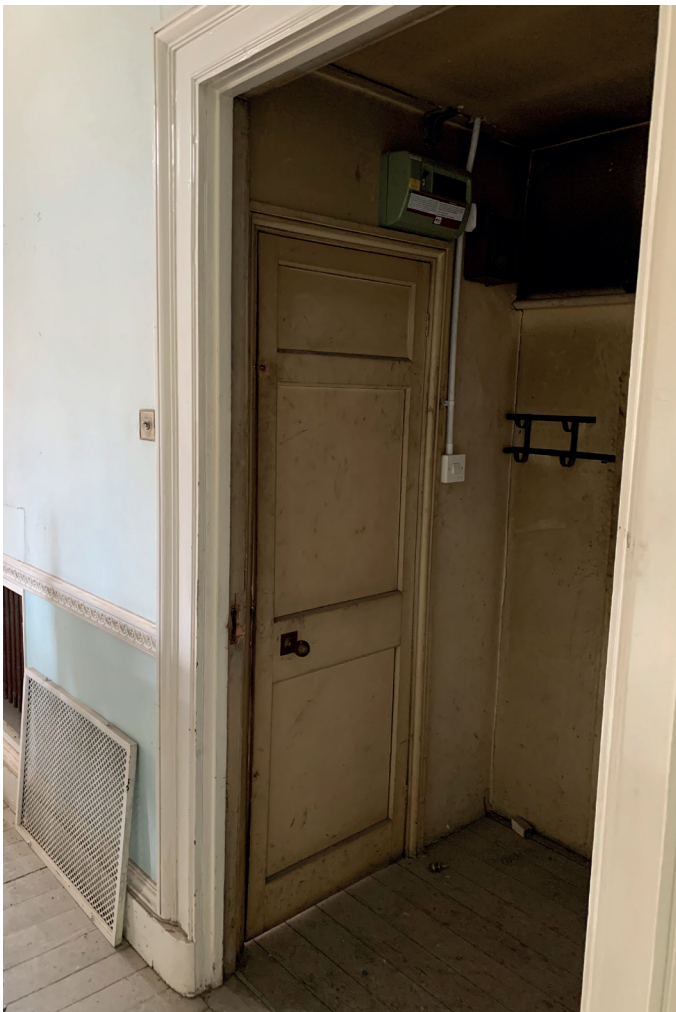
f23_001_14.05.20 - inserted C20 door
Ashcombe Park - Historic Building Record
