Well House Cottage Wellhouse Lane Headbourne Worthy Winchester

Level 2/3 Historic Building Recording

CA Project: AN0194

August 2020

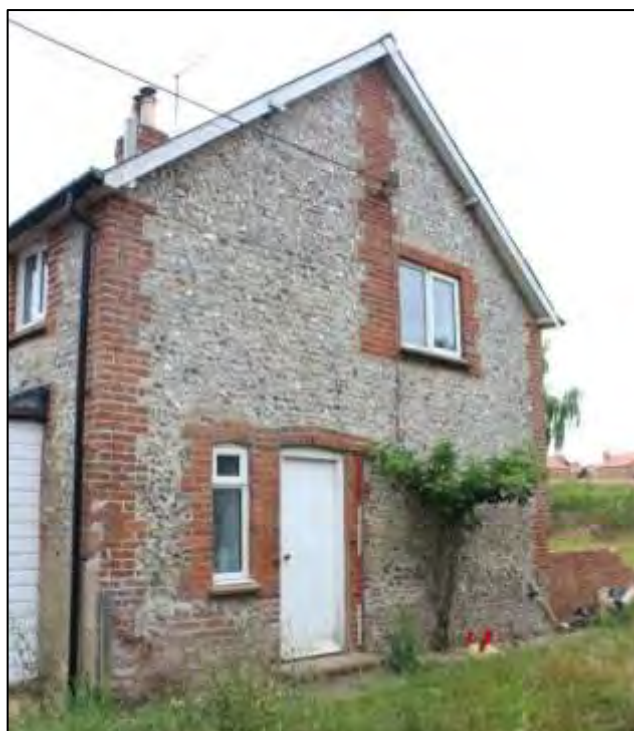
- 4.18. The north gable is similarly constructed in flint with brick detailing and is sparsely fenestrated. At ground floor, a narrow window sits to the east of a door, both with cambered arches over (Photo 3). The door is now blocked internally and is the only remaining traditional timber feature of any age in the cottage. The door position is mirrored on the south elevation by a similar, now altered opening, believed to be the 'back door' to the cottages respectively. Below the window, at the north-east corner of the cottage there appears to have been some rebuilding, or possibly underpinning, as shown by the later brickwork infill (Photo 4).

Photo 3 North elevation

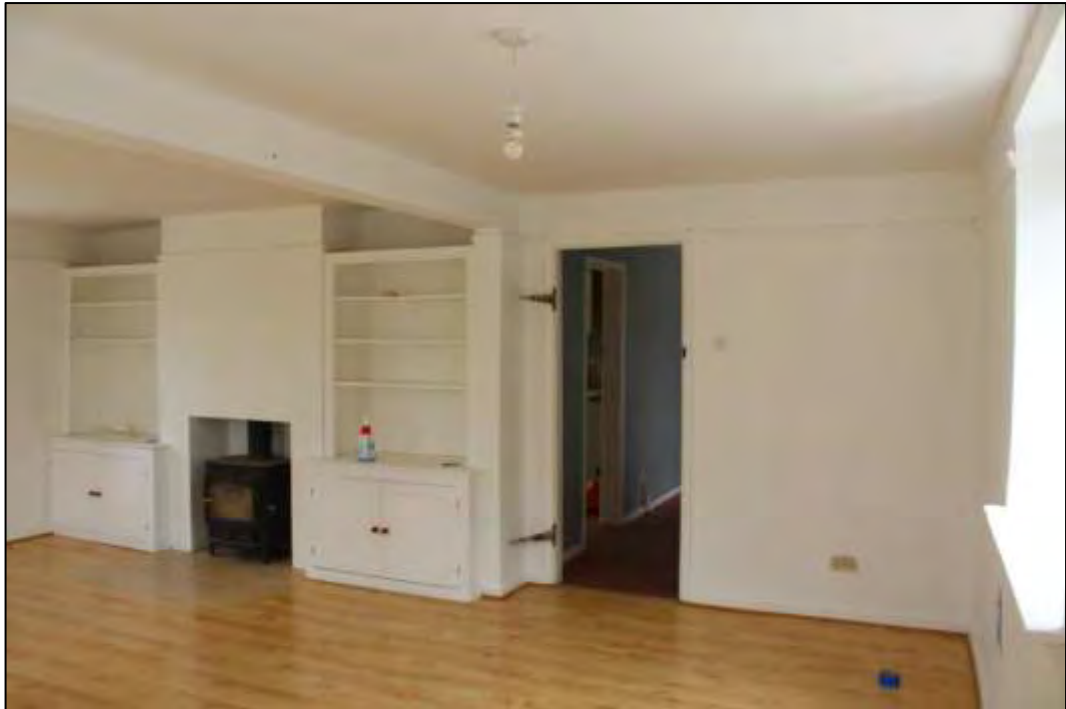
Photo 11 View north-west in the sitting room

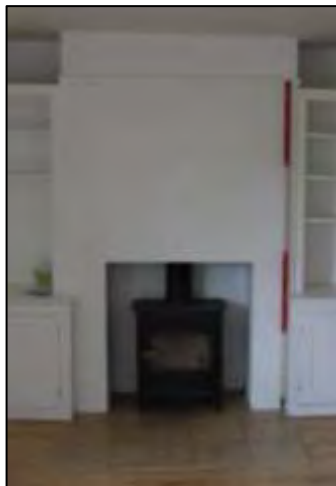
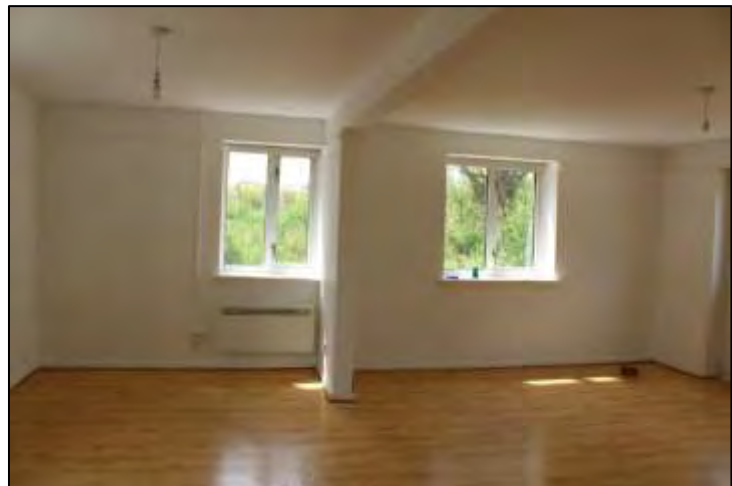
Photos 12 & 13 Chimney detail (left) and view south within the sitting room (right)

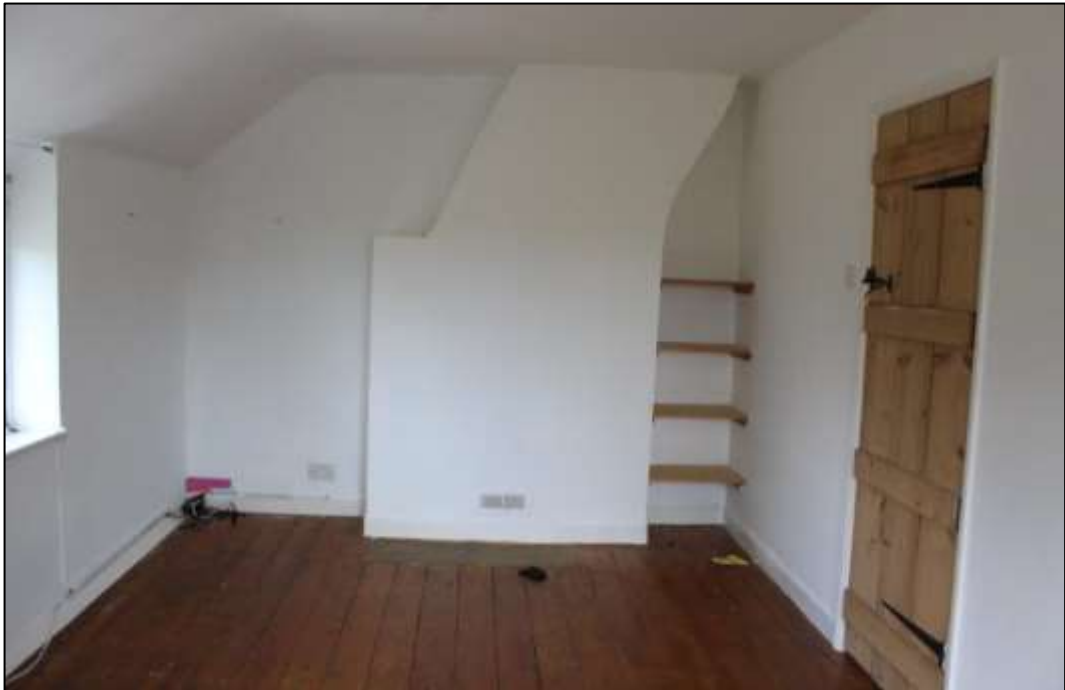
4.35. Whereas the rooms to the east appear to have been unheated, as at ground floor, the two rooms to the west have visible chimney protrusions (Photo 21). In both

Photo 21 'Front' (west) bedroom in the former southern cottage
