**An Historic Building Photographic
Survey at
12 – 16 De Montfort Street,
Leicester**

NGR: SK 5940 0382

ULAS Report No. 2019-066
©2019

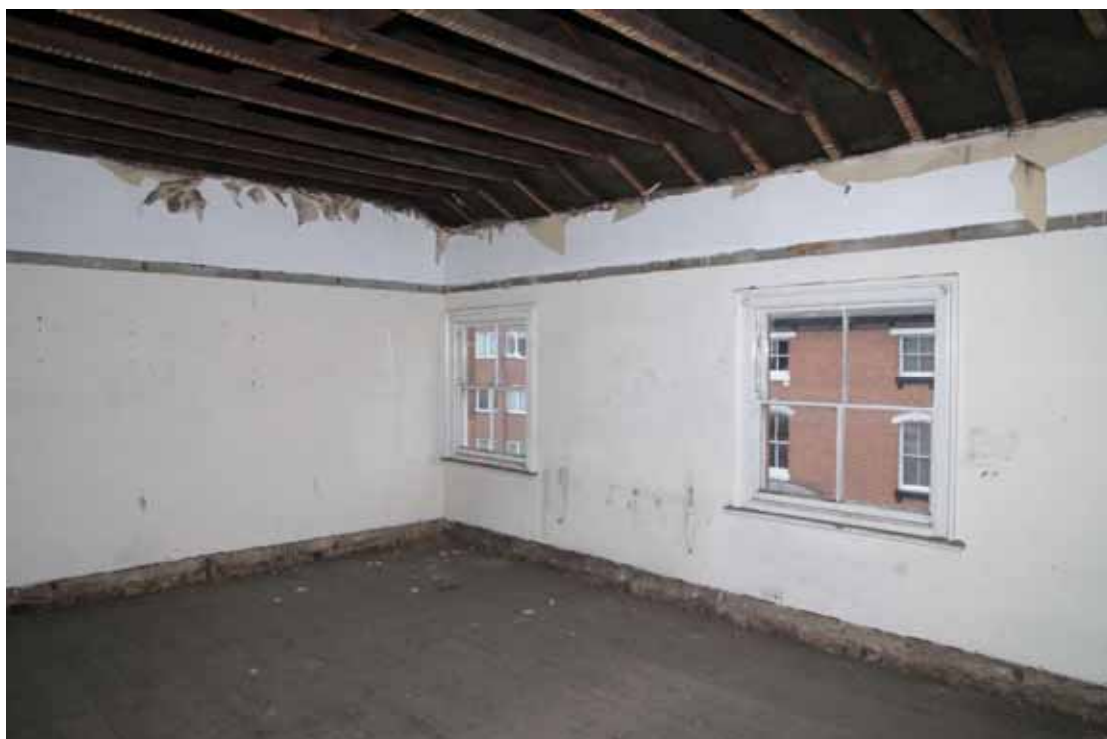
Figure 63 Number 14 second floor front room
Looking west
