**An Historic Building Photographic
Survey at the former
Rose and Crown Public House,
Leicester Road,
Kibworth Harcourt,
Leicestershire**

ULAS Report No. 2019-080
©2019

For: Staniforth Architects Ltd

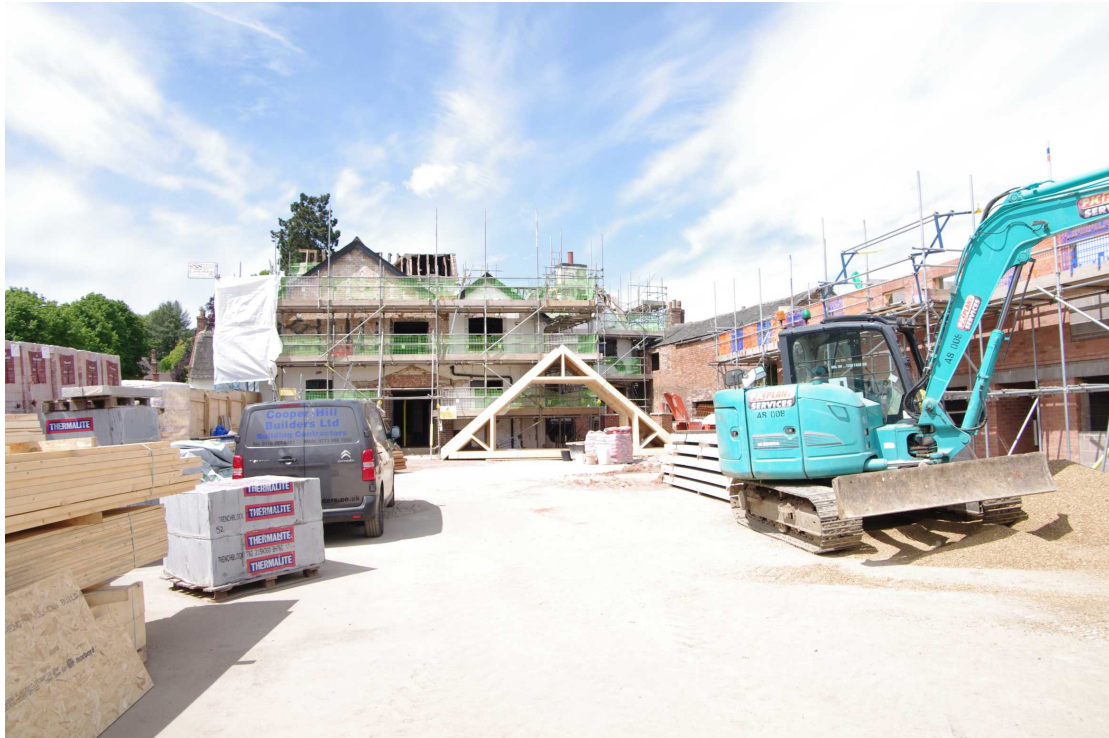
Figure 9 Site viewed from rear yard
Looking west. New dwellings on right

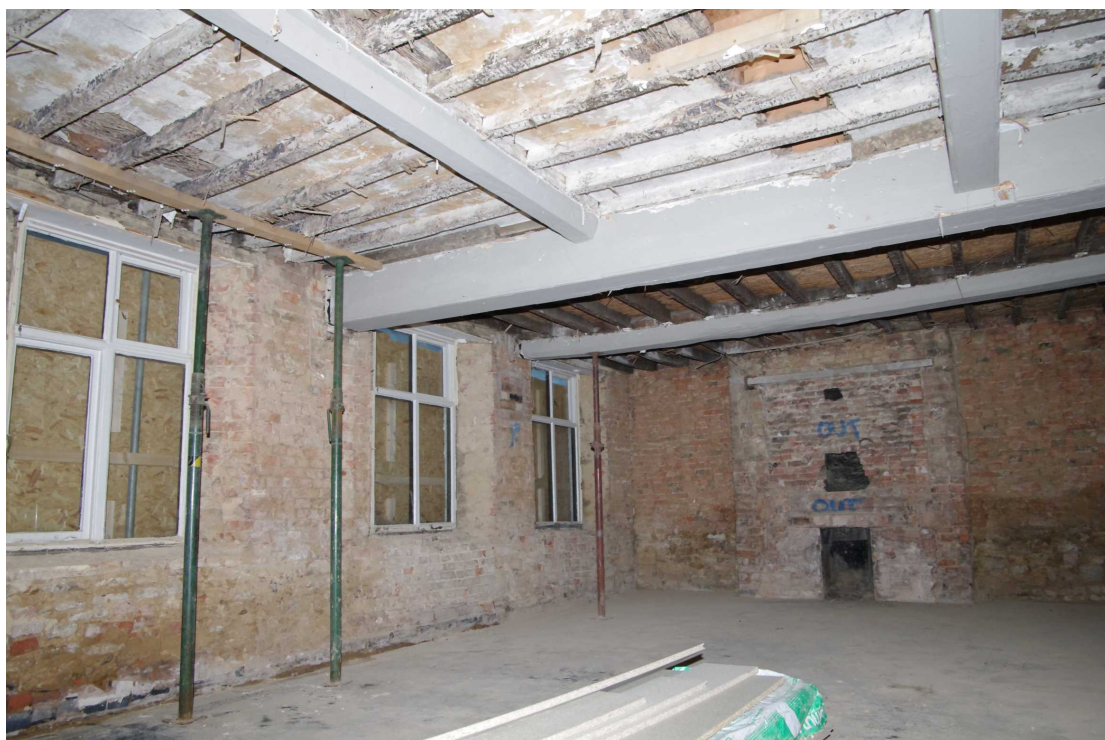
Figure 22 Northern ground floor room (1) of Main Street range
Looking north-west

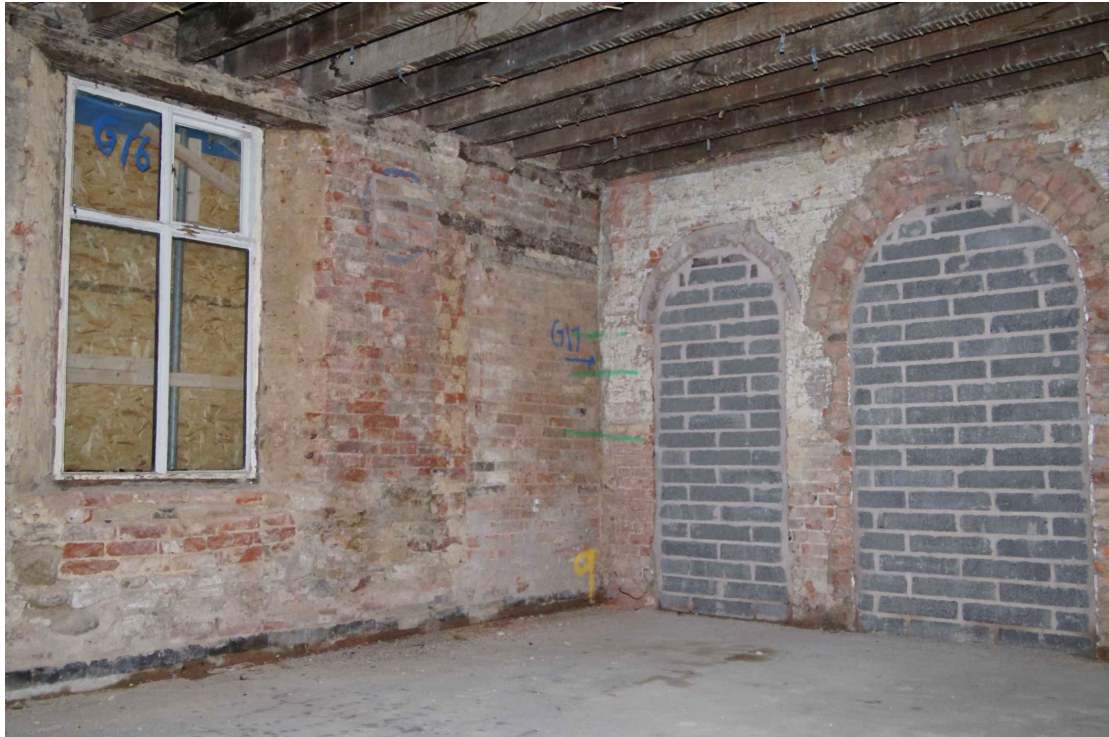
Figure 26 Southern room (2) of Main Street range
Looking north-west

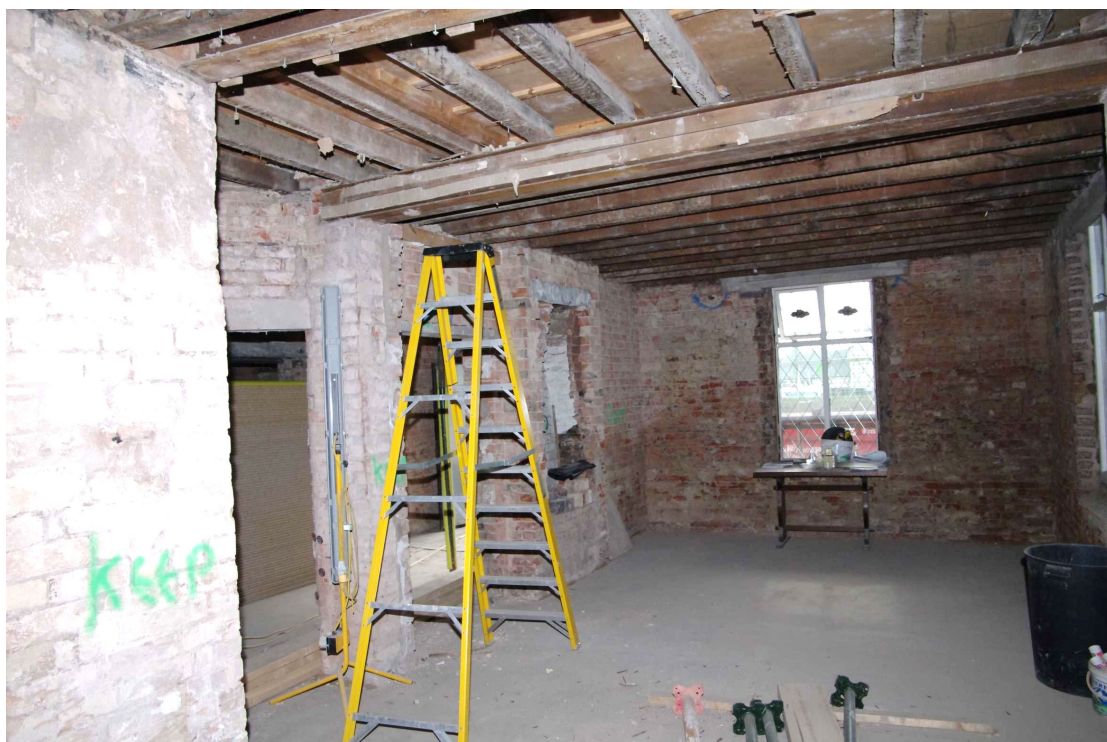
Figure 29 Southern extension Room 3 looking into Room 4
Looking east

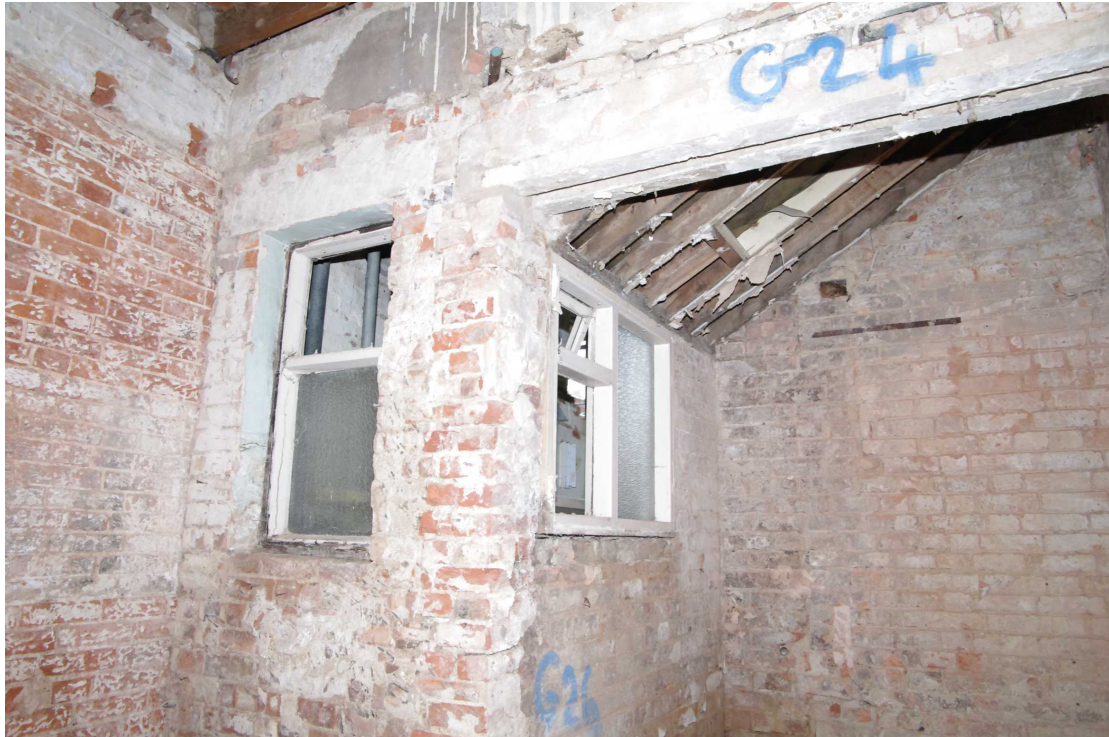
Figure 38 Ground floor Room 6
Looking north-east.

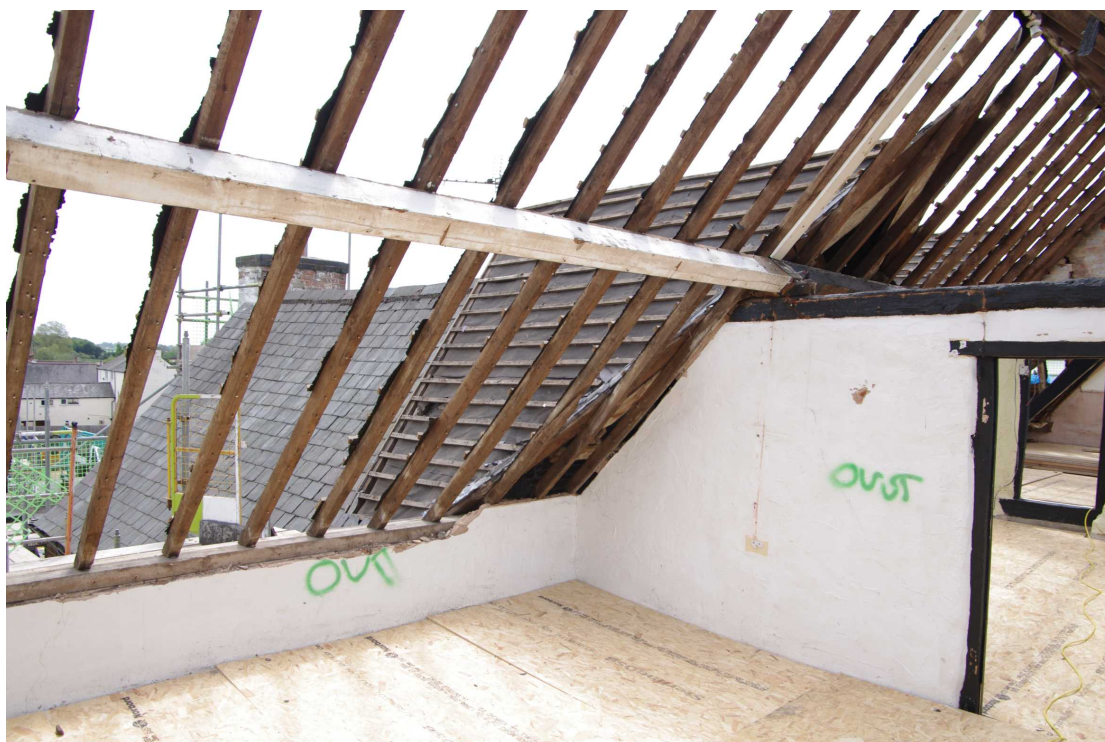
Figure 59 Room 17
Looking south-east. Room 18 on right

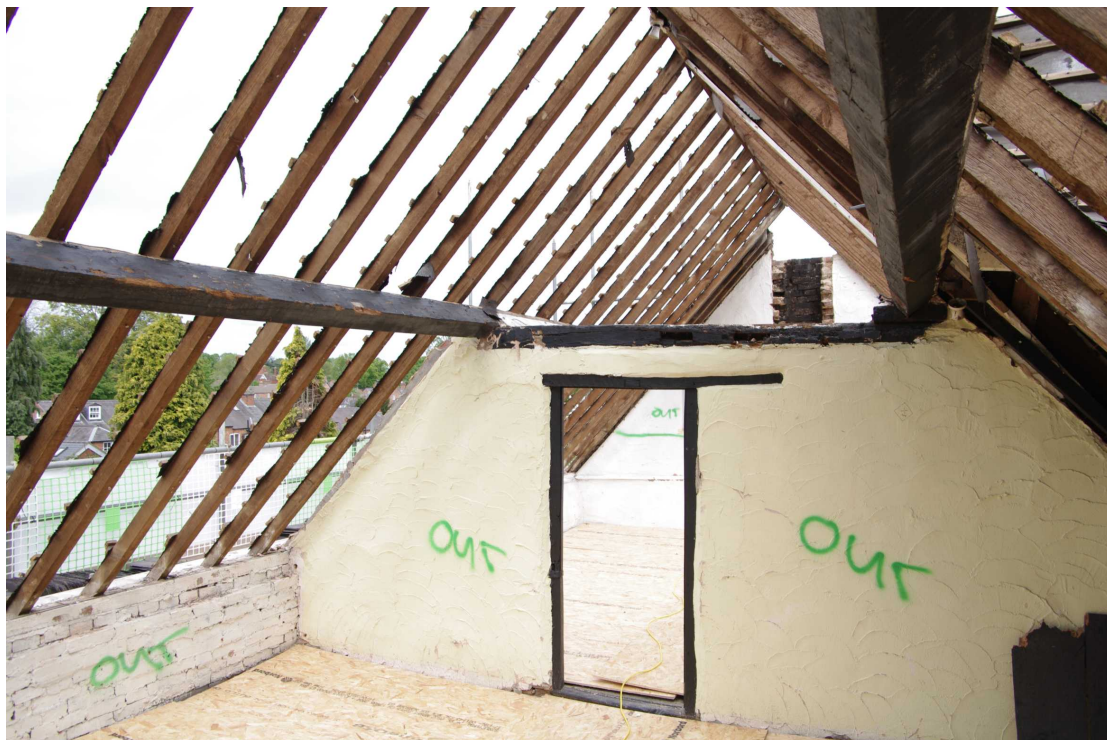
Figure 64 Room 18
Looking north-west

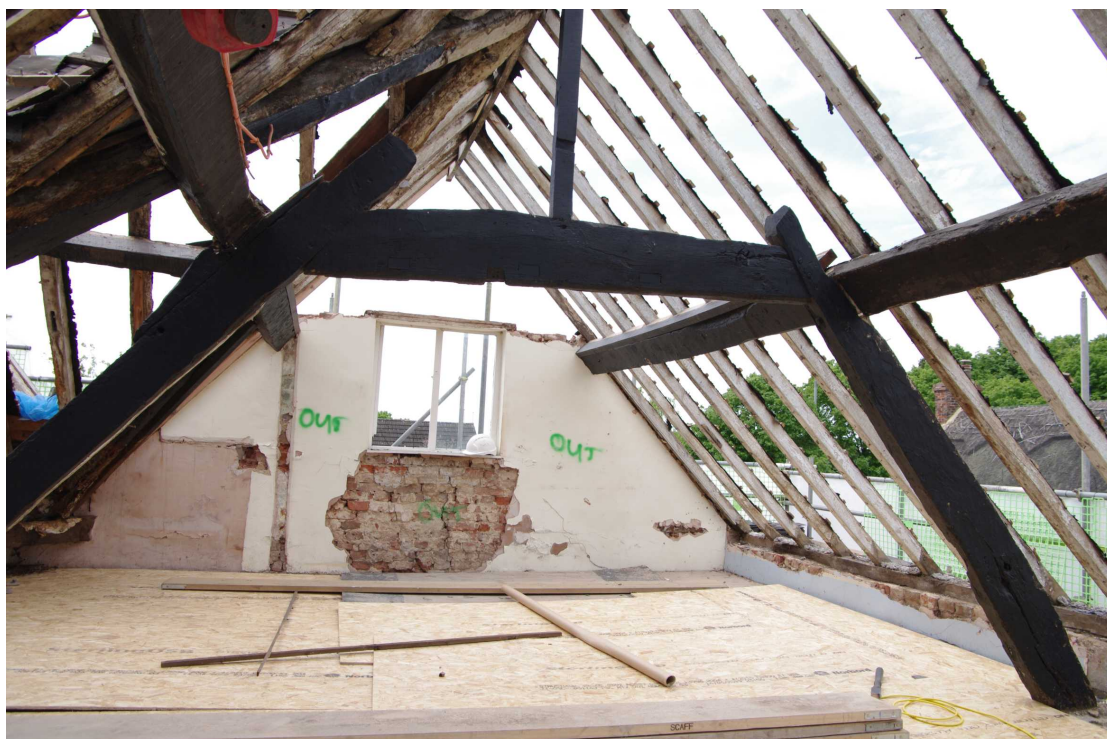
Figure 65 Second floor, Room 19
Looking south

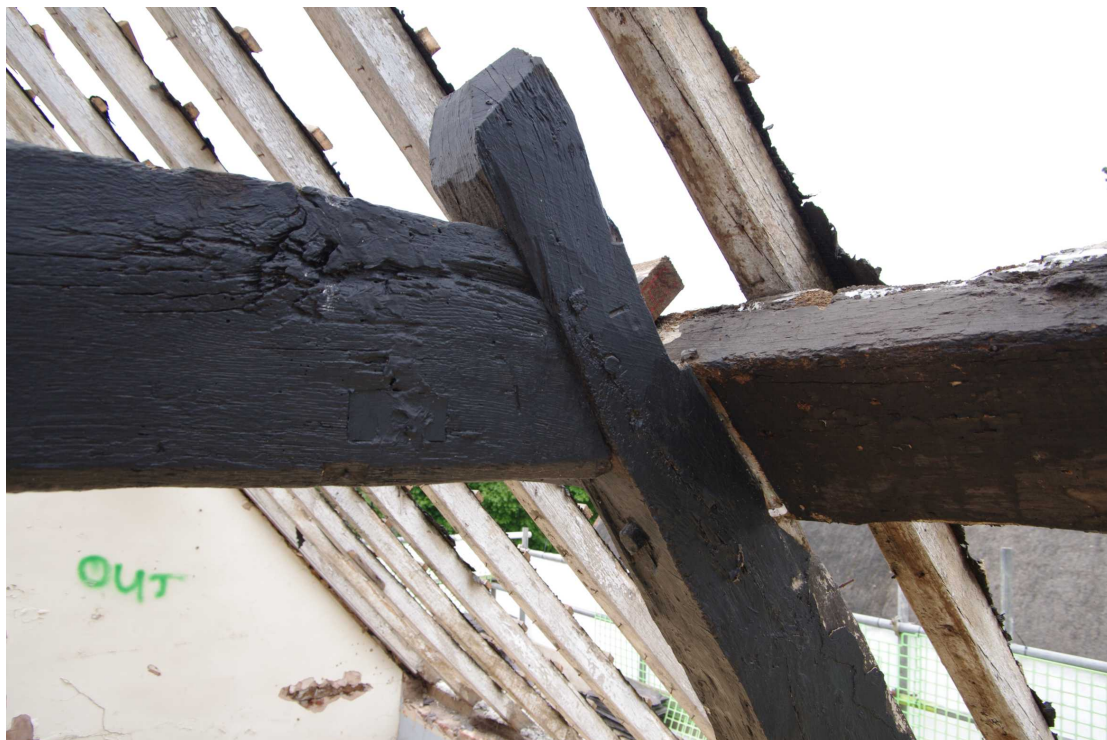
Figure 66 Room 19 joint detail of eastern frame
Looking south-west

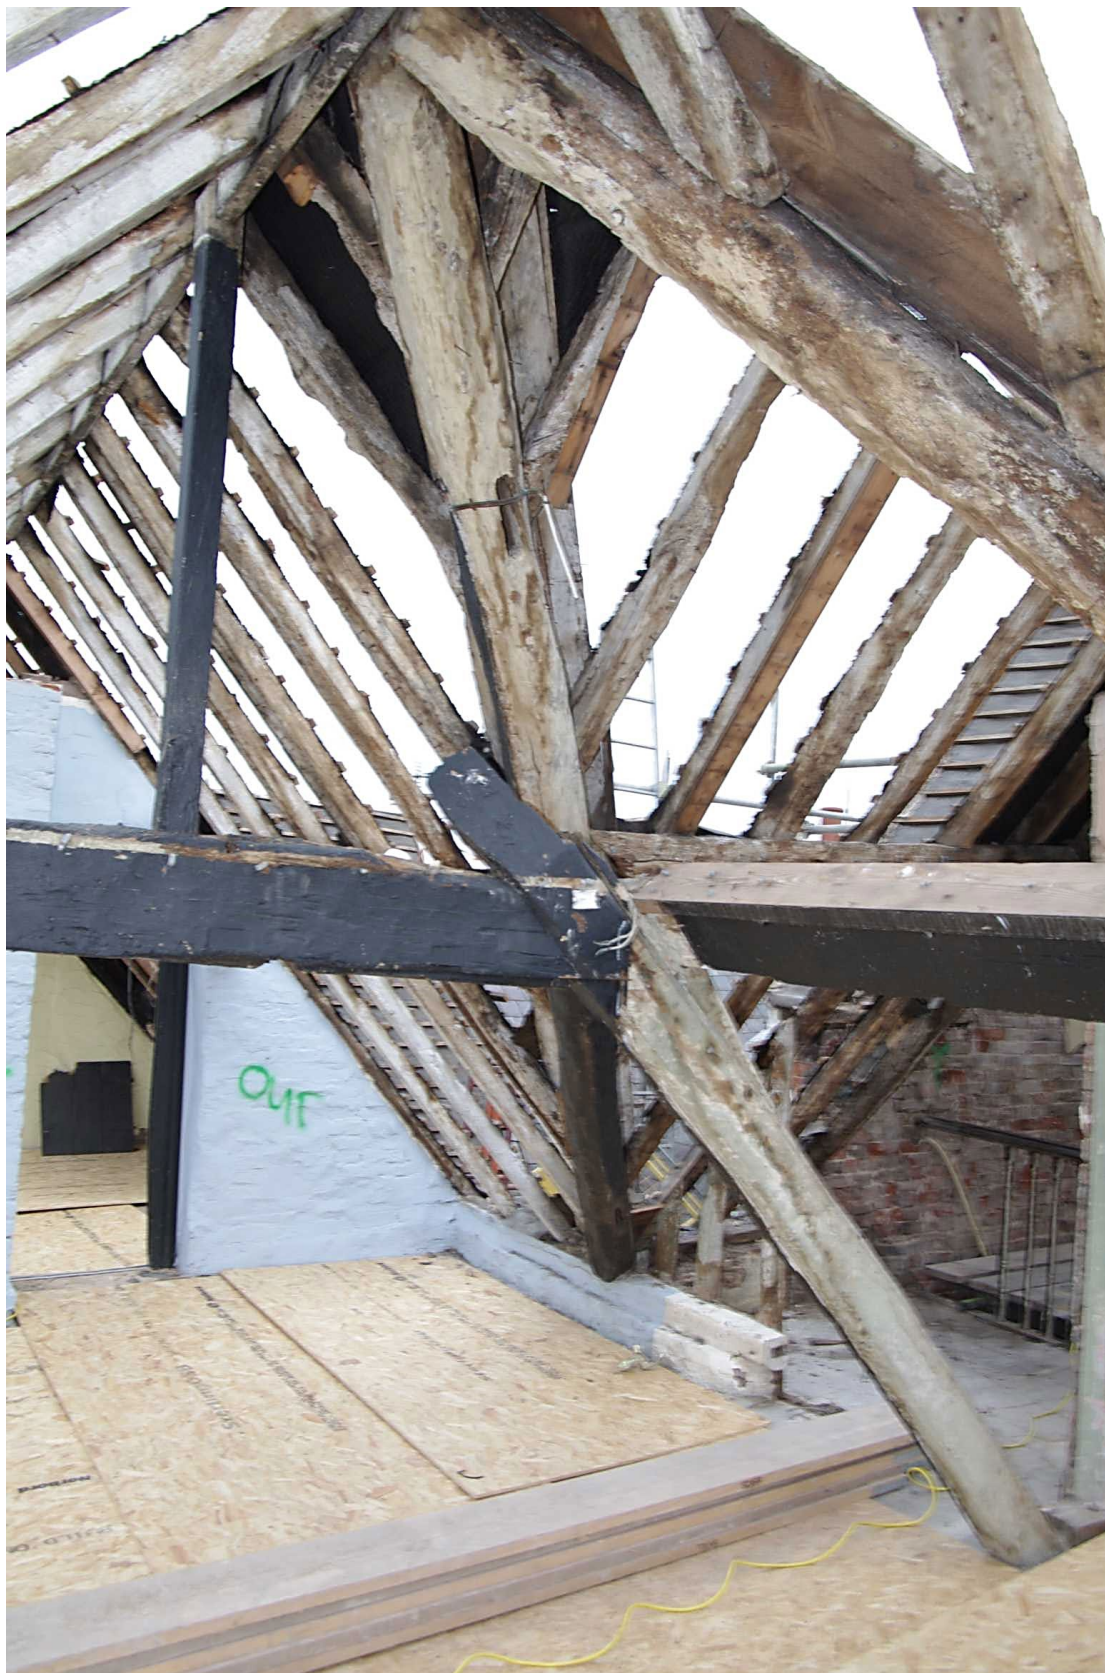
Figure 68 Room 19 roof detail
Looking north-east. Stairs and hallway on right

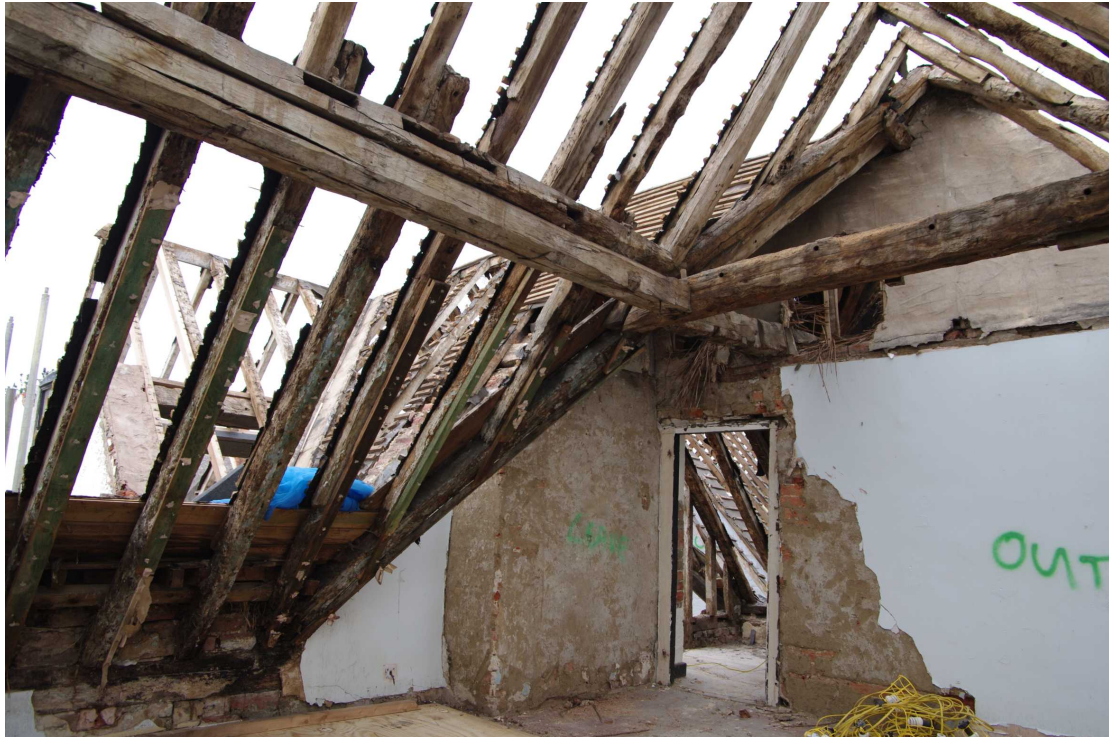
Figure 74 Room 20
Looking north-west. Note circular holes in tie-beam on right
