**An Historic Building Photographic  
Survey at  
Saddle House, Churchgate,  
Hallaton,  
Leicestershire**

ULAS Report No. 2019-092v2  
©2019

**For: Mr D Pochin.**

## **An Historic Building Photographic Survey at Saddle House, Churchgate, Hallaton, Leicestershire.**

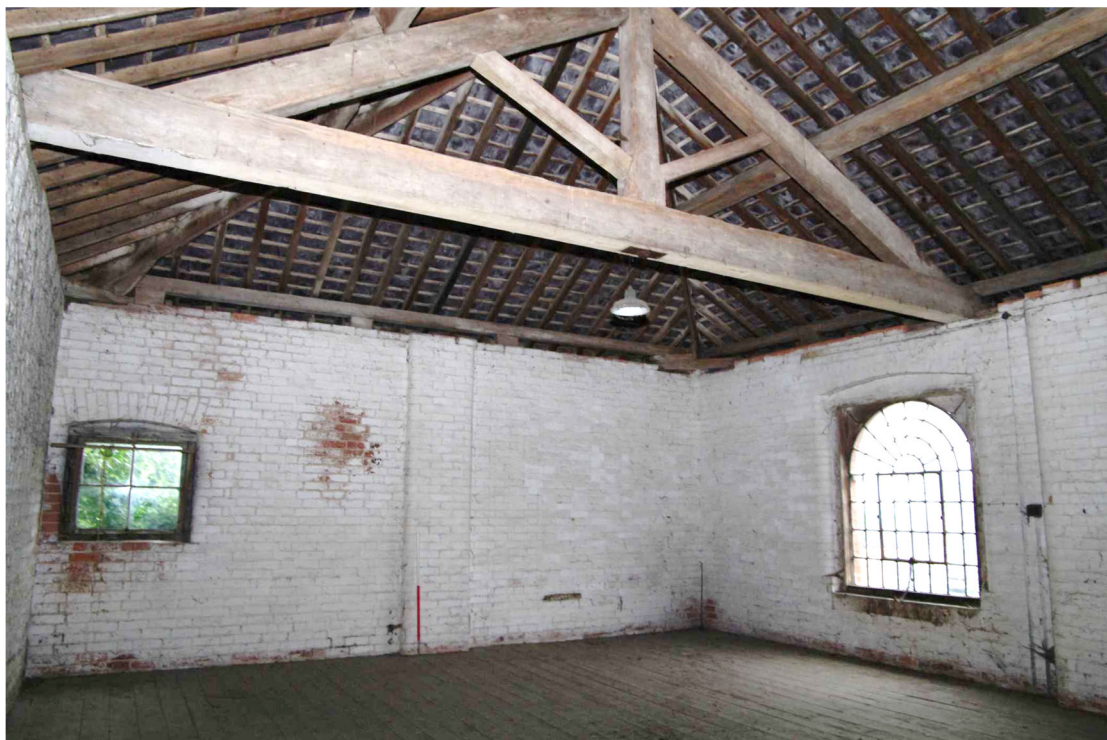
Figure 55 The Coach House first floor  
Looking south-east. 1m scale
