**A Standing Building Survey  
of Farm Buildings,  
Old Hayes Farm,  
Ratby,  
Leicestershire  
(SK 490 064 centre)**

**For Lychgate Homes Ltd**

Report No 2006-021

## **A Standing Building Survey of Old Hayes Farm, Rathby, Leicestershire (SK 490 064)**

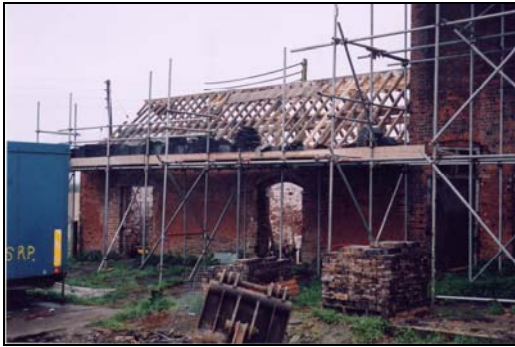
There are two door openings on the east elevation both of which have a small recess in the brickwork around them which allowed the former stock doors to close flush with the external face of the wall (plate 1). The doors are no longer present but there are iron pintles built into the brickwork indicating their former presence. The northern most door has a segmented head formed from two rows of header brickwork the lower of which is recessed back from the external face to accommodate the former door (plate 3). The southern door has a square head formed from a timber lintel spanning the opening. There are some repair and repointing works to this door opening at the left hand side and also above suggesting that a segmented arch may have been replaced when repairs to the structure were undertaken (plate 4). There is no north elevation to this structure and it is simply butt jointed to the south elevation of the Pigeon House (plate 5). Three rows of corbelled brickwork form an eaves course on the east elevation

Plate 1 General view of east elevation of building one.

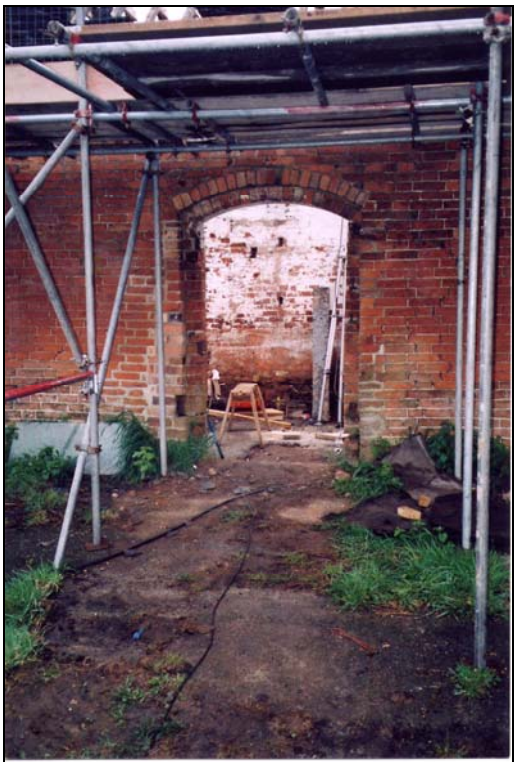
Plate 3 The northern door on the east elevation.

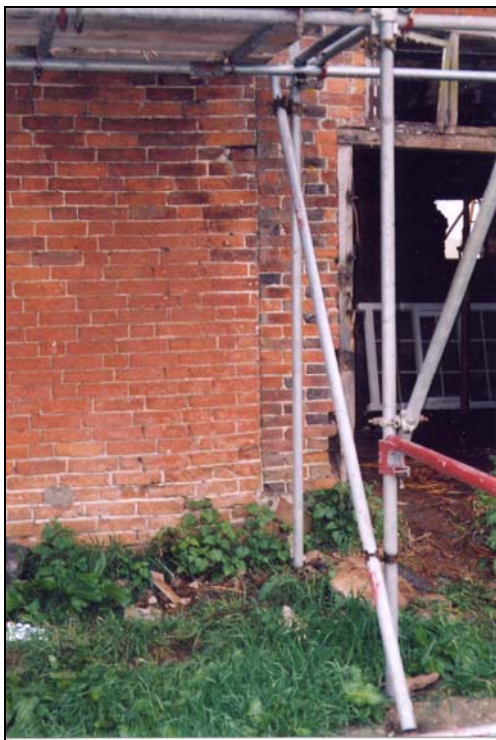
Plate 5 Northeast corner butt joint of southern wall of Pigeon House. Plate 6 The south elevation gable wall.

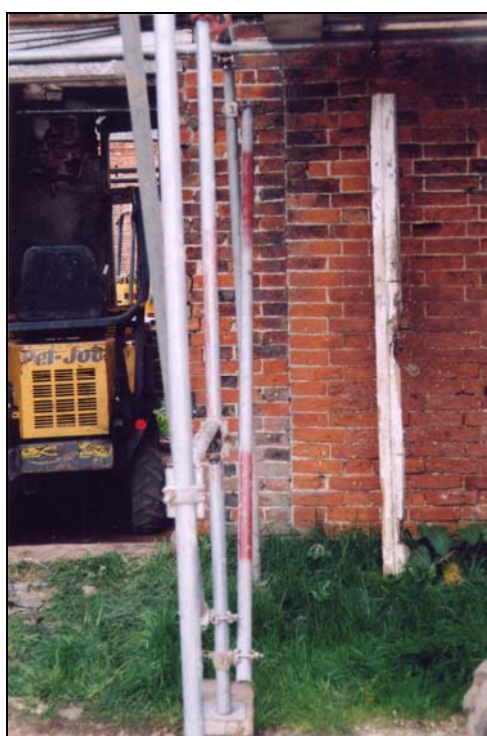
There are no openings on the west elevation and the brickwork is the same as elsewhere on the structure laid in Flemish garden wall bond and finished at eaves level with three rows of corbelled brickwork. Placed centrally on this elevation is a large patch of rebuilt brickwork which may indicate a structural repair or alternatively a blocked door opening although the former seems more likely (plate 2). This wall finishes on the northwest corner with a butt joint to the south wall of the Pigeon House.

Plate 8. The northwest corner butt joint to the south wall of the Pigeon House.

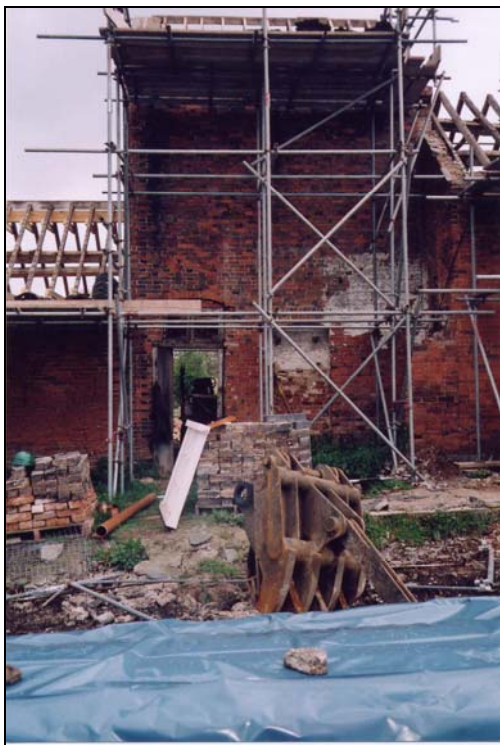
The east elevation is constructed using a combination of two courses of Flemish bond with three courses of stretcher bond. This unusual pattern is used to enable the construction of the nesting boxes internally. A decorative scheme of flared headers has been used within the Flemish bond sections of the brickwork to give a distinctive pattern similar to that on the barn opposite but not as pronounced due to the poor condition of the pointing (plate 9). The bricks used in the construction are on average 230 x 55-60 x 110mm. There is a single door opening on the left side of this elevation with a vent light above, under a segmented arch formed from a single row of header brickwork (plate 10). The left portion of the ventlight has been partially bricked up, as has the segmented arch section between the top of the ventlight frame and underside of the solid brickwork. The ventlight itself is of timber construction with single pegged joints and appears to be a reused window frame. The timber door is missing but the timber frame remains. The frame is crudely constructed and may again indicate salvaged material. To the right of this door in the centre of the elevation is a blocked former door opening with a segmented soldier arch above, formed from alternating headers and stretchers. The brickwork blocking this opening is set back from the exterior wall face by 230mm and is laid in stretcher bond (see plate 11). The upper part of this elevation has an iron restraint tie in the top left corner and evidence of a blocked window opening at first floor level just below the eaves. At eaves level there are three rows of brick corbelling.

Plate 9. General view of east elevation of the Pigeon House. Plate 10. A view of the blocked central east door and remains of former flue.

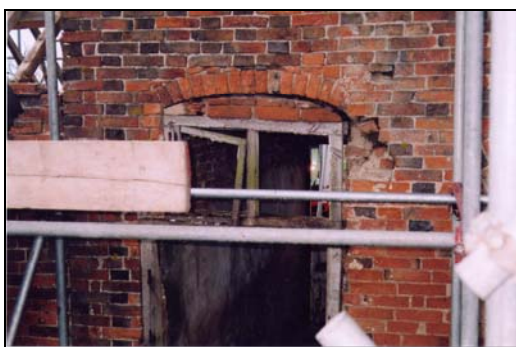
There are the remains of a hearth and flue on the northern corner of this elevation situated on the return of the south wall of building 3 (plate 11). There are several patches of white paint on the east elevation and around the flue which may indicate the presence of a former structure here.

Plate 11. The segmented arch above the east elevation door. Plate 12. East elevation of building three showing former milking shed outline.

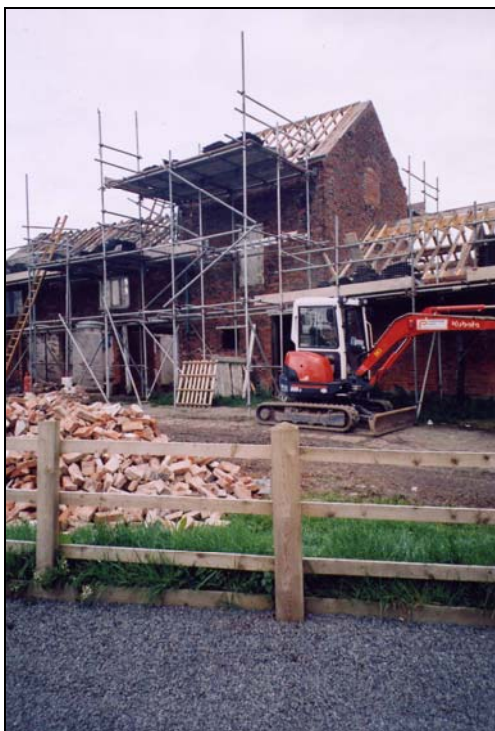
The south elevation also forms the northern wall of building 1. This elevation is constructed of brick and rubble at low level and then the same pattern brickwork as described above. There are three holes in the fabric of this elevation corresponding with the purlin positions from building 1. Also at high level there is a blocked window opening with a segmented arch formed from alternating headers and stretchers (plate 13).

Plate 13. South-western aspect of Pigeon House.

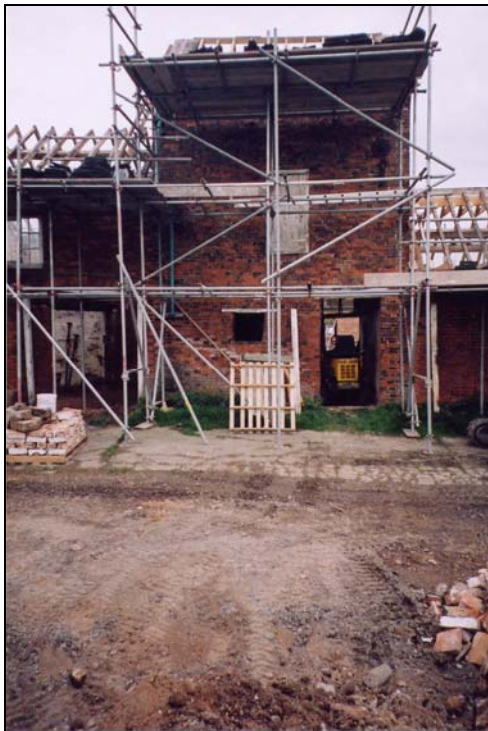
The brickwork on the west elevation has the same bond as that on the east. There are three openings on this elevation: a door opening in the southwest corner with a timber lintel above; a small square window opening centrally also with a timber lintel above and finally a door opening at first floor level with a timber lintel over it (plate 14). At higher level just below the eaves is a blocked window opening and an iron wall restraint both of which correspond with similar details on the east elevation. The wall terminates at eaves level with three rows of brick corbelling.

Plate 14. West elevation showing door and window openings.

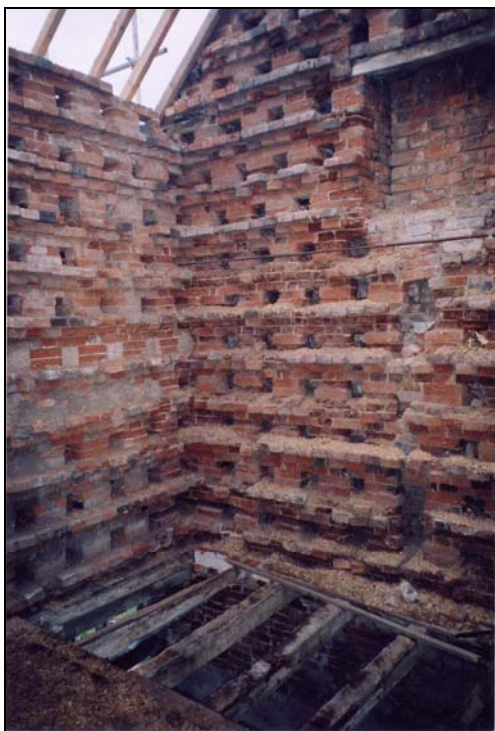
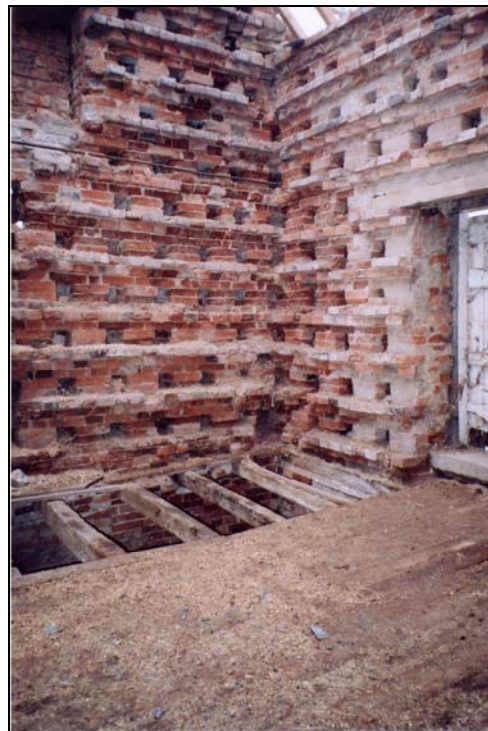
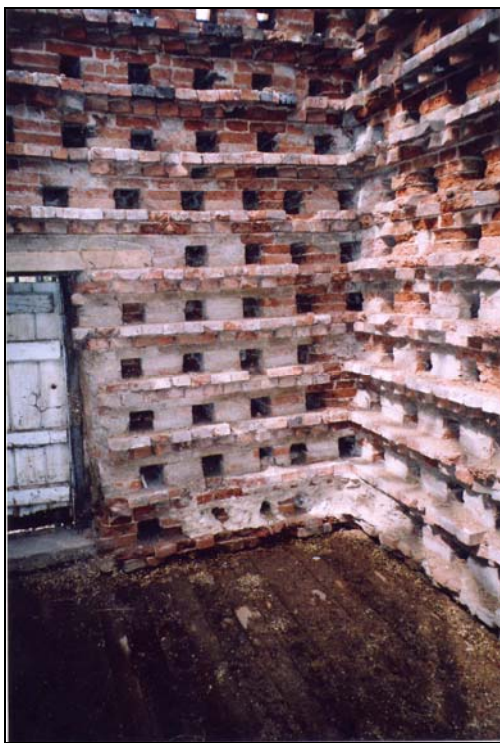
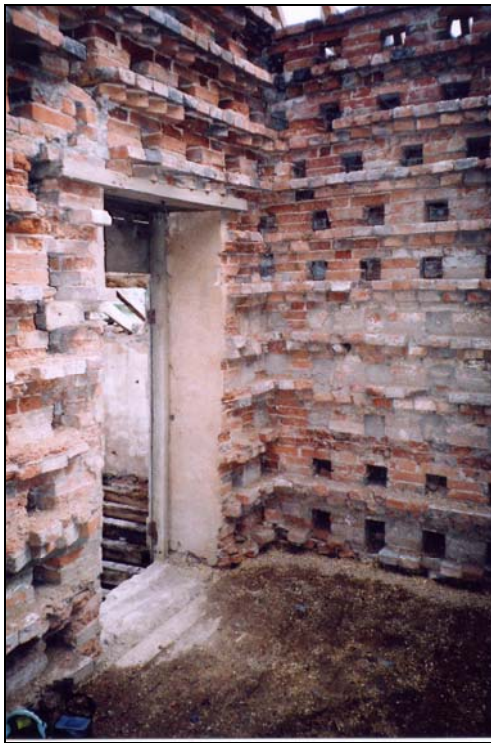
At first floor level the walls are entirely taken up with pigeon nesting boxes (plates 15-18) although a number of them have been blocked or damaged. The blocked window on the north and south elevations are incorporated into the structure of the nesting boxes and may therefore be contemporary with them. The north and west doors however seem to be later insertions.

Plate 15. First floor southeast corner internally.

Plate 16. First floor southwest corner internally, note west door opening.

Plate 17. First floor northwest corner internally.

Plate 18. Northeast corner internally showing first floor north door.

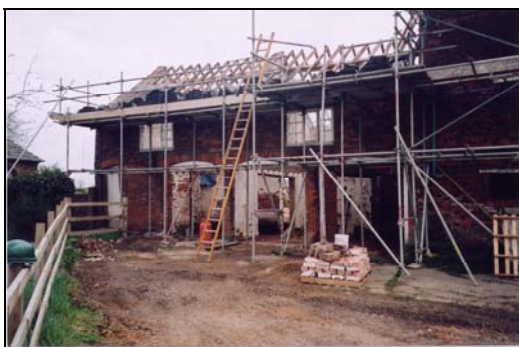
The west elevation is of brick construction using the same bond as mentioned above. This wall however has four large segmented arched openings with intermediate piers (plate 19). The northern most opening has been partially bricked up and now access is via a small timber door (plate 21). A small section of segmented arch has been replaced directly above this door. Some structural work has also been undertaken on the next arch (central left) and the segmented arch soldier course has been replaced and the left hand jamb strengthened with an additional narrow brick pier (plate 22). Other evidence of structural repair is from the iron restraint ties in between the left and central left arches corresponding with a tie on the east elevation.

At first floor level there are two three light Yorkshire sash windows placed centrally above the piers (see plate 19). These windows are detailed in the interior description. The elevation terminates at eaves level with four rows of brick corbelling. This structure has no south wall and built onto the north elevation of the Pigeon House using a butt joint (plate 23).

Plate 19. West elevation showing four arched openings.

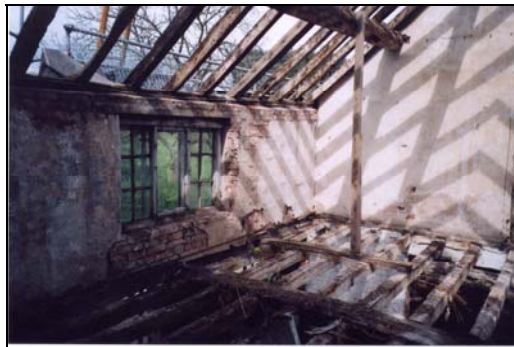
Plate 20. The first floor southern Yorkshire sash on the west elevation.

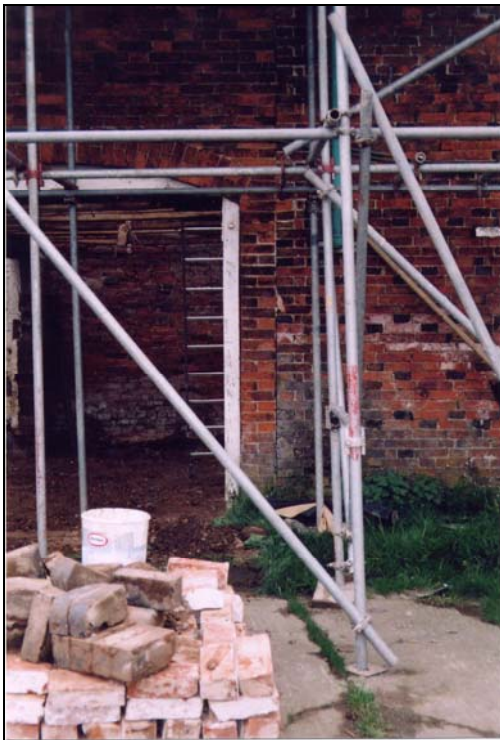
Plate 23. Southwest corner butt joint to north wall of Pigeon house.

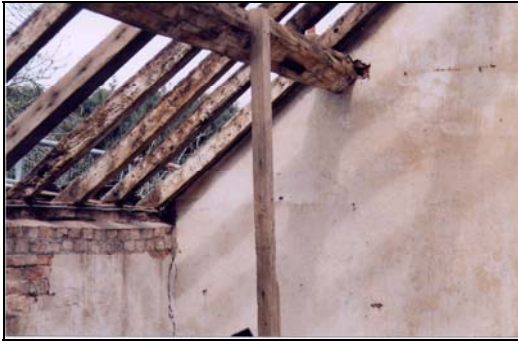
The roof construction comprises of common rafters and four purlins (plate 26), the latter built into the fabric of the wall. There are a number of mortice sockets and holes in the purlins suggesting re-use from an earlier structure (plate 28).

Plate 28. General arrangement of roof structure.

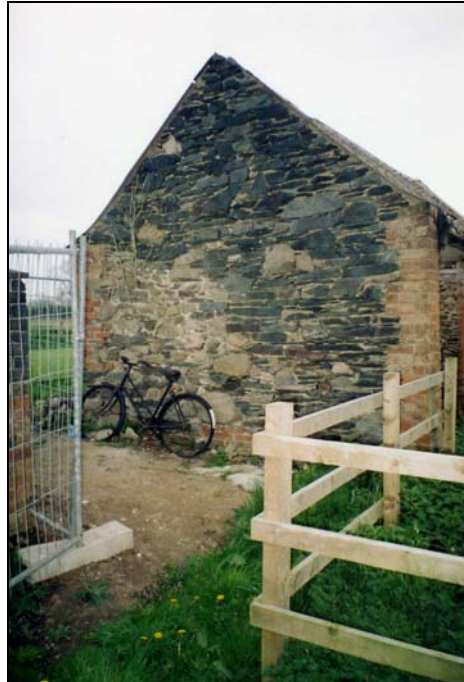
Plate 32. Detail of north elevation showing blocked door. Plate 33. West elevation of building four.

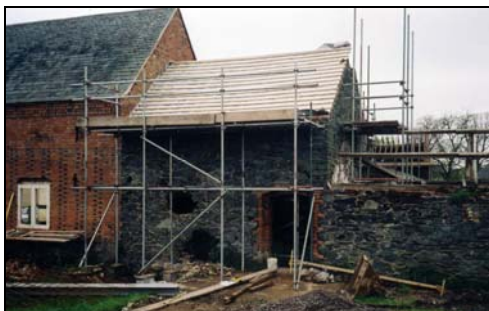
Plate 43. East elevation of building six.

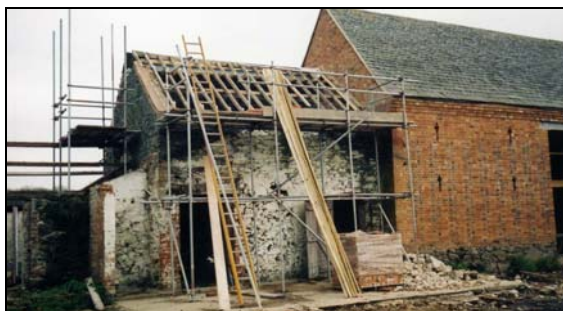
Plate 44. Northwestern aspect of building six.

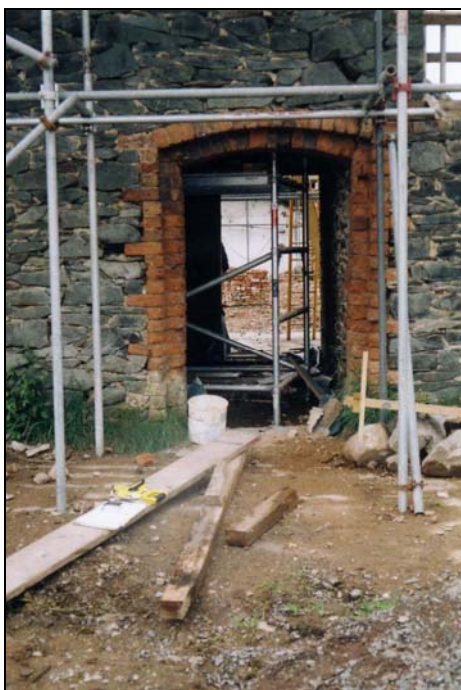
Plate 45. Detail of east elevation door opening.

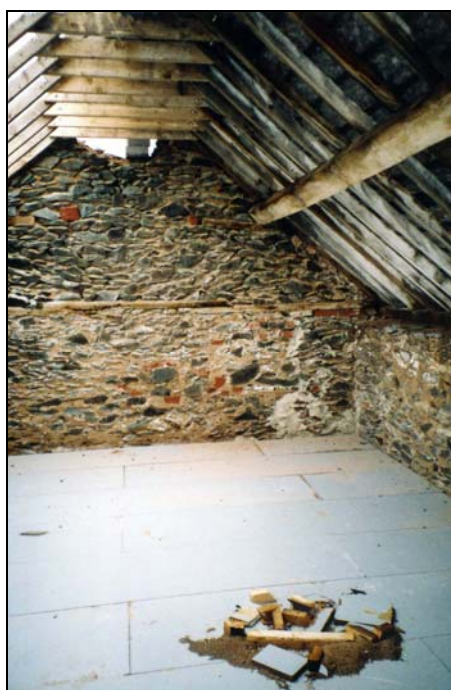
Plate 46. Interior first floor level looking north, building six.

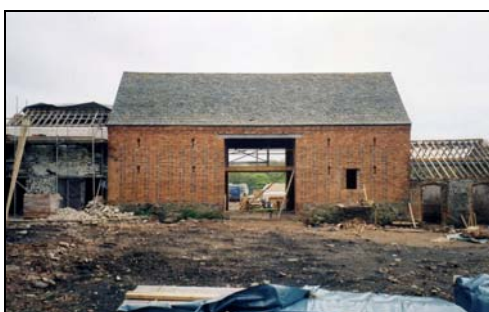
Plate 47. West elevation of barn (building seven).

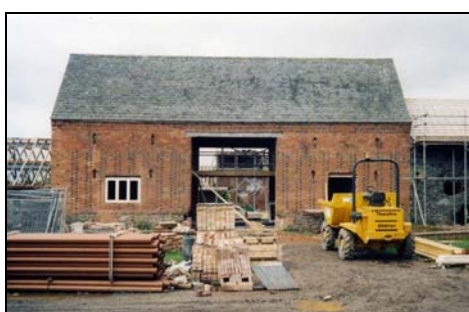
Plate 48. East elevation of barn.

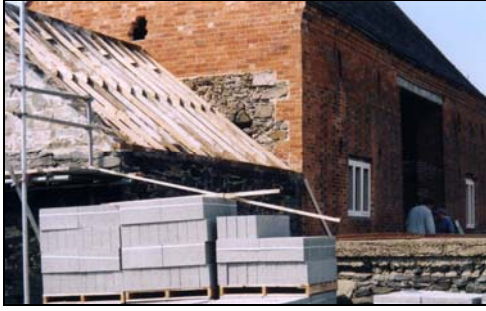
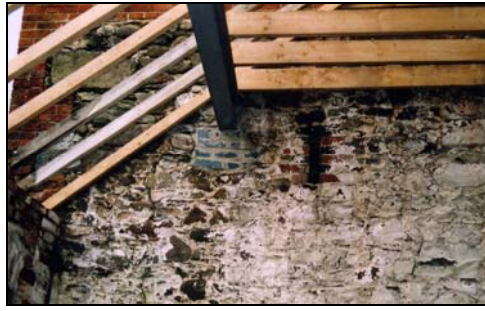
Plate 49. Southeast corner of barn showing rubble walling. Plate 50. South wall of barn showing rubble construction.

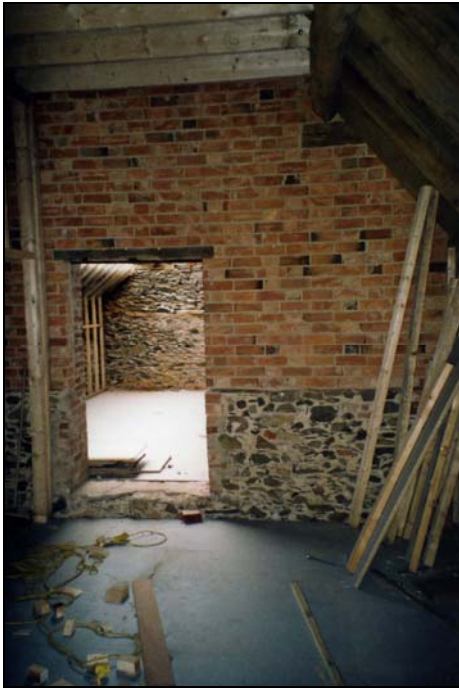
The north elevation is largely similar to the south and rubble fabric again extends at least to half wall height, above which brickwork of the larger gauge is again employed (see plate 51). There are two door openings on this elevation, one at ground level and a further one at first floor level; these are described below.

Plate 51. Internal north wall of barn..

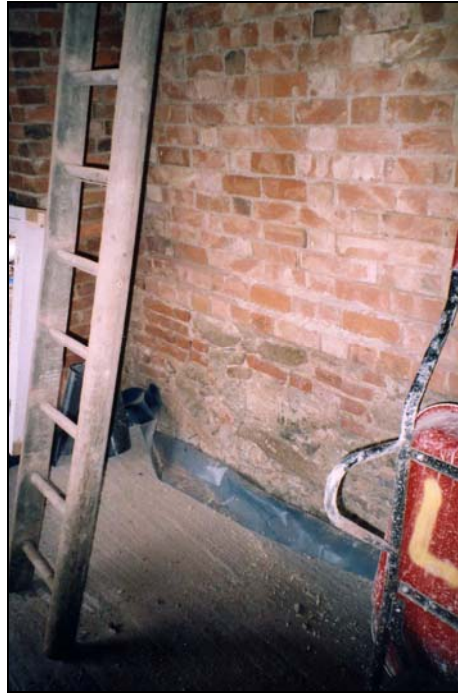
Plate 52. Internal plinth on east wall.

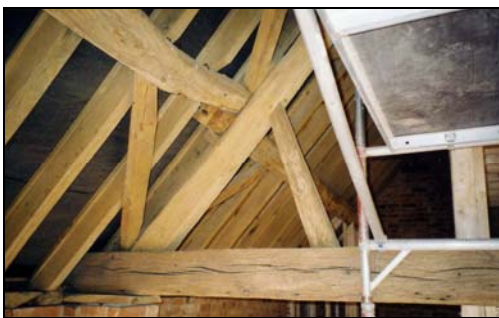
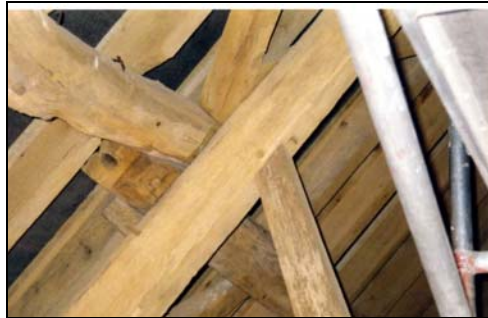
The roof structure is one of the most striking features of this building. The roof itself is supported by two-principal rafter trusses positioned either side of the threshing door opening on large brick piers. The principal rafter trusses support four through purlins, two to each roof slope (see plate 53, 55 and plan sheet section 4). The trusses comprise of a tie beam, raking struts and a high level collar. Wind bracing is also provided from both purlin positions back to the tie beam or principle rafter and is fixed using mortice and tenon joints. There are a number of carpenters marks visible, these are mainly confined to the south face of the timbers (see plate 54). The roof covering is of Swithland slate type with graded slates getting progressively smaller up the roof slope.

Plate 53. Southern aspect of principle truss on the east wall. Plate 54. Close up view of 53 above illustrating example of carpenter's marks.

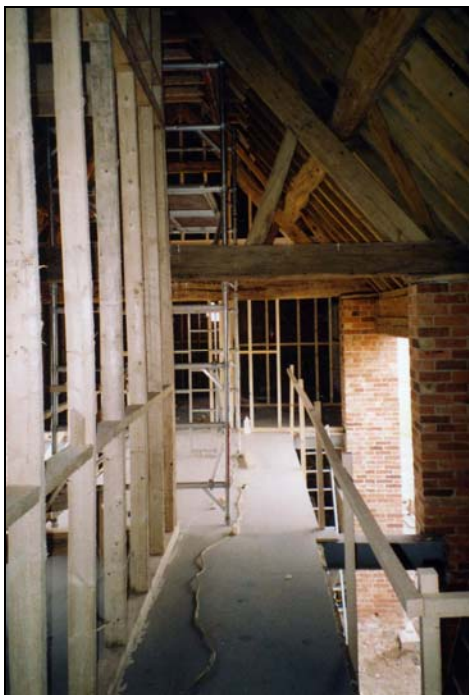
Plate 55. General view of roof construction along the west wall.

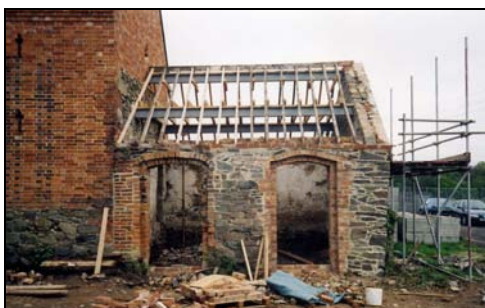
To the south of the main barn is a single storey two-bay stable block beneath a pitched roof. This addition is butt jointed to the main barn, with the south elevation of the barn forming the north wall of this structure. The only openings on this building are two single west-facing doors with recessed brick surrounds and a segmented arch formed from two rows of soldier brickwork headers. The infill between the northern door and the barn is of brickwork whilst the rest of the walling material is roughly coursed slate. The southern door appears to have been recently rebuilt and the masonry adjacent to it repointed. There is a single row of brickwork at eaves level (plate 56).

Plate 56. West elevation of building eight.

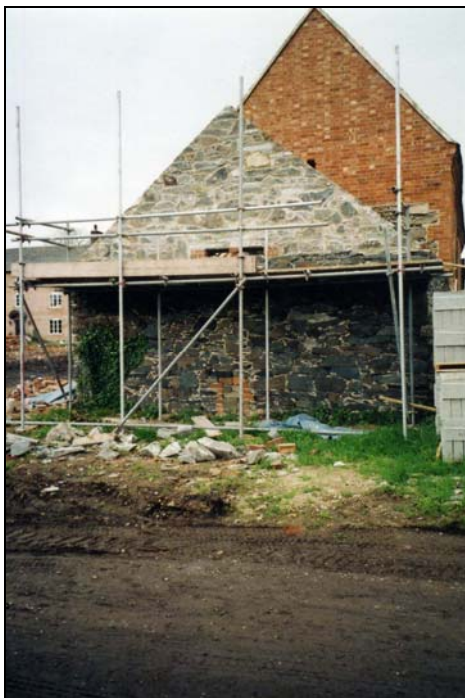
The south and east elevations are constructed from roughly coursed slate with few architectural features apparent (plates 57 and 58). The single row of bricks is repeated on the east elevation at eaves level and there is a small blocked opening centrally at ground level on the south elevation which is also visible internally. This small feature has been edged with brickwork and may have been used for drainage and cleaning of the building when it was used as a stable block (plate 59). Internally this feature has a small timber lintel over it.

Plate 57. South elevation of building eight.

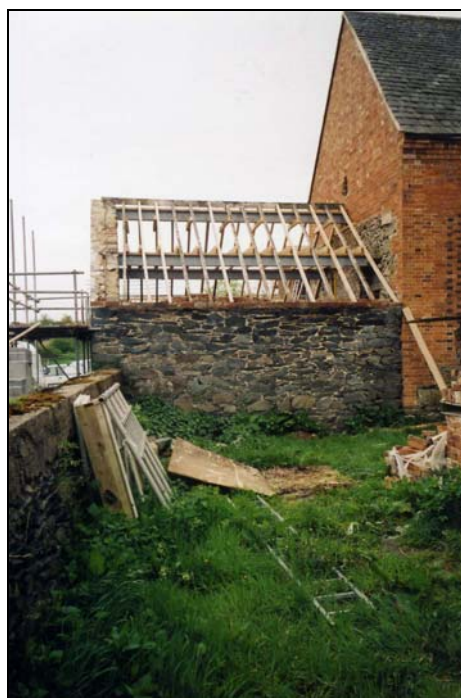
Plate 58. East elevation of building eight.

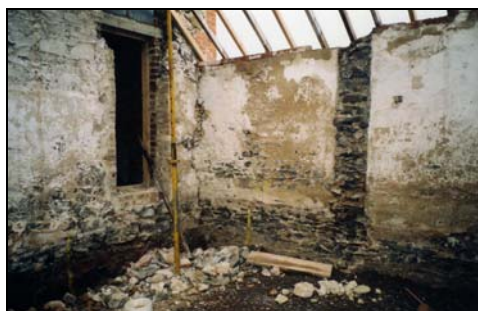
Internally the roughly coursed slate construction is visible although much of it concealed beneath plaster and paint. Centrally within this building a former internal partition has been removed (plate 60). This partition appears to have been bonded in with the external walls and may therefore be contemporary with the rest of the structure.

Plate 60. General view of interior of building eight looking northeast.

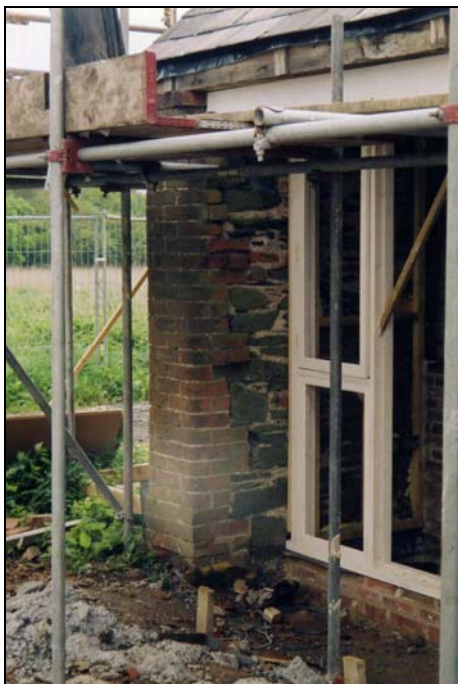
bullnosed brickwork on the interior corner (plate 61). Above the piers are plain timber lintels. On the west elevation the north and south corners both have brickwork quoins whilst the rest of the wall is a roughly coursed slate construction (plate 63). The south elevation and east elevation have similar details (see plate 62).

Plate 61. Northeast quoin of building nine.

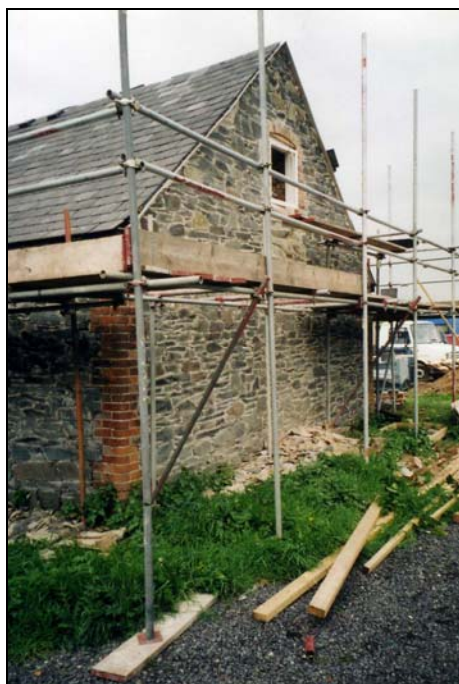
Plate 62. Southeast aspect of building nine.

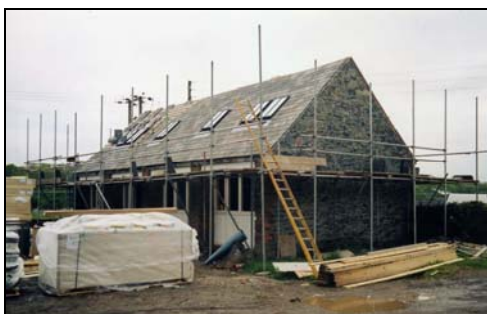
Plate 63. Northwest aspect of building nine.
