**A Level 2 Historic Building Survey at  
Limes Farmhouse Barns,  
22 Main Street,  
Breedon on the Hill,  
Leicestershire  
NGR: SK 40569 22848**

**ULAS Report No 2021-156  
©2021**

**Site Name:** Limes Farmhouse Barns, 22 Main Street, Breedon on the Hill, Leicestershire.

**Author:** Andrew Hyam

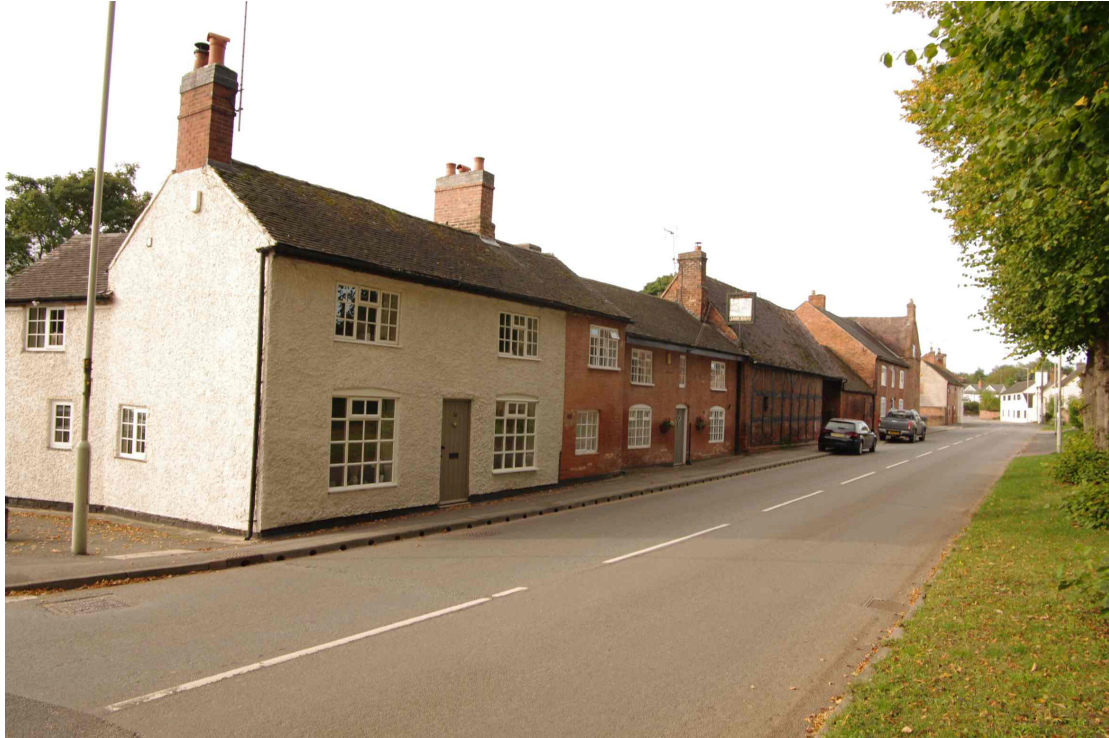
Figure 9 View of site from Main Street  
Looking south-west

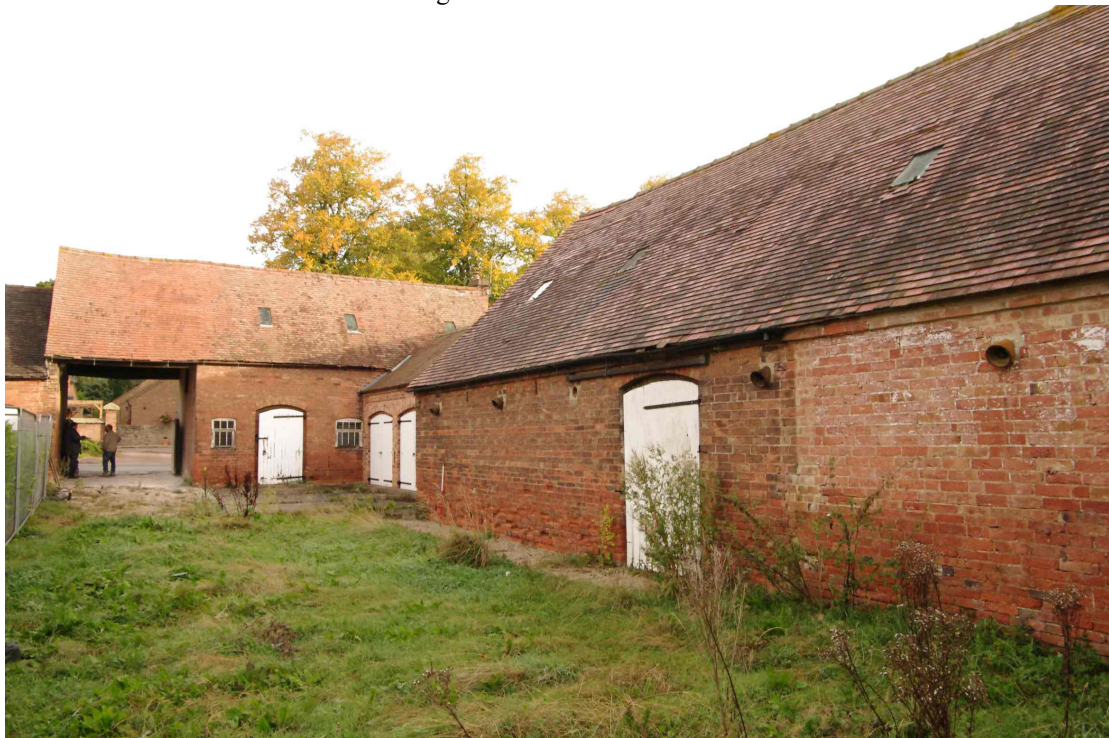
Figure 12 General view of the barns  
Looking north-east
