**A Level 2 Historic Building Survey at
Winfrey Farm,
Dadlington Lane,
Stapleton,
Leicestershire
NGR: SP 4234 9844**

Client: David Granger Architectural Design Limited

ULAS Report Number: 2021-158

A Level 2 historic building survey at Winfrey Farm, Dadlington Lane, Stapleton, Leicestershire (SP 4234 9844)

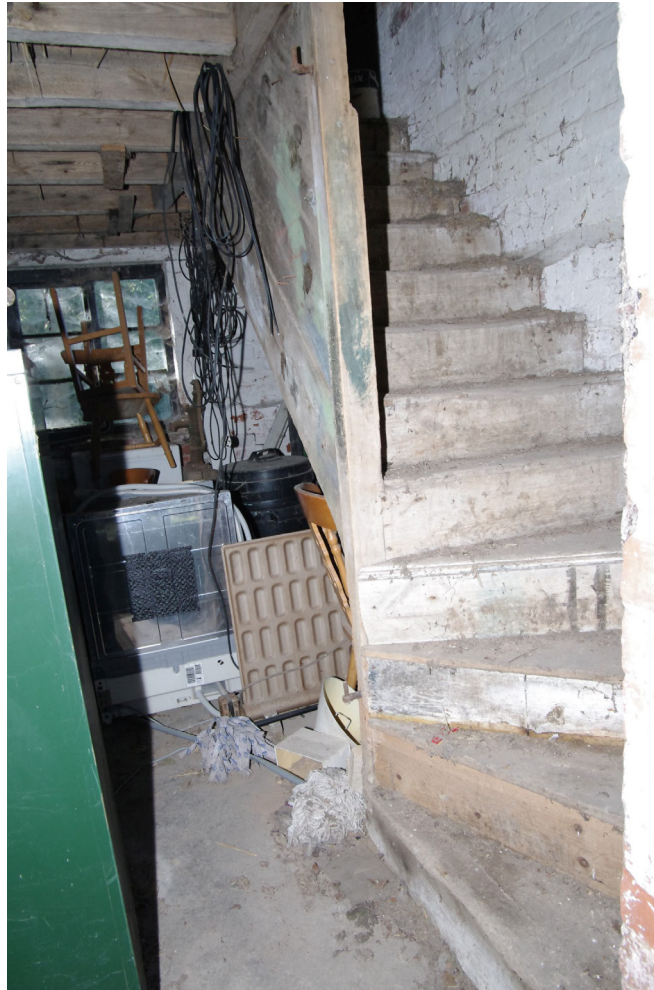
Figure 78 Building 7. Room 2

Looking south-east. This room has a small water pump and copper water boiler in the SE corner

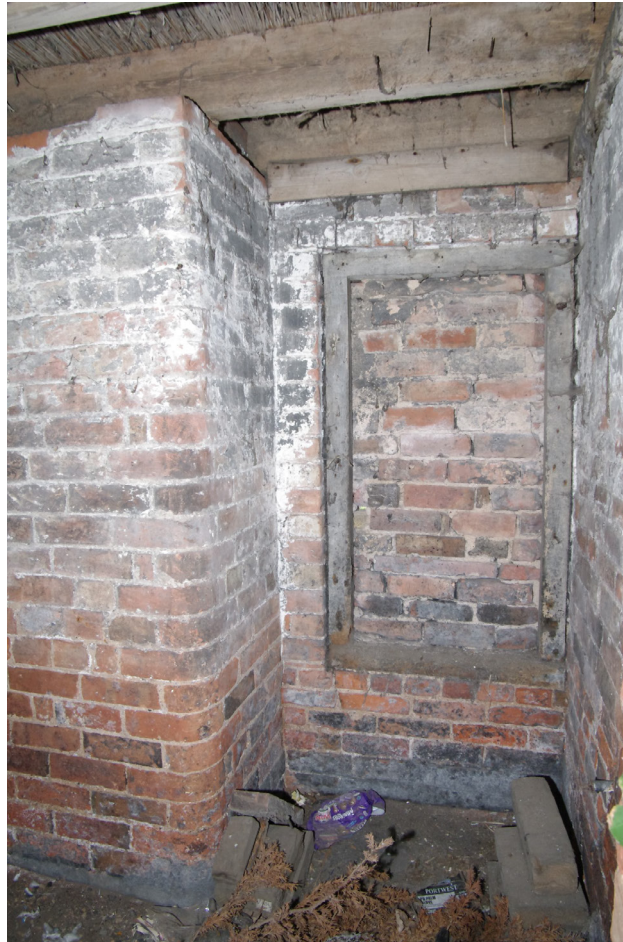
Figure 82 Building 7. Room 4

Looking south-east. This room appears to have been used as a coal store. Note reed and plaster ceiling for the floor above
