396–410 GORGIE ROAD, EDINBURGH

Historic Building Recording

commissioned by 3DReid Architects

November 2014

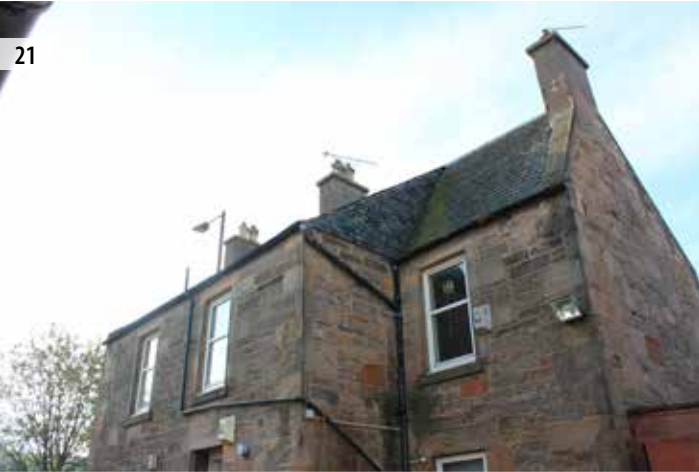
PHOTO 21

window surrounds of broached ashlar sandstone. The rear corners had been swept at ground floor level (Photo 020). Some of the stonework was in poor condition, especially where it had been tooled. Some of the masonry was of a different character (described below), but the whole appears visually consistent due to a fairly recent re-pointing. The three chimneys, one on each gable and one off centre, laterally (serving a fireplace on the ground floor) also appear to have been re-rendered. The pitched slate roof was in good condition, formed to a steeper angle to cater for the recessed north-eastern corner (Photo 021). Modern uPVC sash windows had been installed to replace timber originals.

398 Gorgie Road, oblique view of north-east external elevation

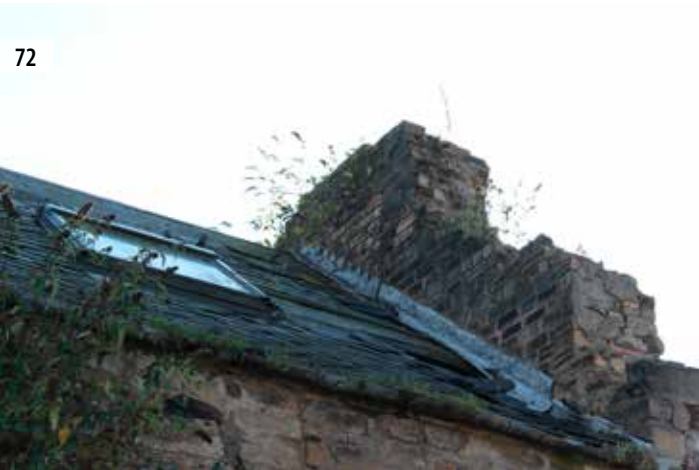
72

Gorgie Mill, general view of remaining section of north-east external elevation of demolished three-storey stone building

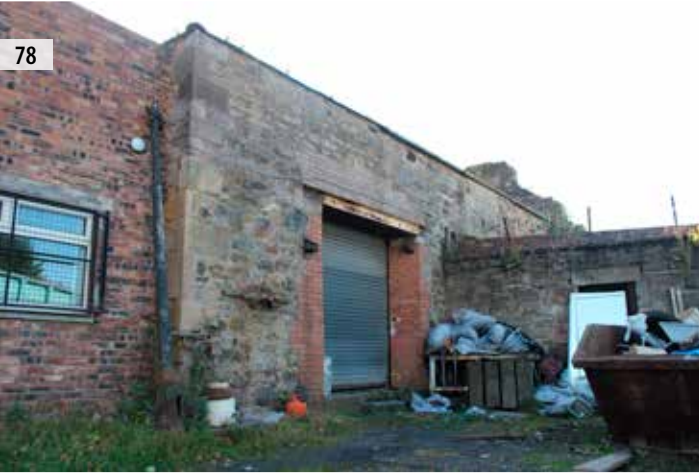
78

Gorgie Mill, oblique view of north-west external elevation

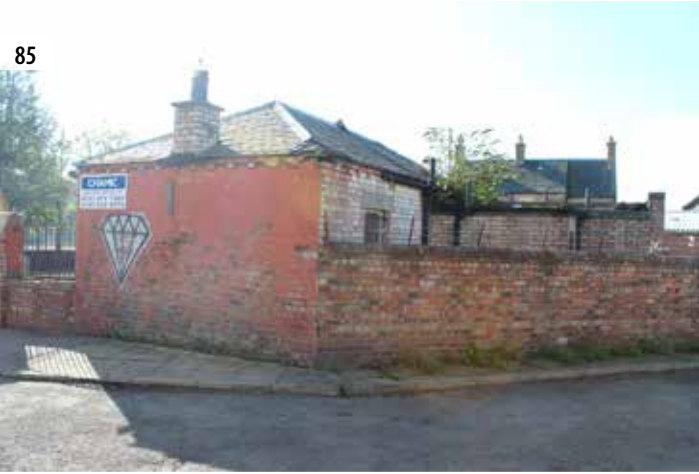
PHOTO 85

396 Gorgie Road, general view of north-east external elevation

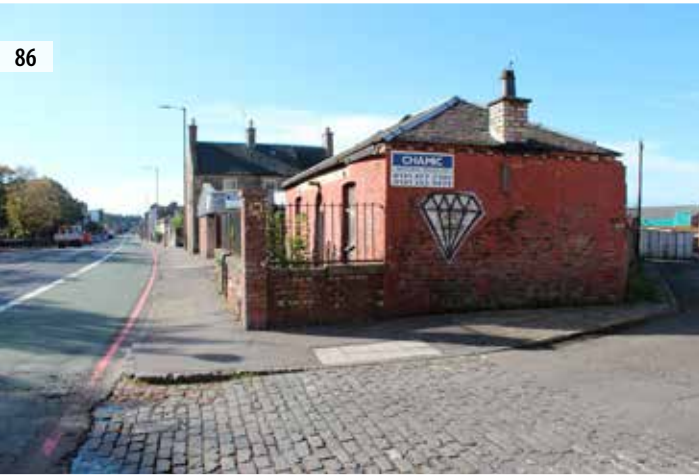
PHOTO 86

396 Gorgie Road, general view of north-east external elevation

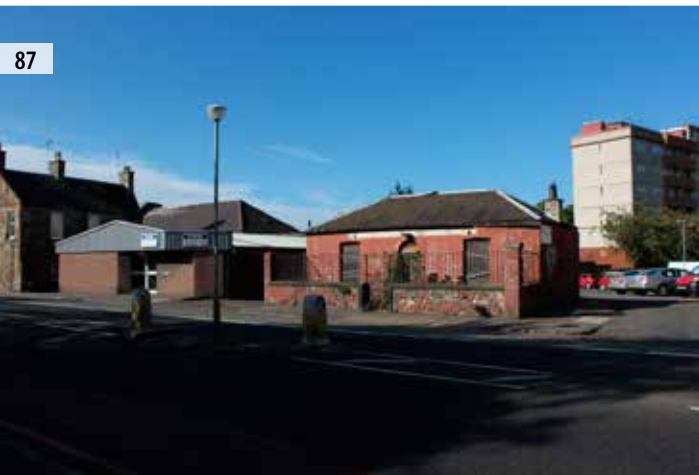
PHOTO 87

396 Gorgie Road, general view of south-east external elevation

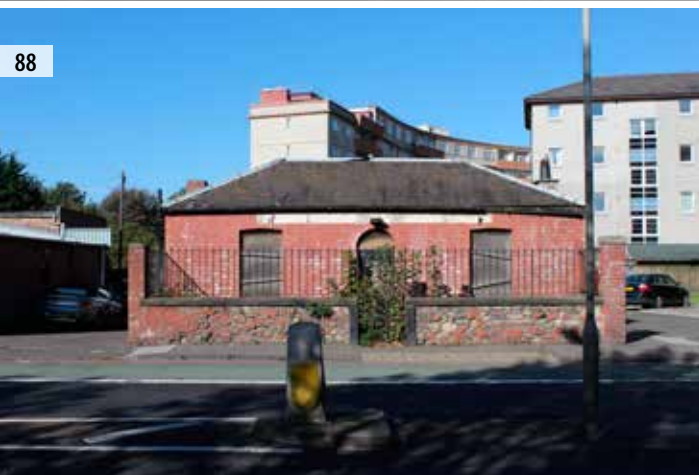
PHOTO 88

396 Gorgie Road, general view of south-east external elevation

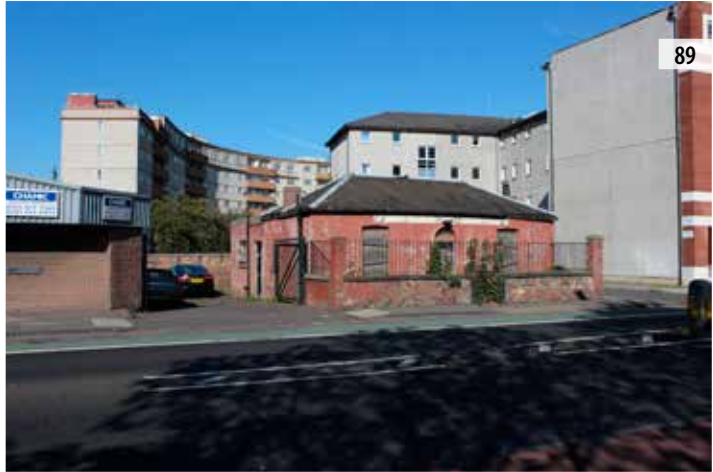
PHOTO 89

396 Gorgie Road, general view of south-east external elevation

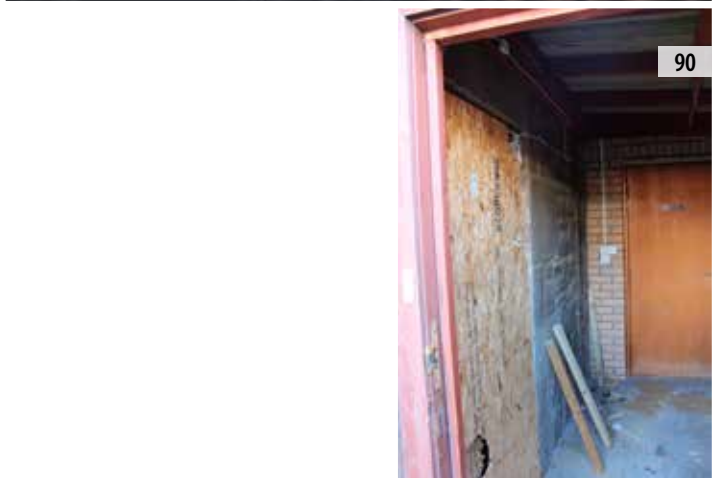
PHOTO 90

400 Gorgie Road, general view of north-west external elevation inside timber lean-to

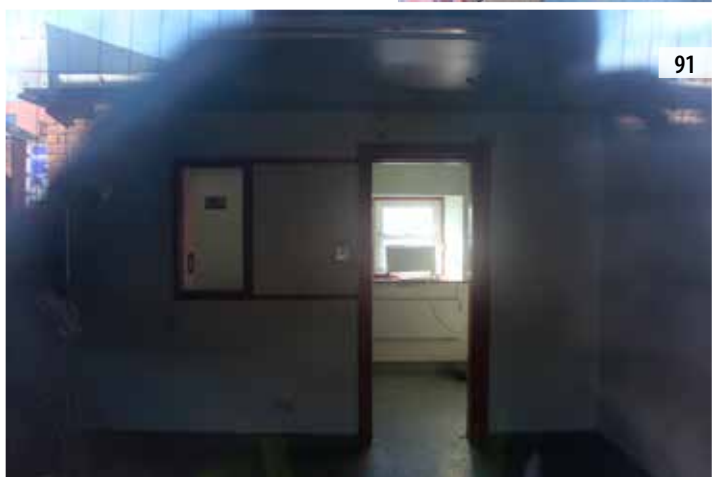
PHOTO 91

400 Gorgie Road, general view of ground floor interior through window

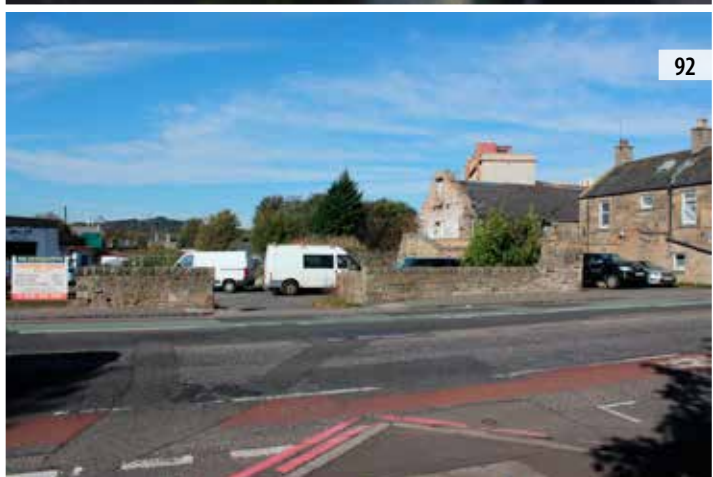
PHOTO 92

Gorgie Mill, general view of stone wall fronting Gorgie Road

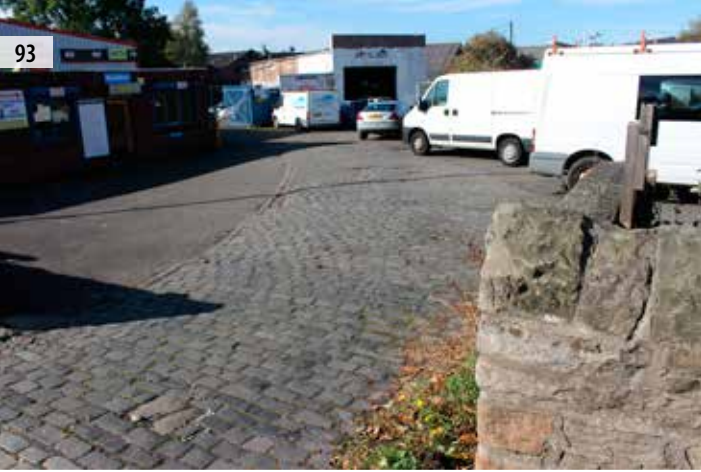
PHOTO 93

Gorgie Mill, general view of cobbled road south-west of Gorgie Mill
