HANSON HOUSE  
SNYDALE ROAD  
NORMANTON  
WAKEFIELD  
WEST YORKSHIRE

Historic Building Recording

**Planning Application Ref: 07/00704/FUL & 07/00705/LBC**

74352.02\_BDG\_V0\_3

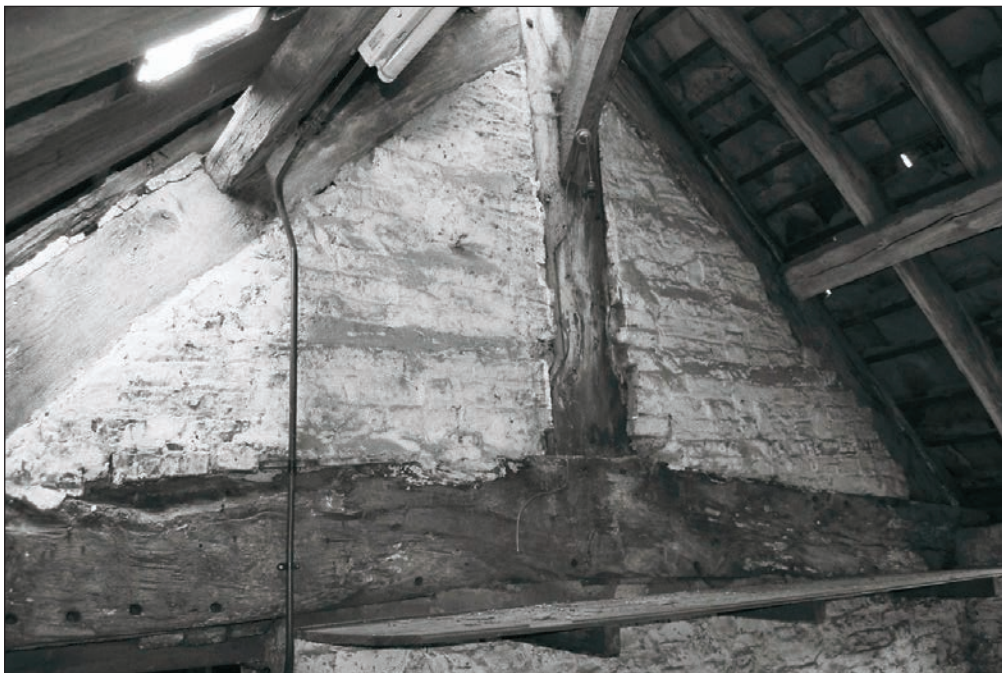
- 5.2.11 At first floor there was a single room (F2) accessed from an inserted door in its south wall (**Plate 78**). The nesting holes were positioned within the north wall, although some had been lost when the gable collapsed. A rotated tie beam set in the wall supported the gable (**Plates 78, 79 and 81**), which contained simple timber supports carrying the ridge piece and purlins of the roof. The inserted floor truncated the lower nesting holes in the wall. There was a blocked window within the east and west walls, and the early timber truss dividing the north and central bays had been infilled with brick when the dovecote was inserted (**Plate 82**).

Plate 82: Detail of timber truss with later brick infill, F2, Building 1 (Film 06.09)

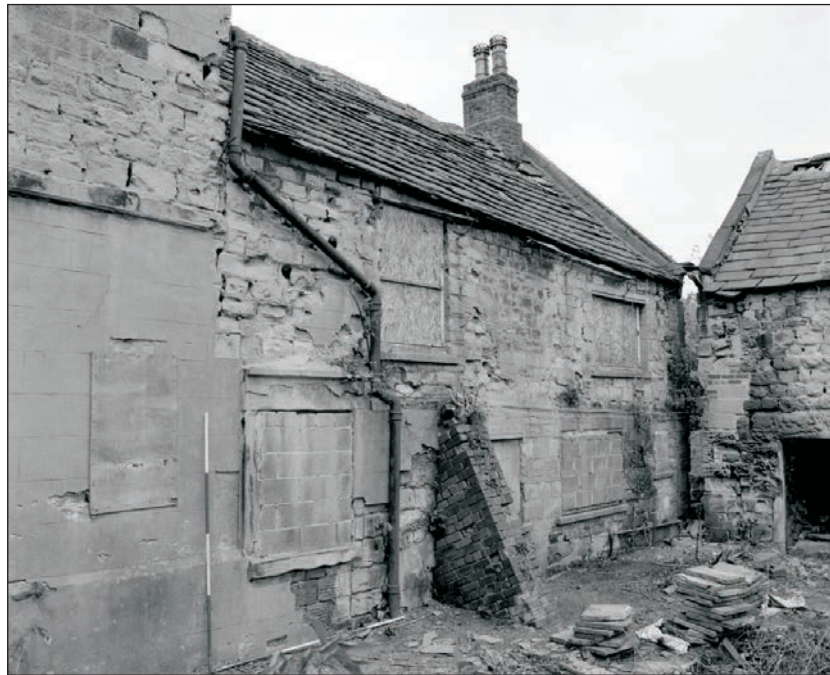
- 5.3.3 The south elevation (**Figure 15 and Plates 96, 97**) did not contain any timber framing externally, all having been replaced by coursed sandstone. It appears that this was replaced prior to the addition of the phase 3 wing to the west. The south elevation contained an altered door to window (blocked) at the junction with the addition to the west, with stone lintel and sill, and three windows at ground floor of various sizes, each with rendered lintels and sills (all blocked at the time of survey) (**Plates 98-100**). Positioned off centre to the west against the elevation was a brick buttress (**Plate 101**). At first floor centrally positioned within each bay was a window, each with rendered lintel and sill. The window within the west bay was tall and narrow, whilst that within the east bay was shorter and wider (**Plates 96, 97**). There was a vertical joint within the stonework at the east end of the elevation with the gable of the building, indicating their different phases (**Plate 99**). Much of the stonework was heavily eroded and as a result areas of the elevation had been rendered and contained some raised modern pointing. The roof was pitched and covered with stone tiles.

Plate 96: General view of the south elevation of Building 2 (Film 10.08)

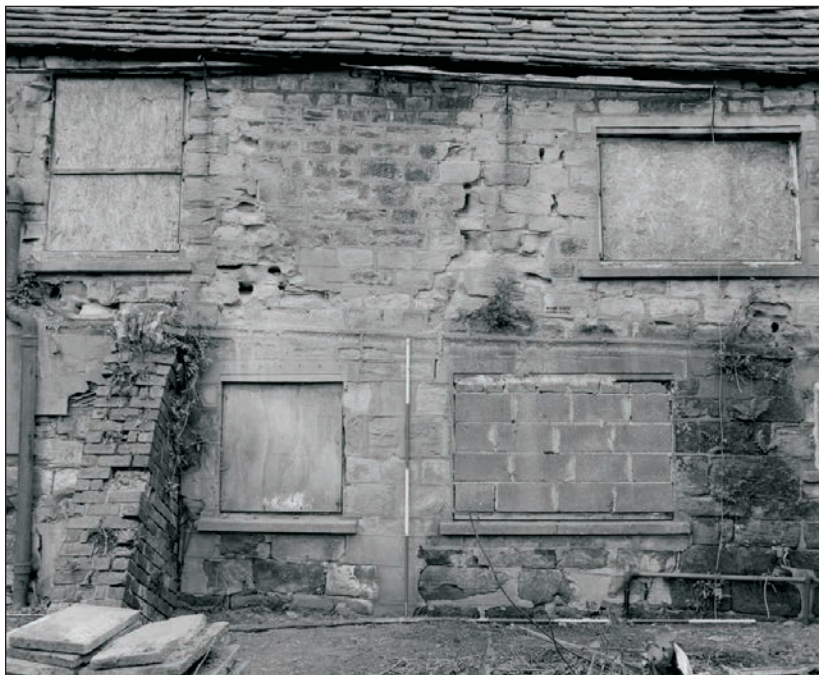
Plate 97: General view of the south elevation of Building 2 (Film 10.03)

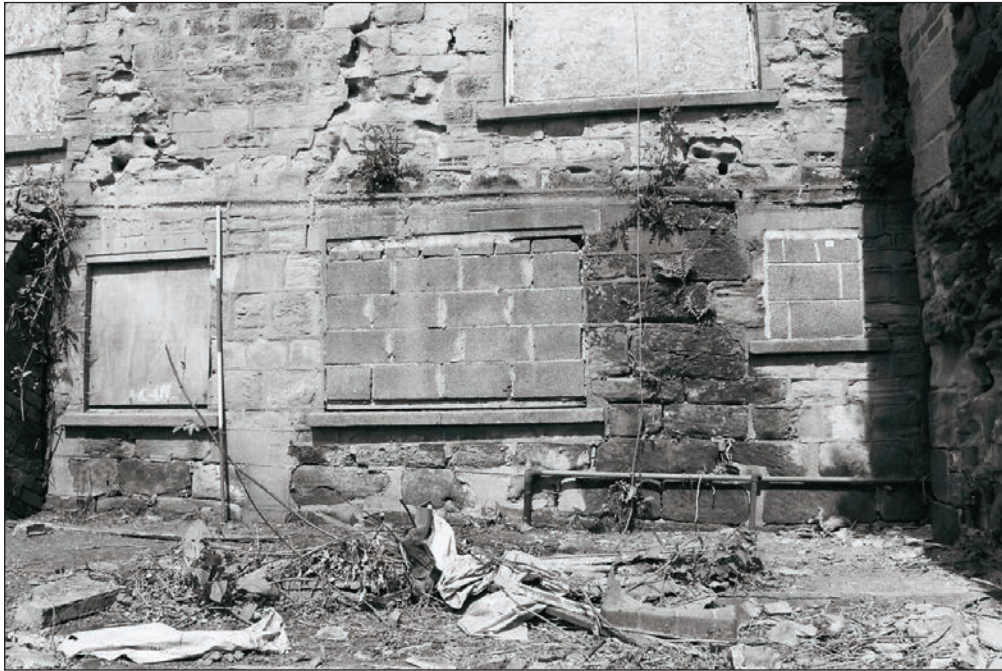
Plate 98: General view of the south elevation of Building 2 (Film 01.27)

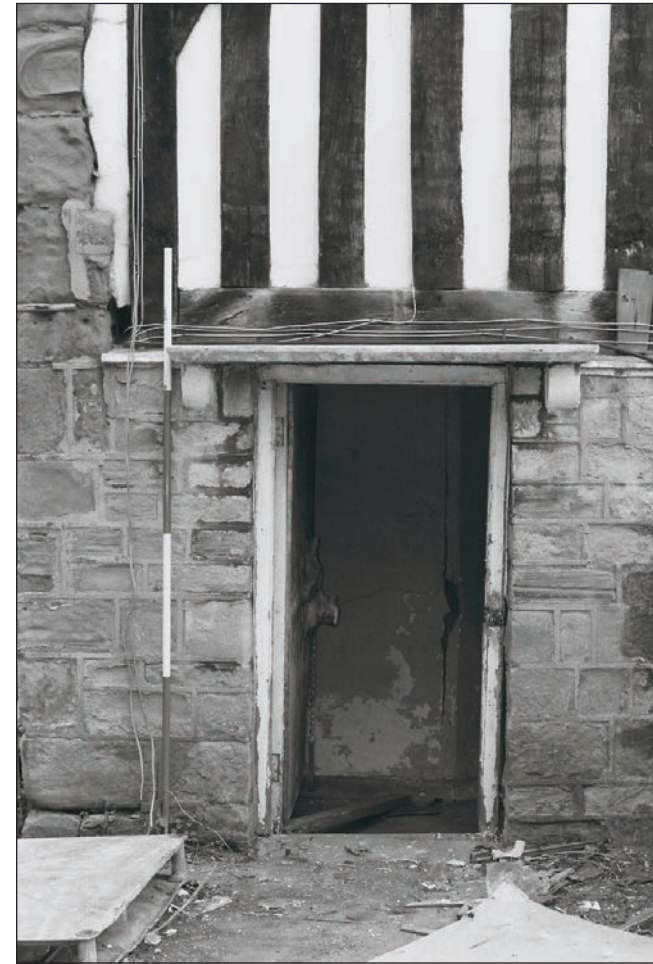
- 5.3.7 At ground floor the elevation was constructed with coursed sandstone. The former close studding below the mid-rail had all been removed and replaced with stone wall. Positioned at the east end was an inserted doorway with flat stone pediment (**Plate 109**). To the west of this was a stone built buttress, an altered or inserted window (blocked) and a small window at the west end in the position of a former doorway, opposing the former doorway within the south elevation (**Plate 107**). Two pairs of peg holes within the mid-rail indicated the position of the former doorway within the timber framed building (**Plate 116**).

Plate 109: Detail of doorway, north elevation of Building 2 (Film 04.30)

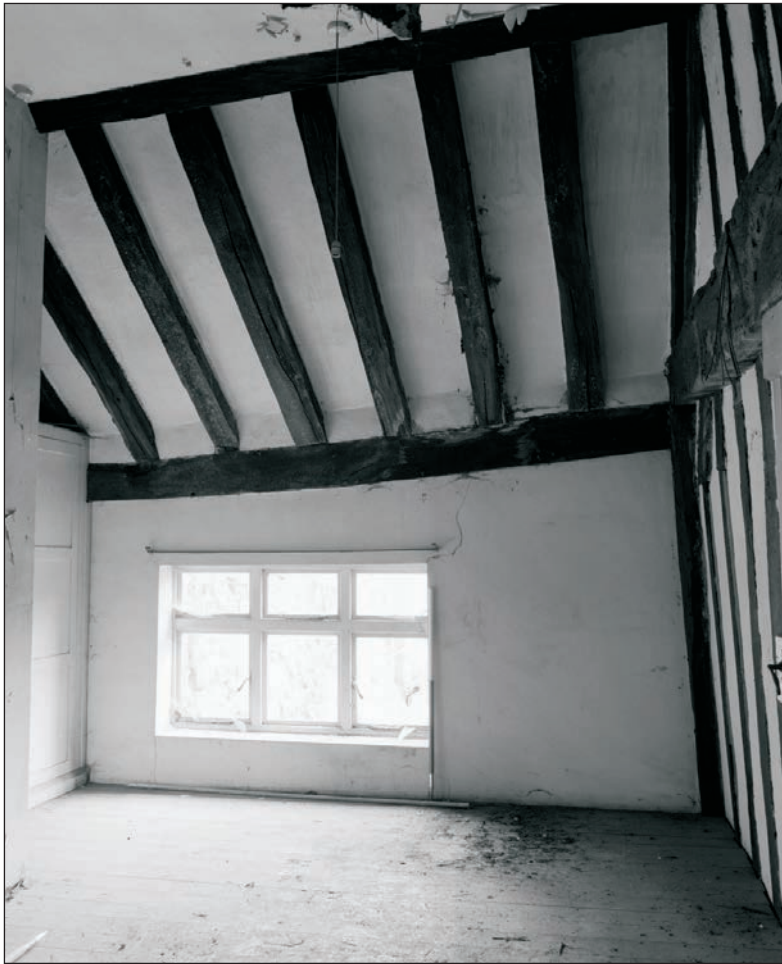
Plate 185: General view of F1, showing window to the south, Building 2 (Film 17.03)

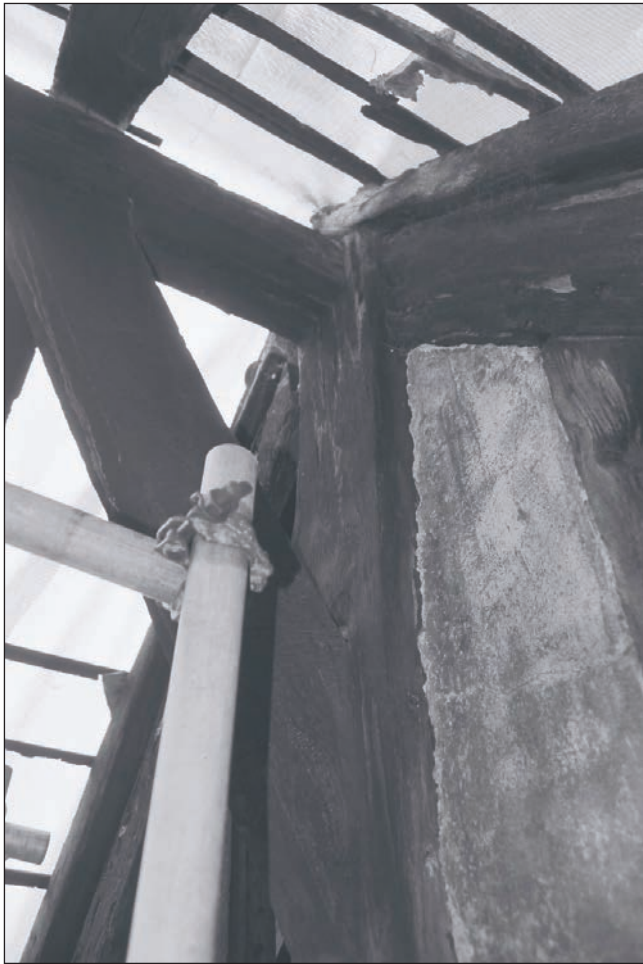
Plate 215: Detail of King-Post and ridge brace, F1, Building 2 (Film 41.03)

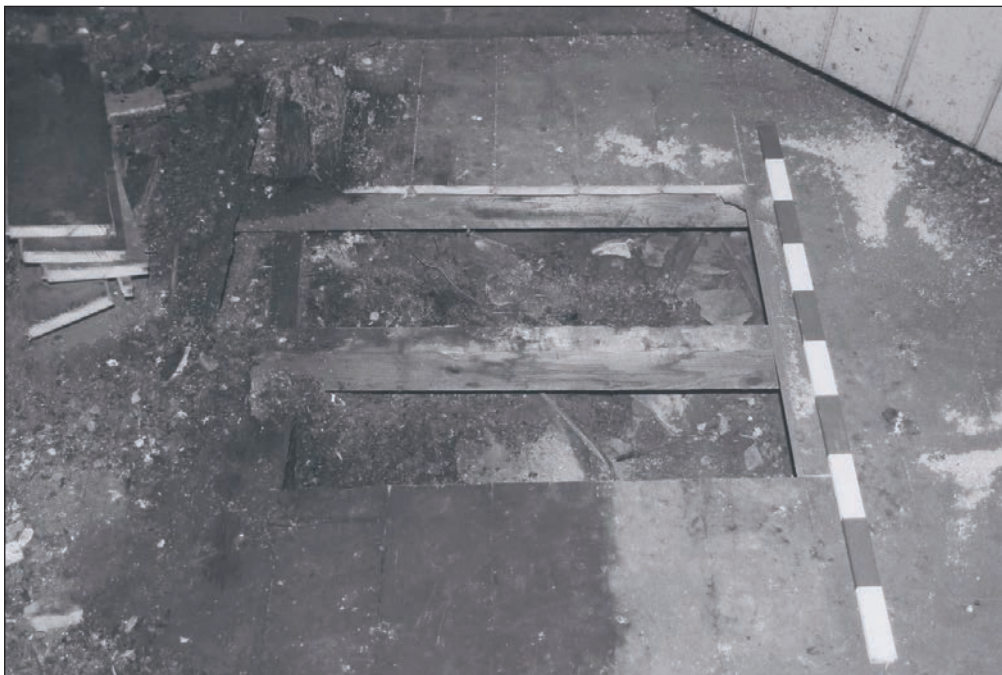
- 5.3.19 The watching brief on the first floor monitored the lifting of the modern floor boards, revealing an original lime-ash floor beneath. Within room F2/F3 the limeash sat directly on top of the laths between the joists as well as over the top of the joists. A boarded-over gap in the limeash corresponded with the original ladder opening within the floor, observed within the ceiling of G1 and G4 below (**Plates 224-225, 227, 228**). The floor within room F1 had been constructed slightly differently, with the limeash resting on the laths between the joists at a level flush with the top of the timber joists. Some slate tiles had been added to the lime-ash floor in order to level it (**Plates 226, 229, 230**). The whole of the floor across the building slumps downwards to the east.

Plate 226: General view of lifted floor boards, Area 3, F1, Building 2 (Film 38.29)

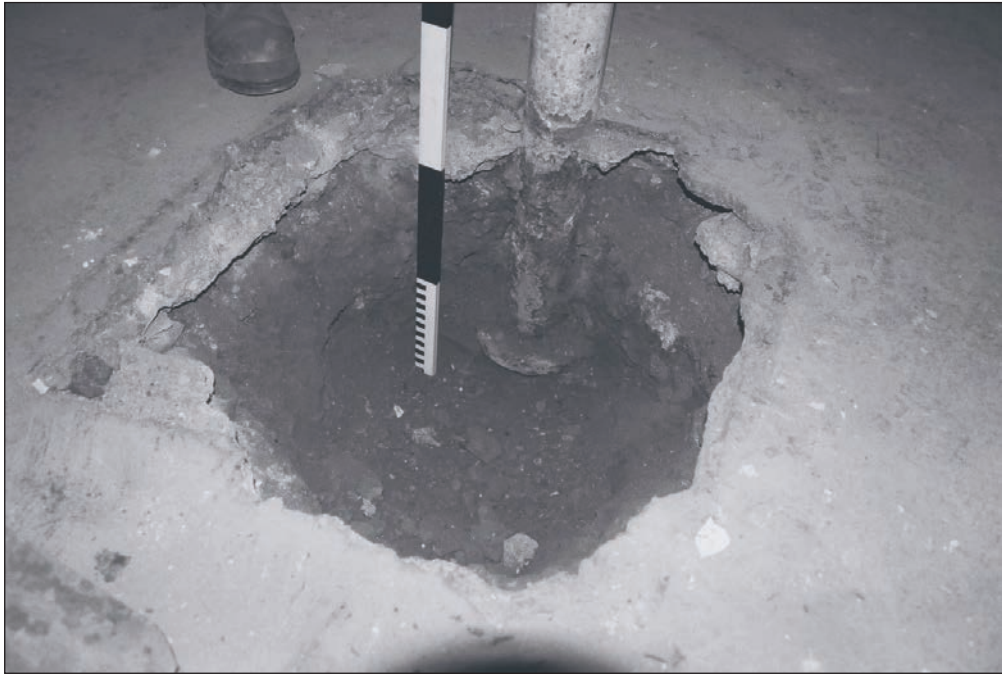
(**Plate 233**). The base of the central supporting iron post was seen 0.36m below floor level in Test pit 5, and was set on sandstone slabs (**Plate 231**).

Plate 231: General view of Test Pit 5, G1, Building 2 (Film 35.28)

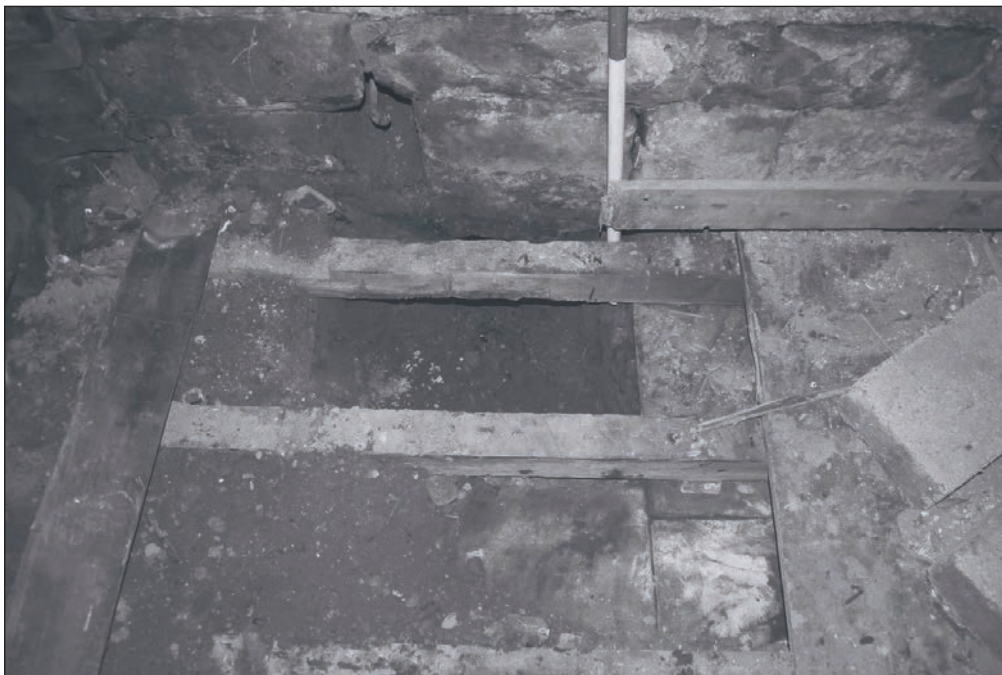
- 5.3.20 Stone flagstones were revealed 0.4m below the timber floor in Test Pit 11 (**Plate 232**), and the base of internal brick wall dividing Building 2 from Building 3 was revealed 0.2m below ground level in Test Pits 12 and 14

Plate 232: General view of Test Pit 11, G4, Building 2 (Film 37.35)

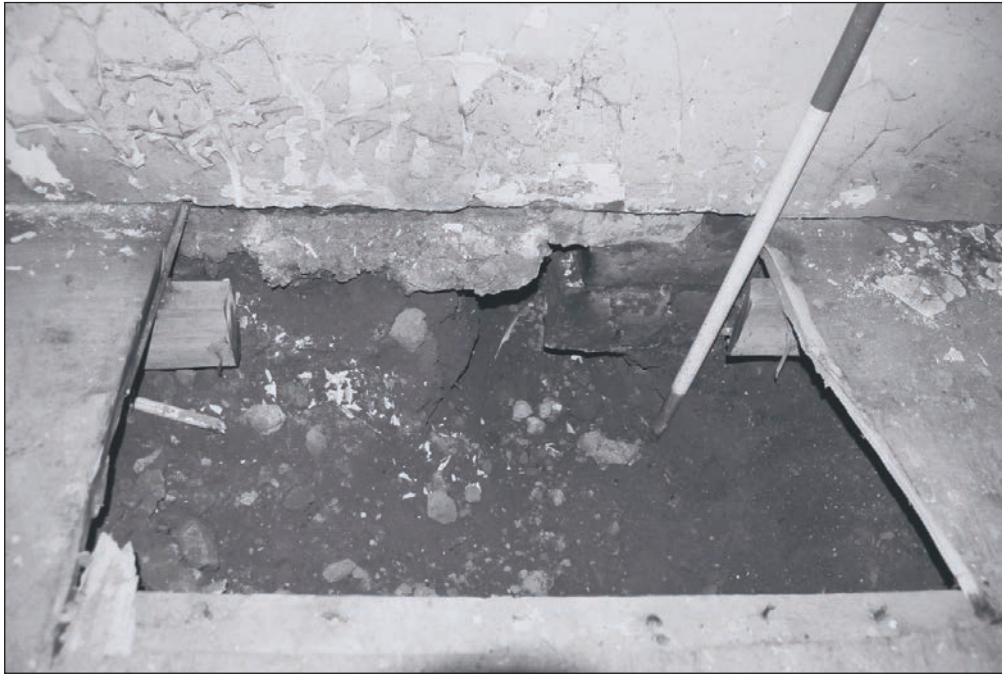
Plate 233: General view of Test Pit 12, G3, Building 2 (Film 37.27)

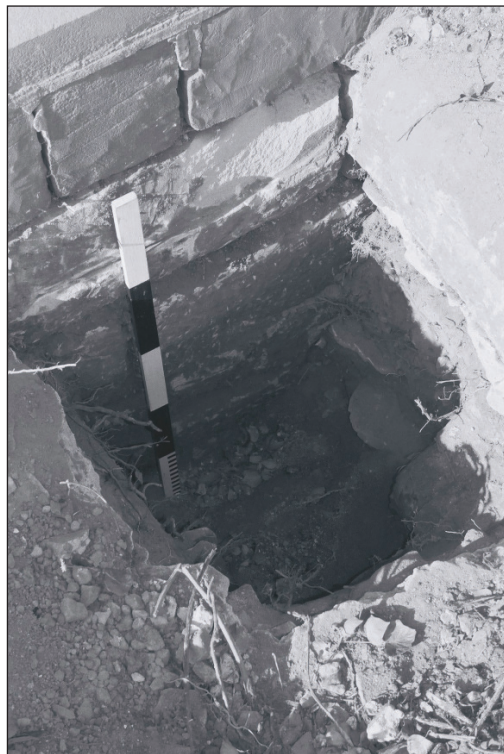
- 5.4.5 The southern foundations of Building 3 were revealed at 0.67m depth in Test Pit 10 (**Plate 249**).

Plate 249: General view of Test Pit 10 (Film 35.27)

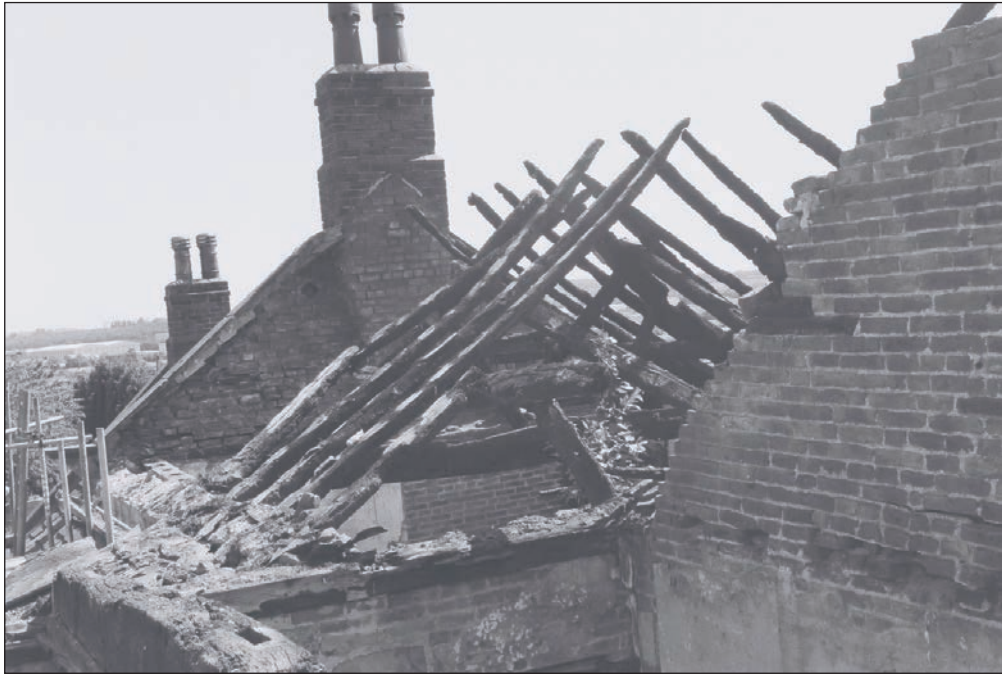
Plate 310: General view across roof of Buildings 3 and 4 (Film 25.01)

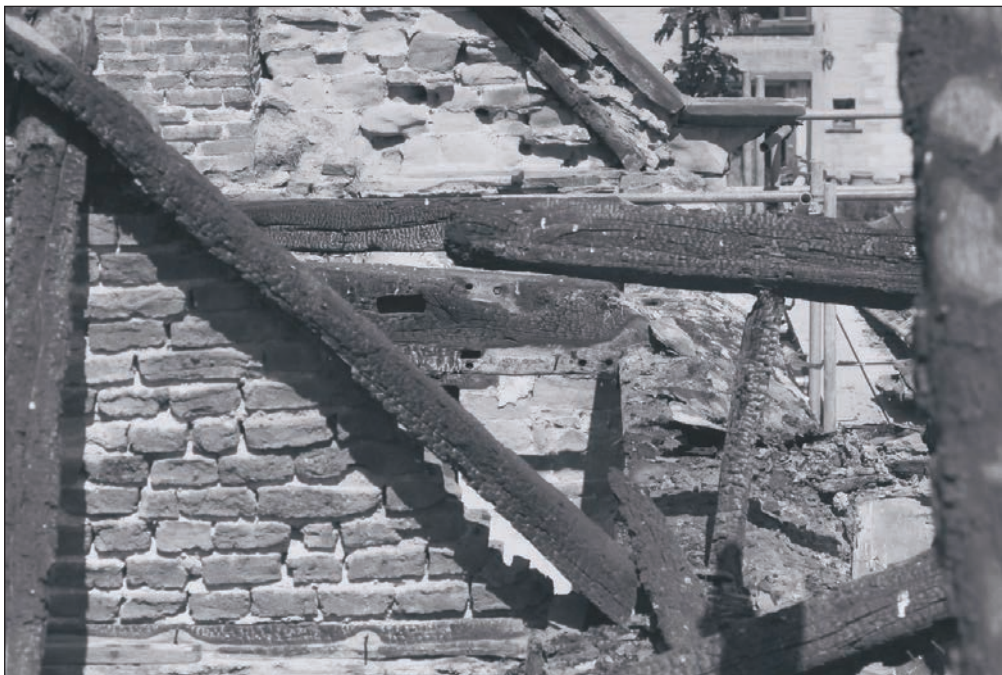
Plate 311: Detail of north end of east wall head, Building 4 (Film 25.03)

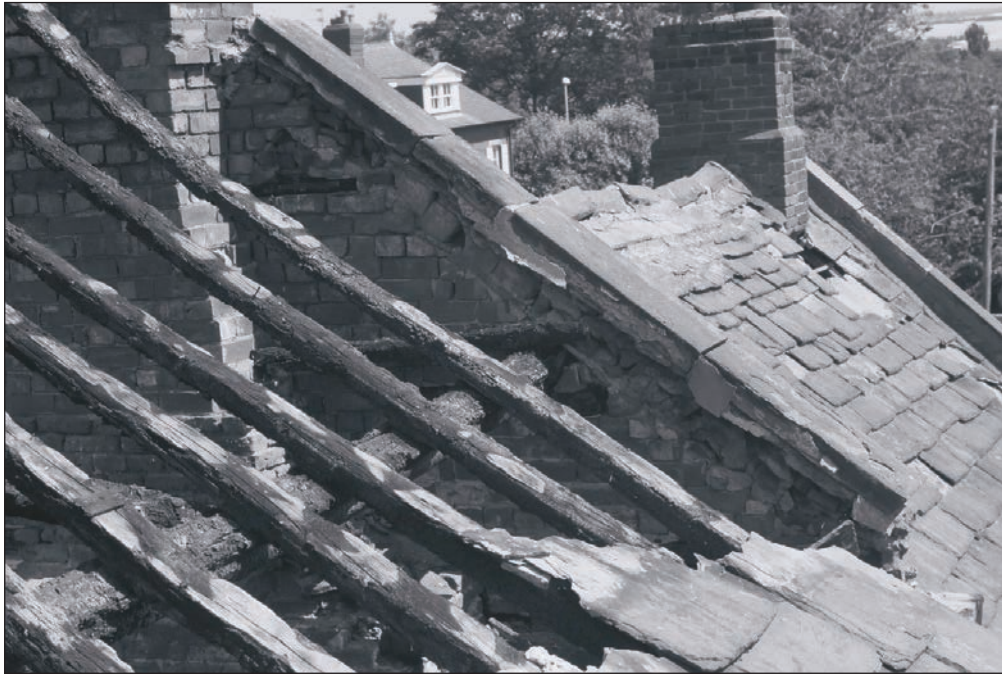
Plate 312: General view across roof of Buildings 3 and 2 (Film 25.04)

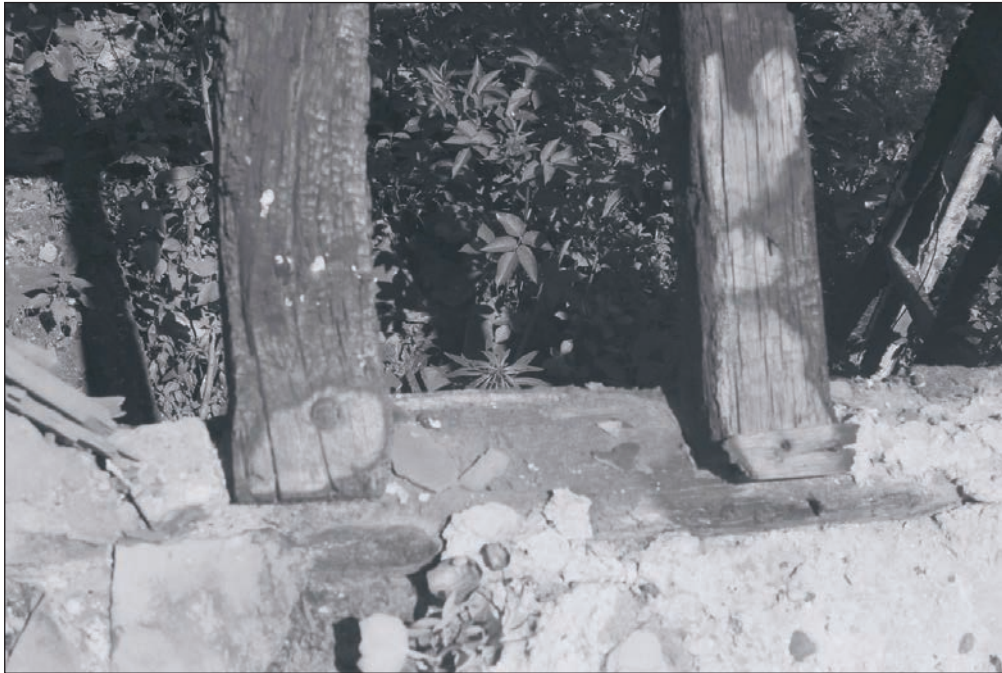
Plate 314: Detail of south wall plate, Building 3 (Film 25.08)

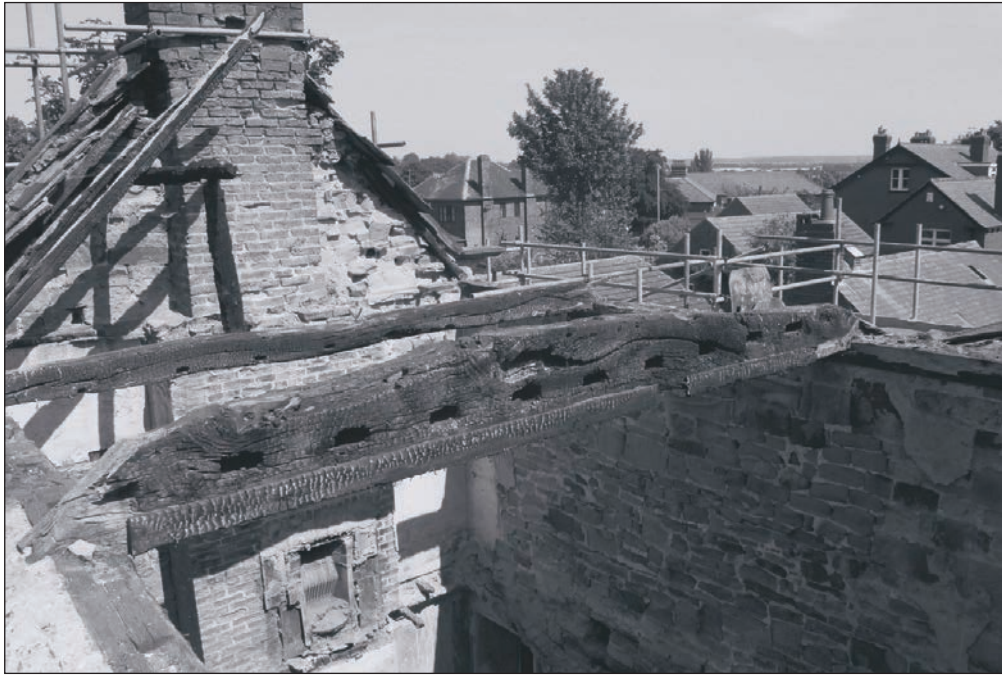
Plate 324: General view of roof timbers, north end of Building 4 (Film 25.28)

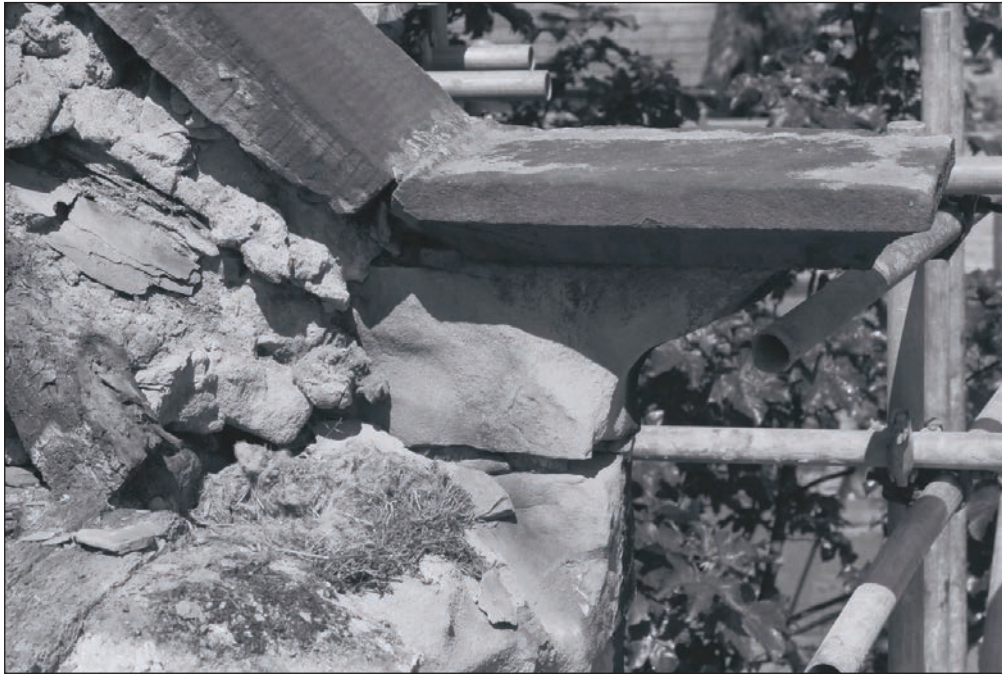
Plate 328: Detail of north gable east kneeler, Building 4 (Film 26.01)

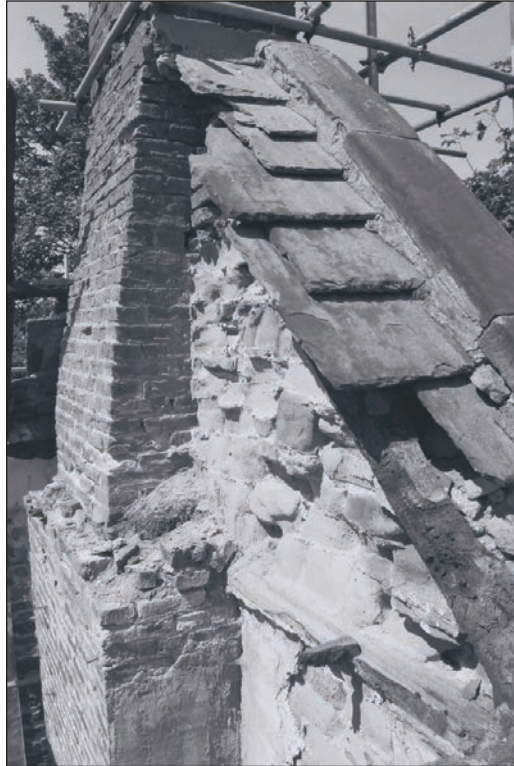
Plate 342: View of the north gable of Building 4, from the southeast (Film 26.29)

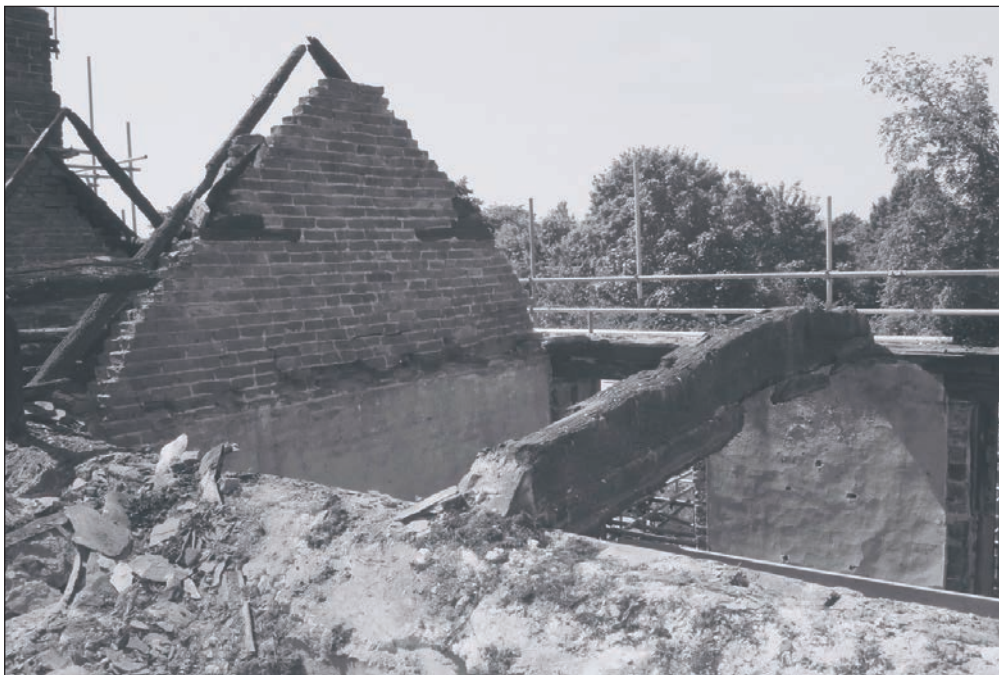
Plate 345: General view of central brick gable and tie beam, Building 4 (Film 26.34)

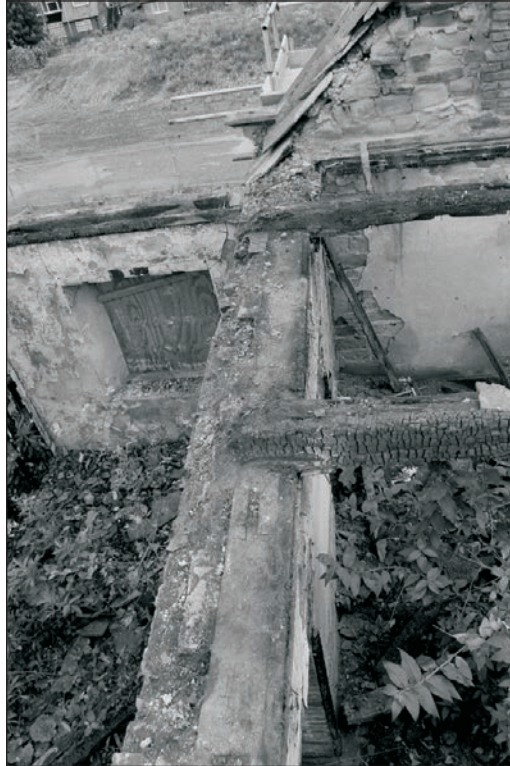
Plate 348: View along wall head, south end of east wall, Building 4 (Film 27.22)

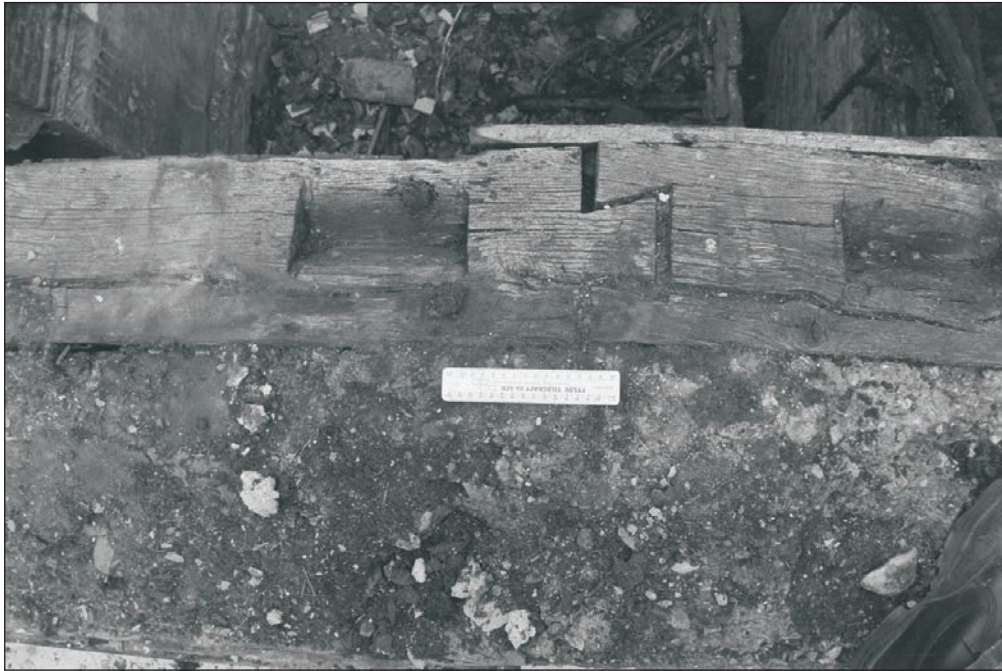
Plate 354: Detail of scarf joint, west wall plate, Building 4 (Film 27.33)

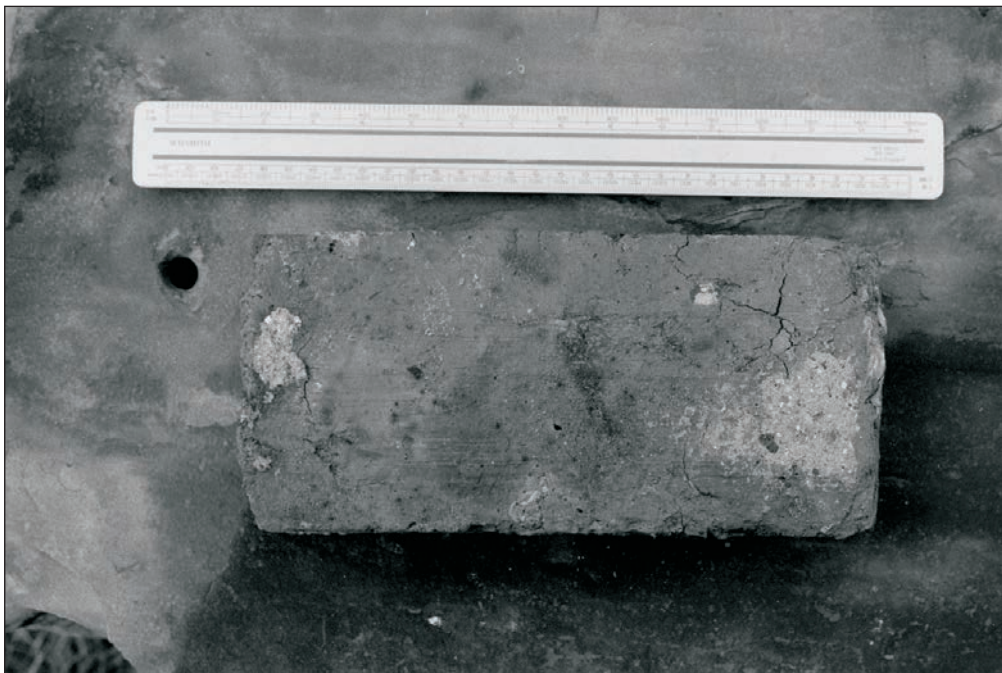
Plate 355: Detail of hand made brick from gable of Building 4 (Film 27.16)

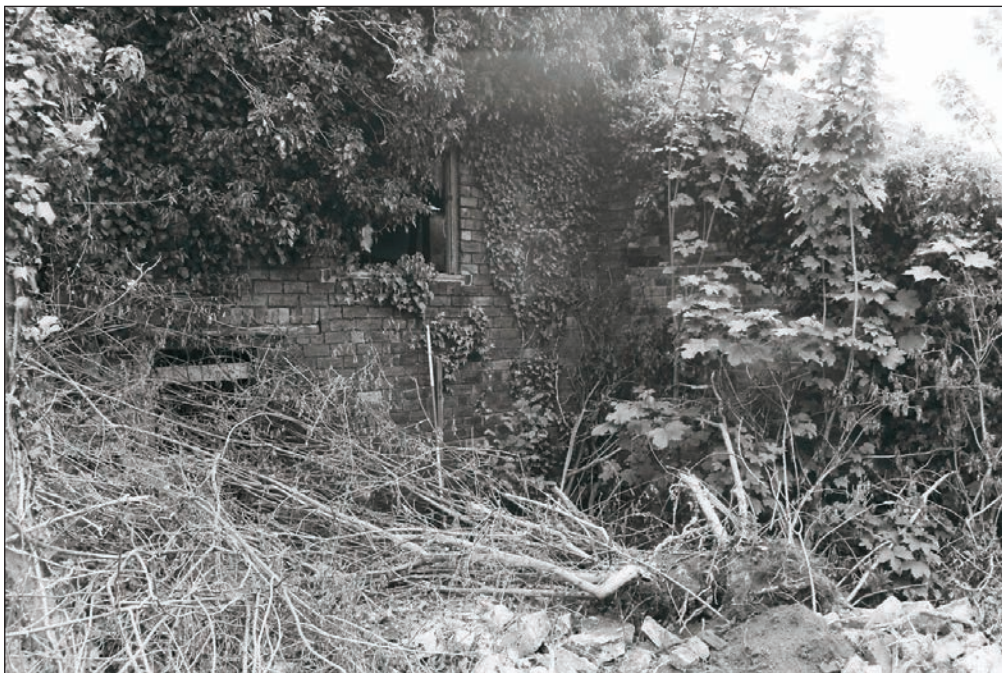
Plate 359: General view of the northwest corner of Building 5 (Film 06.25)

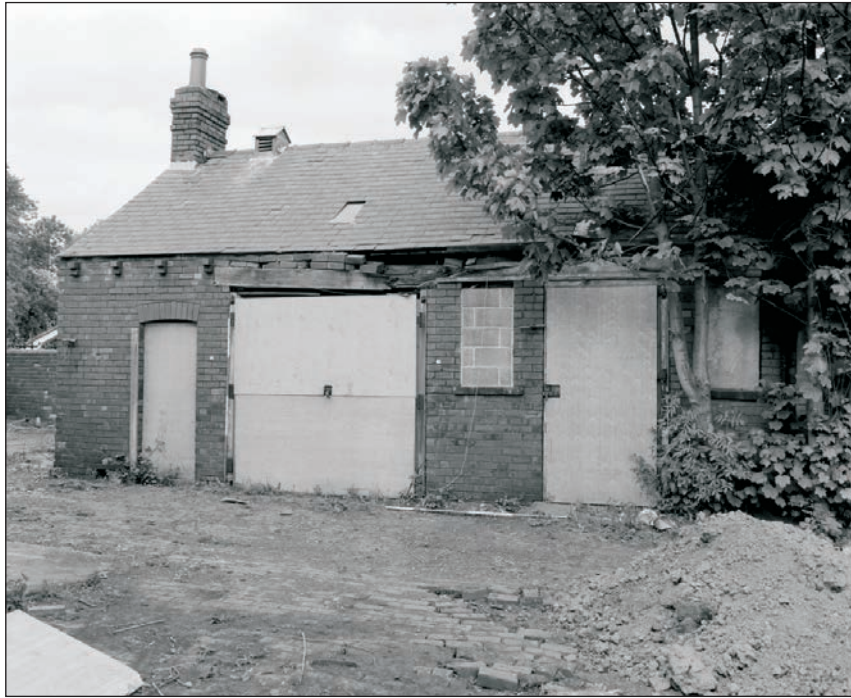
with a slate covering and a chimney within the east gable. A small lean-to was also attached to the east elevation (**Plate 369, 370**). The south elevation contained a large vehicular doorway with an adjacent pedestrian door, and a second doorway to the east with flanking windows (**Plate 368**). Decorative brick dentils along the eaves level of the elevation would have once supported timber guttering. A small timber louvered ridge vent was positioned at the west end of the roof. The building appeared to have two separate internal rooms, one possibly utilised as a small stable (**Plate 371**).

Plate 368: General view of the south elevation of Building 7 (Film 08.01)

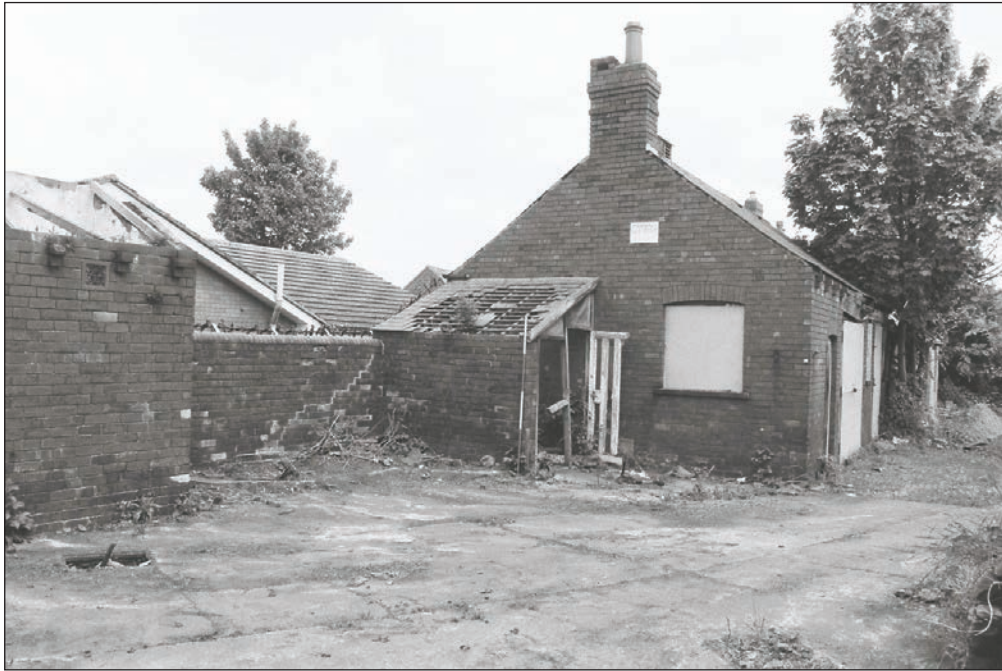
Plate 370: General view of yard to the north showing Buildings 7 and 8 (Film 01.01)

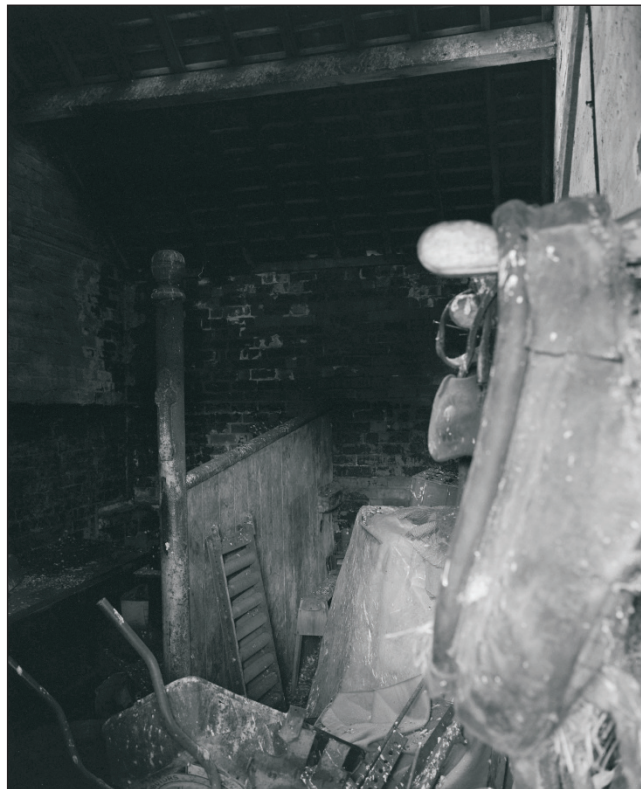
Plate 371: General view into Building 7, showing stable stalls (Film 22.08)

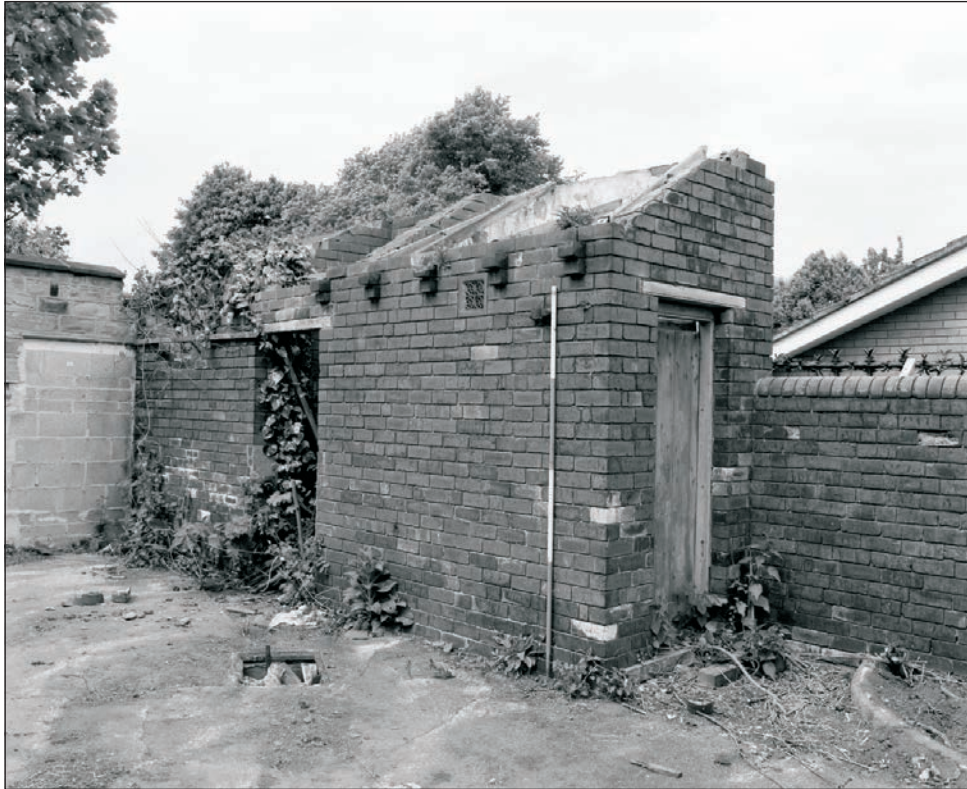
- 5.7.2 Building 8 to the southwest was constructed in the same style as Building 7, but was a much smaller lean-to, with doorways to the south and east (**Plate 372**). This was likely an outside W.C. and store.

Plate 372: General view of Building 8 (Film 08.06)
