Field Farm, Ashby Road Kegworth, Leicestershire

Historic Building Record

Ref: 101406.02
February 2017

Prepared for:
CgMs Consulting
140 London Wall
London
EC2Y 5DN

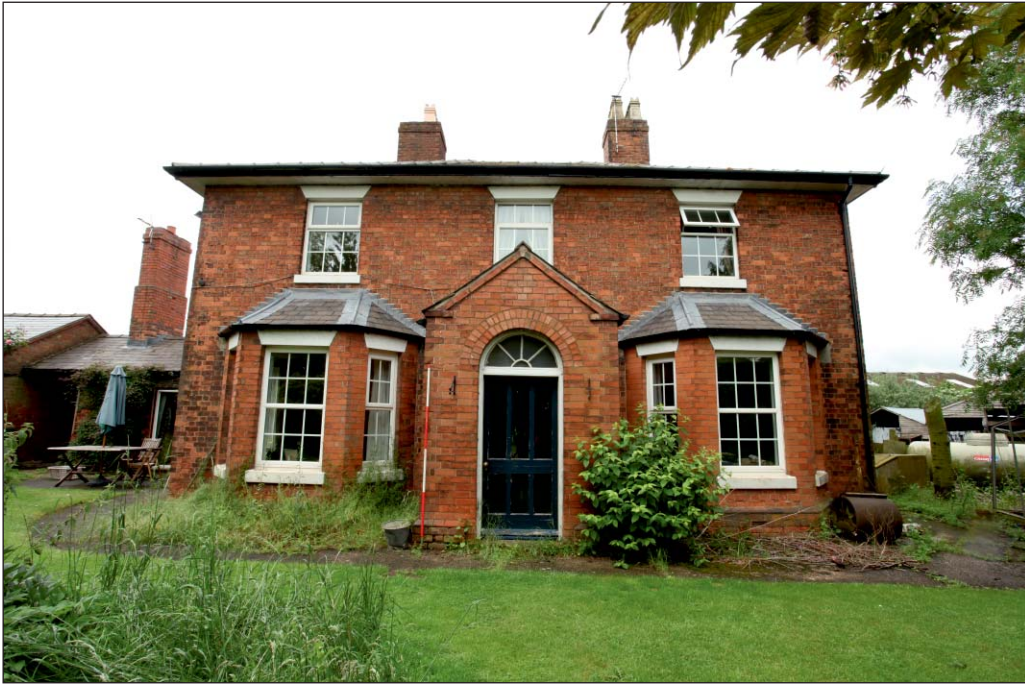
- 6.2.4 The majority of the building has red brick walls that vary in shade, which suggest an uneven firing process. The bricks are predominantly laid in stretcher bond but there are areas of irregularity, whilst the east, principal elevation, of the main house is laid in Flemish bond (Plate 3). This elevation has the central porch and bay windows either side at ground floor level and three windows above. All the windows have masonry heads and sills but the window frames are uPVC replacements. The bricks of the bay windows are different from the rest being brighter and more homogenous in colour and they have a lozenge shaped frog and are marked 'TUCKER LOUGHBORO'. This suggests the porch and bay windows are additional features constructed prior to 1884 (Figure 2A). The date of these features is discussed in more detail in section 7.7. The east porch entrance (Plate 3) has a glazed, six-panel timber door and semi-circular fan-light, consistent with a 19th century date.

Plate 3: View of Building 1 showing the principal (east) elevation

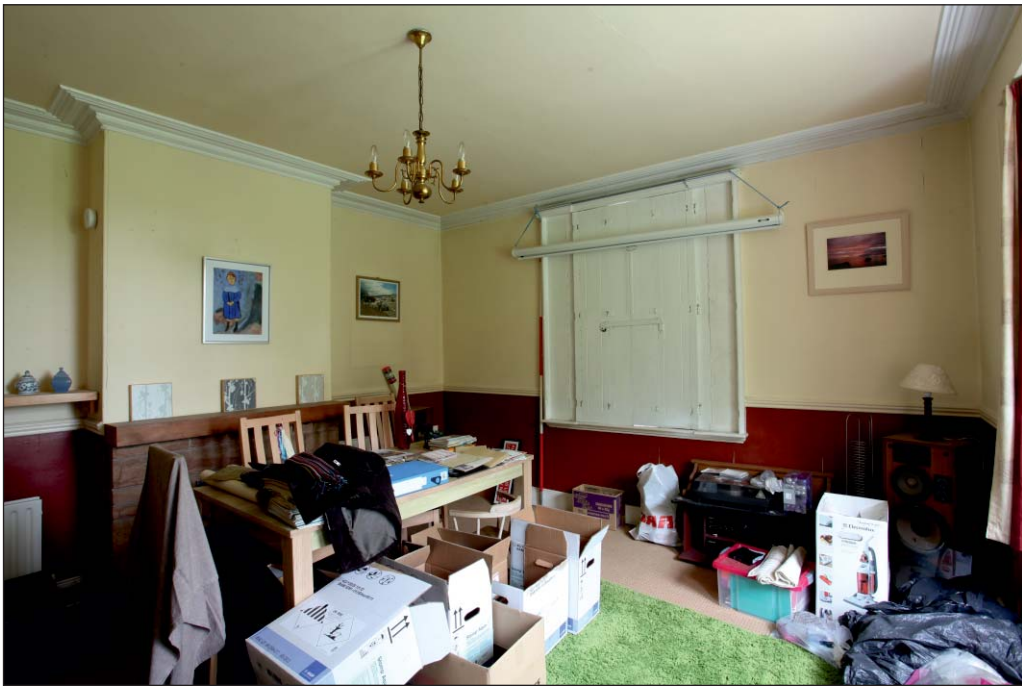
Plate 14: View of reception room G02, Building 1, viewed from the south-east

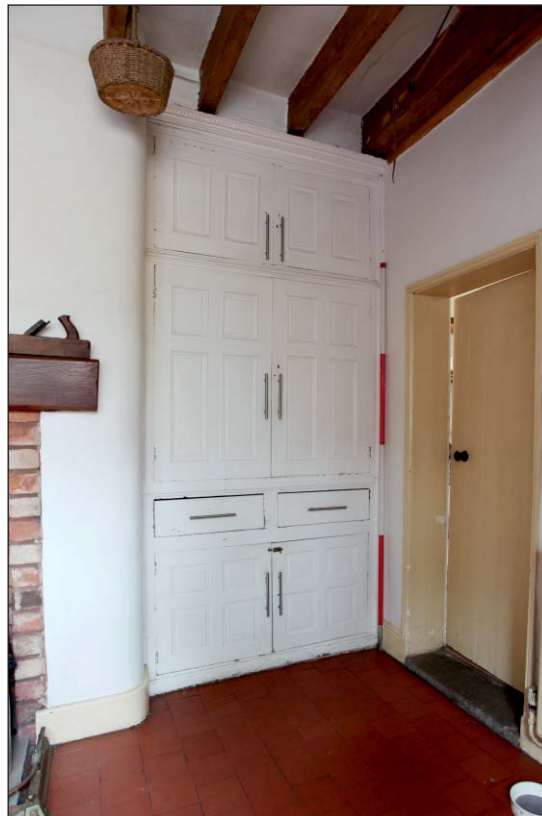
- 6.2.20 The kitchen (G05) (Plate 17) has been updated with modern kitchen units and wood-burning stove inserted in the fireplace on the east side of the room. In addition, the kitchen window is a later insertion (although likely in the position of a smaller original window) with a uPVC frame and there is a blocked door in the north-west corner of the room that previously provided access to F06 via a staircase. This staircase is no longer accessible or visible from ground level. However, the kitchen does retain some historic features consistent with the date of the building including the beams overhead, quarry tiled floor and a dresser/cupboard in the south-east corner of the room with moulded two- and four-panel doors and dentil cornice (Plate 18).

Plate 18: View of kitchen dresser/cupboard in the south-east corner of G05, Building 1

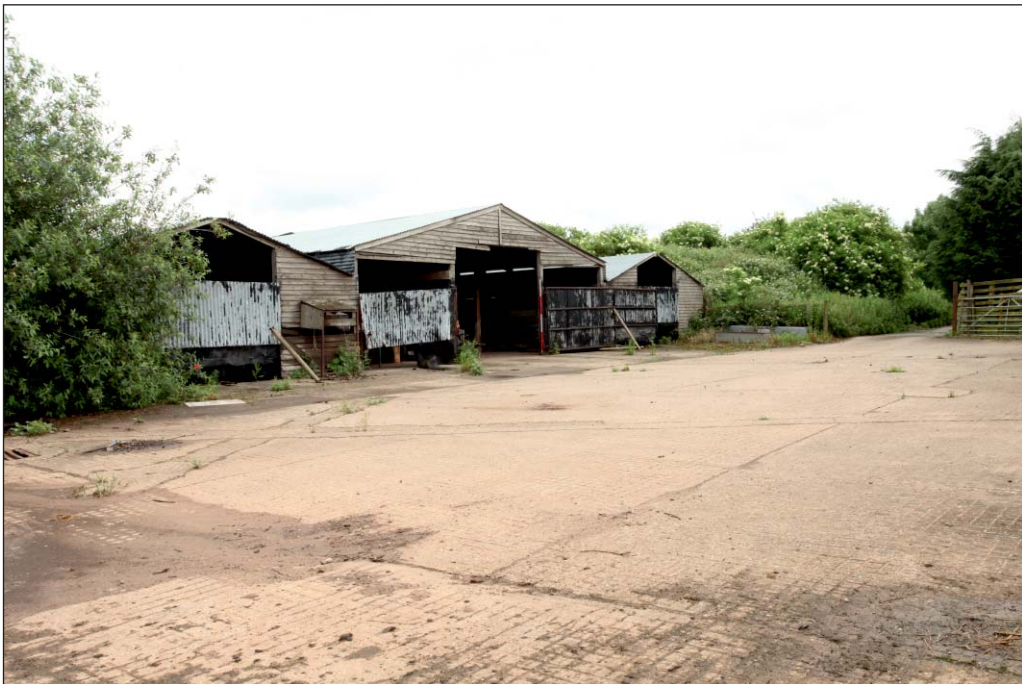
Plate 78: Cow houses to the north of Buildings 1 and 3

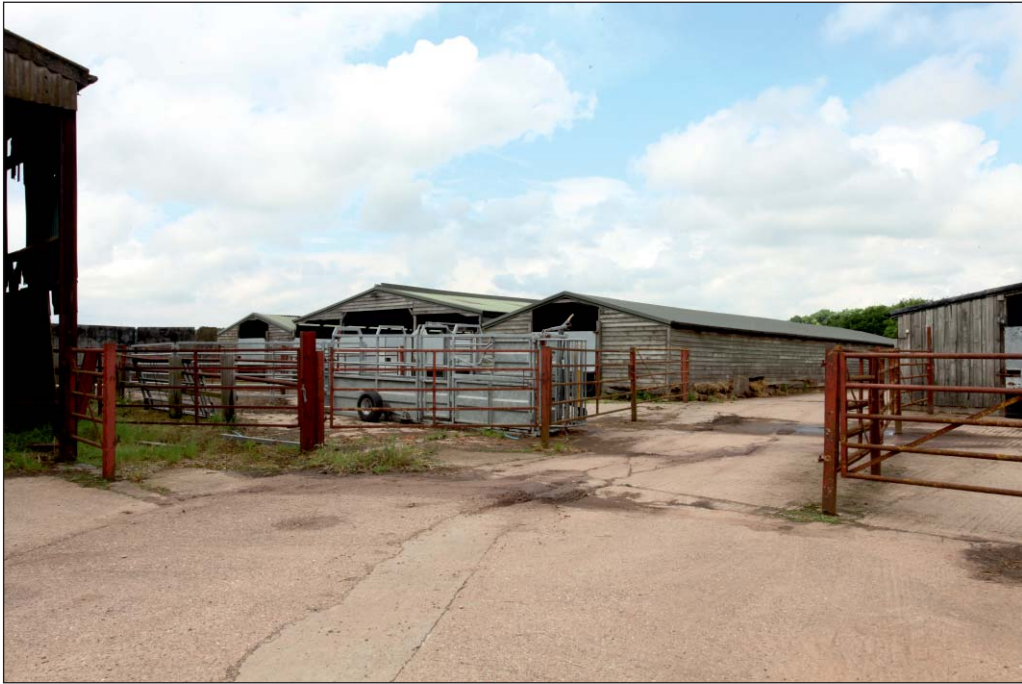
Plate 81: Cow houses to the north-west of the farmyard complex

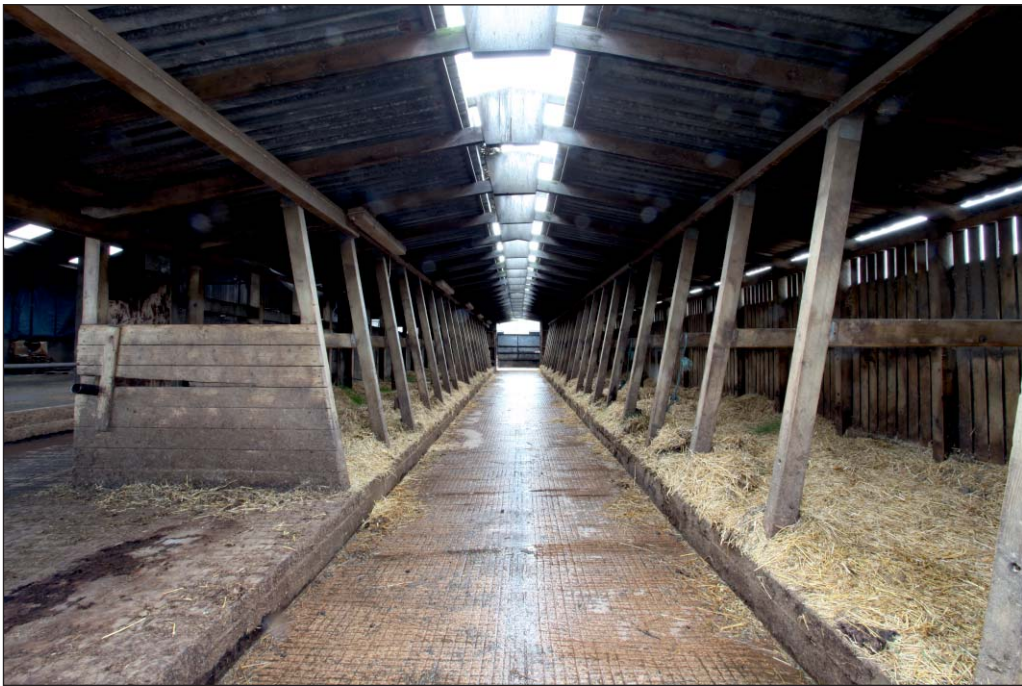
Plate 82: Typical view of cow house interior

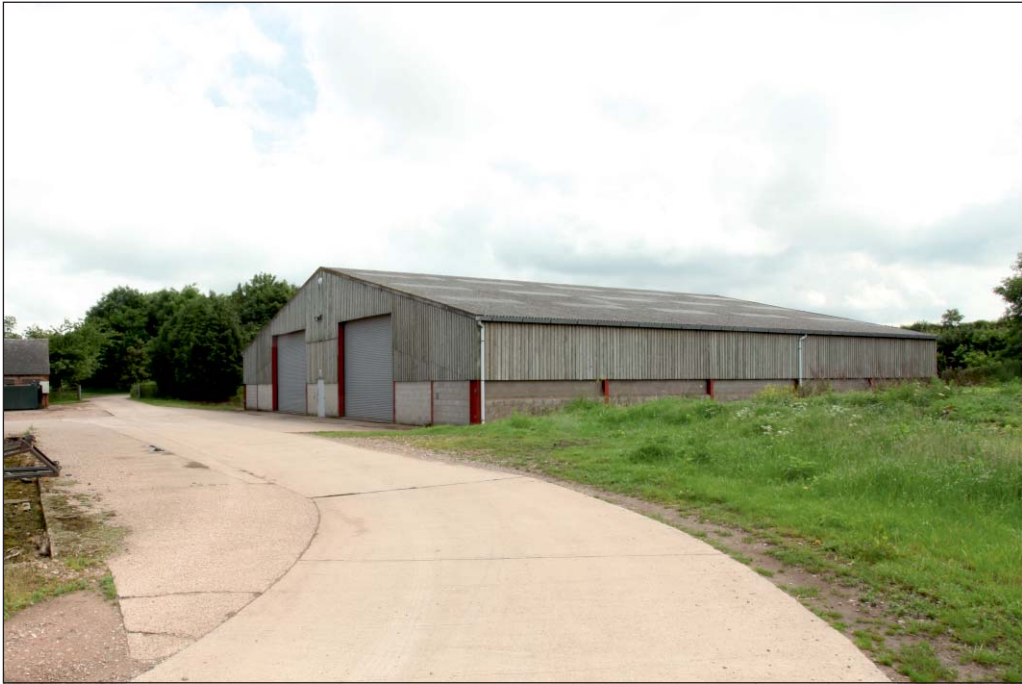
Plate 85: Granary to the south-west of the farmyard complex
