# IFA2: The Excavation and Recovery of a MKII Fairey Barracuda from the Solent, Hampshire

Marine archaeological technical report

Ref: 202920.13  
January 2020

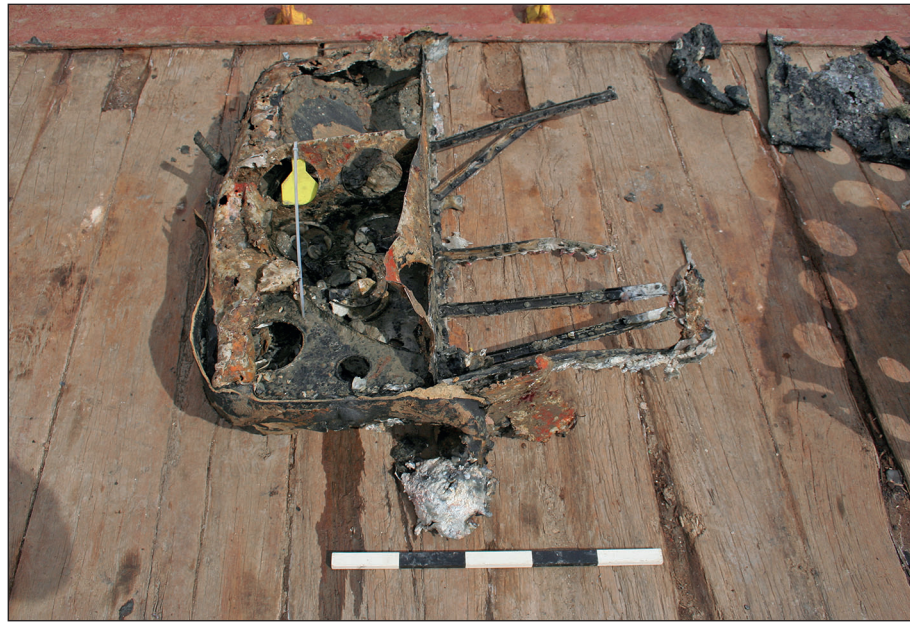
Plate 1: Starboard wing fragment- inboard fuel tank

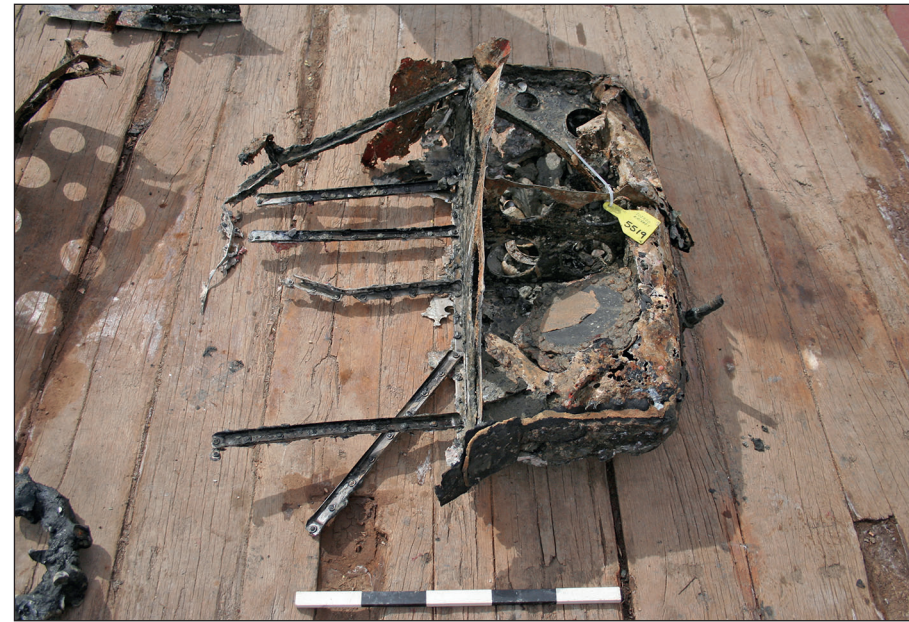
Plate 2: Starboard wing fragment- inboard fuel tank

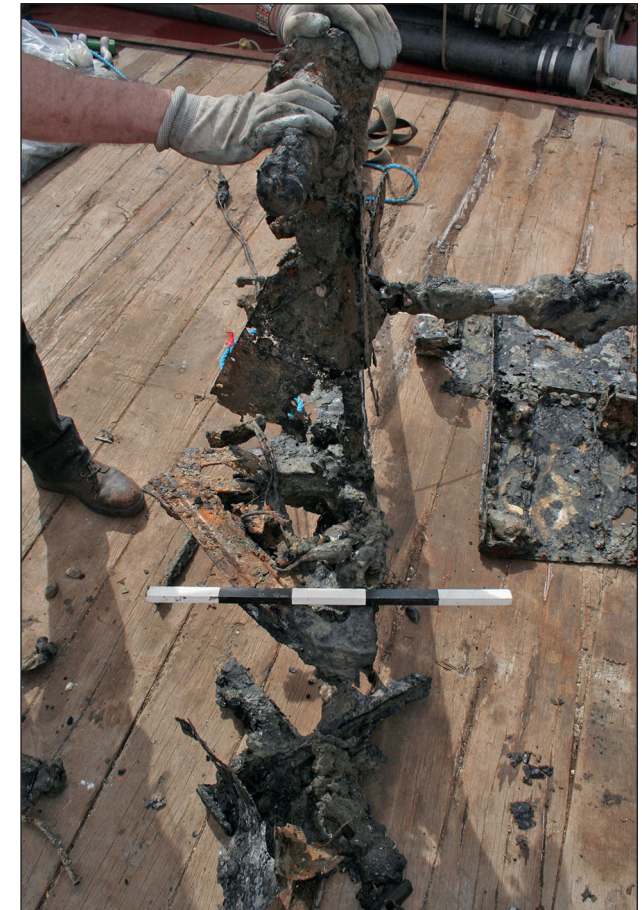
Plate 3: Starboard wing fragment- Rear spar fragment with piston for Youngman flap

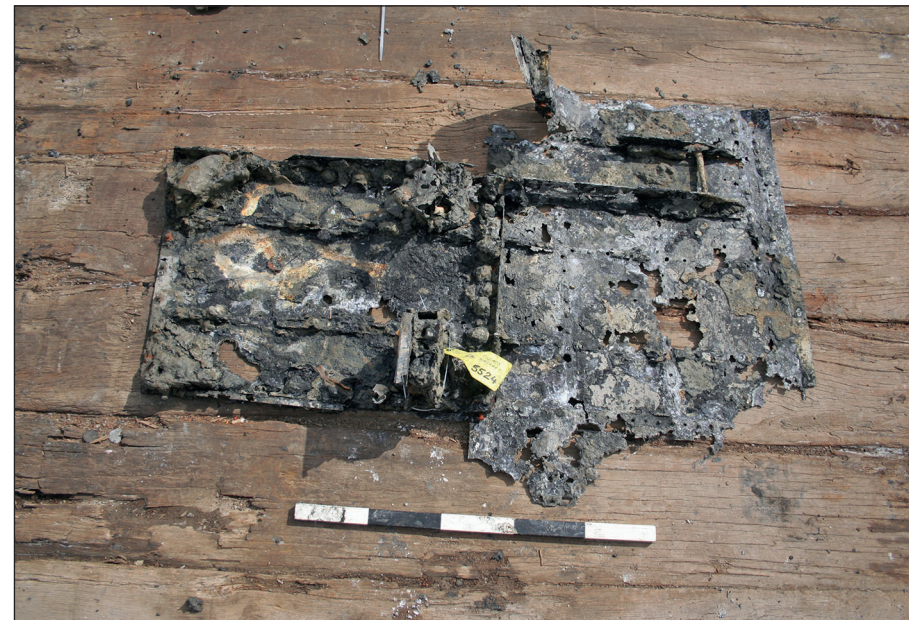
Plate 5: Starboard wing fragment- inner face of lower wing skin with stiffeners

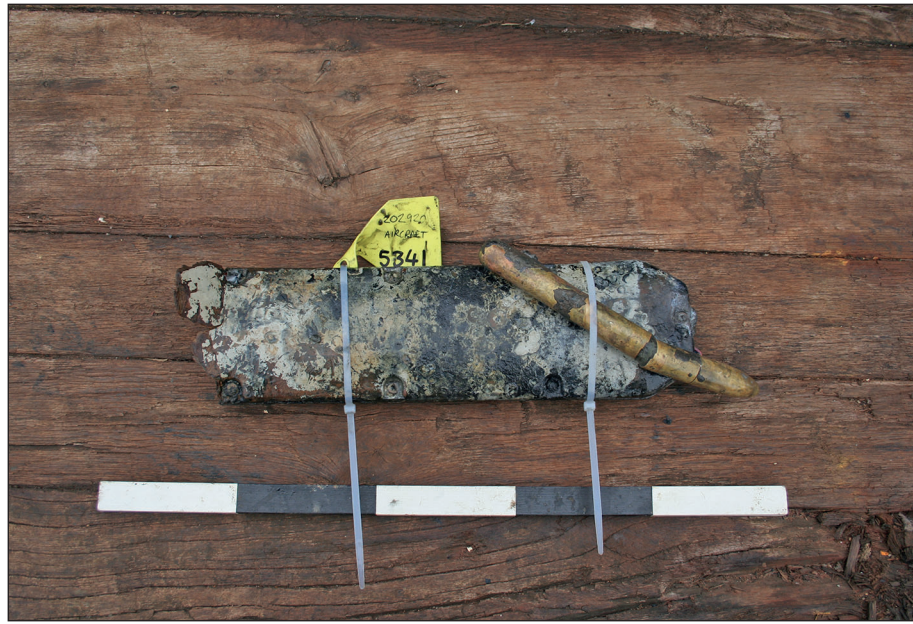
Plate 6: Pitot tube and mast

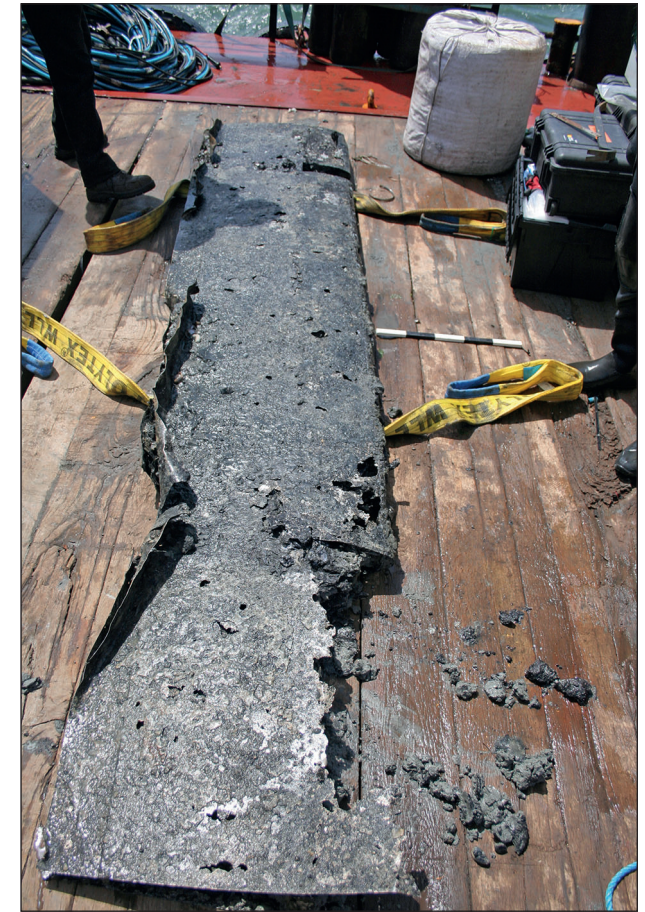
Plate 8: Starboard Youngman flap

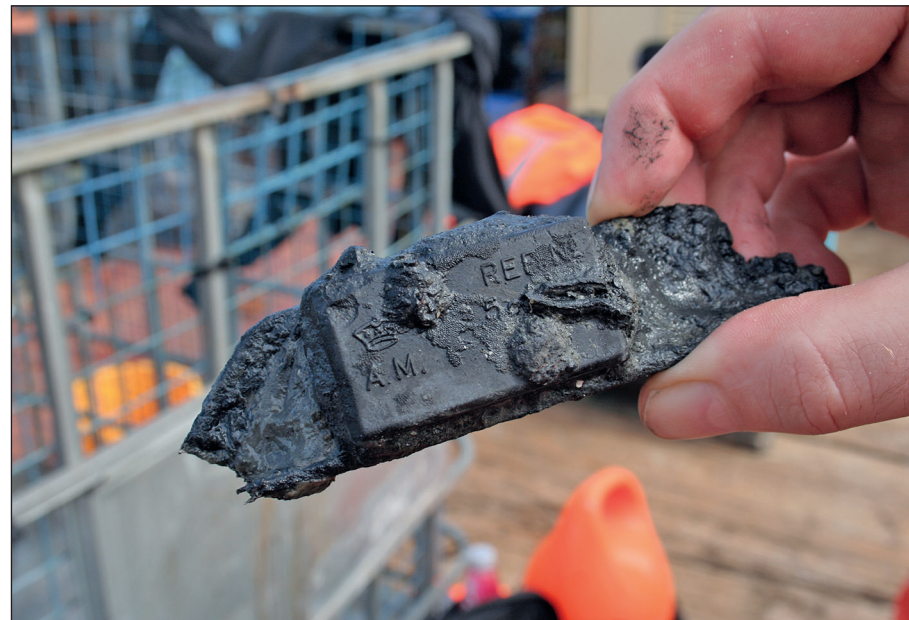
Plate 10: Air Ministry standard Bakelite electrical fitting

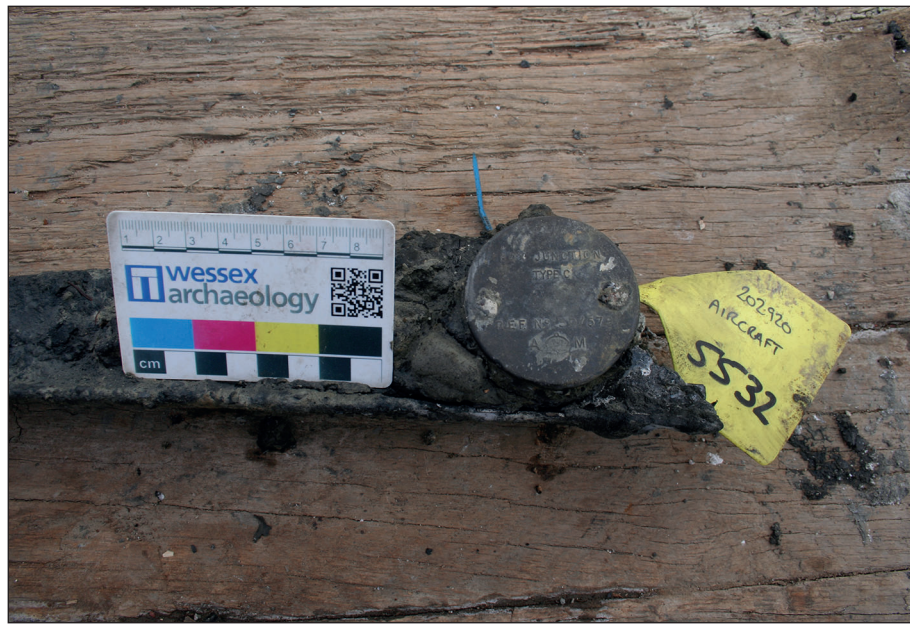
Plate 11: Air Ministry standard Bakelite electrical fitting

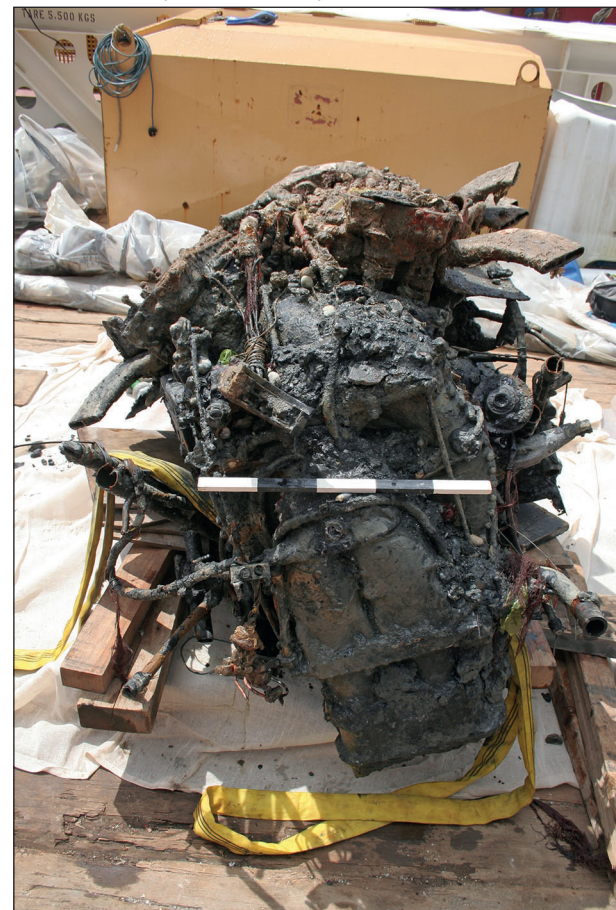
Plate 15: Rolls Royce Merlin 32 engine- rear of engine showing supercharger

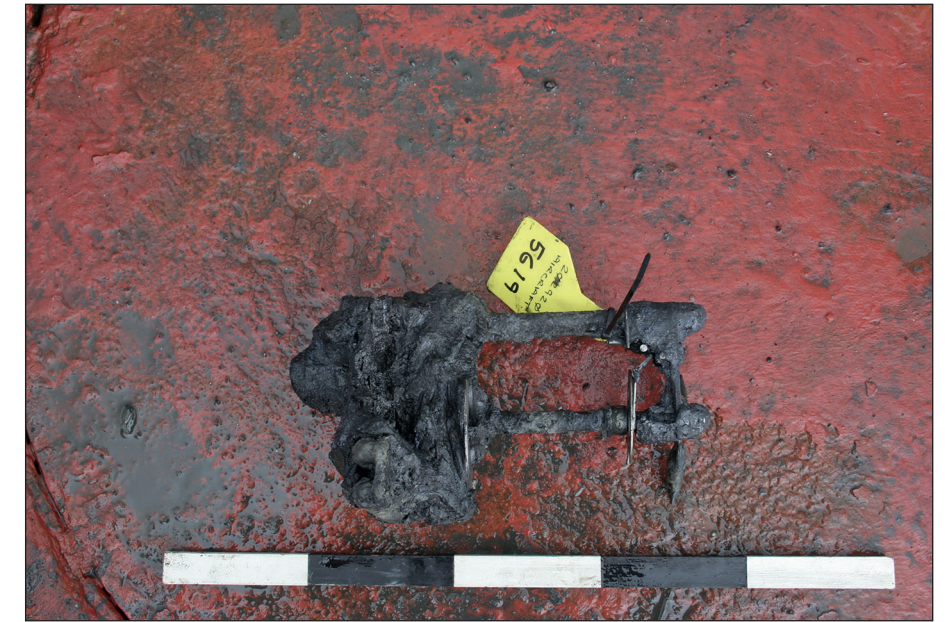
Plate 18: Coffman starter cartridge holder after cartridges removed for EOD clearance

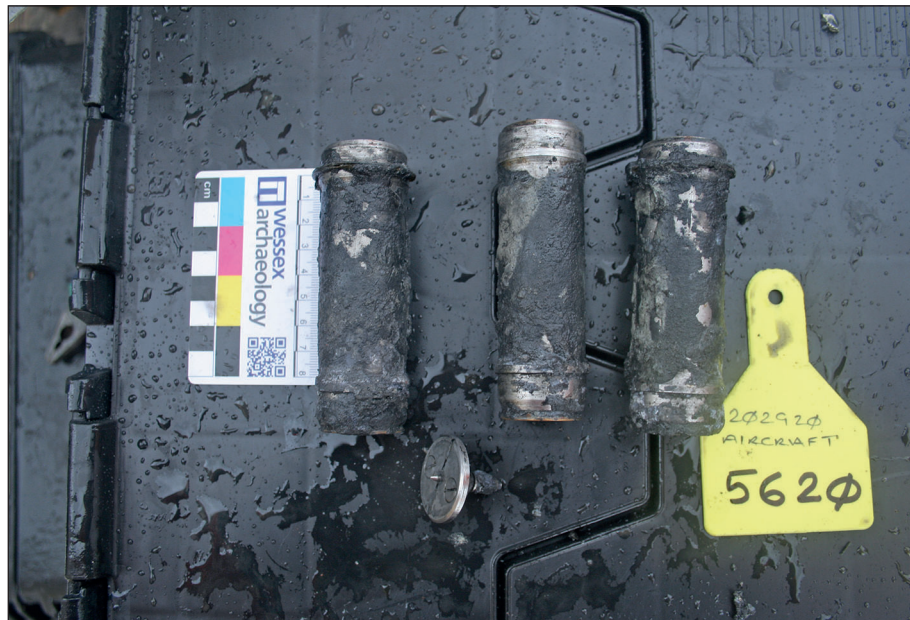
Plate 19: Coffman starter cartridges after EOD clearance

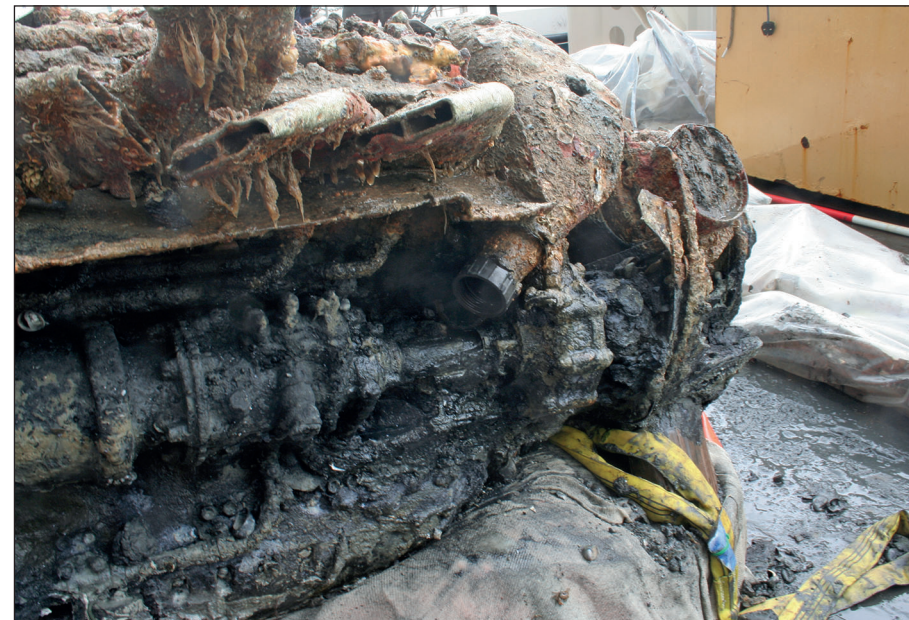
Plate 20: Starboard side of engine showing high degree of preservation

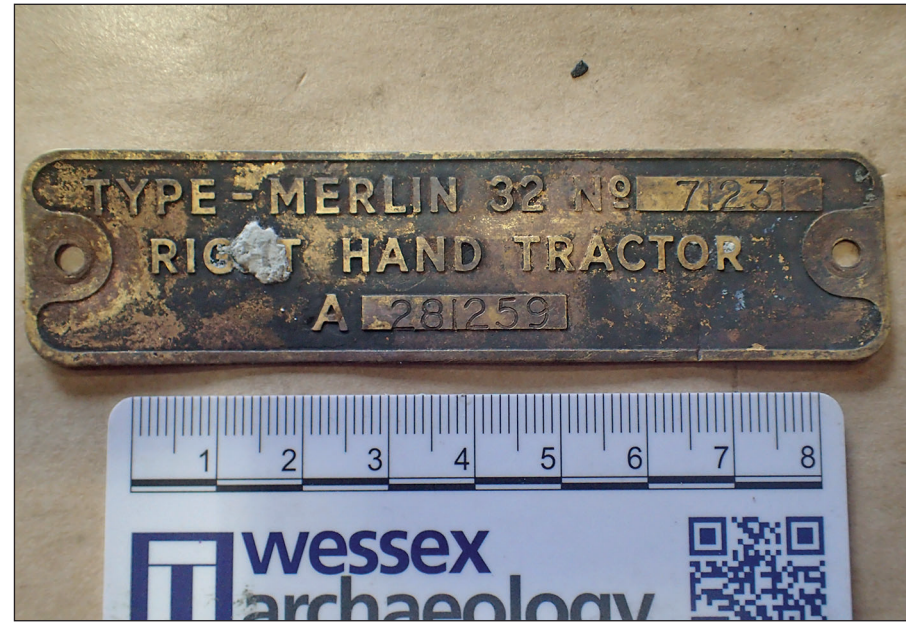
- 7.2.4 Research following the recovery by Wessex Archaeology and the FAAM into the recovered engine plate (**Plate 22**) received a response from the Rolls Royce Heritage Centre that appears to confirm the aircraft as LS473. They report that engine 71231 was a Merlin 32 built 8 October 1943 and despatched to Fairey at Stockport on 13 October 1943. It was one of a batch of 280 Merlin 32 built at Derby as part of Air Ministry Order C/ENG/426/C.28(a) and delivered between 11 September 1943 and 17 December 1943. The 281259 number is the Air Ministry identification for the engine. Using this information, and the fact that LS473 came off the production line in November 1943, along with the other pieces of evidence the case becomes stronger for it to be an aircraft manufactured at Fairy, rather than one of the other aircraft manufactures producing the Barracuda.

Plate 22: Identification plate for Merlin 32 engine

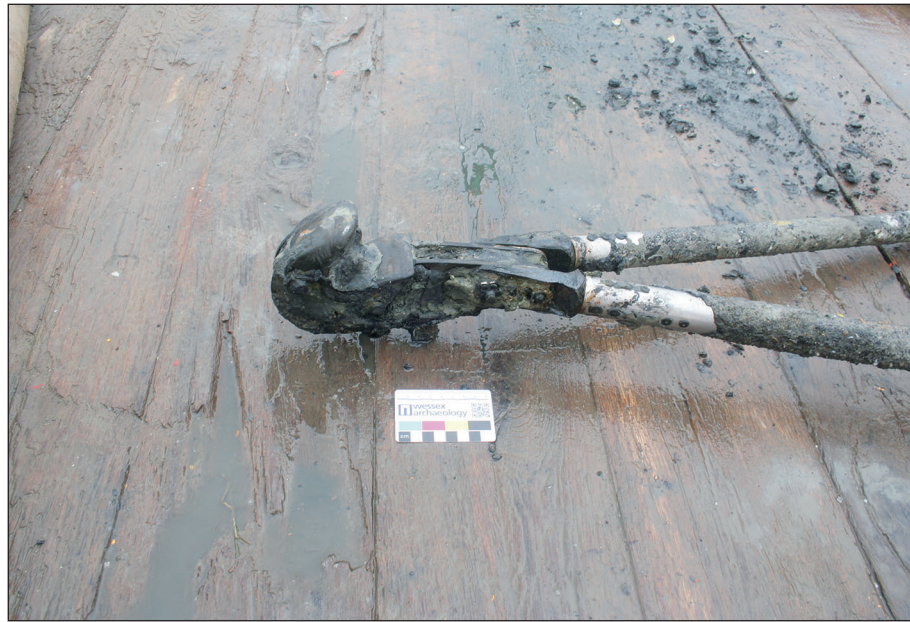
- 7.2.5 Observations from the team at FAAM during the work on the recovered aircraft have also shown some additional indicators of an aircraft with a short life (Dave Morris, Pers. Comms.). Though both aircraft had short lives the dates for the manufacture of the engine point to the latter aircraft. LS473 was factory released on the 24 November 1943, and lost on the 6 January 1944 (**Plate 69**), giving the aircraft a life of 42 days. Additionally, amongst the recovered material from the Solent was the aircraft's arrestor hook (**Plate 26**)

Plate 26: Arrestor Hook

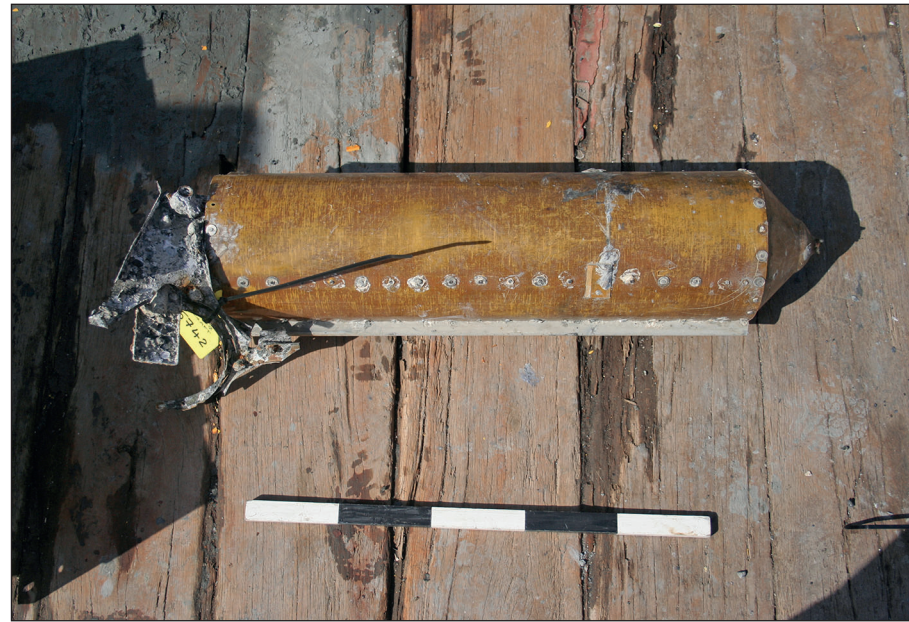
- 3.4.37 The smoke bombs were held in resin tubes behind the TAG cockpit (**Plate 46, Plate 47** and **Figure 18**) along with sono-buoys and were deployed by dropping them through the chute on the port side of the cockpit floor. These were sometimes used as markers showing downed aircraft or similar emergency situations but were also used as navigational markers dropped on an outward flight for the Barracudas to use to navigate back to the carrier. They were made up of phosphorus mixed with a colourant and would mark the sea for up to an hour as well as releasing smoke.

Plate 47: Resin tube for holding smoke floats

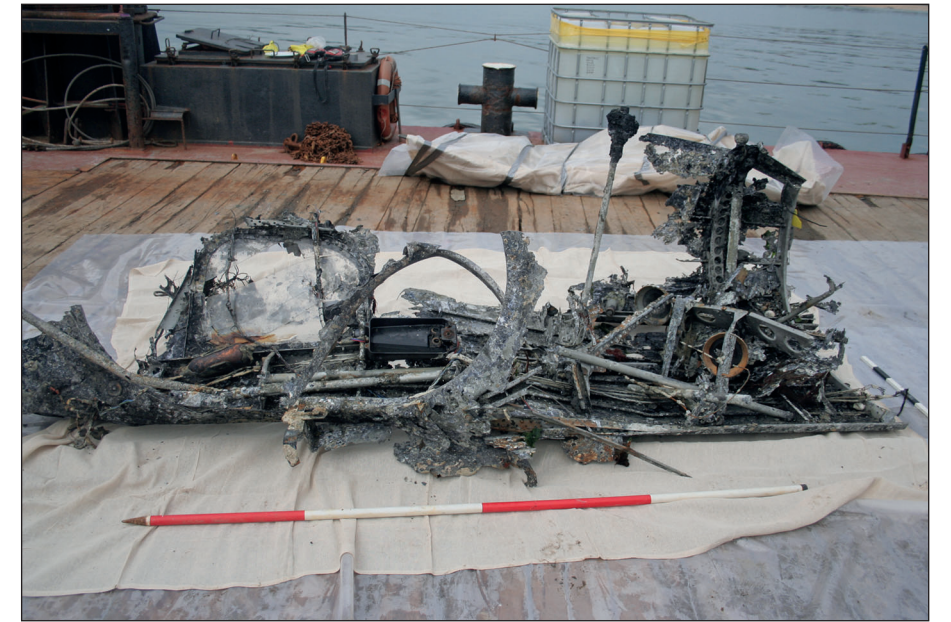
- 3.4.38 Within the TAG cockpit (**Plate 48, Plate 49, Plate 50, Plate 51, Figure 19** and **Figure 20**), many of the fixtures and fittings were still in place, including the large radio set (5437) (**Plate 52** and **Plate 53**), trailing aerial reel (5438) (**Plate 54**), seat back and its cover (5650, 5651) (**Plate 55**) and bucket seat base. The TAG bucket seat (5650) (**Plate 56**) used a similar bucket seat to that of the Supermarine Spitfire, albeit with a shorter and more reinforced back. The bucket seat was to allow the aircrew to sit on their parachutes. This was mounted on a spigot so that the TAG could rotate between radio and gun. Due

Plate 48: Section of TAG cockpit

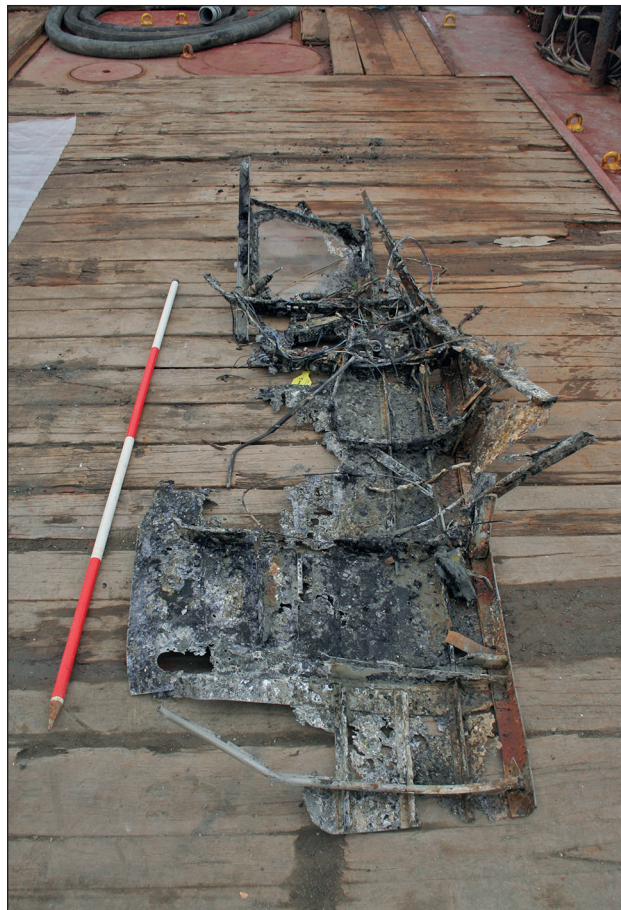
Plate 49: Section of TAG cockpit

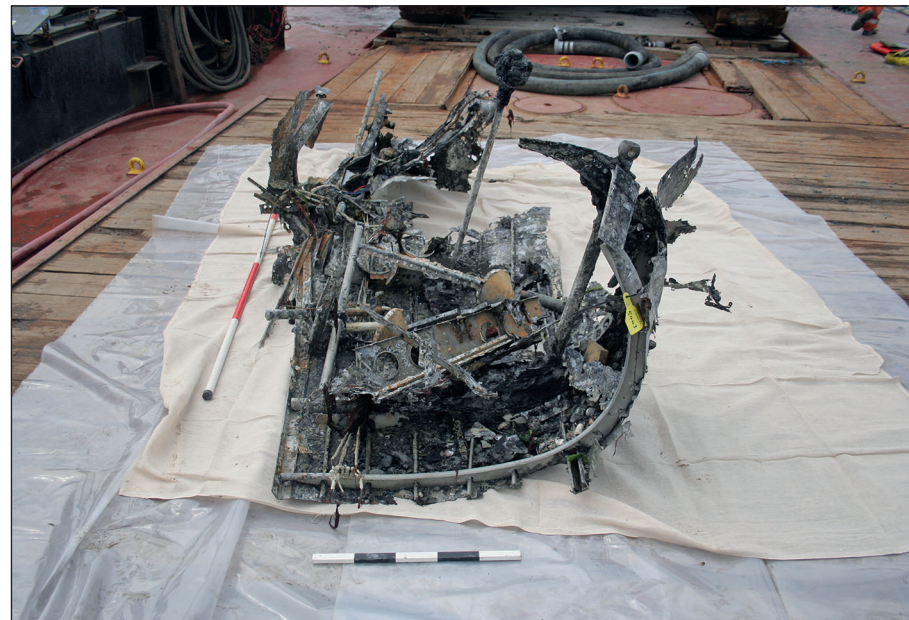
Plate 50: Section of TAG cockpit

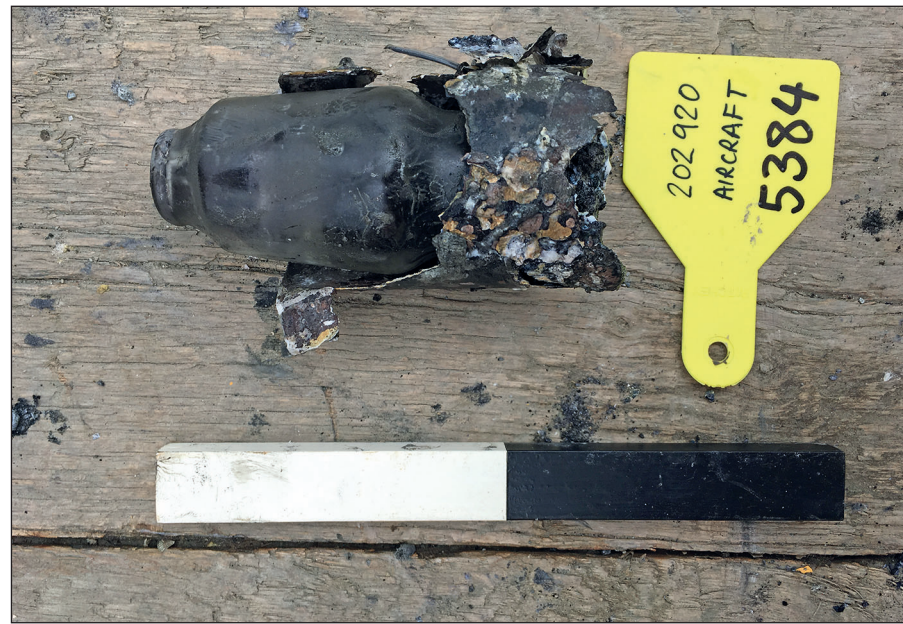
to their locations obstructing the EOD diver from completing the UXO search, these were removed and brought to surface individually. The R3078 receiver radio set was held within a frame and included a series of glass valves (5384) (**Plate 57** and **Plate 58**), one of which was recovered fully intact. As the photos illustrate (**Plate 52** and **Plate 53**), much of the radio is complete, including the buttons and tuning knobs and with further cleaning back at the FAAM it is hoped that this artefact can be prepared for display. The trailing aerial reel was also found complete, with the string of lead balls at its trailing end in place (5438) (**Plate 54**). These would have helped it to stream out straight behind the aircraft and be recovered easily. On the floor of the cockpit, a complete Morse key was found (5389) (**Plate 59**). During the recovery of the full fuselage, a further two keys (5460, 5464) similar to this were also found as well as a second design, more like a switch (5463) (**Plate 60**). These were all in near perfect condition, including some of the wiring.

Plate 57: Glass radio valve

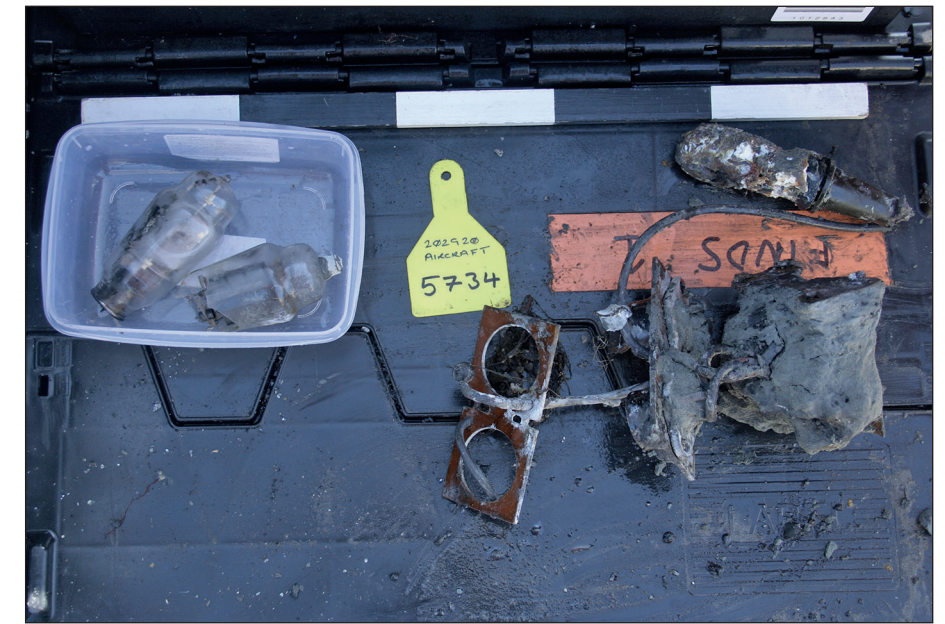
Plate 58: Glass radio valve

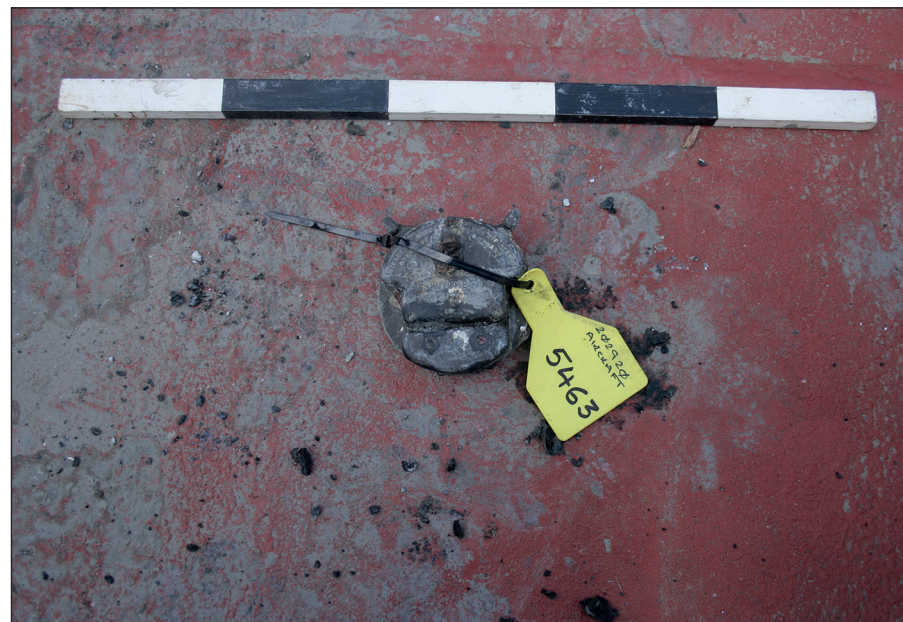
Plate 60: Switch style Morse key

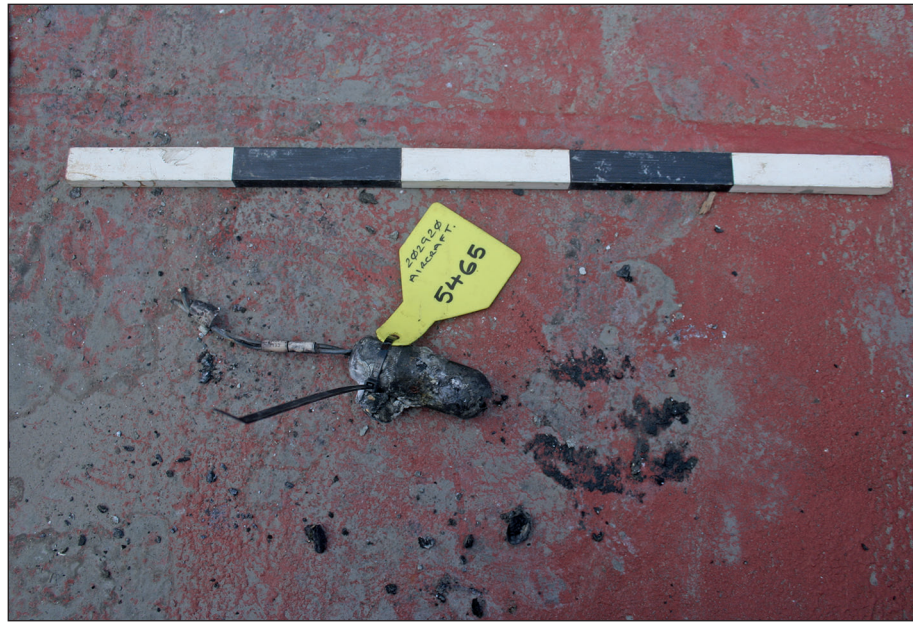
- 3.4.39 To illuminate the cockpit a series of small light fittings were attached to the frames, several of which were recovered, still with their identification labelling on the wiring (5465) (**Plate 61** and **Plate 62**). A stamped label on the forward-facing rim of the TAG cockpit reminded the TAG that they should be facing aft for assisted take-off (**Plate 63**). "If you can read this, you're facing the wrong way."

Plate 61: Cell lamp with cable label

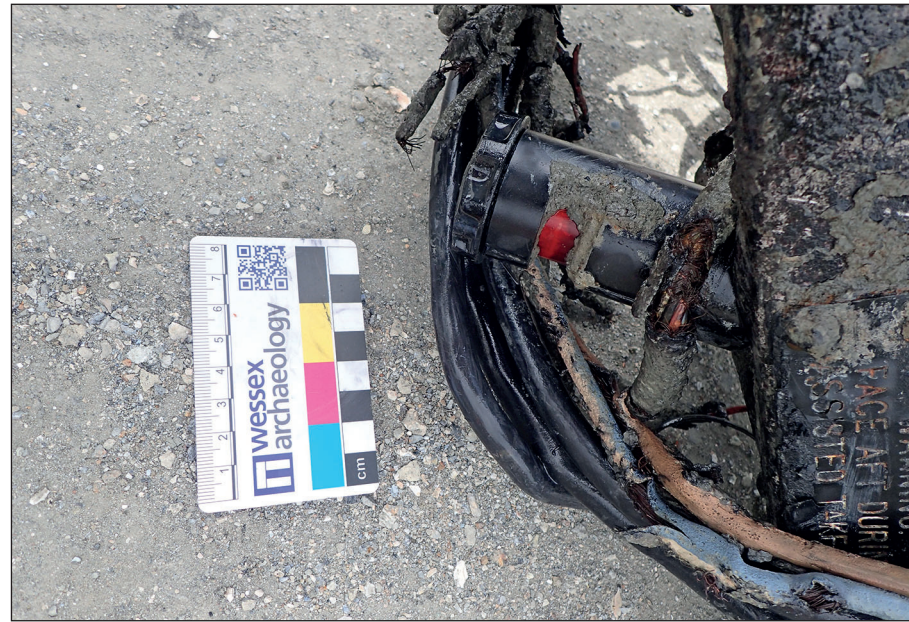
Plate 62: Cockpit light and warning label

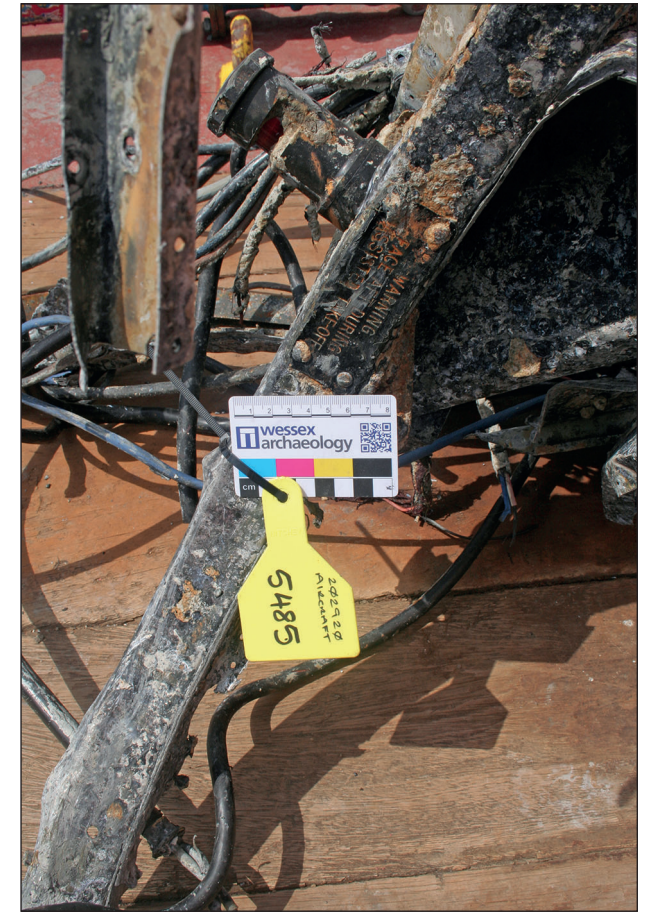
Plate 63: TAG Cockpit Rim label

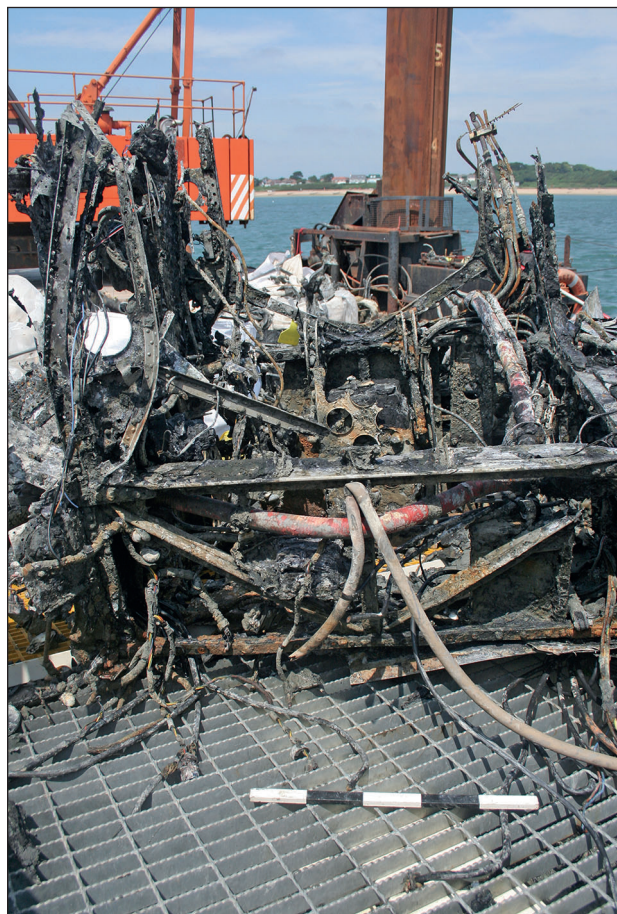
- 3.4.40 Forward of the TAG cockpit was the observer's station (**Plate 64**, **Plate 65**, **Figure 21**, **Figure 22** and **Figure 23**), sat in between the wings with the large bulbous underwing windows to allow for good vision out of the aircraft, and the pilot's cockpit. These cockpits were covered by the same large domed Perspex canopy which reached back to the lifting hatch of the TAG's cockpit, which was also missing although fragments of it were found within the silt all around the aircraft. A sliding section above the pilot's head provided access to the forward cockpit while midway along a second sliding hatch gave access to the observer's cockpit, as there was no route through between the two.

Plate 64: Observer's cockpit facing forward (the cockpit is upside down)

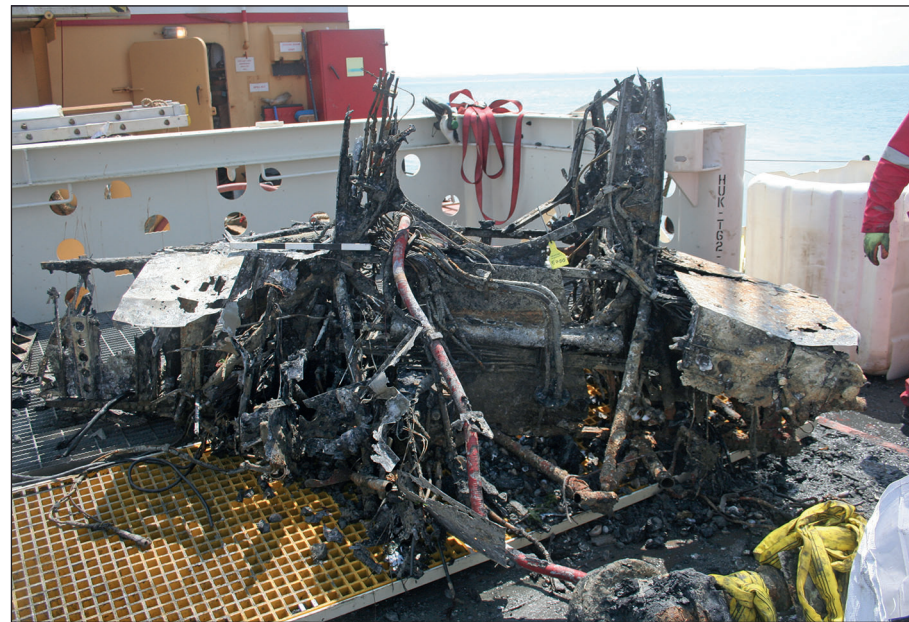
Plate 65: Observer's cockpit and wing stubs (upside down)

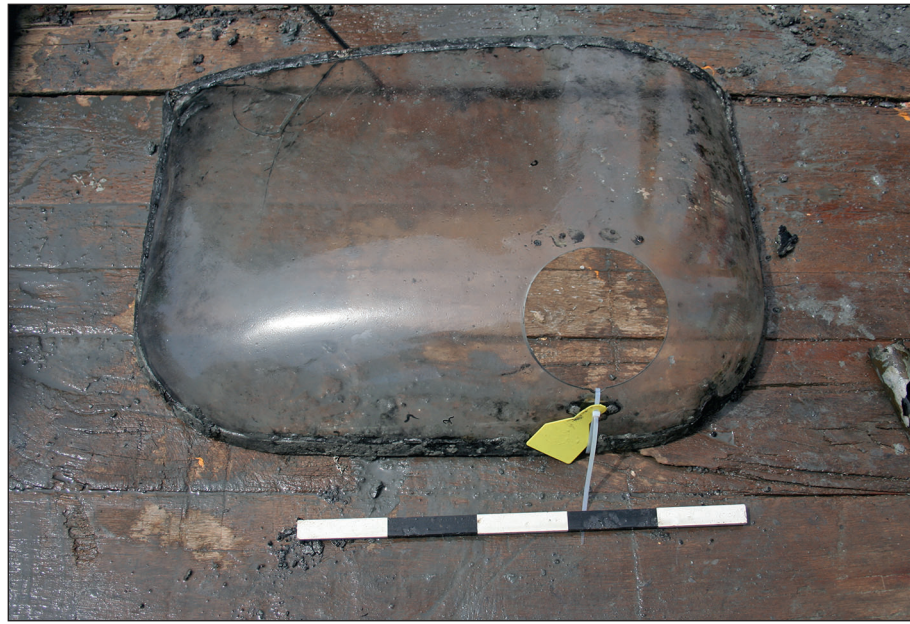
- 3.4.42 The observer's cockpit, with its large domed side windows, one of which was recovered almost undamaged (5345) (**Plate 71**) allowed them to complete navigation as well as keeping a look out for other aircraft or targets to attack. The radar screen, with its rubber hood or cover (5751) (**Plate 72**), was located on the front bulkhead of this cockpit, which also contained a repeater compass from the gyrocompass towards the tail. The sides and floor of the observer's cockpit (5700) were filled with the large batteries and distribution boxes that provided the aircraft with 24-volt lights and power. A large quantity of these were found, including several intact batteries (5733) (**Plate 73**) and the main distribution box (**Plate 74**). Further quantities of labelled wiring were also present, generally still attached to the frames and longerons within the cockpits. Also recovered in this area was the pilot's comfort bag and its holder (5441) (**Plate 75**) and a number of the cockpit lights. The batteries were tested for charge during conservation at the FAAM and were found to

Plate 71: Starboard observers domed side window

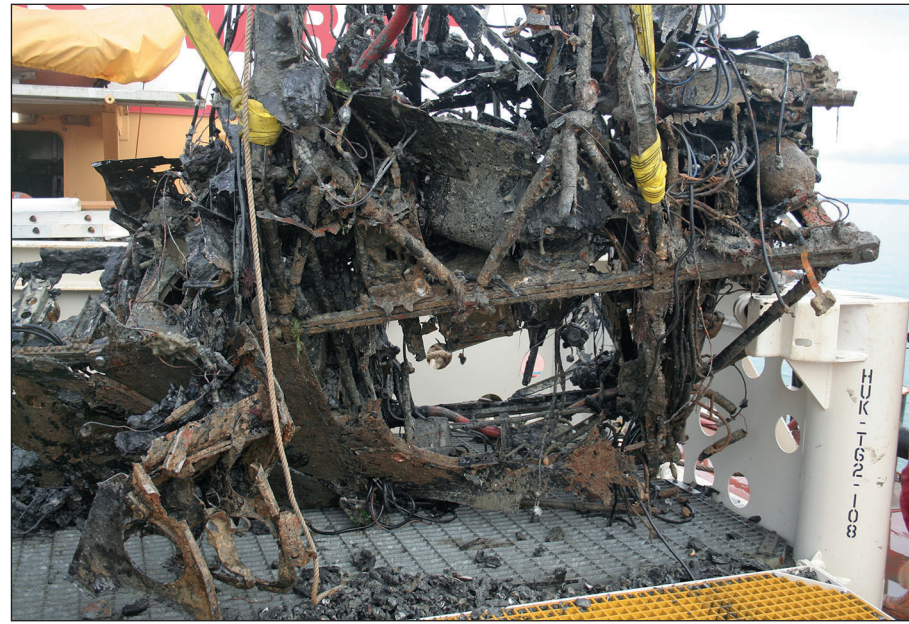
- 3.4.43 Moving forward to the pilot's cockpit (**Plate 77**, **Plate 78** and **Plate 79**), while at least some of the upper parts of it had been damaged by the shellfish dredging, leading to the loss of some of the dials, the blind flying panel (5770) (**Plate 80** and **Plate 81**) was recovered, including several *in situ* gauges including the airspeed gauge and artificial horizon, and from within the cockpit itself came the control column (missing the top) (5414) (**Plate 82**), the base of the pilot's seat (5430) (**Plate 83**), and a rubber oxygen mask (5416) (**Plate 84**) which probably belonged to the pilot. The same pattern of oxygen mask can be seen in the photo of Flt Lt Sandes (**Plate 70**). Interestingly the observer's seat was not recovered, suggesting that it had been removed at some point previously. The dials were removed from the blind flying panel, which has undergone conservation at the FAAM (**Plate 85**).

Plate 77: Pilot's cockpit

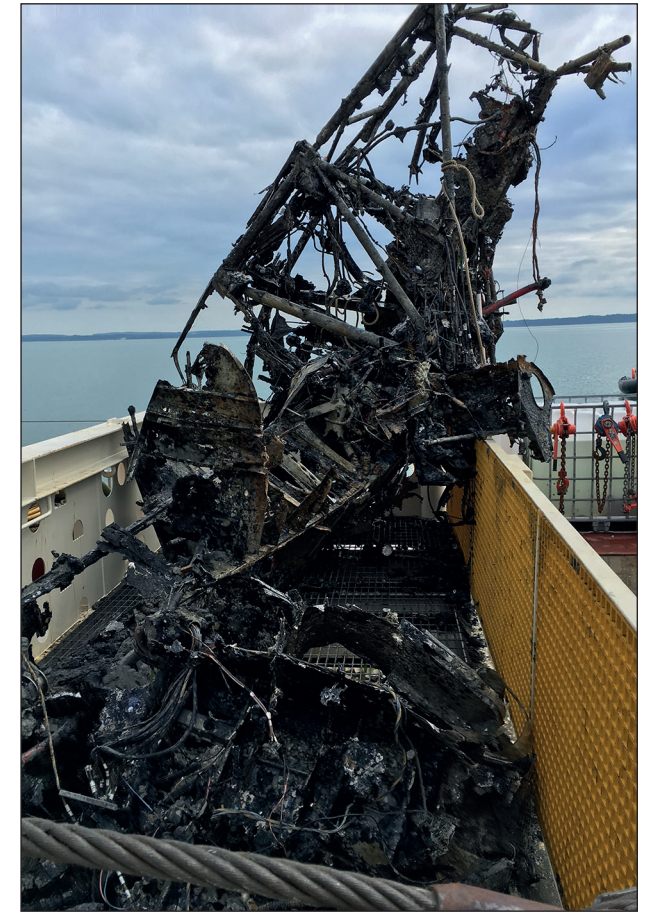
Plate 78: Pilot's cockpit, Observer's cockpit and wing stubs

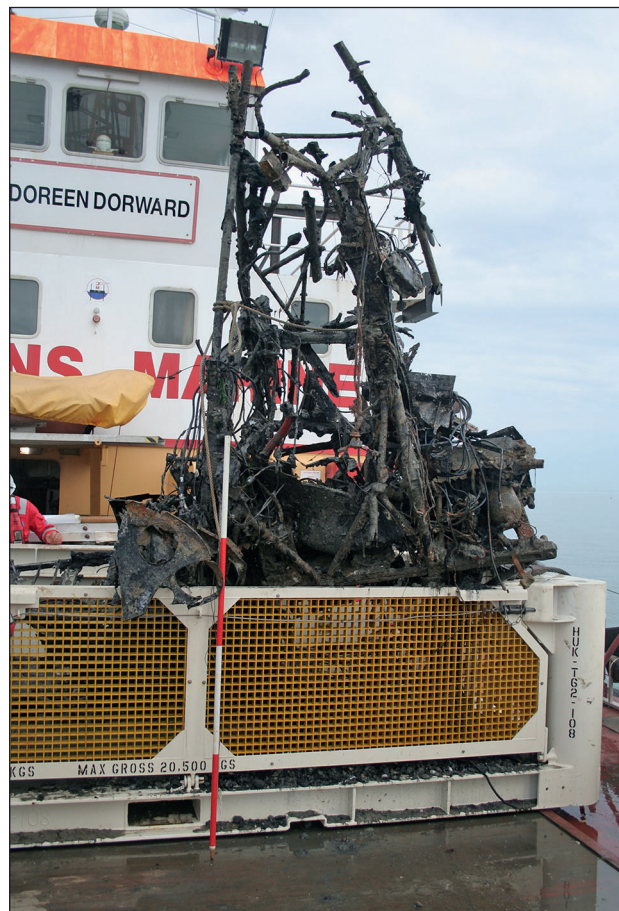
Plate 79: Pilot's cockpit, Observer's cockpit and wing stubs

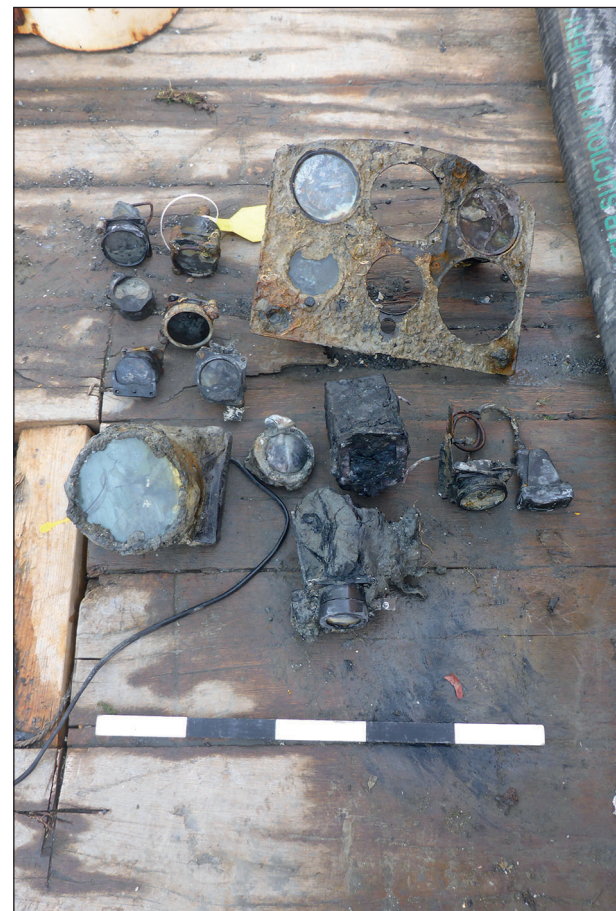
Plate 80: Radium painted dials in the Blind flying panel

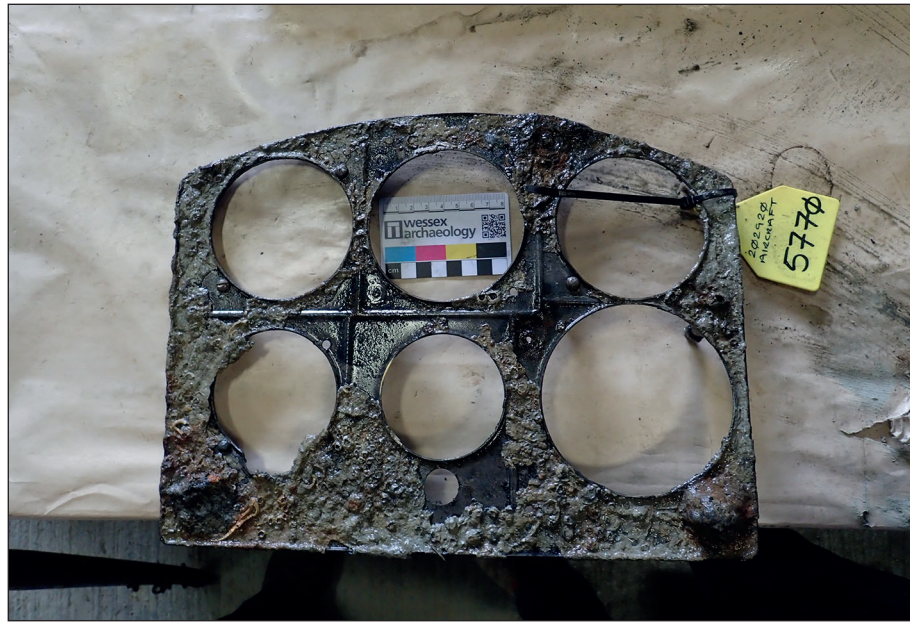
Plate 81: Blind flying panel

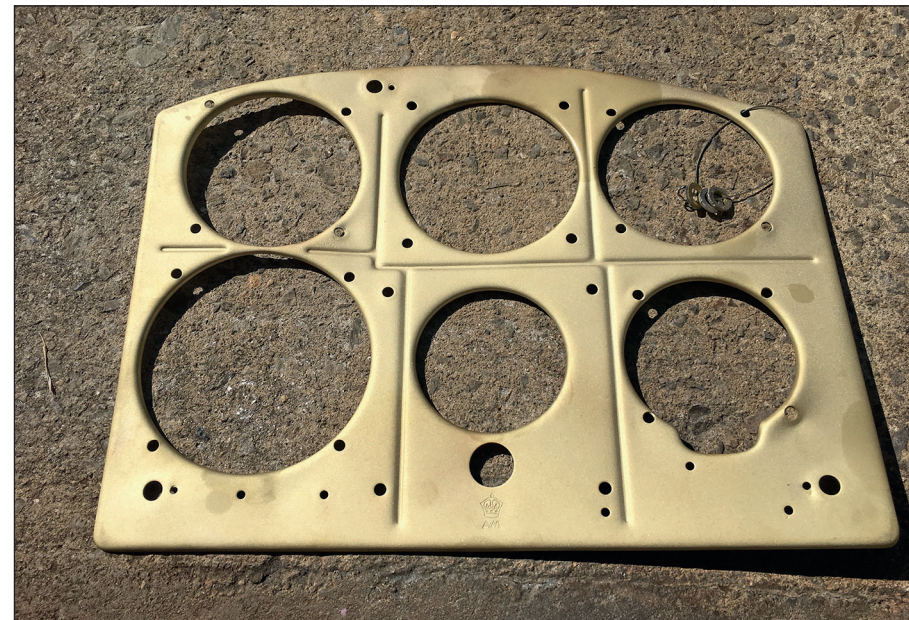
Plate 85: Cleaned blind flying panel © Tony Jupp

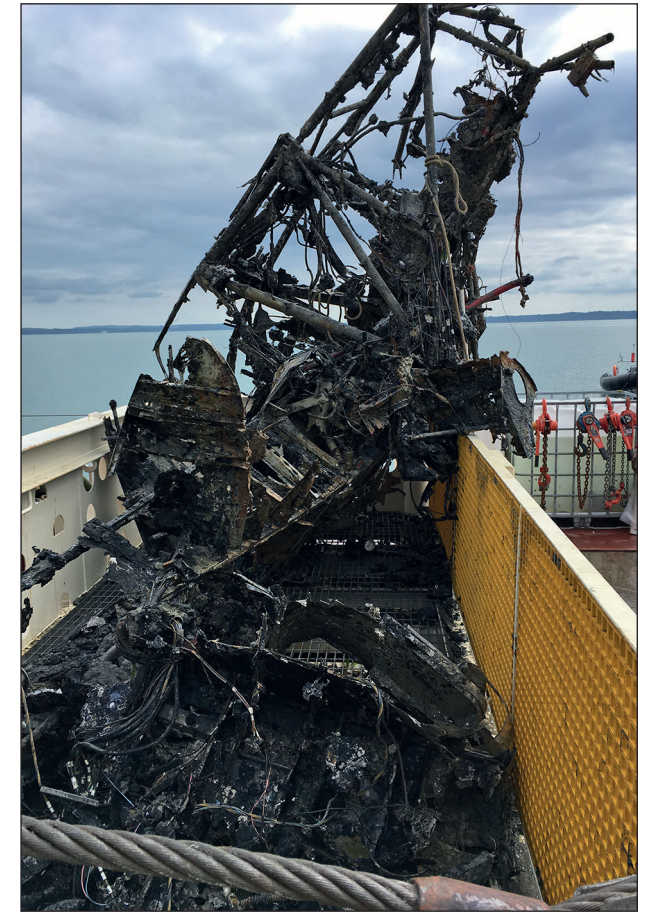
- 3.4.46 The main fuselage (5700) with wing stubs and undercarriage (5455, 5473) was recovered using a subsea basket following the failure of the initial lift (**Plate 88**). The divers followed this up by carrying out search and recovery sweeps after the main part was recovered. These sweeps recovered further heavy material that had been left in position following the lift such as the batteries and other electrical system items which had fallen through the floor of the aircraft. It is clear that the structural integrity of the wreck was not as good as it appeared, with particularly some of the aluminium skin and frames acting as anodes for the iron and steel onboard, making them considerably weaker than on first appearance.

Plate 88: Main section following recovery in subsea basket

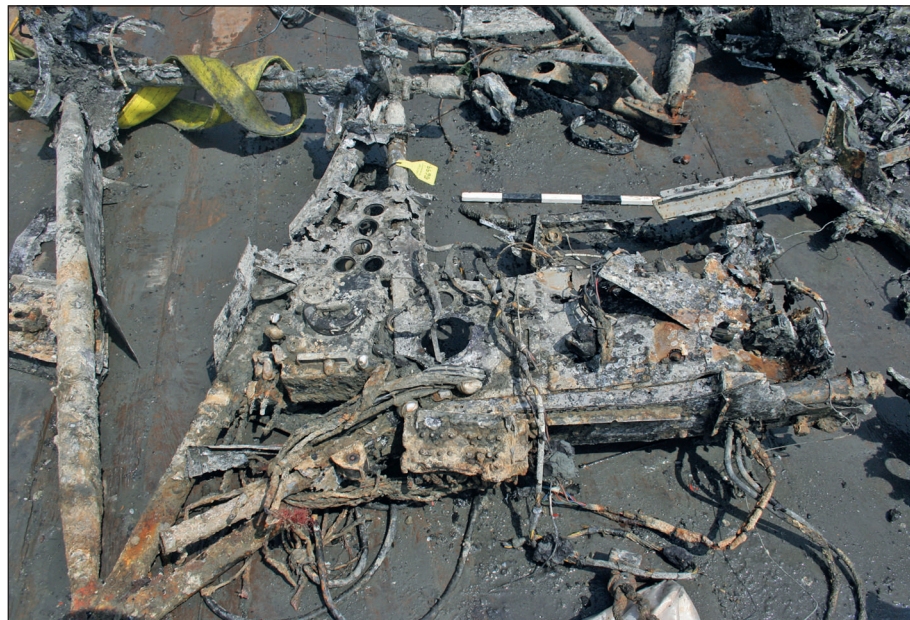
- 3.4.47 Following their recovery to deck in the subsea basket, the large pieces of the port wing and main fuselage were assessed, and decisions made on where to cut, as they were too large for transport as they were. In consultation with the FAAM engineers it was decided to separate the pilot's cockpit tubing (**Plate 89** and **Plate 90**) from the framing of the observer's cockpit, which would remain attached to the wing stubs which contained important hydraulic and oxygen system parts. It was also decided to cut the pilot's cockpit into separate port and starboard sides to assist with transport and storage. These tubes were left with any fittings that were found on them, including wiring systems, oxygen, fuel and hydraulic hoses and clamps. The port wing was split into the forward and aft main spars, which were cut into three pieces each to reduce their length. Skin panels with their

Plate 89: Pilot's cockpit tubing sections
