# IFA2: The Excavation and Recovery of a MKII Fairey Barracuda from the Solent, Hampshire

Marine archaeological technical report

Ref: 202920.13  
January 2020

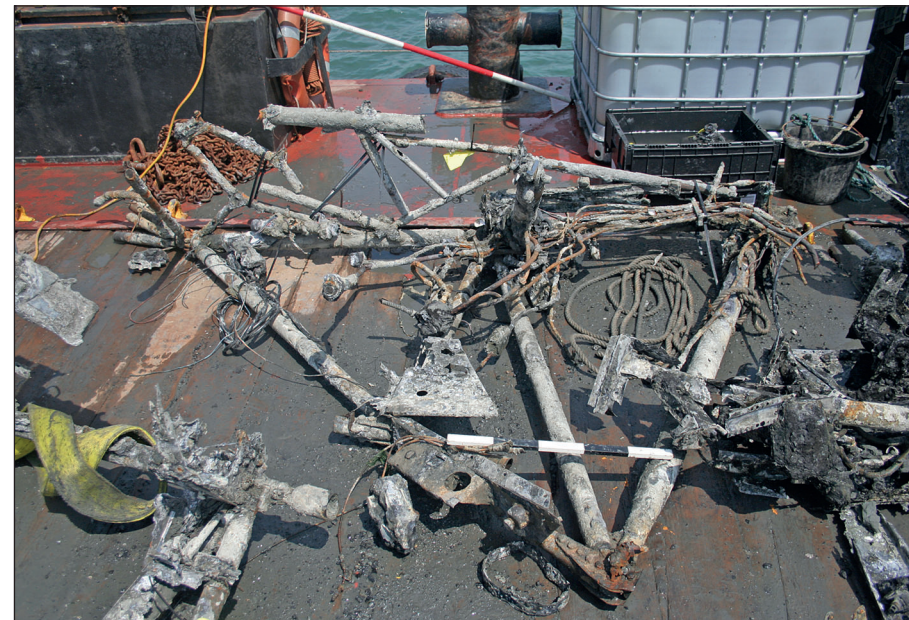
- 3.4.47 Following their recovery to deck in the subsea basket, the large pieces of the port wing and main fuselage were assessed, and decisions made on where to cut, as they were too large for transport as they were. In consultation with the FAAM engineers it was decided to separate the pilot's cockpit tubing (**Plate 89** and **Plate 90**) from the framing of the observer's cockpit, which would remain attached to the wing stubs which contained important hydraulic and oxygen system parts. It was also decided to cut the pilot's cockpit into separate port and starboard sides to assist with transport and storage. These tubes were left with any fittings that were found on them, including wiring systems, oxygen, fuel and hydraulic hoses and clamps. The port wing was split into the forward and aft main spars, which were cut into three pieces each to reduce their length. Skin panels with their

Plate 90: Pilot's cockpit tubing sections
