**BARN AT TREVOLLARD FARM,
ST VEEP, nr LOSTWITHIEL,
CORNWALL**

PHOTOGRAPHIC SURVEY

January 2012
Report 767

The required photographic survey recorded a redundant barn in the southwest portion of the farmyard at Trevollard prior to proposed conversion to a domestic dwelling. The survey was undertaken to compile a record of the site for posterity.

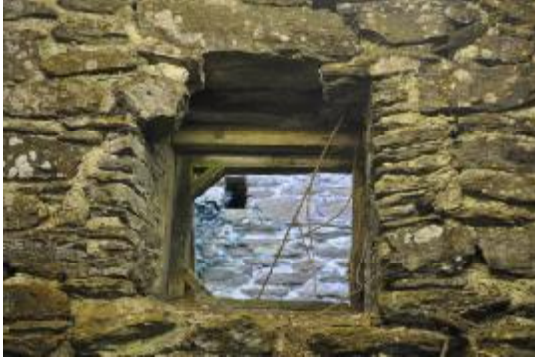
- 4.2.12 Building 2 adjoins the southeast side of Building 1; the northeast wall is butt-jointed to Building 1 (Figure 12, 017) and is therefore later in date. At the time of the survey the roof covering had been removed (the slate tiles were stacked inside the building) although the modern rafters remained. The original building had two floors, as indicated by the holes for the joists in the brick work (Figure 23, 081). The roof-line showed some repair and concrete mortar, which could suggest the upper walls had been slighted; if not, the upper floor of this building had a very low ceiling at its southeast end. In addition, window 13 is unusually close to the wall plate, which forms its lintel.

073: BUILDING 2: SE ELEVATION, WINDOW 13, NW FACING.
