ARCHAEOLOGICAL  
SERVICES  
DURHAM UNIVERSITY

Sheraton Hill Farm  
Sheraton  
County Durham

archaeological building recording

report 5050  
May 2019

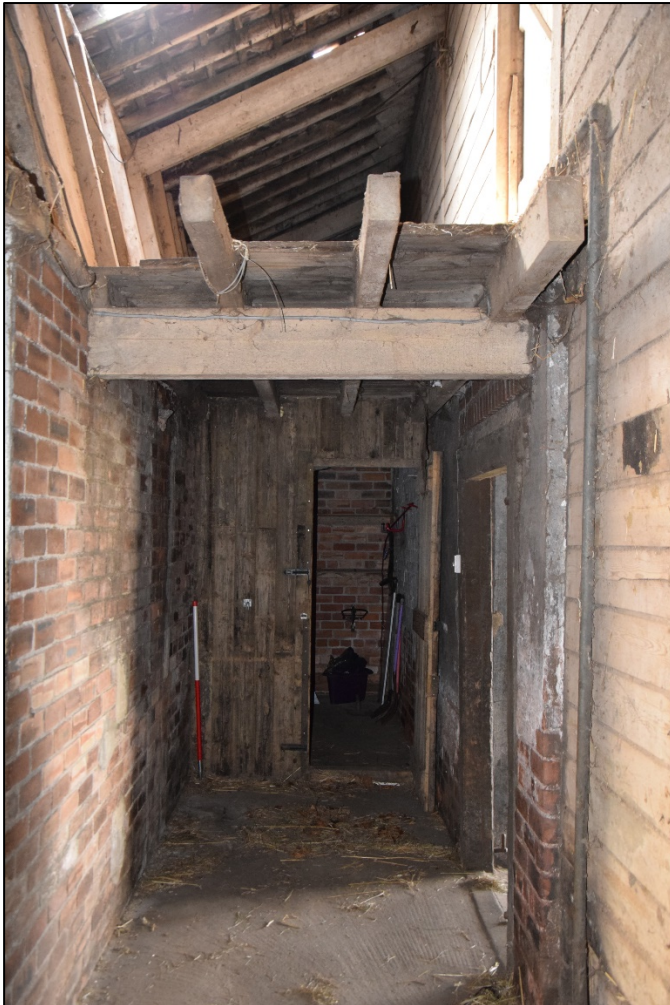
stock yards and byres; there is a small store room at the west end (Photographs 46, 47).

Photograph 46 (left): The west end of the passage [10], with the truncated floor of the upper passage above

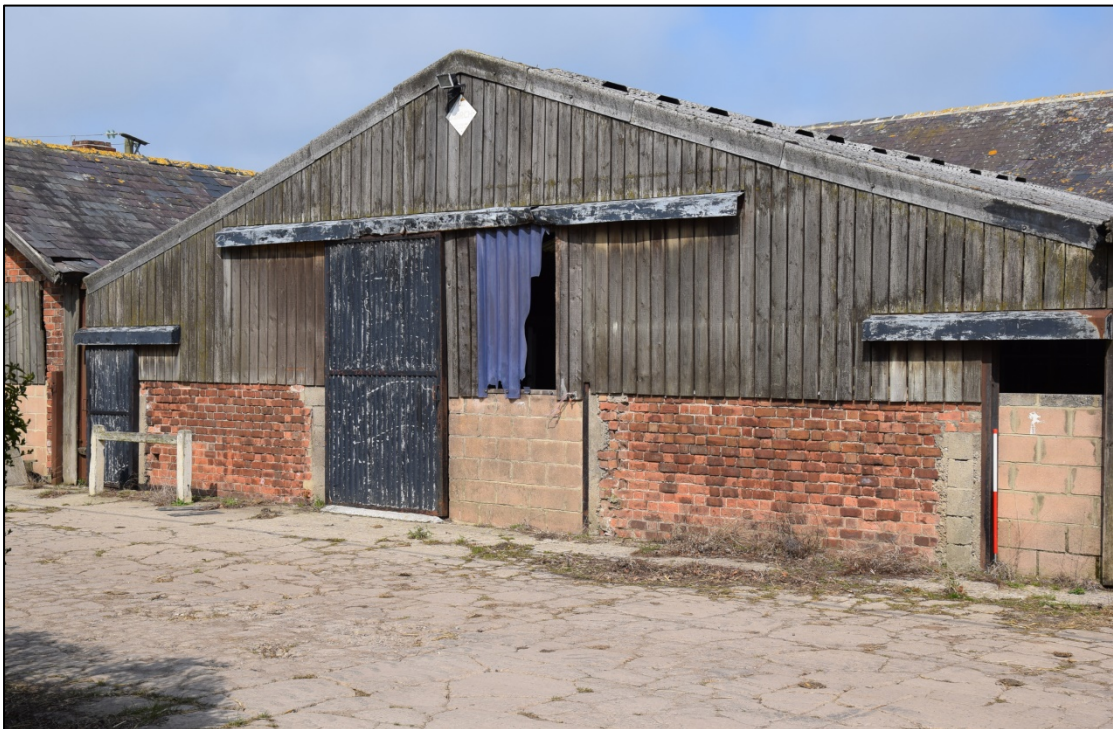
Photograph 62: The western covered yard [16]
