ARCHAEOLOGICAL
SERVICES
DURHAM UNIVERSITY

Buildings at East Field House
Mickleton
Co Durham

archaeological building recording

report 5173
October 2019

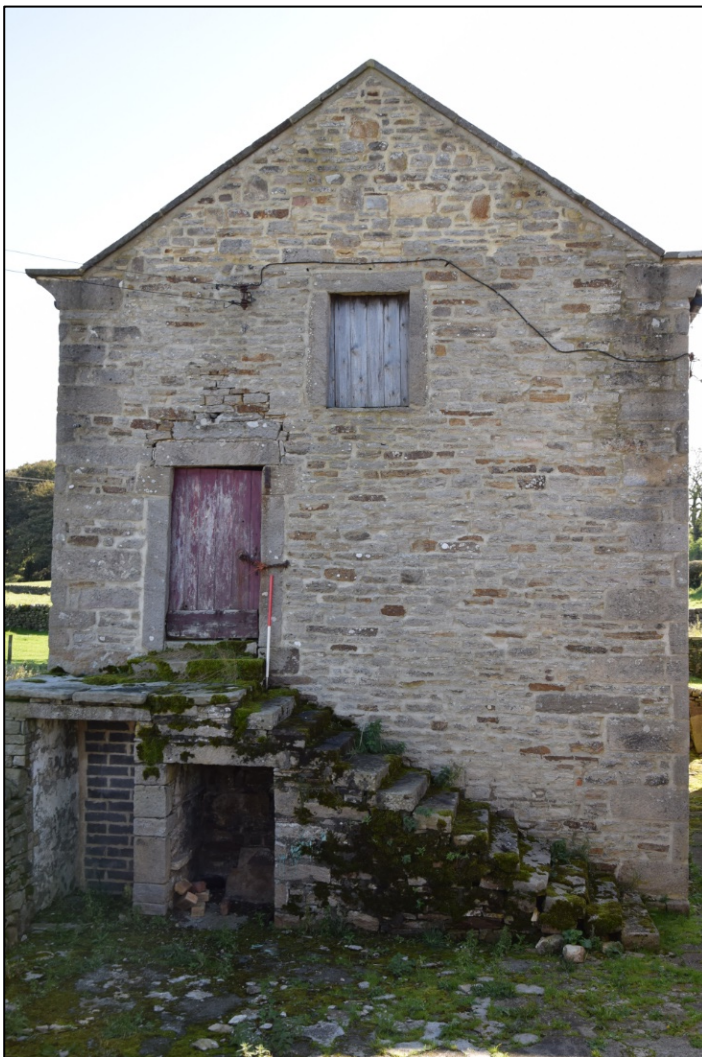
external stair runs across the west end, under a central loading door. The gable above this has been repaired recently (Photograph 8). Beneath the stone platform outside the upper door is a small door to the ground floor, now closed up with concrete blocks.

Photograph 8 (left): The west end of building 1, with a loading door and stone staircase. The concrete blocks, bottom left, block a later door into the byre. The top of the gable has been rebuilt

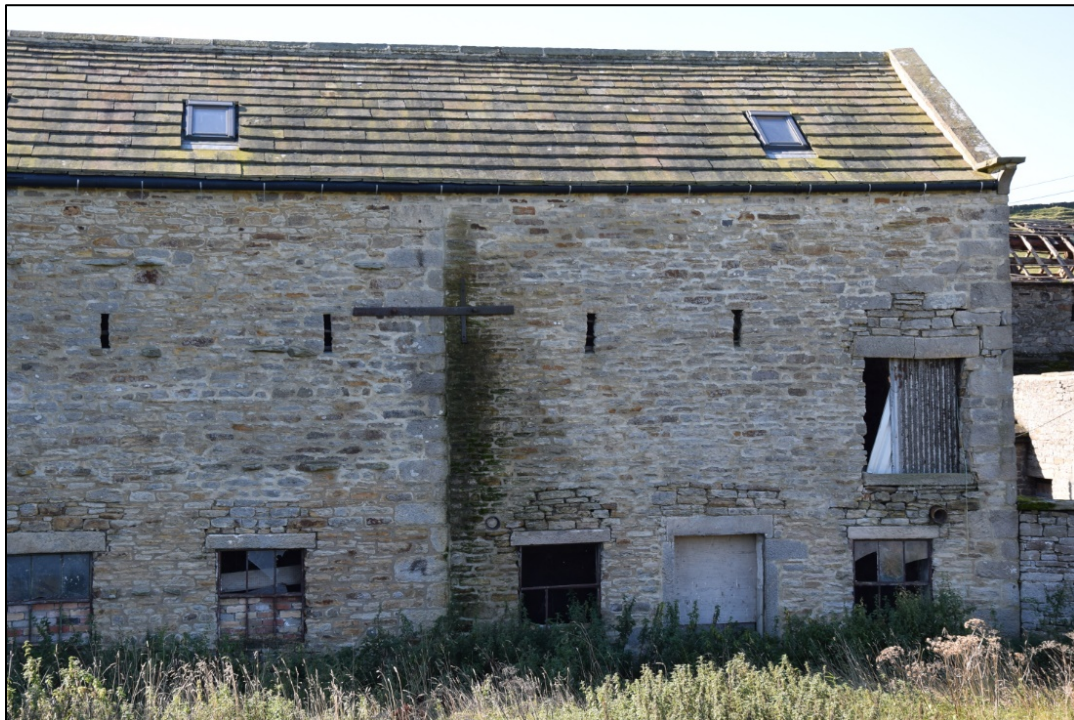
Photograph 12: The north face of the extension, with the reinforcing iron band across the junction

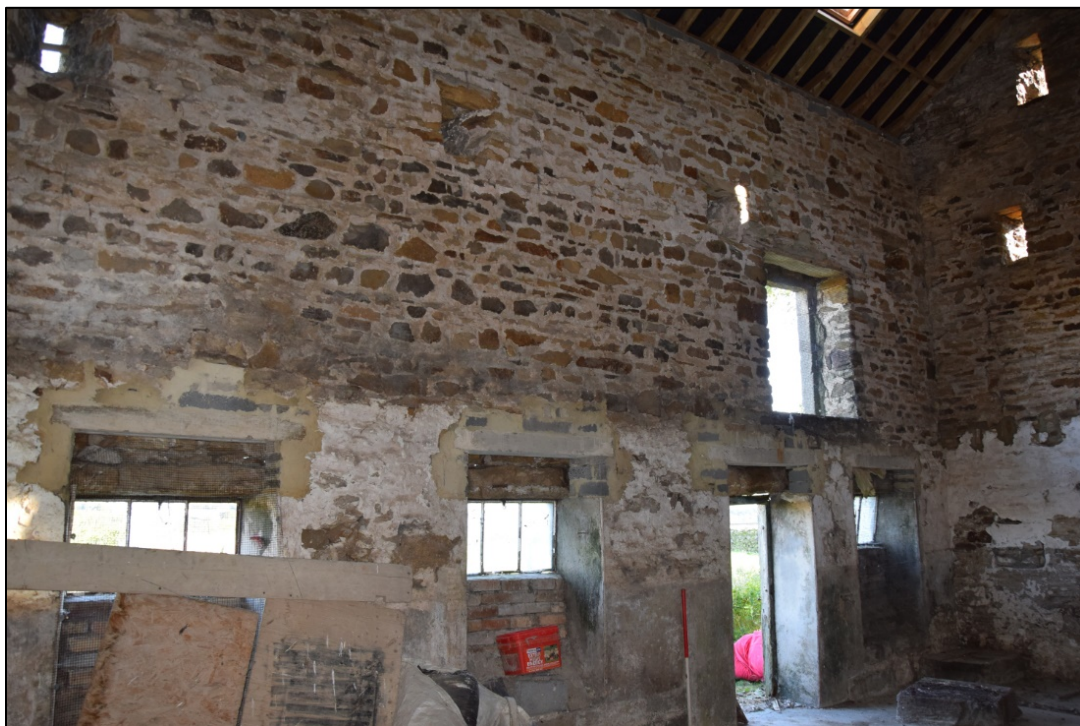
Photograph 18 (below):
The north wall of the
older section is similar
to the east end, with
bare walls and small
breathers in the hay loft

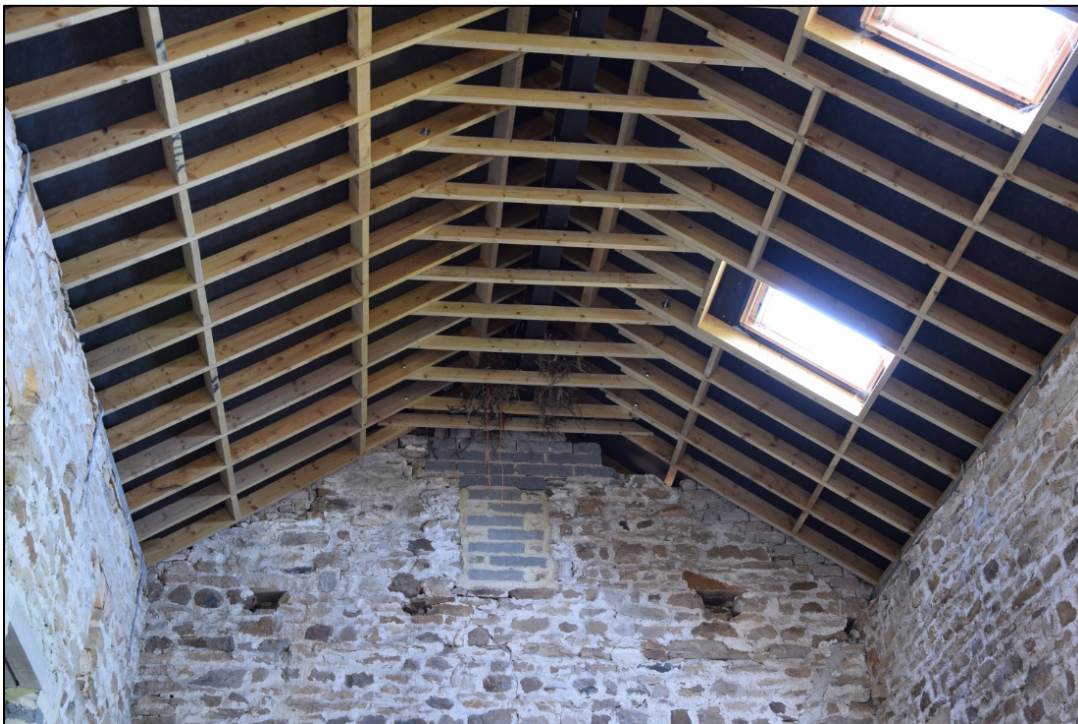
Photograph 20 (below): Detail of the upper window in the gable and the new roof in the internal wall

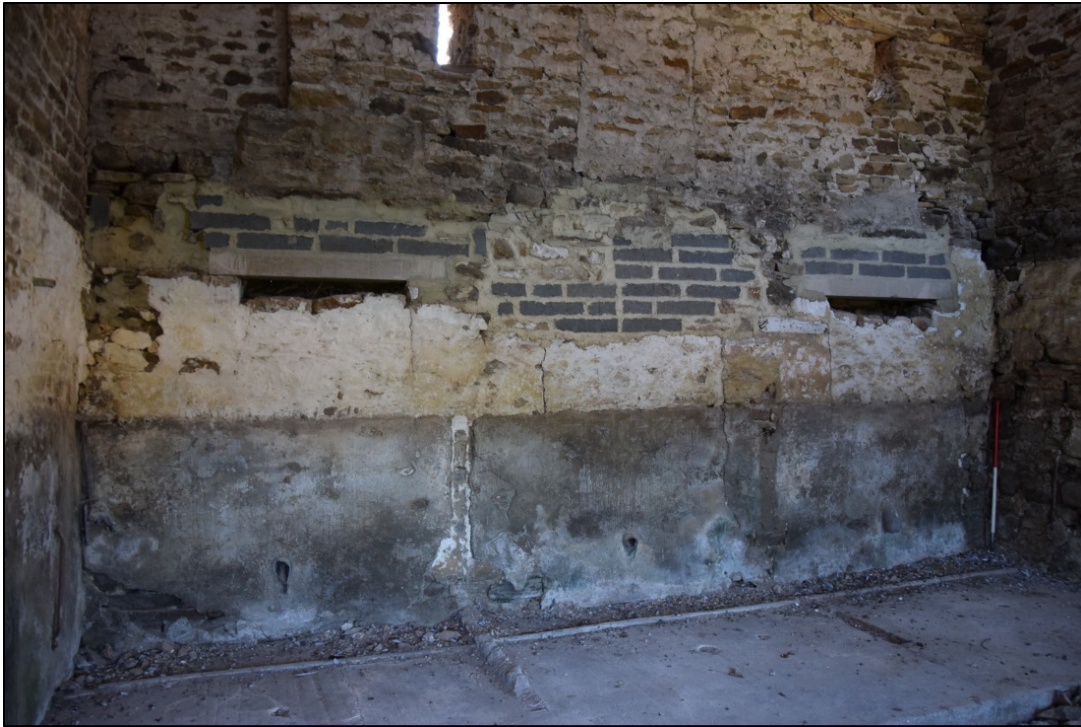
Photograph 21: The south wall of the byre in the west extension. The arrangement of stalls, the wall finishes and the recent repairs are the same as those seen elsewhere in building 1

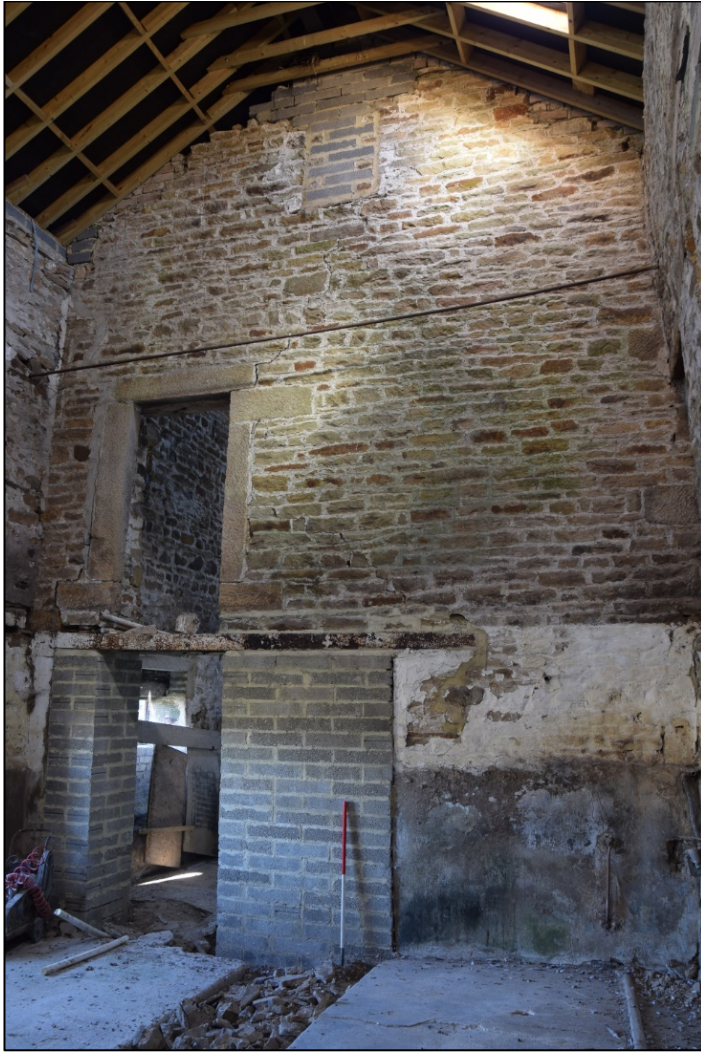
Photograph 23 (left): The west face of the internal wall, formerly the end of the building

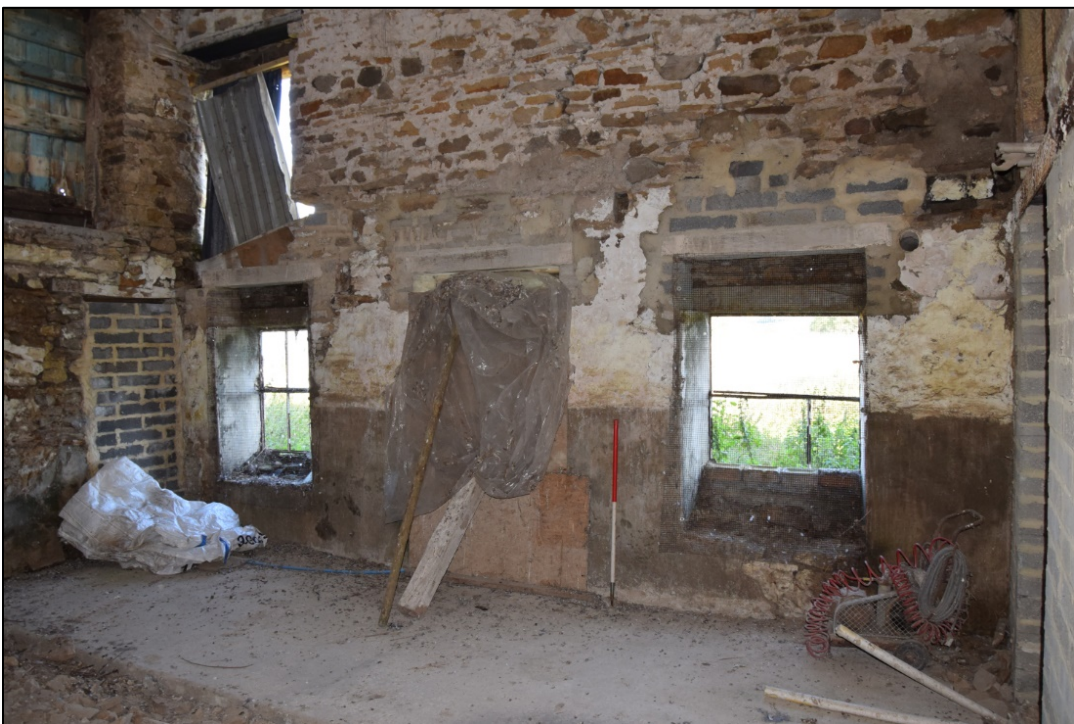
Photograph 24 (below): The north wall of the byre in the extension

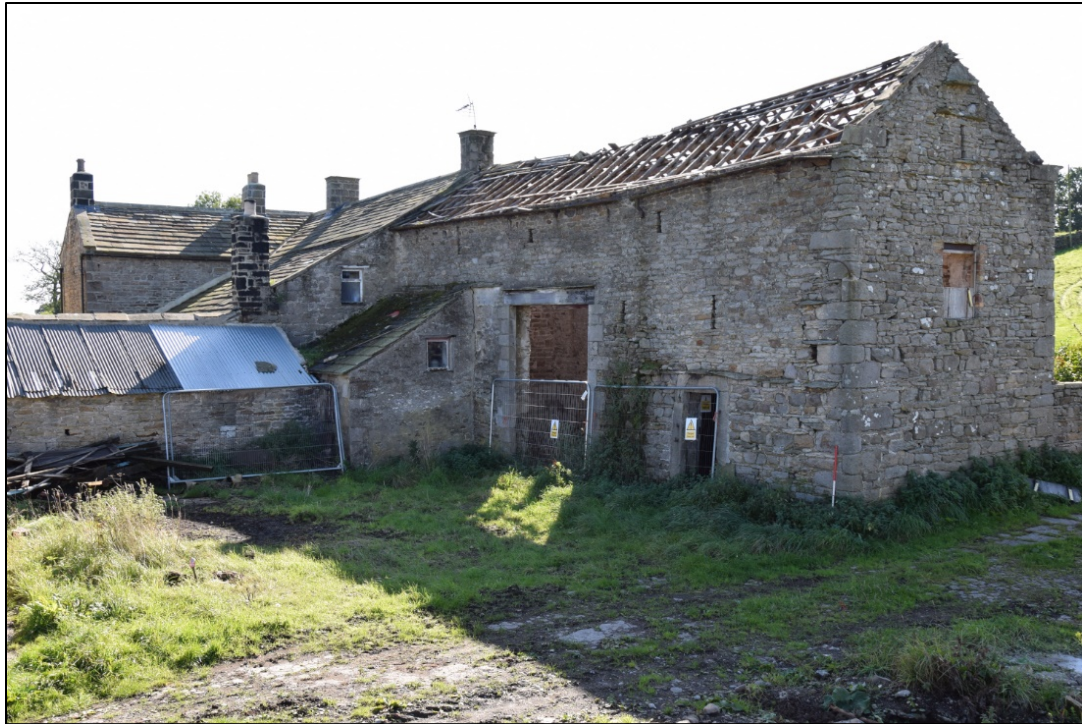
Photograph 27: Building 2, with the L-plan block of houses and their outshut rear extension beyond. The low lean-tos are building 3, outside the study area

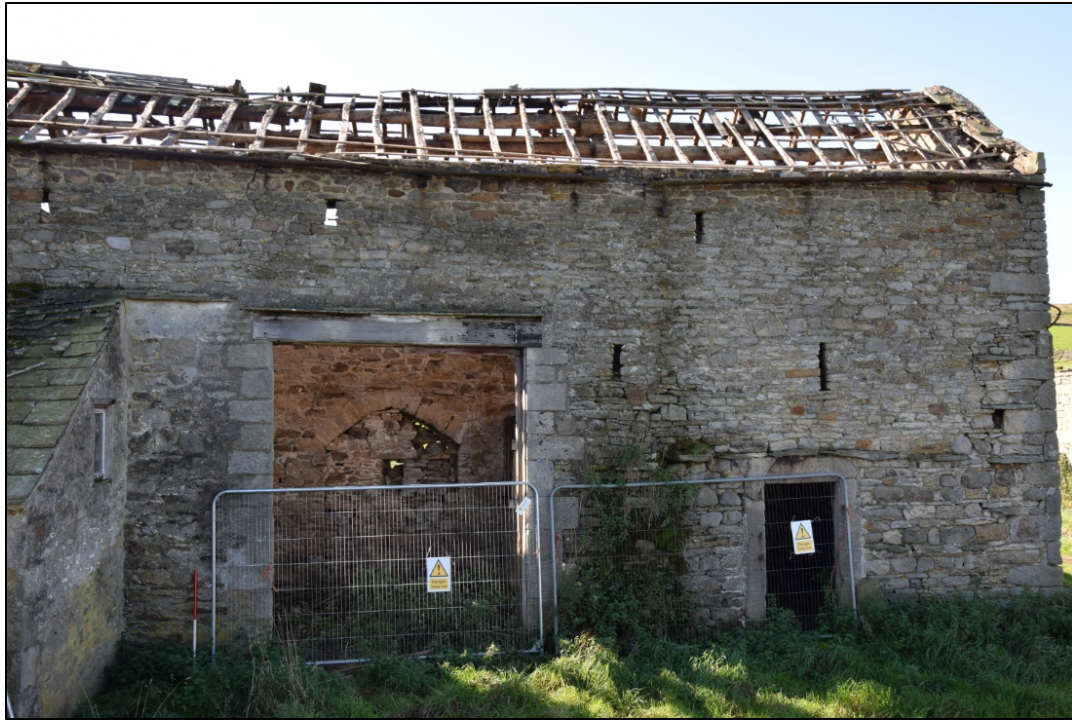
Photograph 29 (above):
Detail of the north wall
showing the change in
the quoins at the right

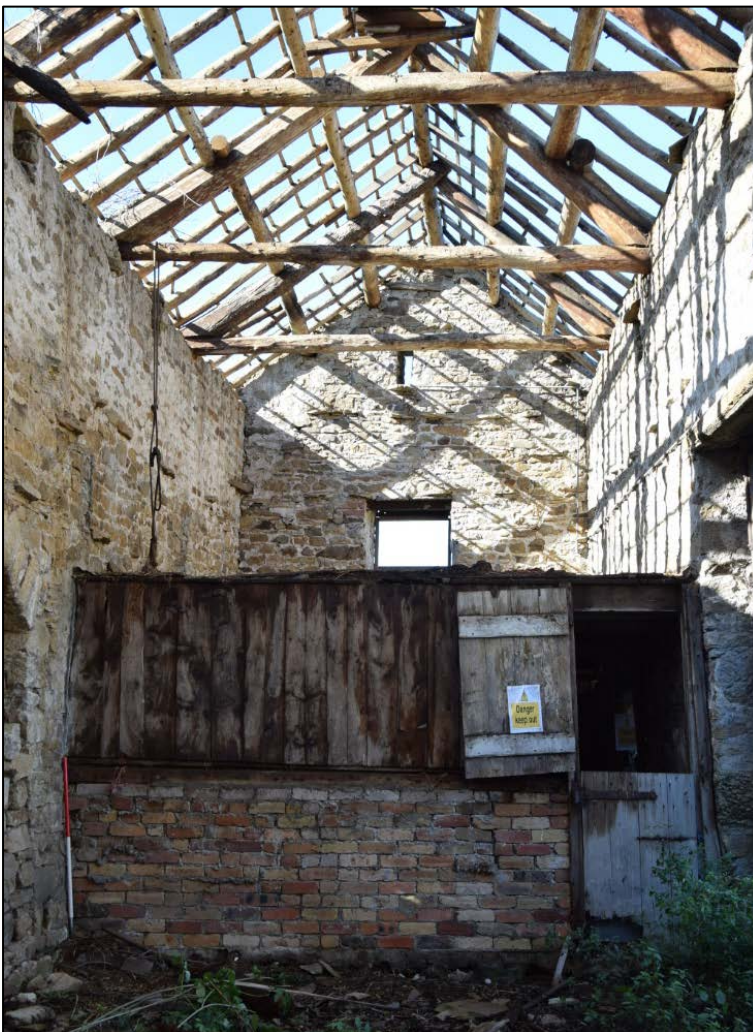
Photograph 36 (left): A
view looking west
inside building 2. The
later brick and timber
byre rises to the
original floor level

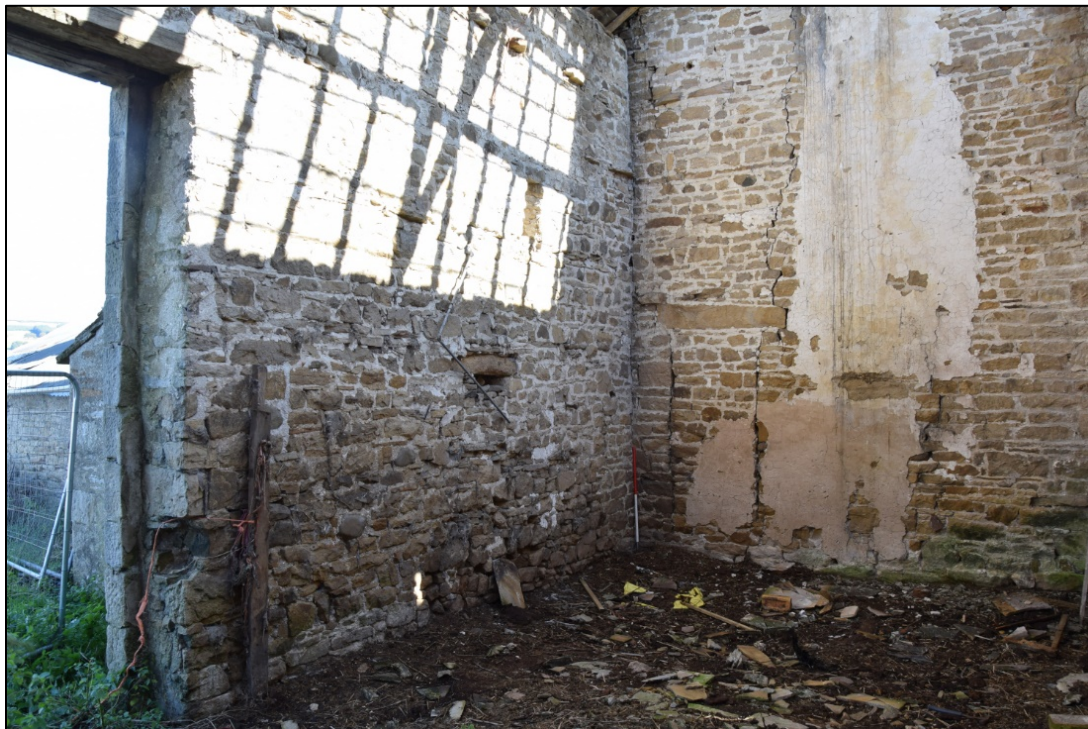
Photograph 44 (below):
The east end of the
north wall, with a small
blocked window that is
now covered by a lean-
to shed outside

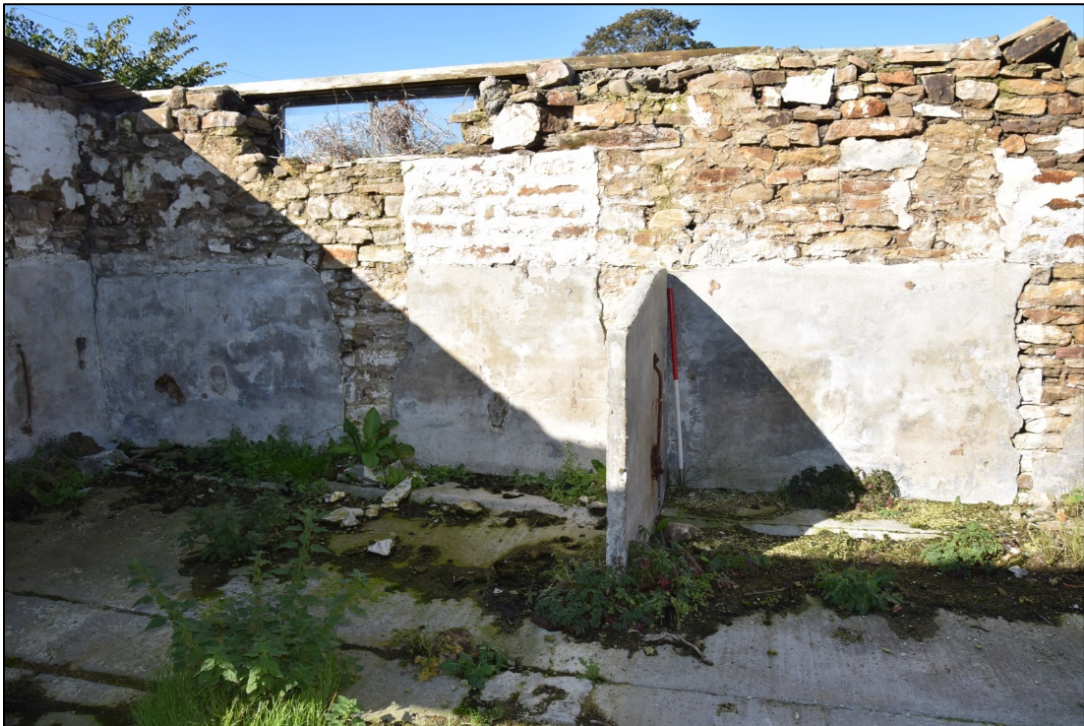
Photograph 54: The remains of cattle stalls inside building 4

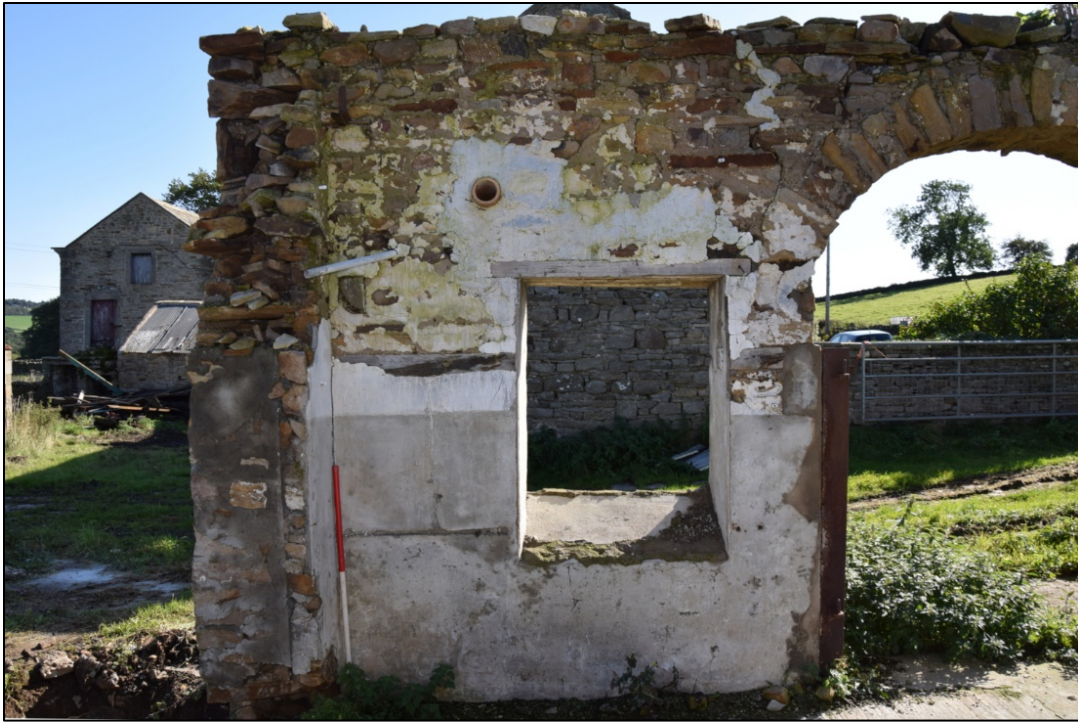
Photograph 57: The north-east corner has no sign of joists or sockets to correspond with those seen in Photo 56

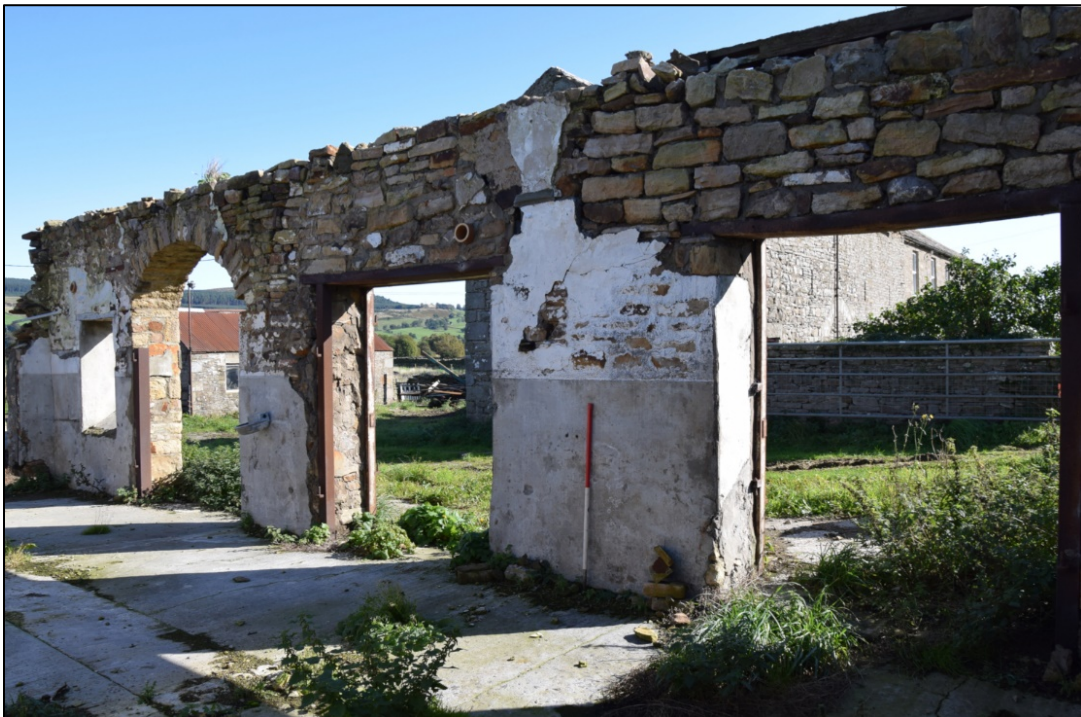
Photograph 58: Much of the upper part of the east wall has been rebuilt in recent times

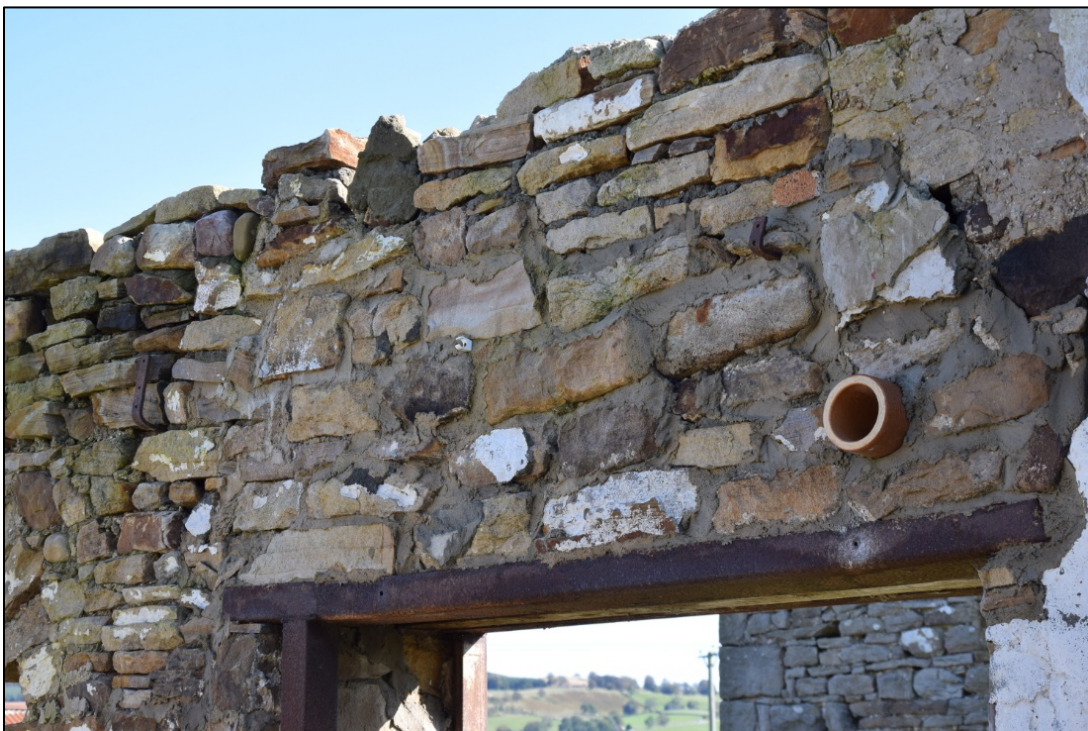
Photograph 60: The same pattern is seen over the middle door of building 4

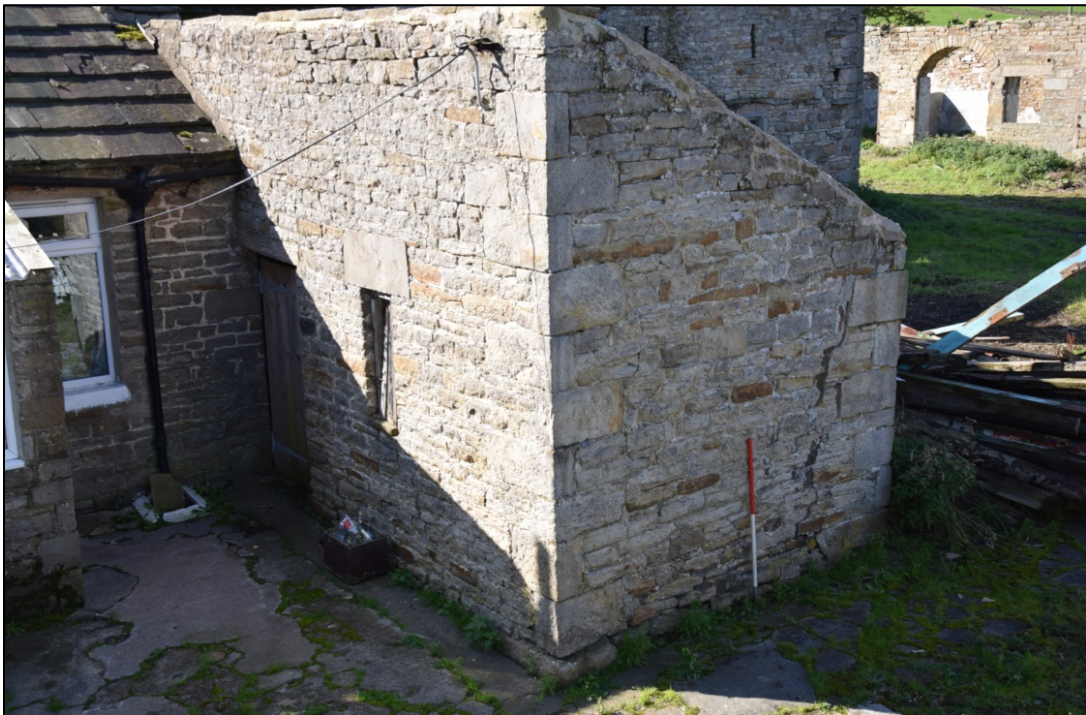
Photograph 70: Building 3. The masonry here is very similar to that of the much later building 5
