THE FORMER GARIBALDI PUBLIC HOUSE  
6, THE GREEN, CHALVEY  
SLOUGH SL1 2SN

AN HISTORIC BUILDING RECORD

Planning Application Reference: P/11098/003

COMPASS ARCHAEOLOGY  
250 YORK ROAD  
LONDON SW11 3SJ

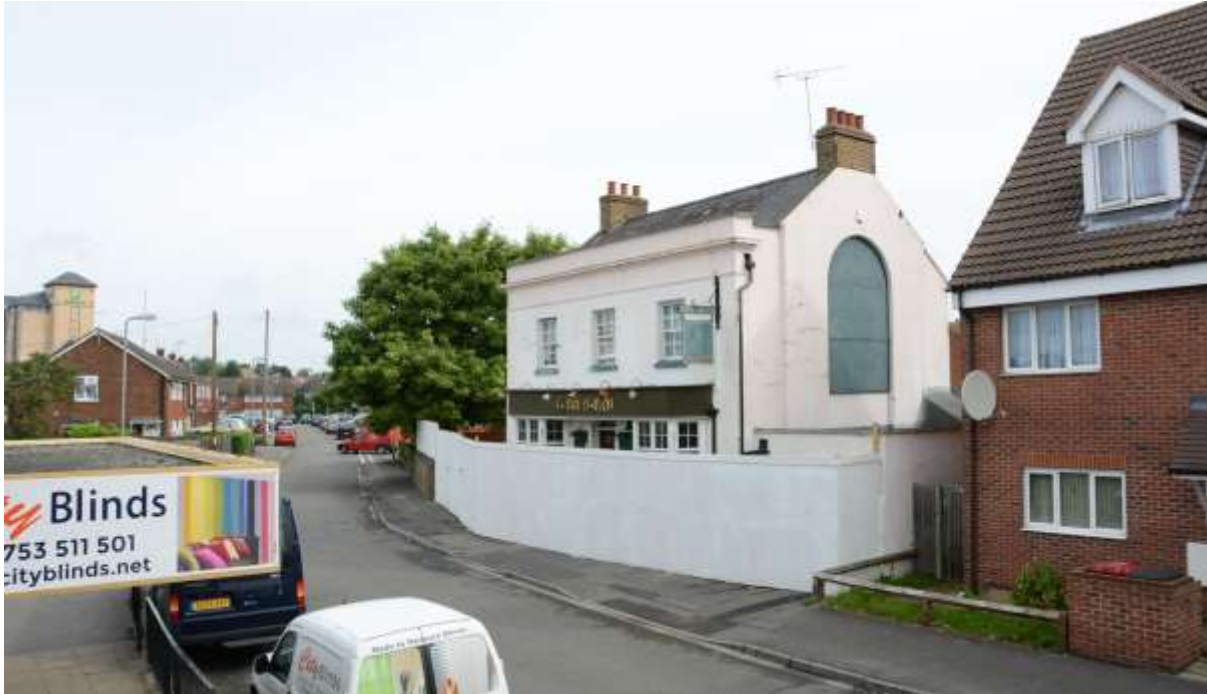
Fig.10: *General view from The Green looking north*

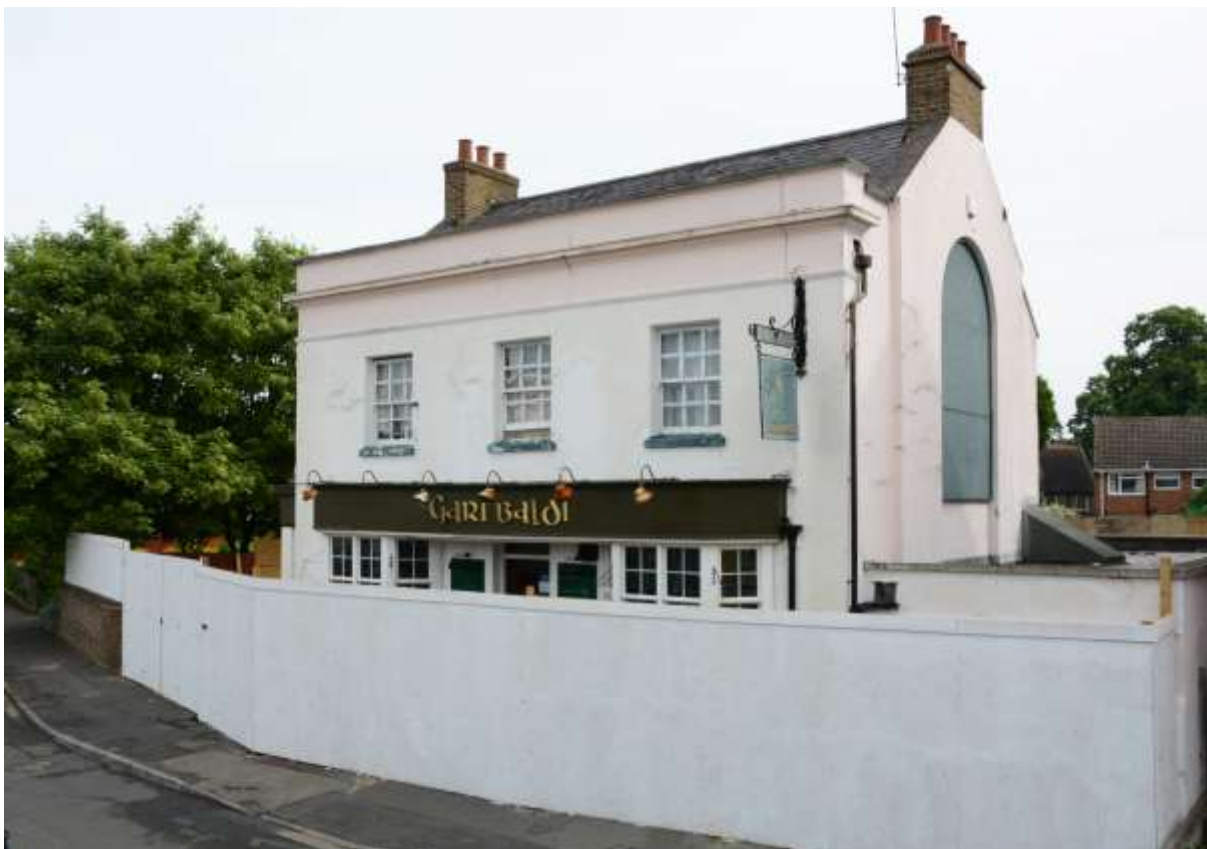
Fig.11: *Closer view of the property from The Green, looking approximately NNE*

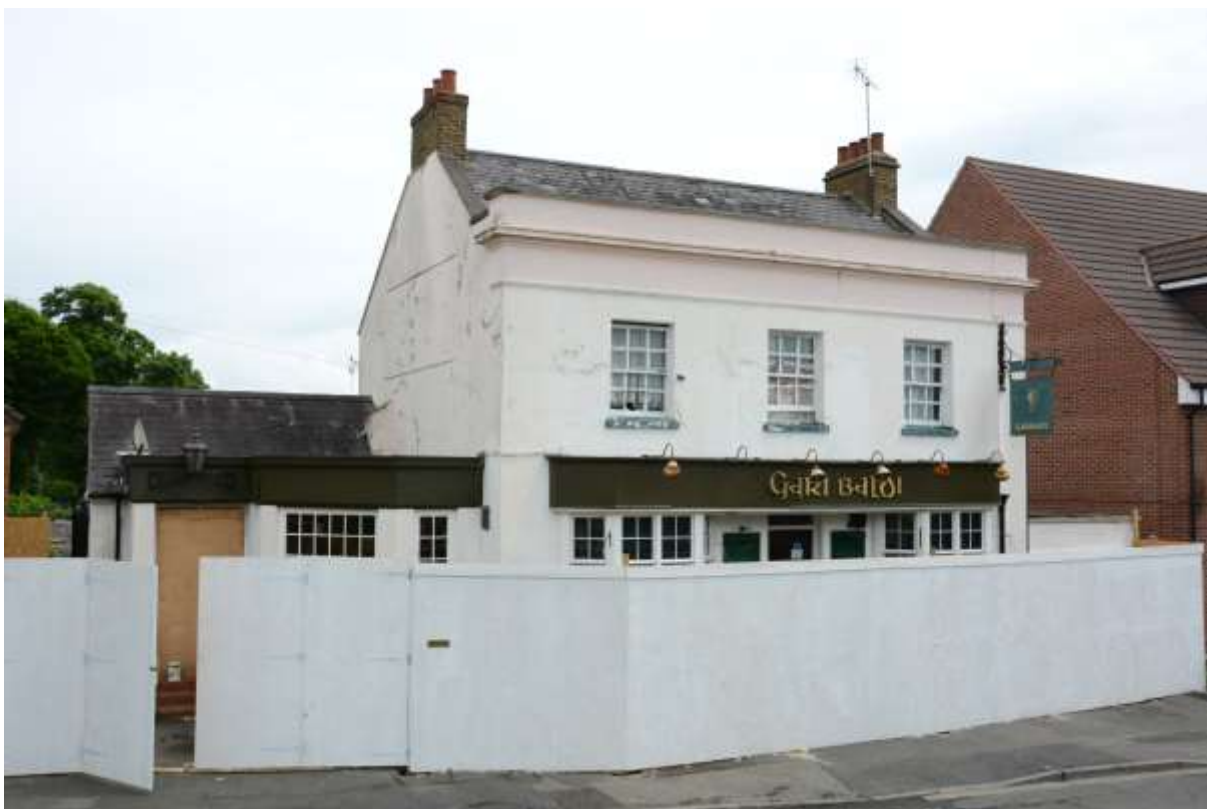
Fig.13: *View from The Green, looking approximately ENE*

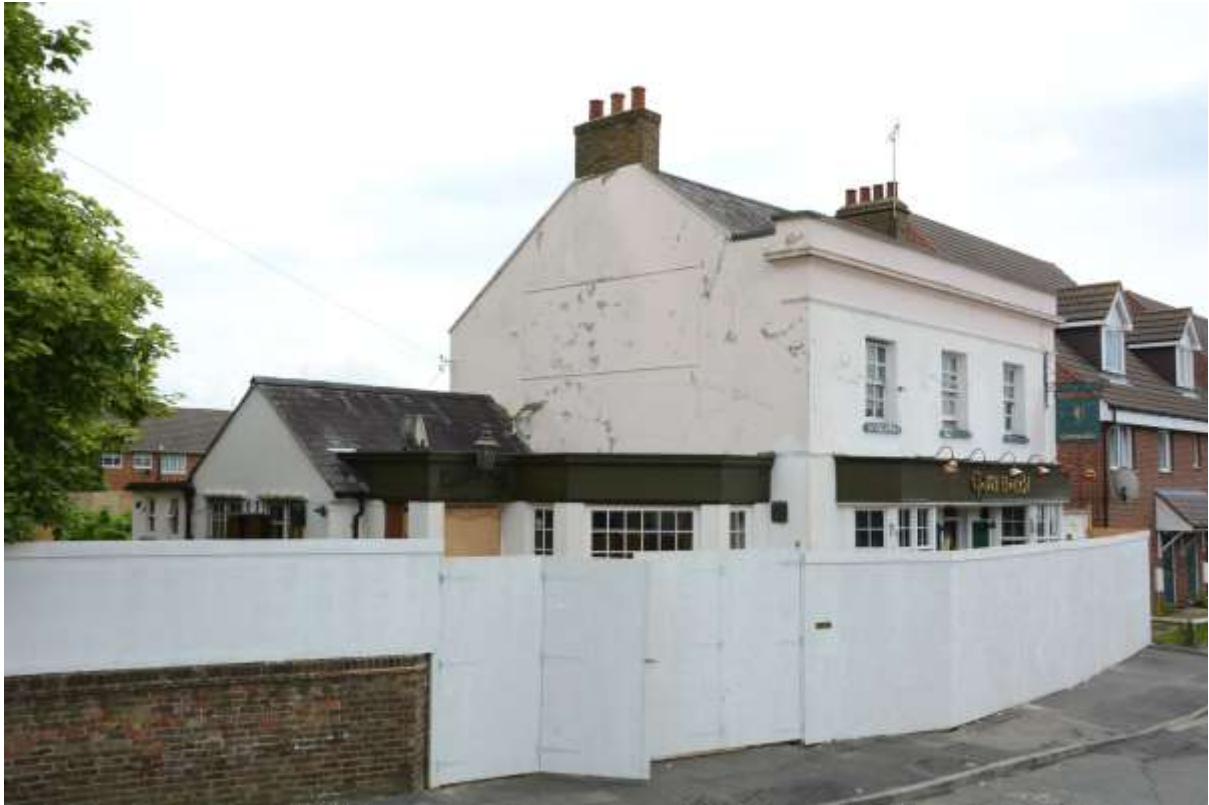
Fig.14: *View of the property, looking approximately ESE*

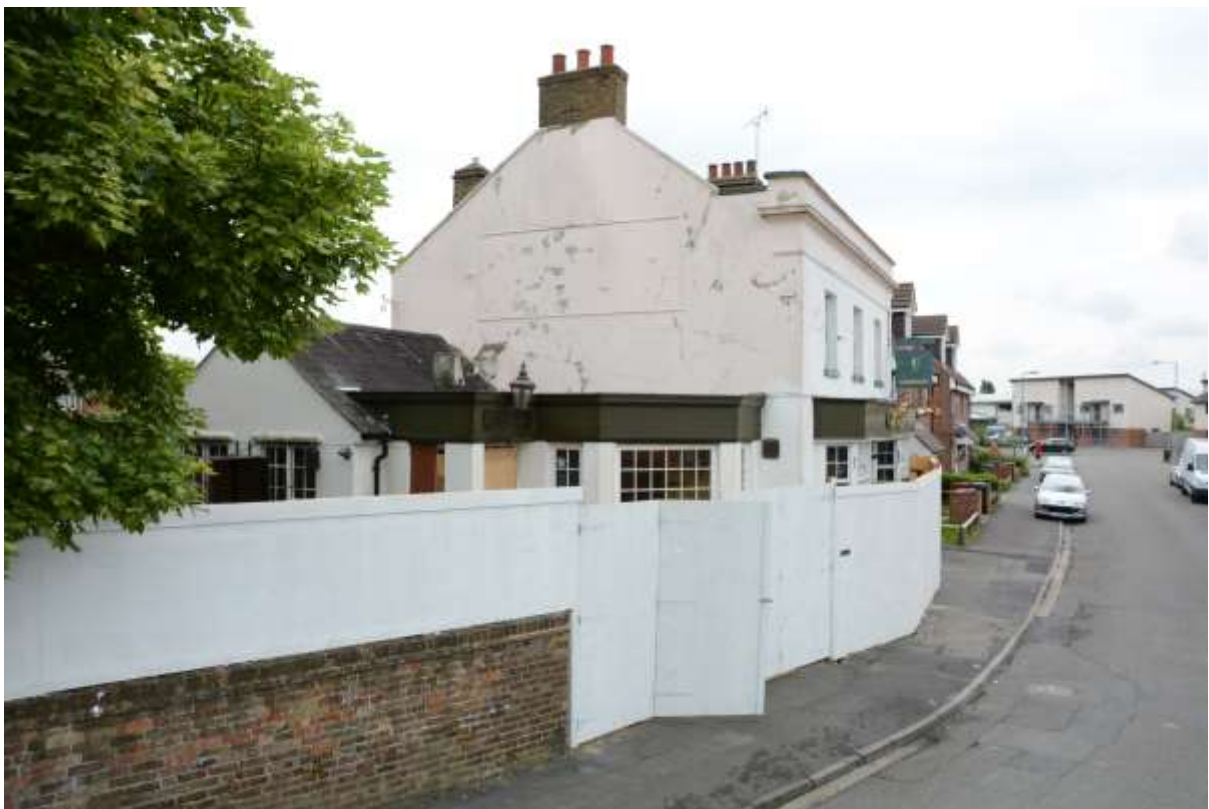
Fig.15: *View looking southeast along the line of The Green*

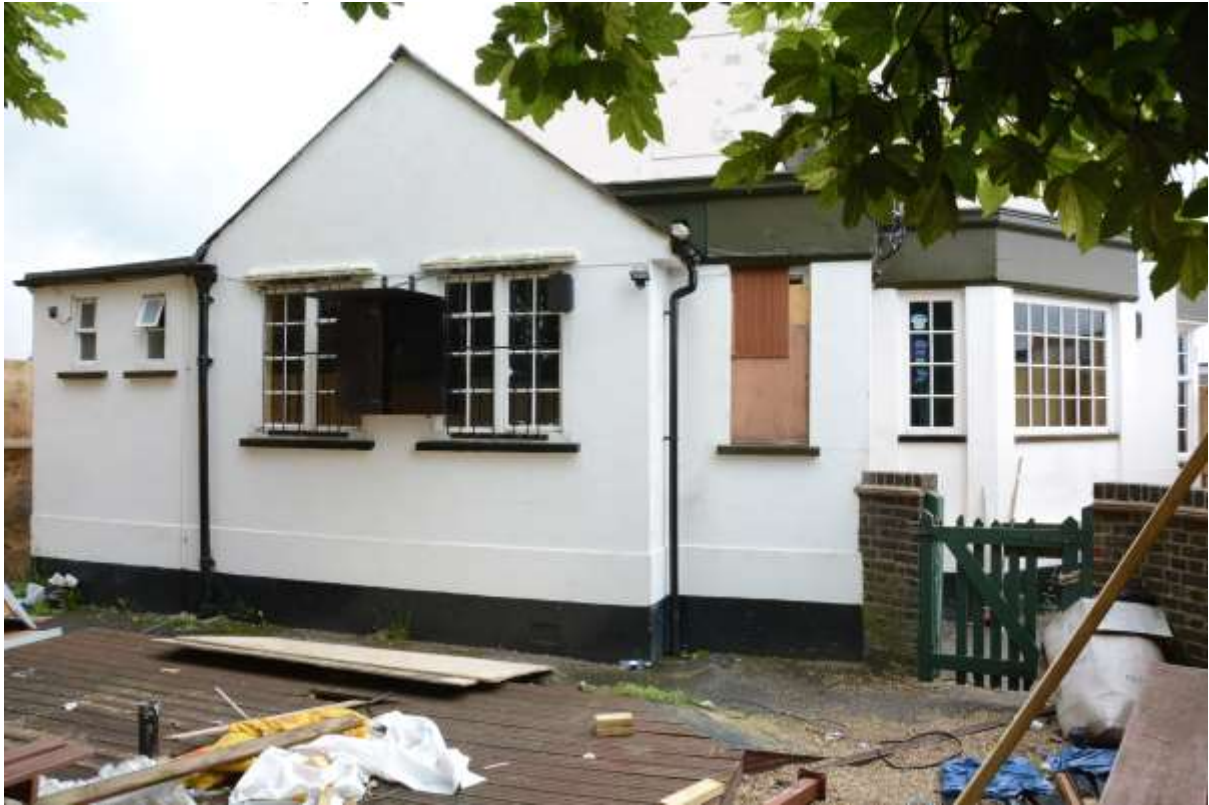
Fig.16: *The northwestern end of (& earlier 20<sup>th</sup> century extensions to) the property*

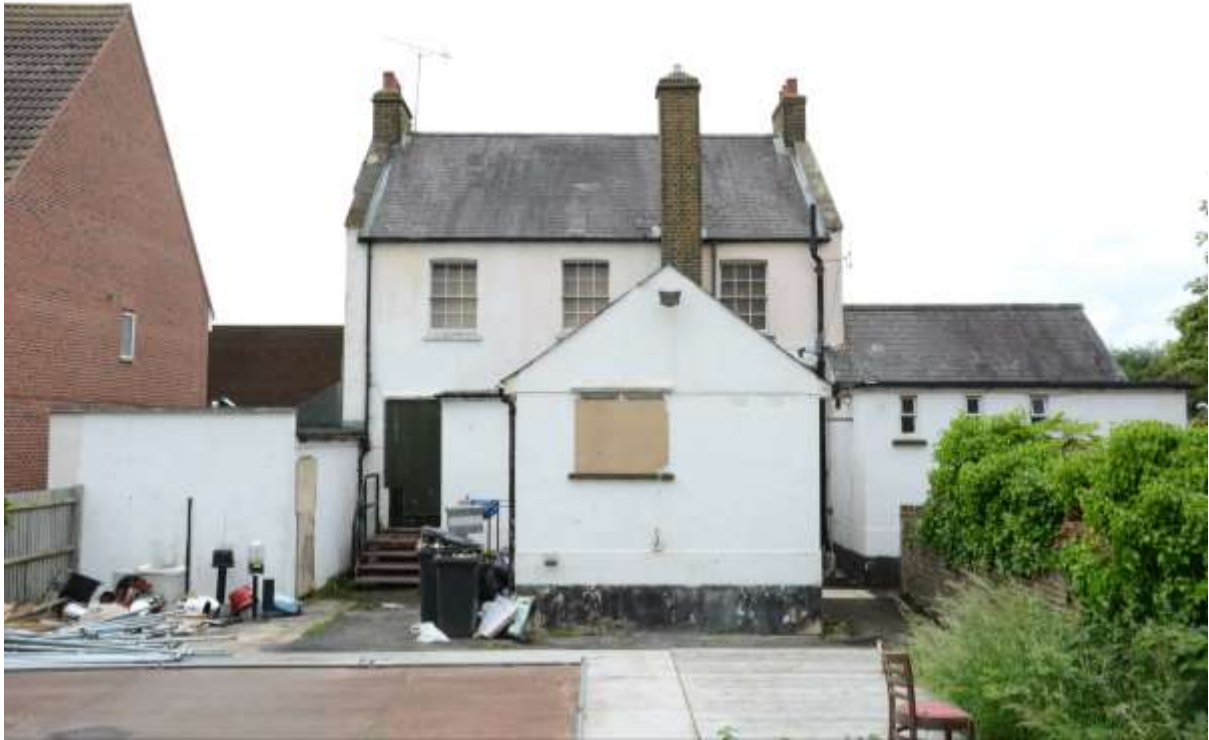
Fig.18: *Rear view of the property, looking southwest*

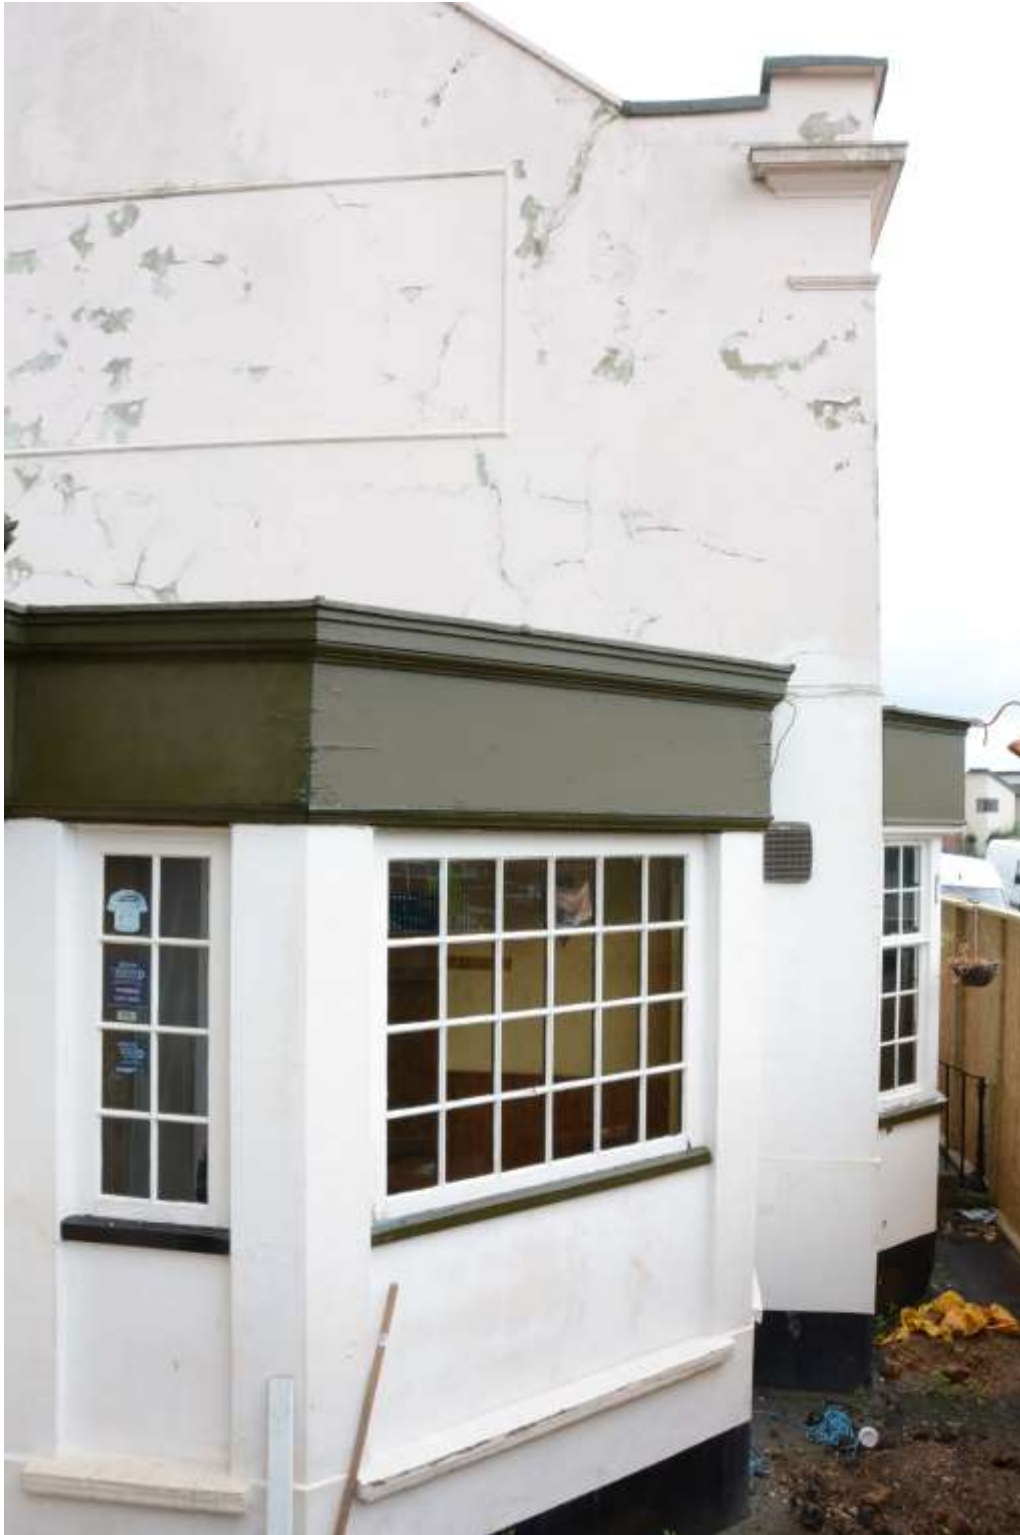
*Fig.25: Single storey northwestern extension housing the secondary front entrance*

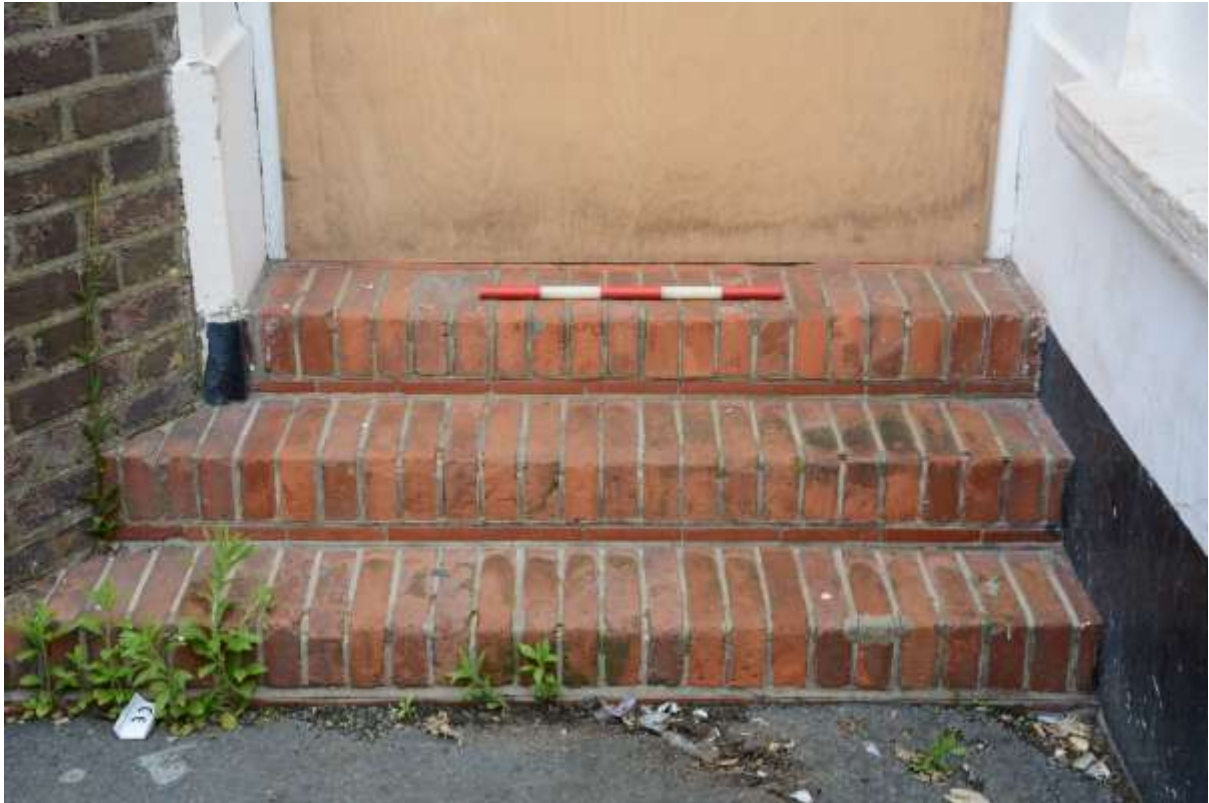
common to all areas – notably the layered tile sill construction, also found on the front bays (*cf.* Figs.32-35), and at the front and back entrances the brick steps (Figs.30-31).

Fig.30: *Brick steps to the secondary front entrance (0.5m scale)*

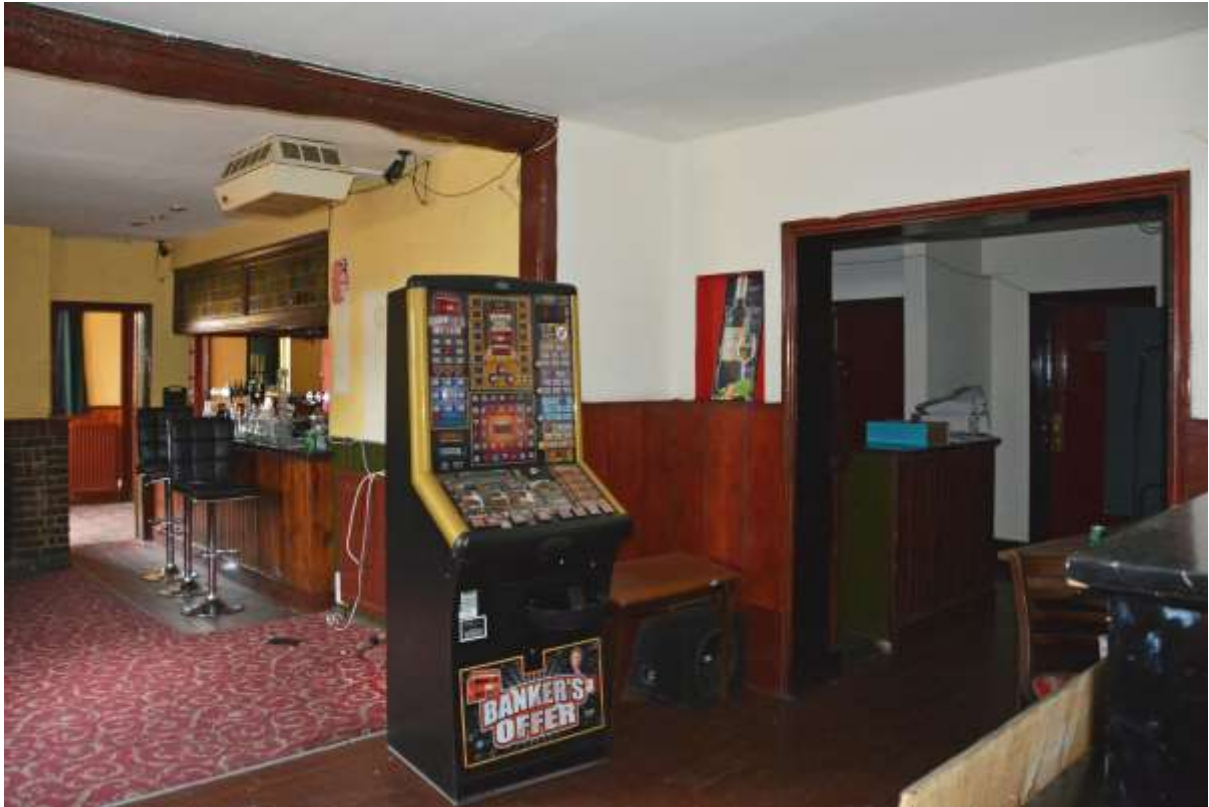
Fig.58: *A further view of the southeastern end of the main bar*

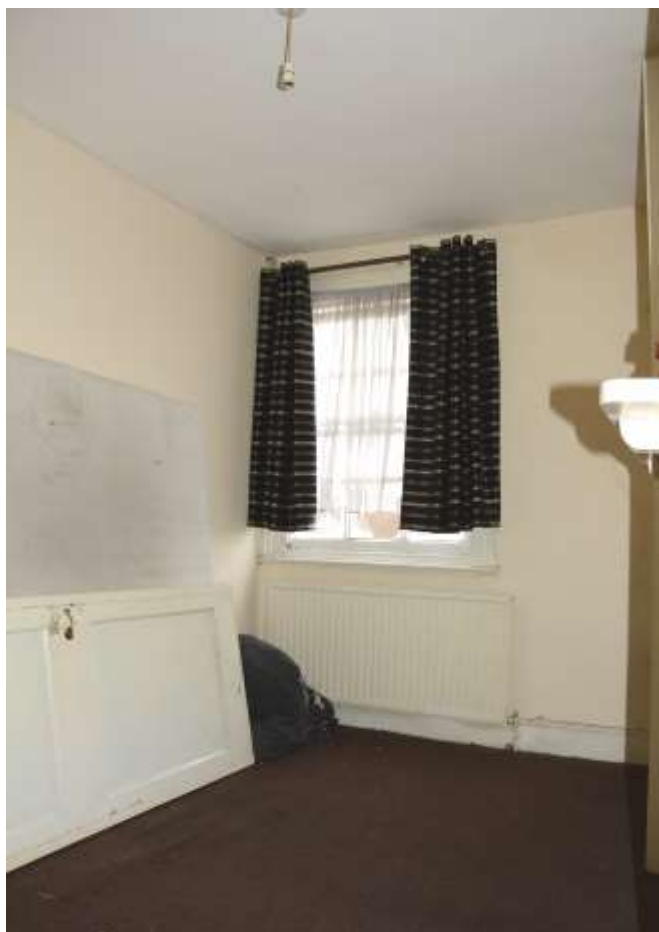
*Fig.106: The northwestern bedroom, looking towards the sash window*
