**FORMER 'SHIP AGROUND' PUBLIC HOUSE
142 LEA BRIDGE ROAD, HACKNEY, LONDON, E5 9RB**

**HISTORIC BUILDING RECORD
(English Heritage Level 2)**

**Commissioned by
Singh Sabha Gurdwara North East London**

Report No. 2013154 (rev. 1)

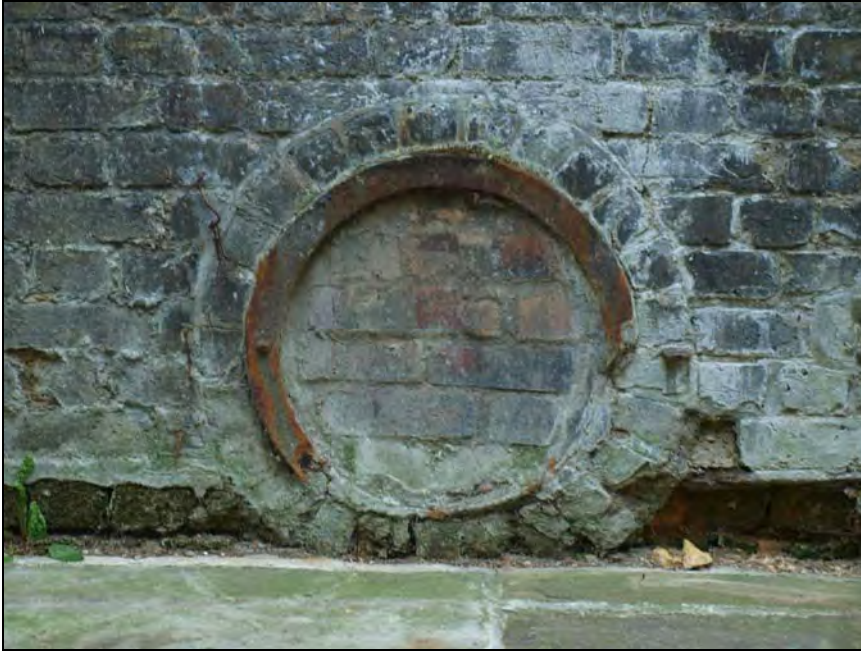
Plate 13. Northeast elevation, blocked circular opening. Facing southwest (11)

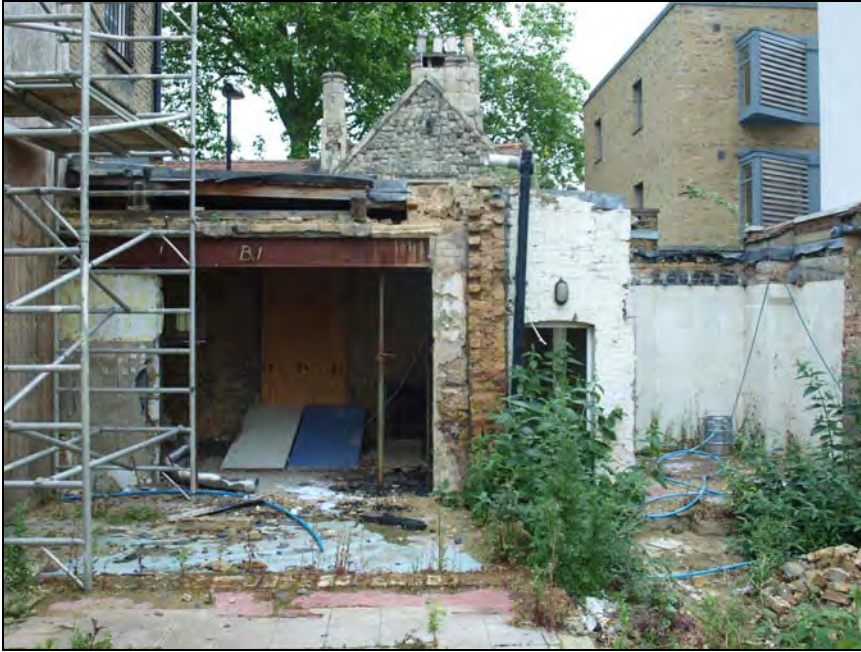
Plate 19. Outbuilding in northern corner. Facing northwest (18)

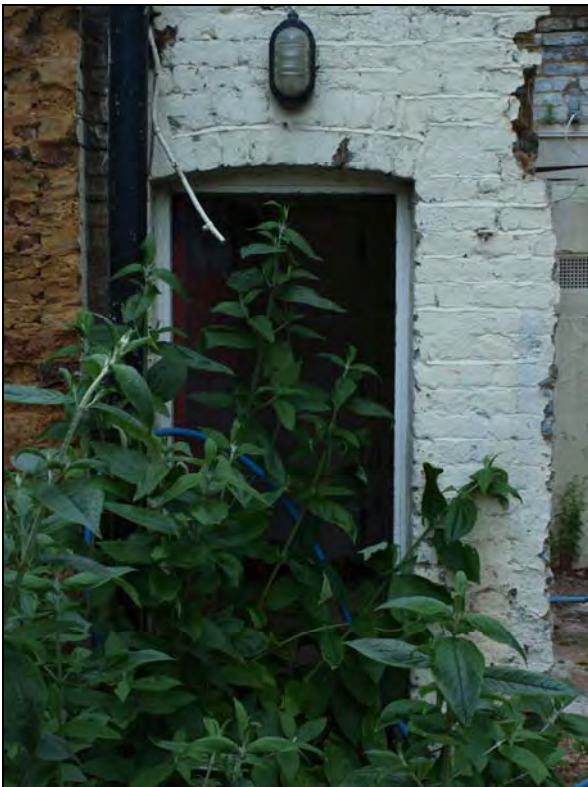
Plate 20. Doorway of extant outbuilding to rear courtyard. Facing northeast (26)

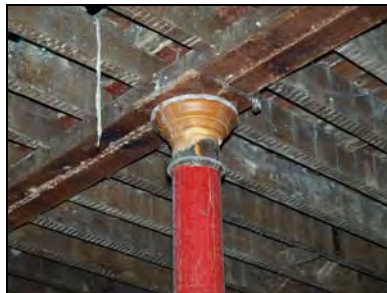
e2668-41
Interior, detail of pillar. Facing east

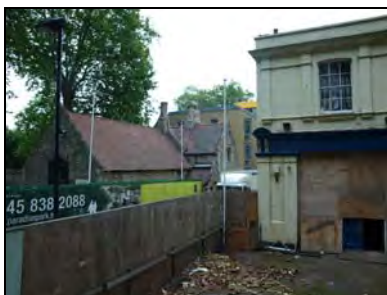
e2668-70
General shot showing relationship with old school. Facing east
