15-17 High Road, Ickenham, Hillingdon, London

Historic Building Record

**ASE Project No: 170719
Site Code: HRI17**

**ASE Report No: 2017434
OASIS id: archaeol6-298779**

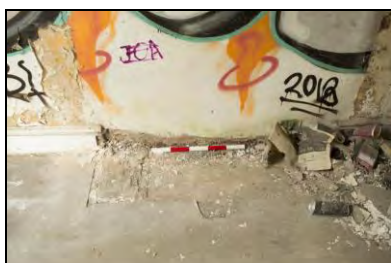
HR117-0051

Detail of removed chimney, room 9
