**AN ARCHAEOLOGICAL WATCHING BRIEF AT 45 PARK LANE WITH A
SUPPLEMENTARY HISTORIC BUILDING RECORD DURING REPAIR AND
REFURBISHMENT WORK AT 45 AND 47 PARK LANE, SLINDON, WEST SUSSEX**

Project No: 3492
Site Code: PLS08

ASE Report No. 2008198
OASIS id: archaeol6-55483

COMMISSIONED BY
THE NATIONAL TRUST

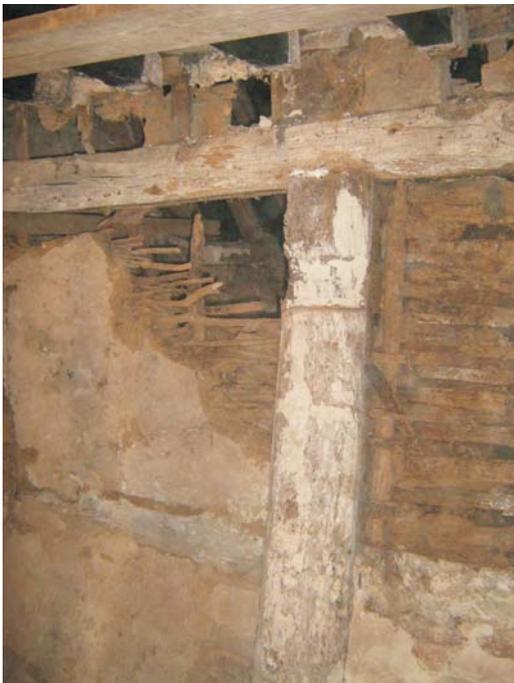
Plate 3: Detail of the two types of in-fill on the south partition wall of the living room

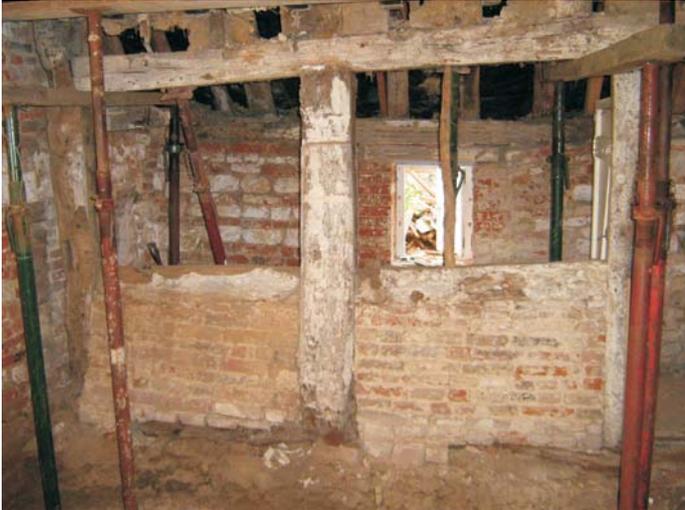
Plate 5: The lower panels of the south wall, fully stripped to reveal the later brick in-fill

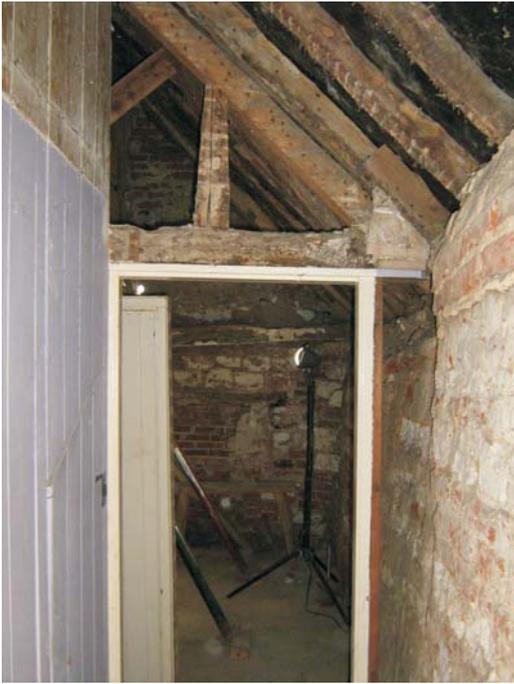
Plate 13: The south wall of the building with continuous chalk and brick construction - viewed through the doorway to the former bathroom

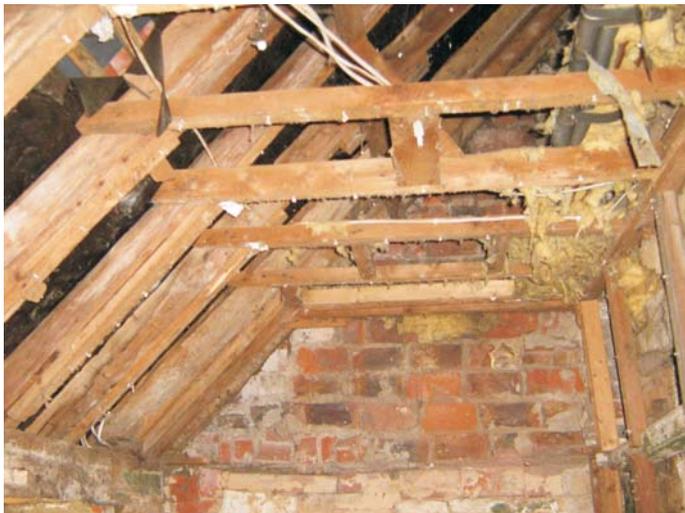
Plate 15: The construction of the west wall of the outshot with brick laid on edge above the off-set. The added softwood struts for the inserted under-plastered ceiling are also visible

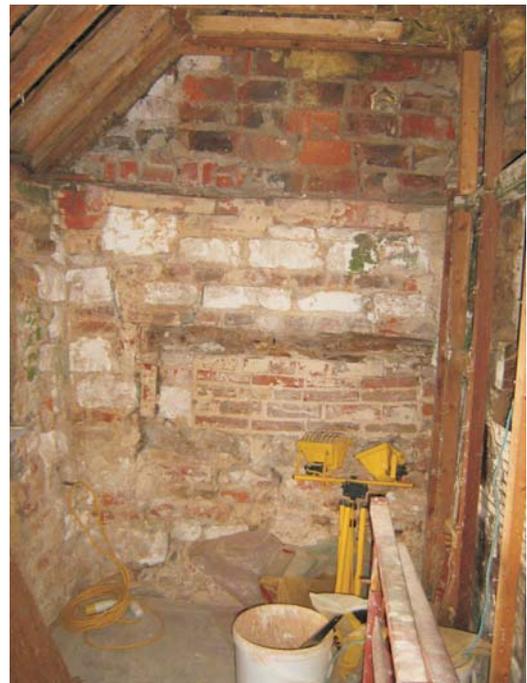
Plate 16: The lower chalk and brick built west wall of the outshot- with timber lintel and blocked feature/ recess

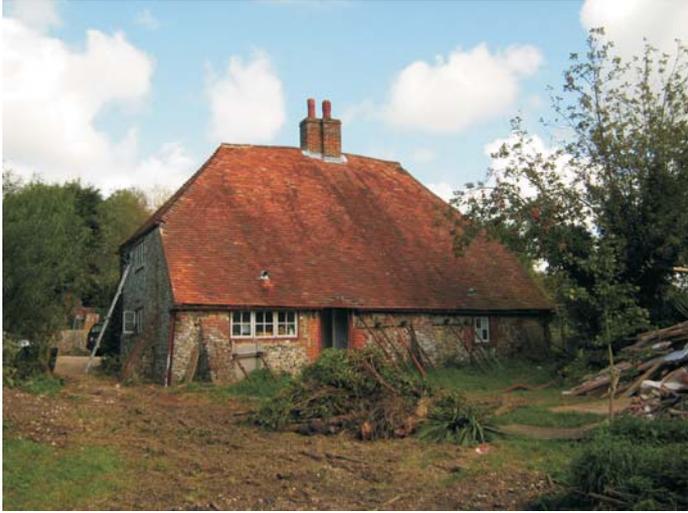
Plate 17: The external south elevation of the house shows 19th century brick quoins to the west window

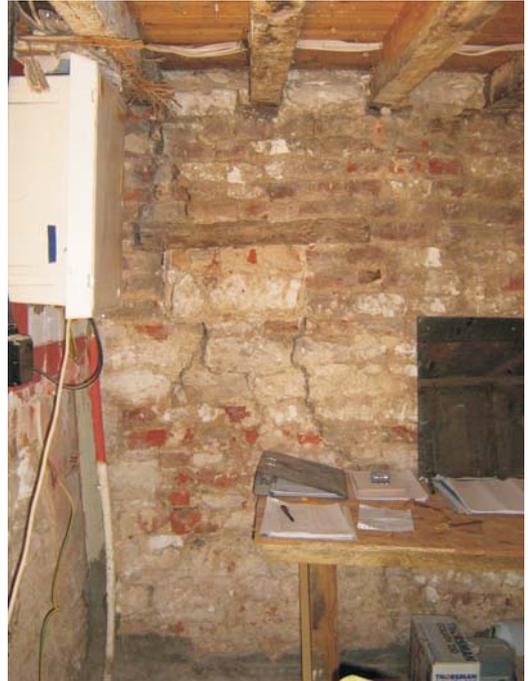
Plate 18: Detail of small blocked recess with timber lintel in the south wall of the kitchen. Also visible are the remains of the reed under-plaster ceiling above the junction box.

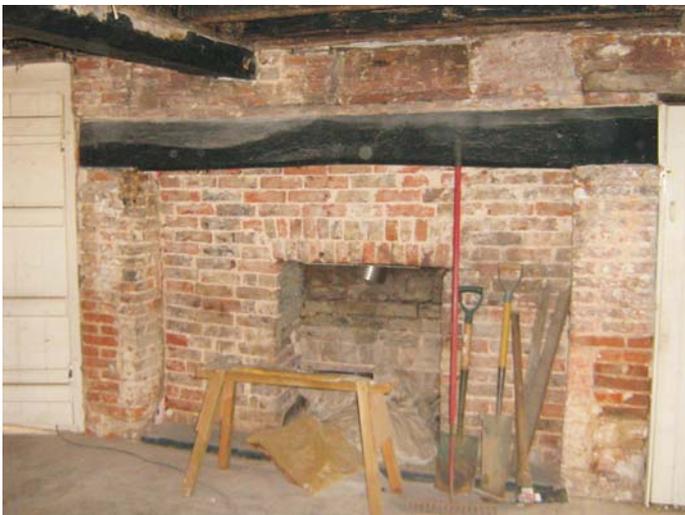
Plate 19: The later in-fill of the kitchen inglenook

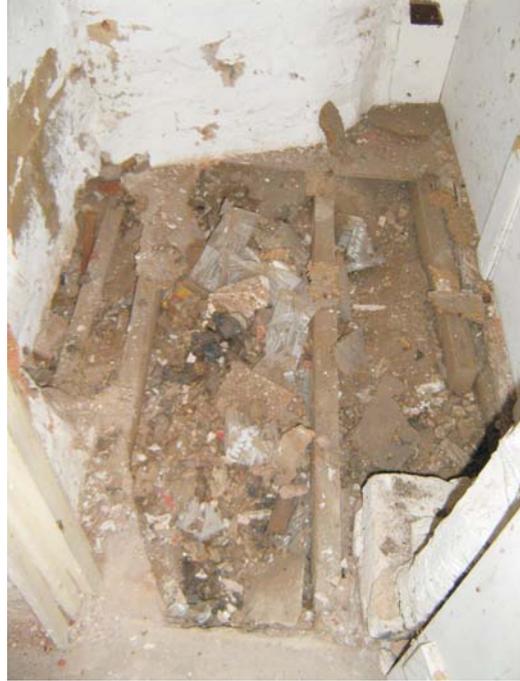
Plate 22: The floor of the cupboard after the removal of the covering plywood boards

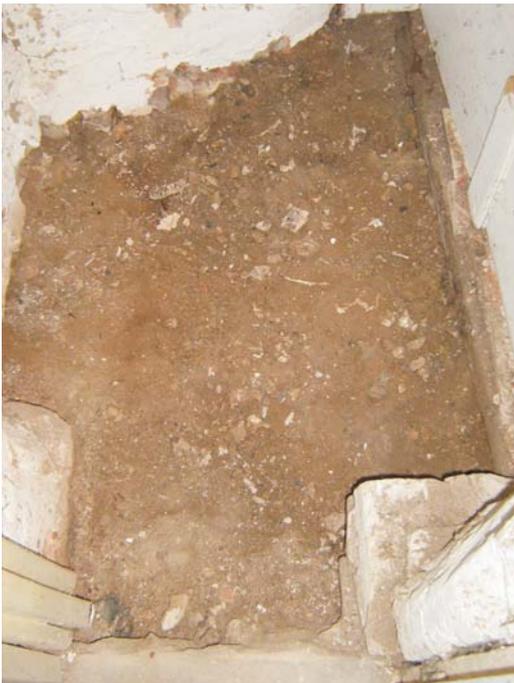
Plate 23: The floor after the removal of the softwood framework which had supported the boards

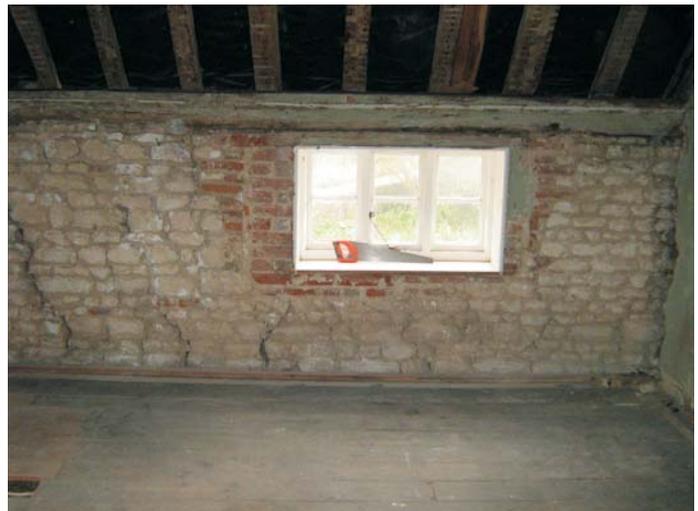
Plate 24: The north wall of Bedroom 1 shows 19th century casement within reduced original opening

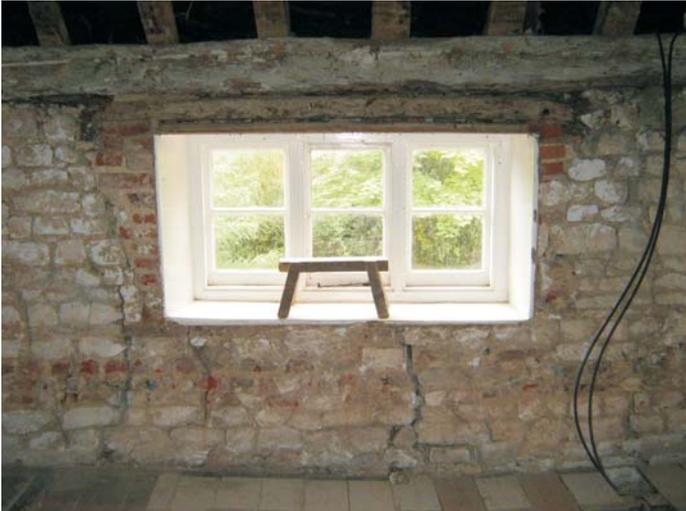
Plate 25: The west wall of bedroom 1 shows chalk block and brick construction

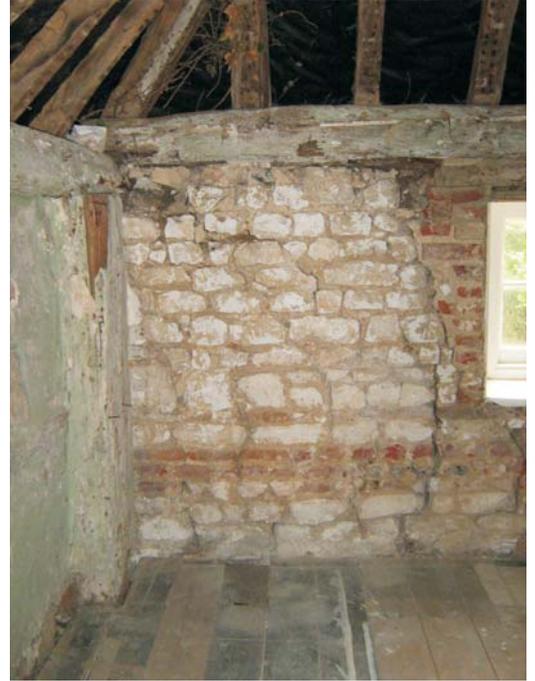
Plate 26: Detail of the south side of the window in the west wall of bedroom 1 - insertion rather than reduction of original opening as shown by the brickwork

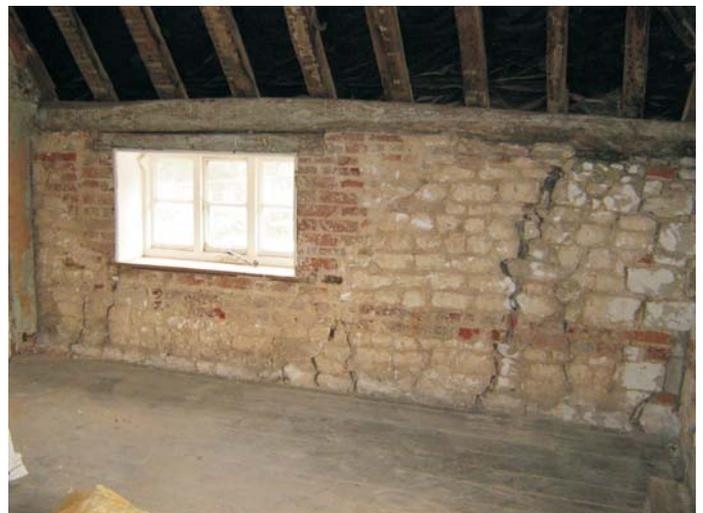
Plate 28: The fabric of the north wall of bedroom 2 (formerly 2 & 3)

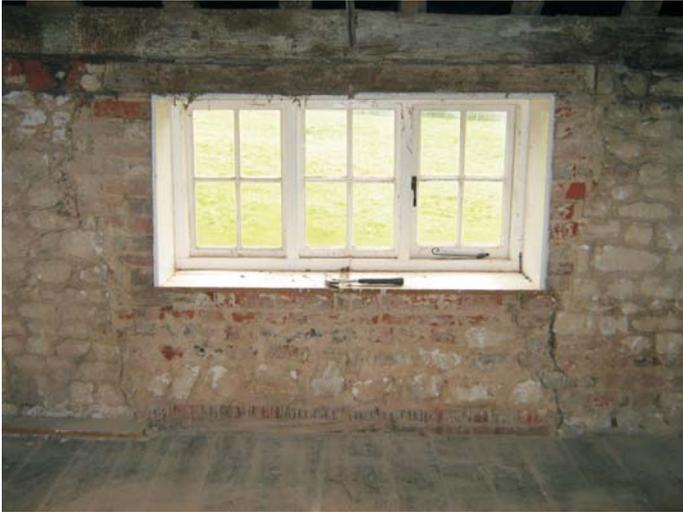
Plate 29: The east wall of bedroom 2 shows window inserted into the formerly un-breached fabric - shows a 19th century casement

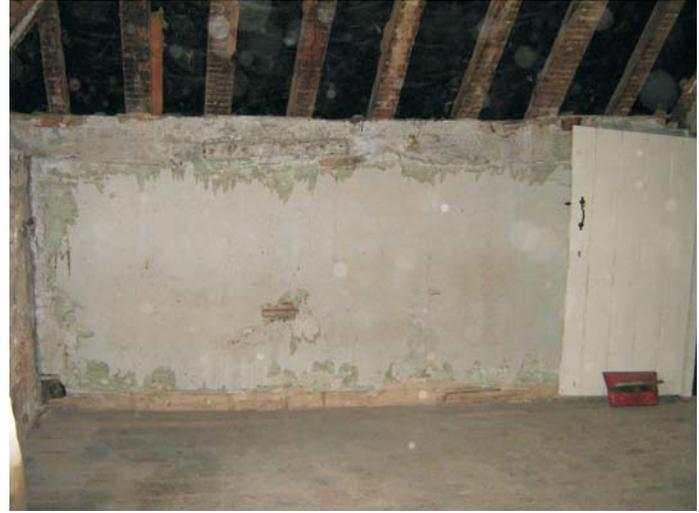
Plate 30: The timber framed south wall of bedroom 2 with the plaster *in situ*

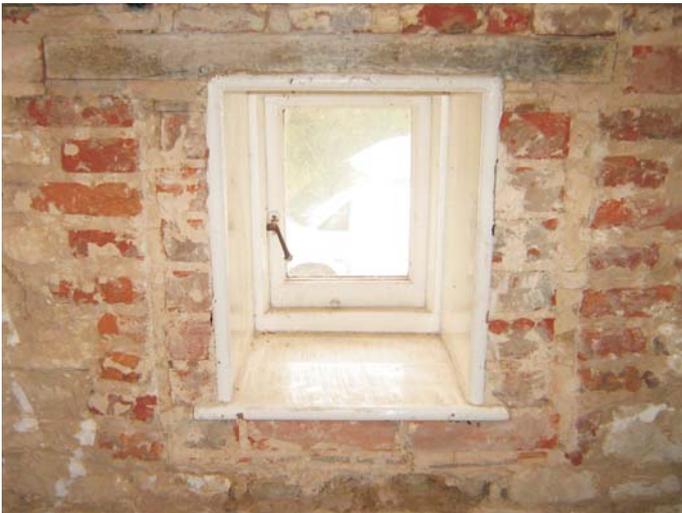
Plate 31: The reduced window opening within the bedroom 2 closet (store)

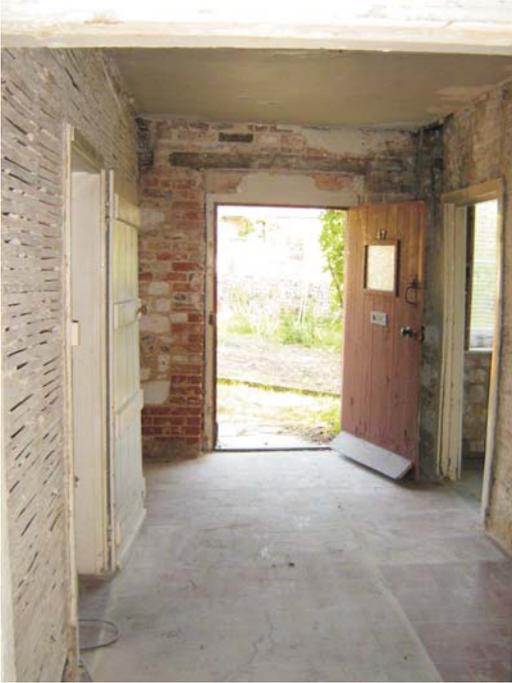
Plate 32: The front door on the north side of the entrance hall viewed from the interior

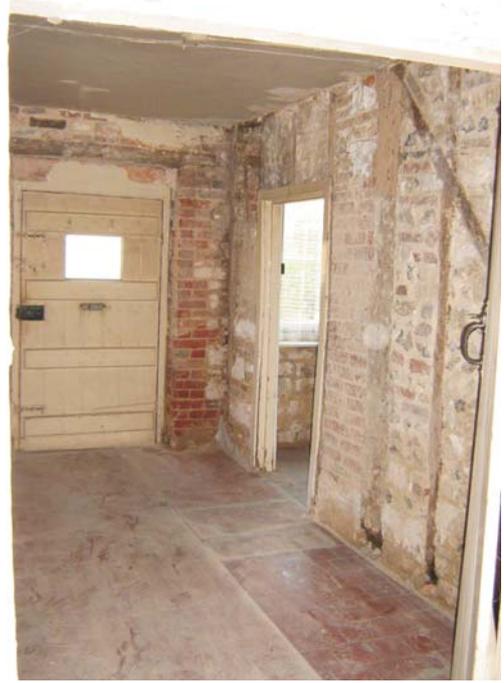
Plate 33: The timber frame partition wall between entrance hall and sitting room

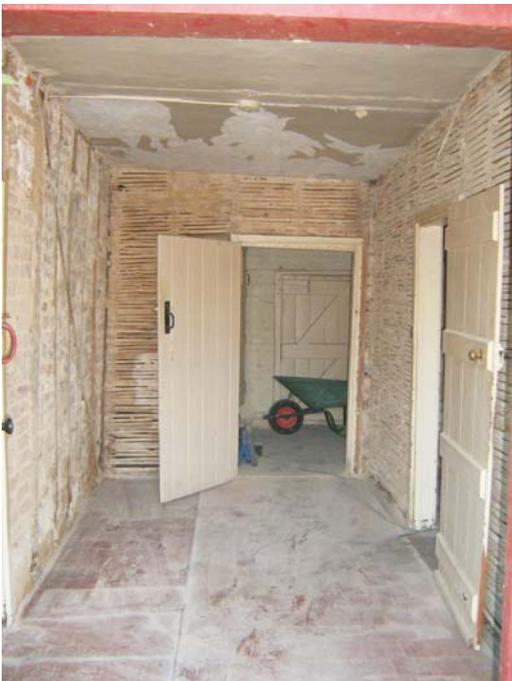
Plate 34: The south side of the entrance hall with quarry tile floor

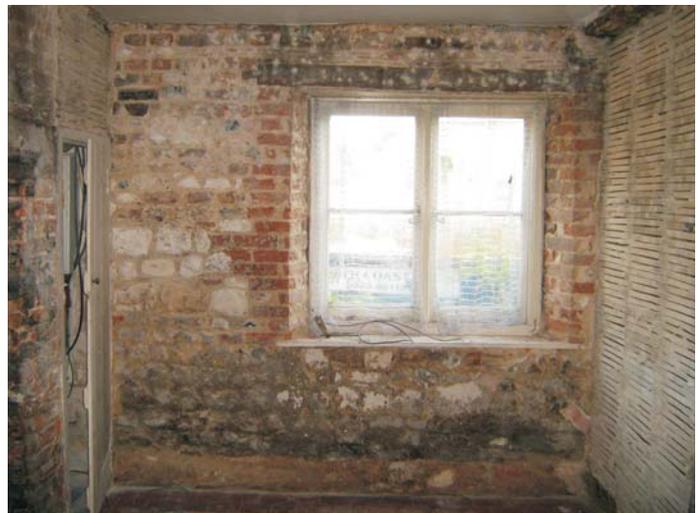
Plate 35: The north wall of the living room

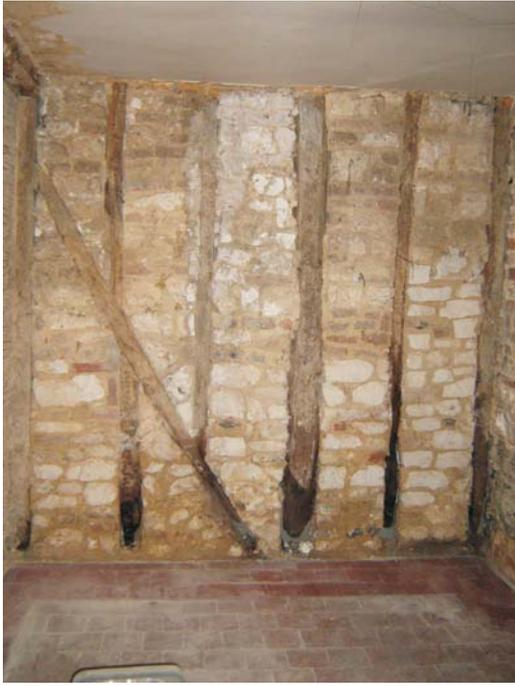
Plate 36: The timber frame south wall of the living room

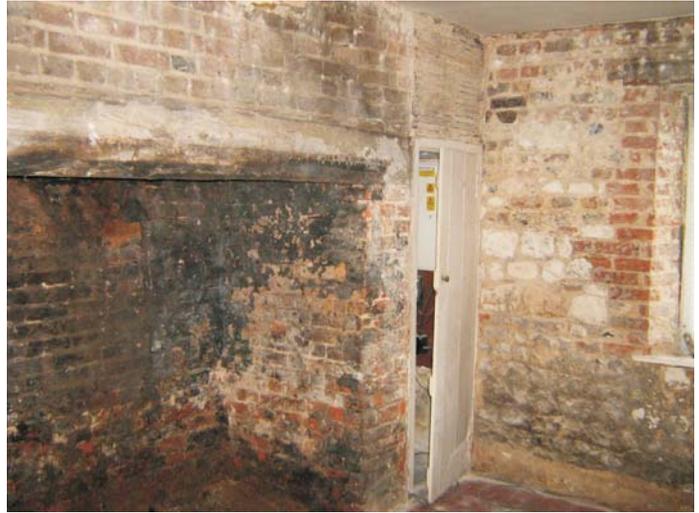
Plate 37: The fireplace in the west wall of the living room with the north cupboard

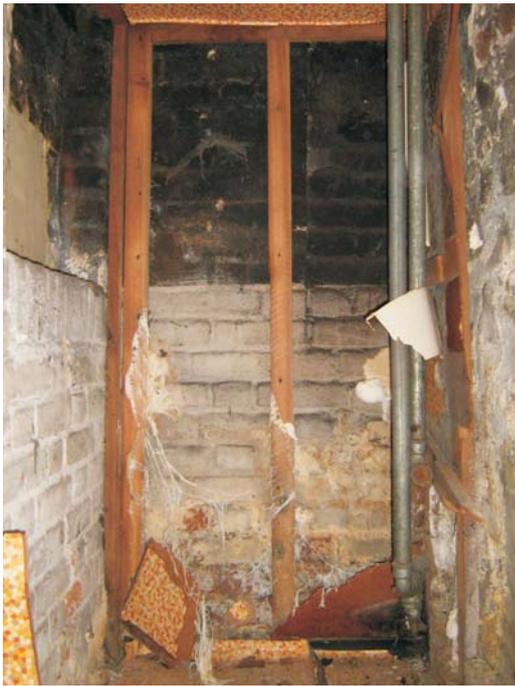
Plate 38: The interior of the inserted cupboard to the south of the fireplace in the living room

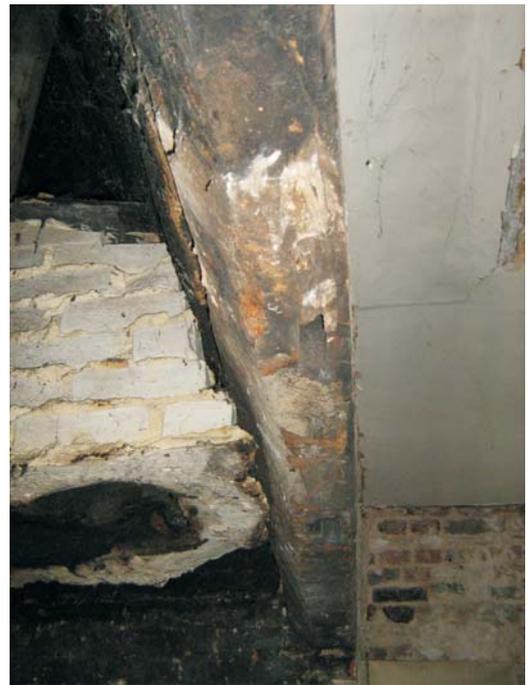
Plate 39: The bressumer over the fireplace in the living room with redundant mortises in the soffit

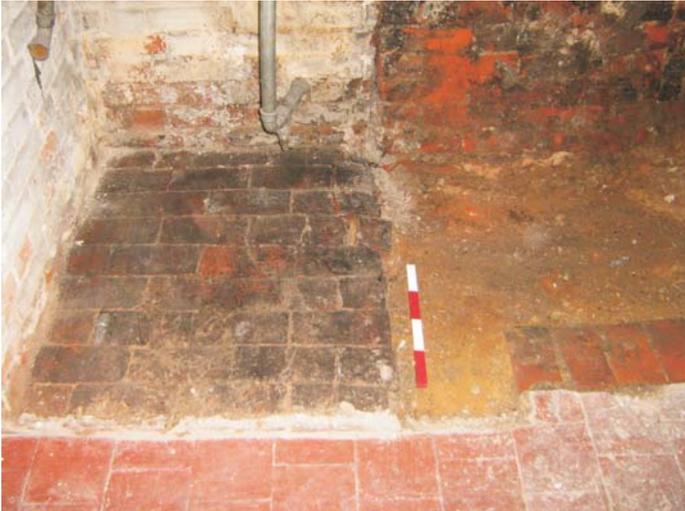
Plate 40: The hearth of the fireplace still *in situ* where the south cupboard had been added

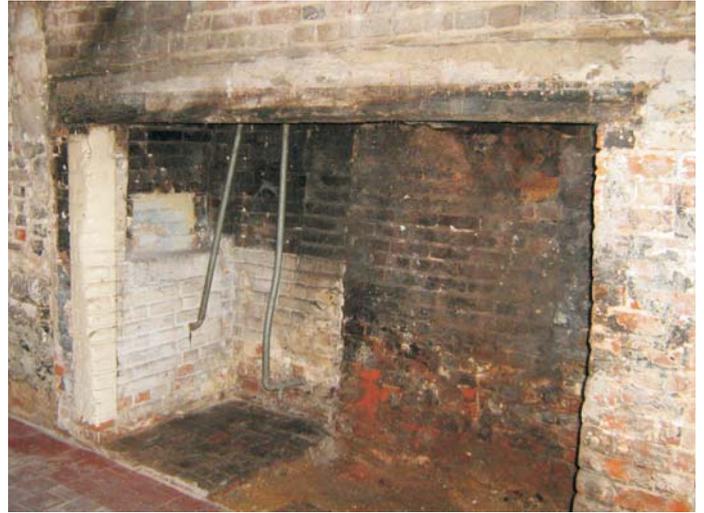
Plate 41: The south side of the inglenook with probable bread oven which had been hidden by the added south cupboard

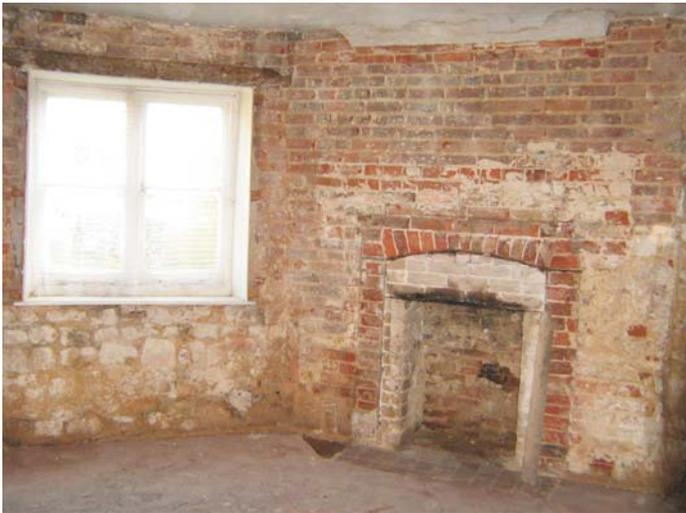
Plate 42: The north wall and angle-set fire place in the Sitting room

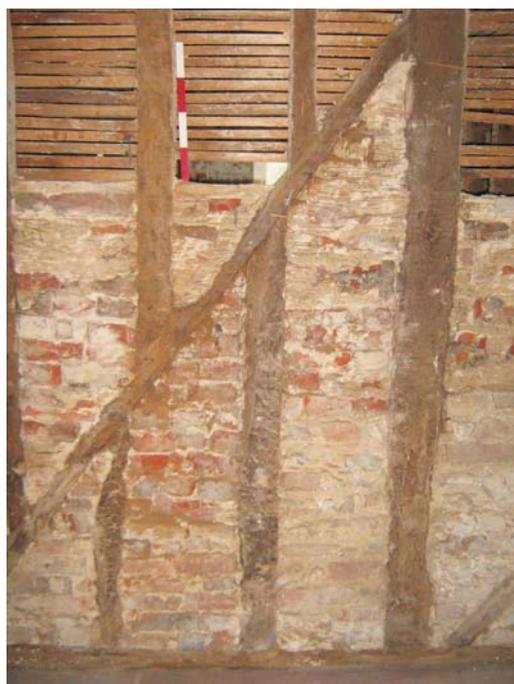
Plate 45: Detail of the timber framed south wall of the sitting room with *in situ* predominantly brick nogging to the lower part and the later laths visible on the bathroom side

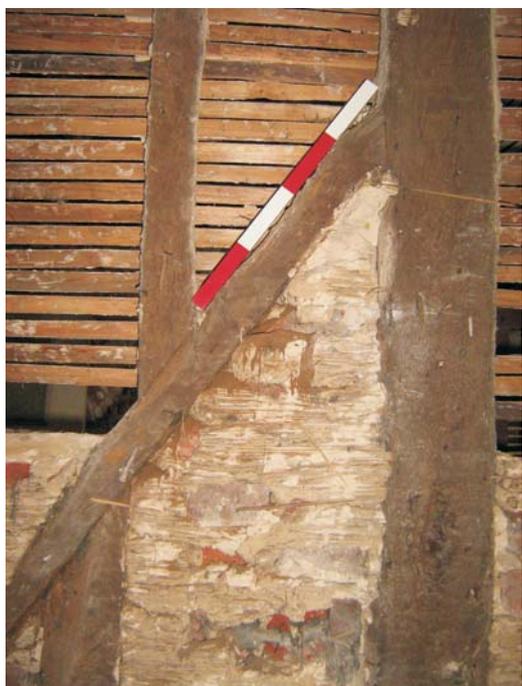
Plate 46: The south wall of the sitting room detail of the plaster in a reed matrix overlying the brick nogging

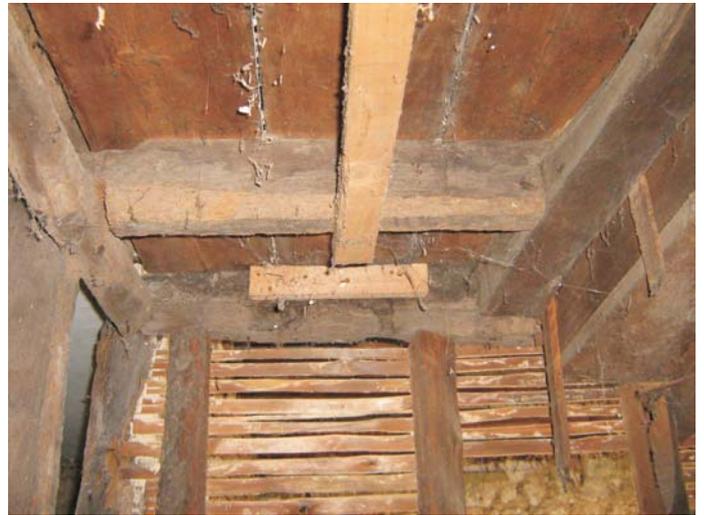
Plate 56: Truncated strut at the base of the doorway in the south partition wall of the sitting room

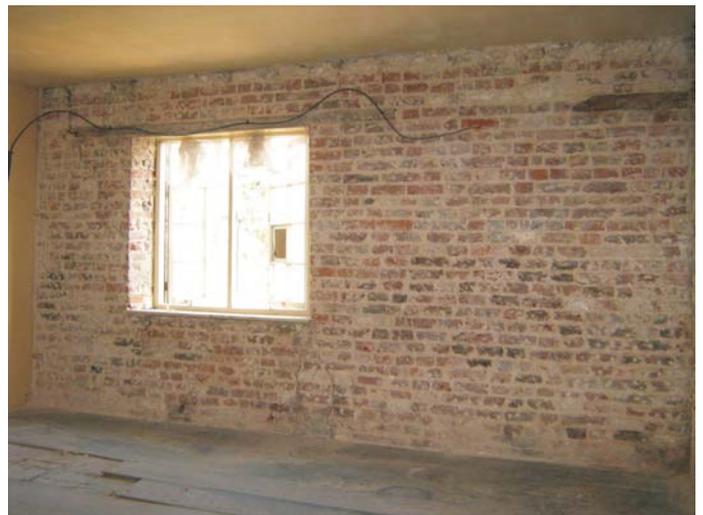
- 9.43 The east wall is the partition between the two bedrooms and is timber framed with two straight raking primary shores interrupting studs at 70 mm thick, the various lengths jointed into the plate or sill, but nailed in place to the shores. The in-fill is a mixture of brick and chalk, with the centre of the wall comprising mainly brickwork with bricks at 40 – 45 mm thick by 210 mm in length of a pinkish brown fabric (Plate 60).

Plate 60: The east timber framed, brick and chalk in-filled partition wall between the bedrooms

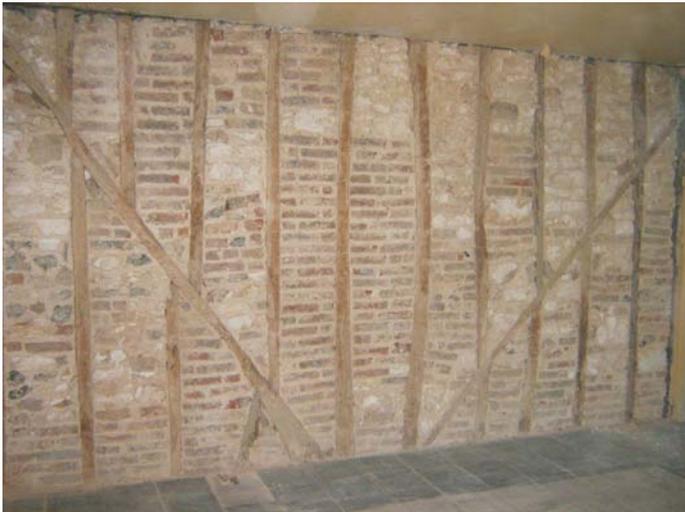
- 9.44 The west wall (Plate 61) has a plastered brick chimney stack with integral 19th century register grate fireplace flanked by a stud-work cupboard (with boiler) to the south and a plain cupboard to the north. The interior of the cupboard reveals the chalk block and brick construction of the west wall (Plate 62). The fabric of the wall to the south of the stack, within the sloping roof of the outshot shows a continuation of the brick and chalk fabric but includes a small window of the same type described above for the east end of the building. The window is trimmed with red brick quoins, has a timber lintel and timber frame still in situ (Plate 63).

Plate 61: The west wall of bedroom 1 with *in situ* register grate

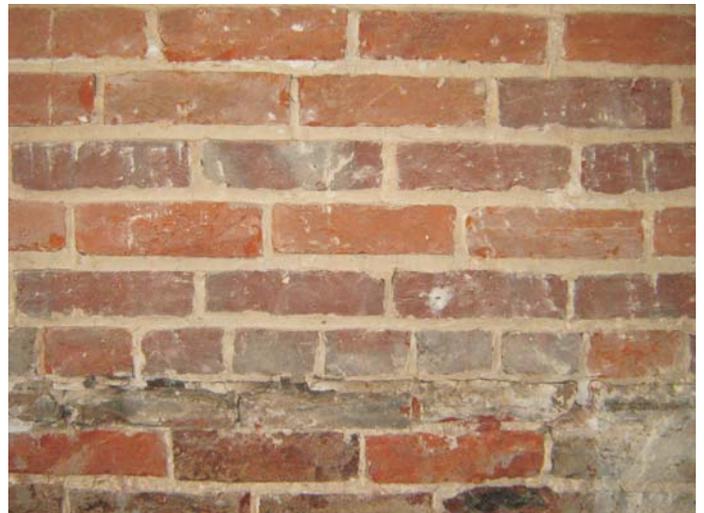
- 9.51 The east wall (Plate 68) is predominantly chalk block construction with squared, coursed masonry at an average of 100 –110 mm thick and various widths. There is a single flint course at 640 mm above floor level. The flint course is 100 mm thick but peters out towards the north. The fabric includes intermittent brick courses with the bricks at 60 mm thick, there is also some random placement of flint. The east wall includes a small brick trimmed window within the outshot as described above.

Plate 68: The contrast between the later brickwork and the earlier chalk block construction of the chimney breast and the east wall of bedroom 2

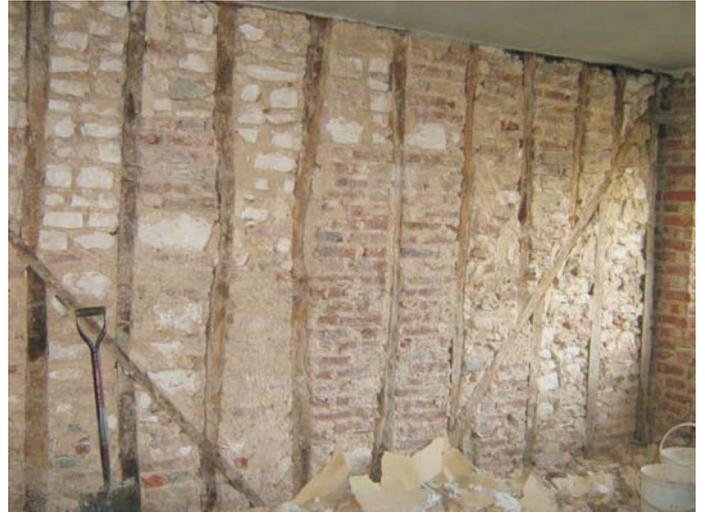
- 9.52 The west wall (Plate 69) is timber framed and is described above for bedroom 1.
- 9.53 The south wall (Plate 70) is timber framed with studs of 110 by 100 mm section jointed between sill and plate. Primary straight raking shores extend from the central stud to the post at the east end of the wall and to the east side of the west doorway. The studs are nailed at the junction with the shores, the nails placed in pre-sawn slots to control the splitting of the members. The doorway is in its original location and the head beam is jointed to the posts.

Plate 70: The timber framed south wall of bedroom 2

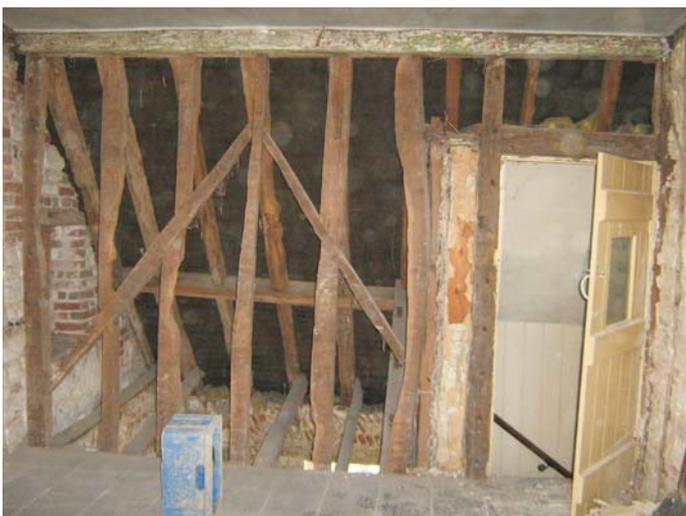
- 9.56 Floor – the floor is carried on north – south oriented joists with a primary joist at 170 mm wide by 110 mm deep adjacent to the east wall. The remaining joists are between 340 and 400 mm apart and are of smaller and irregular scantling at 90 mm wide by 110 mm deep. The boards are in two layers, with north – south orientated wide boards overlain by east – west narrower boards (Plate 71).

Plate 71: Detail of the two layers of floorboards in bedroom 2
