ARCHAEOLOGICAL SOLUTIONS LTD
BROOK FARM, STATION ROAD, TILBROOK,
CAMBRIDGESHIRE
HISTORIC BUILDING RECORDING

Authors:	Tansy Collins BSc Lee Prosser PhD Peter Thompson MA Kathren Henry	
NGR: TL 08024 69389	Report No: 3629	
District: Huntingdonshire	Site Code: AS 1332	
Approved:	Project No: 3967	
Signed:	Date: August 2010

HISTORIC BUILDING APPRAISAL

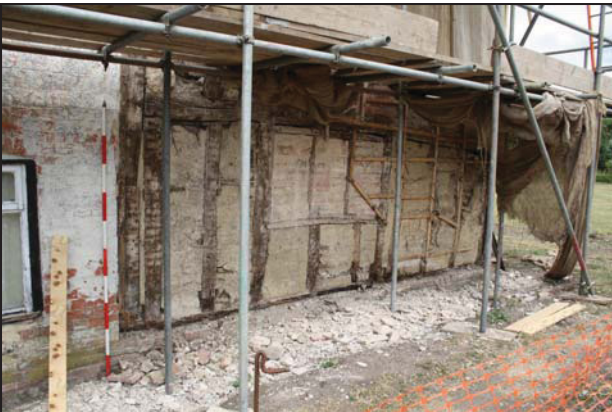
80

East wall of the outbuilding, taken from the south-west

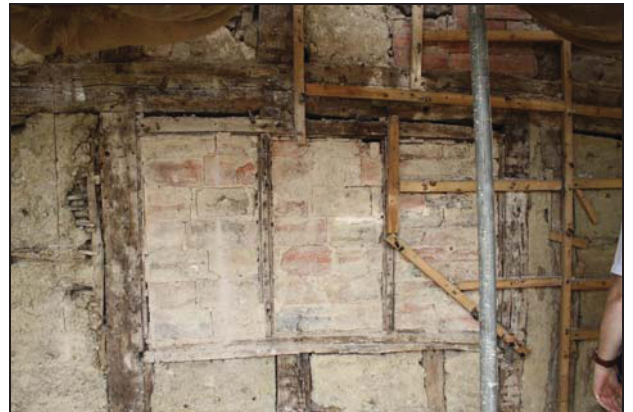
81

South gable wall of the south range at lower level, taken from the south-west

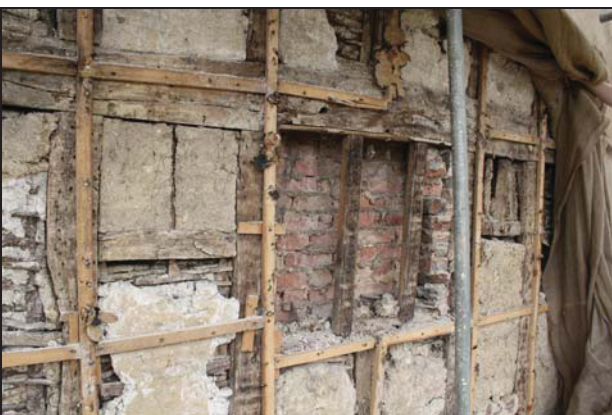
82

Blocked ground-floor window on the south wall (south range), taken from the south

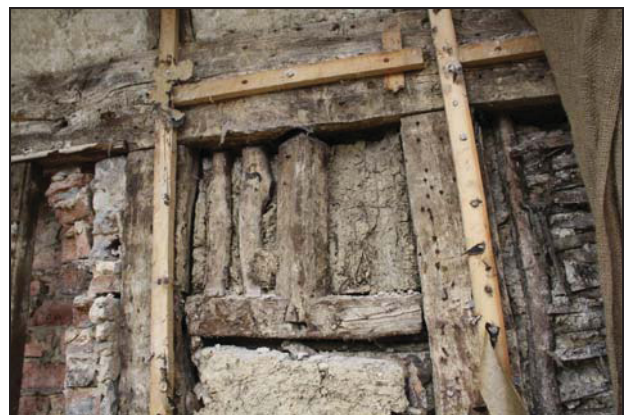
83

Plate 3 Blocked original tri-partite first-floor window on the south wall (south range), taken from the south-west (83)

Blocked original tri-partite first-floor window on the south wall (south range), taken from the south-west

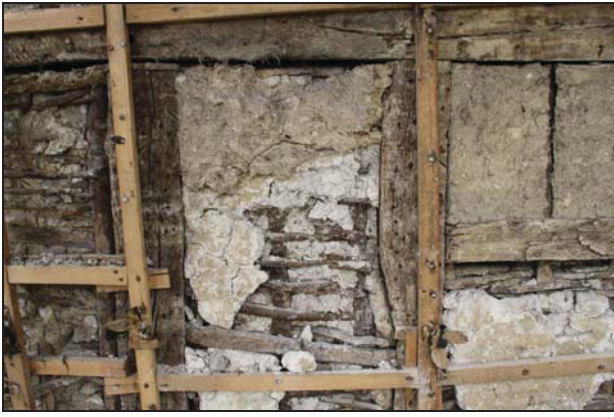
84

Detail of the first-floor window on the south wall (south range), taken from the south

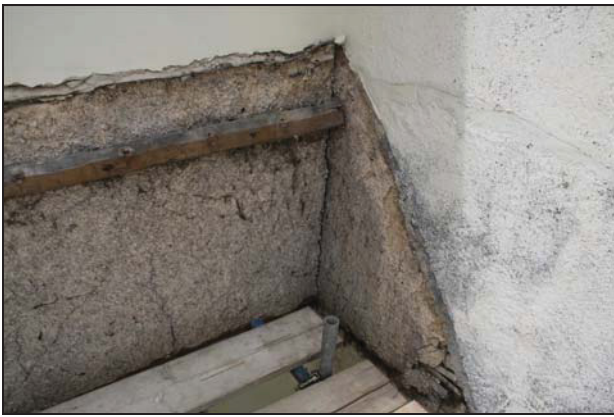
86
Detail of the timber-framing at the west corner of the south gable (south range), taken from the south

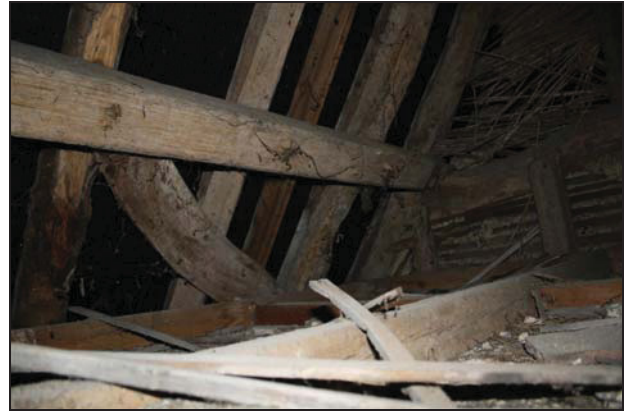
91
View of the roof space above Room FF04 (south bay, north range) , taken from the north
