**ST MARY'S HOUSE, CLACTON ROAD,
LITTLE OAKLEY, ESSEX**

HISTORIC BUILDING MONITORING AND RECORDING

Authors:	Tansy Collins BSc Lee Prosser PhD Peter Thompson MA Kathren Henry	
NGR: TM 2120 2846	Report No: 4035	
District: Tendring	Site Code: LOSM11	
Approved: Claire Halpin	Project No: 4245	
Signed:	Date: March 2012

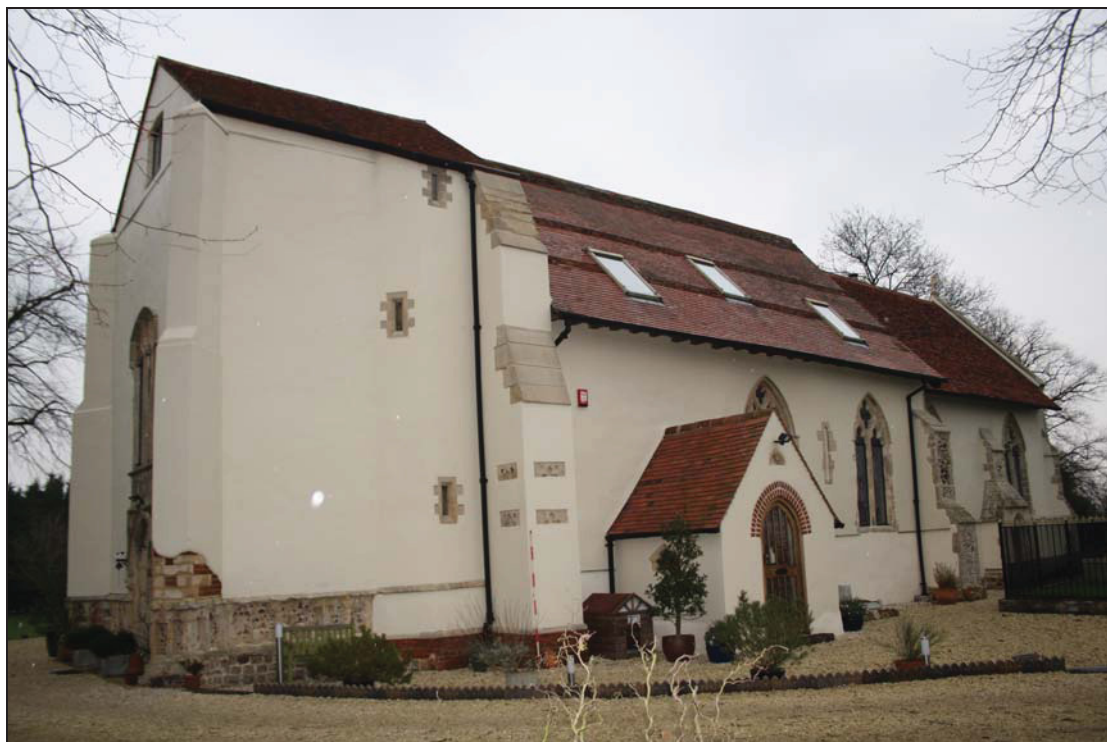
5.1 As a church, the building comprised a simple chancel, nave and west tower arrangement, with porches protecting the south doors into the nave and chancel (Plate 1). The tower is now little more than a stump rising to nave level, having been taken down and partially rebuilt in the 19th century, but never completed. Externally, the building is now mostly rendered in cement, but the stone dressings and one or two features have been left deliberately exposed. Each element has its own peg-tiled roof; that to the nave pierced by modern 'velux' roof lights.

Plate 1 South elevation, taken from the south-west (DP 06)

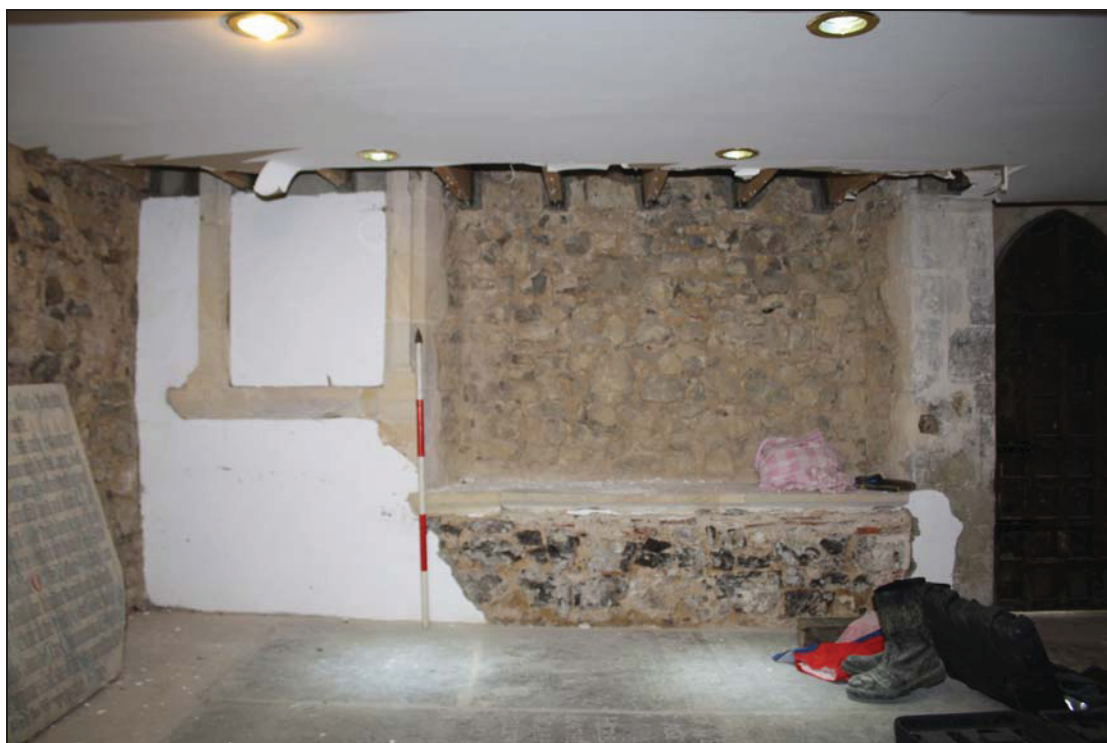
5.15 The string course is present on the south wall, but has been hacked back completely, suggesting that the windows on this side were dropped slightly before being partially blocked in the 18th century. In the former sanctuary, the base of the original sedilia survives, with a blocked area adjoining for the piscina (Plate 6). A minor feature of note is an inscribed 'daisy wheel' on the east jamb of the priest's doorway.

Plate 6 South wall of Room GF01 (chancel), taken from the north (DP 25)

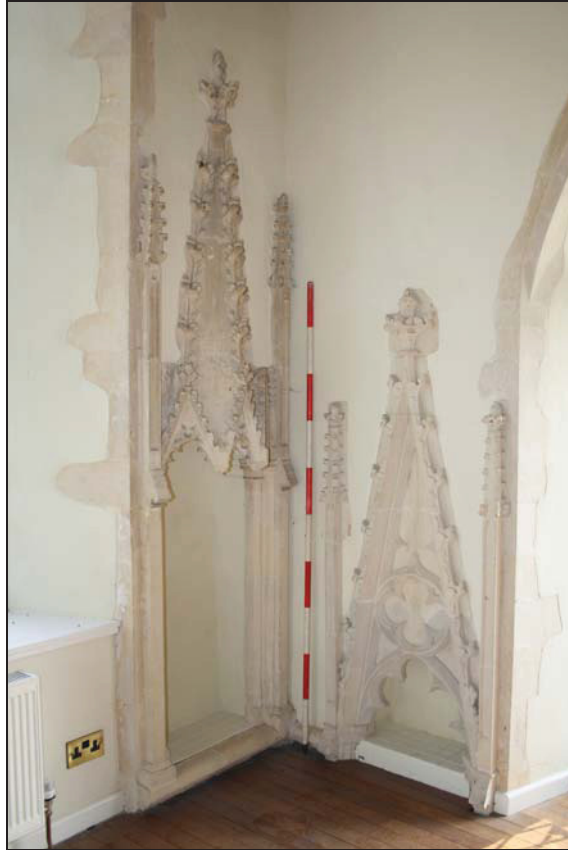
5.17 The new floor was inserted into the chancel at window sill level, thus preserving a sense of its original proportions. The east window is framed by elaborate canopies over niches which once held religious images. These preserve delicately carved rib-vaults within the canopy, but also crocketed pinnacles, some with zoomorphic decoration. The canopy over the piscina is similarly richly embellished, with oak-leaf foliage and acorns, and zoomorphic decoration (Plate 7).

Plate 7 Hoods of image niche and piscina in the south-east corner of Room FF01, taken from the north-west (DP 46)

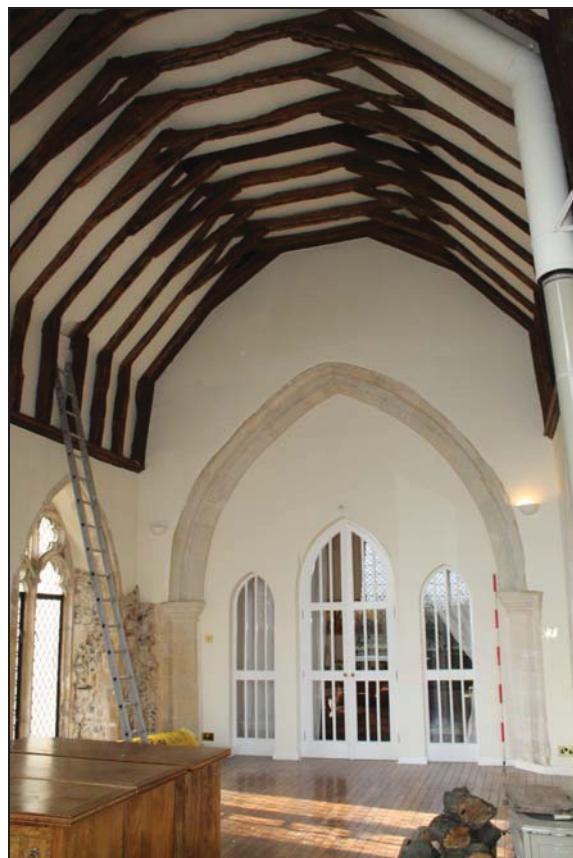
5.19 The roof structure comprises closely-spaced rafter couples with collars and double-pegged soulace-pieces (Plate 8). Ashlar pieces, some having been replaced, spring from a roll-moulded timber string or corbel course, similar in form to its stone counterpart at the base of the windows. The roof was probably once underdrawn or boarded, as distinctive nail-holes survive in the timber. This was a common 17th or 18th century modification, itself often reversed by the Victorians.

Plate 8 Room FF01, taken from the north-east (DP 42)

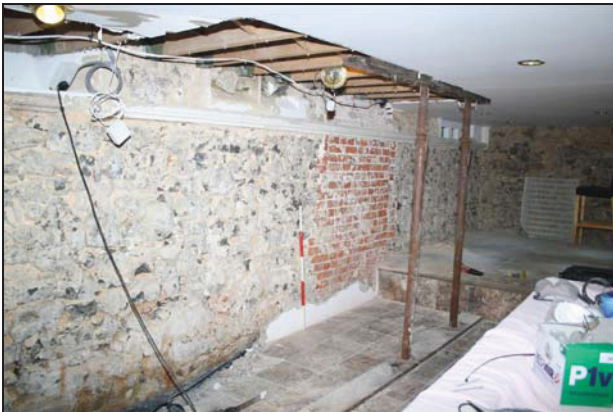
DP 15

5.14 Within the former chancel, the window sill level all round is marked by a contemporary ovolo-moulded string course, built into the masonry. This survives particularly well on the north side, though has been hacked off below the north chancel window (Plate 5). Immediately adjoining, the base of a second, now-blocked window with stone jambs and a single mullion survives. This is noted in the List description as having two square-headed lights with external splays. The inner face of the former vestry door continues the English bond brickwork seen to the exterior, but here laid in a more regular fashion and formerly plastered. The outer jambs have been made good with brick, suggesting the original stone jambs were been removed when the door was blocked. The brick extends above the modern floor joisting. In addition the blocking is spanned by a stretch of moulded string course continuing the medieval form but clearly a more recent addition and perhaps contemporary with the blocking.

North wall of Room GF01 (chancel), taken from south-west

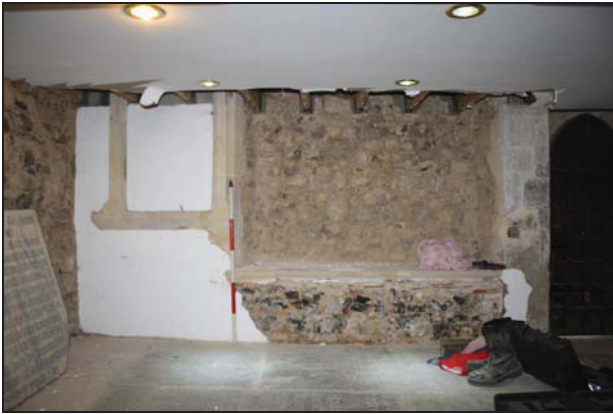
DP 25

South wall of Room GF01 (chancel), taken from the north

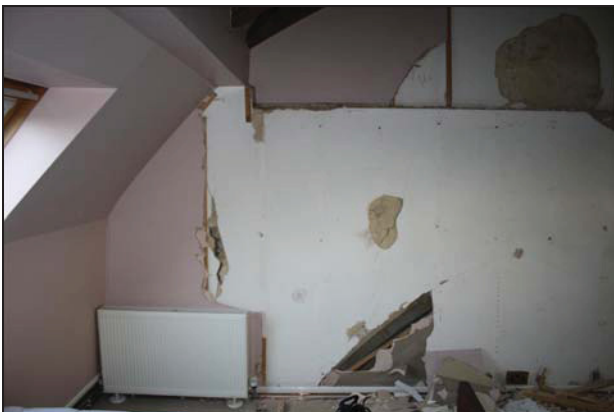
DP 76

East wall of Room SF01 at high level during investigation, taken from the west
