**FORMER WAGGON AND HORSES PUBLIC HOUSE,
1 HIGH STREET, WATTON AT STONE,
HERTFORDSHIRE**

**HISTORIC BUILDING RECORDING
WITH MONITORING AND RECORDING**

Authors:	Tansy Collins BSc Lee Prosser PhD Kate Higgs MA Antony Mystchin MSc (Editor)	
NGR: TL 29705 19690	Report No. 3969	
District: East Hertfordshire	Site Code: AS 1450	
Approved: Claire Halpin MIFA	Project No. 2846	
Signed:	Date: December 2011 Revised: December 2012

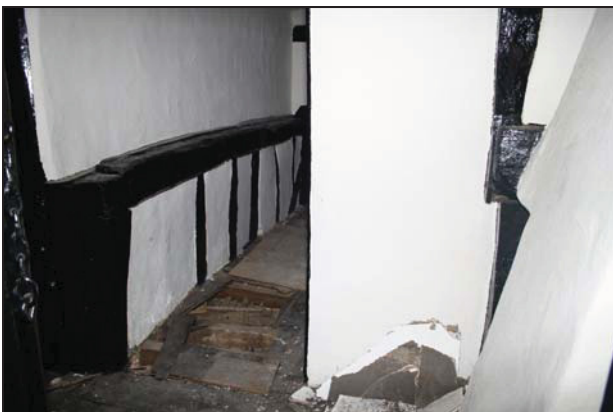
40

Cupboard on the east side of Room FF04 on the south side, taken from the north-east

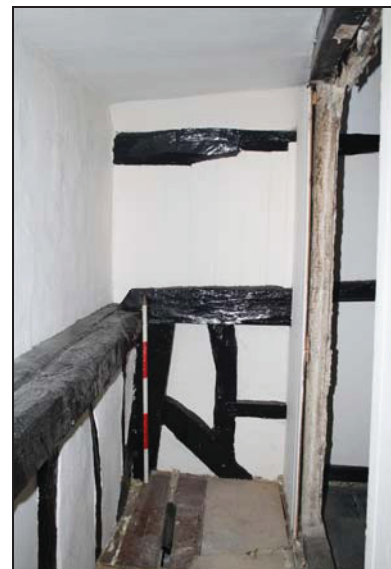
41

View of Room FF05 showing the original north wall, taken from the south-west

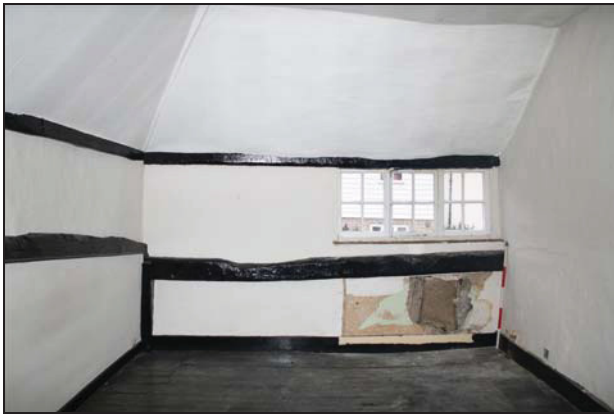
42

East end of Room FF05 showing original wall-plates with lower studwork and later inserted wall-plates above, taken from the west

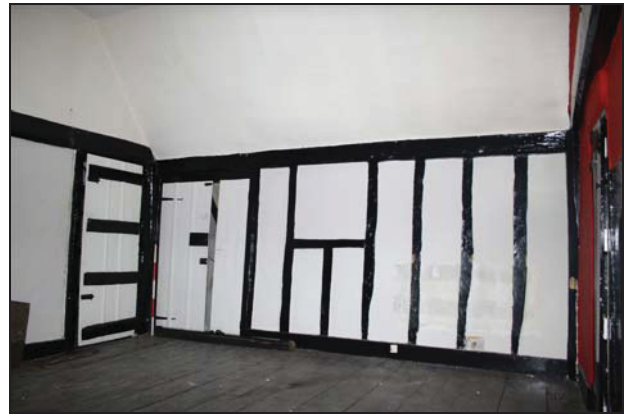
43
South side of Room FF06, taken from the north

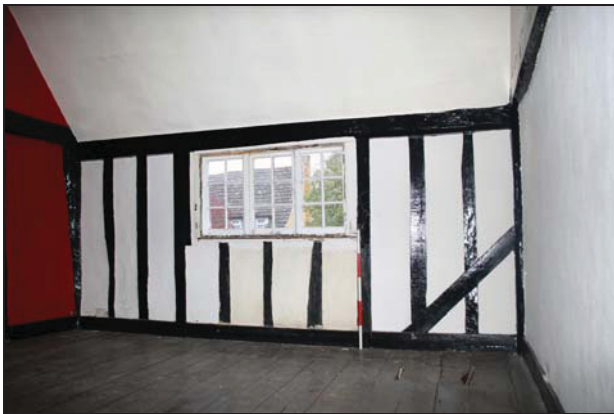
6.1.31 The west wall (Plate 13) is of even studwork, the studs measuring an average of 4" (102mm) and spaced 13" (330mm) apart. They all appear to be pegged at the head although the heavy paintwork makes this difficult to determine. The position of the original window is defined by two studs with a pegged horizontal member. To the south, the wall has been substantially reworked and now contains two doors divided by a single original stud which preserves a fragment of a notch-lapped downward brace, which has been truncated to either side for the two doorways. This stud also displays wattle grooves. Of the two doors the north example is a narrow modern boarded door while its companion is a reused early door of three boards with wide vertical fillets. Strap hinges with circular finials are original although secured to the jamb with modern screws. There are three ledges to the rear with an upright handle with round heads and a rim-lock. The east wall mirrors the west with evenly-spaced studwork but here the downward tension brace survives at the south end. It is likely an original central window on this side was lost with the insertion of a three-light window, each of six panes with moulded central glazing bars with plain, chamfered outer bars.

44
West side of Room FF07, taken from the east

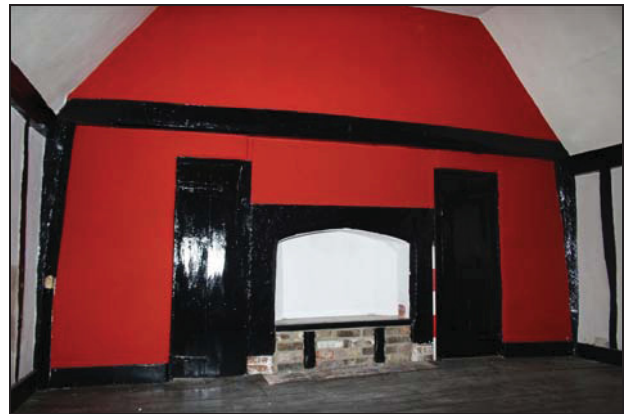
45
East side of Room FF07, taken from the west

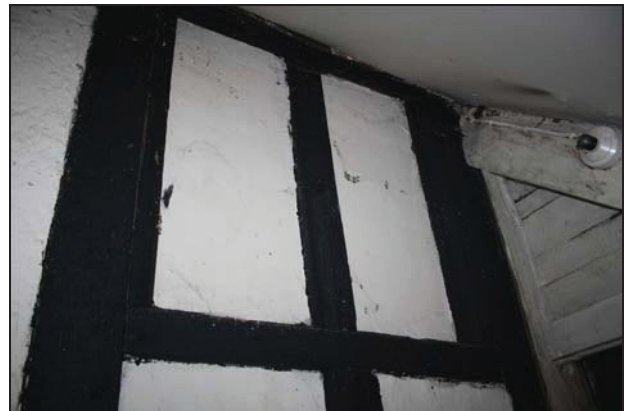
47
Roof of the pent-roofed outshut (Room FF08) showing former external wall of the rear wing, taken from the south-west

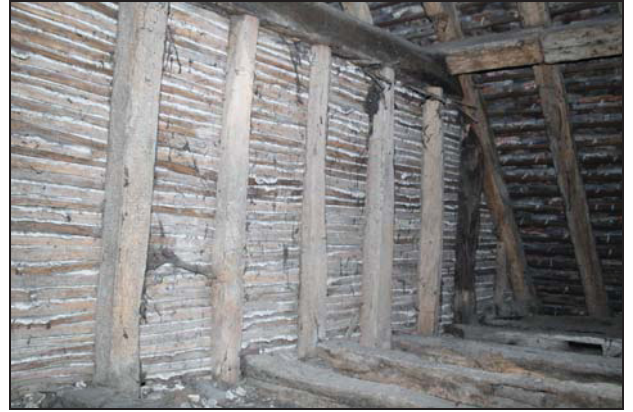
49
Roof over the rear wing, taken from the south-west

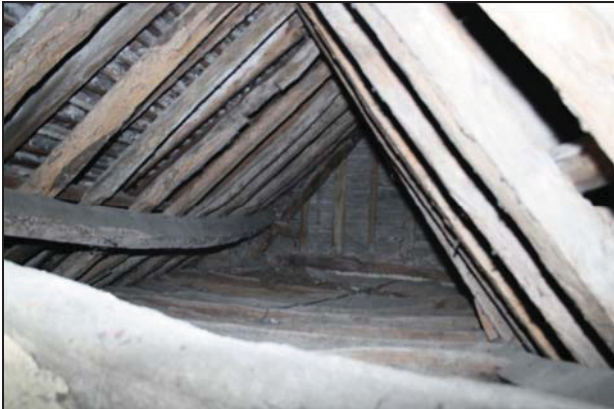
50
Roof over the rear wing below collar level, taken from the south-west

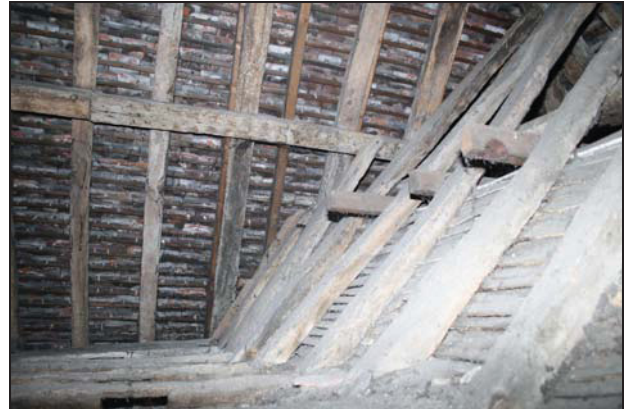
51
Roof over the main range, taken from the north-east

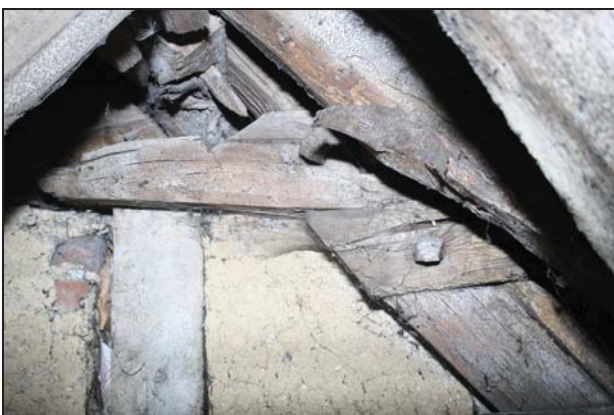
52
View of the roof at the junction of the main range and the rear wing, taken from the north-west

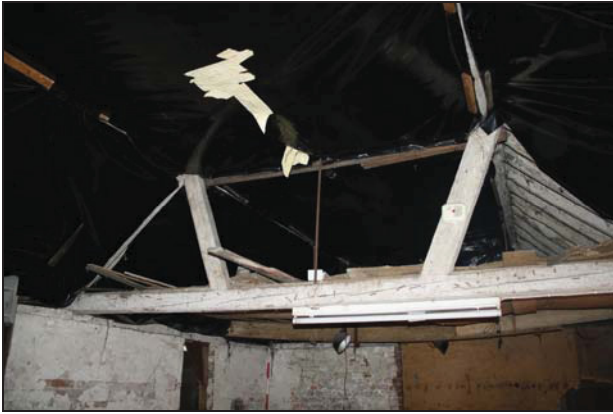
54
Interior of Unit 1 (outbuilding), taken from the south-west

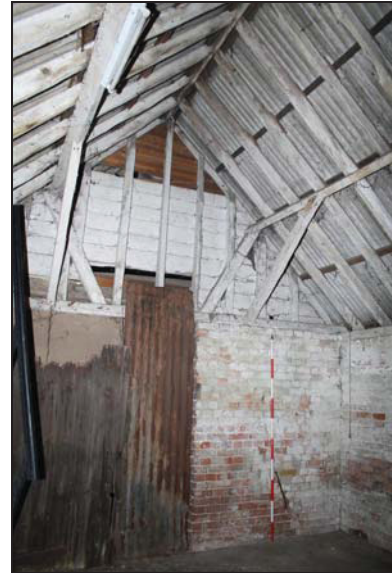
55
Partially exposed roof form in Unit 1 (outbuilding),
taken from the south-west

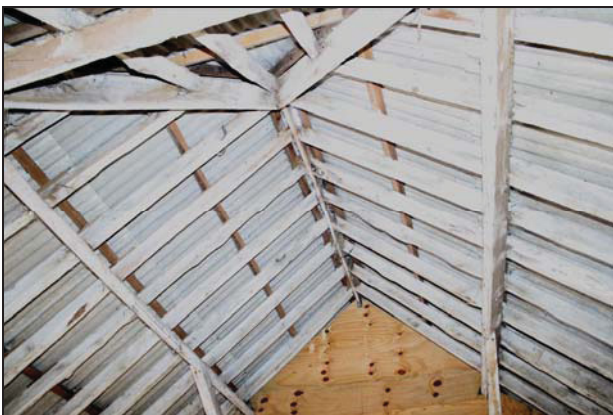
58
North side of Unit 3 (outbuilding), taken from the
south

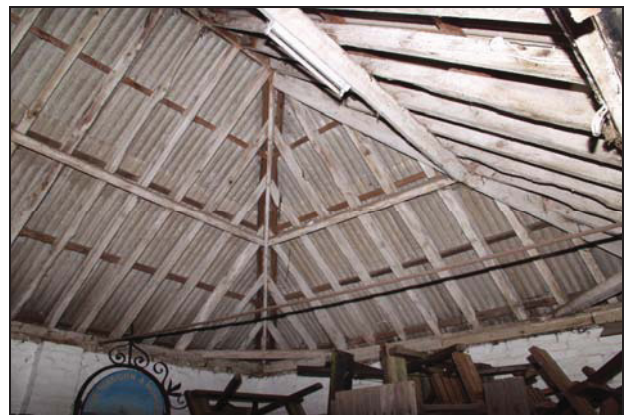
59
Exposed roof form in Unit 3 (outbuilding), taken
from the north
