**ST MARY'S HOUSE, CLACTON ROAD,  
LITTLE OAKLEY, ESSEX**

**HISTORIC BUILDING RECORDING  
WITH MONITORING AND RECORDING**

Authors:	Tansy Collins BSc Lee Prosser PhD Peter Thompson MA Kathren Henry	
NGR: TM 2120 2846		Report No: 4035
District: Tendring		Site Code: LOSM11
Approved: Claire Halpin MifA		Project No: 4245
Signed:		Date: February 2013

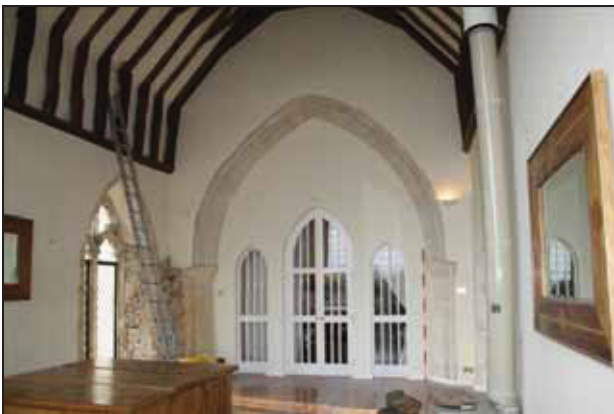
DP 40

Room FF02, taken from the north

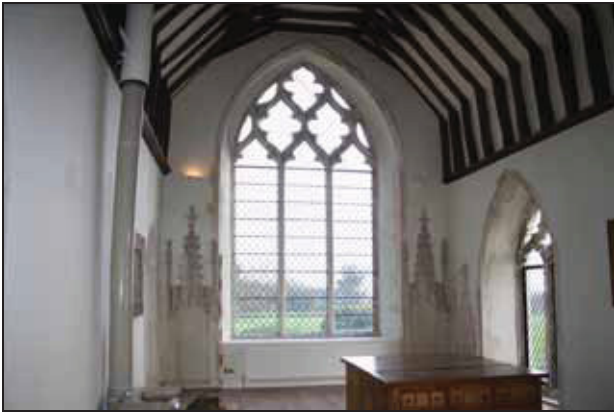
DP 42

Room FF01, taken from the east

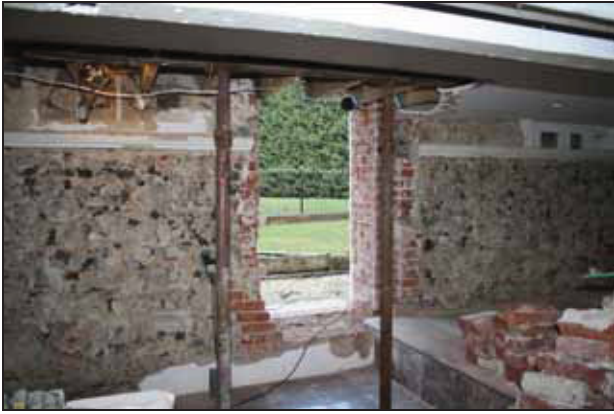
DP 60

Blocked doorway on the north side of Room GF01 during planned works, taken from the south-west

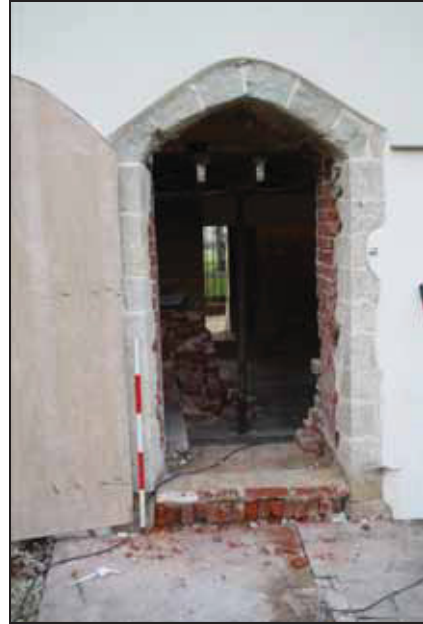
DP 61

*Blocked doorway on the north side of Room GF01 during planned works, taken from the south-west*

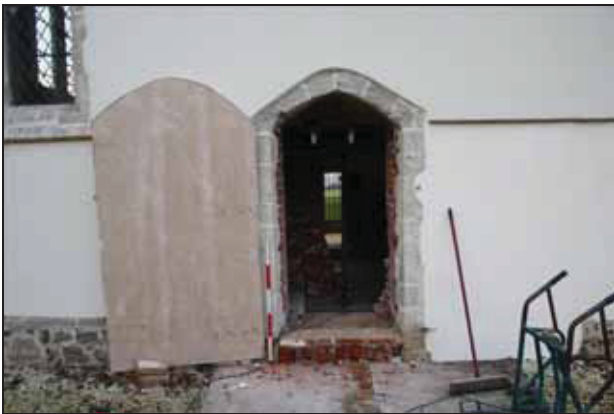
DP 62

*Blocked doorway on the north side of Room GF01 during planned works, taken from the north*

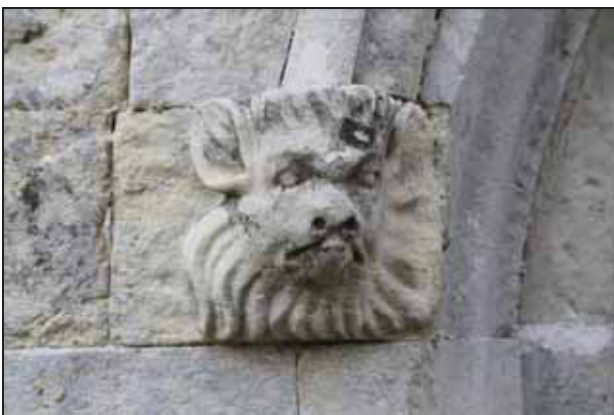
DP 64

*Moulded head on the priest's door, taken from the south*

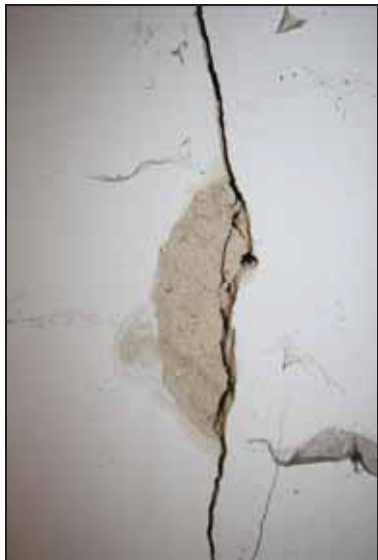
DP 66

*Detail of east wall of Room SF01 during investigation, taken from the west*

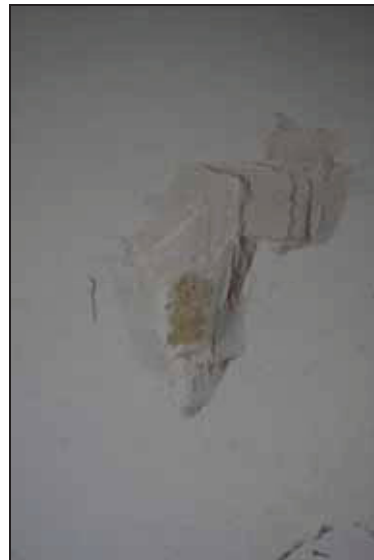
DP 67

*Detail of east wall of Room SF01 during investigation, taken from the west*

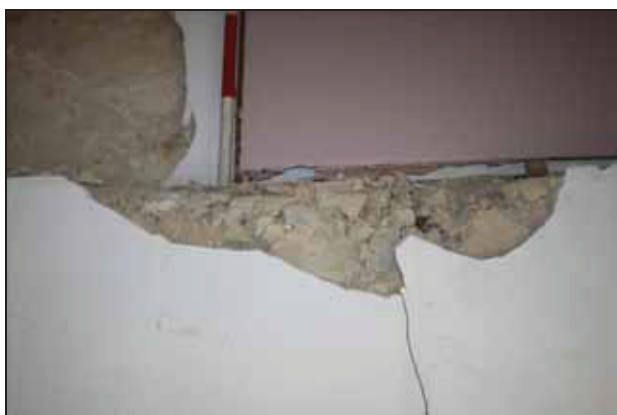
DP 68

*Detail of east wall of Room SF01 during investigation, taken from the west*

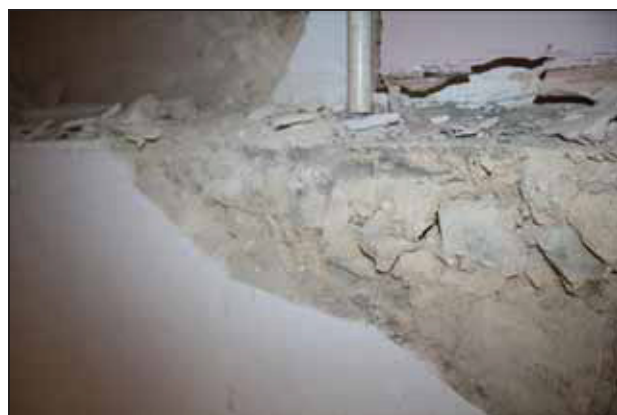
DP 69

*Detail of east wall of Room SF01 during investigation, taken from the west*

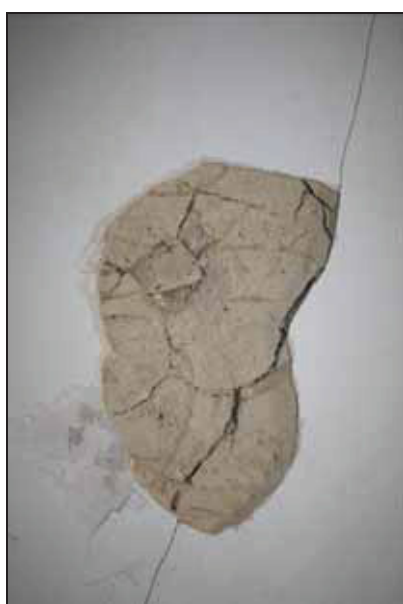
DP 70

*Detail of east wall of Room SF01 during investigation, taken from the south-west*

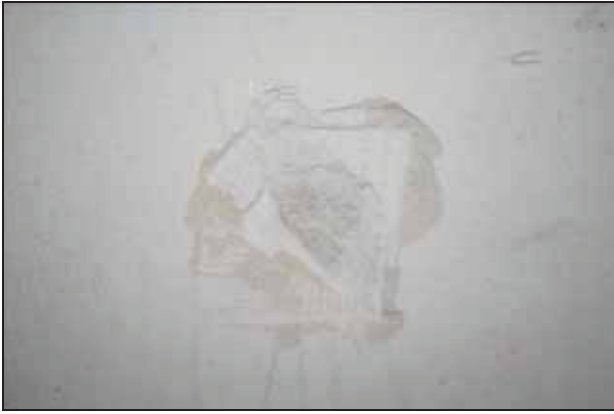
DP 72

*Detail of east wall of Room SF01 during investigation, taken from the west*

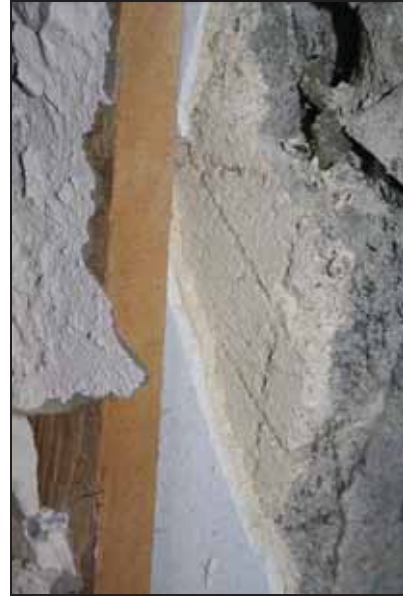
DP 73

*Detail of east wall of Room SF01 during investigation, taken from the west*

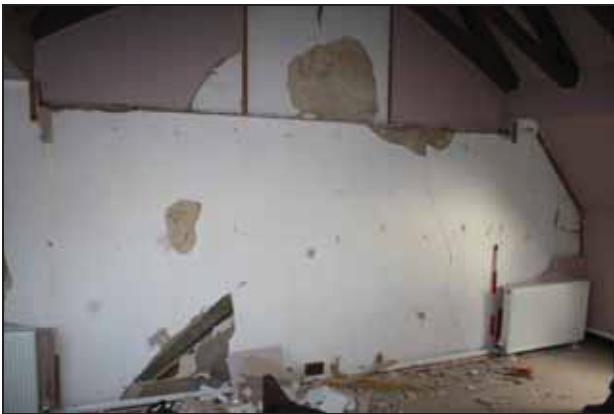
DP 74

*Detail of east wall of Room SF01 during investigation, taken from the south-west*

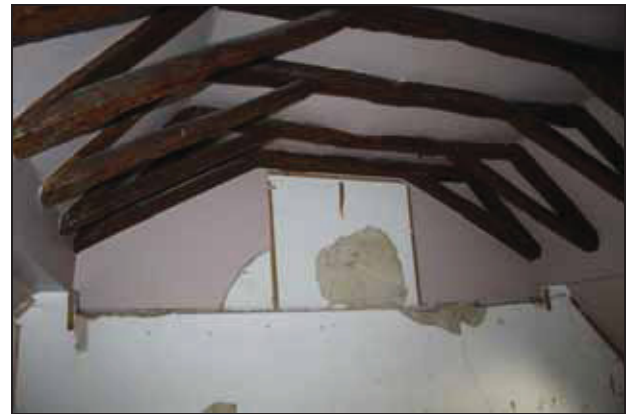
DP 75

*East wall of Room SF01 during investigation, taken from the west*

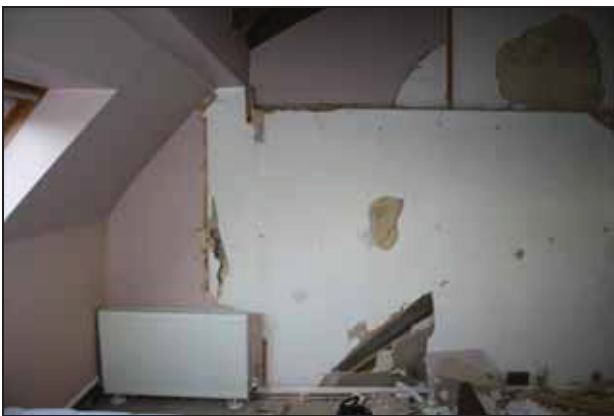
DP 76

*East wall of Room SF01 at high level during investigation, taken from the west*

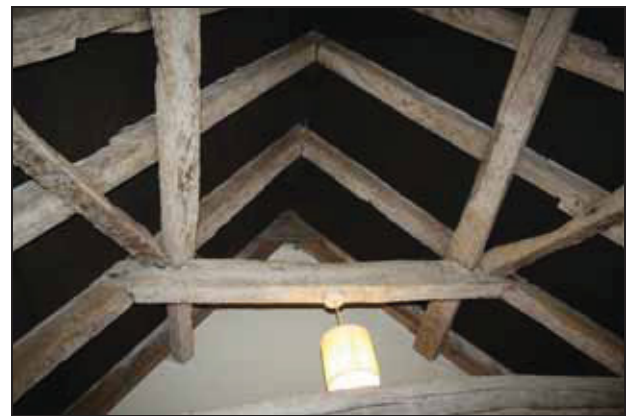
DP 77

*East wall of Room SF01 during investigation, taken from the west*

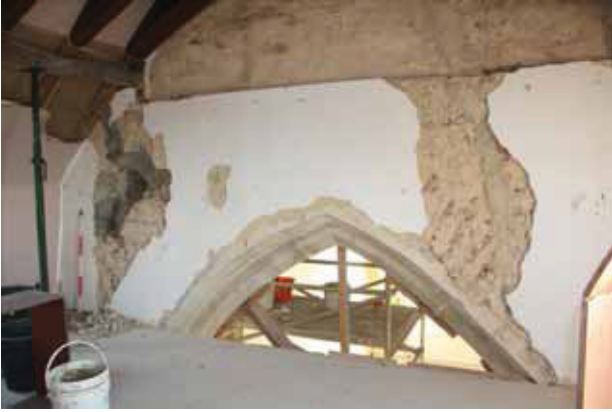
DP 84

*Detail of the north wall of Room GF01, taken from the south*

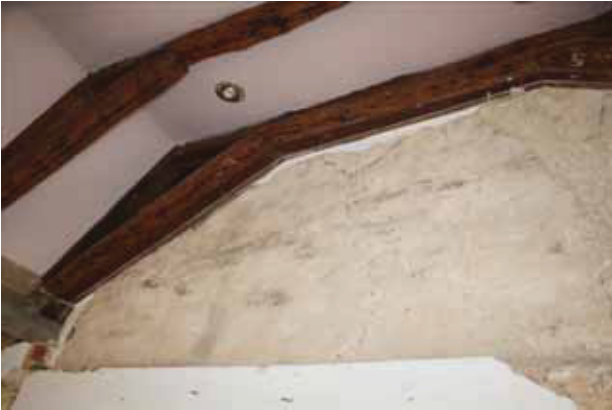
*DP 86  
View of the north side of the chancel arch during piercing of the northern doorway, taken from the south-west*

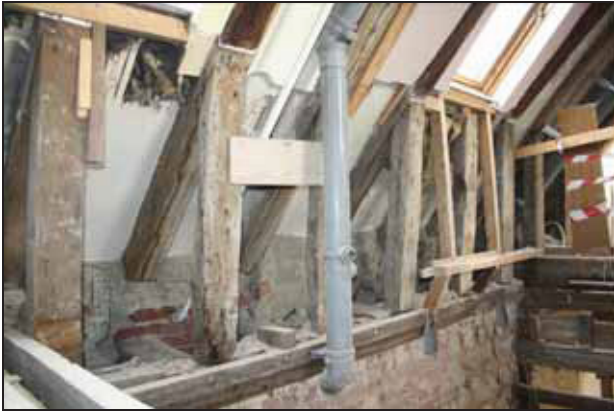
5.20 The roof structure comprises closely-spaced rafter couples with collars and double-pegged soulace-pieces (Plate 8). Ashlar pieces, some having been replaced, spring from a roll-moulded timber string or corbel course, similar in form to its stone counterpart at the base of the windows. The roof was probably once underdrawn or boarded, as distinctive nail-holes survive in the timber. This was a common 17<sup>th</sup> or 18<sup>th</sup> century modification, itself often reversed by the Victorians.

*DP 90  
North side of the nave roof showing replacement ashlar piece with empty mortice for the original (indicated), taken from the south-west*

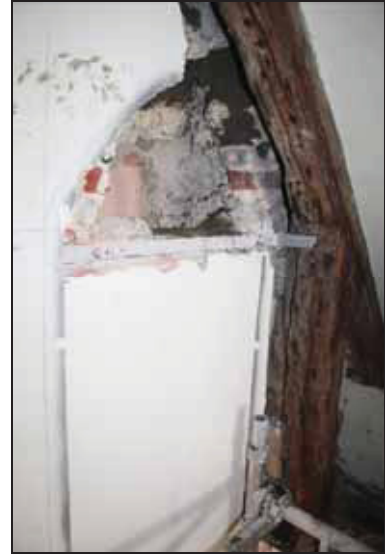
DP 91

*North side of the nave showing roof construction at eaves level, taken from the south-west*

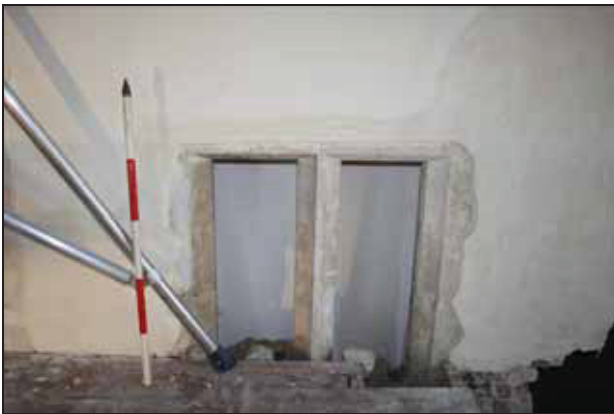
DP 92

*View of the northern doorway pierced through the chancel arch, taken from the south-east*

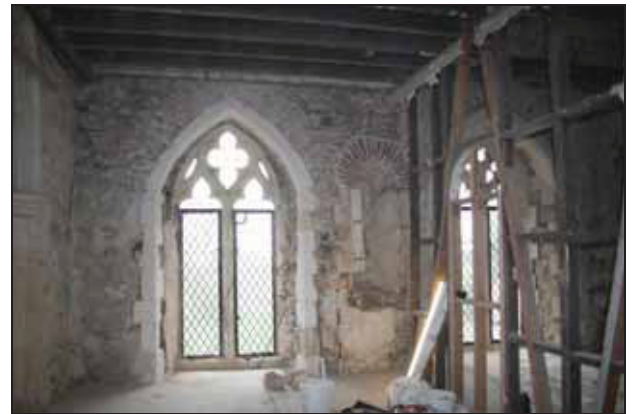
DP 93

*Formerly infilled window on the north side of the chancel at first floor level, taken from the south*

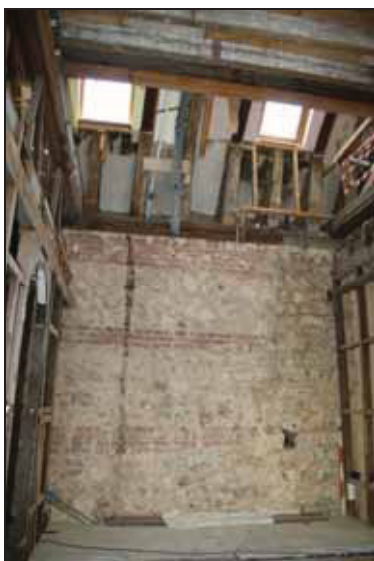
DP 94

*South wall of the nave (FF02) during the planned works, taken from the north*

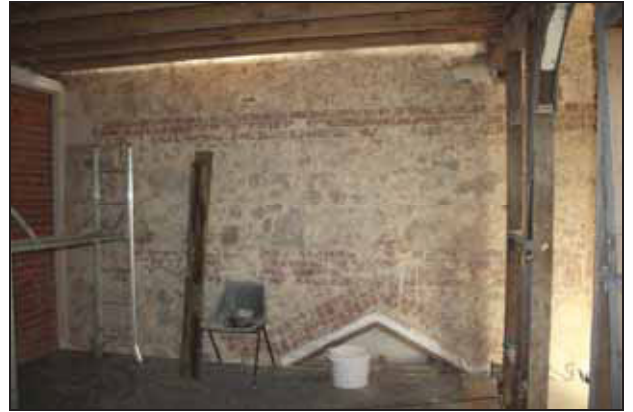
DP 97

*Detail of the brick banding on the north wall of the nave (FF05) during the planned works, taken from the south*

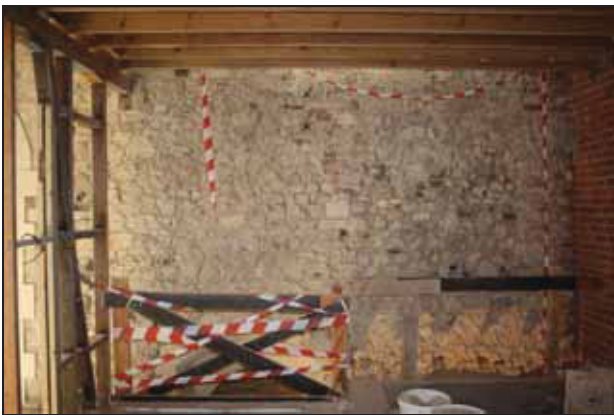
DP 98

*North wall of the nave (FF06) during planned works, taken from the south*

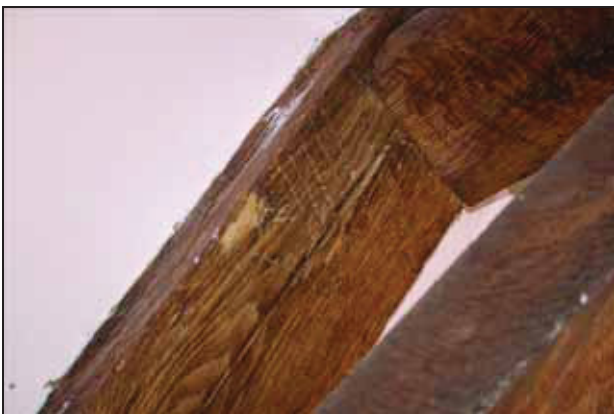
DP 100

*Carpenter's assembly marks on the roof truss over the nave (south side), taken from the north*

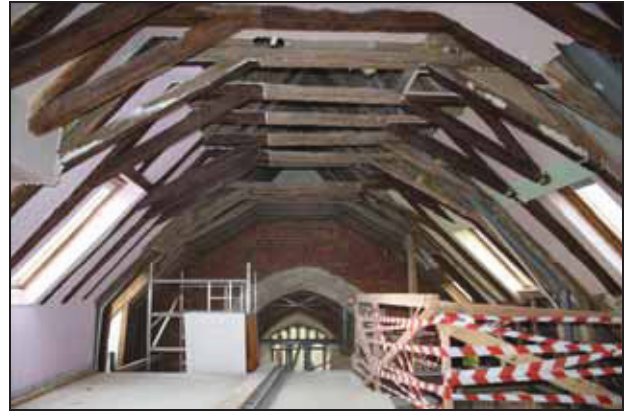
DP 103  
General view of the nave at upper level during the planned works, taken from the west

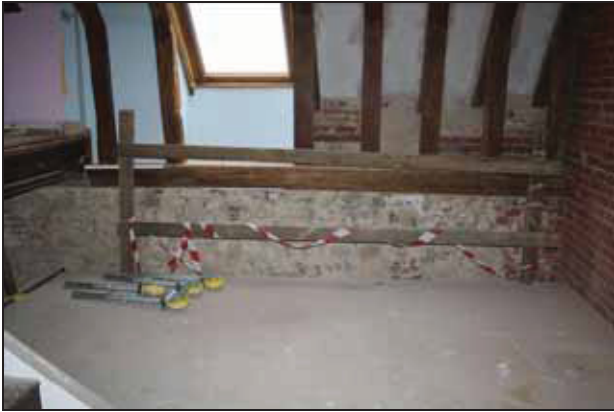
DP 108  
South side of the nave (FF03) during planned works, taken from the north

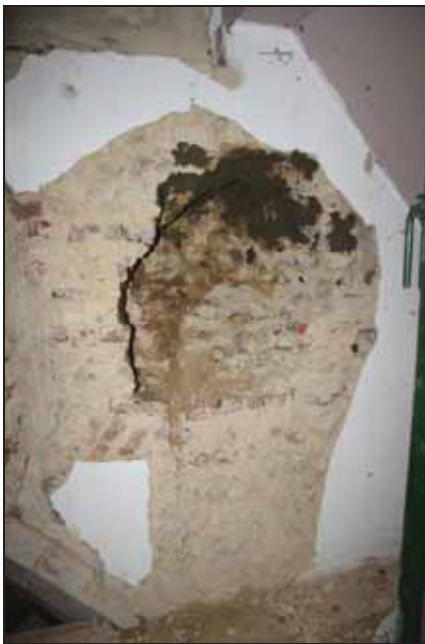
DP 110

*Possible putlog hole or area of repair on the north wall of the nave at upper level (SF06) during the planned works, taken from the north*

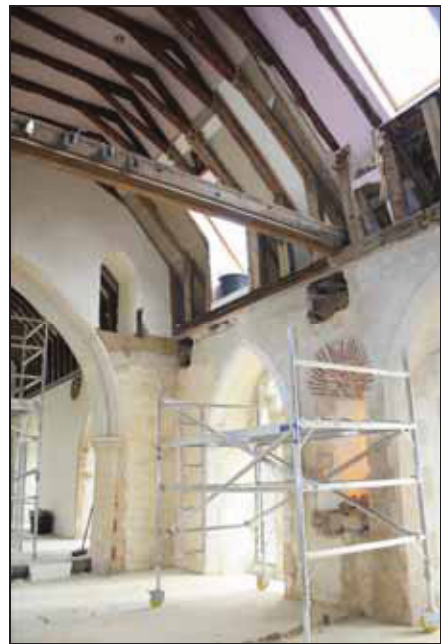
DP 111

*View of the nave wall to the south of the chancel arch during the piercing of the southern doorway, taken from the north-west*

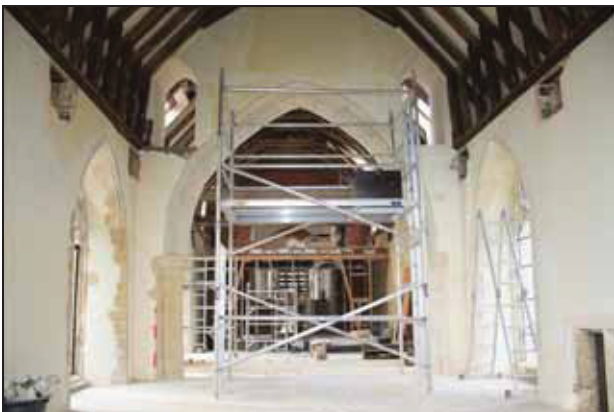
DP 112

*South nave wall after the removal of the upper floor structures and during the planned works, taken from the north-west*

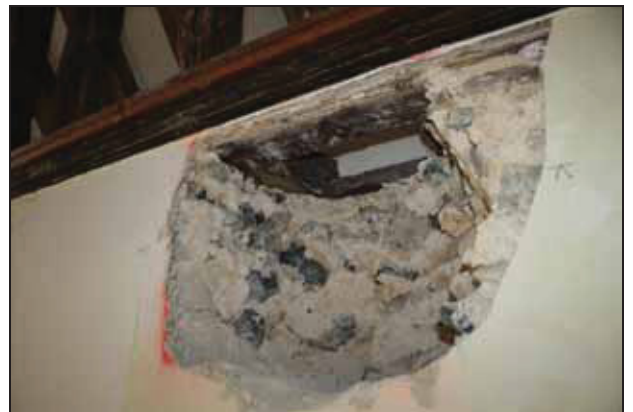
DP 113

*East end of the nave after the removal of the upper floor structures and during the planned works, taken from the north-west*

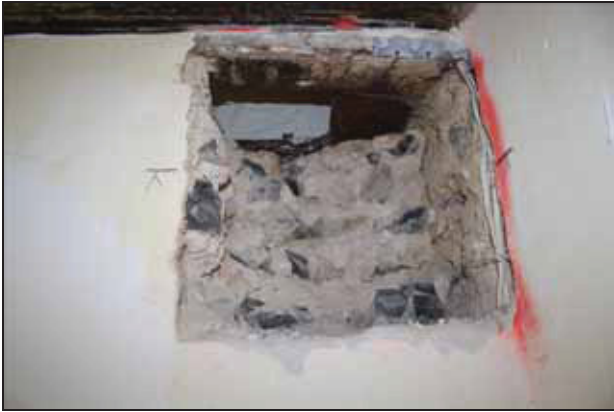
DP 114

*Floor socket 1 on the south side of the chancel during the planned works, taken from the north-west*

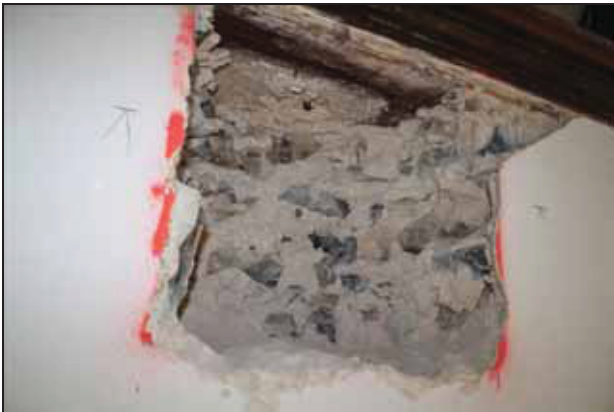
*DP 116  
Floor socket 4 on the north side of the chancel during the planned works, taken from the south-east*

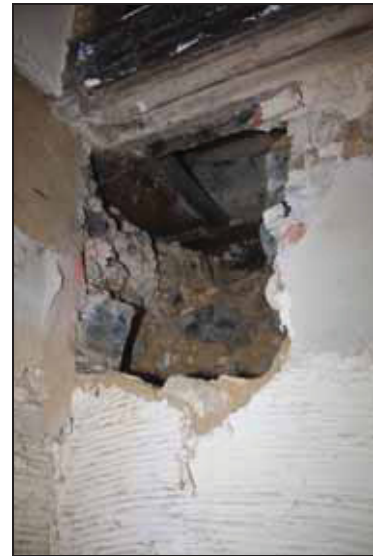
*DP 117  
Floor socket 3 on the north side of the chancel during the planned works, taken from the south*

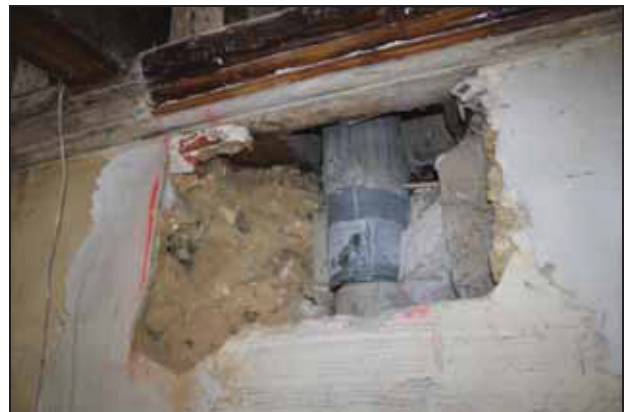
5.27 The eight sockets cut into the outer walls of the nave cut through fabric reflecting the varying phases of work. Sockets 5-8 lie on the north side. No. 5 is cut into an area of earlier repair at the head of the rood stair, while to the west in No. 6 the wall fabric retains the buff-coloured mortar, with some chalk inclusions, bonding a rubble infill of fairly rounded pebbles. This is only visible to the west of a modern pipe. Socket nos. 7 and 8 cut through the red brick banding noted above and reveals this to continue to a depth of 0.35m before the earlier wall fabric is encountered.

*DP 119  
Floor socket 5 on the north side of the nave during the planned works, taken from the south*

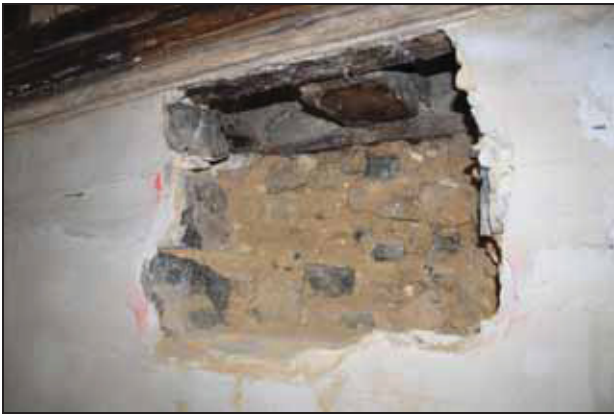
*DP 120  
Floor socket 6 on the north side of the nave during the planned works, taken from the south*

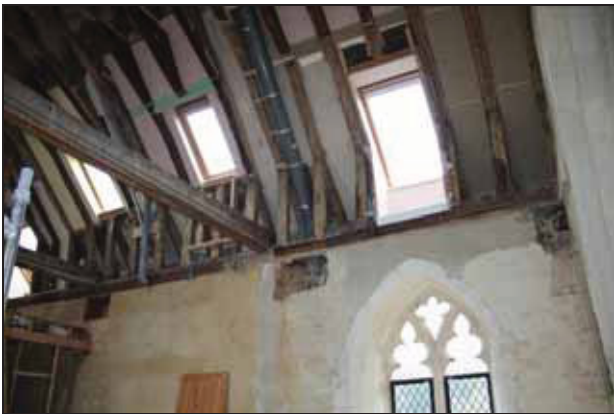
DP 122

*South nave wall after the removal of the upper floor structures and during the planned works, taken from the north*

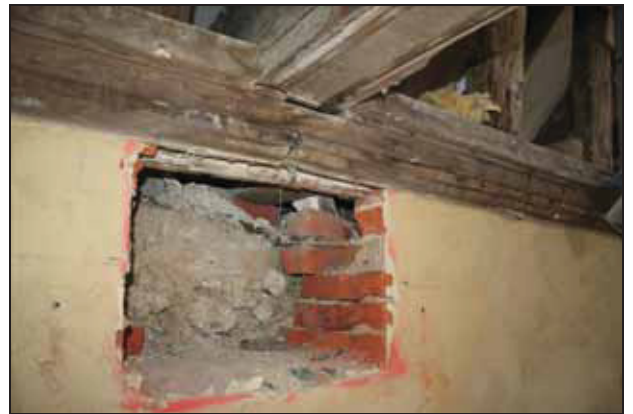
DP 123

*North nave wall after the removal of the upper floor structures and during the planned works, taken from the south*

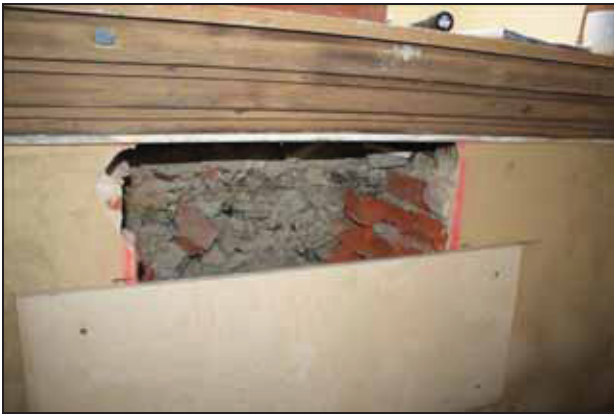
DP 124

*Floor socket 7 on the north side of the nave during the planned works, taken from the south*

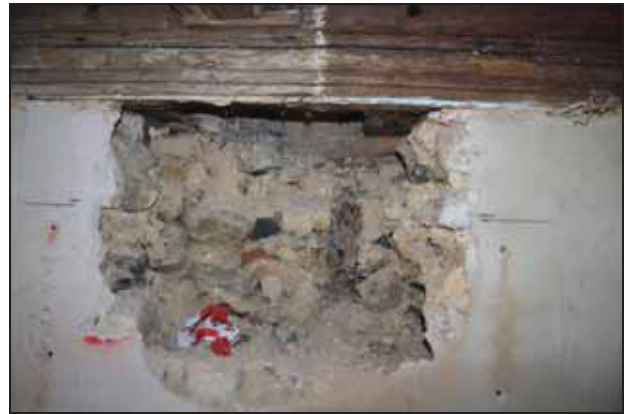
DP 125

*Floor socket 8 on the north side of the nave during the planned works, taken from the south*

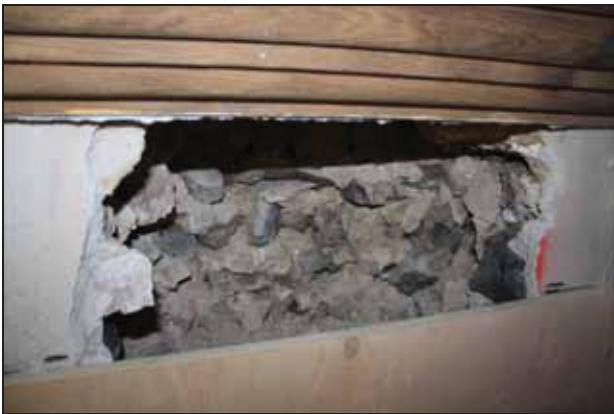
DP 126

*Floor socket 11 on the south side of the nave during the planned works, taken from the north*
