**THE KILN AT READS BRICKWORKS  
ALDEBURGH  
SUFFOLK**

**HISTORIC BUILDING RECORDING  
AND MONITORING**

**Level 2/3**

Authors: Lisa Smith BA Kathren Henry	
NGR: TM 449 569	Report No. 4378
District: Suffolk Coastal DC	Site Code: ADB199
Approved: Claire Halpin	Project No. 4398
MIFA	Date: 25 July 2013
Signed:

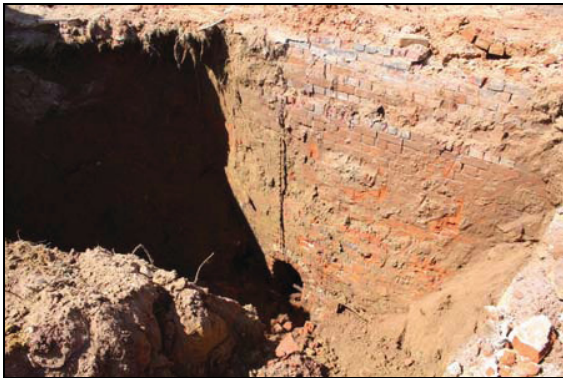
44

*Excavation to the south of the kiln, taken from the north-east*

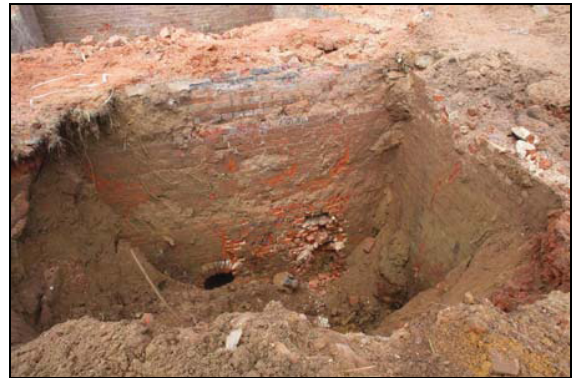
45

*External southern elevation showing central aperture with white brick decorative arch and chain above to raise and lower a door, taken from the south-east*

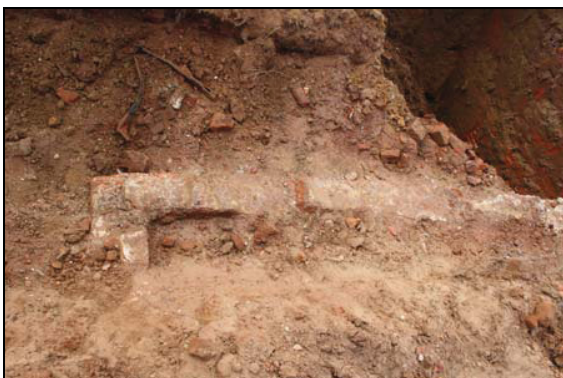
46

*Southern elevation and retaining wall extending to the south, taken from the south-west*

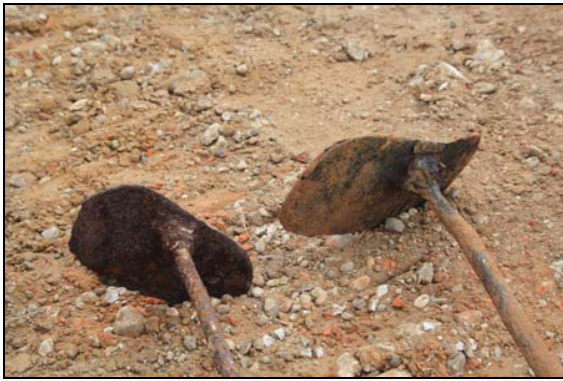
48

*Fire rakes, found within the fire tunnels.*

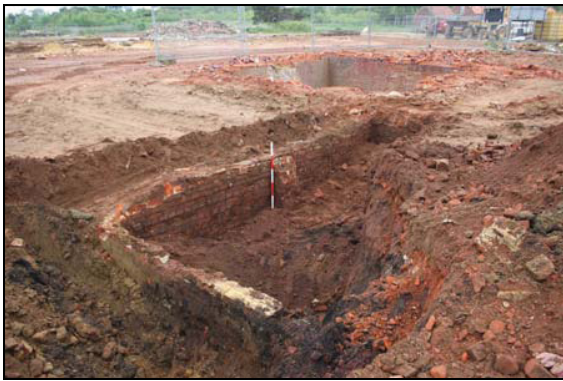
50

*Kiln excavated to the depth of the sand natural taken from the north*

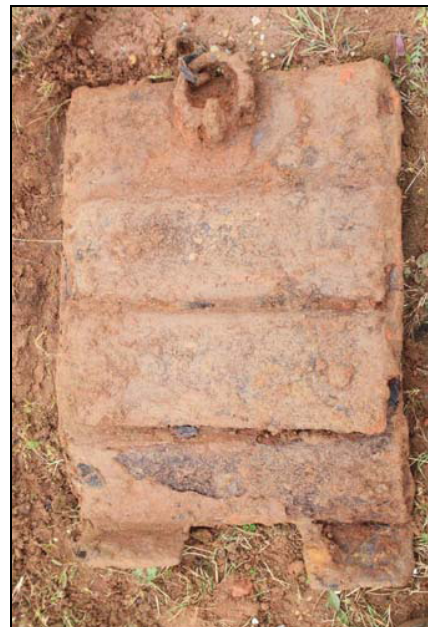
53

*Heavy metal door hung on a chain used to cover one of the archways*

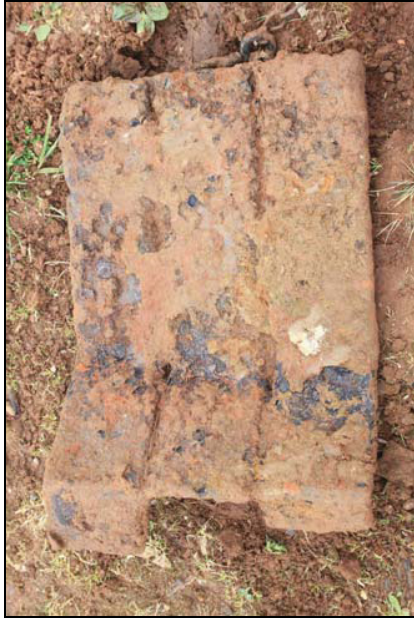
54

*Detail of heavy metal door hung on a chain used to cover one of the archways*

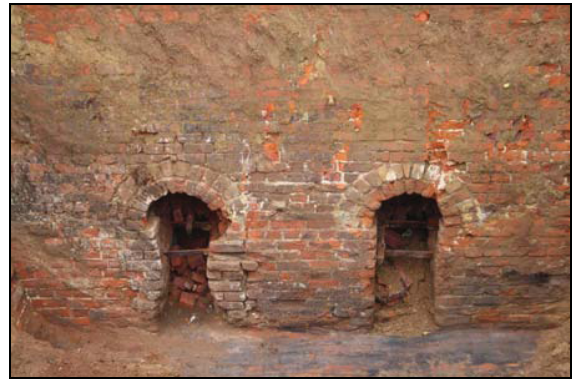
61

*External archways along the south wall of the kiln, taken from the south-west*

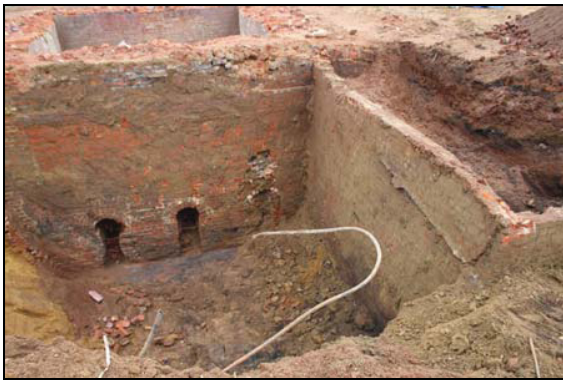
62

*External archways along the south wall of the kiln, taken from the south*

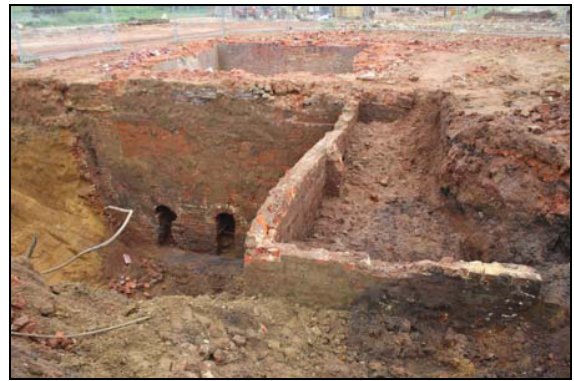
63

*Area to the rear of the kiln, taken from the south-west*

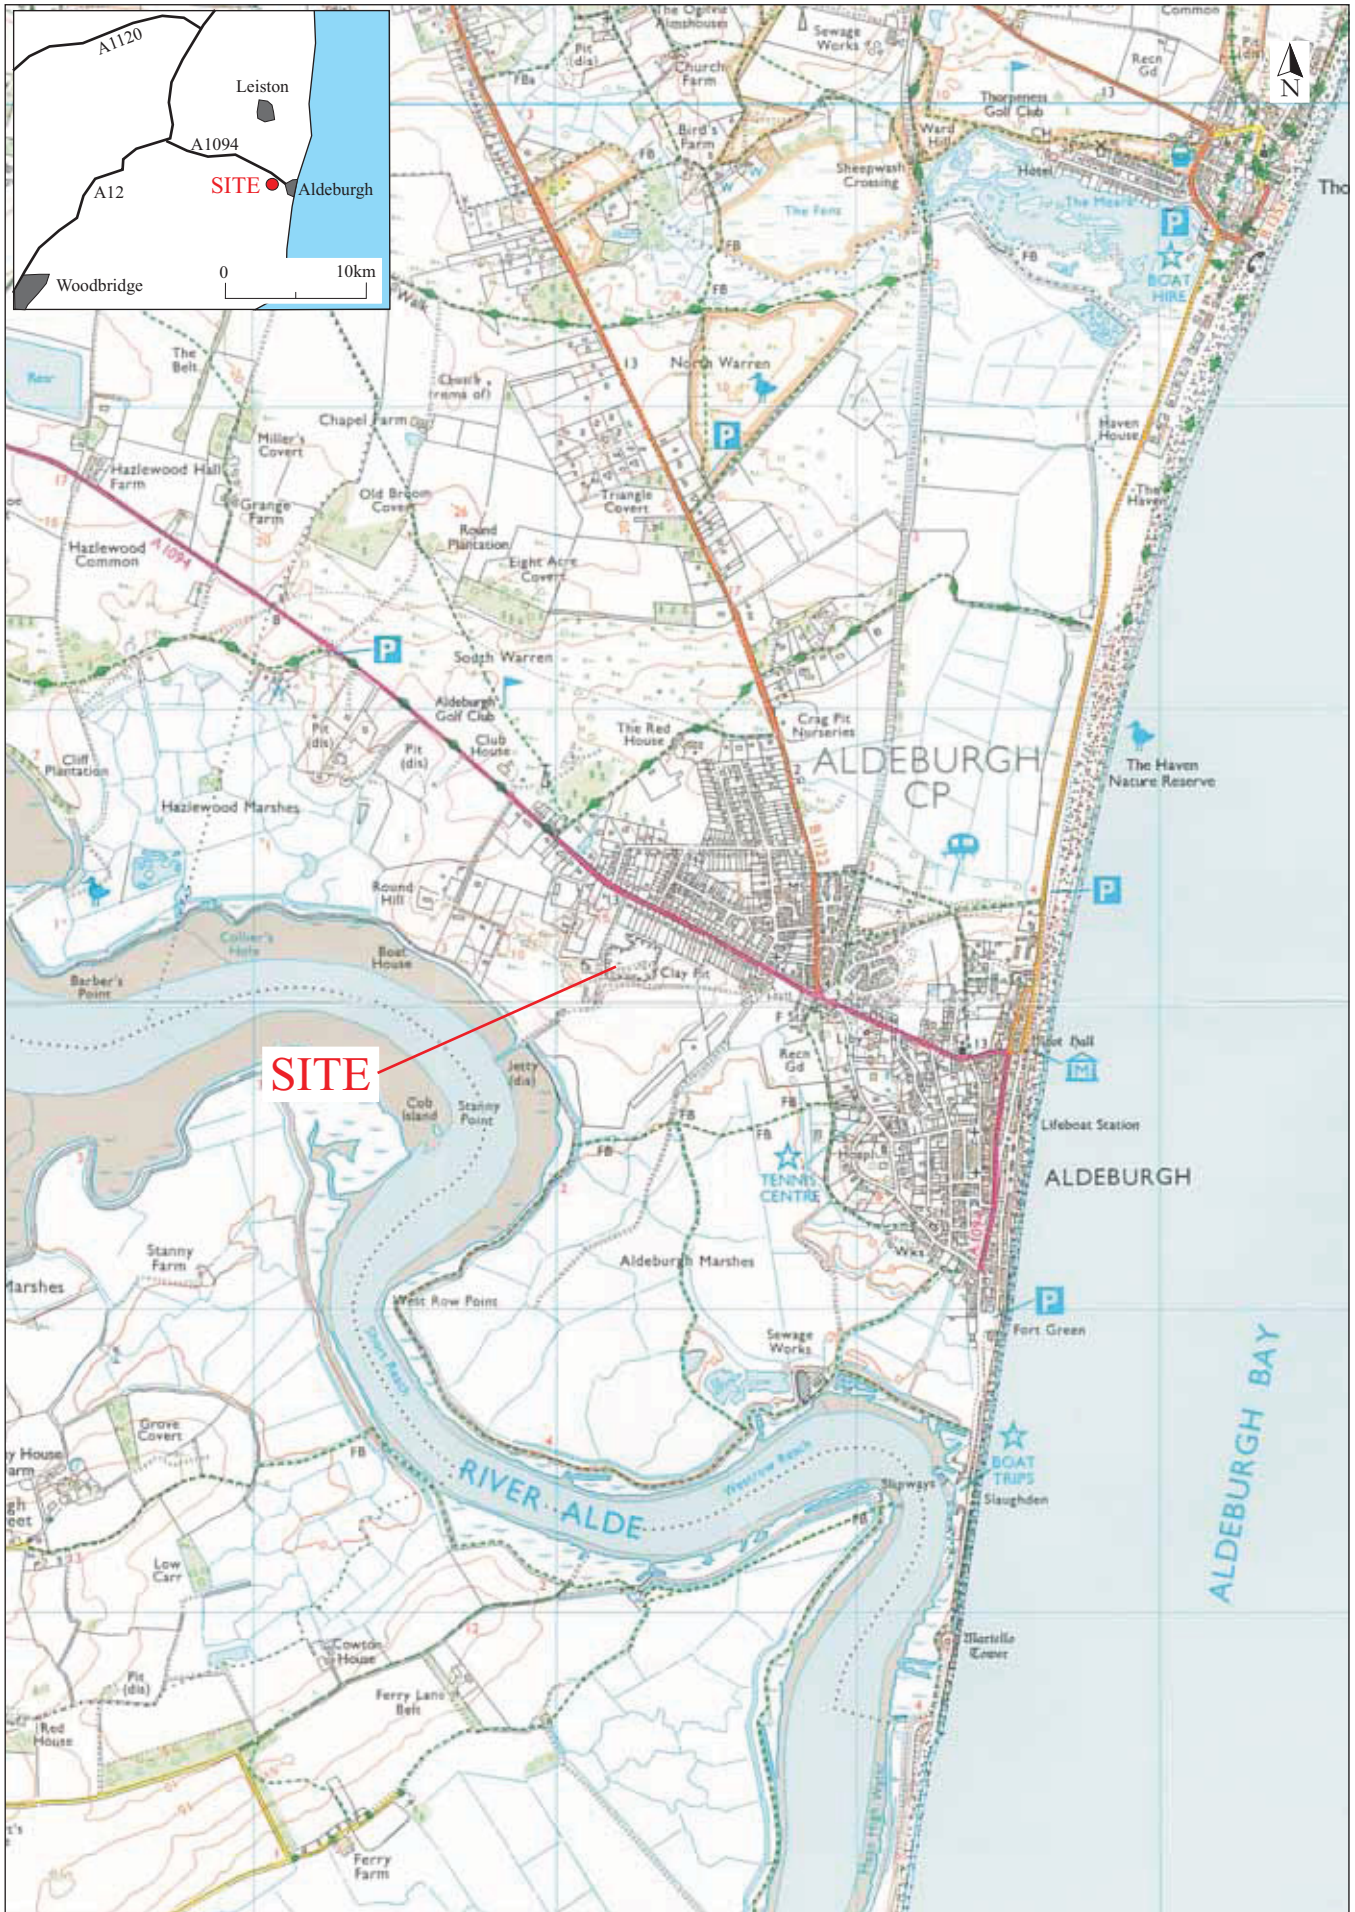
64

*Remains of the 19<sup>th</sup> century 'Suffolk' kiln, taken from the south-east*
