**THE SWAN PUBLIC HOUSE
HIGH STREET, WHEATHAMPSTEAD
HERTFORDSHIRE**

**HISTORIC BUILDING RECORDING
Level 3**

Authors: Dr Lee Prosser BA PhD Lisa Smith BA Kathren Henry	
NGR: TL 17706 13915	Report No. 4458
District: St Albans	Site Code: AS1640
Approved: Claire Halpin MiFA	Project No. 5485
Signed:	Date: 14 November 2013 (Revised 15 th November 2013)

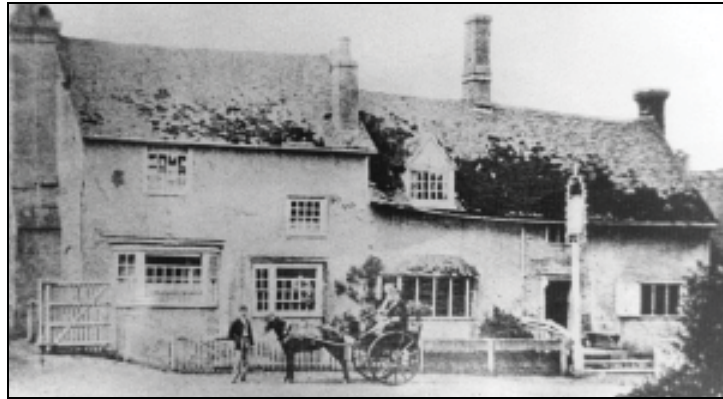
5.31 FF02 occupies the space directly above the bar, and probably formed the original parlour chamber of the medieval building. It is entered from the landing via a four panelled door. It has wide pine floor boards with high ceiling. A built-in cupboard on the south encloses the space below the attic stair. Elements of the medieval timber-framing are visible on the south-east, where the original tie-beam, a straight downward brace and part of the principal post have been left redundant by the raising of the roof by an additional floor (Plate 11). Part of the original wall-plate on the external wall has clearly been truncated to accommodate the existing sash window. A late 19th century postcard of the pub shows this window to be foreshortened, and therefore must have lain below this wall-plate before being extended, thereby sacrificing part of the original frame (Plate 1).

Plate 1 Late 19th century postcard of the Swan

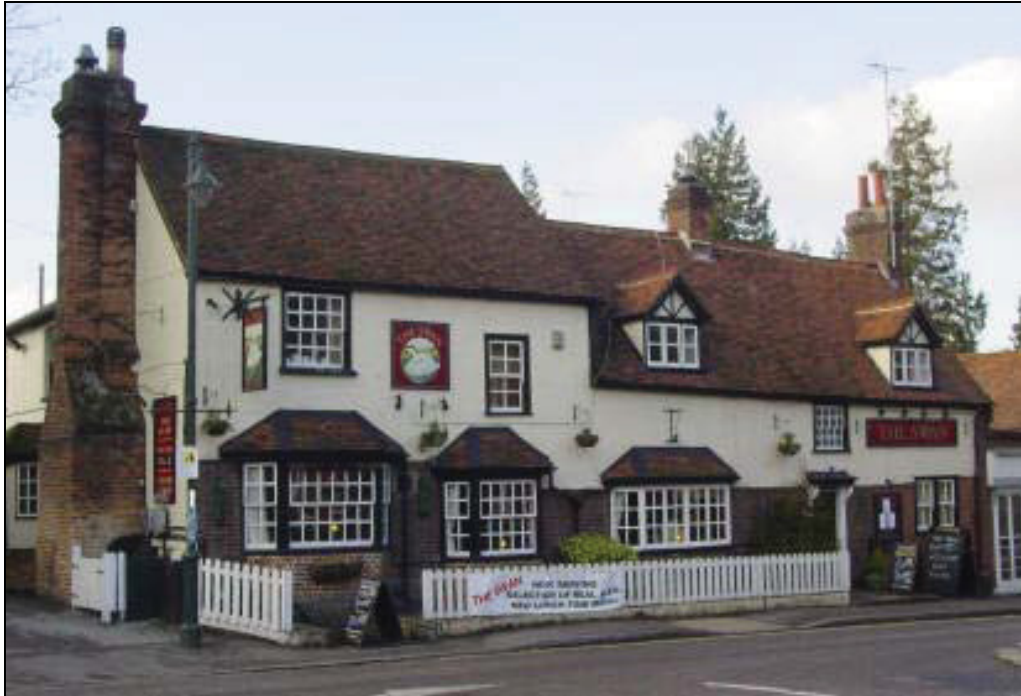
5.1 The Swan enjoys a prominent position on the western side of the High Street at the junction with Marford Road (Plate 3 & 4). The building has undergone a series of extensions and alterations which are clearly expressed in the existing form and layout.

Plate 3 The Swan prior to the fire of July 2013

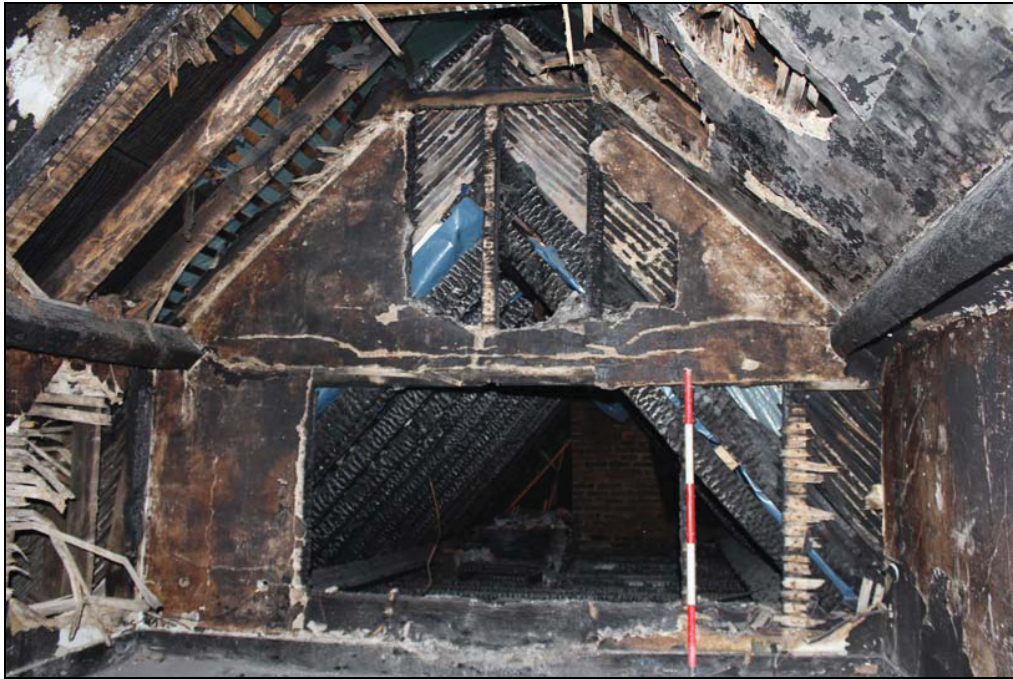
5.46 The roof at this level is of clasped side-purlin form, comprising simple fairly waney oak rafters rising to a ridge-board (Plate 17). Thin hand-split laths and rough lime mortar have been used to ceil the rooms. A gap offers a view into the roof of the south-western range, which is entirely of softwood construction in typical Victorian style.

Plate 17 View into roof space from SF01, taken from the south (DP 86)

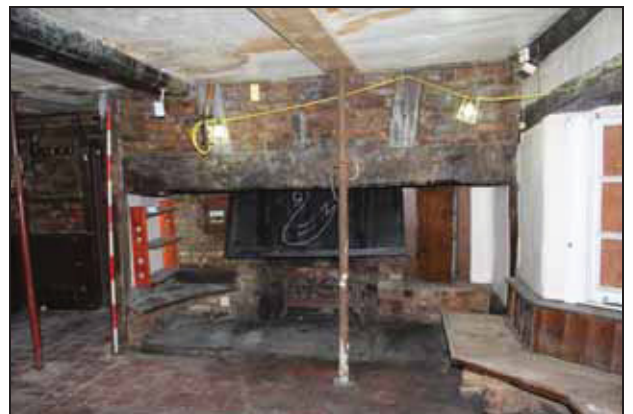
29

Bar, lower bar area, GF01, taken from the north-east

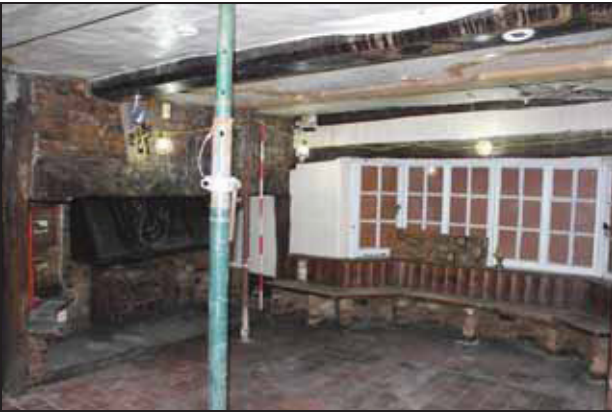
30

Large inglenook fireplace, GF01, taken from the south-east

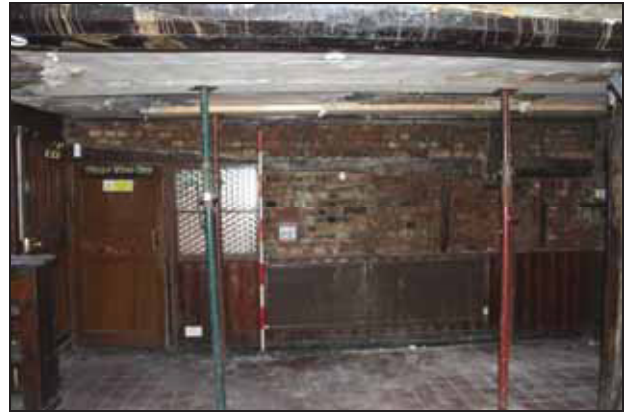
31

Large bay window adjacent to large inglenook, GF01, taken from the south-west

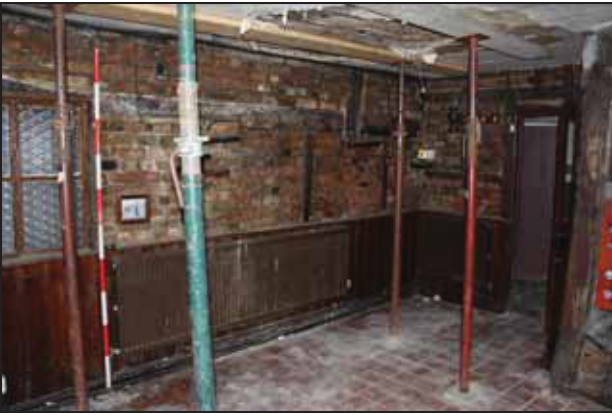
32

Rear wall of GF01, taken from the east

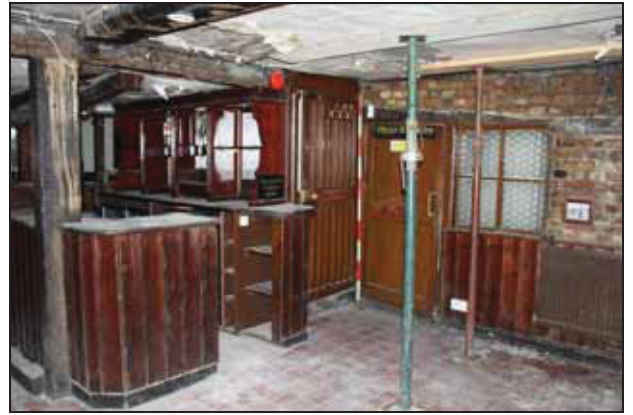
33

Rear wall and access to corridor beyond, GF01, taken from the south-east

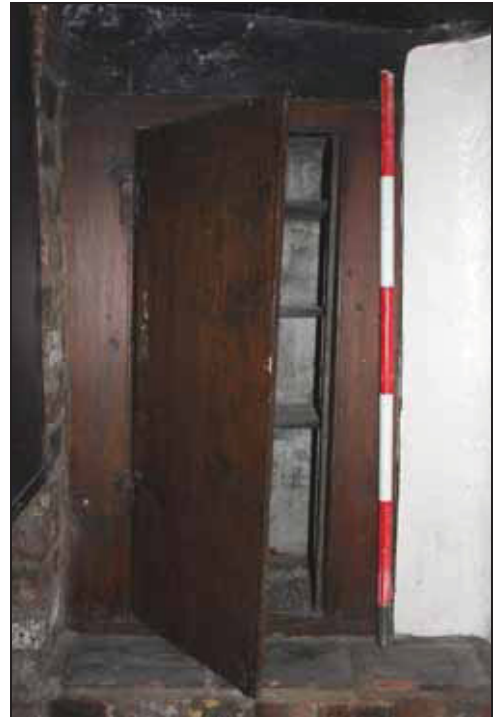
35

Small cupboard within inglenook to the left of the fireplace, GF01, taken from the south

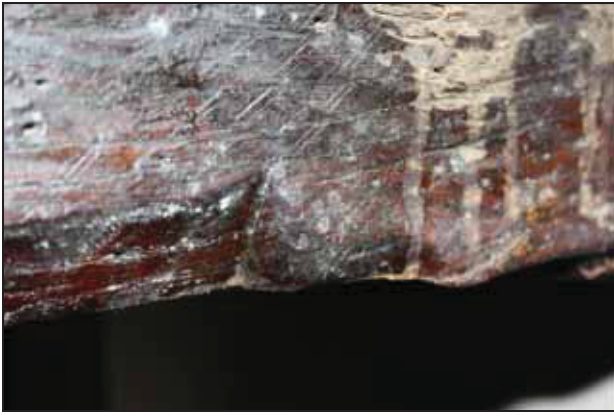
36

Small cupboard within inglenook to the right of the fireplace, GF01, taken from the south

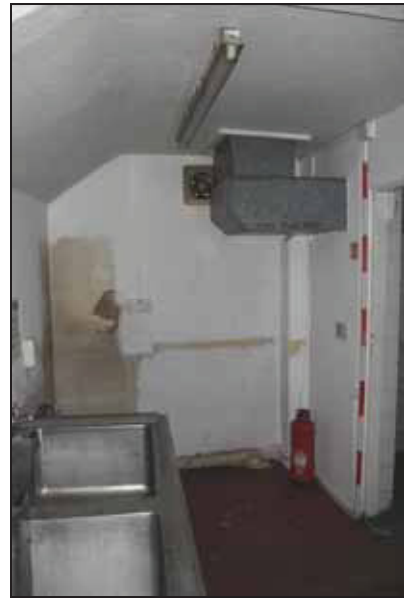
45

GF05, taken from the north

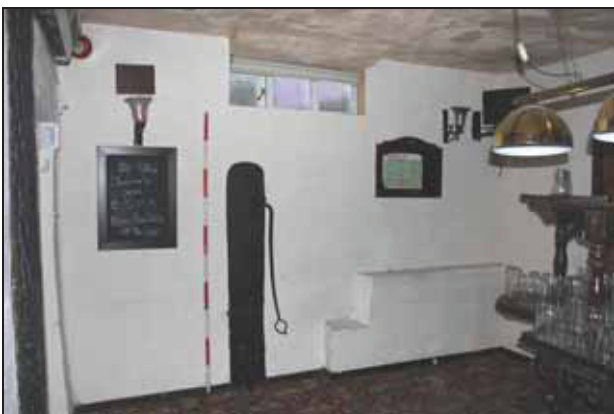
46

GF05, taken from the south

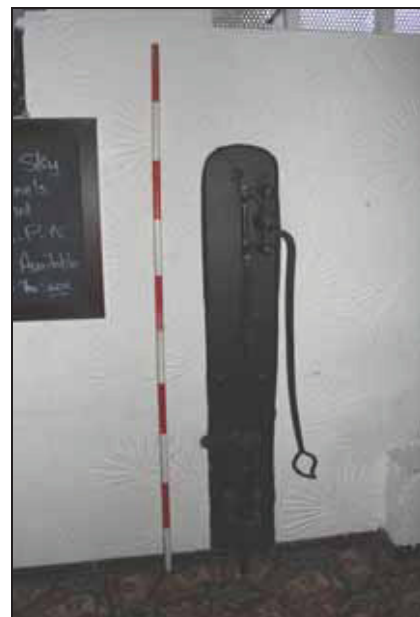
47

GF06, taken from the north-east

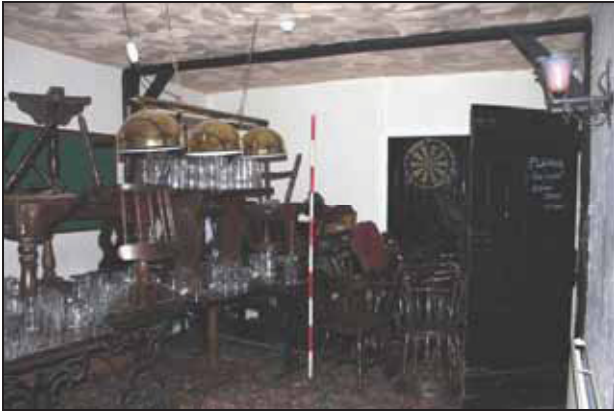
48

Water pump, GF06, taken from the north-east

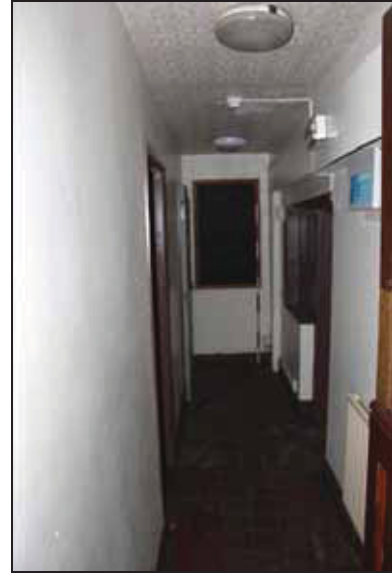
49

GF06, taken from the south-east

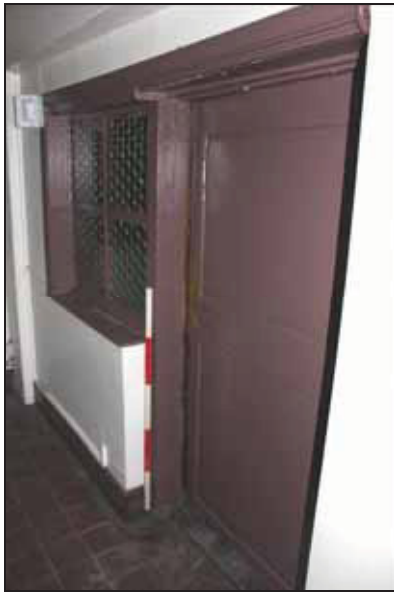
50

Corridor leading to w/cs within GF07, taken from the south

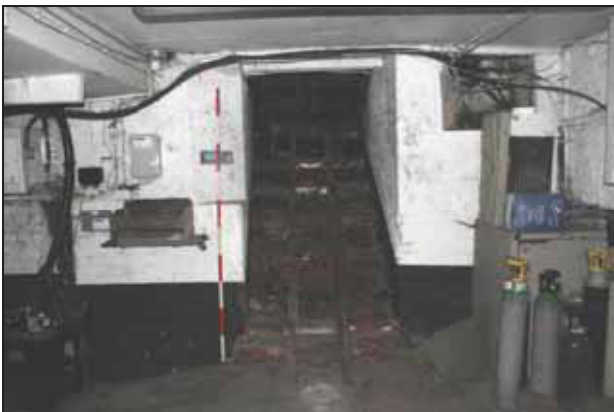
52

BF01, taken from the north-west

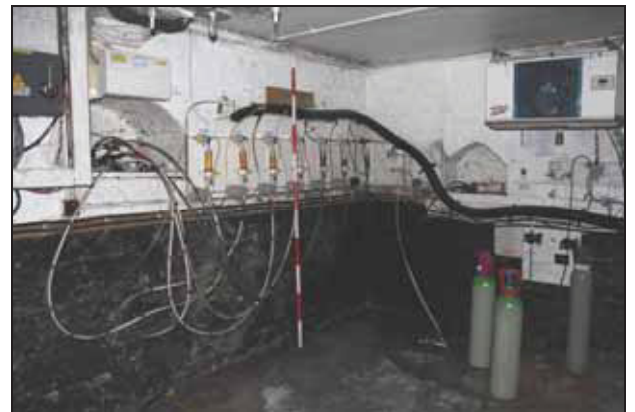
53

Barrel run, BF01, taken from the west

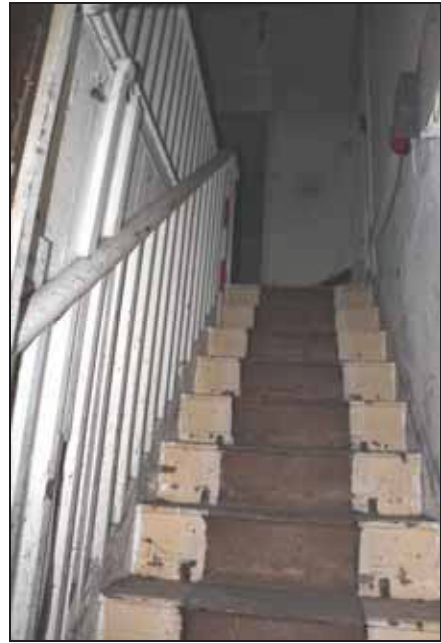
55

BF01, taken from the south-east

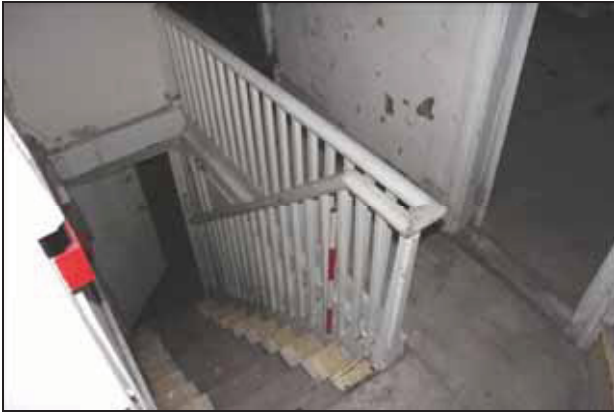
56

Stair leading from GF02 to first floor level, taken from the north

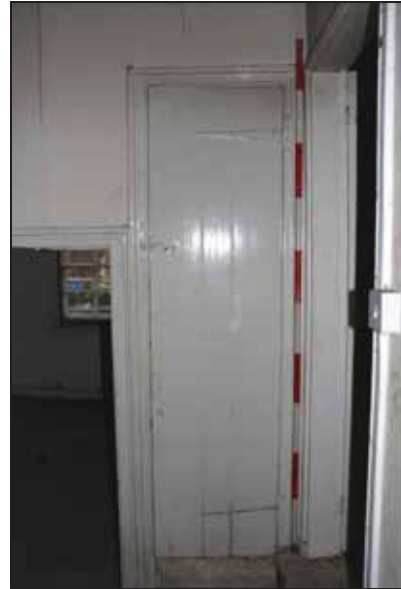
57

FF01, taken from the south-west

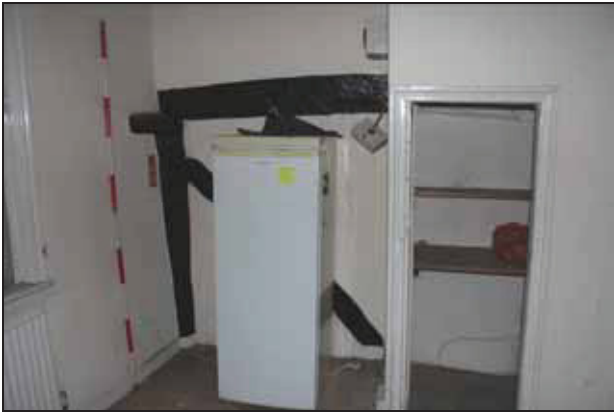
60

FF07, taken from the south-east

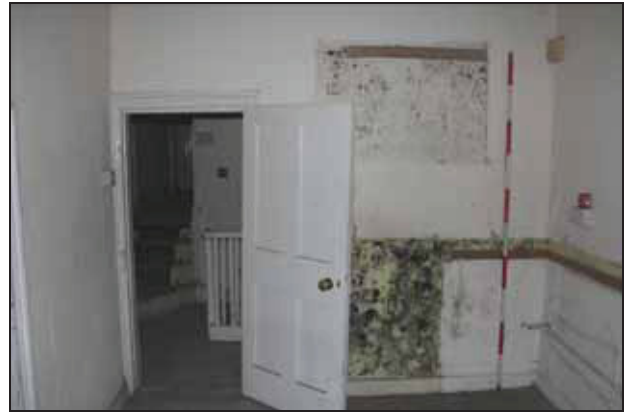
61

FF02, taken from the north

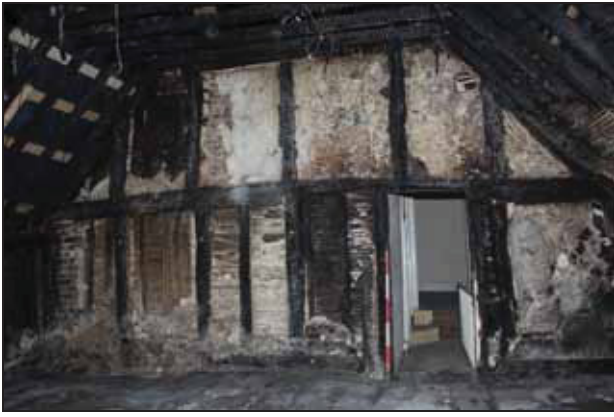
66

FF10, taken from the east

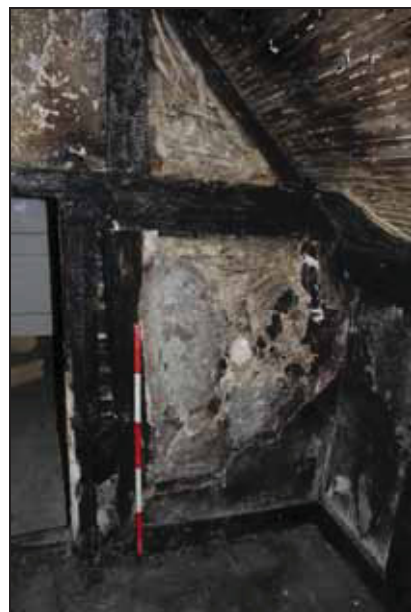
71

North elevation, FF03, taken from the south

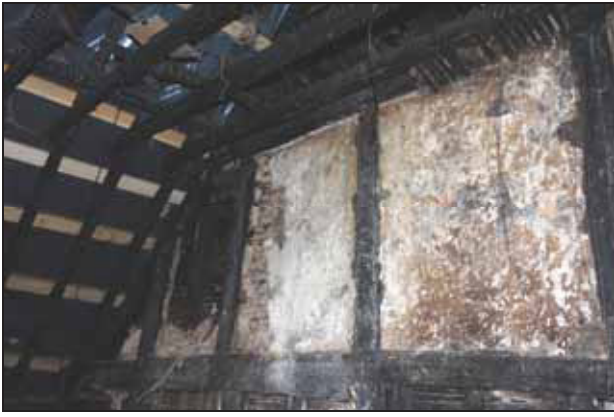
72

Wattle and daub panels to the south elevation, FF03, taken from the north-east

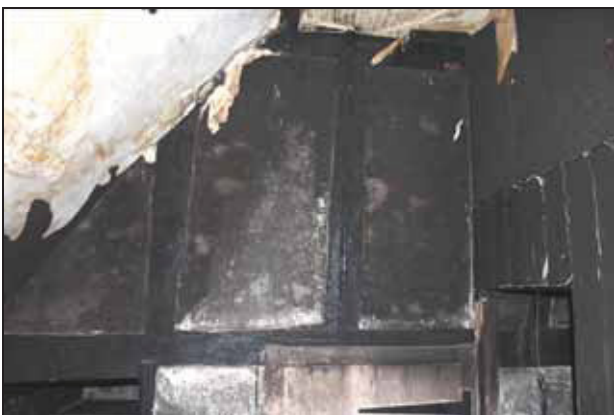
76

Stair well leading from FF04 to GF04, taken from the south-east

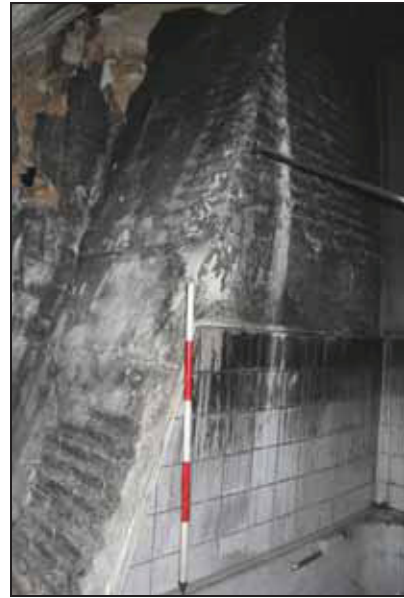
79

Brick chimney stack, FF04, taken from the north-west

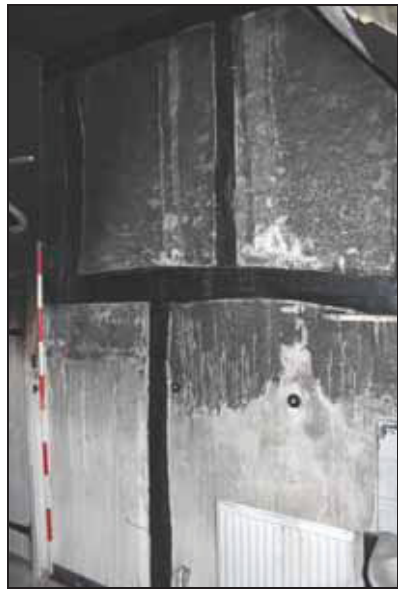
80

Brick chimney stack, FF05, taken from the north-east

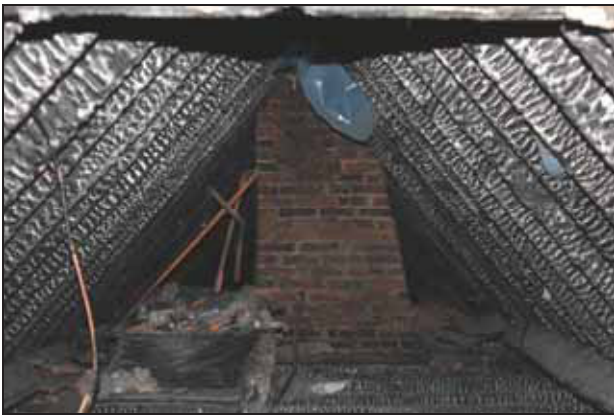
92

Roof structure above the rear range, SF02, taken from the east

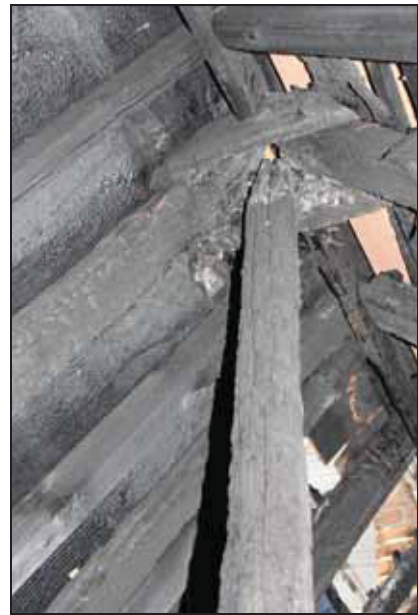
93

Roof structure above FF03, taken from the south
